CORROSION AND RELATED ISSUES FOUND DURING INSPECTIONS

Michael Hollis

NJDEP

ASTSWMO Emerging Fuels Task Force

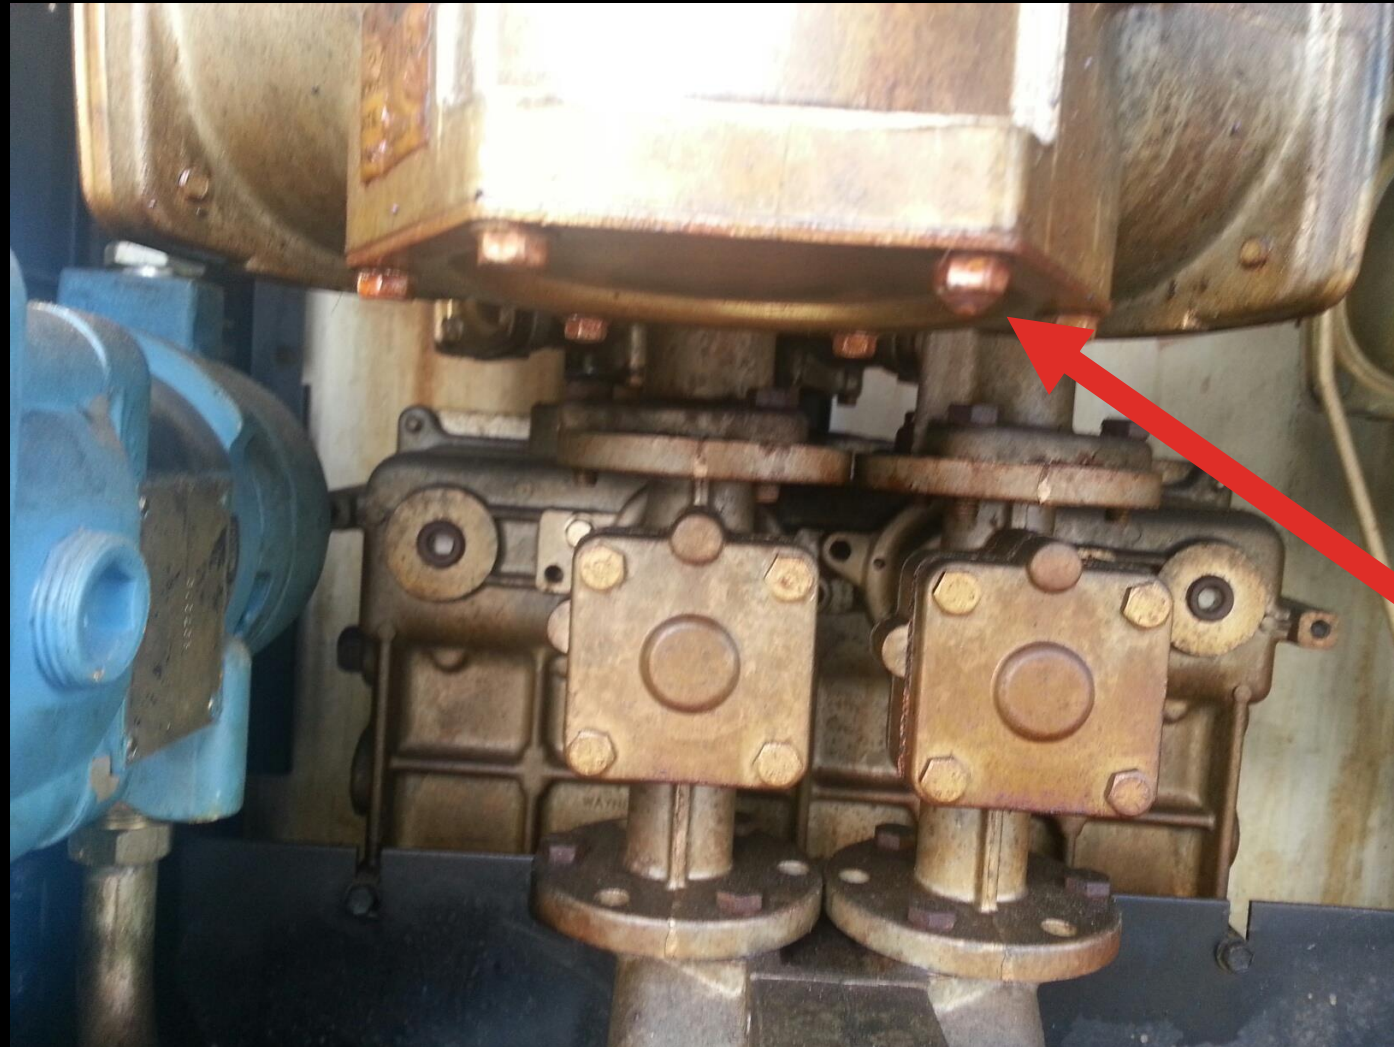
LEAKING DISPENSER METER

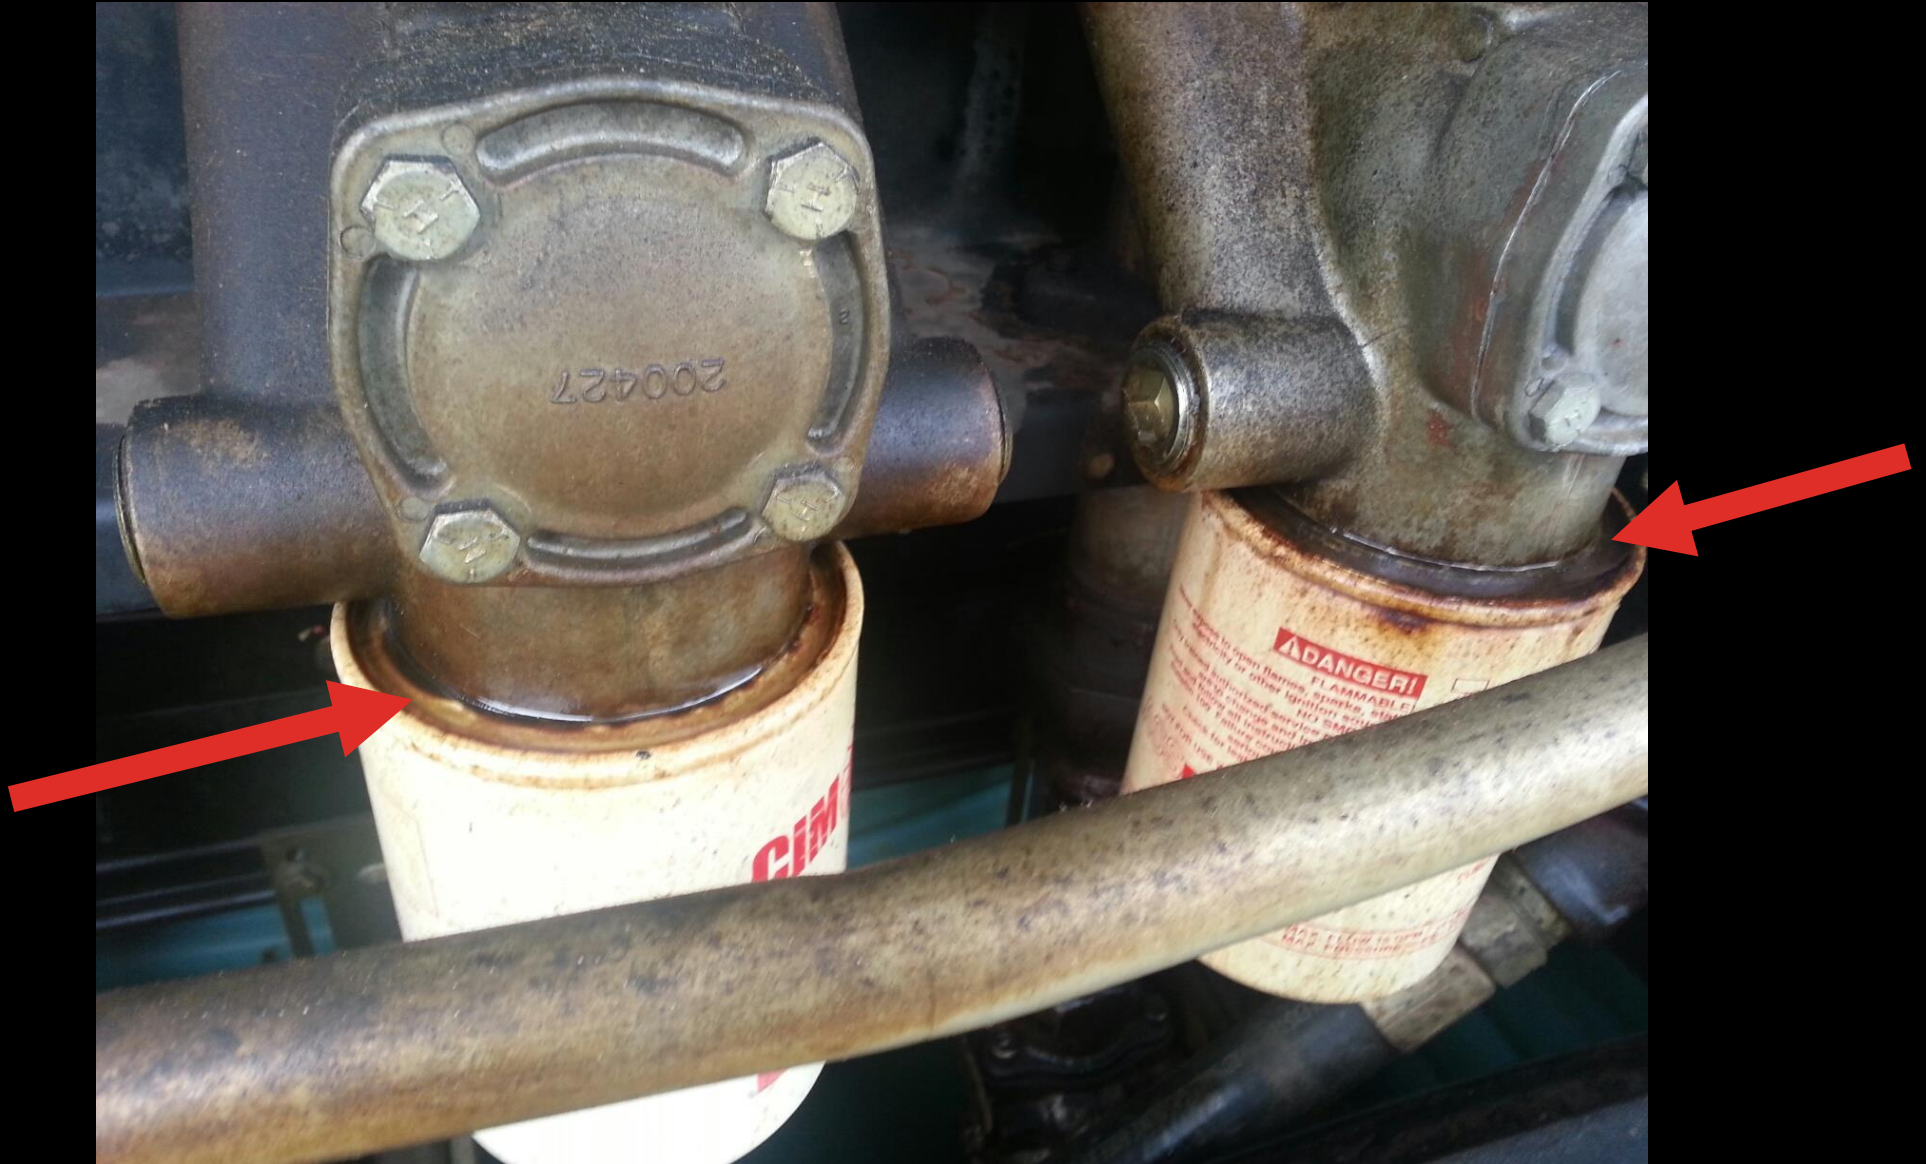
LEAKING FILTERS

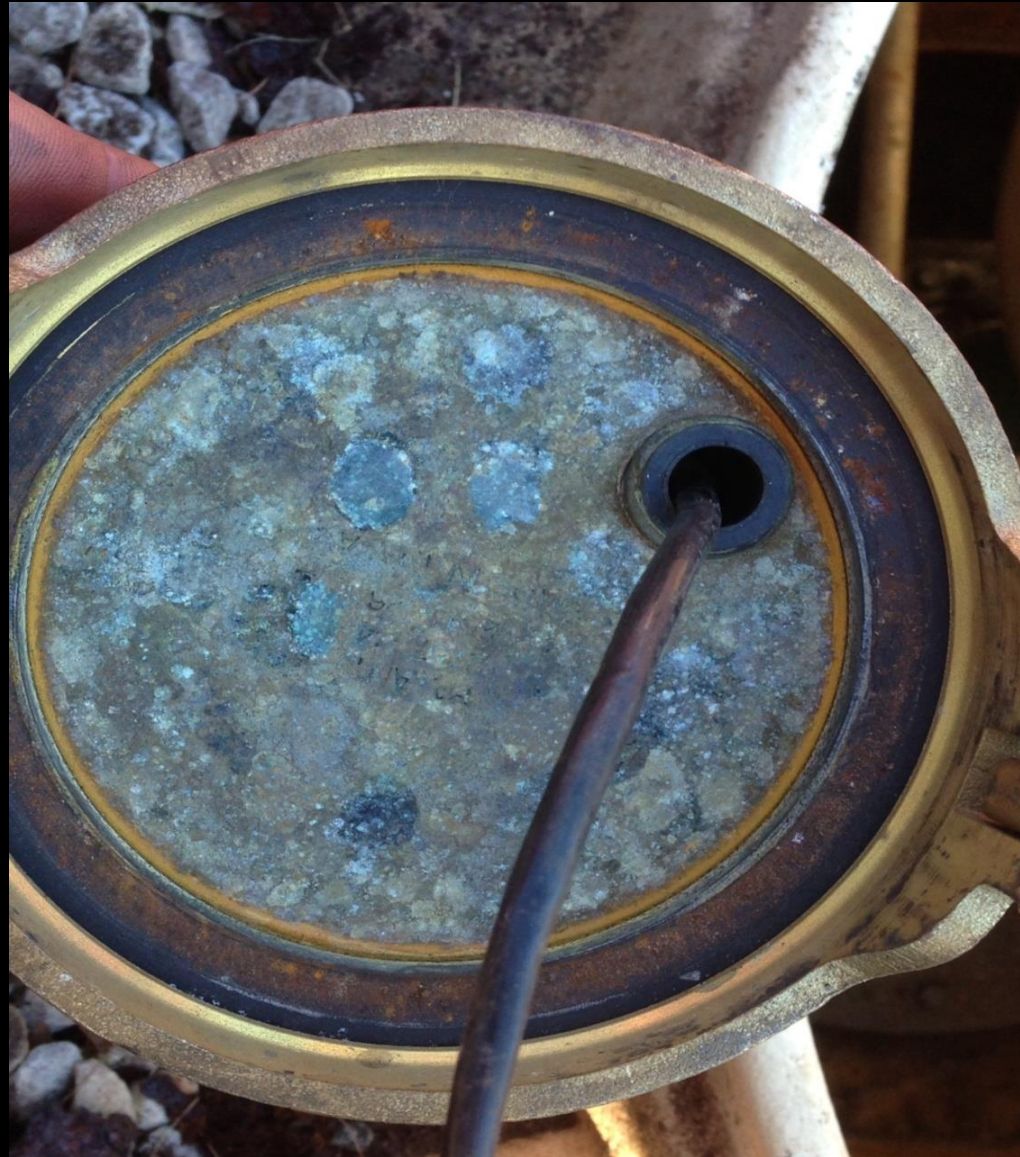
CORROSION UNDER TOGGLE CAP

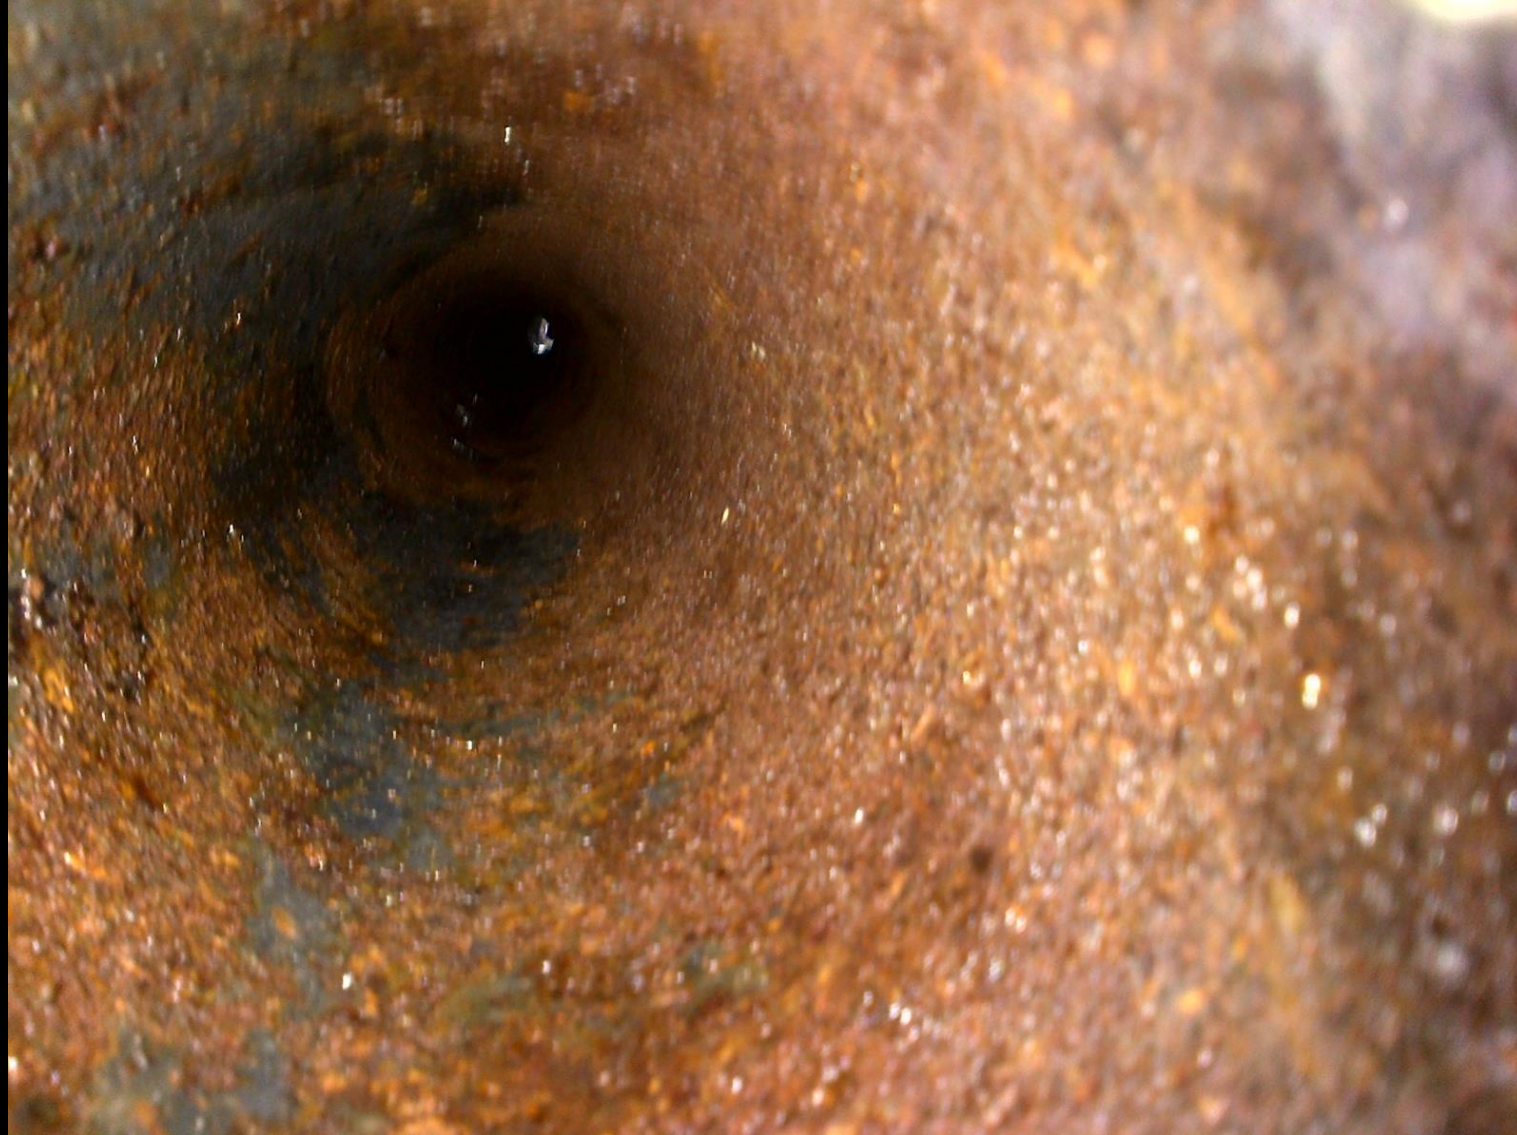
CORRODED RISER

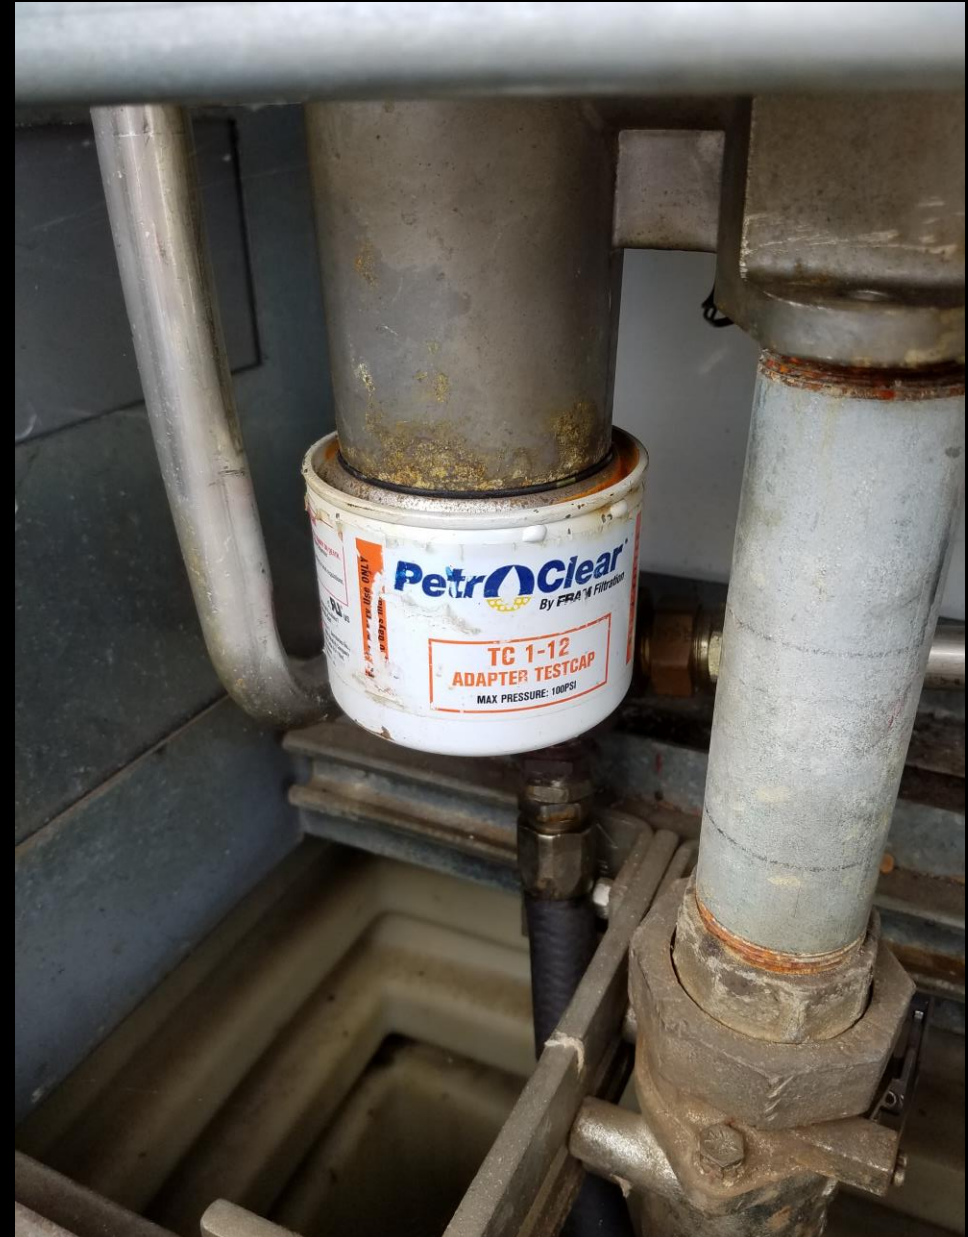
THIS IS NOT A FILTER!

This O/O had trouble dispensing due to clogged filters. So rather than investigate the cause, he decided to not use filters at all, and replaced them with test caps. His problems were much worse than he thought...

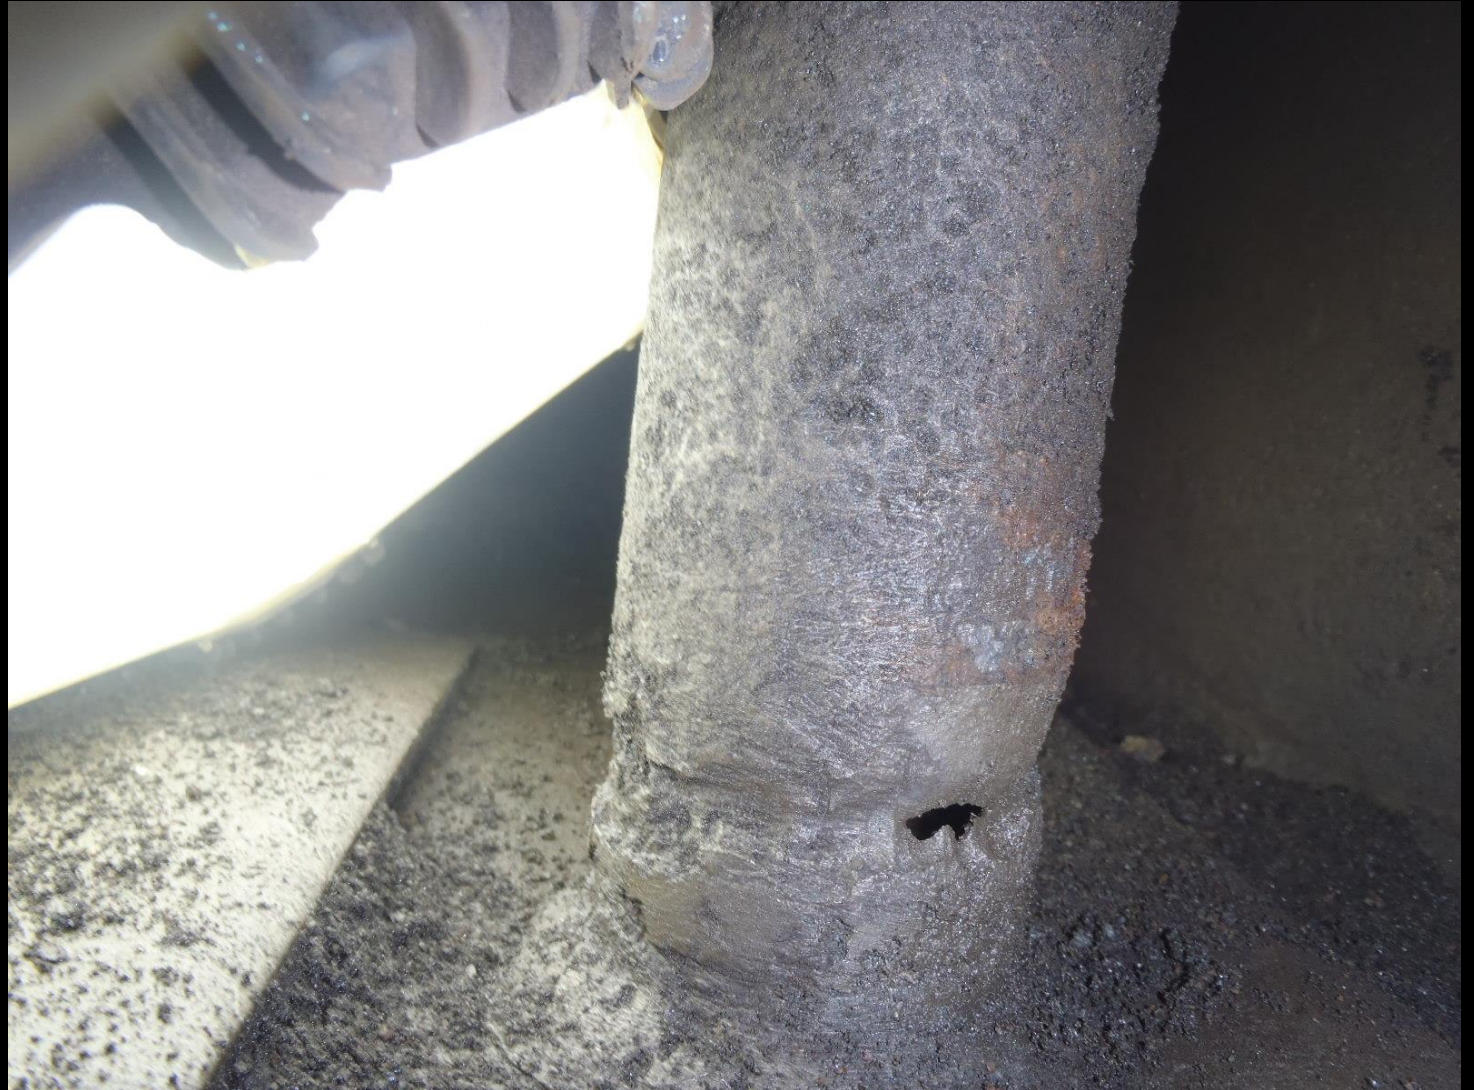
CORROSION HOLE THROUGH ANNULAR RISER

...He had a significant issue with microbes and corrosion. His annular sensor was in alarm due to this corrosion hole at the bottom of his riser. This tank was subsequently removed.

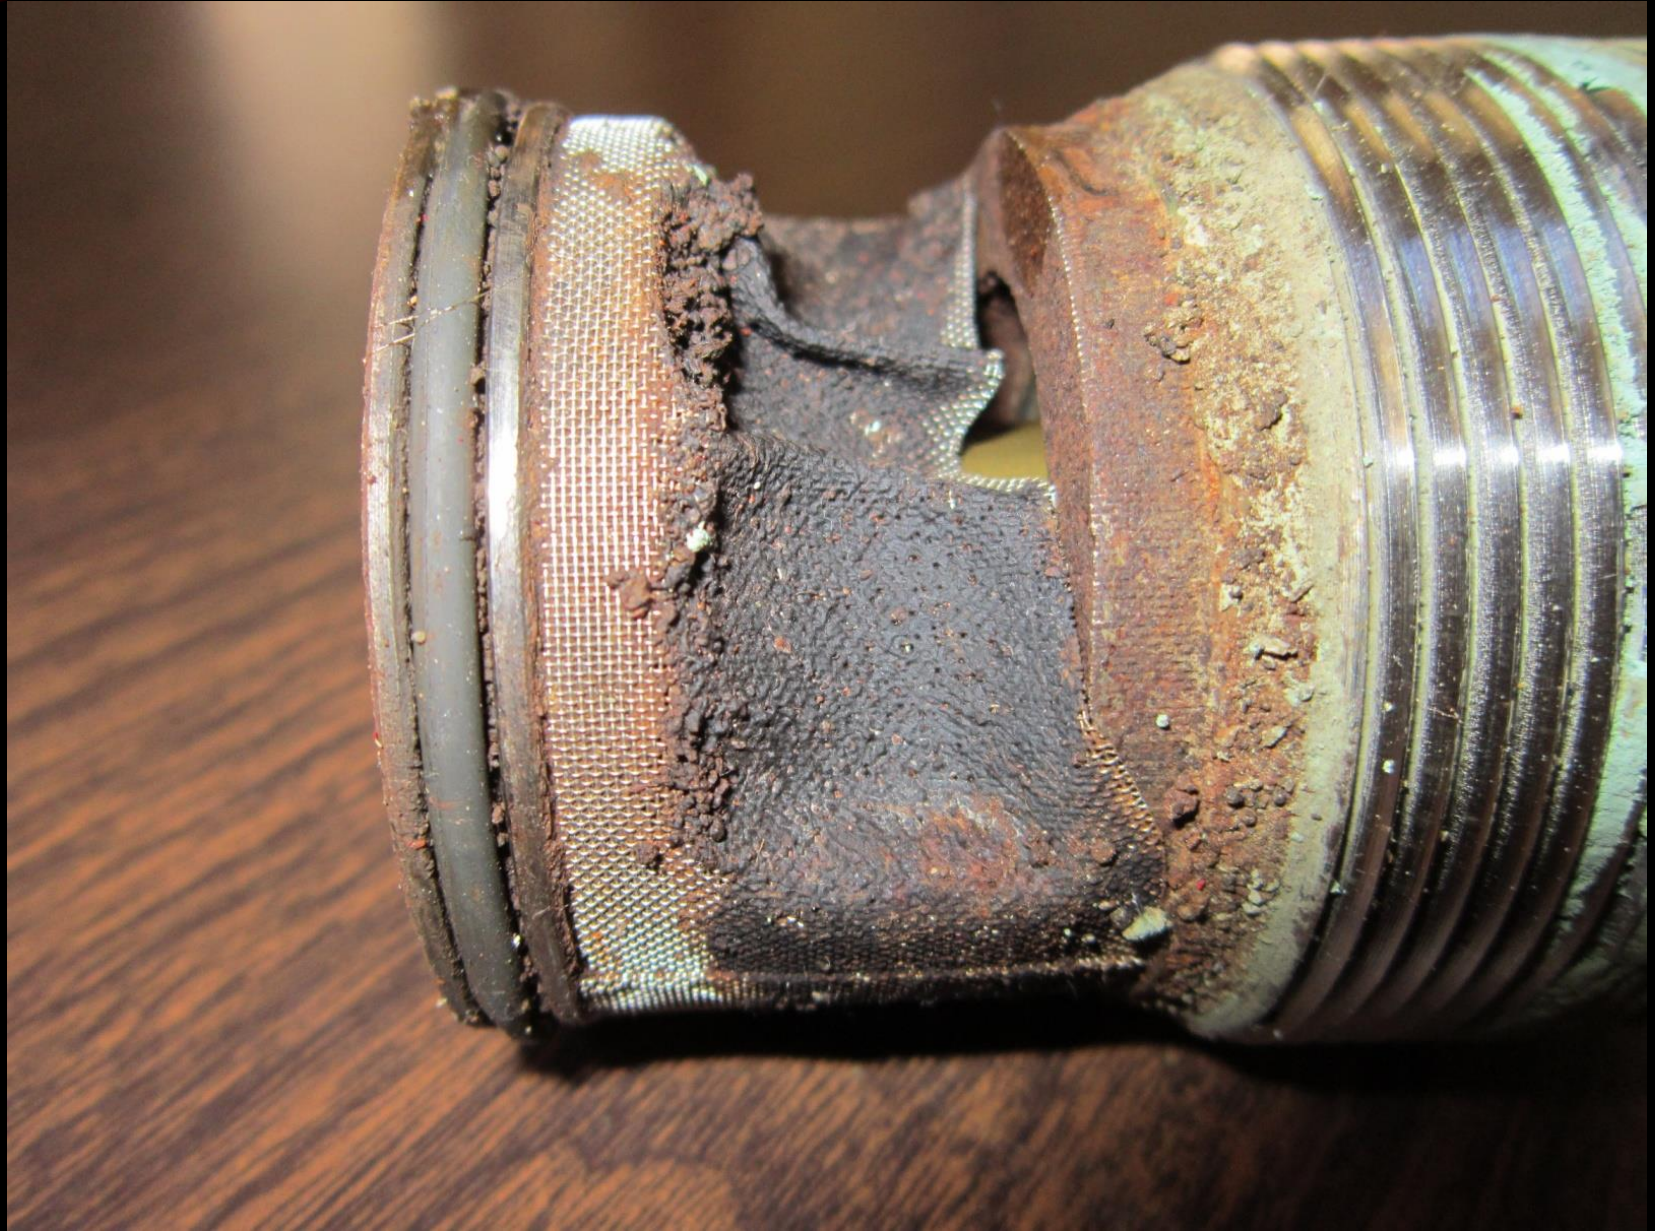
DAMAGED PLLD

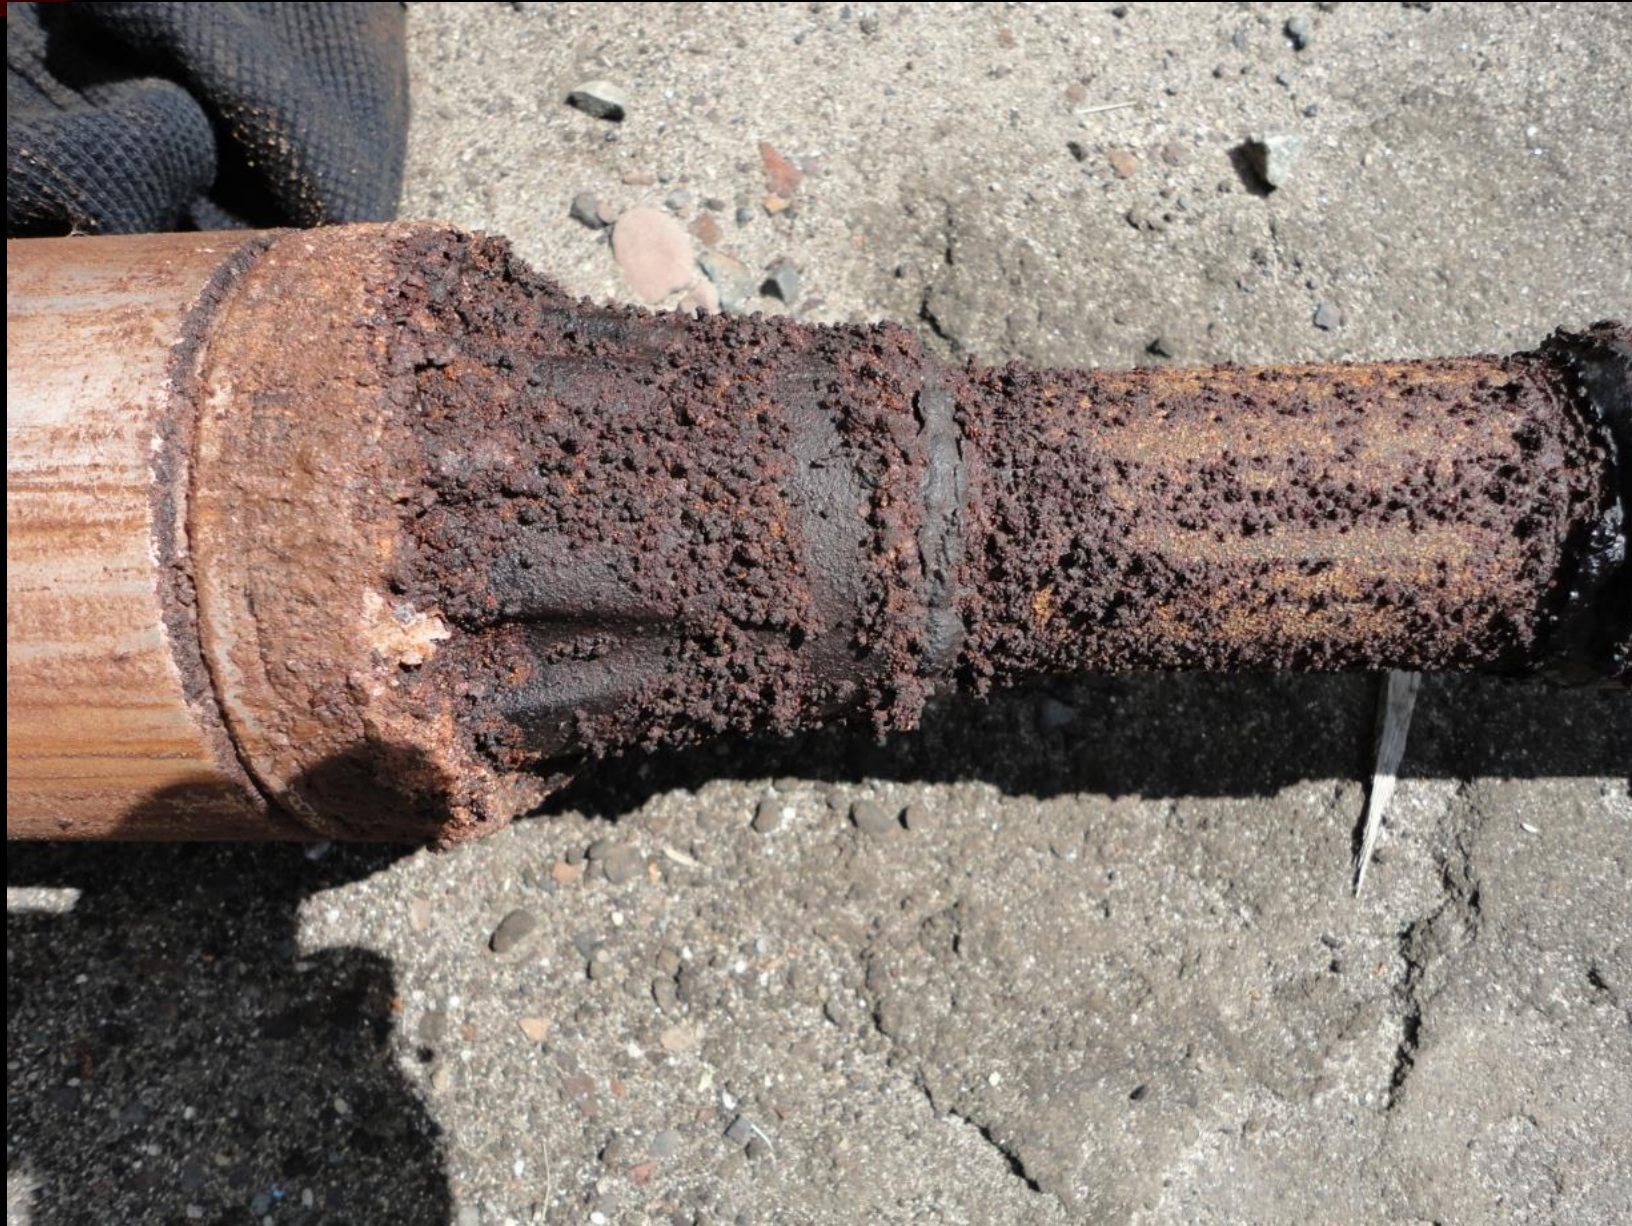
STP CORROSION

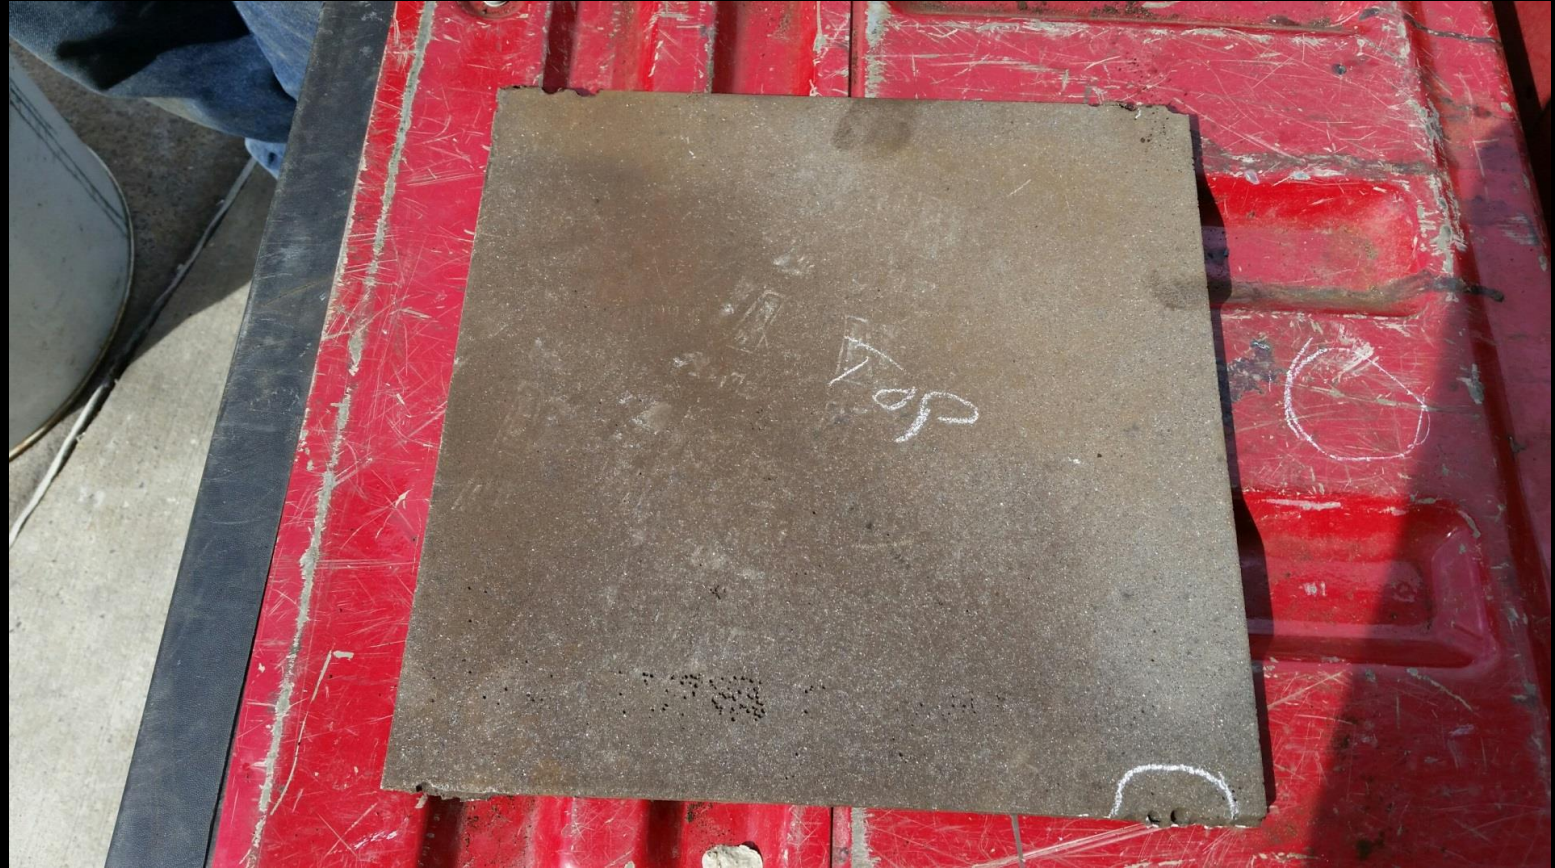
TOP OF STRIKE PLATE

This is a strike plate from beneath the fill of a 7 year old fiberglass-coated steel tank that began with a small amount of water in the annular space that turned to diesel a few weeks later...

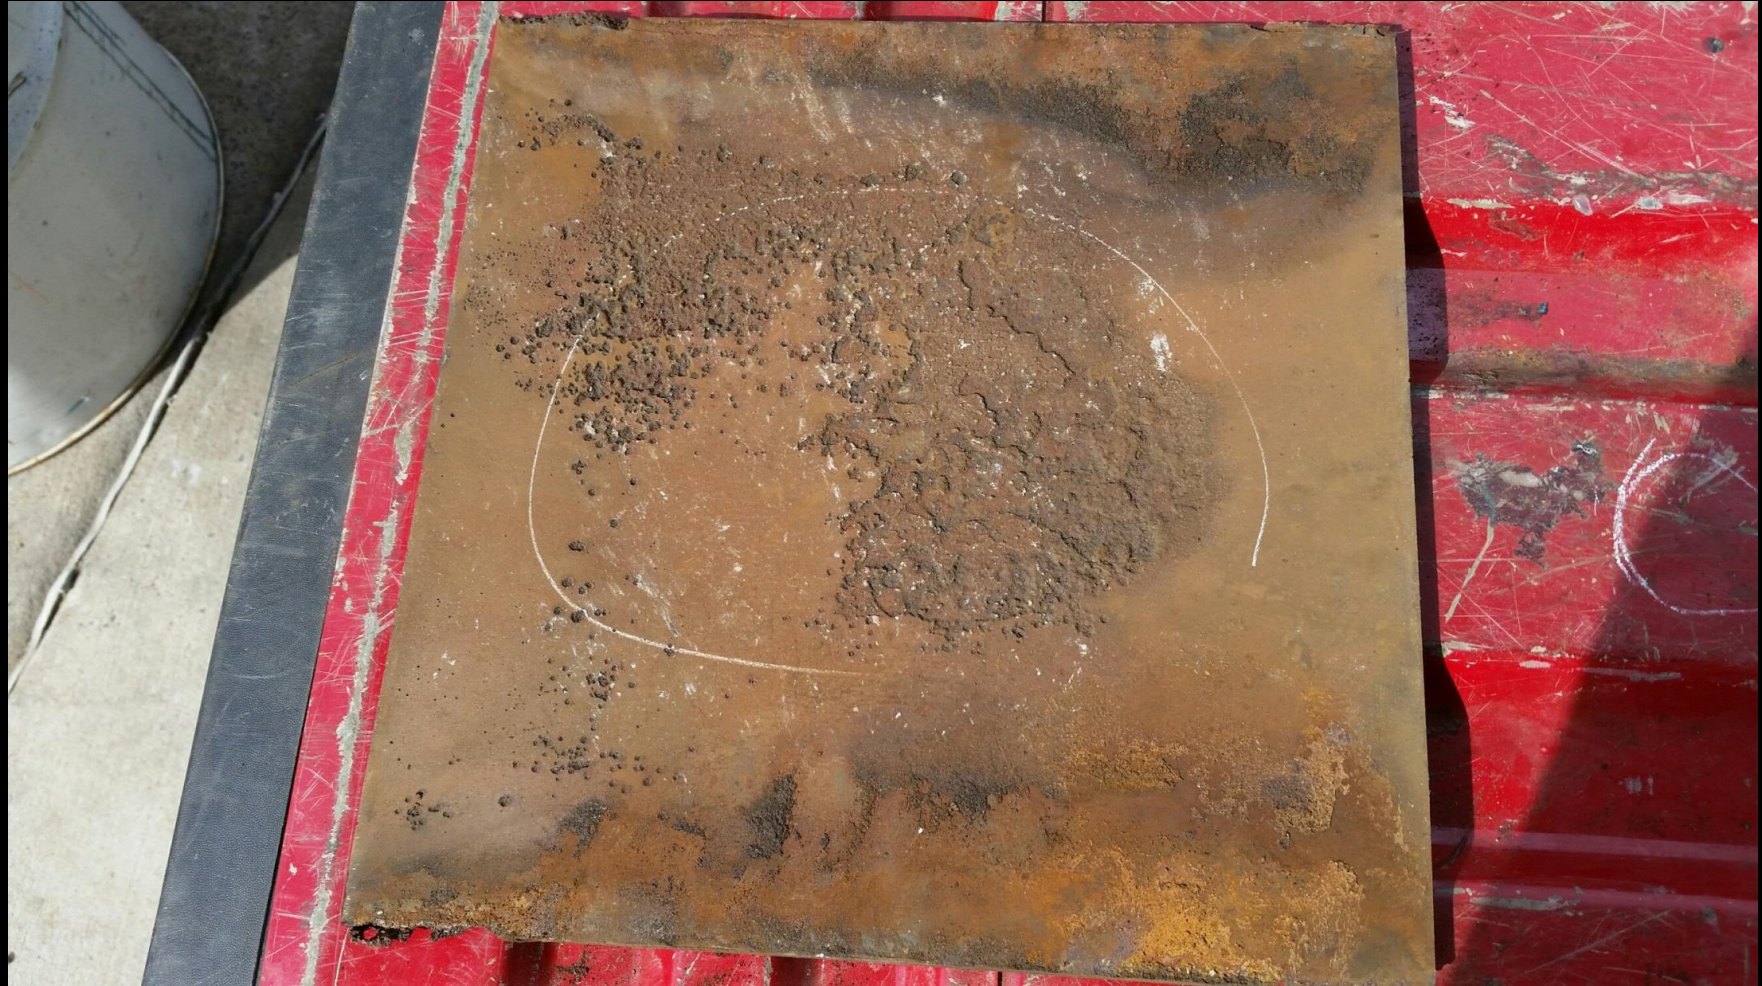
BOTTOM OF STRIKE PLATE

The corners of the plate were no longer welded to the bottom, and the inner steel wall of the tank was pitted much like the bottom of this strike plate. The liquid from the tank bottom was seeping into the annular space.
