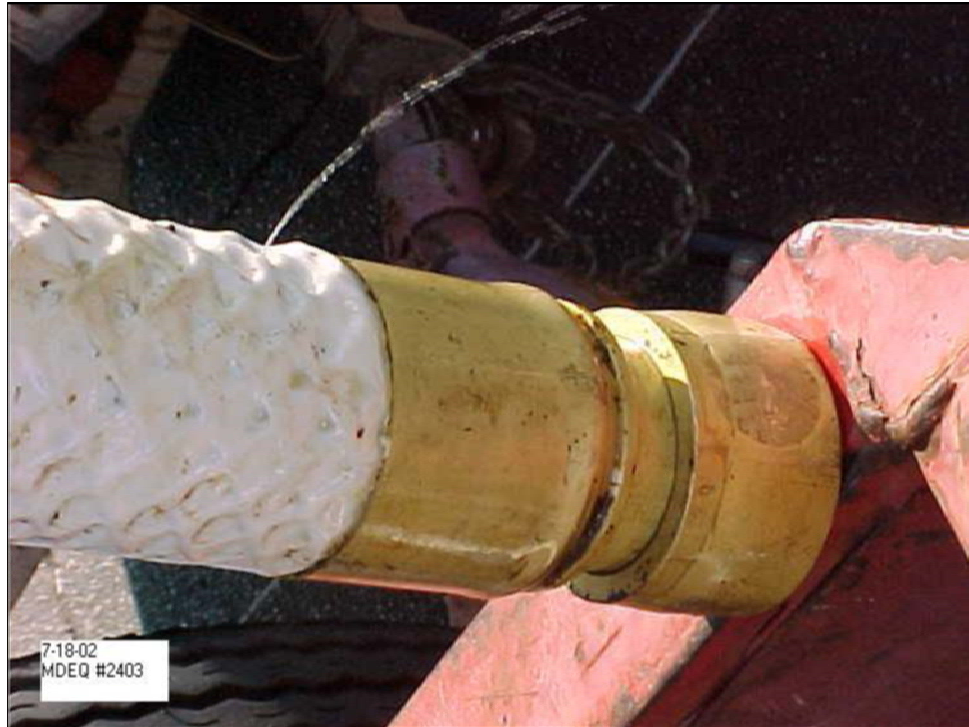
Fuel sometimes became trapped within the layers of Enviroflex pipe. In this photo, fuel is draining out of a pinhole in the outer covering even after the piping itself has been emptied of fuel.

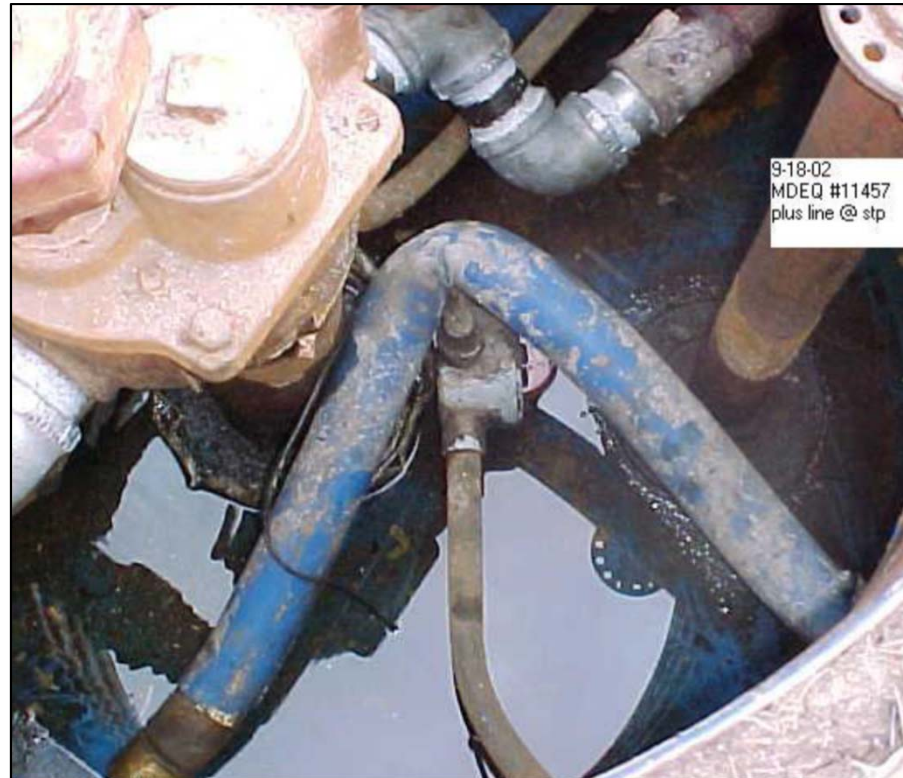
Omniflex piping also had a tendency to swell and increase in length, producing kinks that exceeded the allowable bend radius of the pipe.

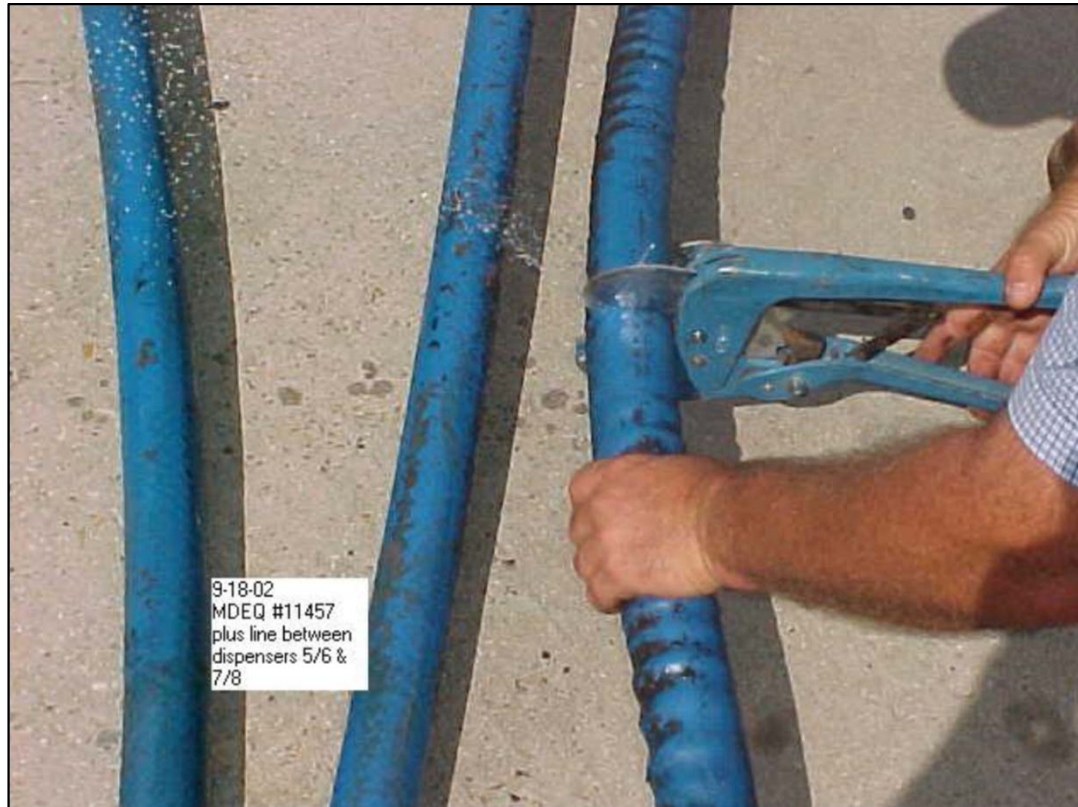
Product leaking through the primary pipe sometimes became trapped between the primary and secondary walls of Omniflex. In this photo, fuel is spraying out of the interstitial space between the walls of the pipe as the pipe is cut.
