Case Study- Release at a Wisconsin High-Throughput Facility

Greg Bareta, PE
Engineering Consultant
Wisconsin Department of Safety and Professional
Services-DSPS
Bureau of Petroleum Products and Tanks
(608) 267-9795
greg.bareta@wi.gov

Facility Background

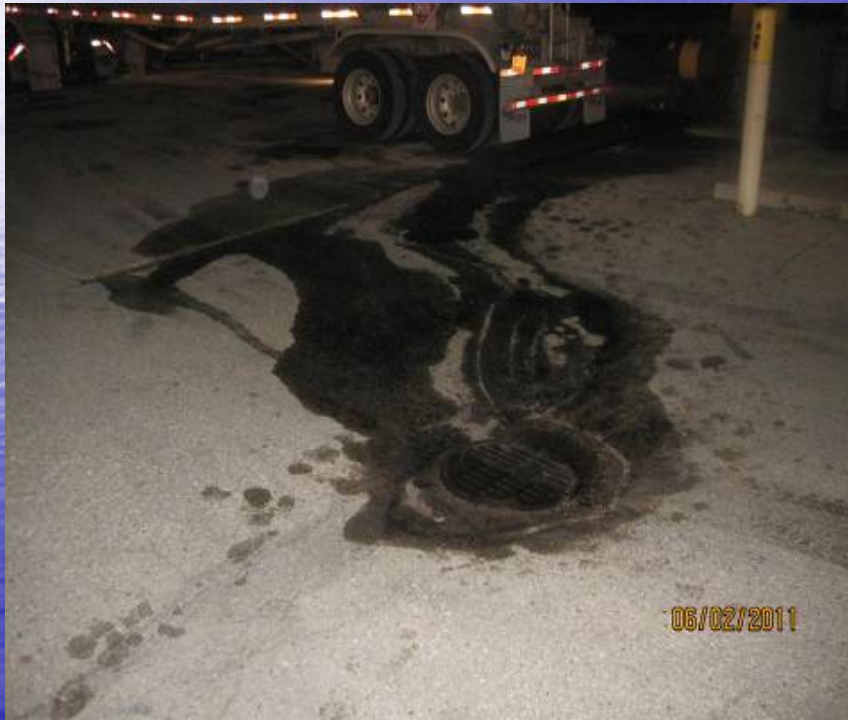
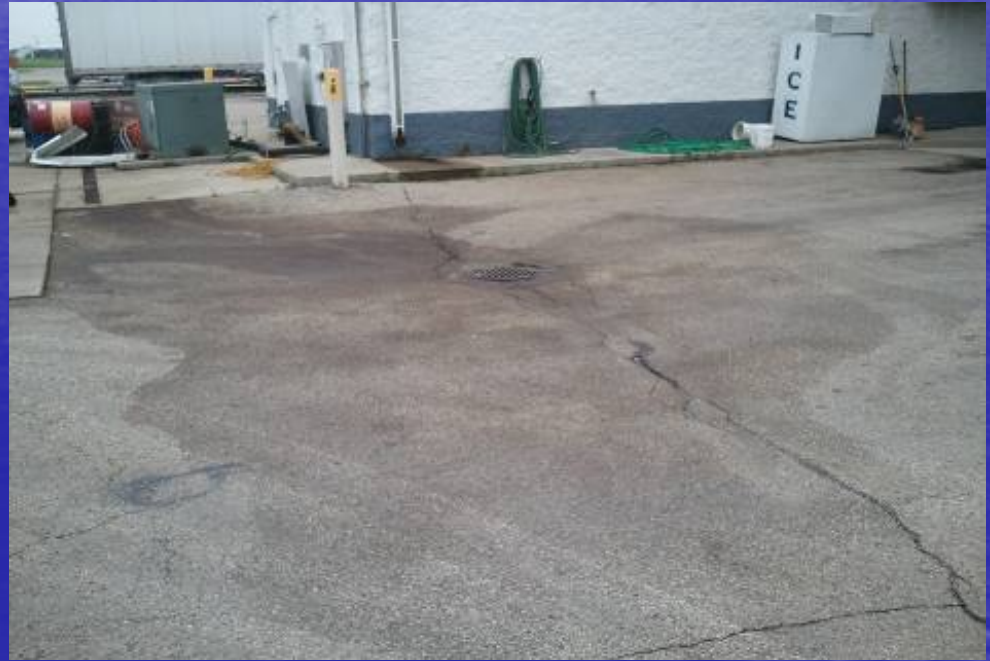
Product staining from trench drain overflow during tank backfill draining

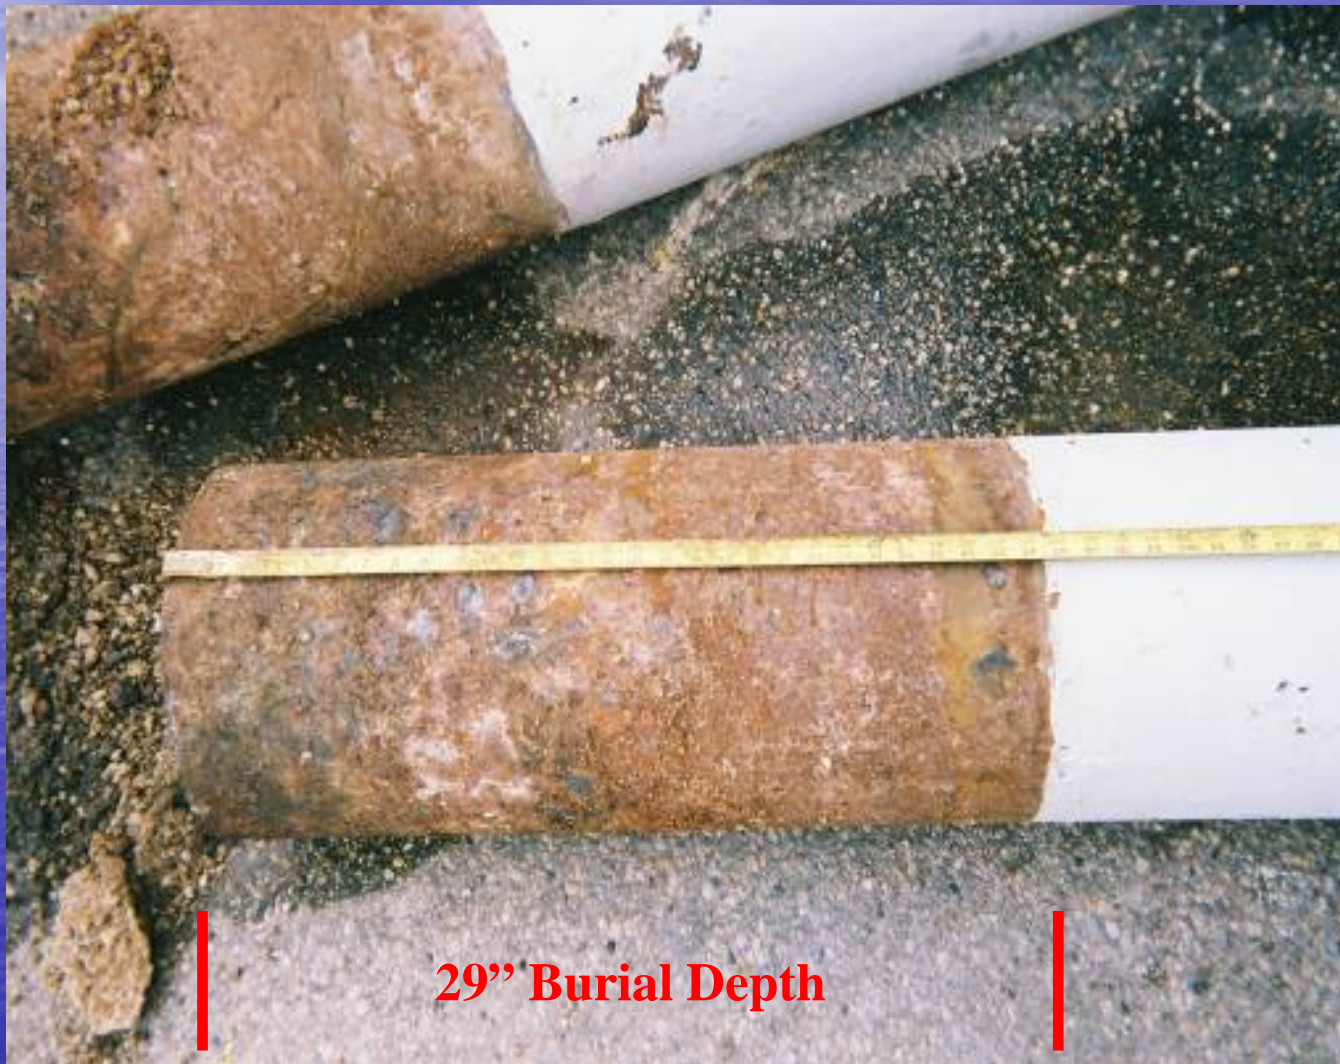
Collision Post Depth

- Poor construction practices.
 - below-grade portion of the bollard was approximately 29-inches deep; WI required depths are at least 36-inches.
 - 10-inch bollard too close to the product piping, approximately 4-inches. PEI/RP 100 minimum of 6-inches wide with no obstructions placed in the trench.
 - The bollard diameter itself was probably too large for its intended purpose; typically dispensers are protected with smaller -6 inch- bollards so they bend above-grade instead of cantilevering below grade.

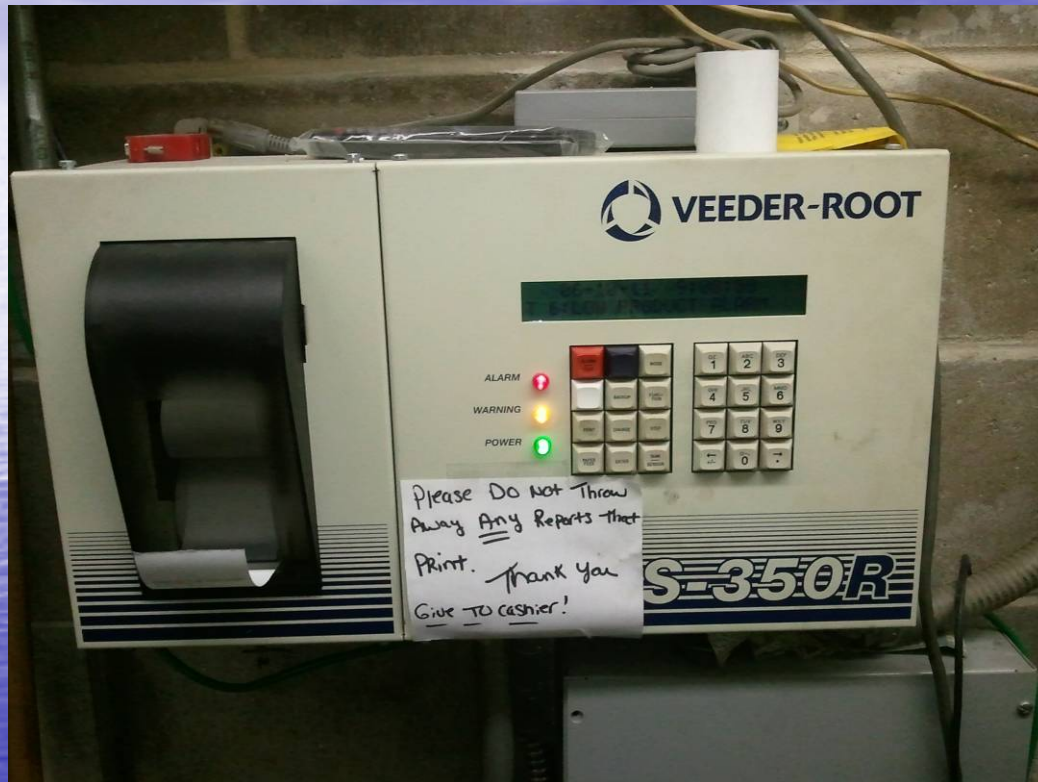
ATG Printout- PLLD Test History

- Configuration/ATG Set-up
 - Estimated line lengths of manifolded piping exceeded actual programmed for premium and on-road diesel.
 - Estimated line length of manifolded_piping exceeded the third-party certification of the Veeder Root PLLD system.
 - PLLD system programmed to perform monthly 0.2 gph and annual 0.1 tests

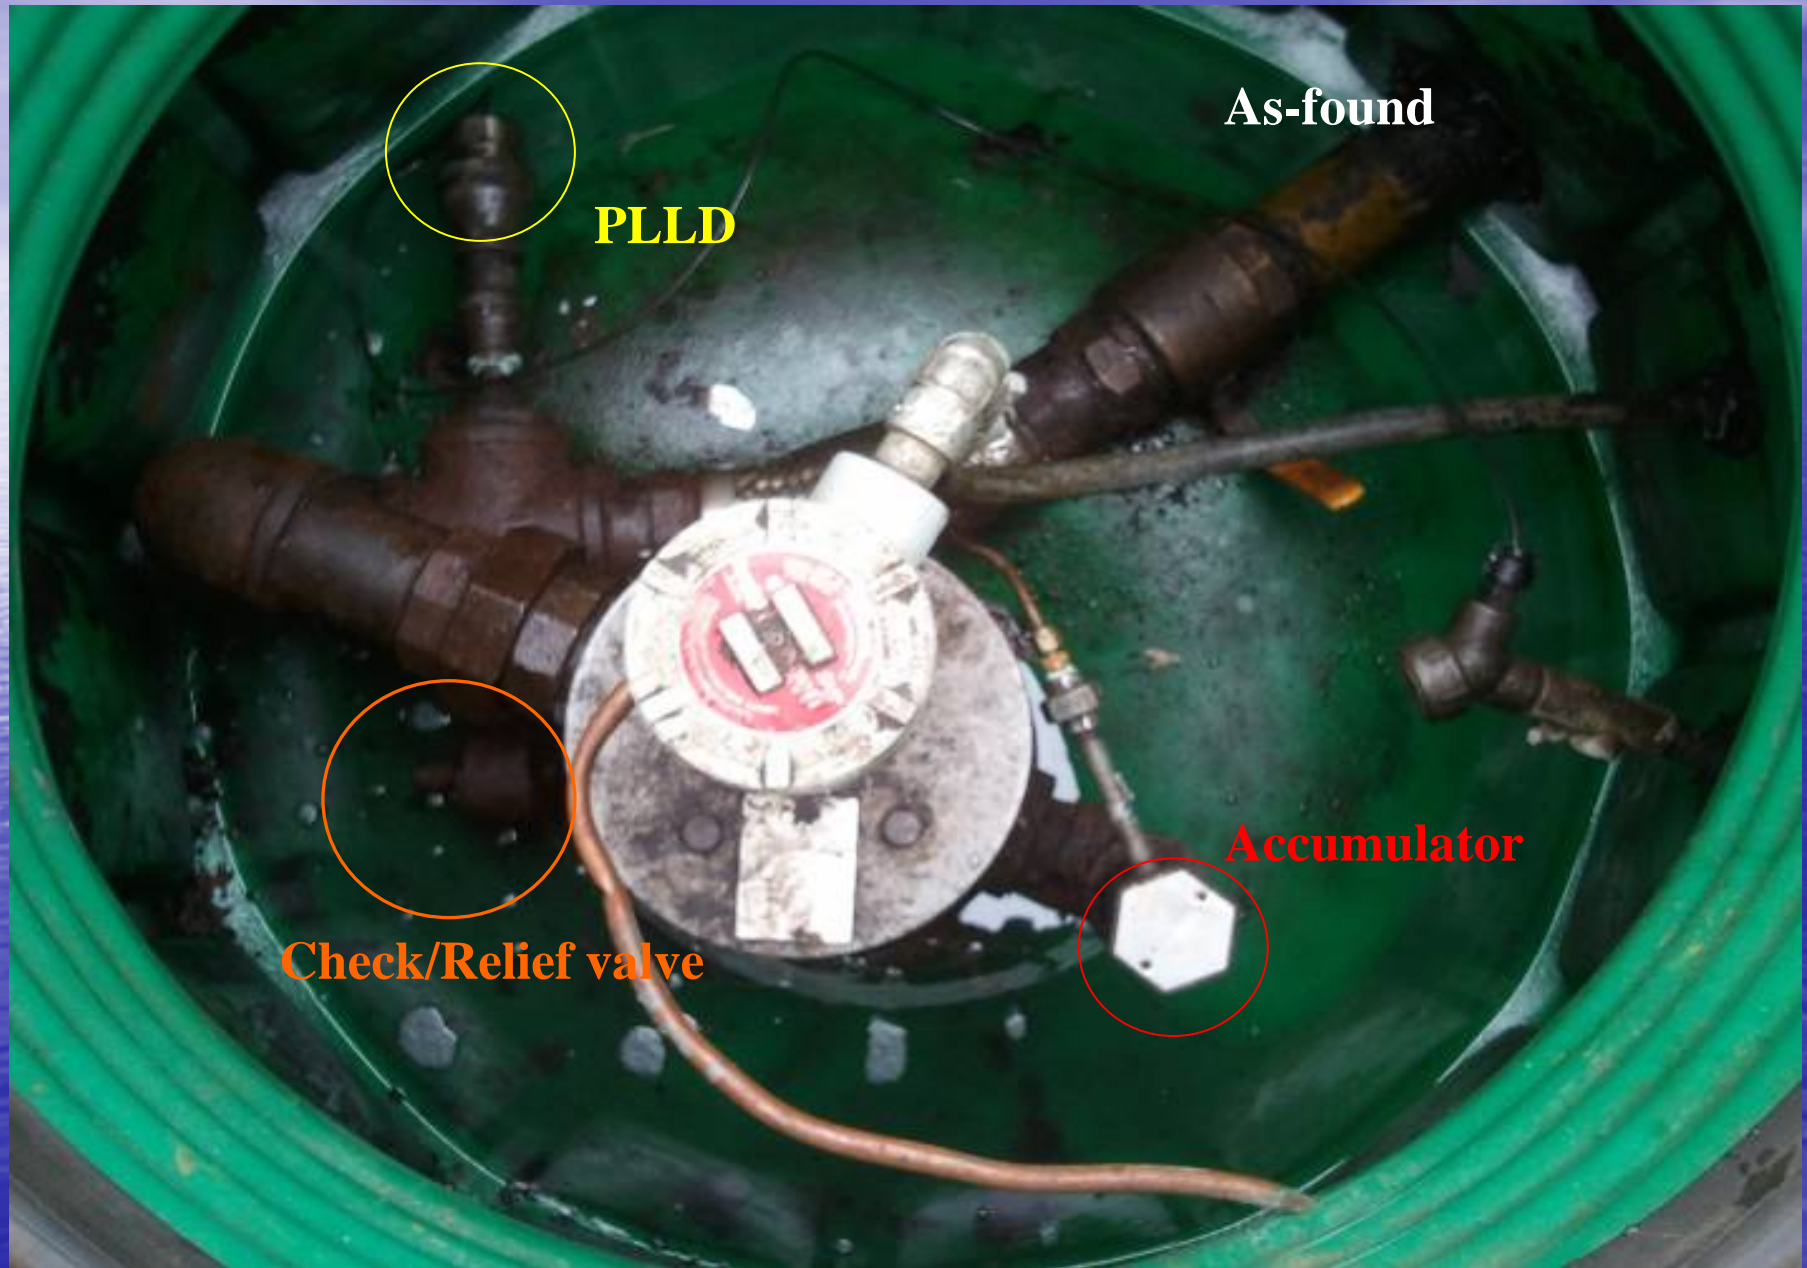
As-Found LLD

As-found LLD issues

- Configuration/ATG Set-up
 - The original Red Jacket line leak detection equipment (accumulator, check/regulating valve, in-line check valve) was left installed
 - The PLLD transducers were installed in a horizontal position
 - V/R "Pressurestat" kit not installed

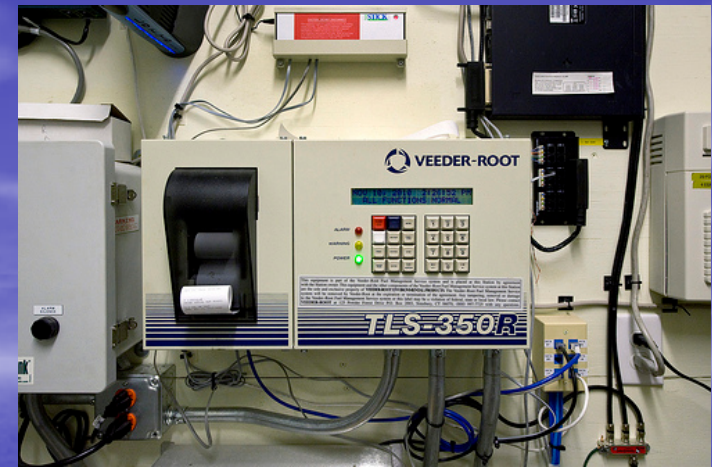
Causal Factor

- Poor installation practices.
 - Programming line length based on old setup data from original leak detection equipment;
 - not performing a walk-down or system plan review to confirm actual manifolded line length;
 - ATG mis-application for performance of 0.2/0.1 gph testing when not certified for use by Veeder Root with RJ Big Flo submersible;
 - leaving old leak detection system equipment in place and not installing equipment as required by Veeder Root application manual No: **577013-465**.

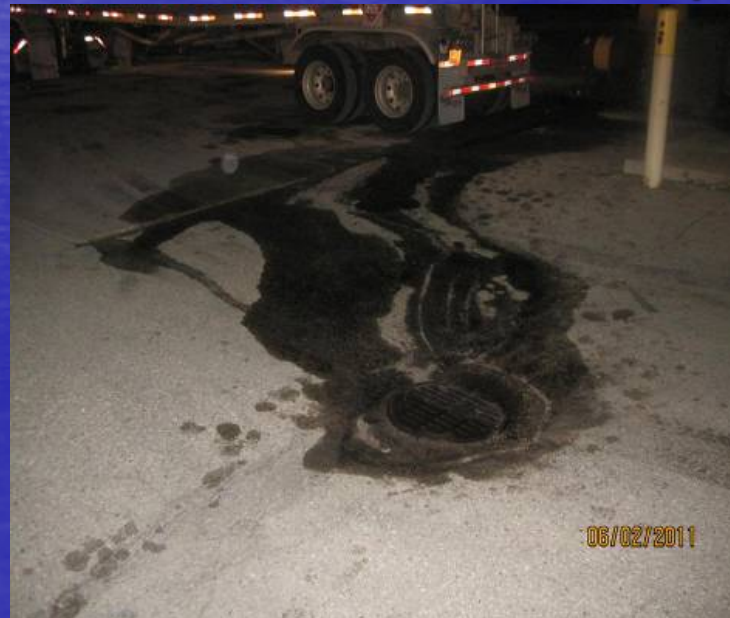
Causal Factor

- Poor site work practices.
 - Use of on-site drain system by owner and service company technicians to remove product/water from tank backfill instead of bringing in a tanker for waste disposal.
