# System Malfunctions – The View from Below

Dennis Healy  
Infiltrator Water Technologies  
Area Sales Representative

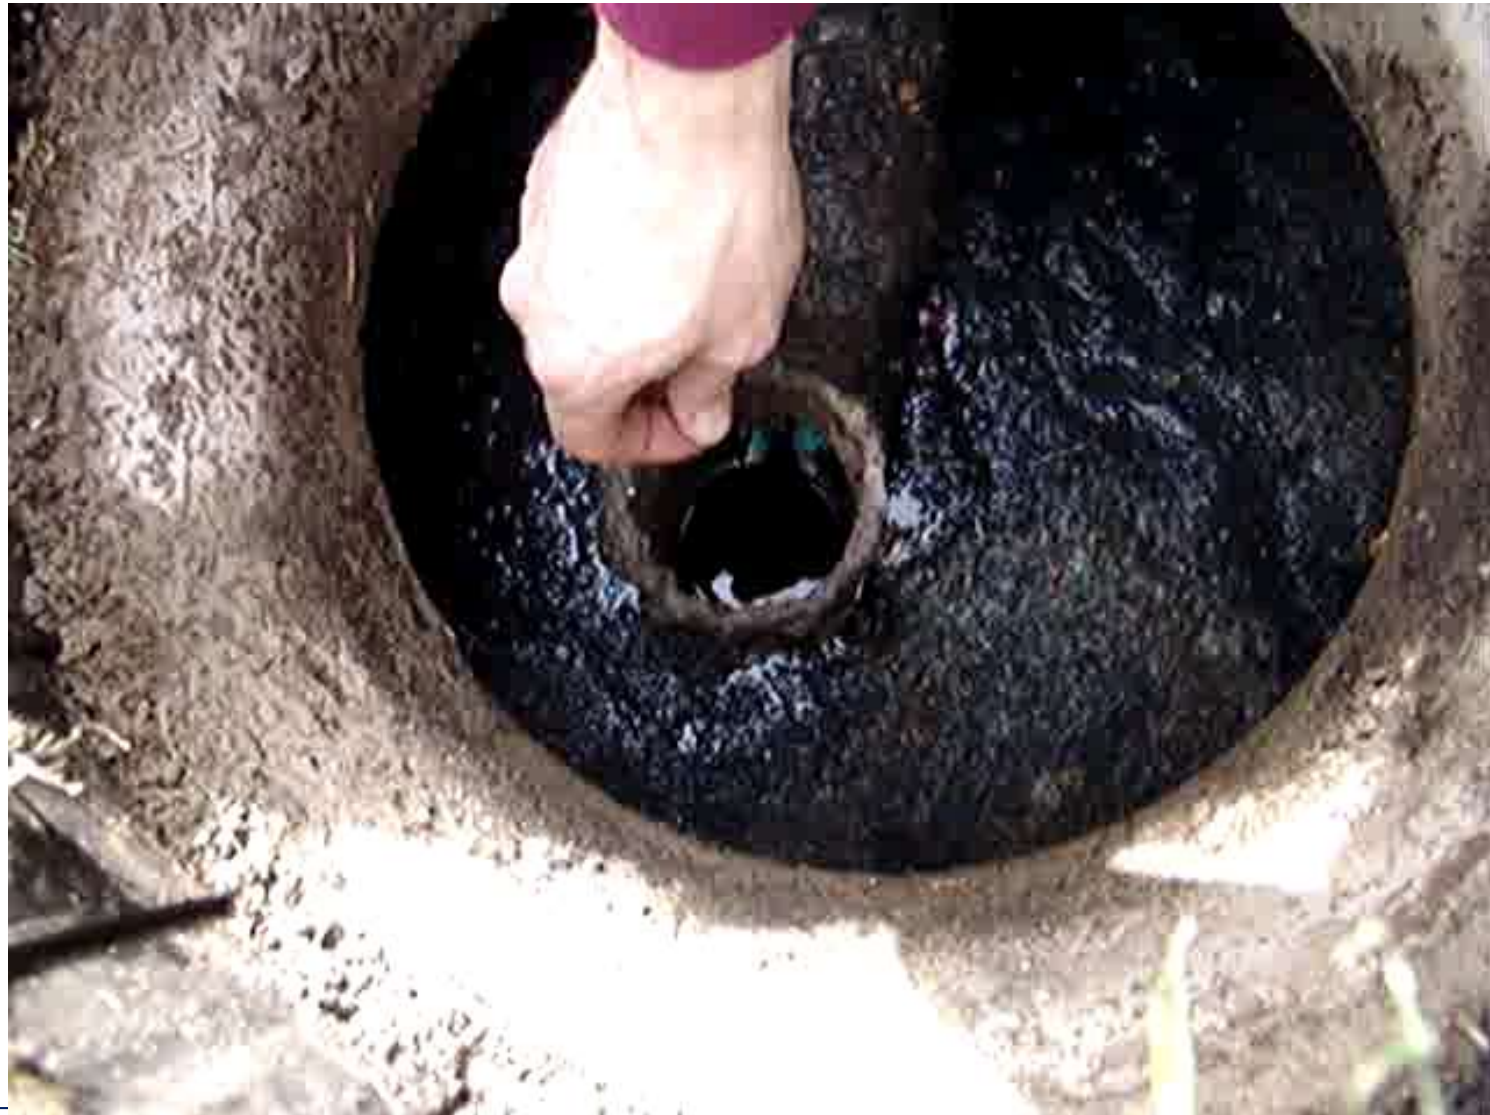
# Issue: Hydraulic overload

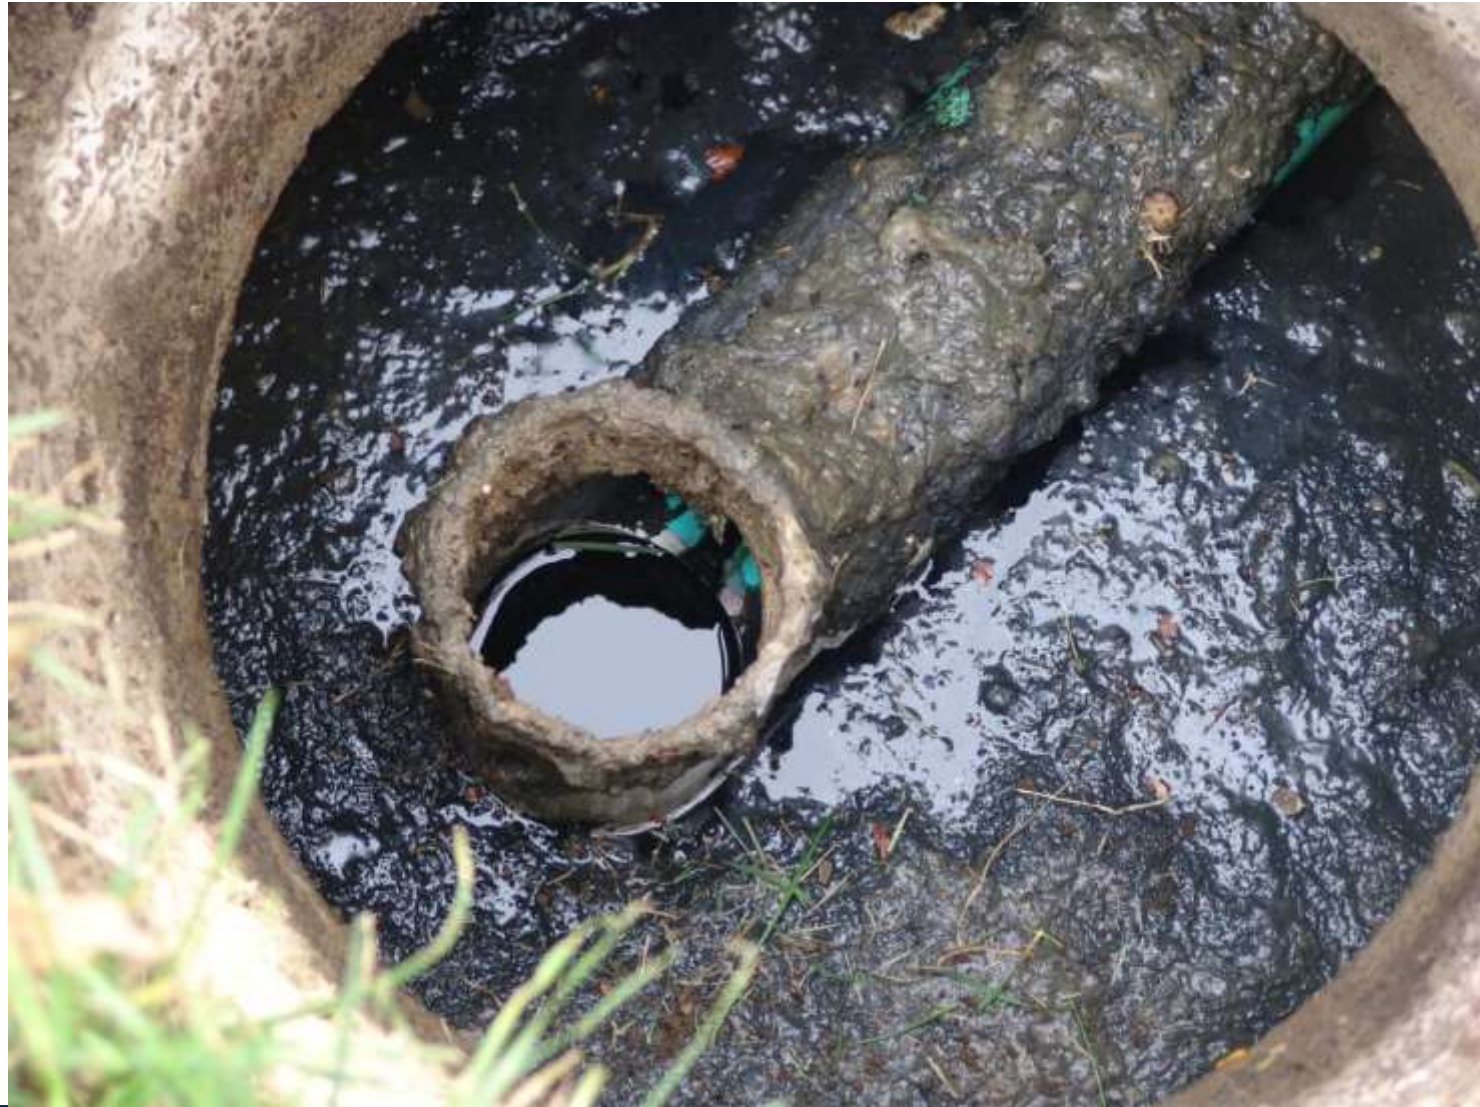
# Issue: Excessive scum height

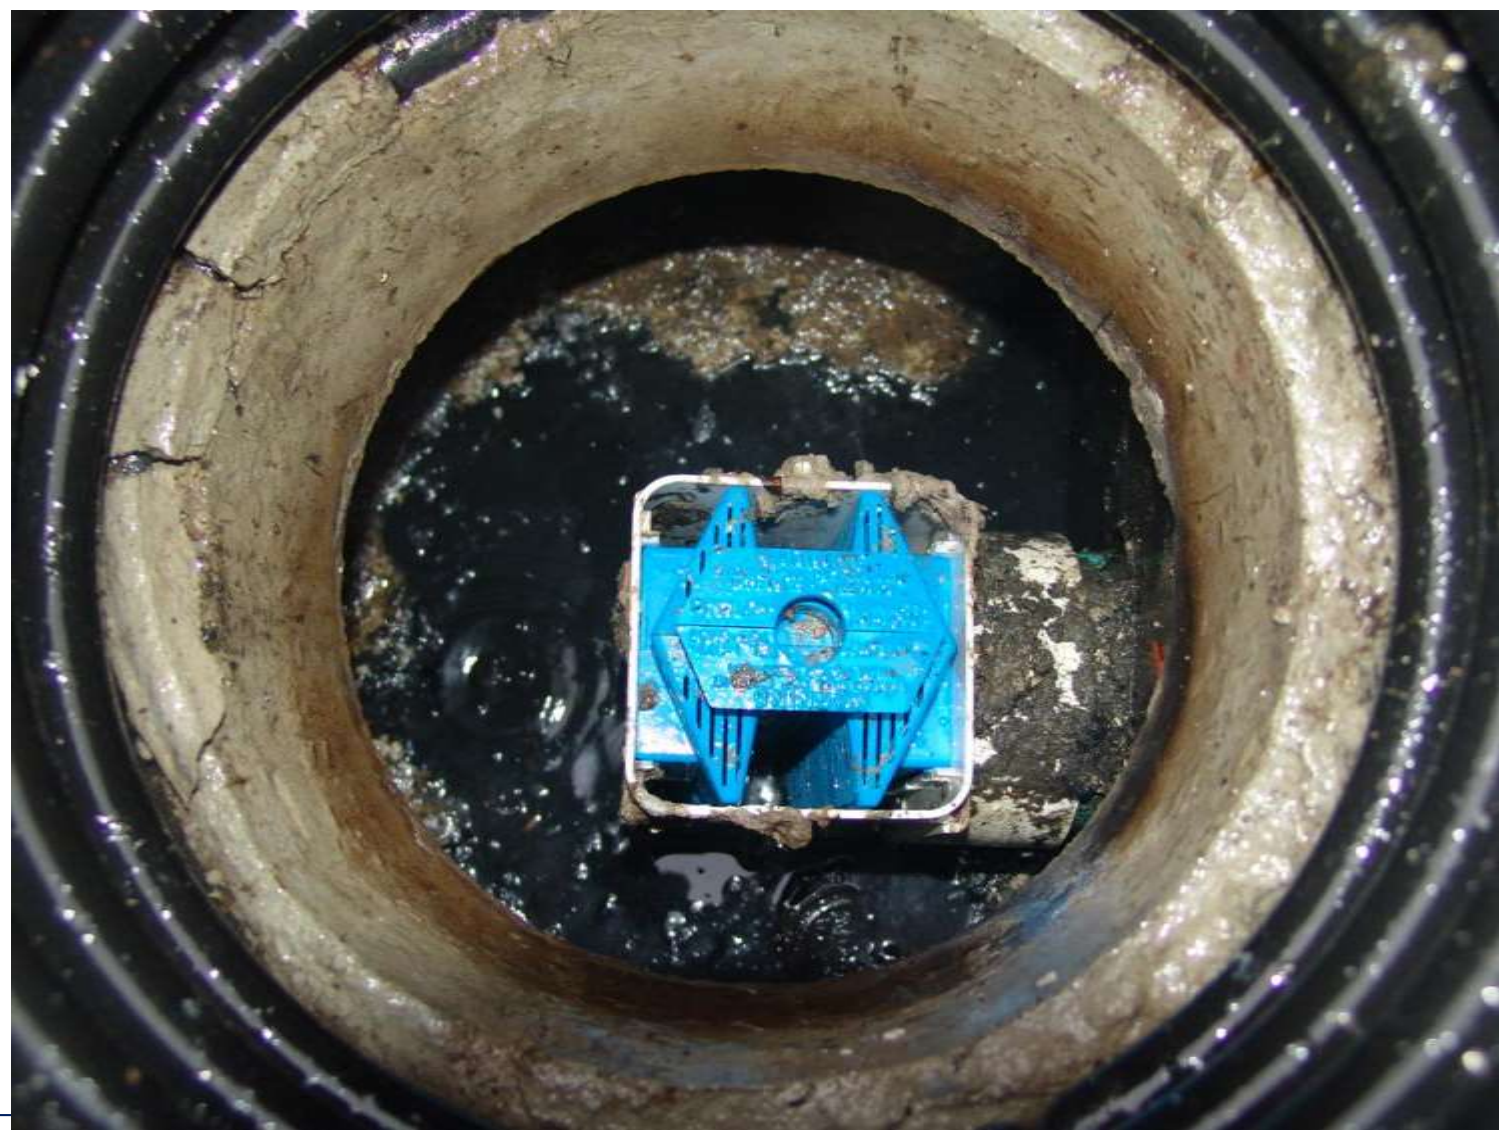
# Issue: Scum in screen

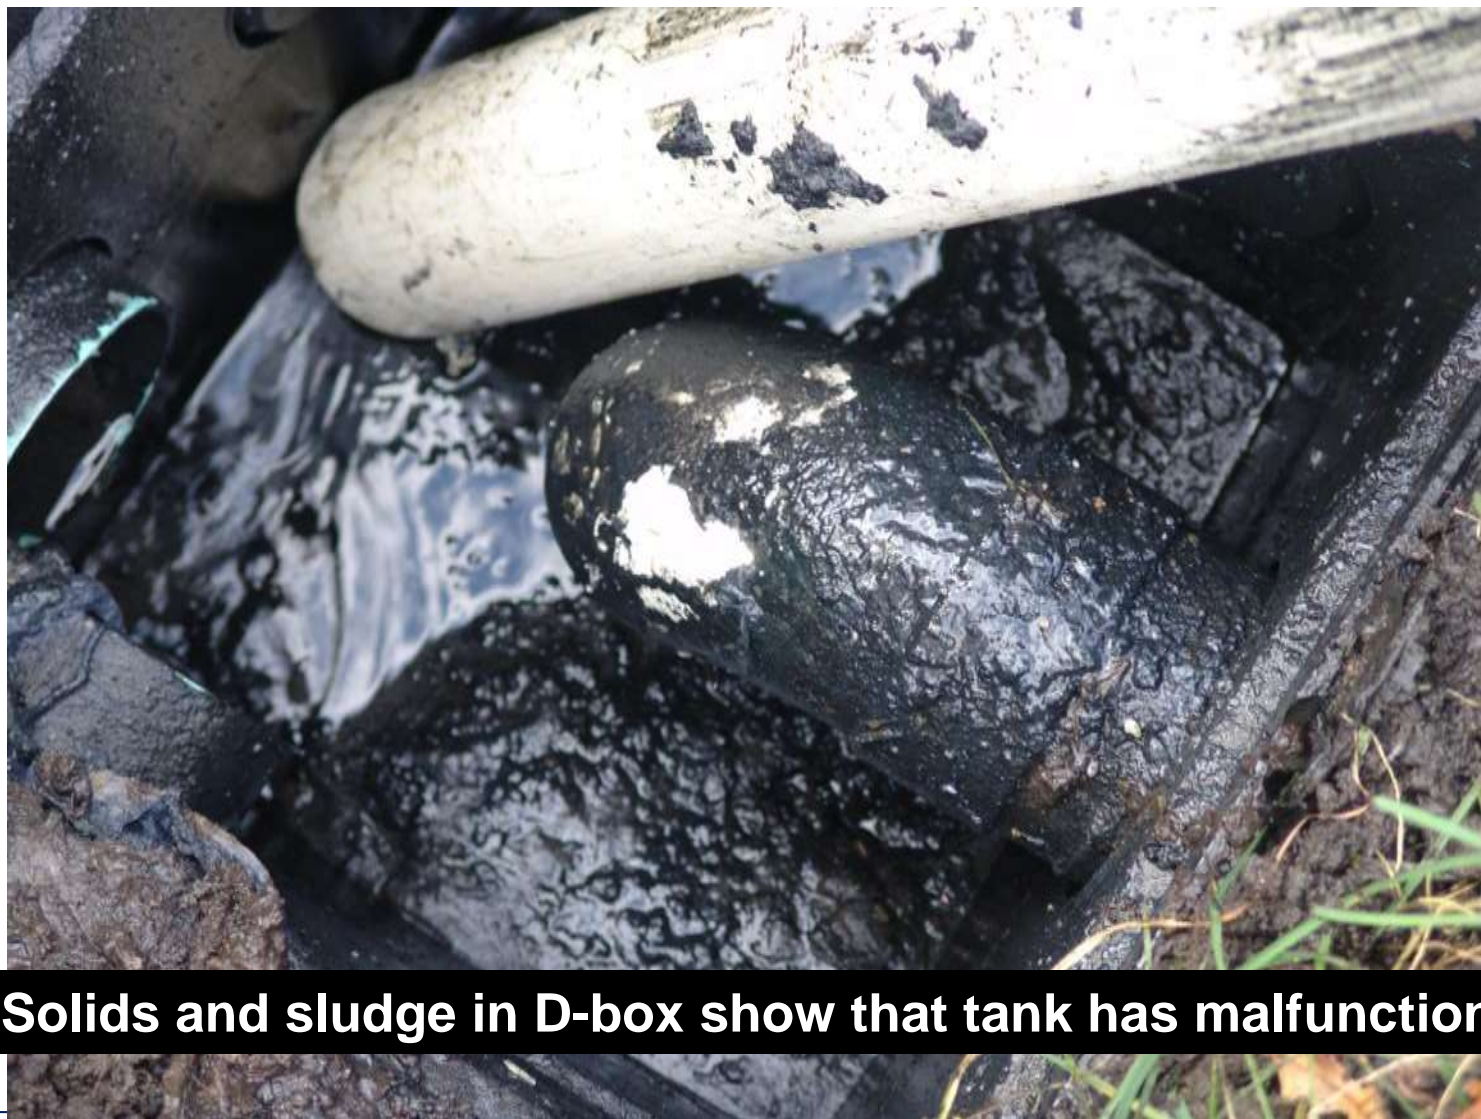
## Issue: Solids in D-box

**Solids and sludge in D-box show that tank has malfunctioned**

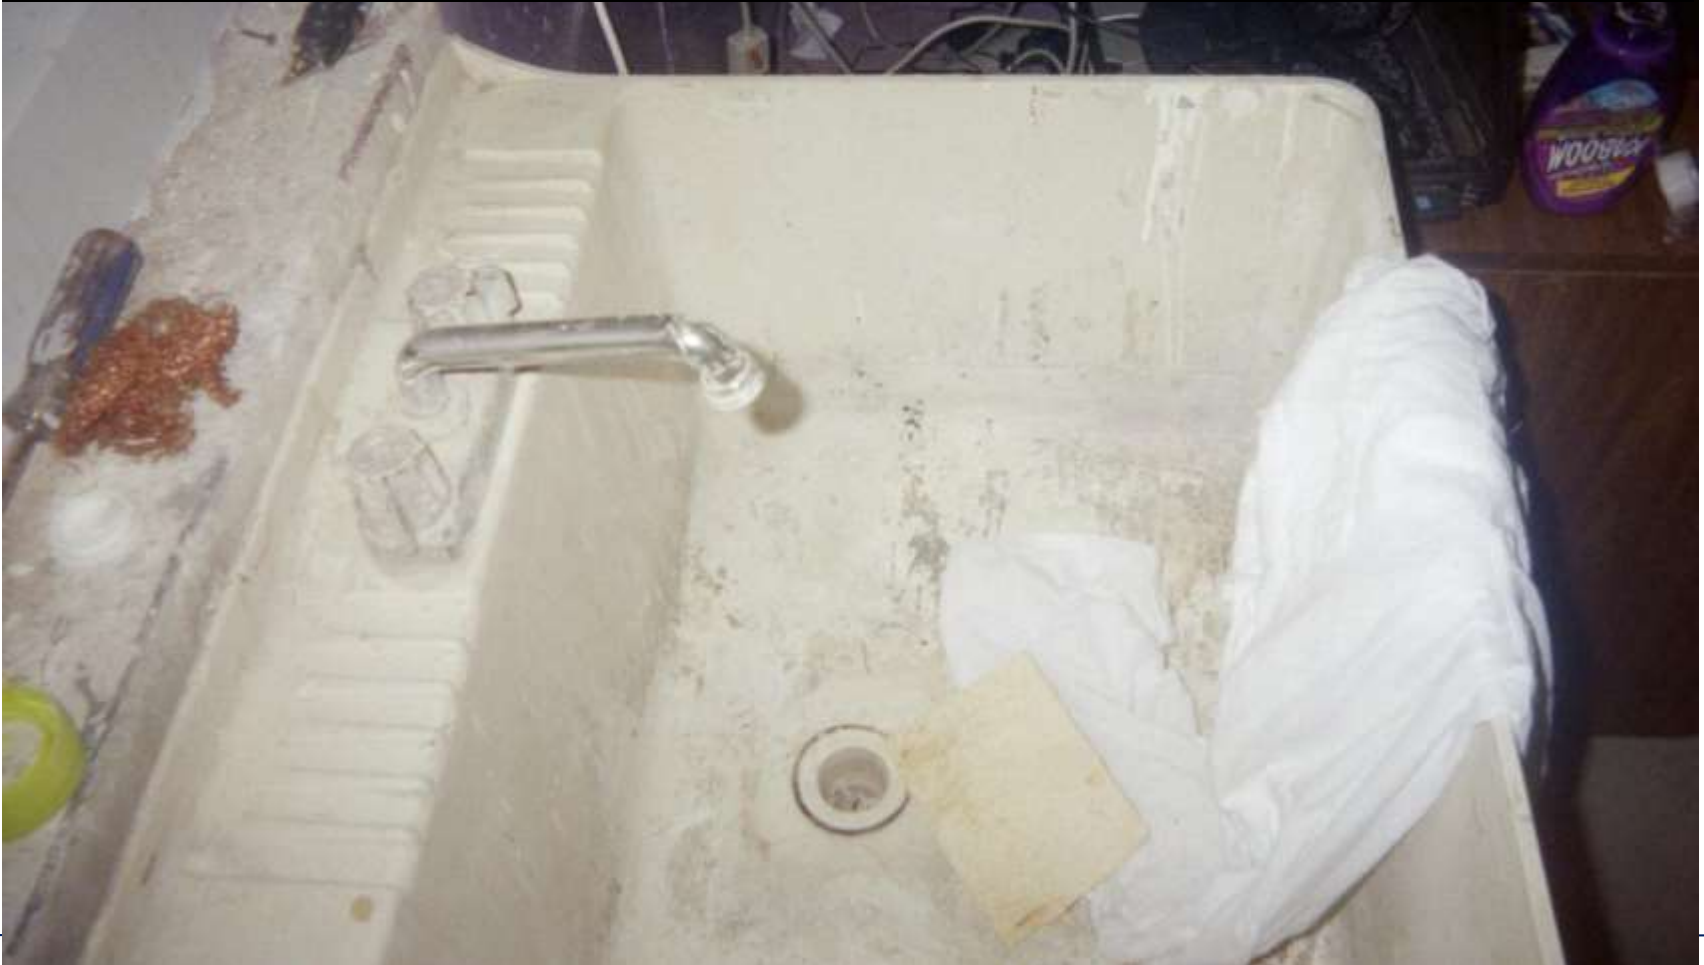
# Issue: Latex discharge

**Slop sink in basement is caked with dried latex paint. Drainfield was not functioning as a result of latex discharge.**

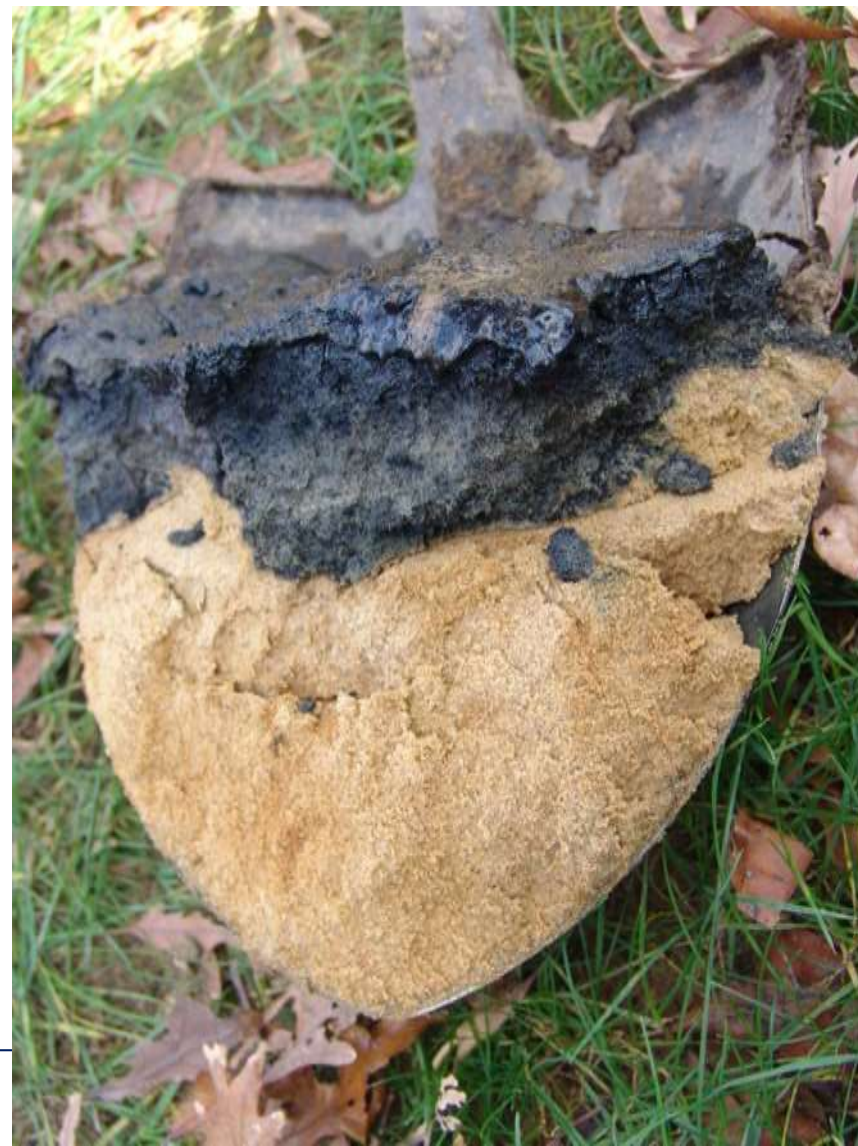
## Issue: Solids in drainfield

- Solids clogged trench bottom
- No vertical water infiltration, distinct color change, not a nice transition in color
- Sand at trench bottom shows no evidence of treatment taking place (absence of discoloration)

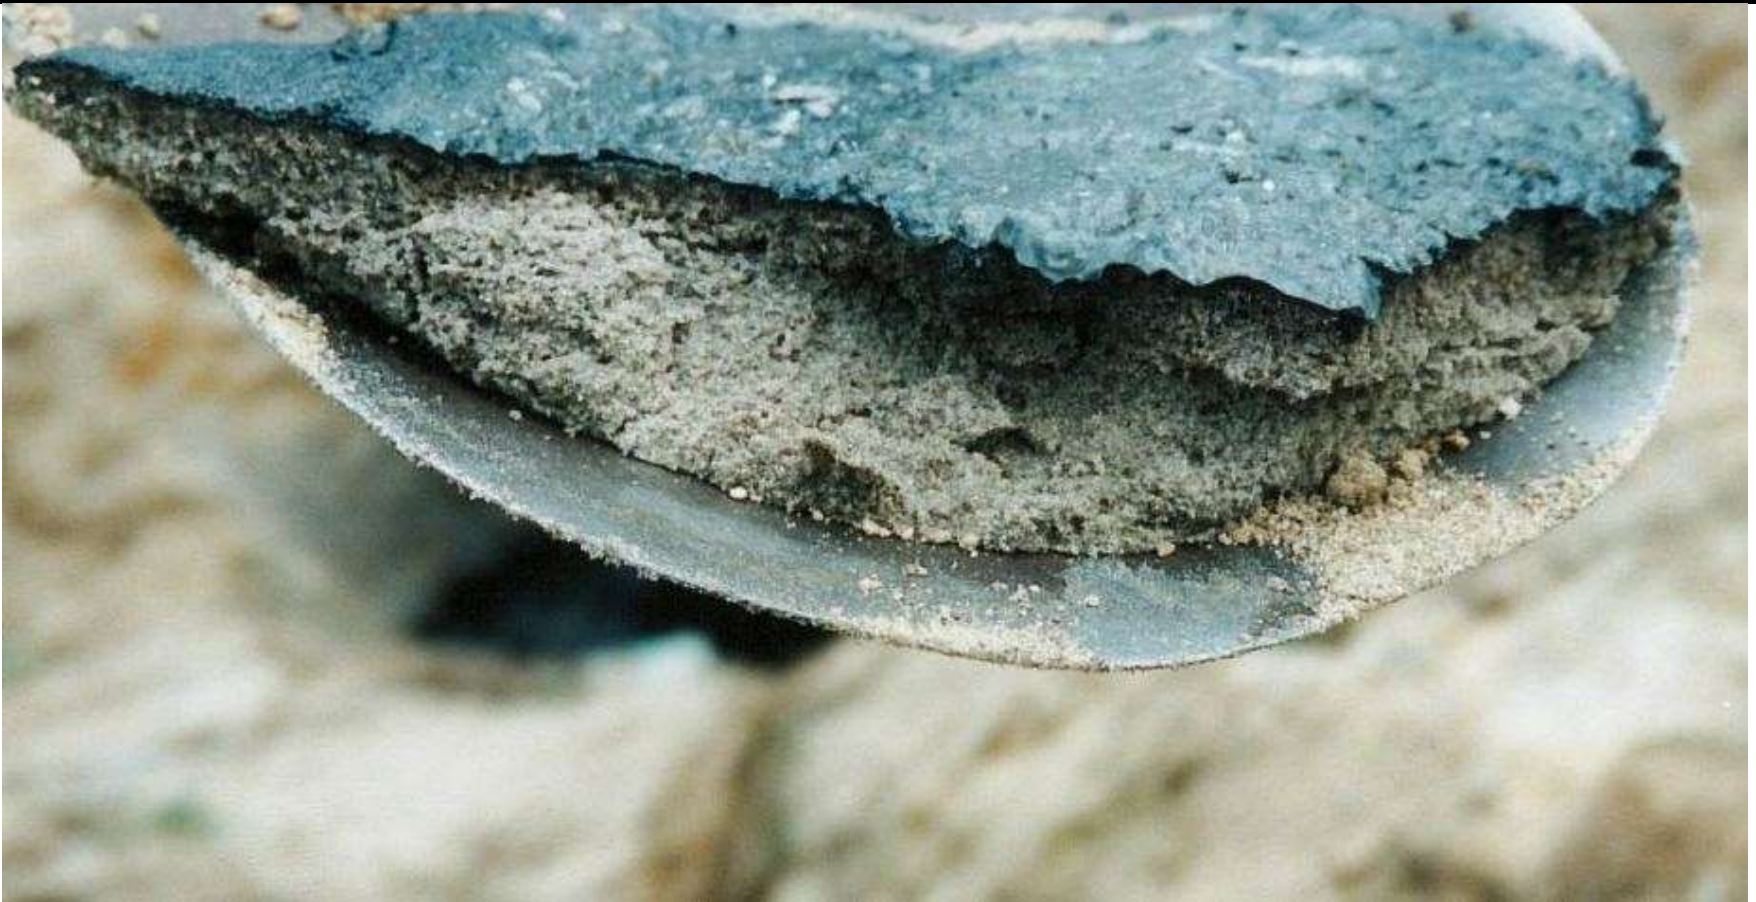
# Issue: Solids in drainfield

**Sand below biomat/solids layer is clean – no evidence of vertical infiltration**

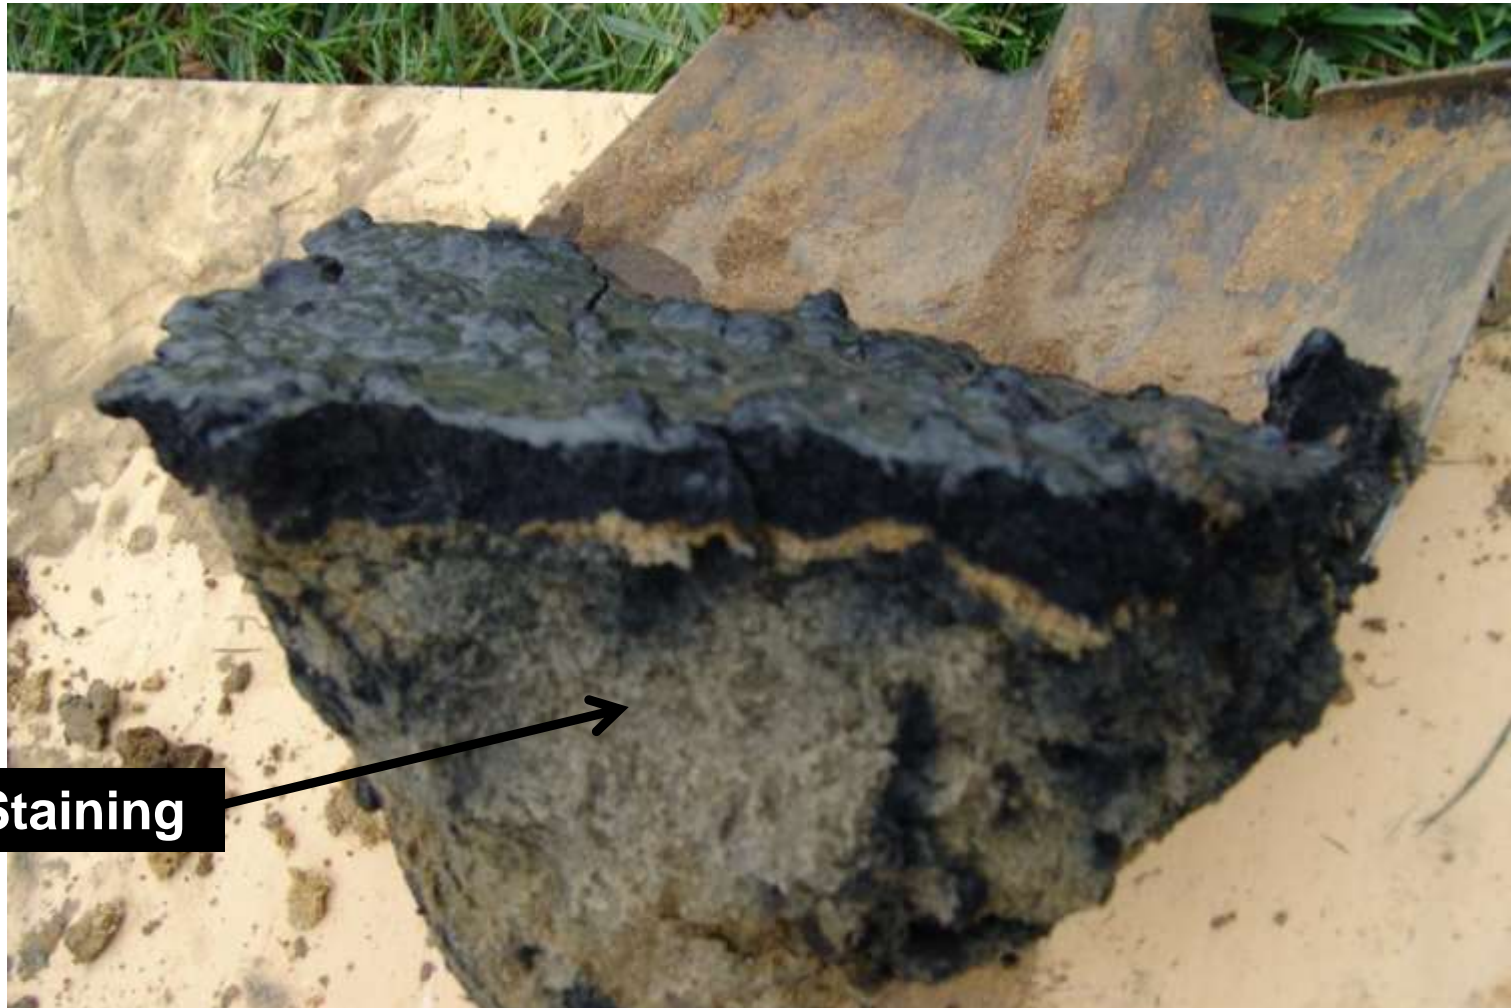
# Issue: Solids in drainfield

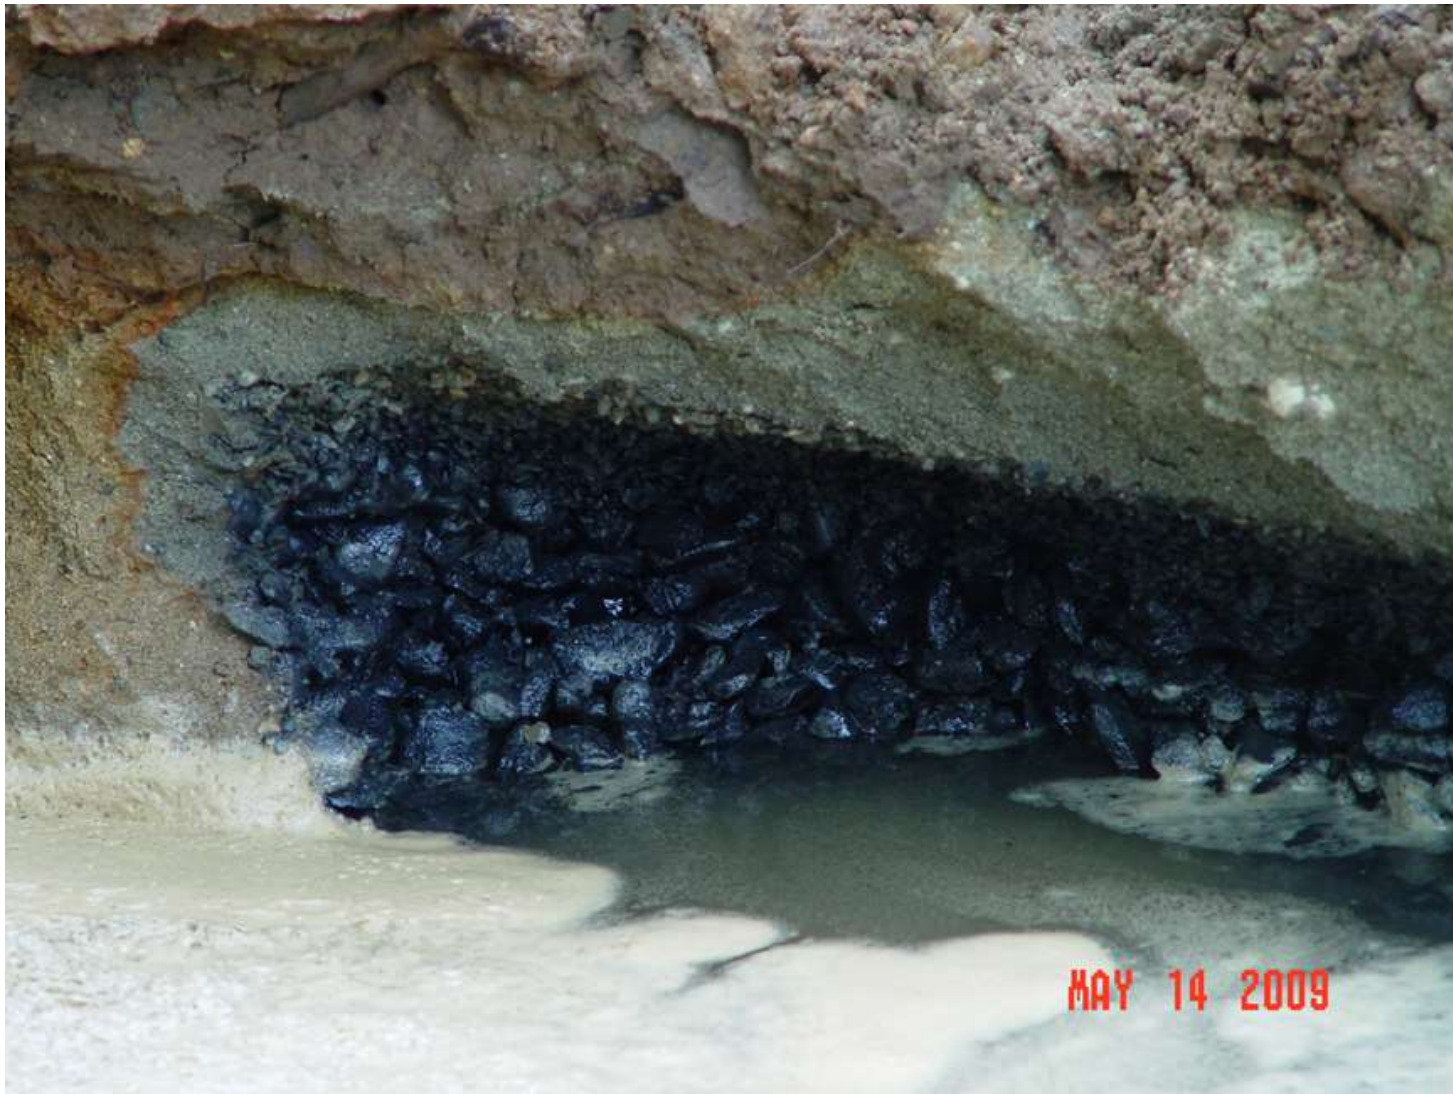
**White Biomat? No, it is an inorganic material from drywall contractors...**

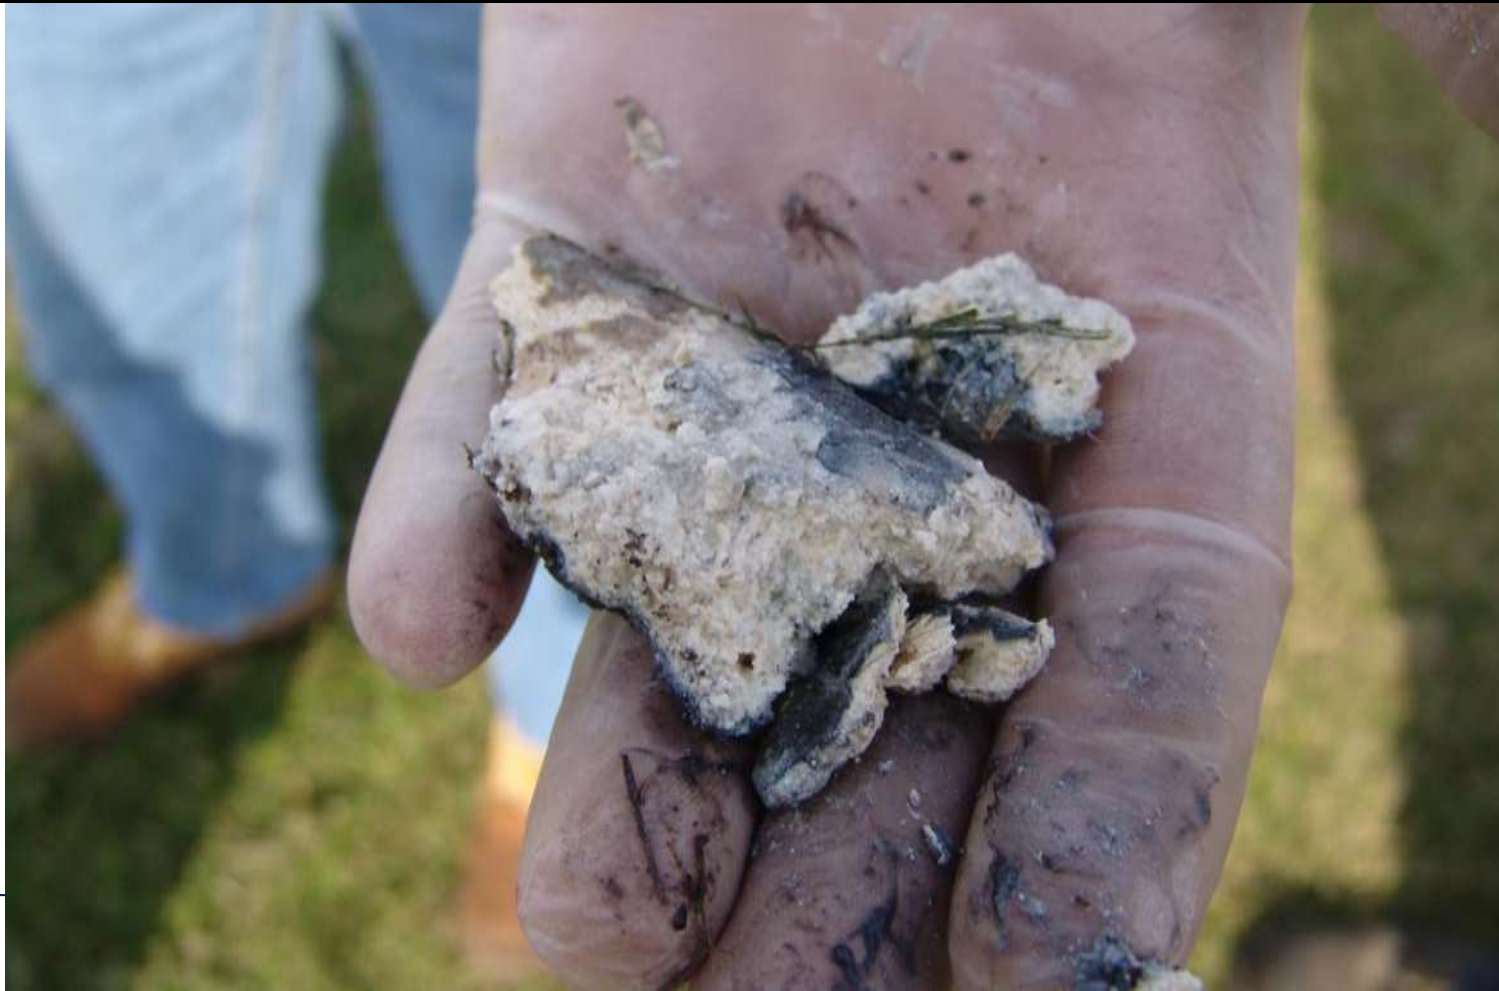
## Issue: Solids in drainfield

**Clod of powdered laundry detergent found in chamber; demonstrates that effluent flowed over top of both baffle and outlet tee in septic tank to carry material to drainfield**

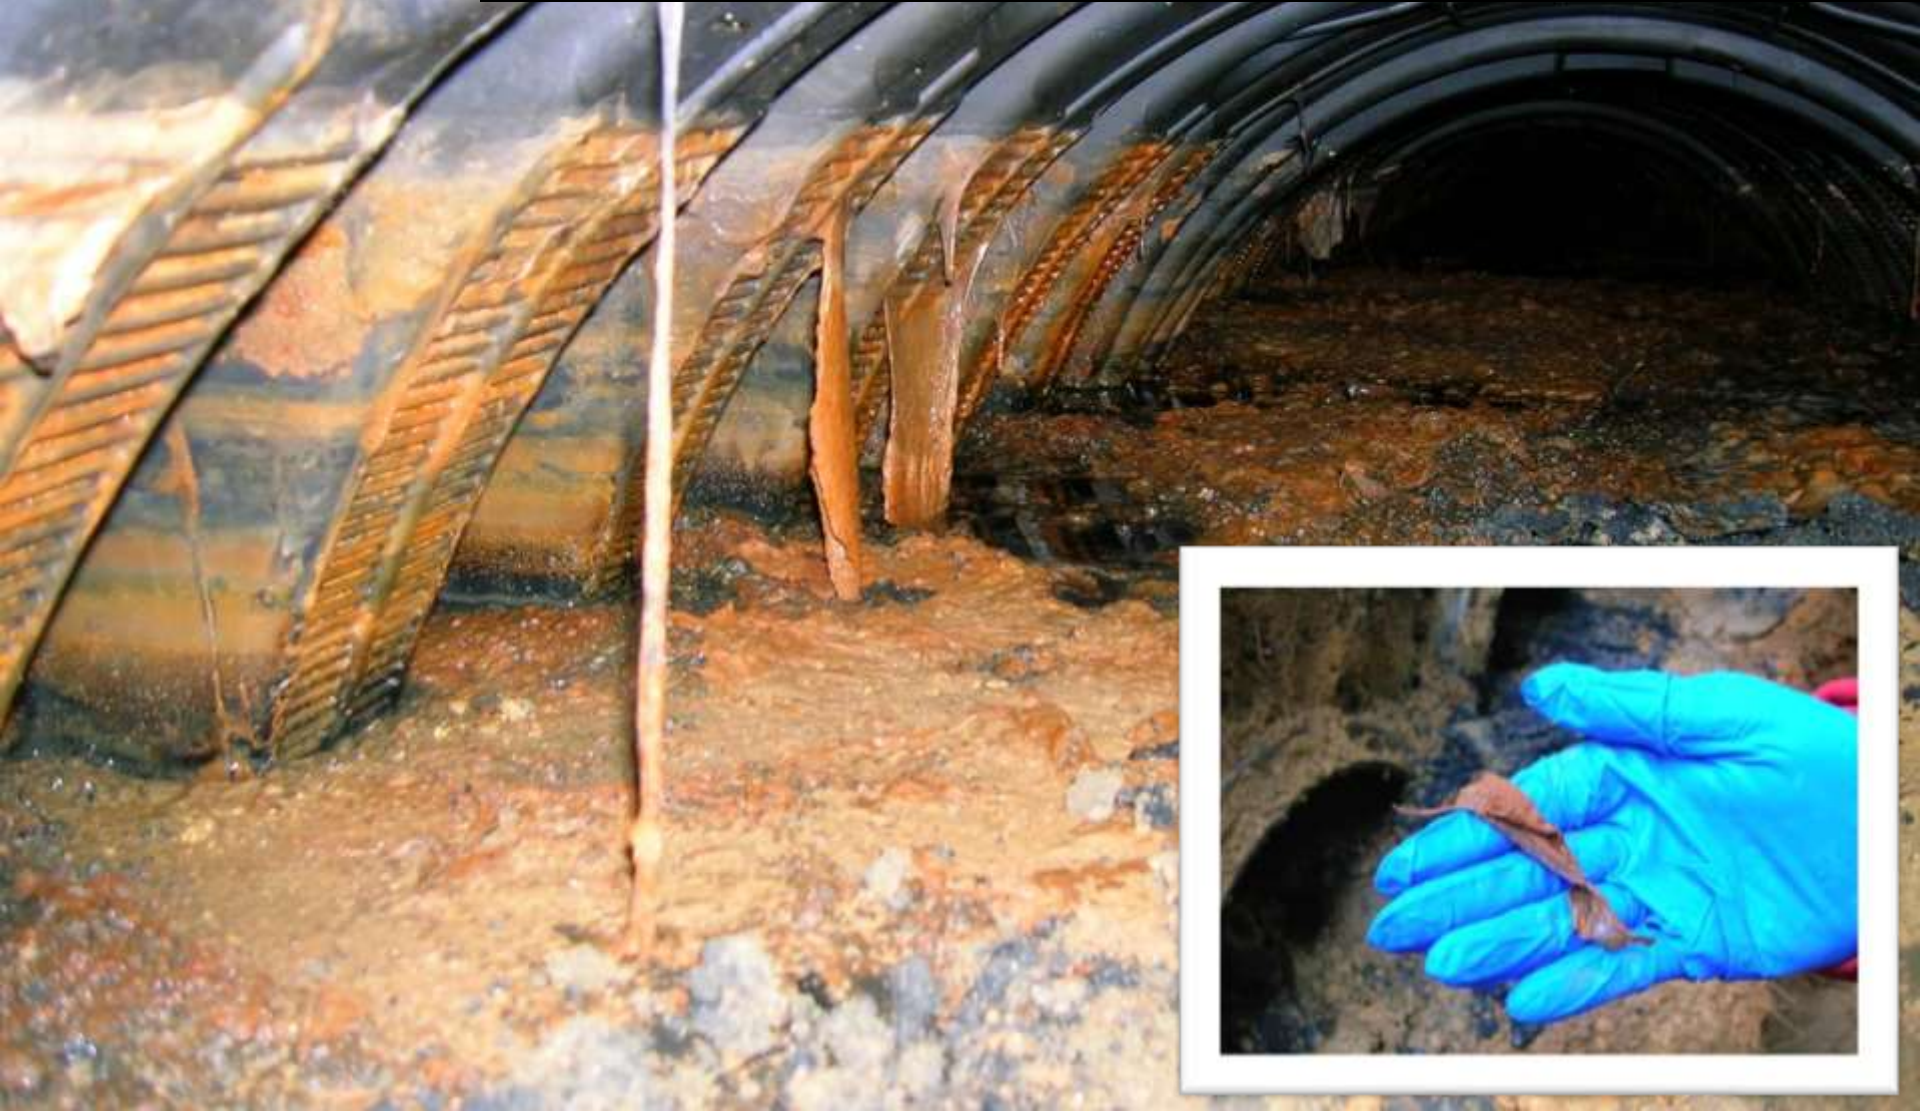
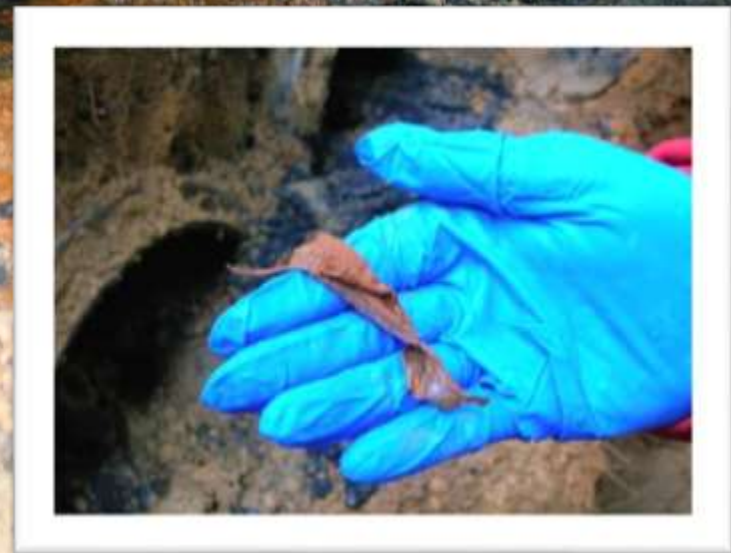
**Excavate the system, you would be surprised what you will find. In this case inorganics (paint) have sealed up the system. Homeowner still claimed innocence.**

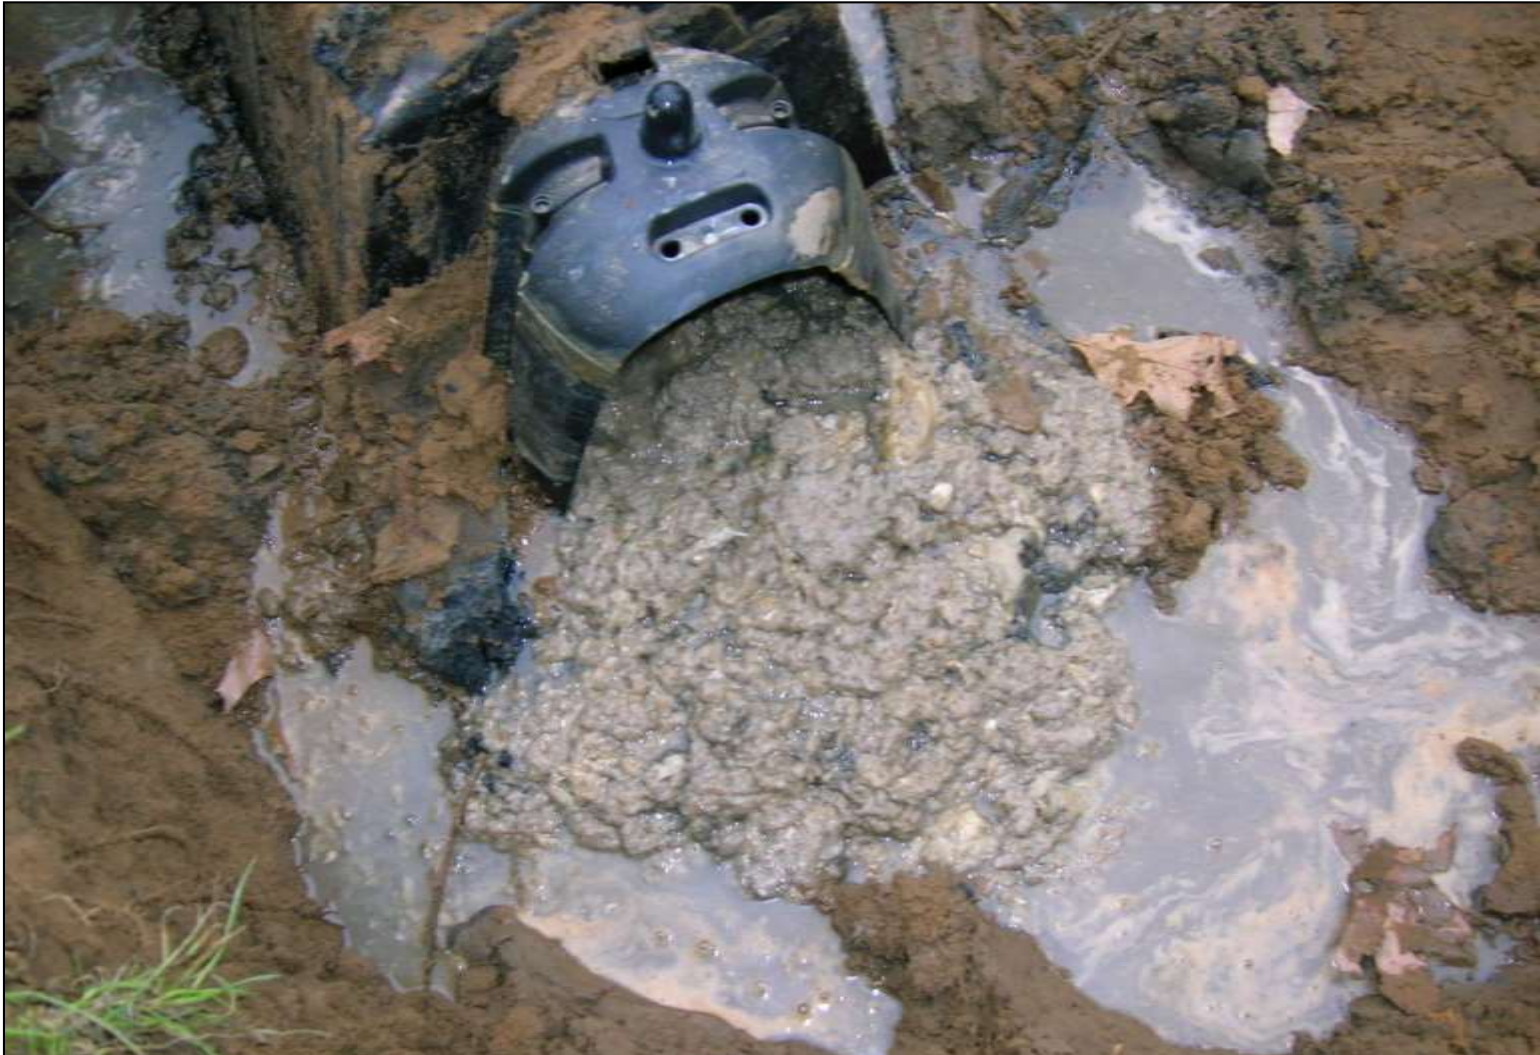
# Issue: Unknown substance clogging infiltrative surfaces

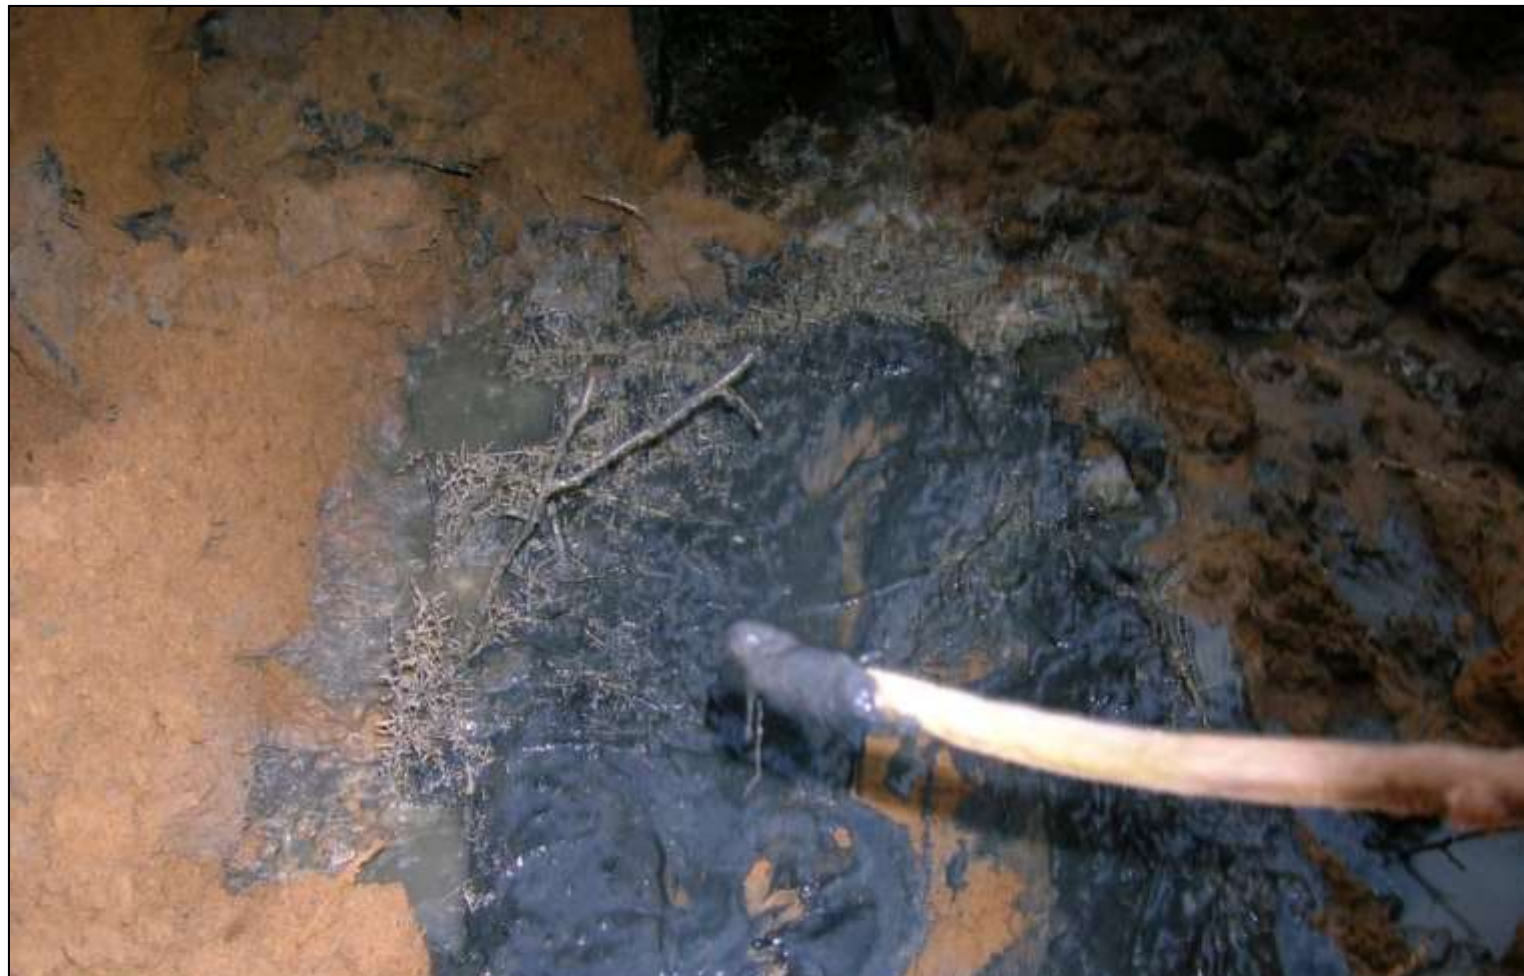
## Issue: Fats, oil, and grease discharge

**Oily slime was discharged to this drainfield, clogging the infiltrative surface and causing malfunction**

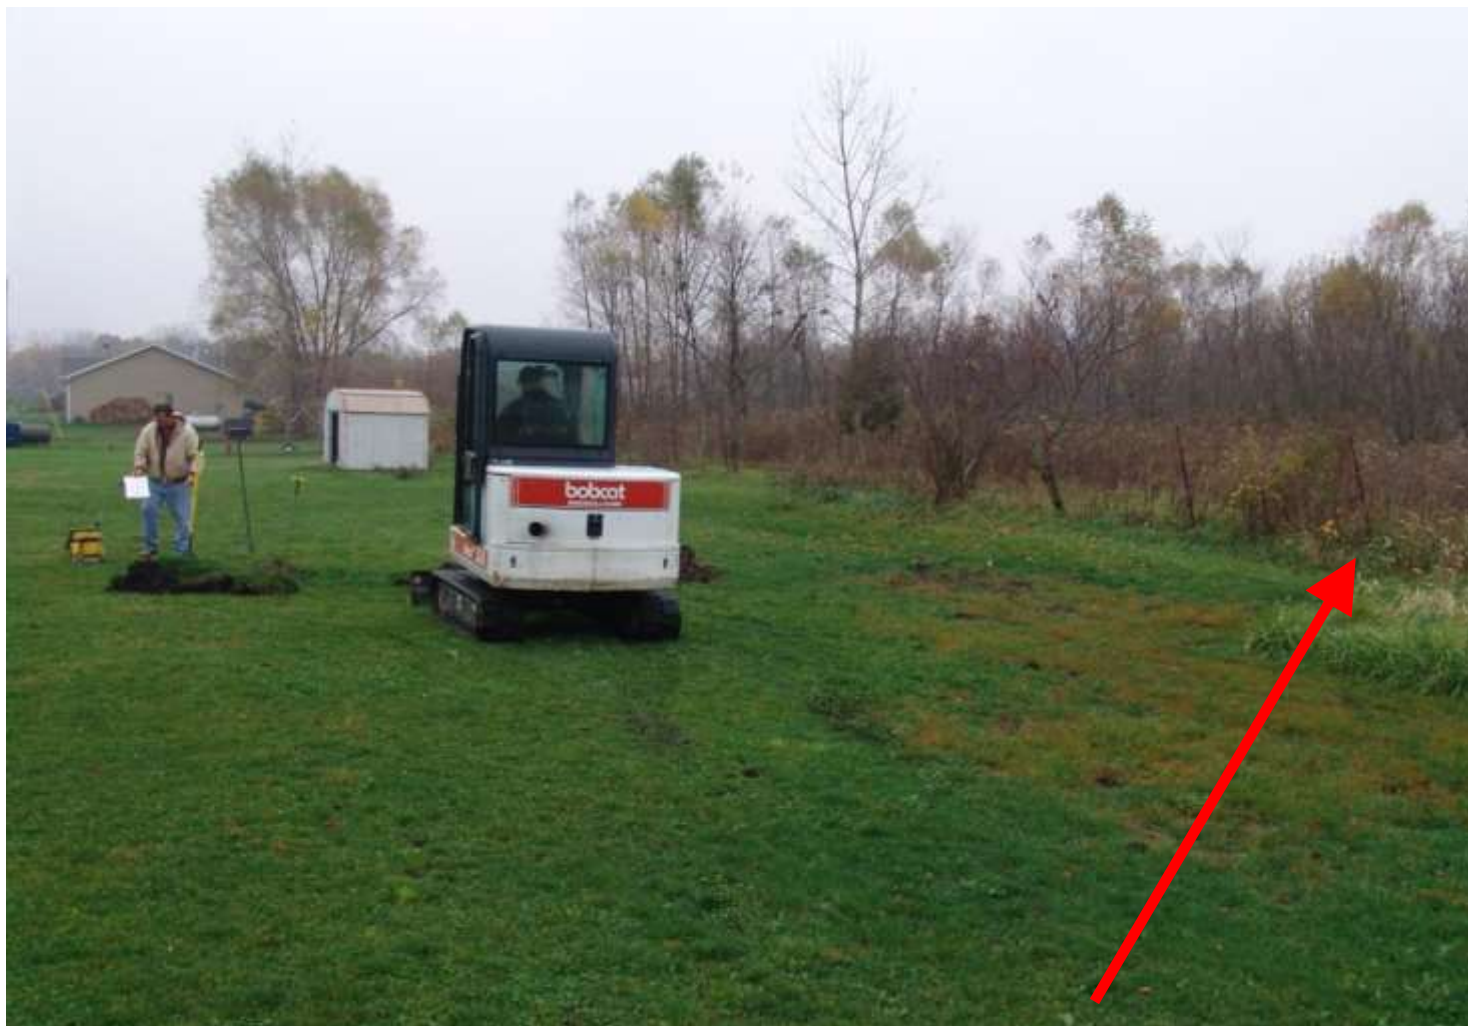
# Issue: Siting in wetland soils

**Drainfield was constructed near wetlands**
