# System Malfunctions – The View from Below

Dennis Healy  
Infiltrator Water Technologies  
Area Sales Representative

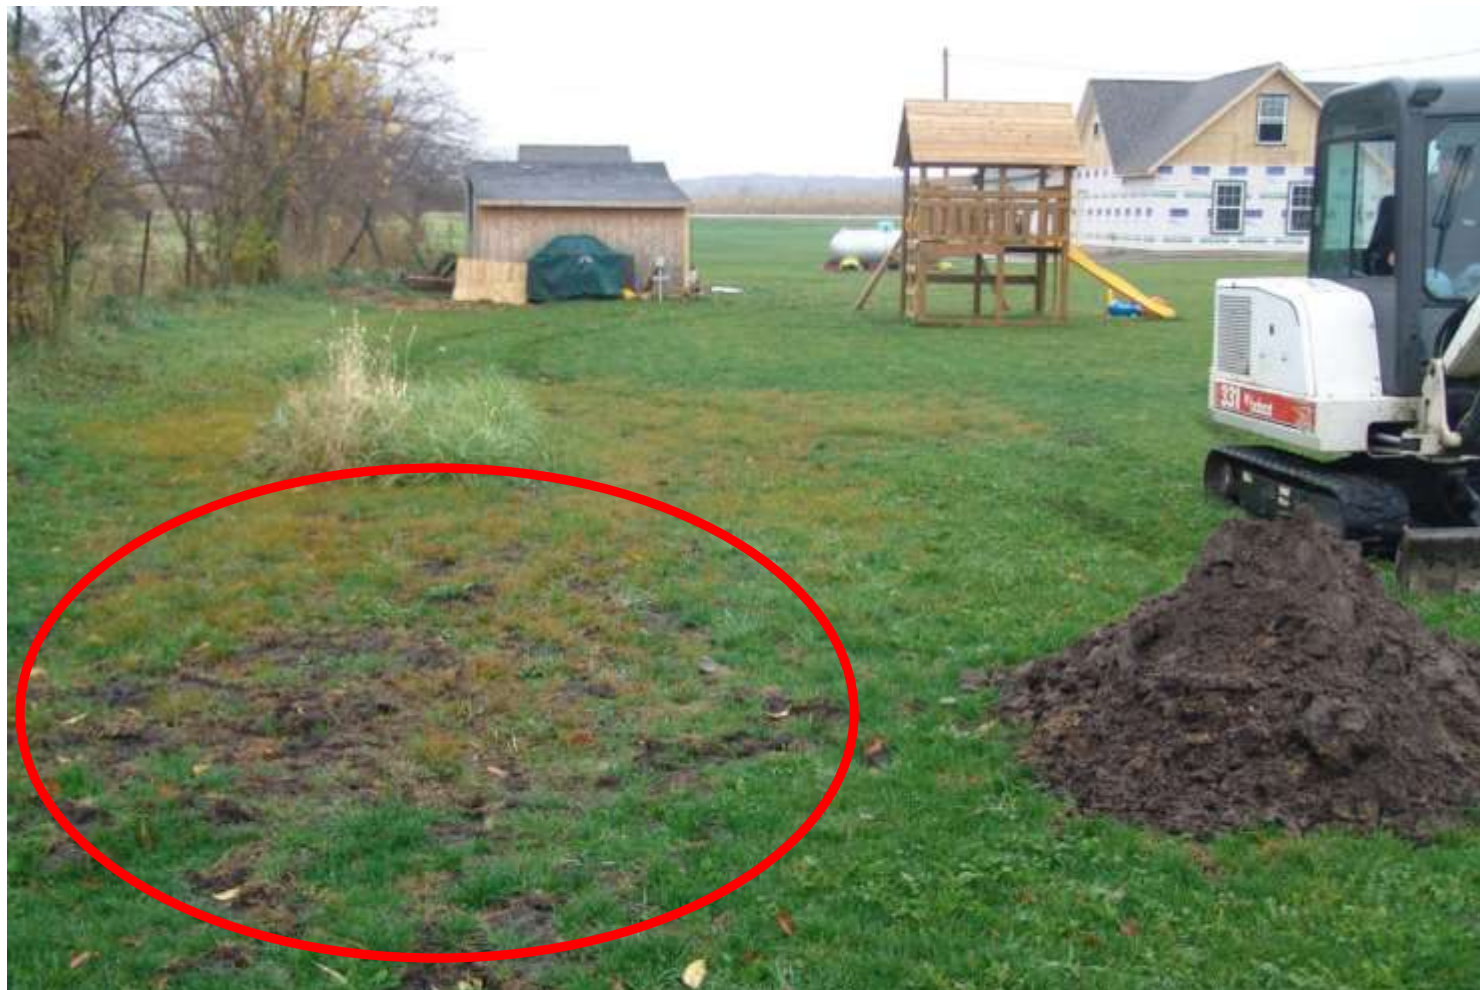
**Drainfield was constructed proximal to area of surficial ponding**

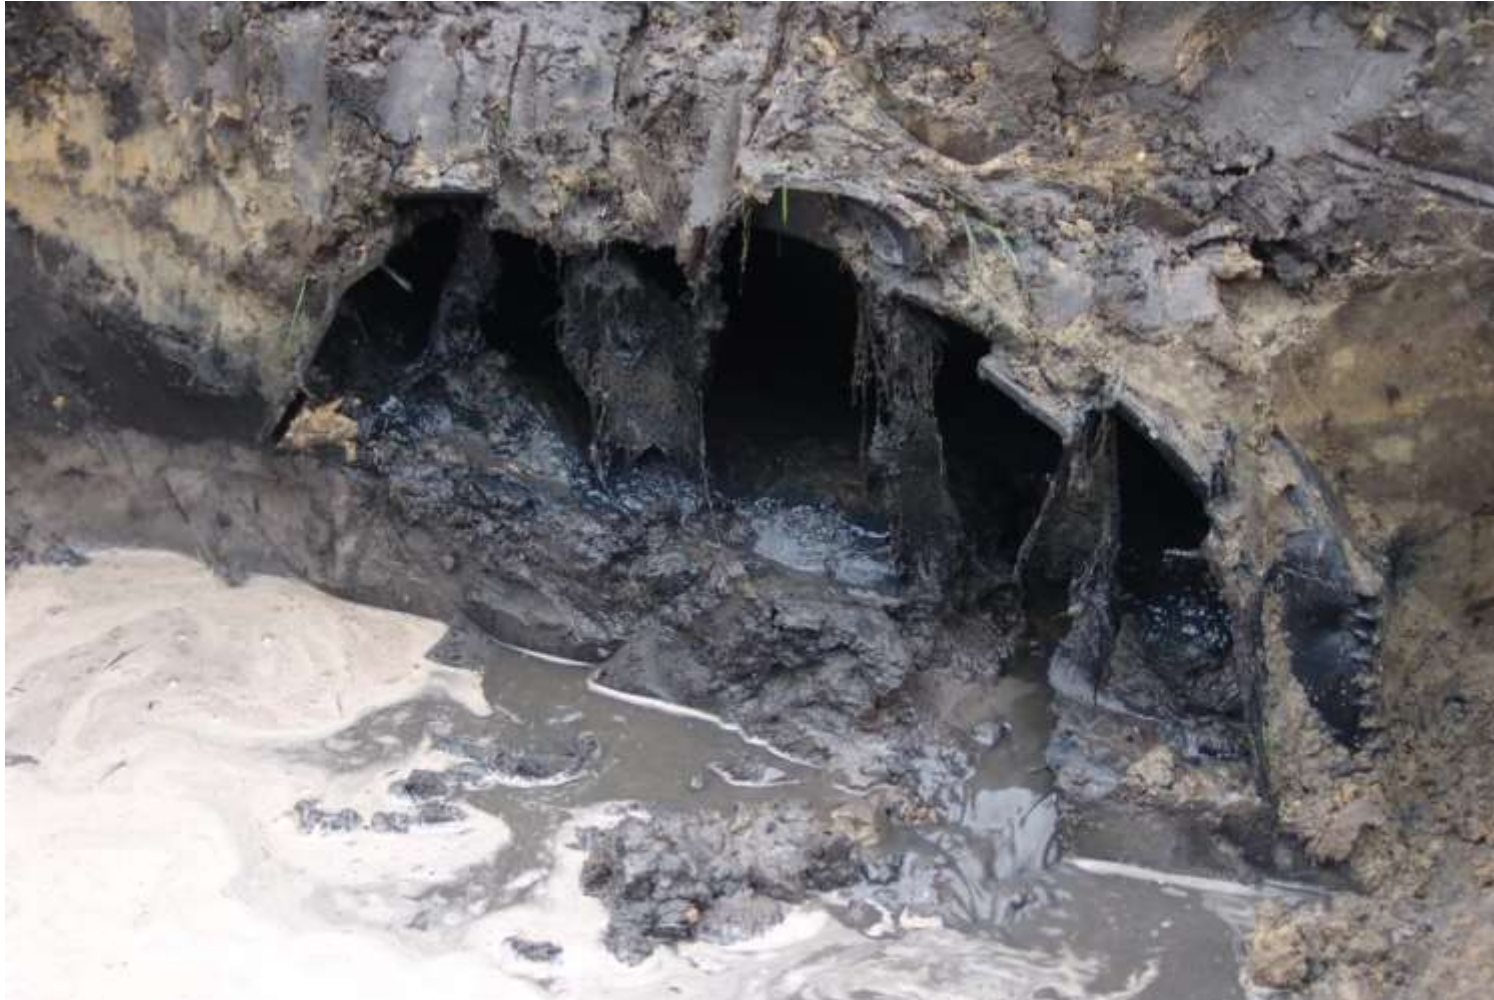
**Drainfield was constructed below groundwater table**

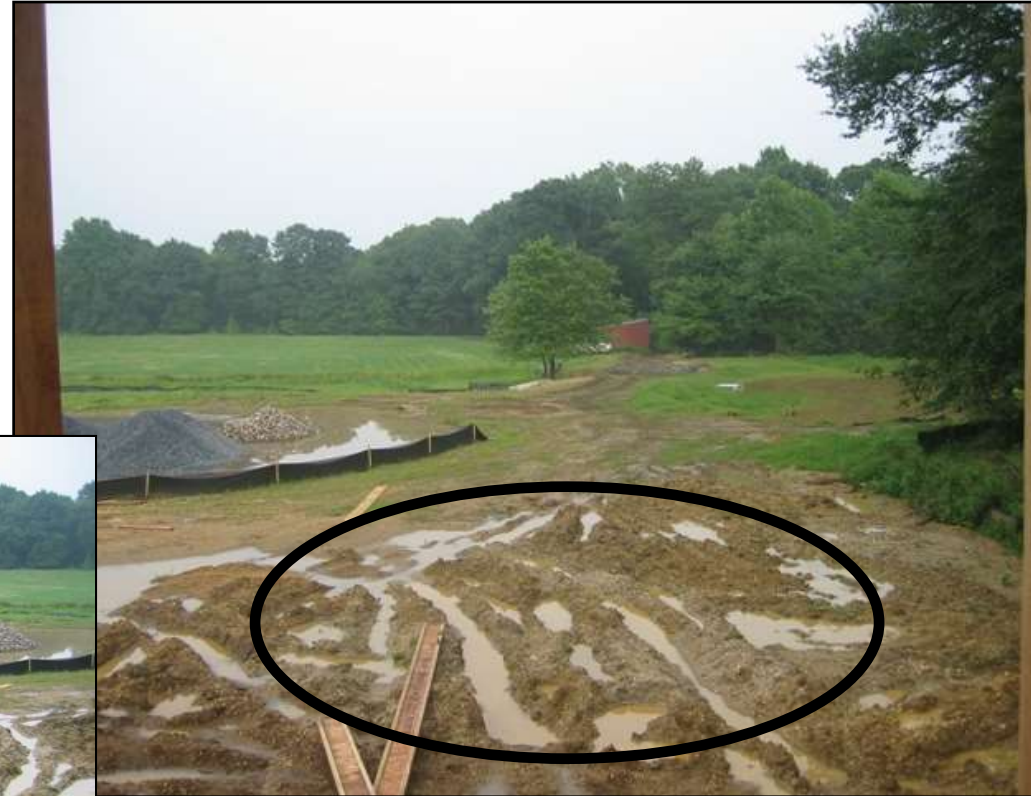
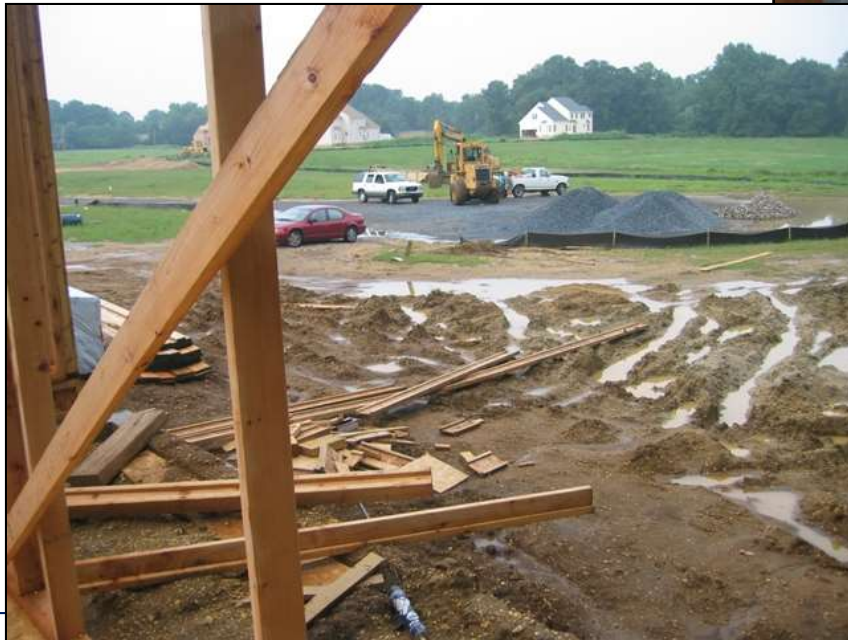
# Issue: Siting within a topographic depression

**The septic system was installed here**

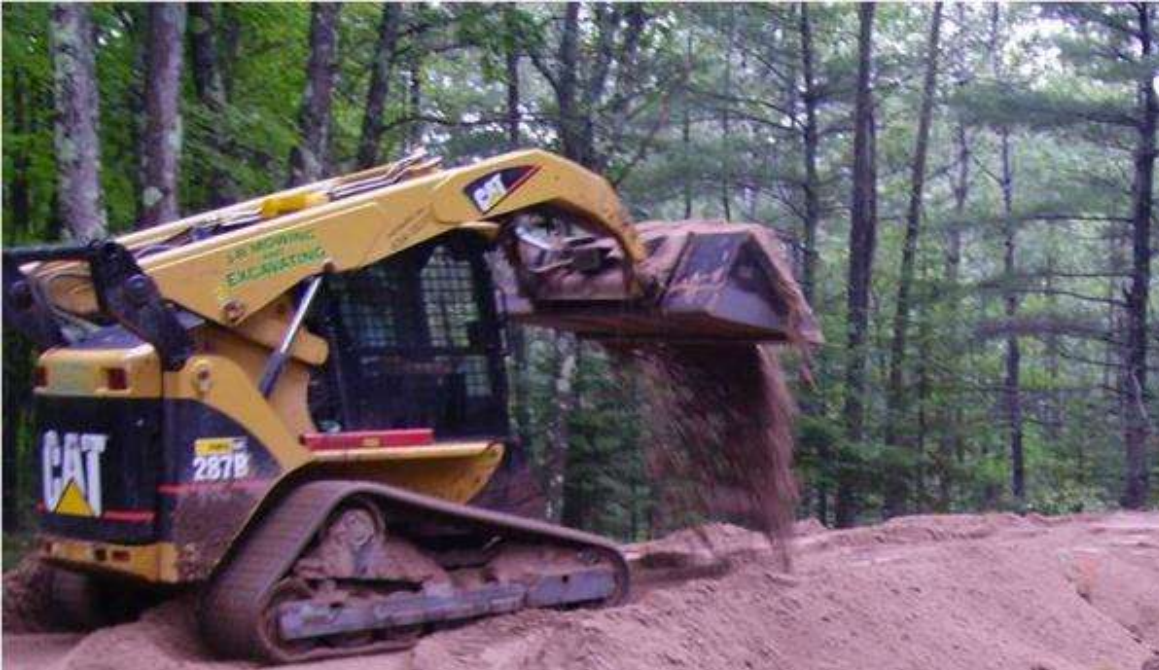
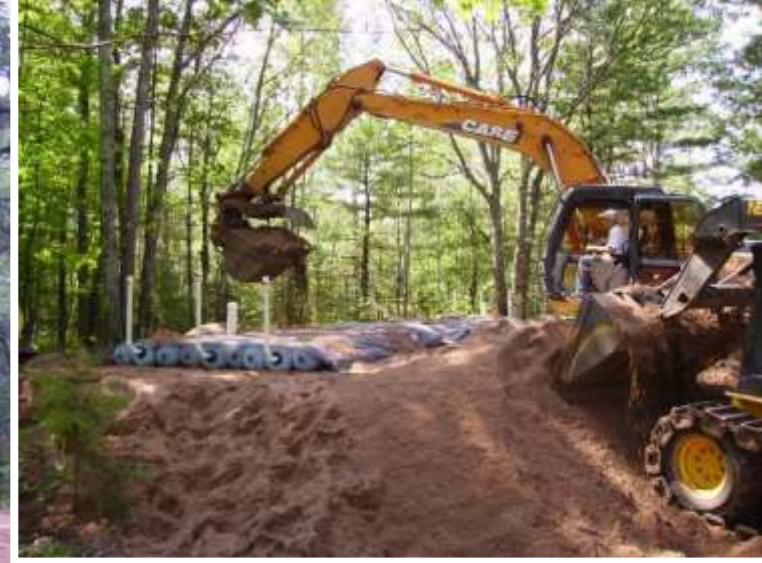
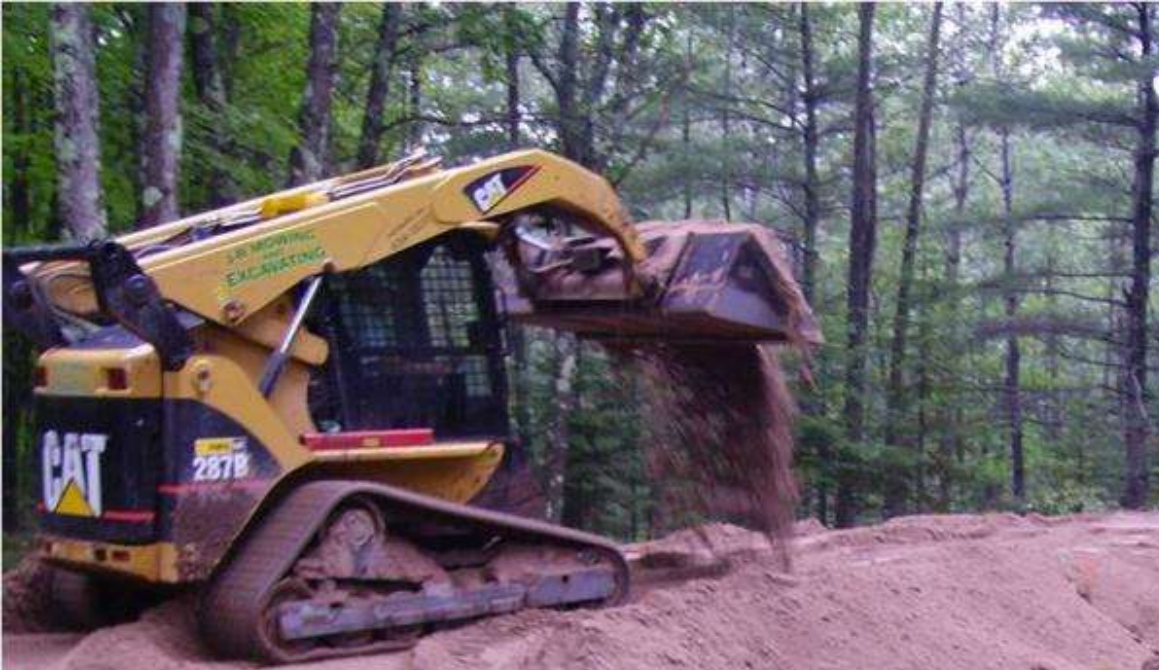
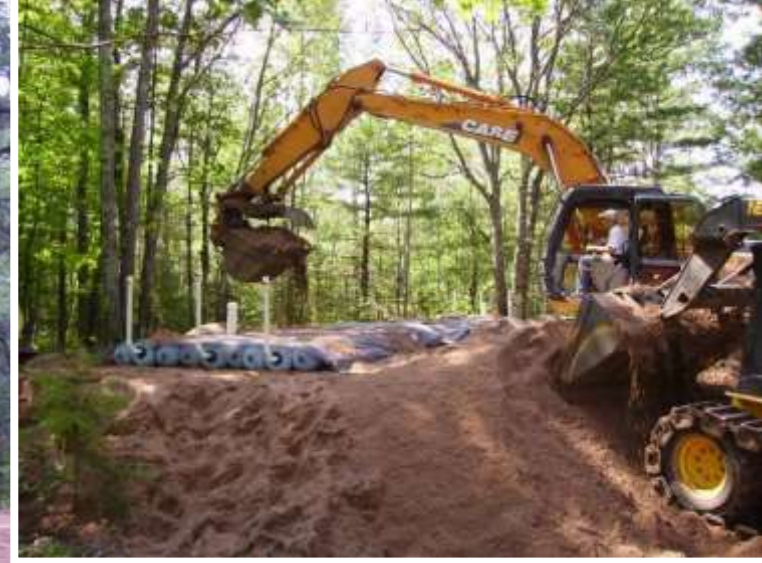
**PROBLEM:  
Siting**

**SOLUTION:  
Relocate  
Elevate**

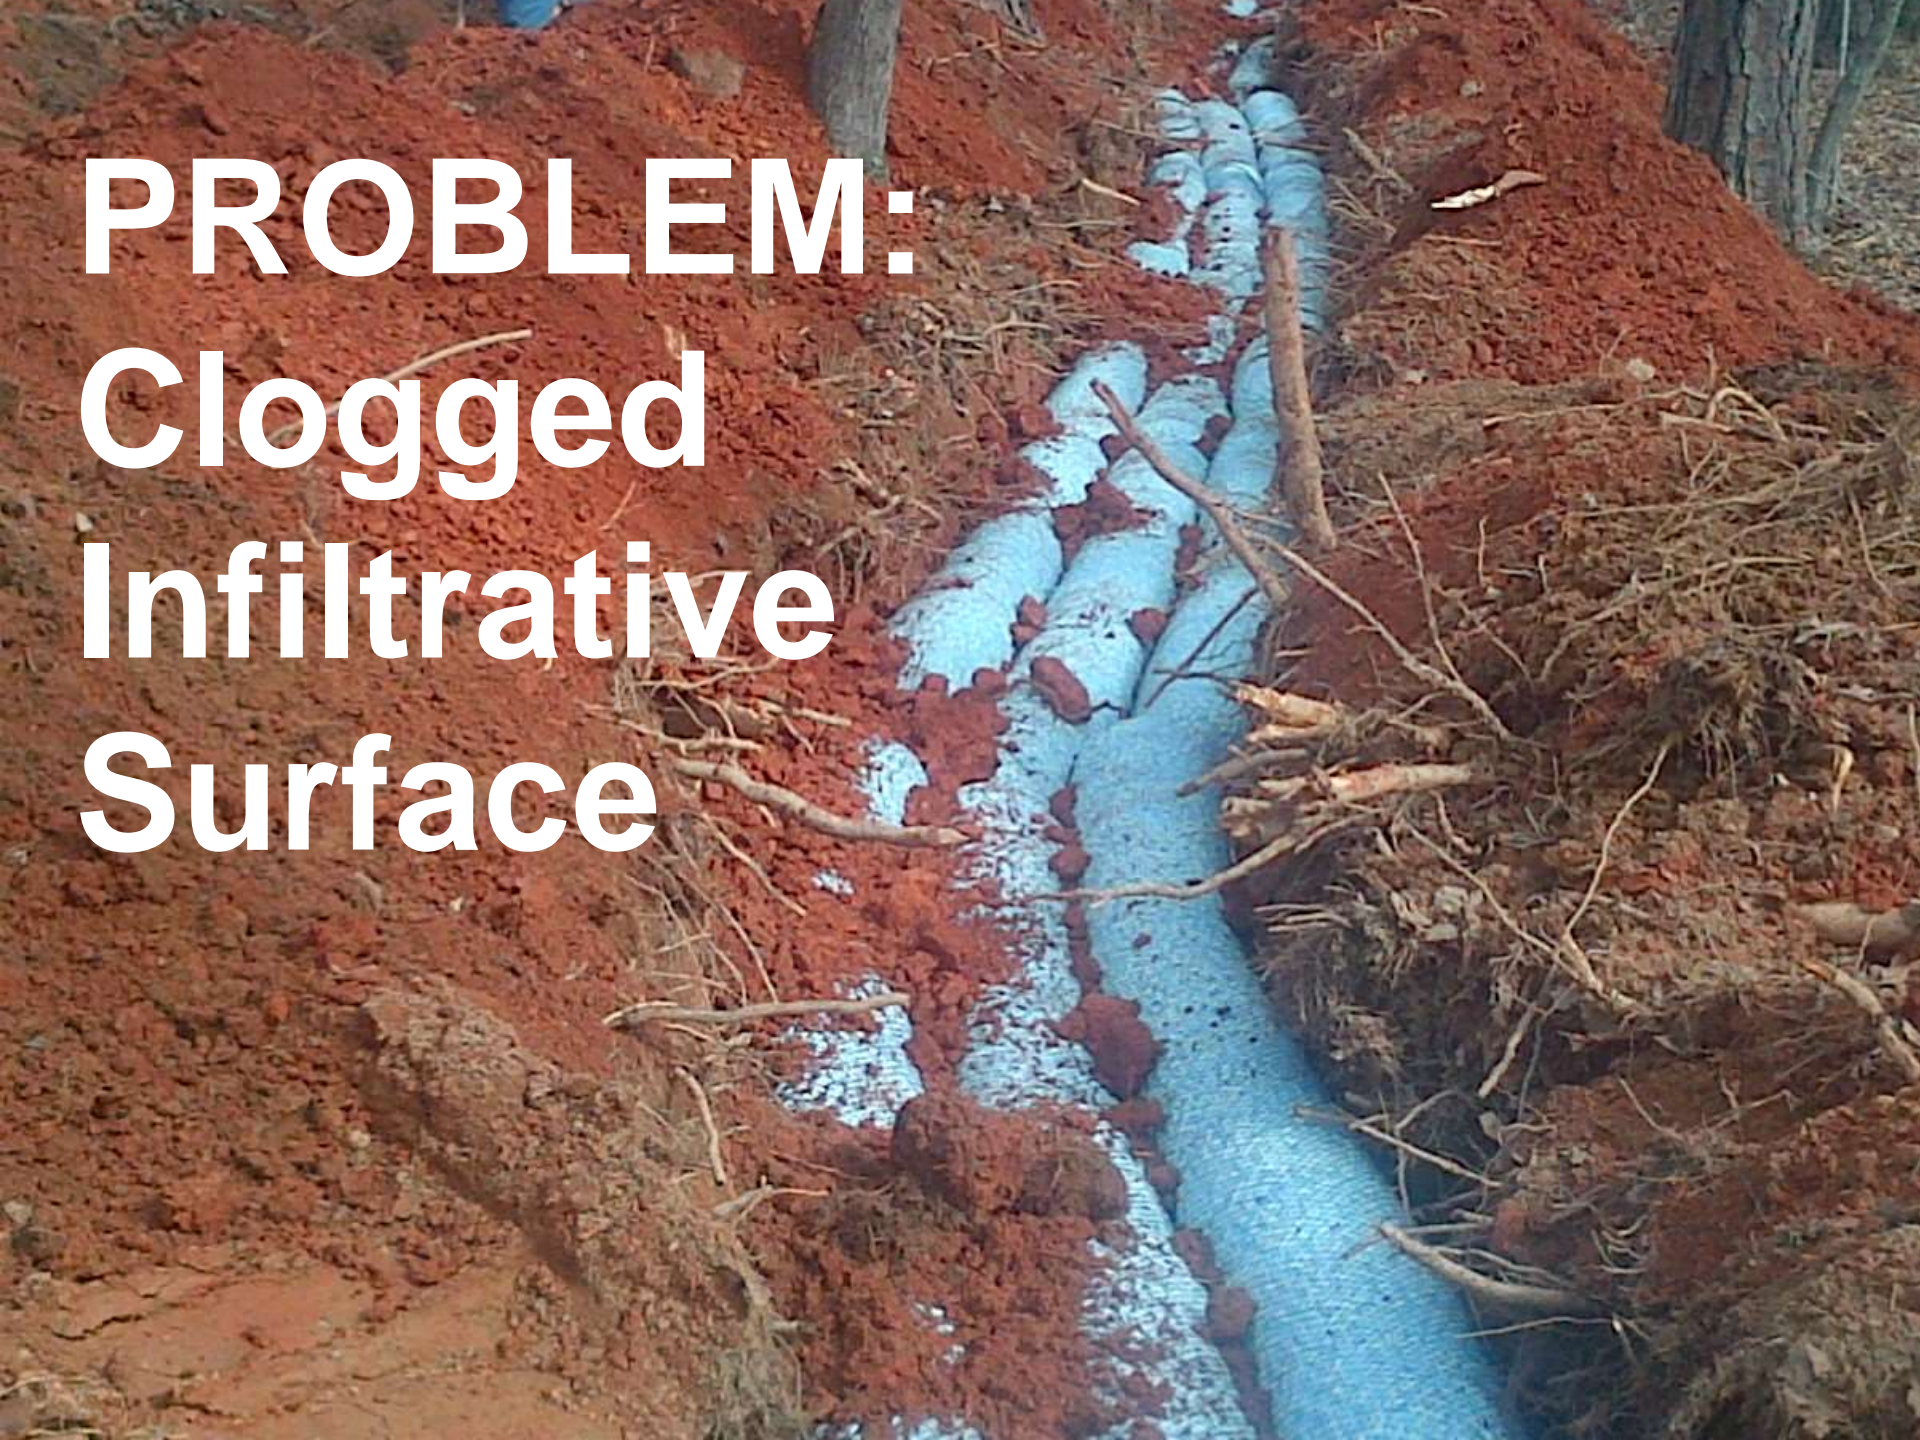
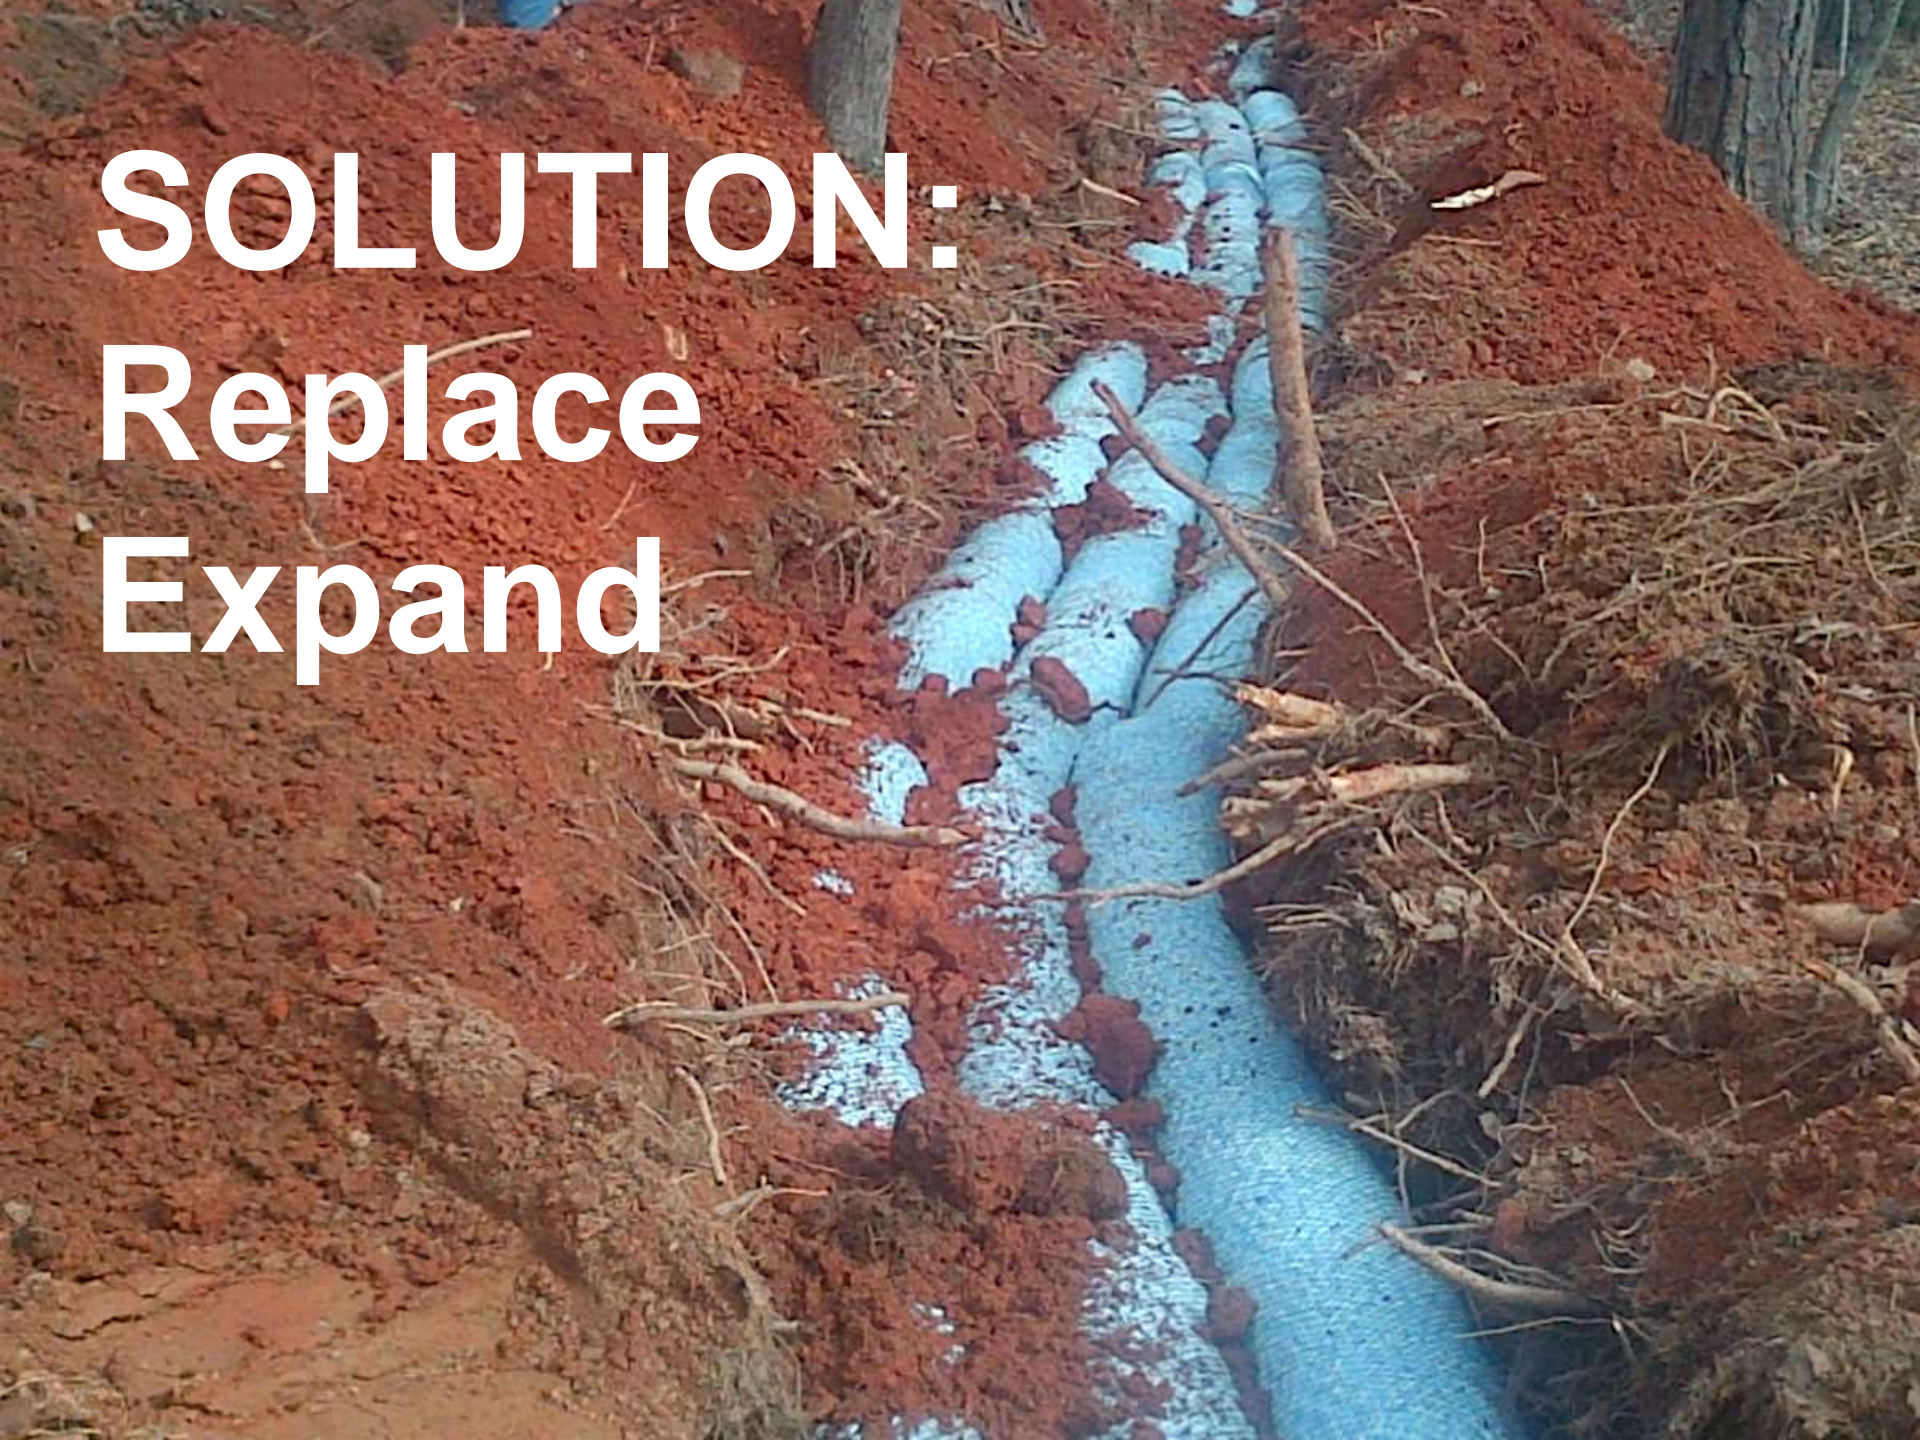
# PROBLEM: Clogged Infiltrative Surface

**SOLUTION:  
Replace  
Expand**

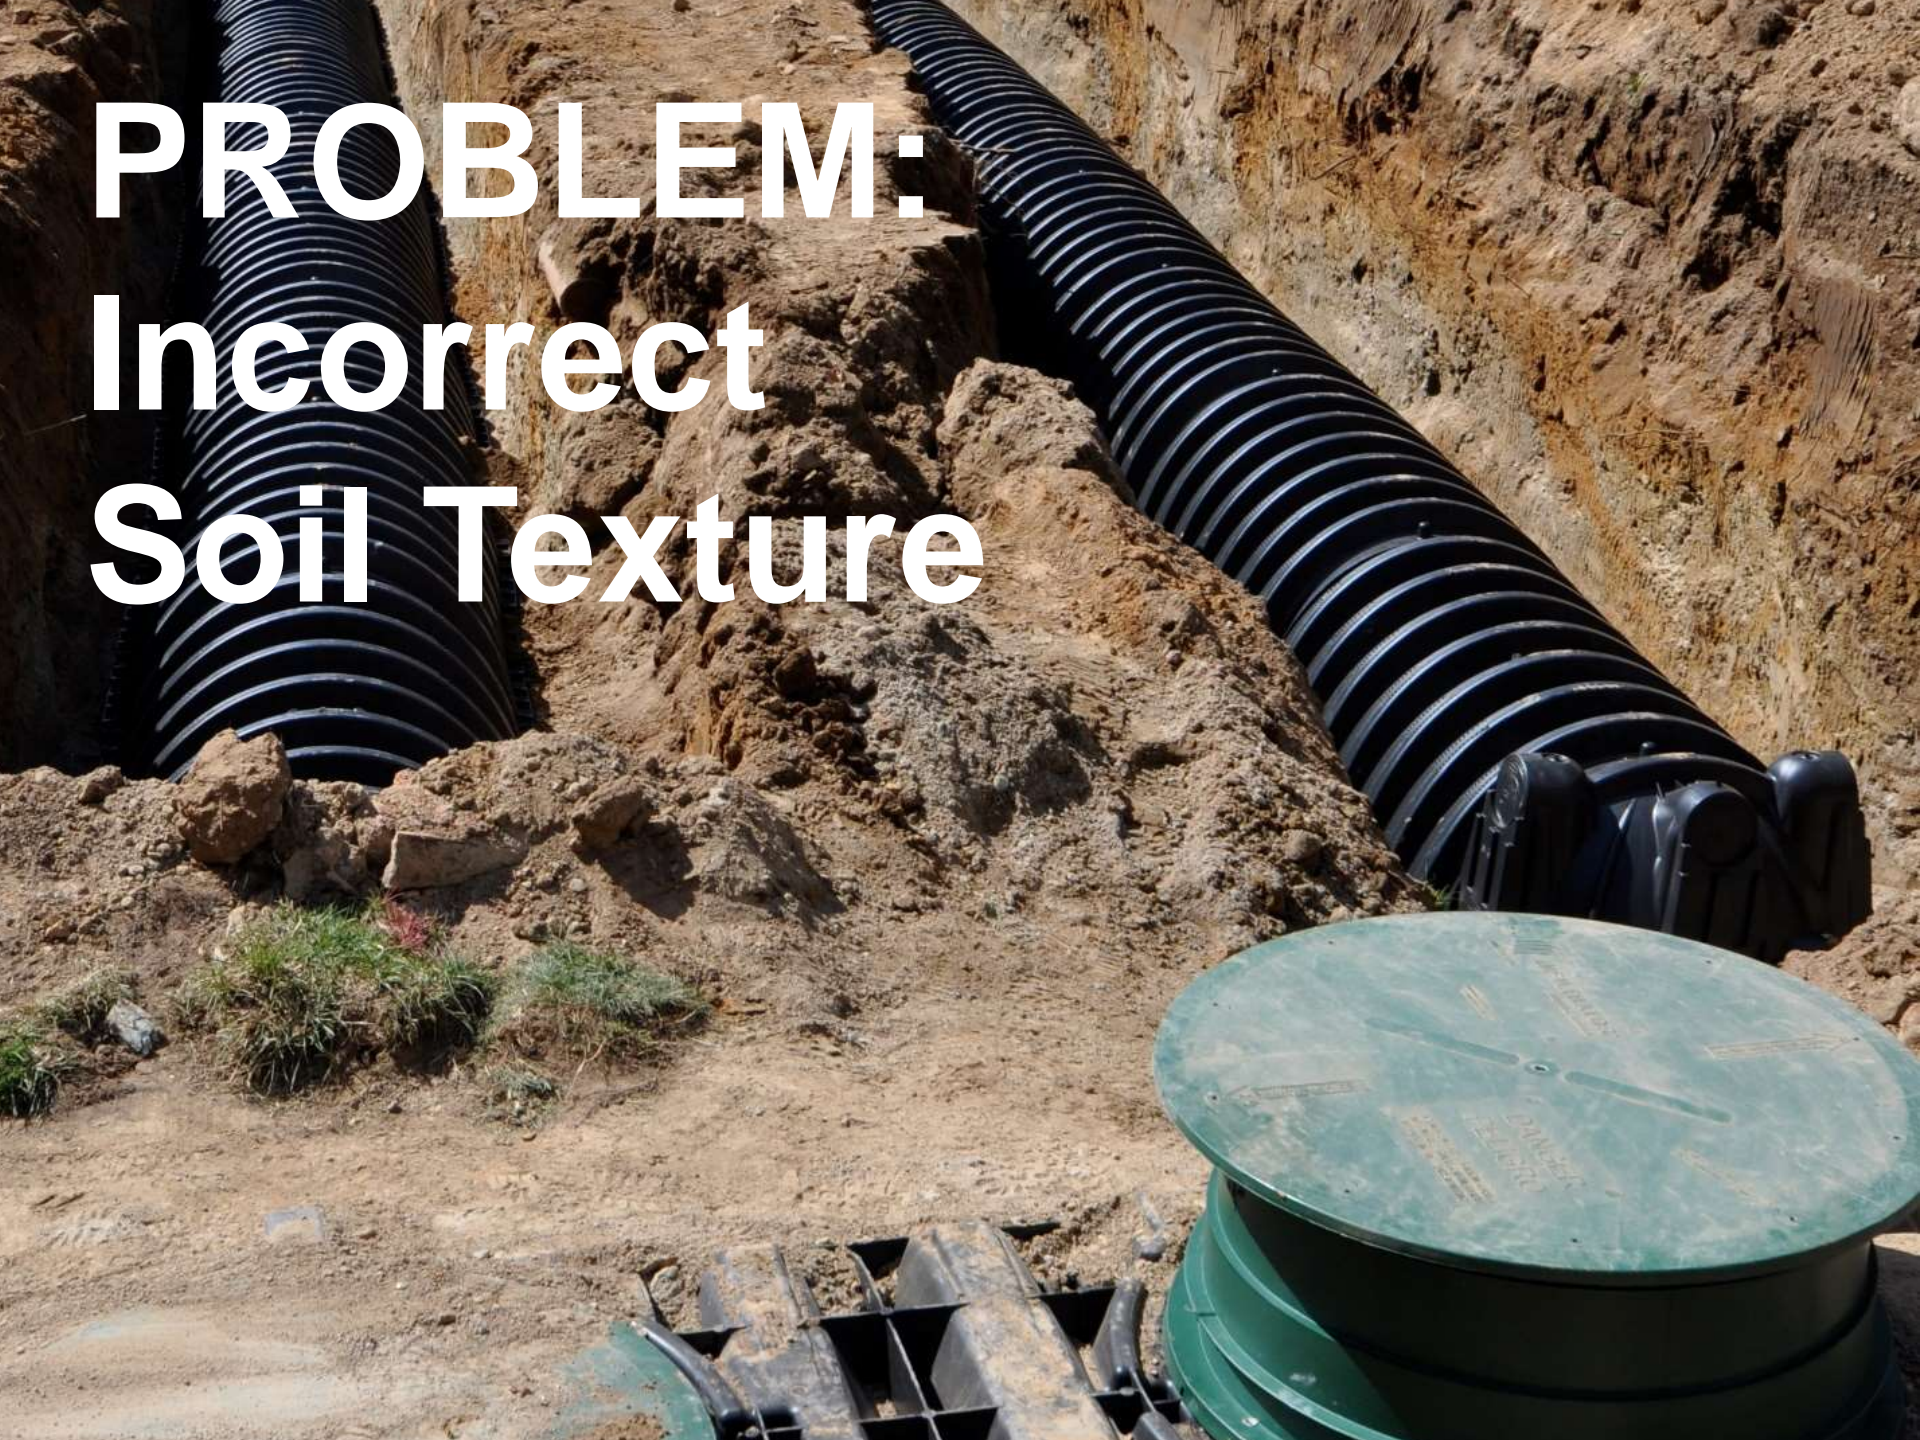
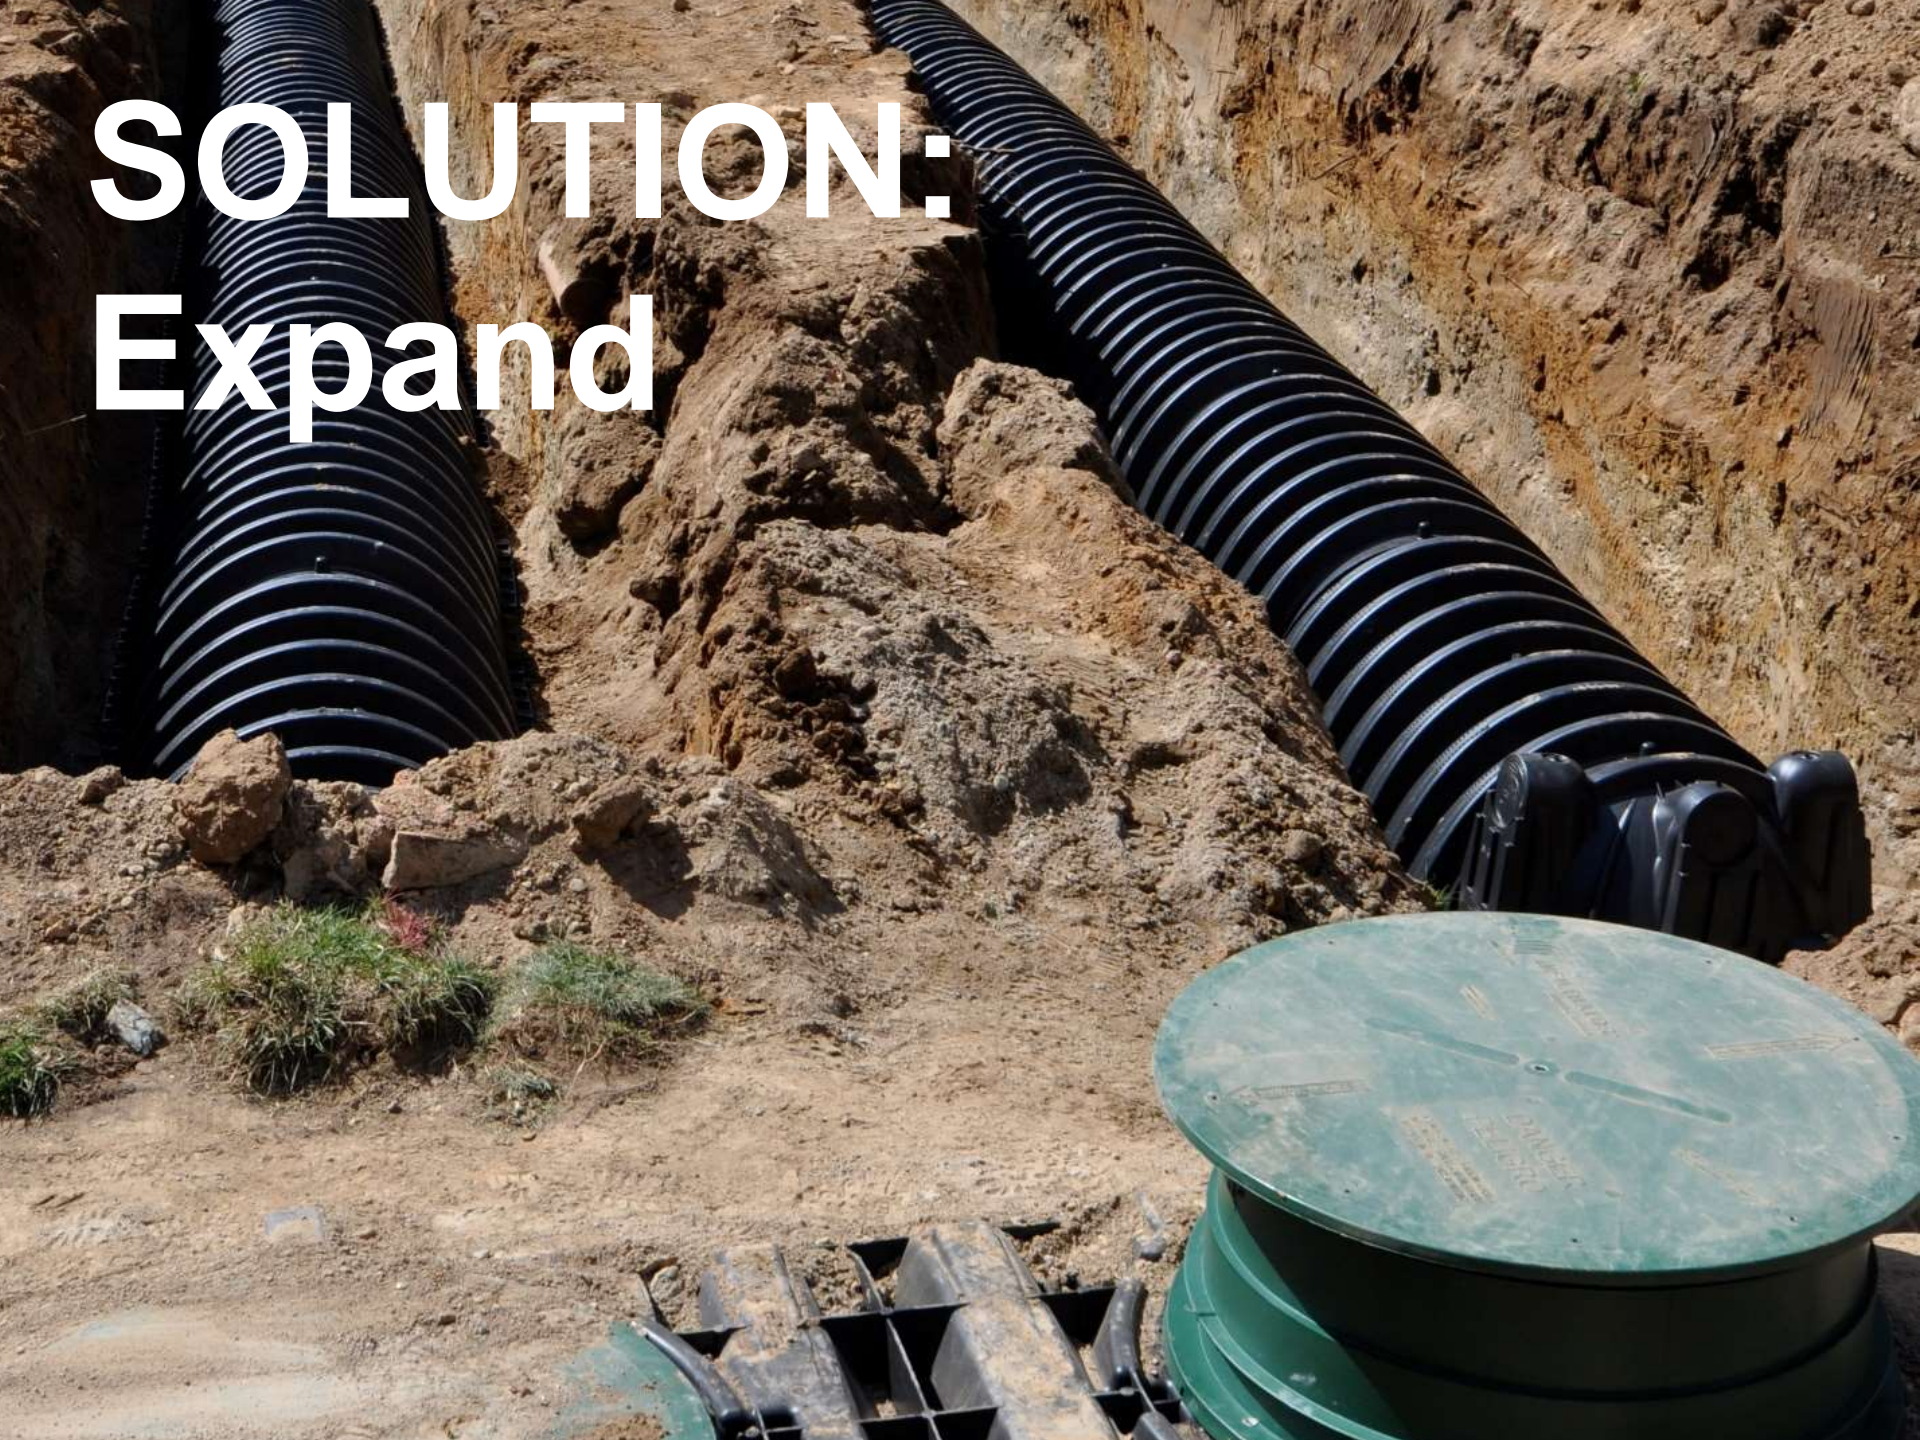
# PROBLEM: Incorrect Soil Texture

# SOLUTION: Expand

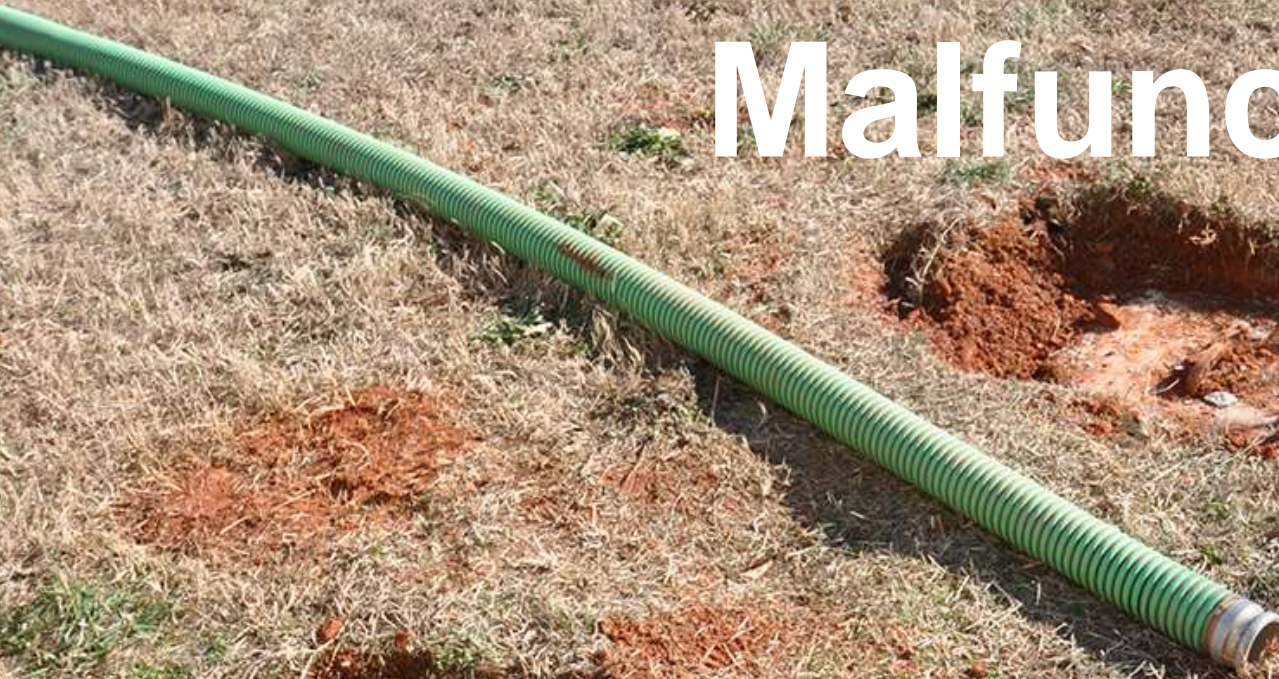
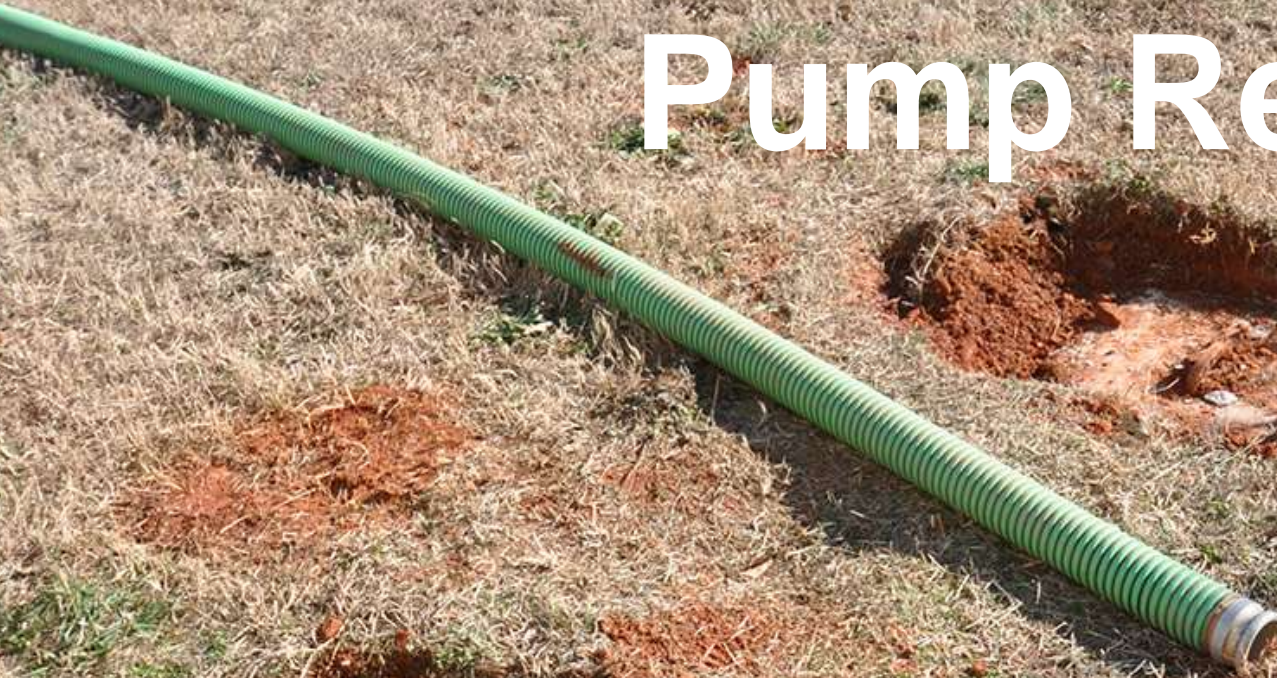
# PROBLEM: Malfunctioning Tank

# SOLUTION: Pump Regularly
