# System Malfunctions – The View from Below

Dennis Healy  
Infiltrator Water Technologies  
Area Sales Representative

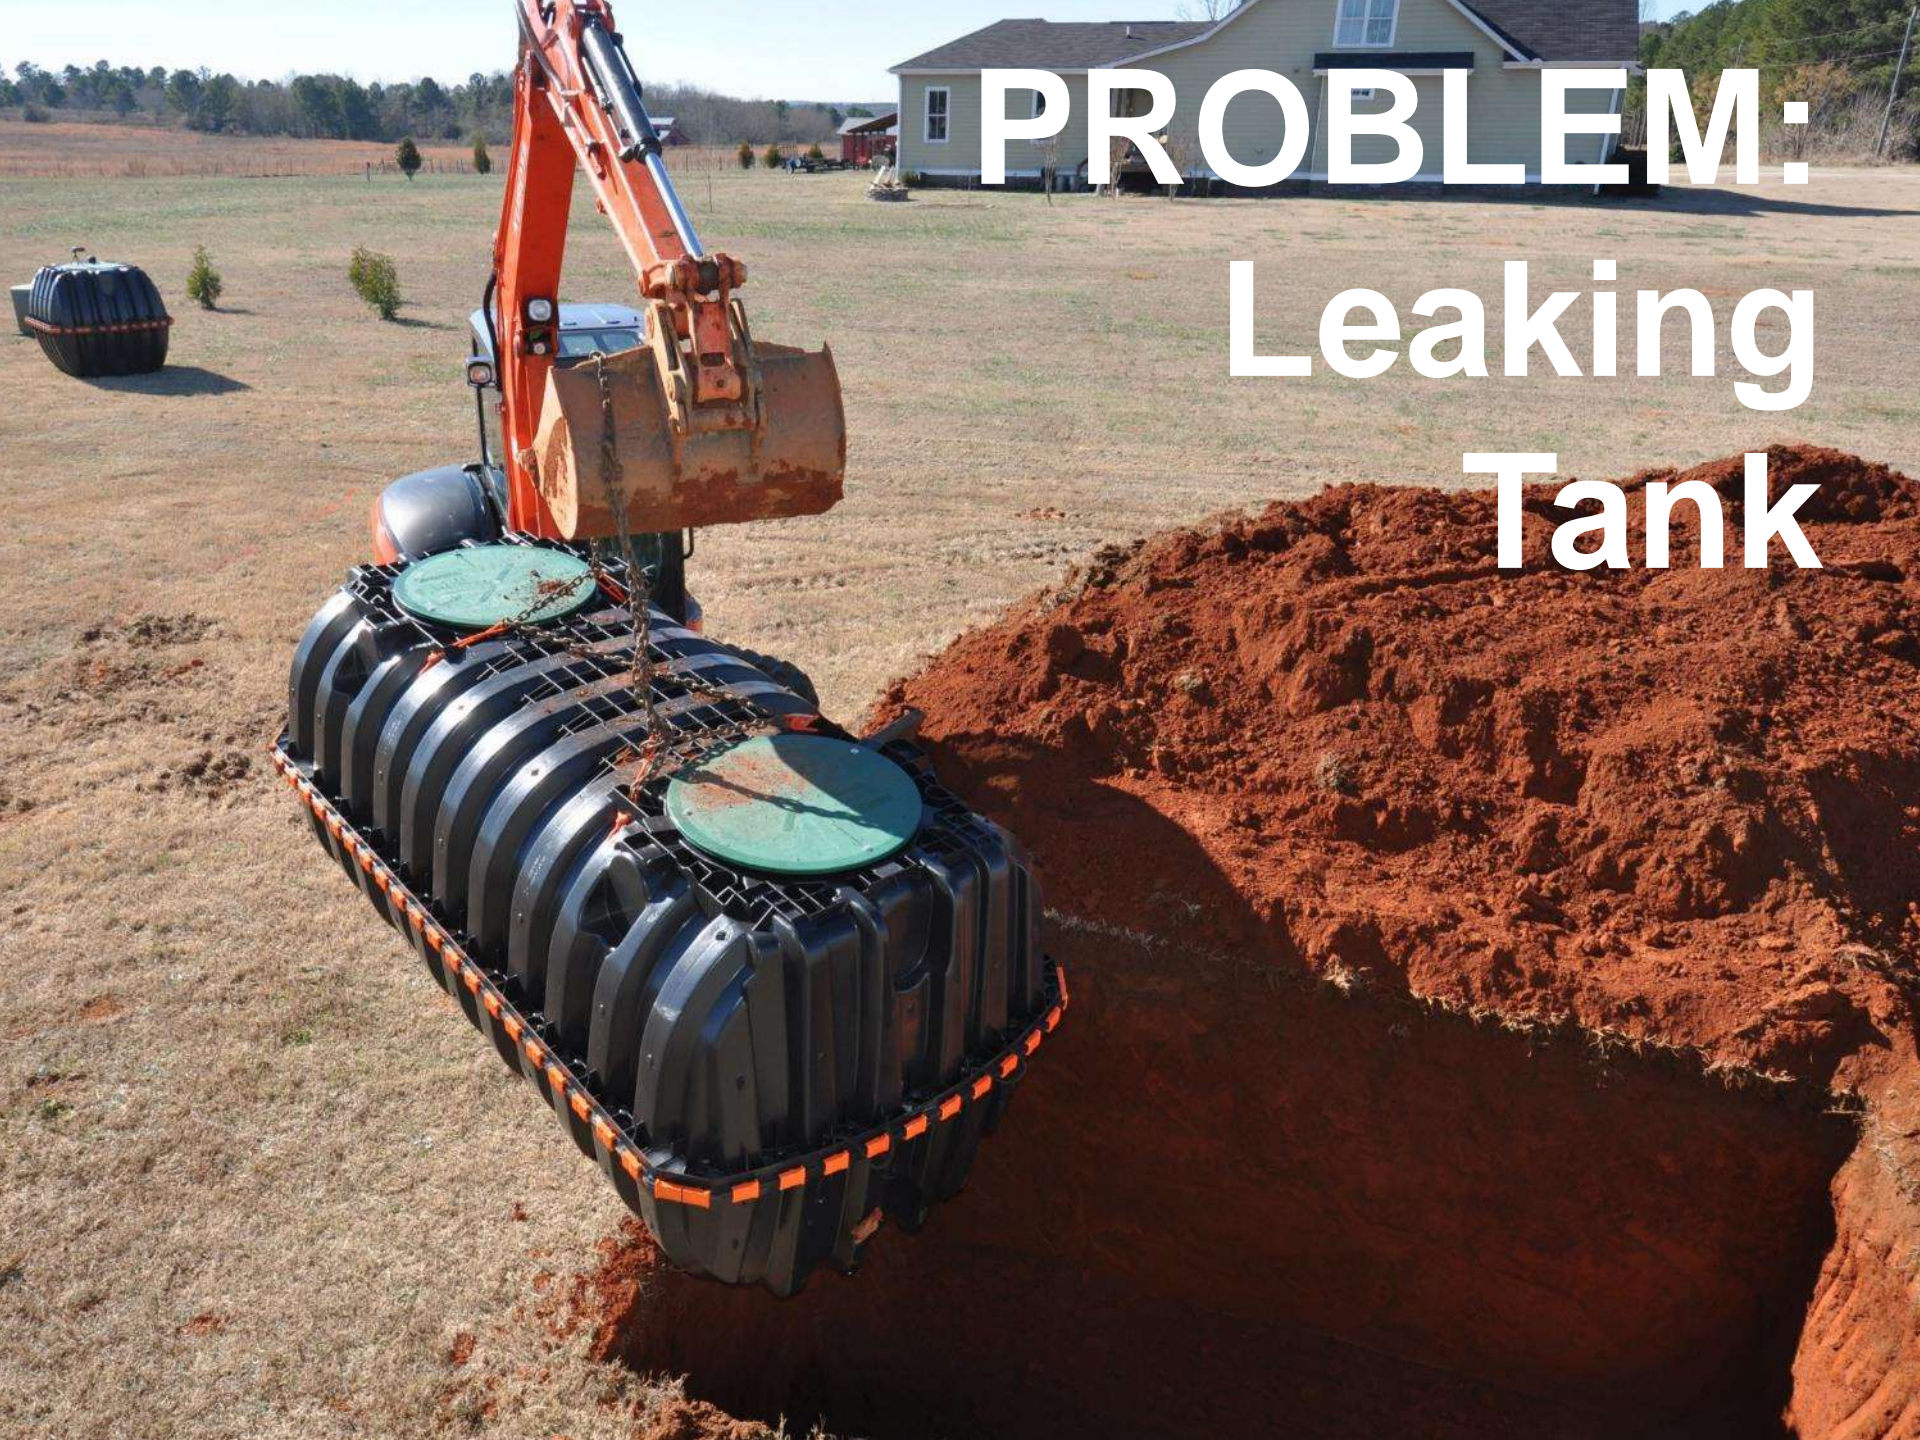
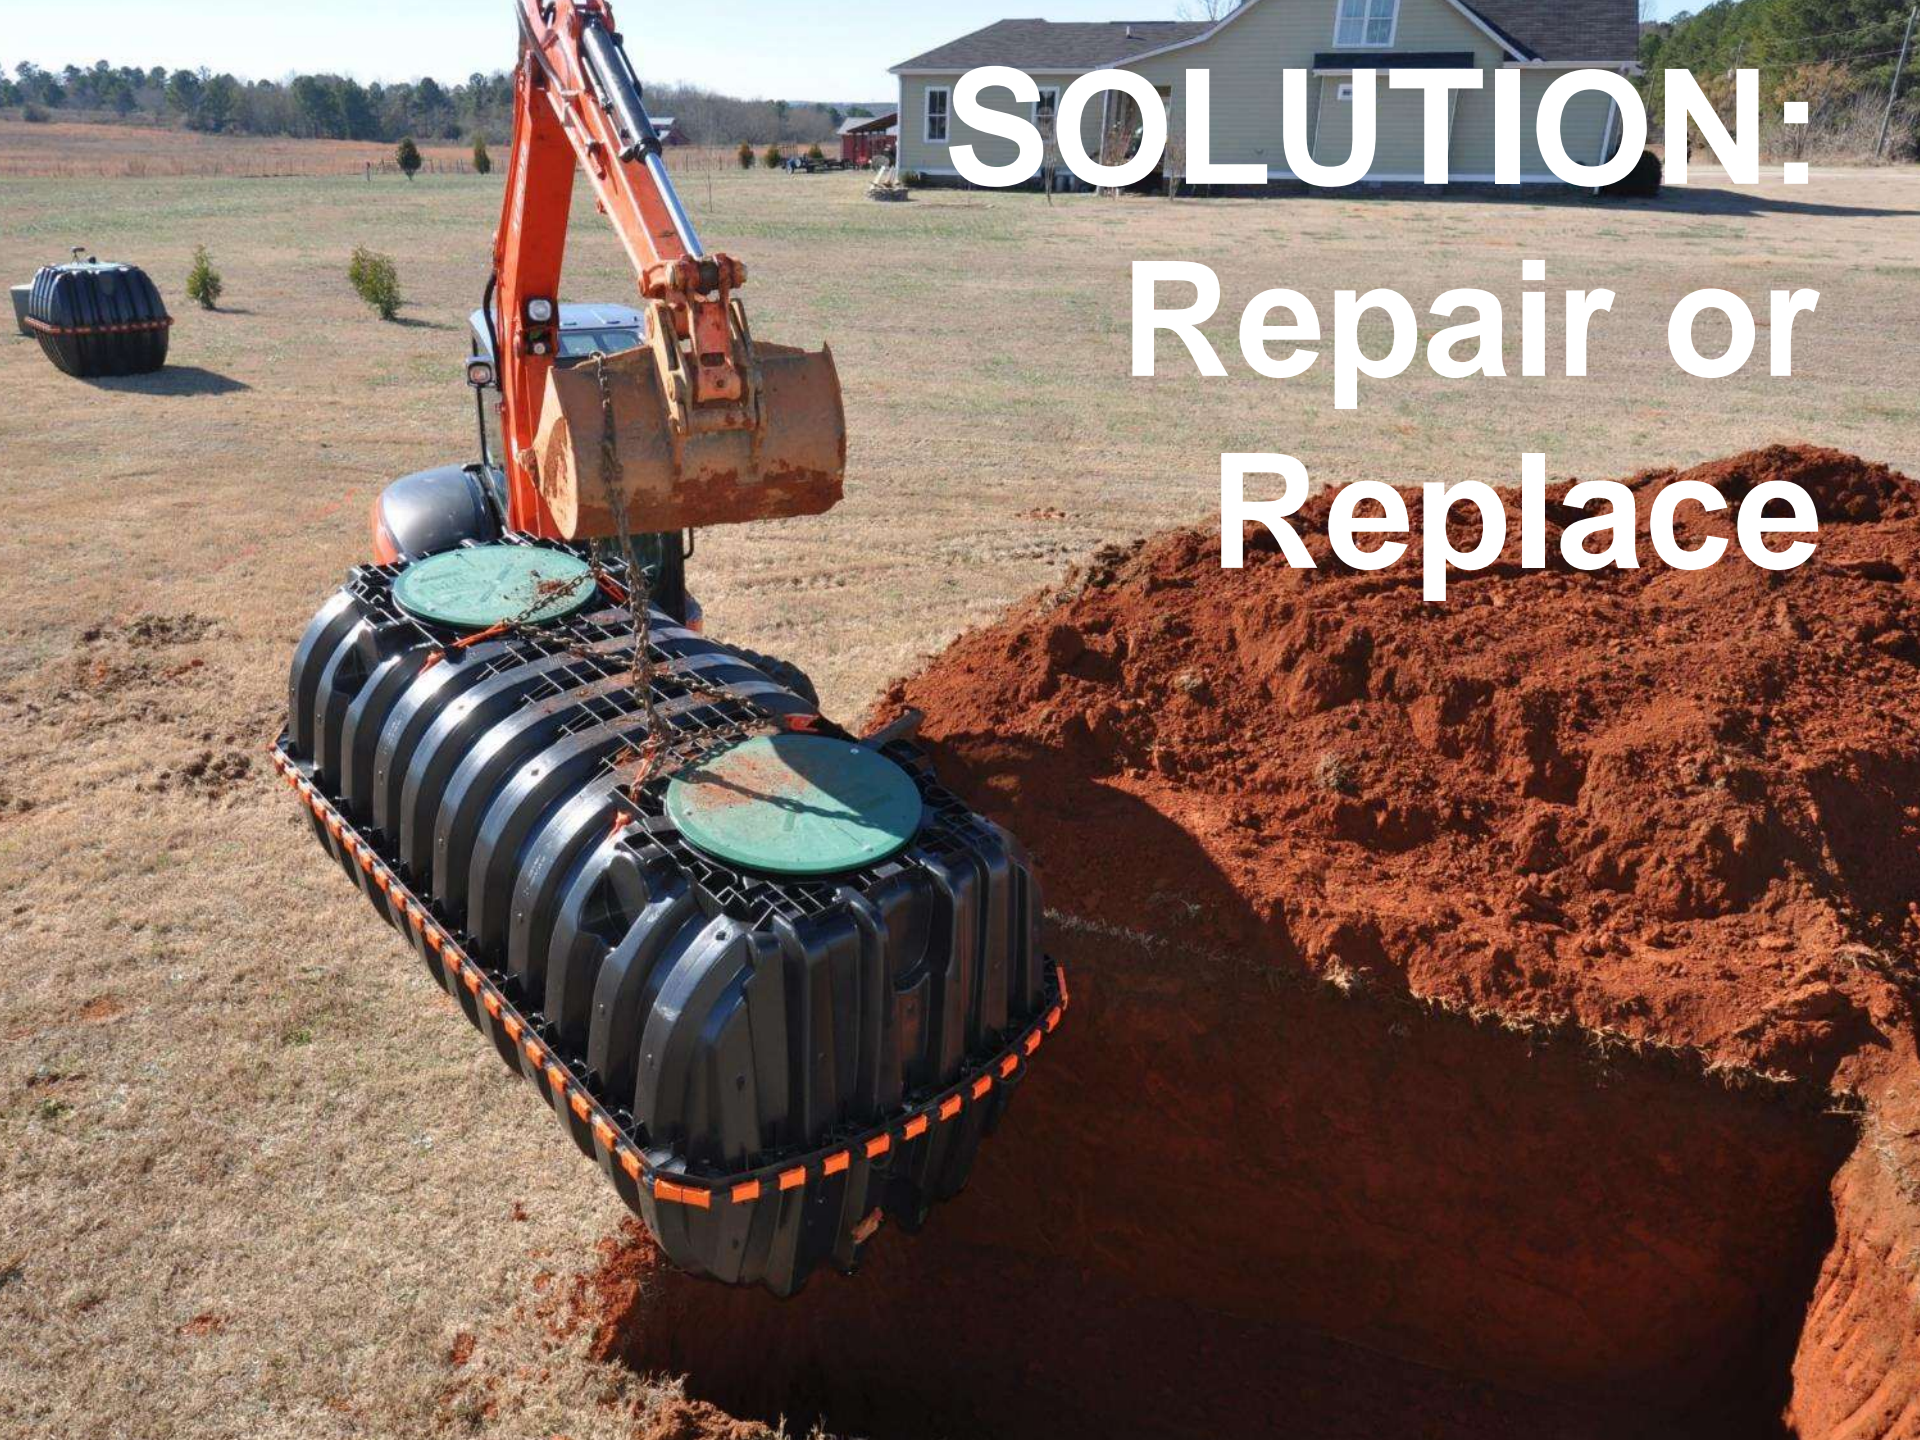
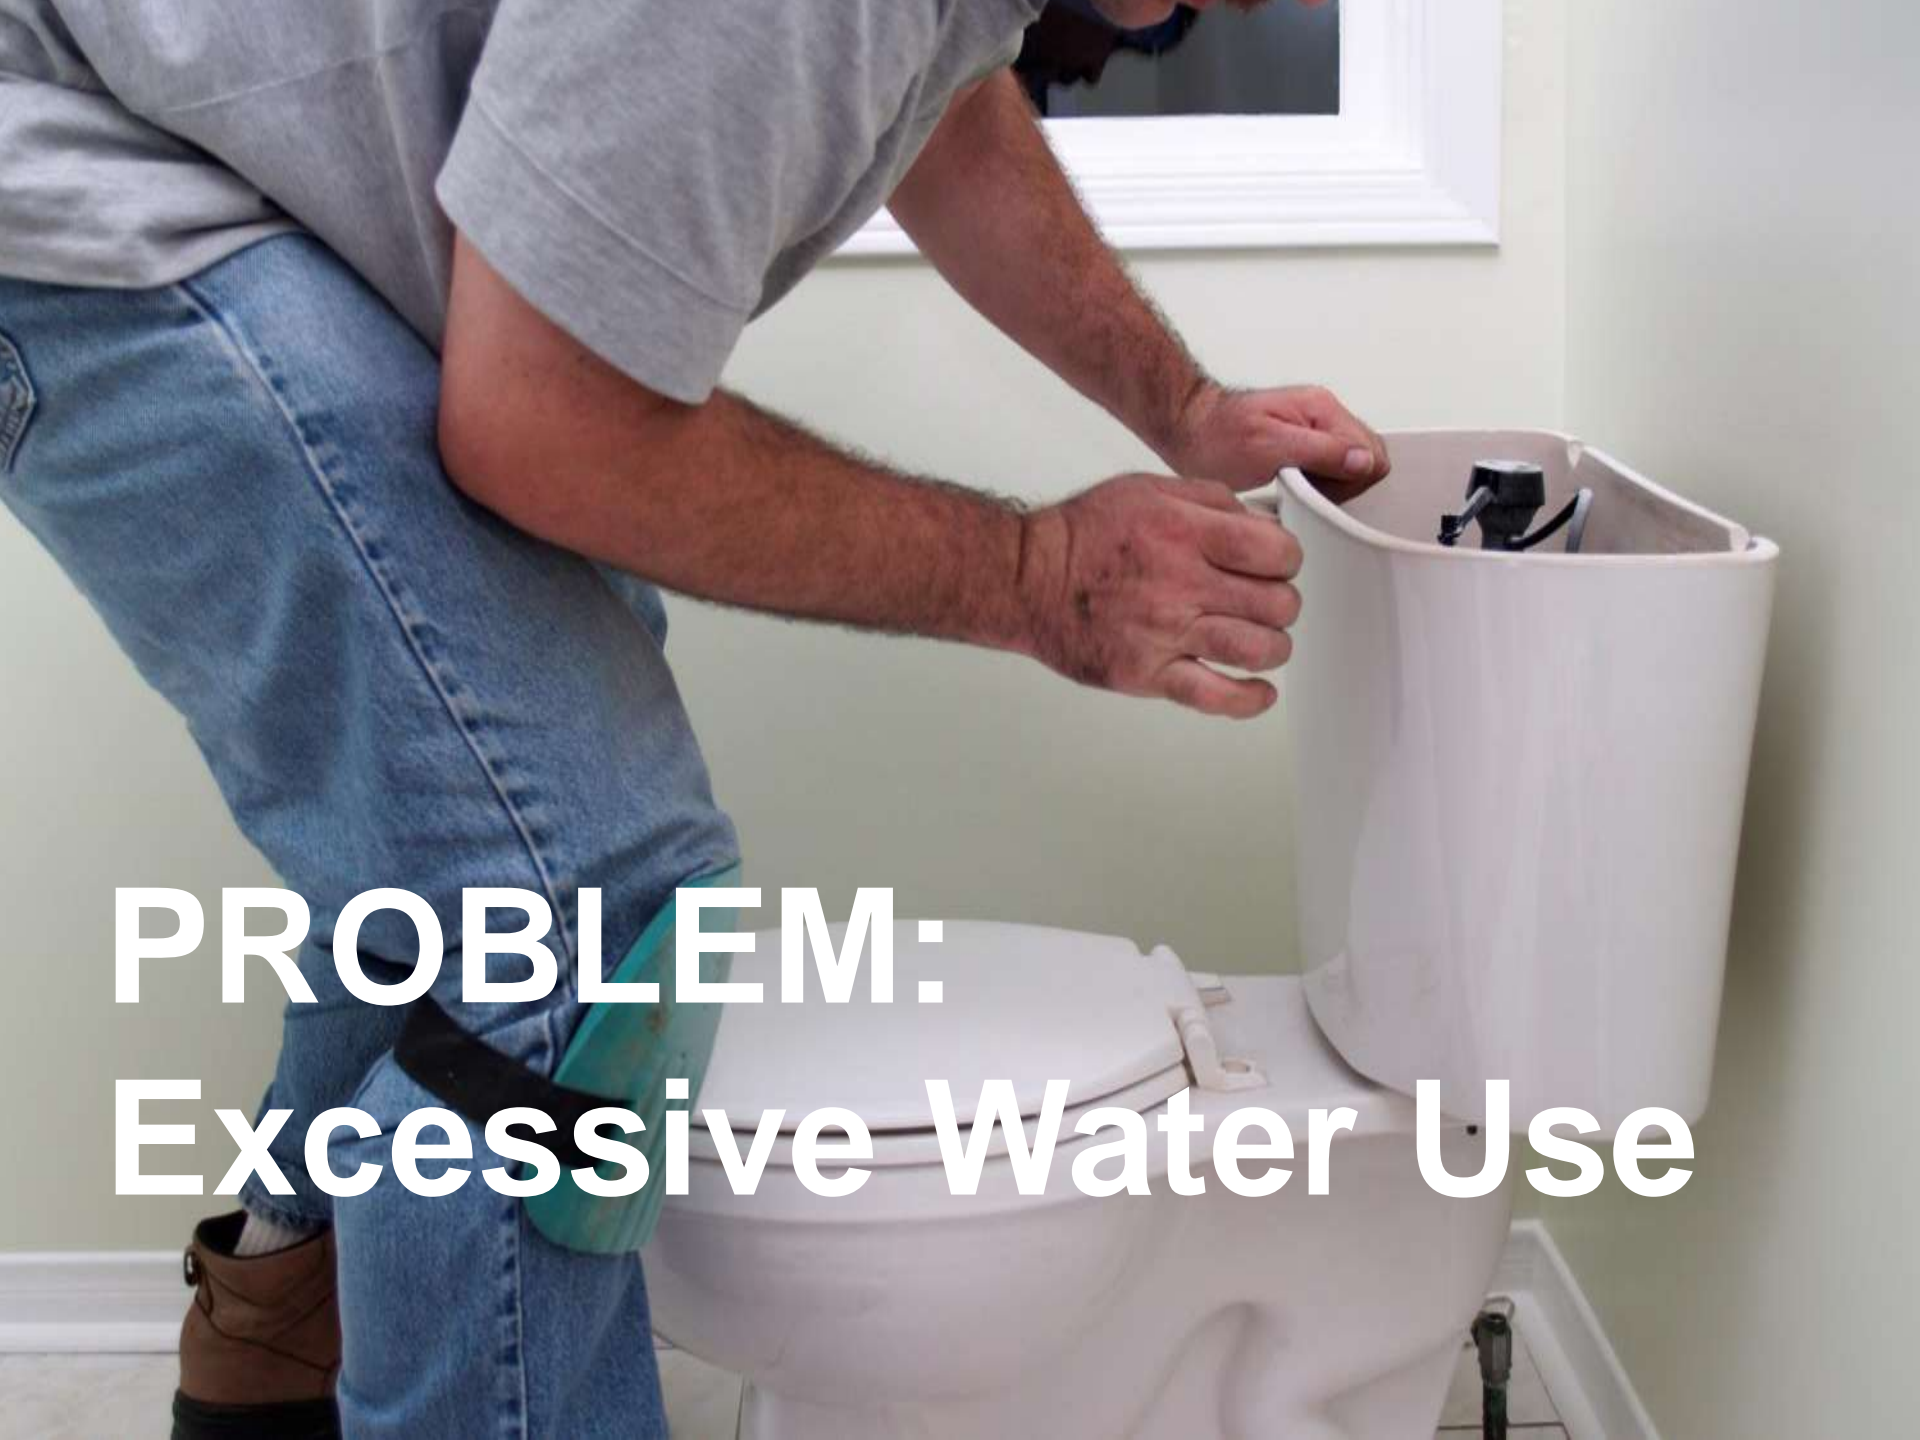
**PROBLEM:**  
Leaking  
Tank

**SOLUTION:  
Repair or  
Replace**

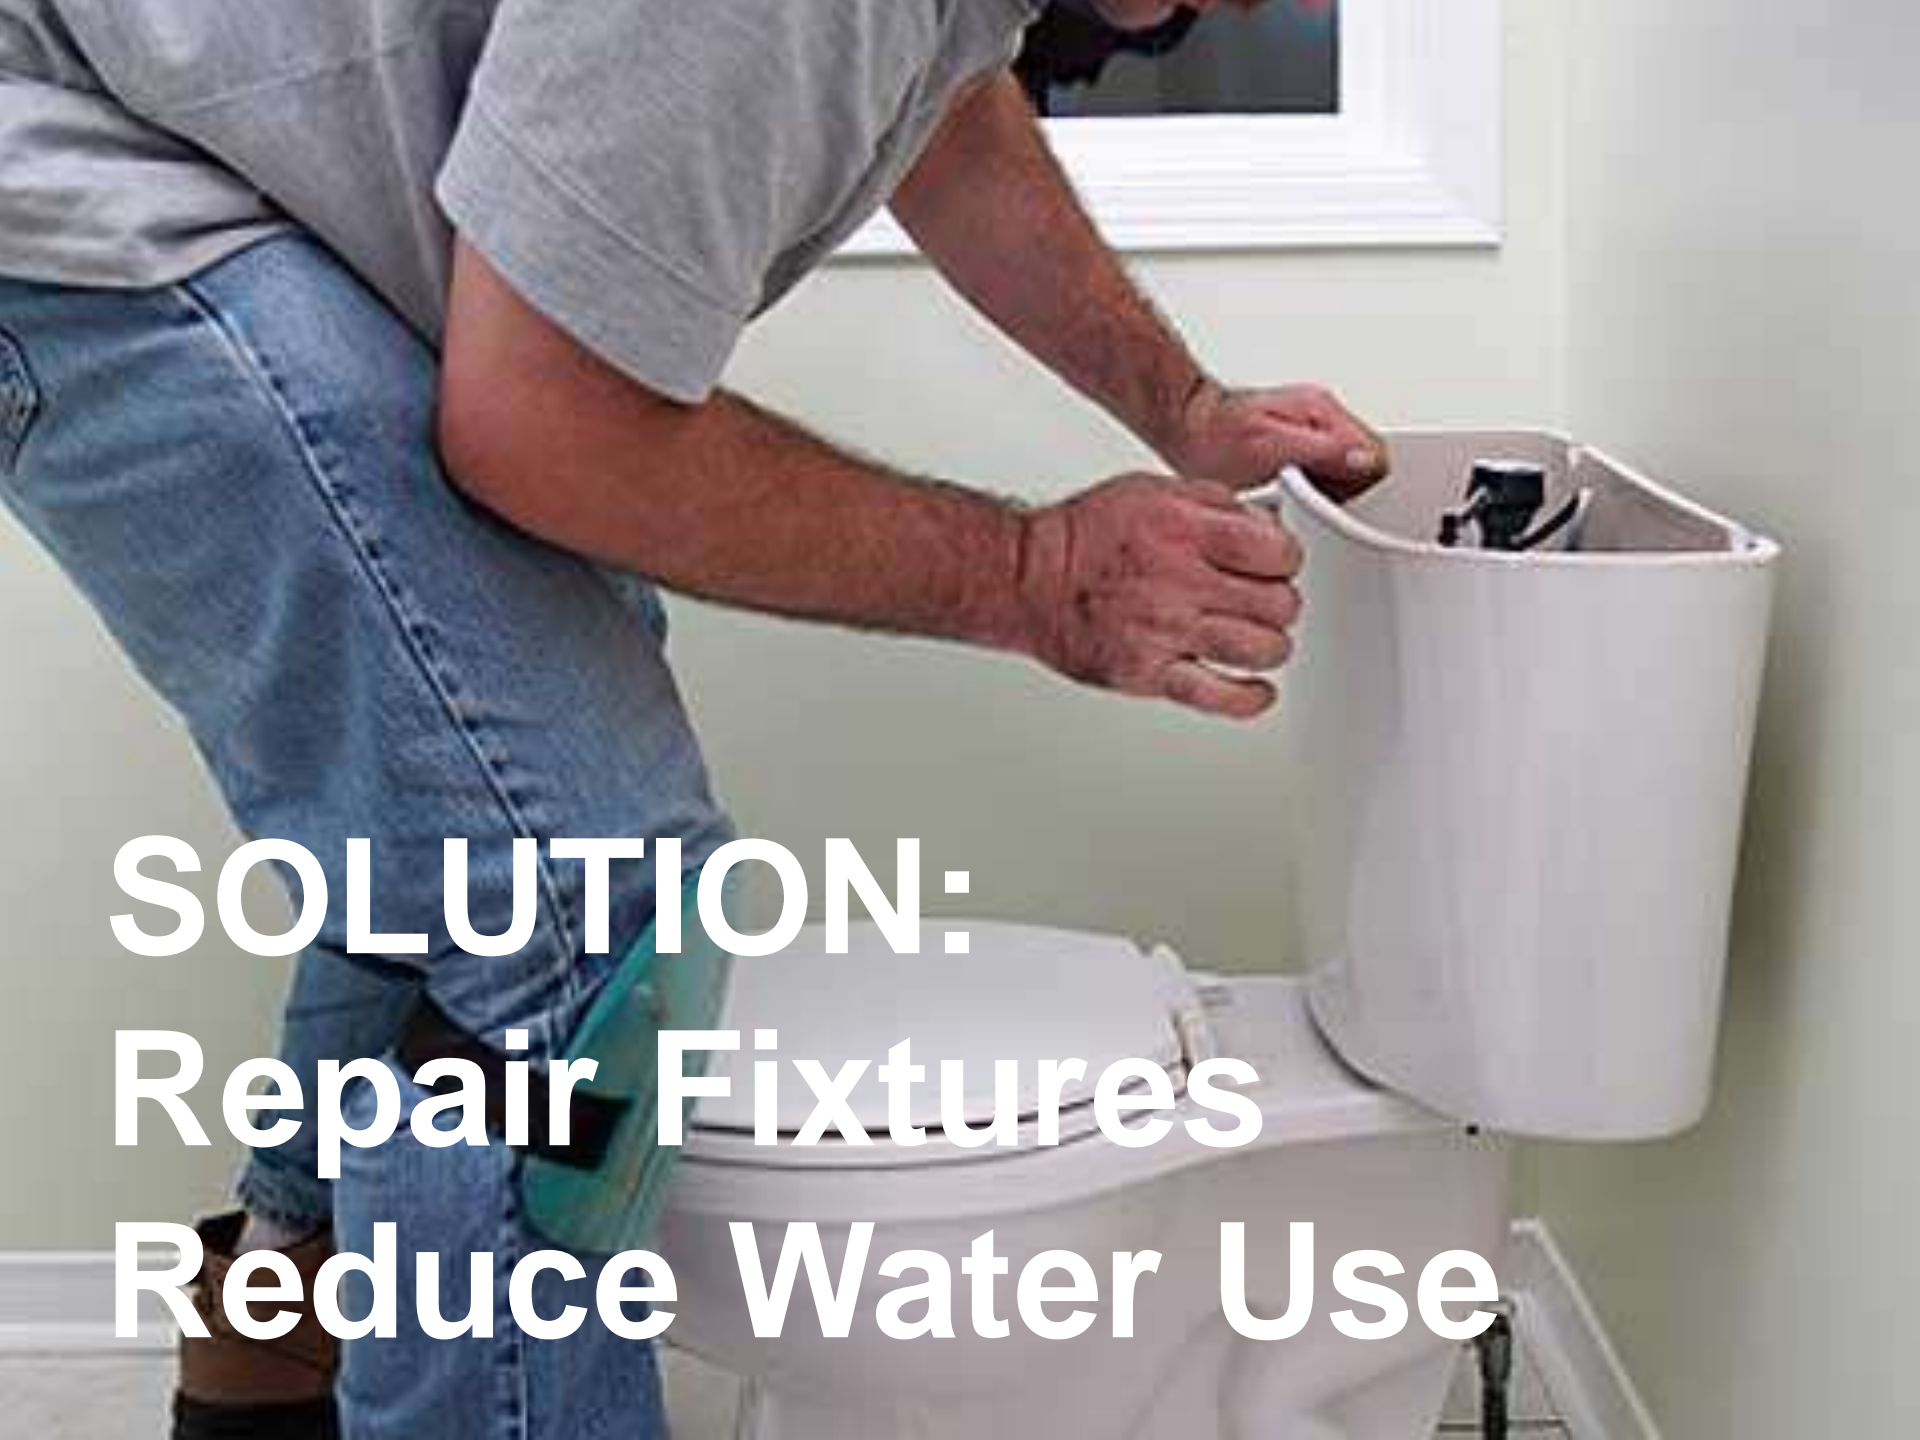
**PROBLEM:  
Excessive Water Use**

**SOLUTION:  
Repair Fixtures  
Reduce Water Use**
