# L.U.S.T.LINE

## Tanks at Ground Zero

### World Trade Center Response Petroleum Bulk Storage Tank Inspections for WTC Area

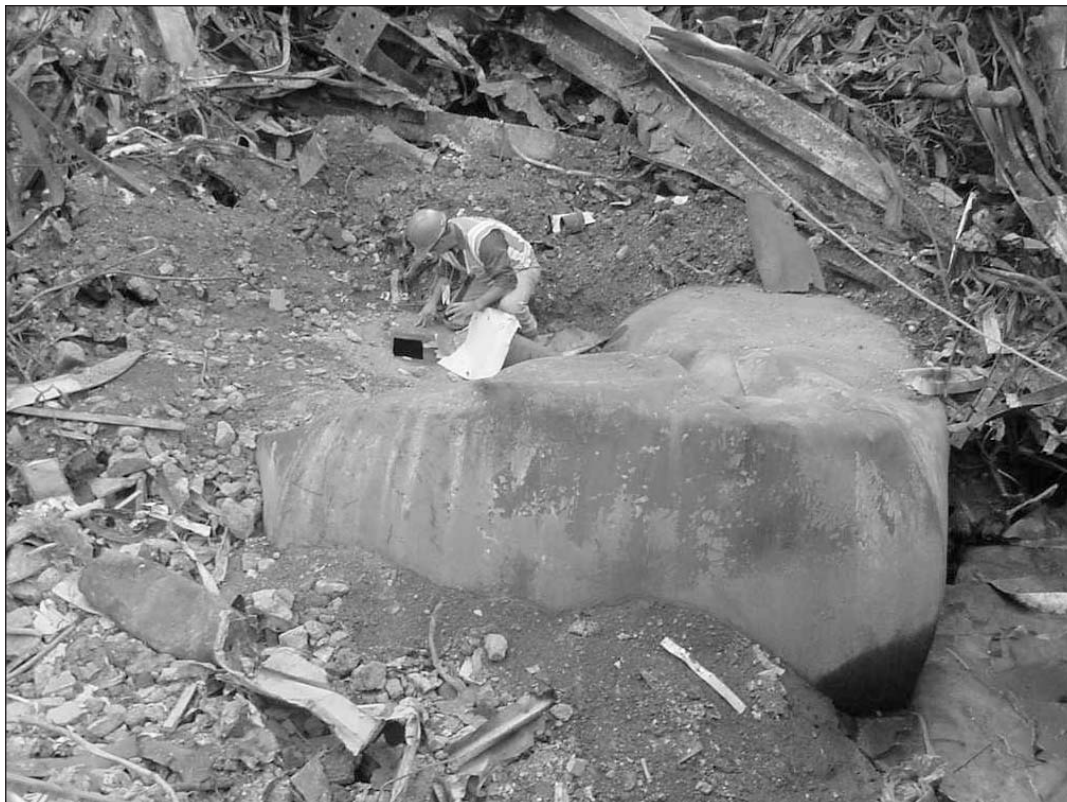
*DEC inspector on top of a 20,000 gallon tank that was crushed by the partial collapse of a building.*

DEC inspectors identified three tanks in two buildings that were damaged as a direct result of building collapses; two buildings with three tanks with piping damage; and two buildings with eight tanks with the fill and/or vent pipes that could not be inspected because they were buried by debris—these will be tested before being put back into service. In addition, one of two chiller plants containing Freon was damaged in Building 1 of the World Trade Center—the EPA made arrangements to recover the remaining Freon from these plants.

Except for one building that suffered minor piping damage, all of the tank and piping damage were in buildings that collapsed or suffered major structural damage. Building owners have already initiated or completed repairs of any tank or piping damage. The inspection results indicated that there were very few tanks that were damaged in Zone 2; however, as a precautionary measure, DEC contacted owners of storage tanks that it did not inspect in Zones 2 and 3 to advise them to independently inspect their tanks and piping. Tank owners were instructed to notify DEC for a follow-up inspection if they discovered piping or tank damage.
