L.U.S.T.LINE

SPECIAL APPENDIX to Michigan's Noninvasive UST Assessment

ODYSSEY

by Dan Yordanich

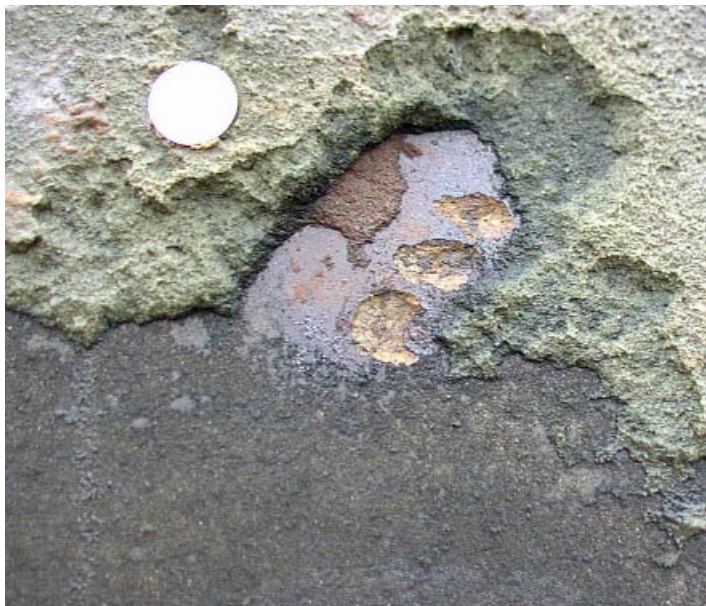
1 Potential "rust plugs."

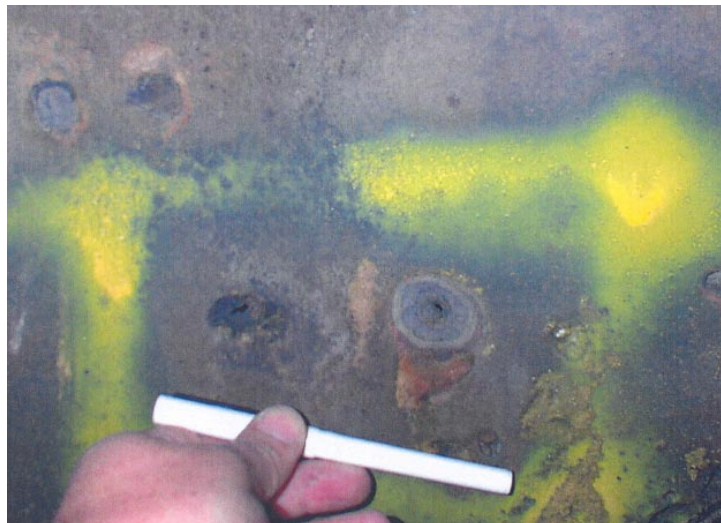
#3 Perforations in tank wall.

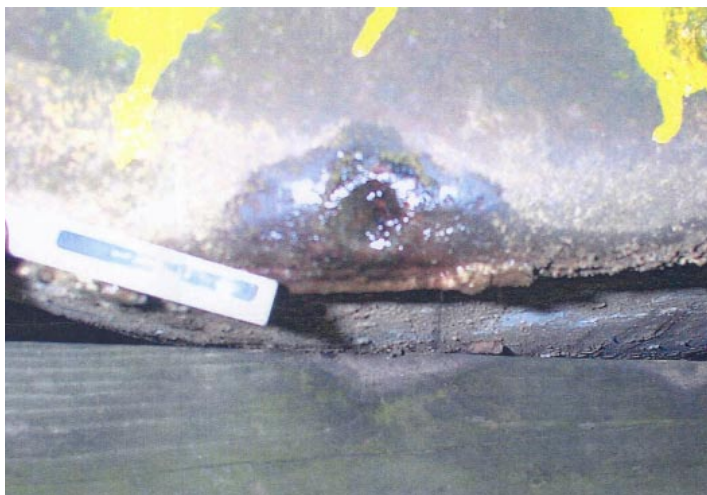
2 : Perforation in endcap.

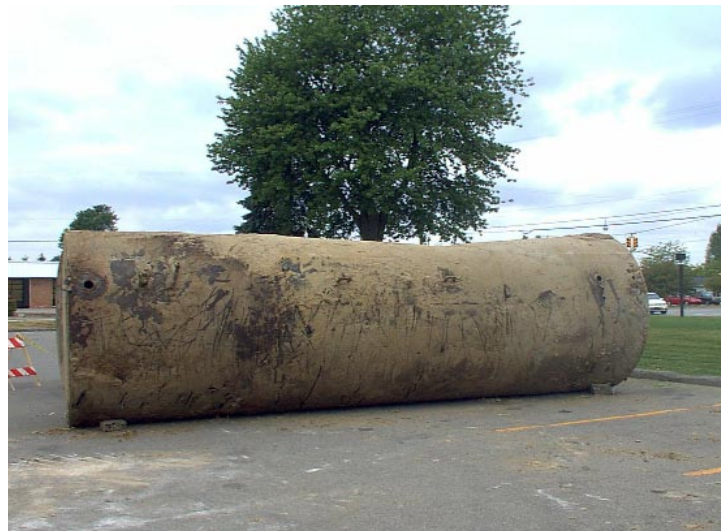
#4 Tank walls out of round

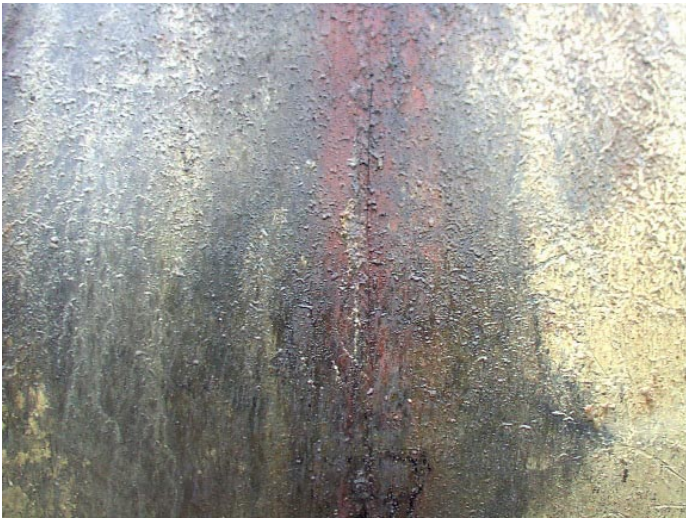
#5 Split weld seam or crack in tank wall.

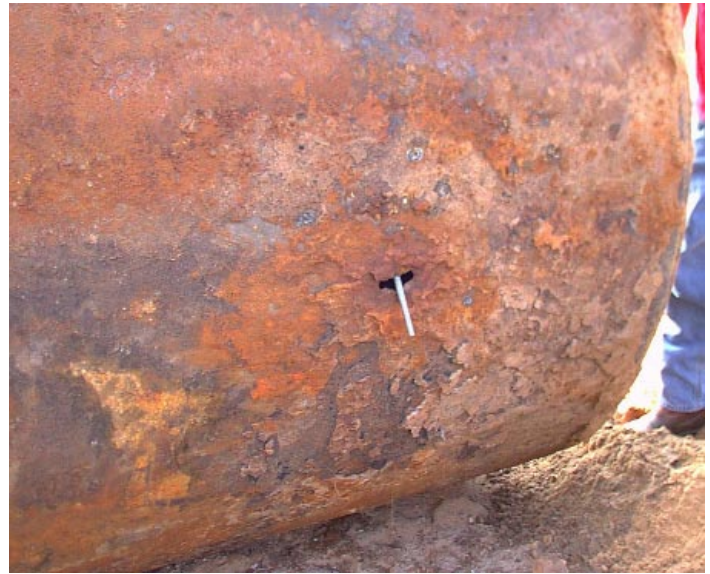
#8 In cases where the non-invasive assessment methodology may have predicted the USTs to be suitable for the installation of a cathodic protection system, it still did not address the need to provide striker plates in USTs to prevent holes being formed under the drop tubes. The non-invasive assessment of this tank predicted uniform corrosion.

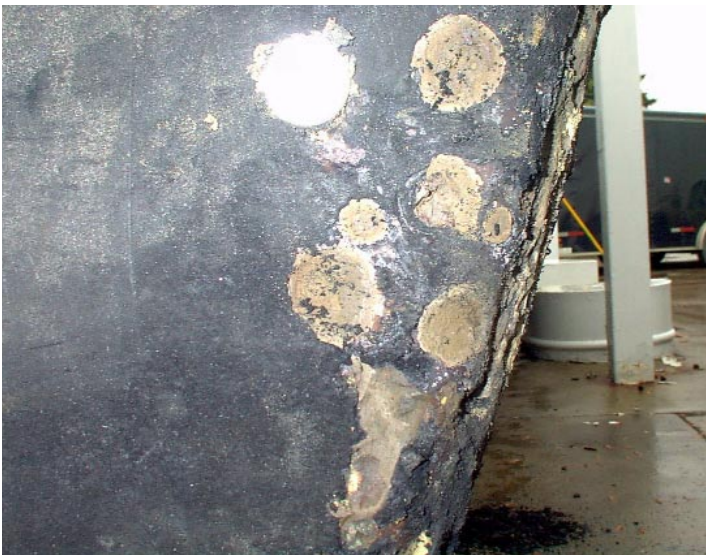
#6 Pitting corrosion and preferential corrosion of the weld seam along the endcap weld.

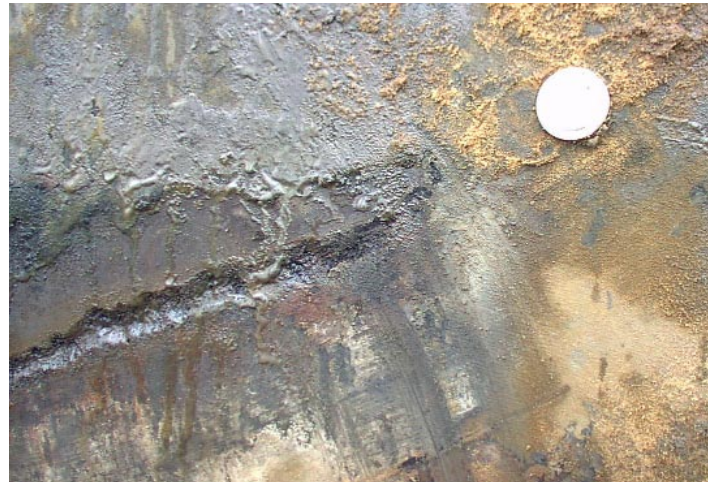
#9 Pitting along damaged area penetrated about 1/4" into the metal. The non-invasive assessment of this tank predicted uniform corrosion.

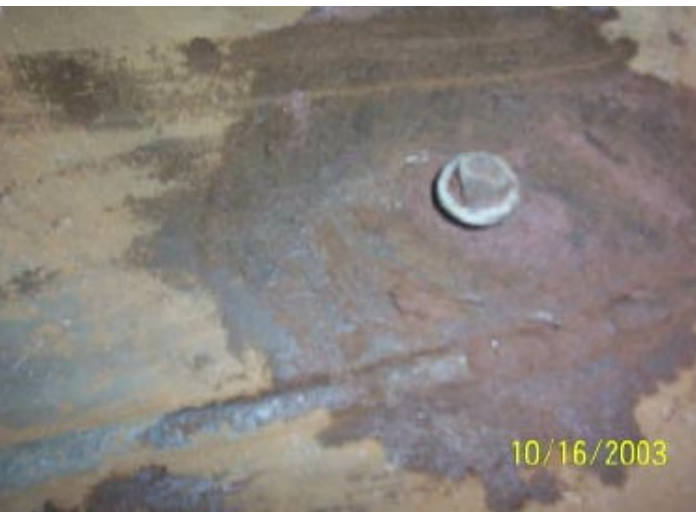
#7 Internal corrosion so severe the tank could not be repaired for lining. The assessment of this tank predicted uniform corrosion.

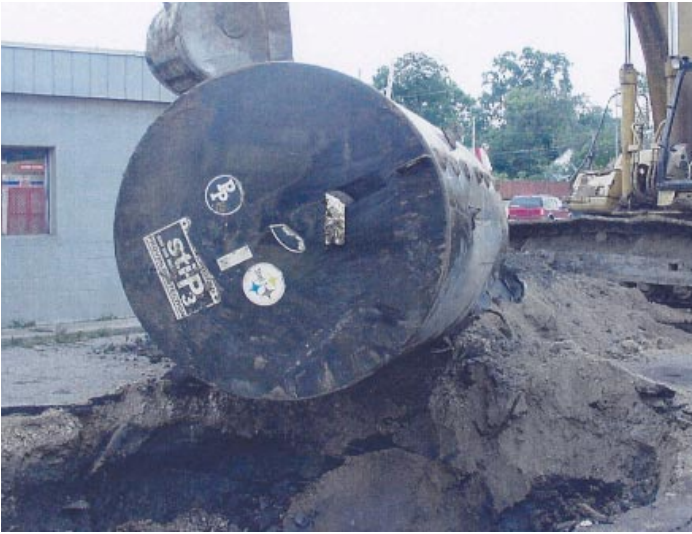
#10 STI-P3 tank in good condition.

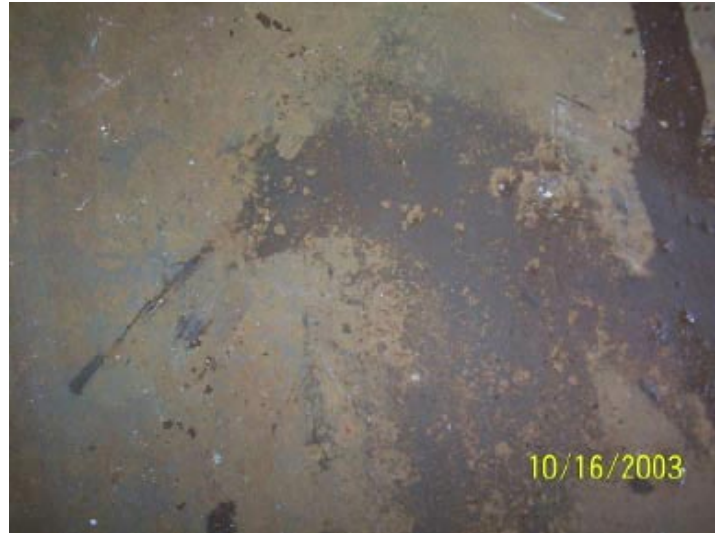
#12 Internal corrosion and pitting.

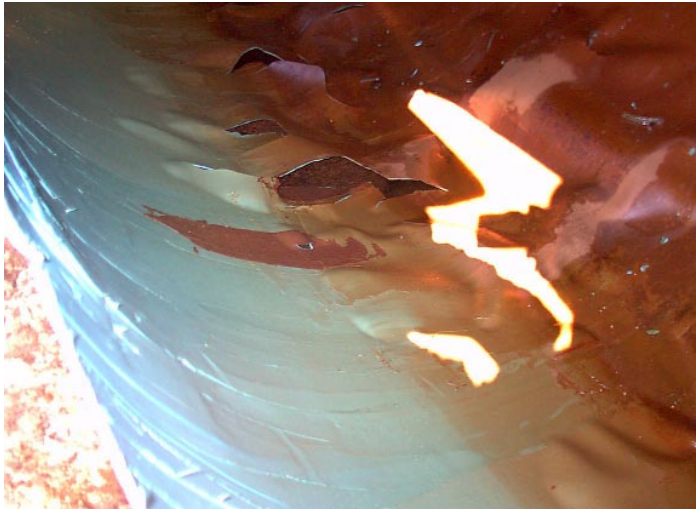
#11 In many cases where tanks were previously lined and subsequently upgraded by cathodic protection, the lining had failed due to cracking, blistering, or product incompatibility. In many of these instances these tanks had been repaired and lined as a result of a previous failure.

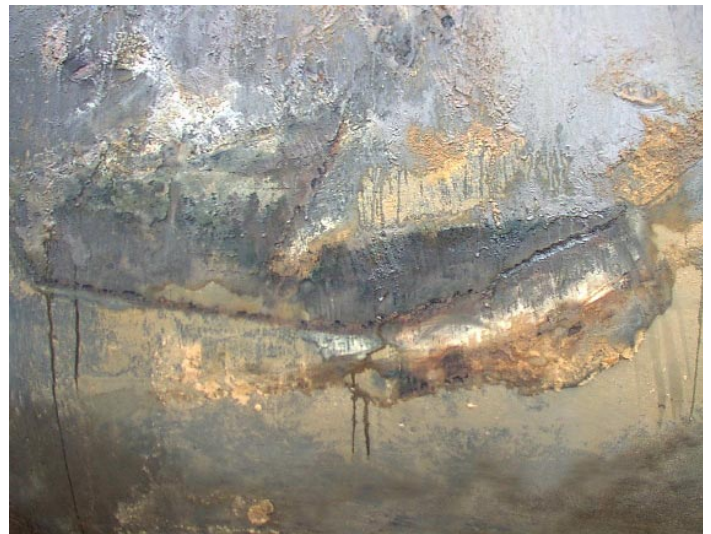
#13 During inspections of excavated USTs we found that damage to the asphaltic or dielectric coating on the outer surface of an UST that occurred during installation could cause preferential corrosion where the bare metal was exposed to the corrosion processes.
