# FRP Tank Autopsy

Presented by Mike Pecorelli

# Will's Canyon Stop

Investigation and Tank Autopsy

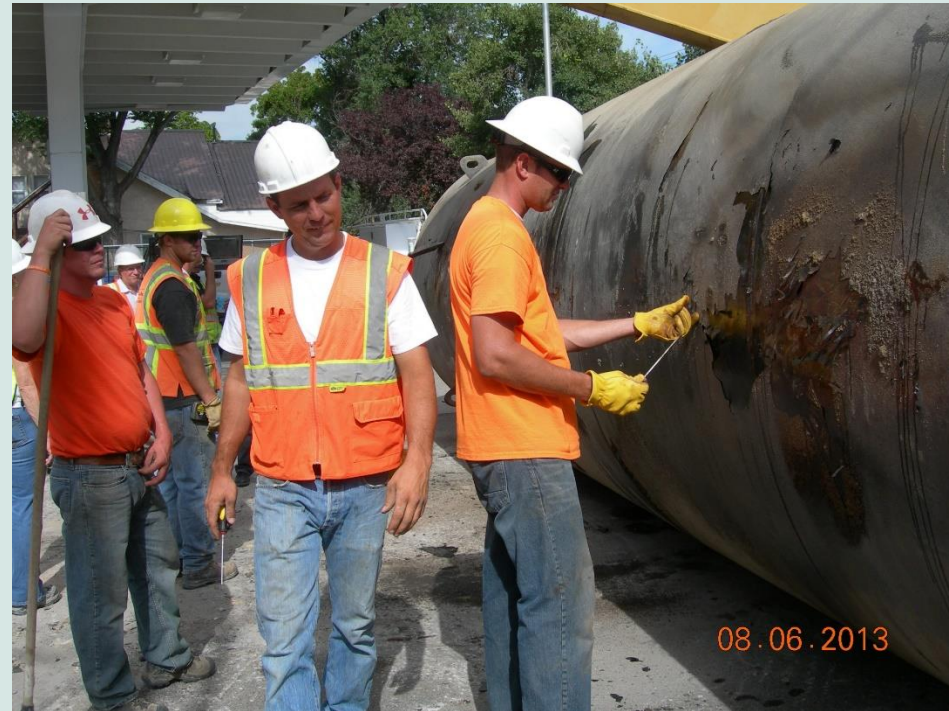
- Site and USTs were being monitored for suspected release but inconclusive.
- Sudden loss occurred: Inventory records showed loss of around 6,000 gallons of gasoline.
- UST Installed March 1985 and taken out of service Aug. 2013.
- All USTs replaced.

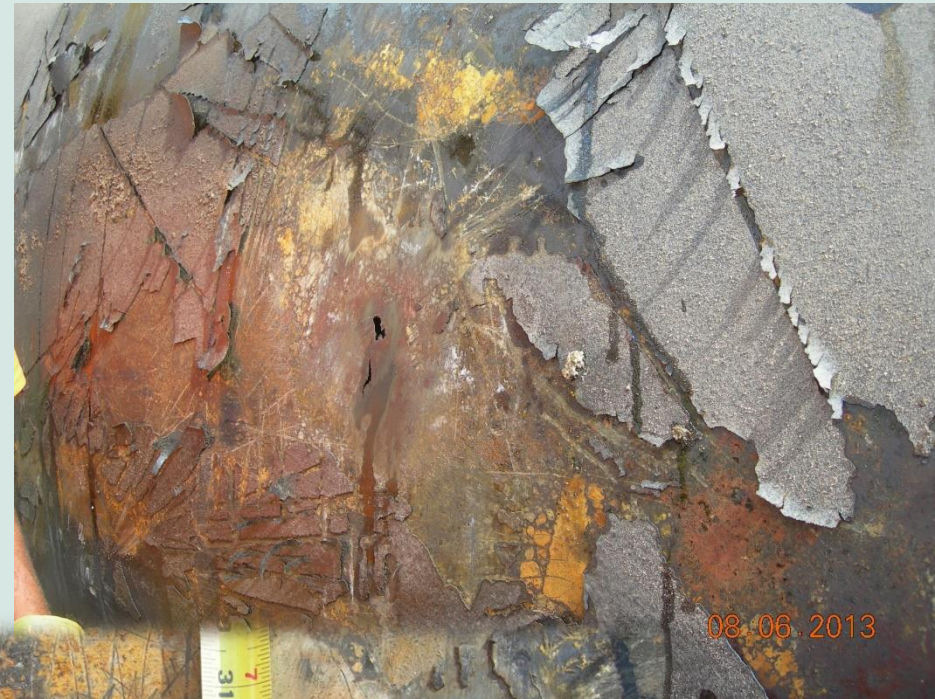
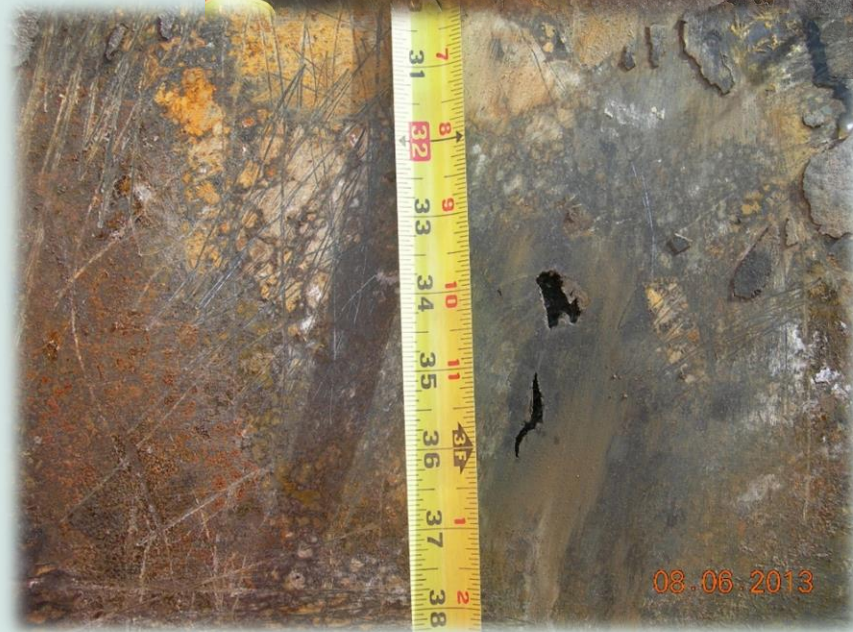
- Coating on outside made it hard to find holes.
- Scraped with a shovel.
- Holes under plate for measuring fuel levels from sludge buildup.
- Spent \$617,000 so far.

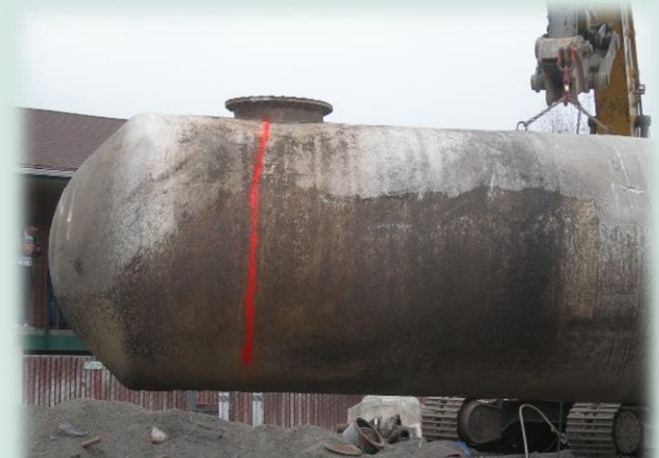
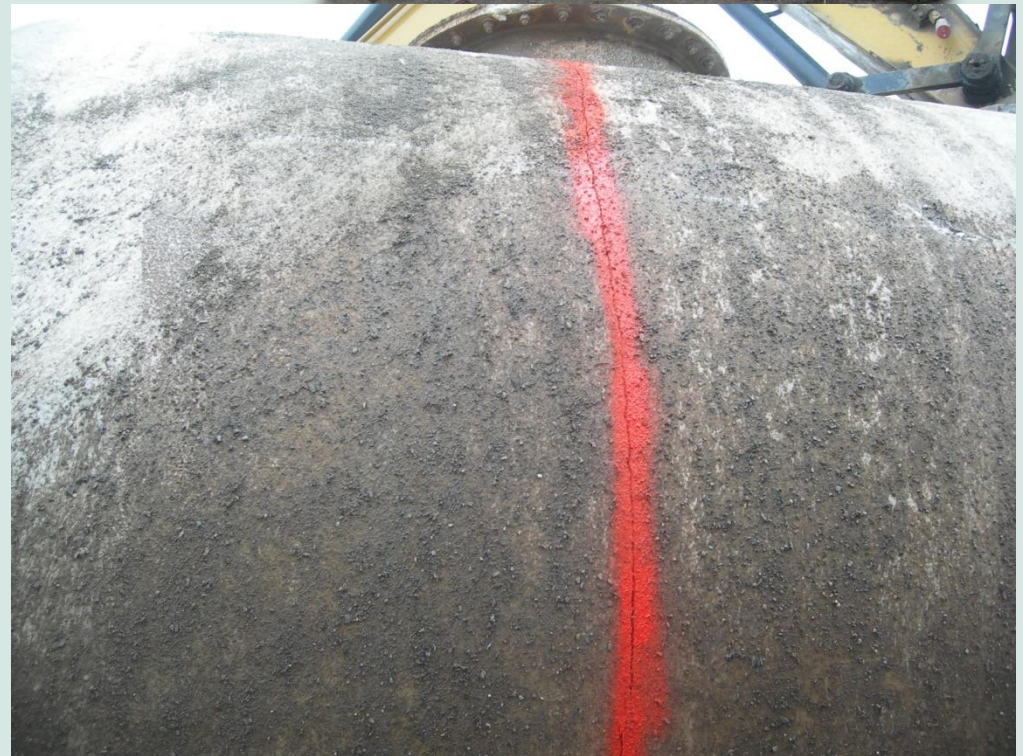
- Installed January 1988 and removed March 2018.
- 10,000 gallon UST.
- Release of 55,000 gallons of gasoline.
- Crack ran down side.
- Cause of the crack unknown.
- ATG gave no alarm.

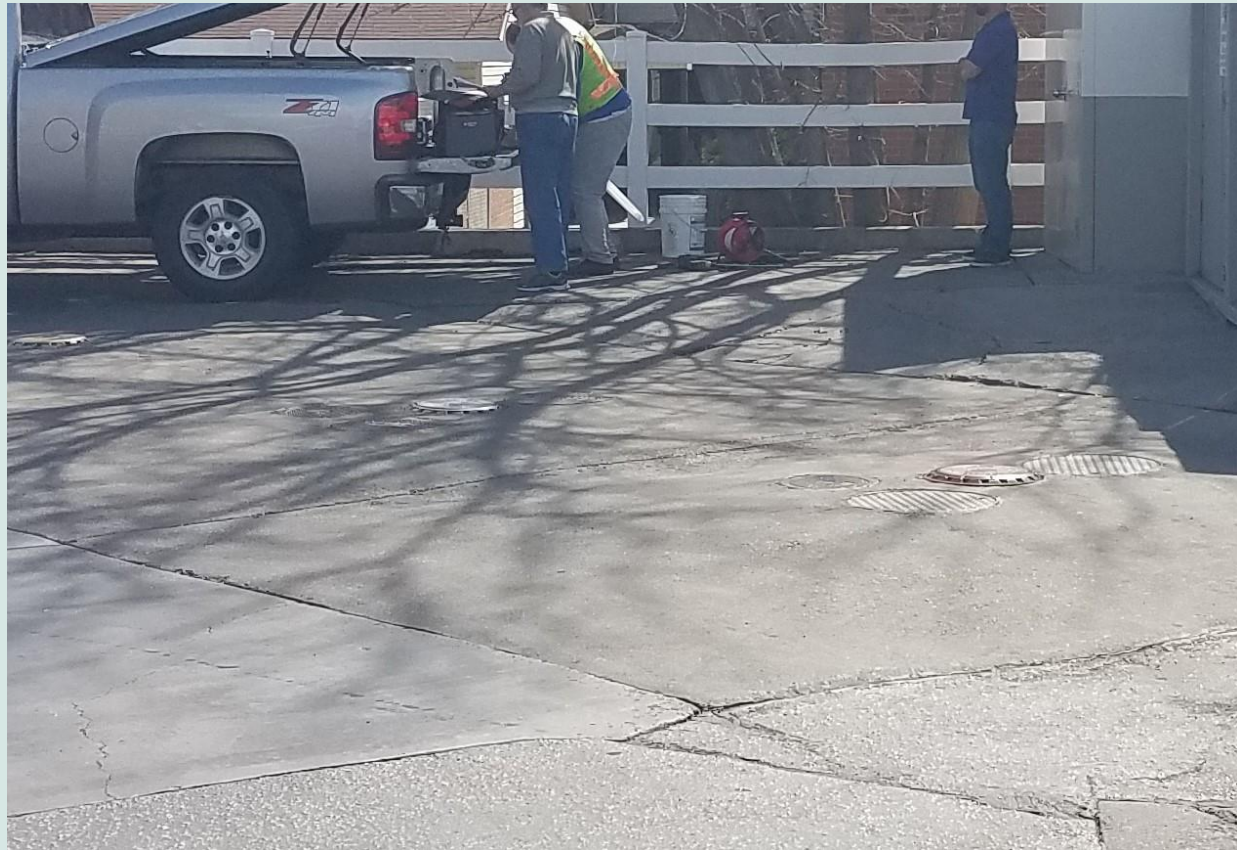
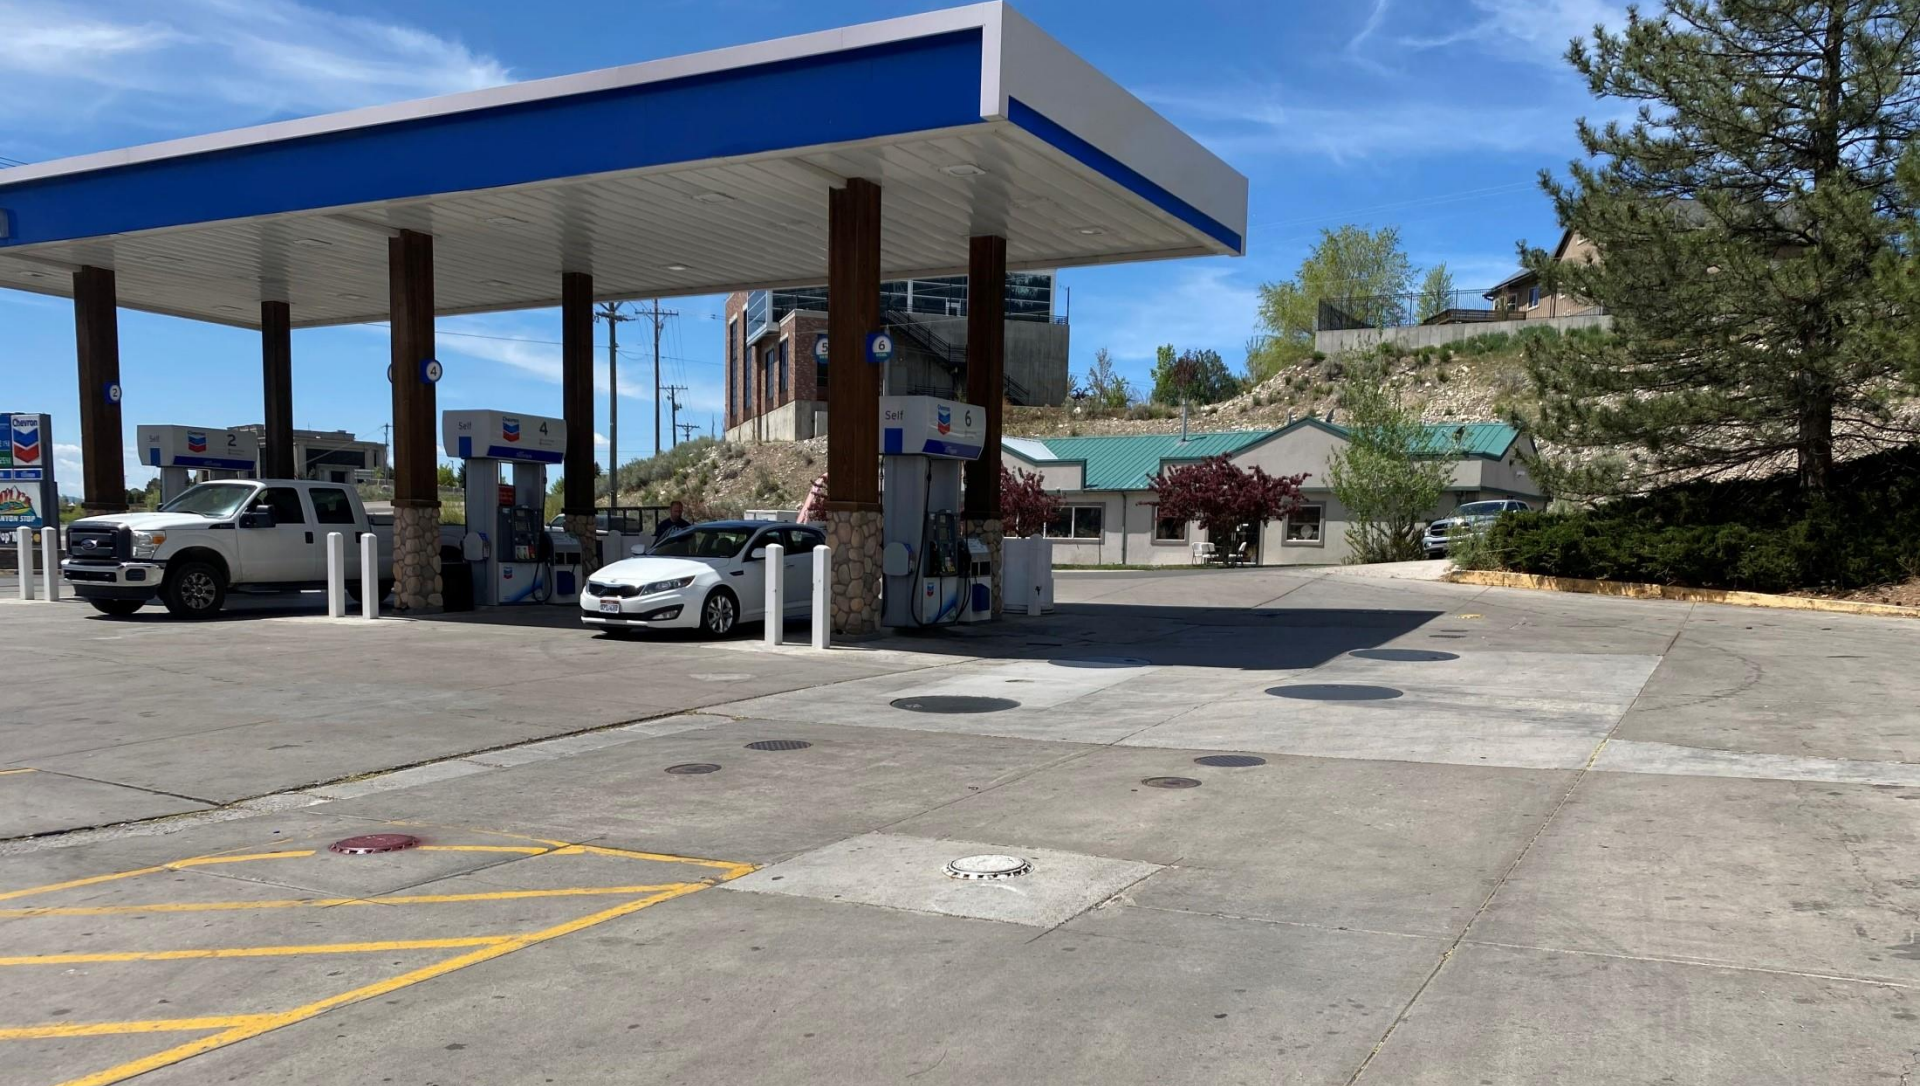
- Install issue of engineered fill depth over the UST.
- No analysis of the FRP UST before it was crushed.
- Spent \$1.6 million so far.

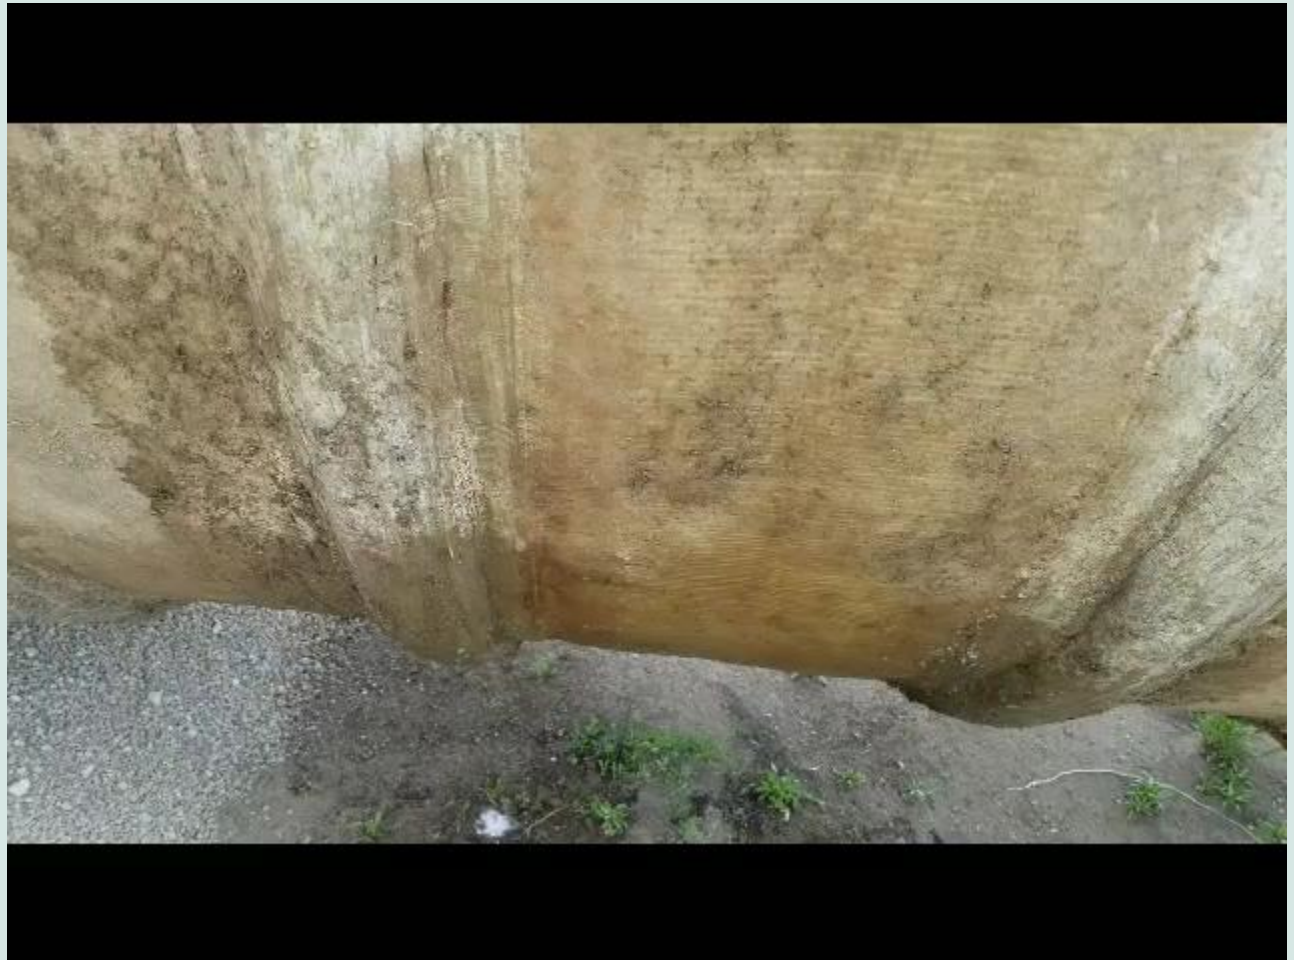
- Sealed the UST and used a small blower to help identify the location of the leak.

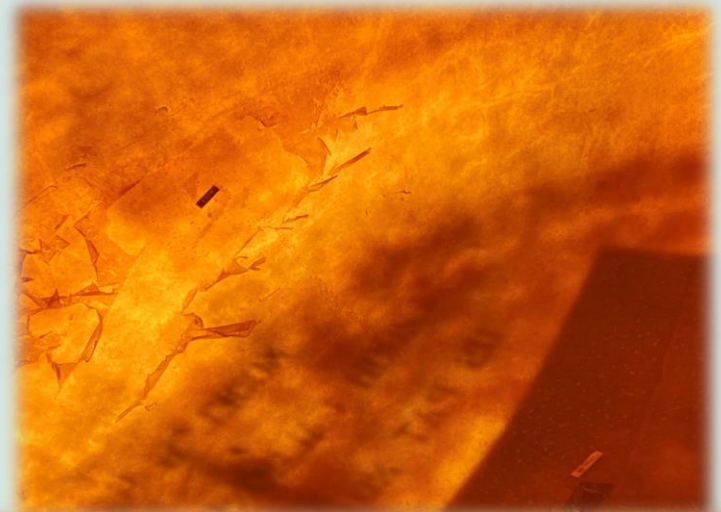
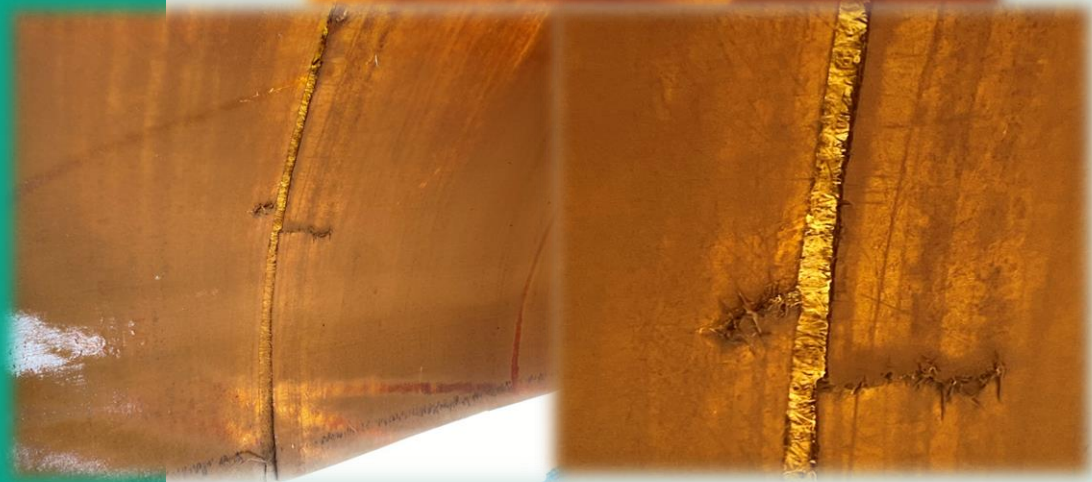
# Inside View Near the Location of the Failure

- Flaking gel coat.
- Fairly large groove.

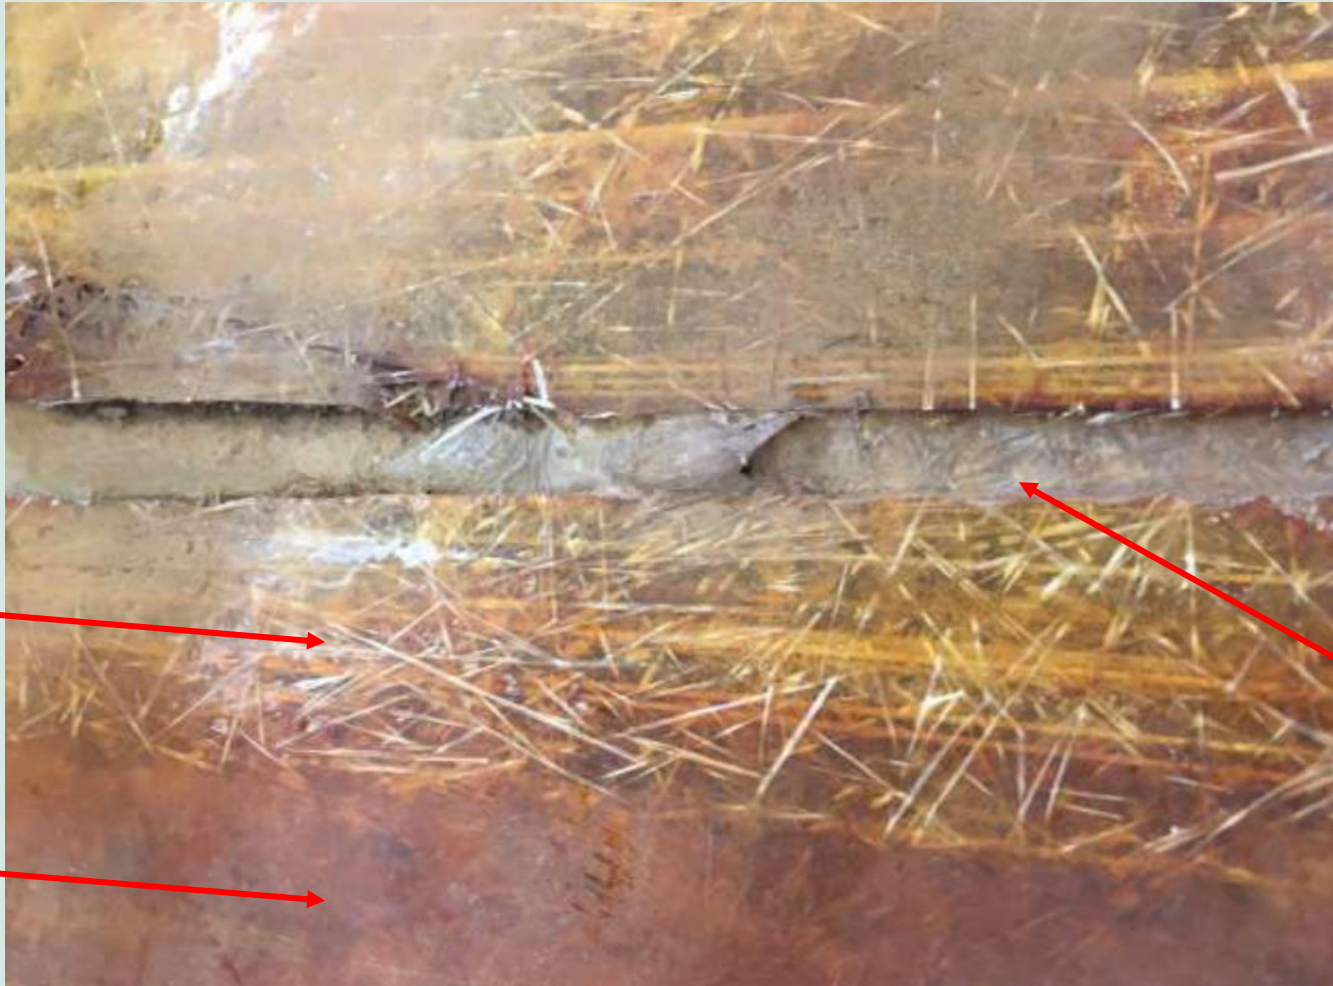
# Groove in the UST

Thin gel coat.  
Fiberglass fibers are visible.

Thicker gel coat.

Groove with gel coat in the groove. Separation of the UST and spray coated with gel coat.

Groove provides a pathway for fuel to permeate in the UST wall and damage integrity.

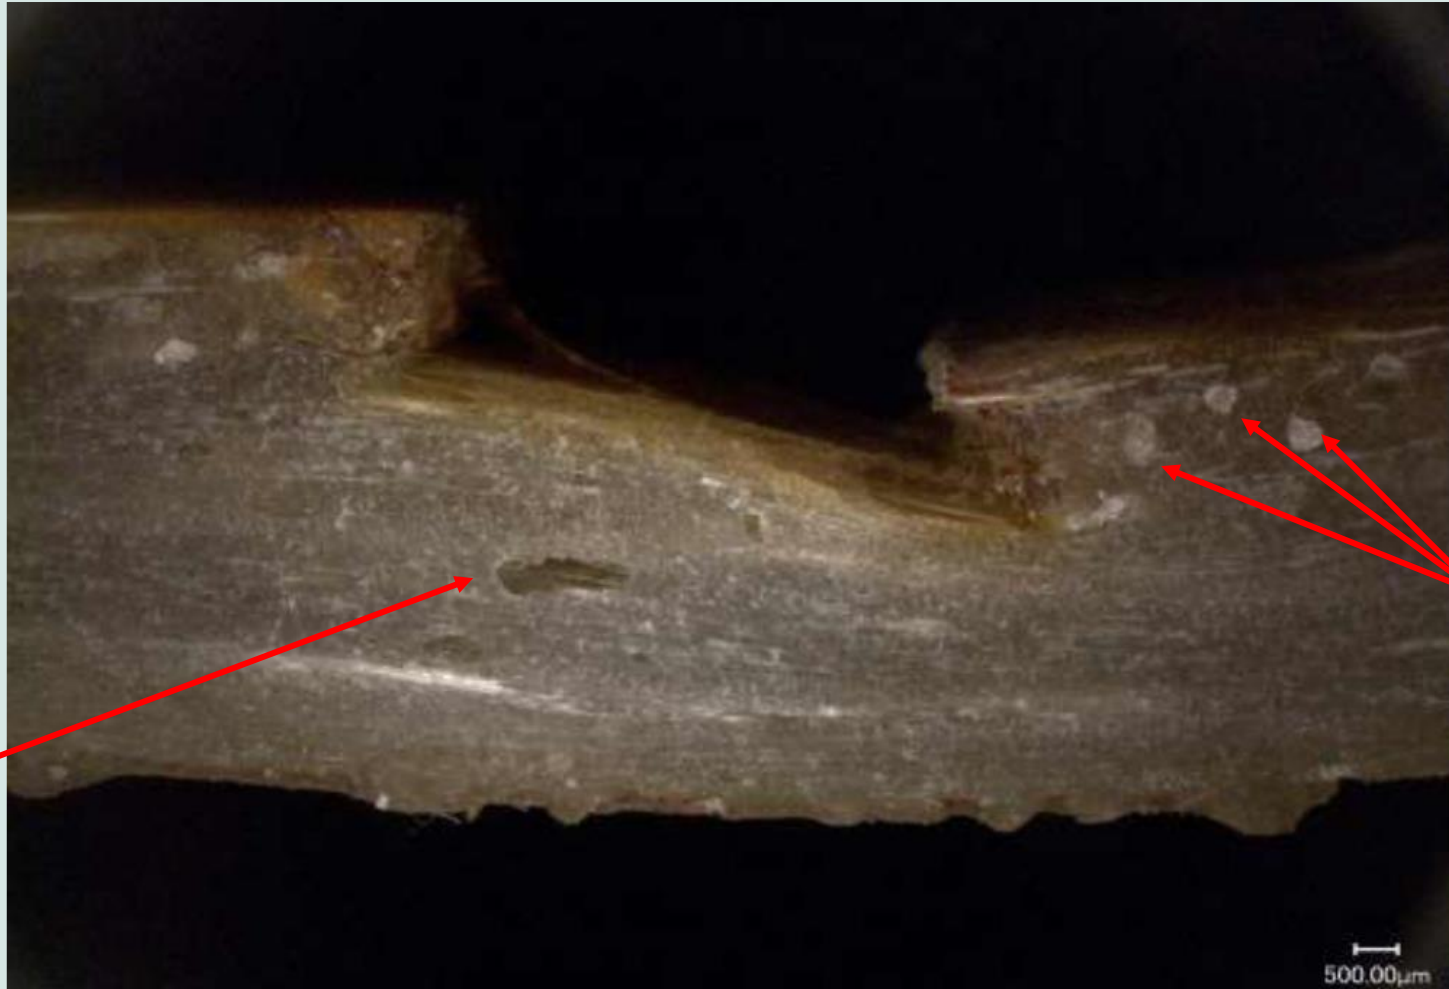
# Groove Cross Section

Void  
space  
that can  
weaken  
UST.

Sand  
particles.  
Should be  
more sand  
particles  
and not as  
close to  
surface.

Groove is approximately  $\frac{1}{4}$  of the UST thickness on the right.

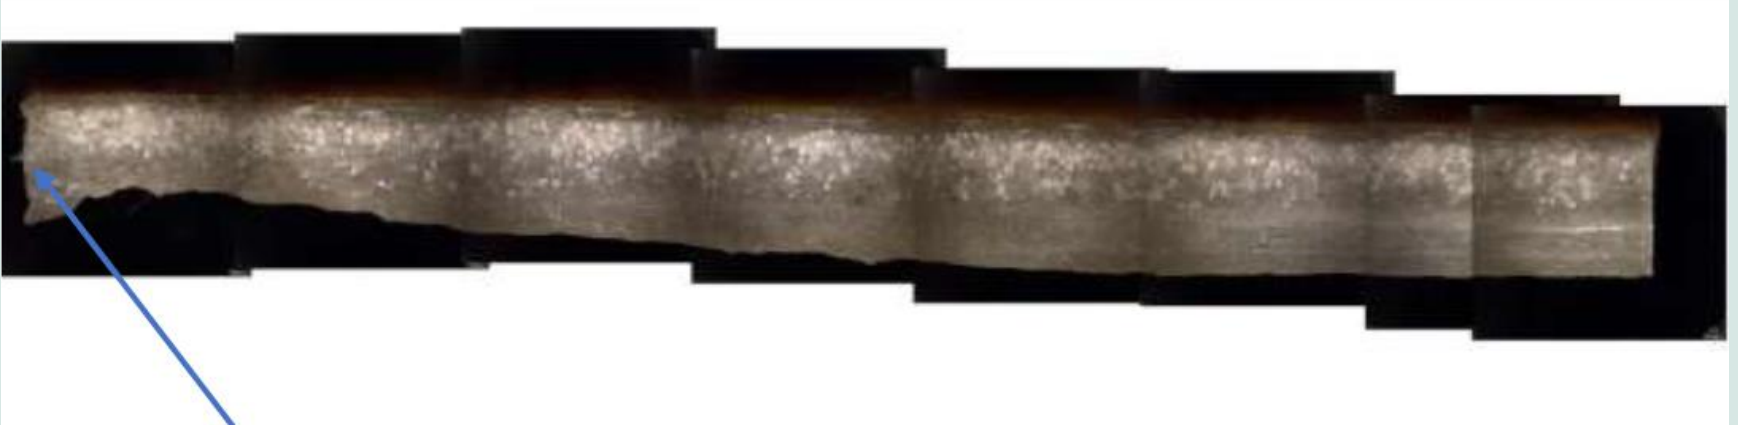
# Composite Photo with Crack

Area of the crack.  
Thinner area of  
UST.

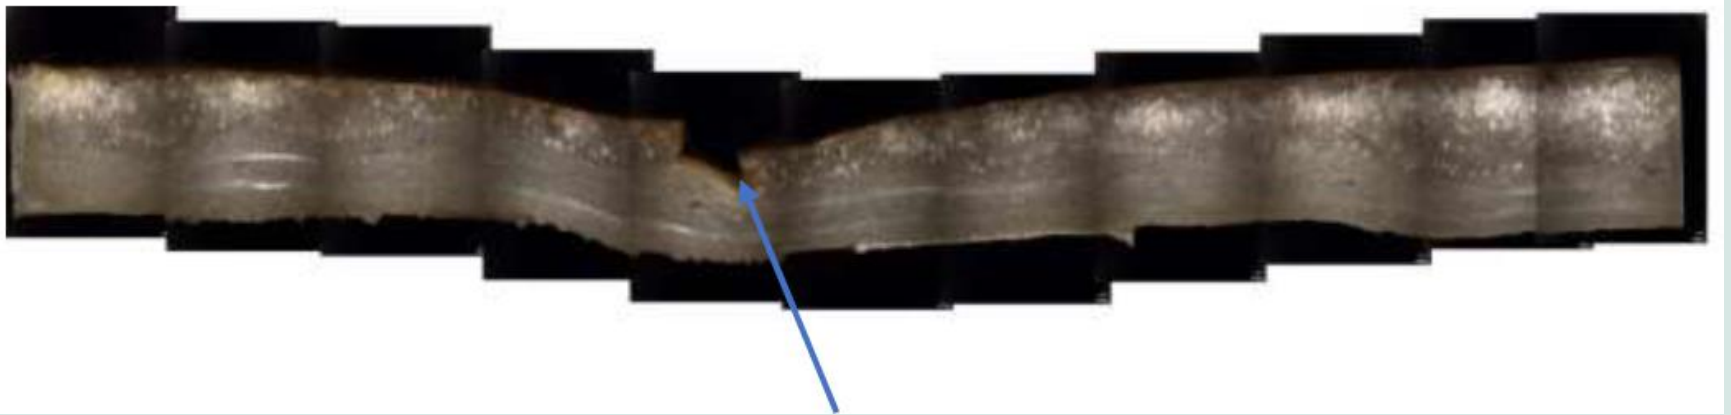
# Composite Photo with Crack

UST has a bow in it near the groove. Likely from stress.

Notice irregularity in the sand reinforcement locations near the surface. Sand should be more towards the middle. Very little sand near the groove.

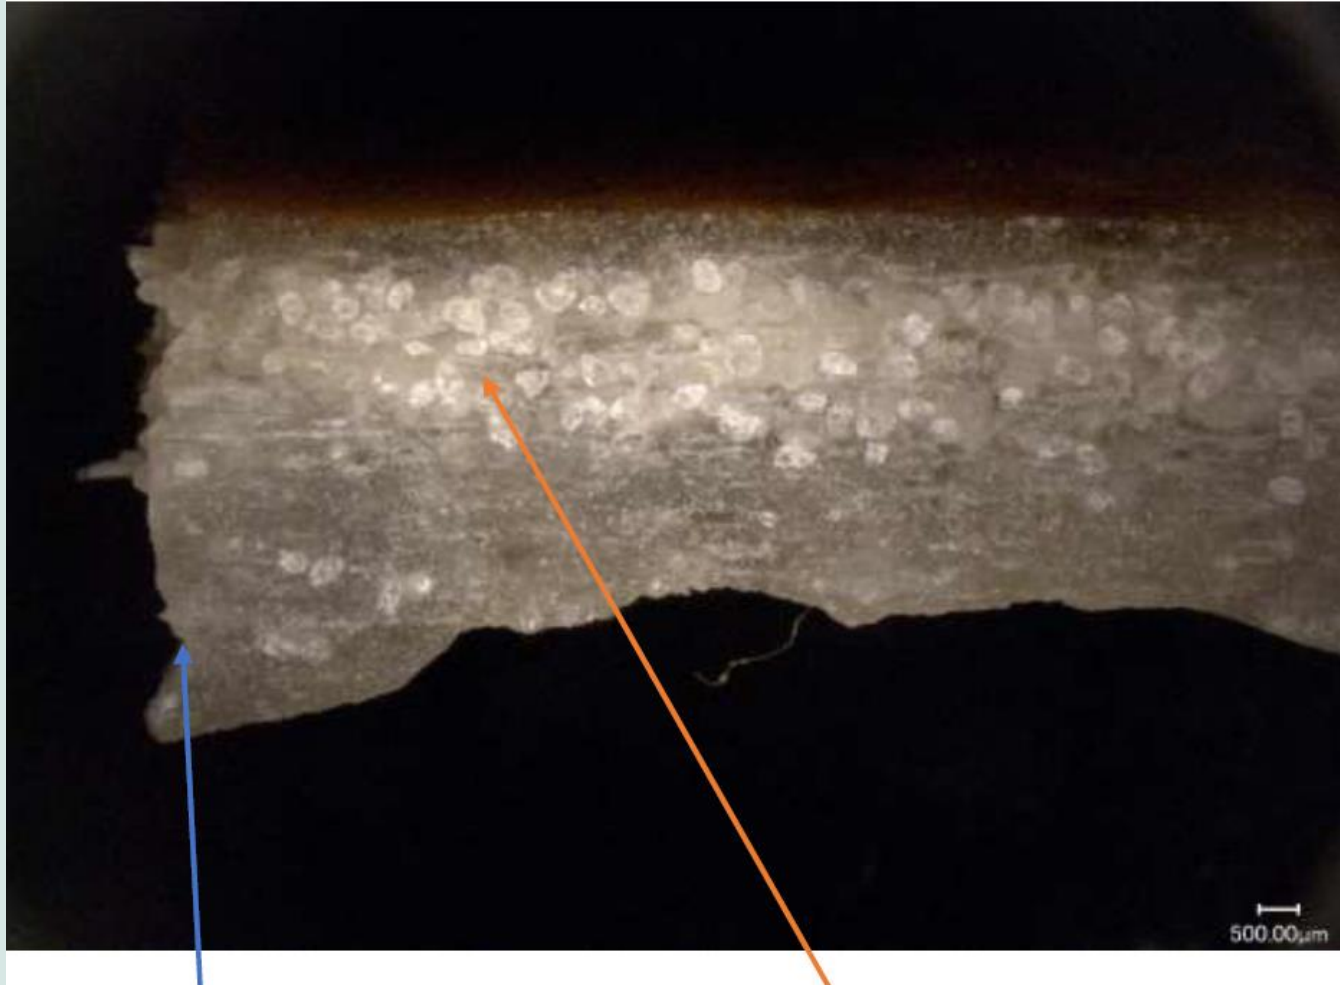
# Crack in the UST

Location of the crack.

Sand is not uniform from other parts of the UST and close to inner wall.

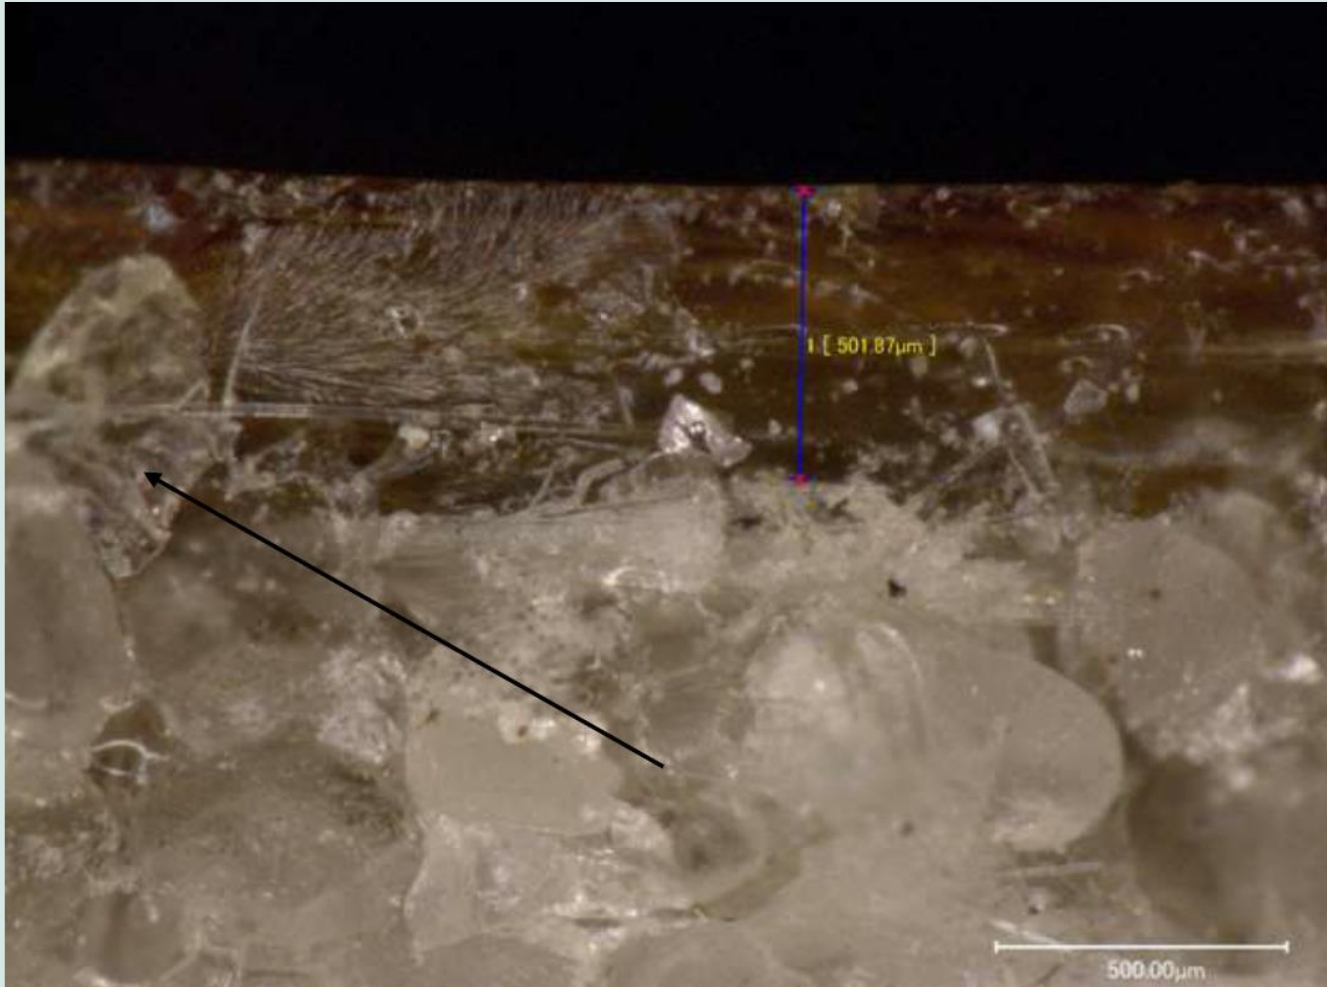
# Gel Coat

View of gel coat (amber color) and sand grains. Black arrow shows sand grain in the gel coat lowering the gel coat thickness. That is a weak point.

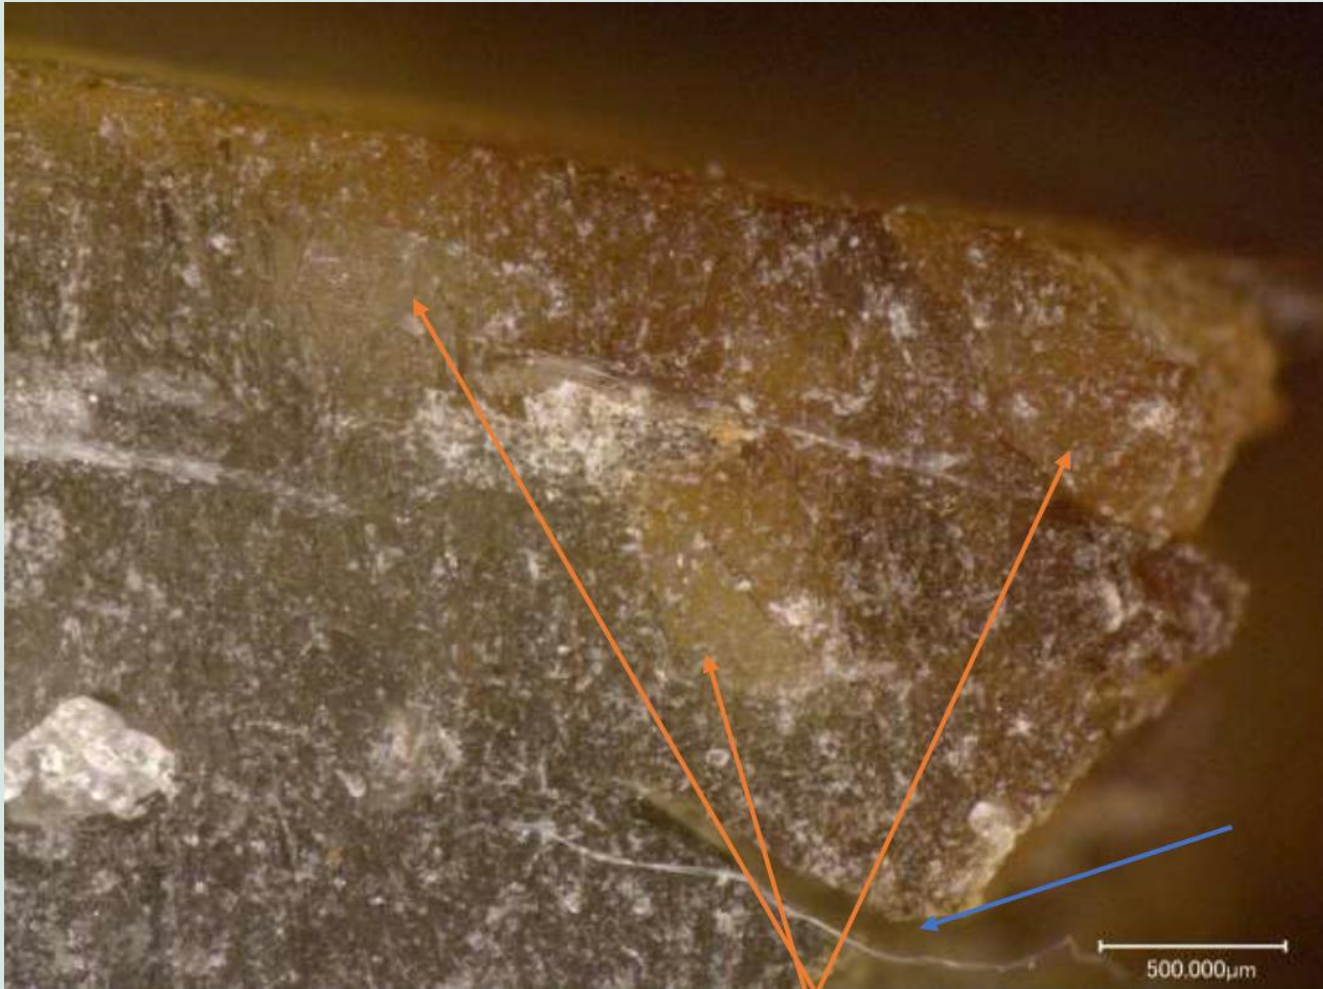
# Permeation at Crack Location

Orange arrows show where gasoline has permeated the gel layer changing the color. Notice color near the crack vs to the left. Blue arrow is another crack perpendicular.

- This release was attributed to manufacturing errors.
- Discoloration and flaking of the gel coat are signs of incompatibility issues.
- Additional analysis with fiberglass USTs is needed.
- Would do this again if conditions present themselves.
- A tank autopsy takes coordination from everyone involved to be done successfully.
