Plattsburgh Illicit Discharge Detection and Elimination Project: Phase 2 Final Report

Stone Project Number: 20-031
NEIWPCC Job Code: 0356-002-001
Project Code: LS-2021-043

Project Period: April 23rd, 2021 to December 31st, 2022

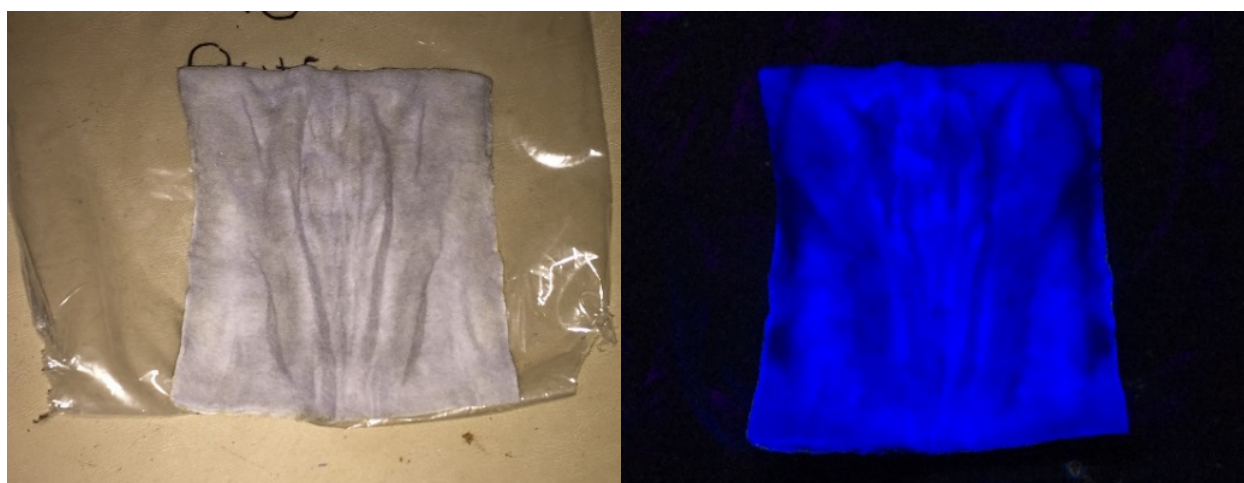
Figure 1. Positive OB monitoring pad under fluorescent (left) and UV (right) lamps.

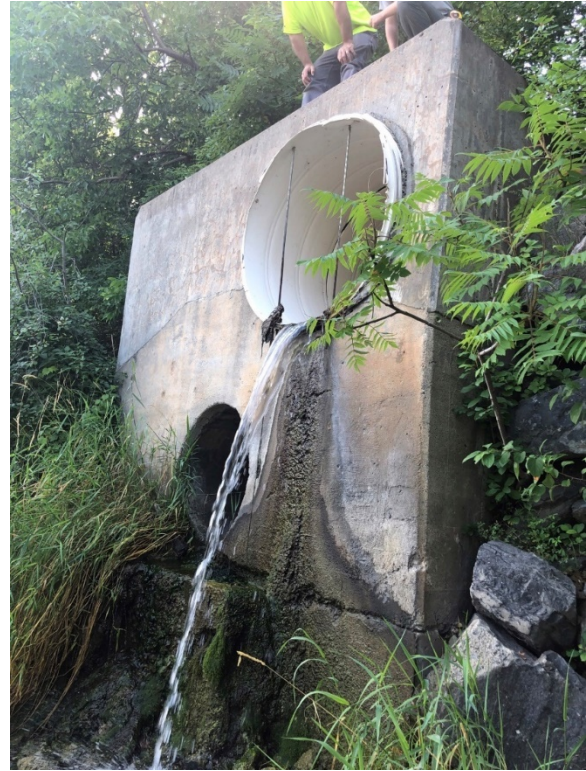
- Samples collected at the outfall on August 5, 2021 had elevated *E. coli* (602 MPN/100 mL) and very low TP (Table 13).
- An OB pad placed at CB02 on August 31, 2021 was positive.

- Samples collected on September 14, 2021 at manhole MH03 and catchbasin CB02 had exceedingly high *E. coli* (>2,420 MPN/100 mL; Table 13).
- OB pads were deployed at all accessible, on-line structures on Rugar Street on October 6, 2022. OB was detected at MH03 and downstream structures. OB was not detected at MH04 or MH07, and the test at MH05 was indeterminate.

Figure 2. PB02 outfall (left) and PB03 outfall (right)

Conclusion: Stone has bracketed a likely wastewater source between MH03 and MH04 on the south side of Rugar Street. The next step is to inspect this pipeline with a sewer camera.

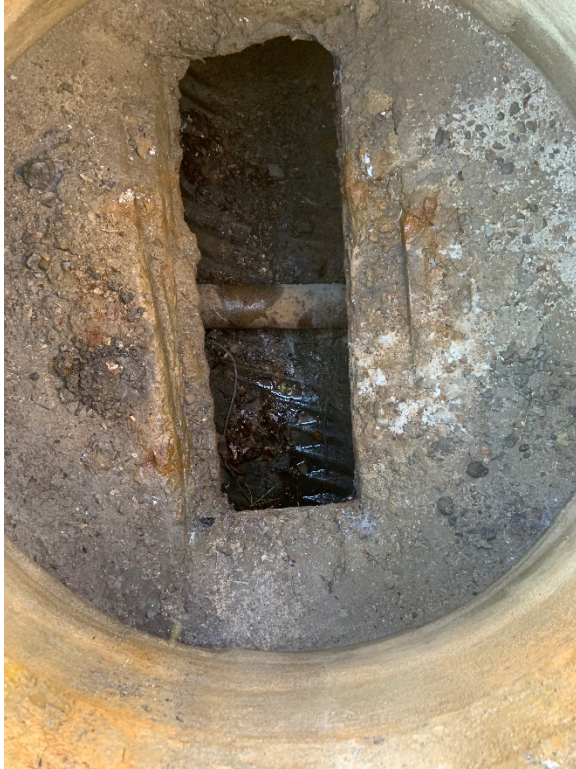
- At least three sanitary sewer laterals cross through the Elizabeth Street stormdrain (Figure 3). A sewer lateral was also seen at manhole MH08.1 on Johnson Street (Figure 4). These laterals were visible within stormwater manholes. Similar laterals may cross the stormdrain between manholes.
- We observed racoon prints and/or scat in several structures in the PB07 system. Scat is visible in Figure 4 on the concrete shelf above the manhole channel.

Figure 3. Sanitary sewer lateral crossing Elizabeth Street stormdrain

Conclusion: PB07 is a large system that is difficult to access due to traffic on South Peru Street. High concentrations of *E. coli* were measured in manholes on Elizabeth Street, Johnson Street, and Monty Street on September 7, 2021. However, *E. coli* concentrations in this system dropped sharply in subsequent sampling rounds. No OB was detected at the outfall or in manholes on Elizabeth Street and Flynn Avenue. The absence of OB indicates that residential wastewater is unlikely the source of *E. coli*. Despite some concern regarding the sanitary sewer crossings observed through this stormdrain, we conclude the likeliest source of *E. coli* is wildlife living in or traveling through the stormdrain, for which there was abundant sign. Since it can be challenging to collect water samples from manholes under low flow conditions without scraping sediment into the sample, fecal contamination of the sediment by wildlife may have contributed to the high *E. coli* concentrations on September 7, 2021.

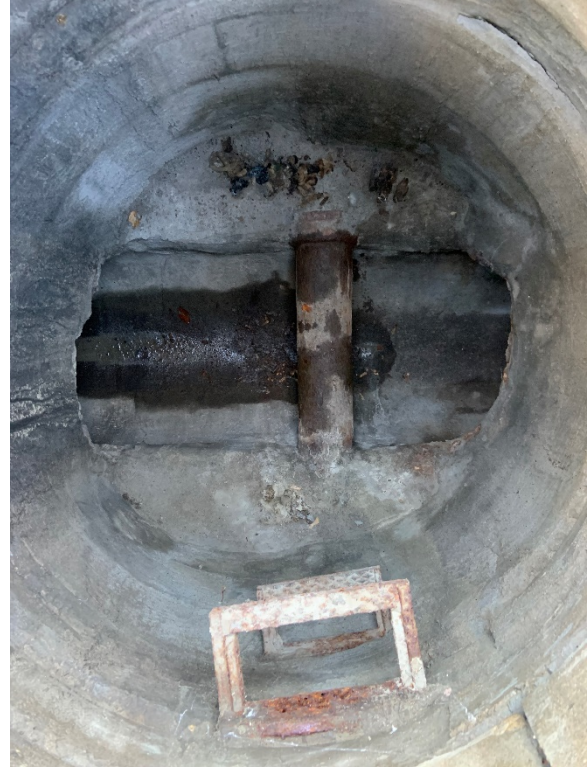
Figure 4. Sanitary sewer lateral crossing Johnson Street stormdrain

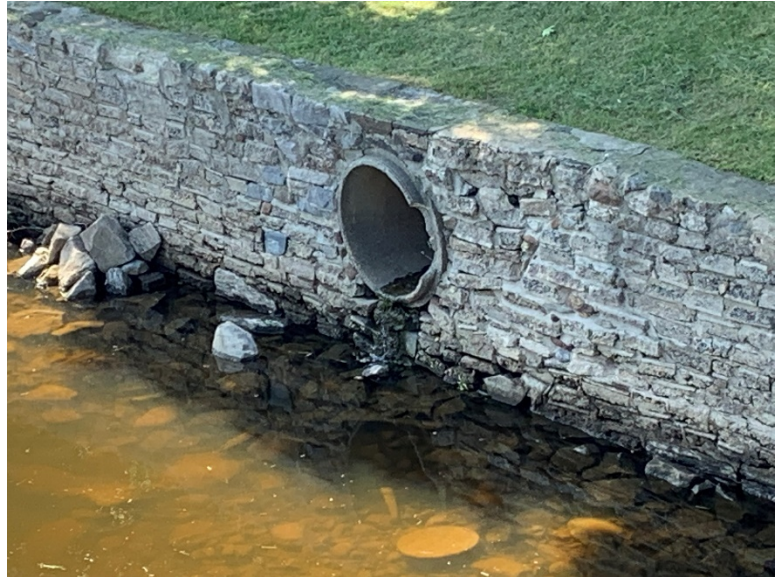
Figure 5. Outfall PB11

The PB11 system drains parts of City Hall Place, Cornelia Street, Miller Street, and Margaret Street in downtown Plattsburgh (Appendix C, Map 6). The outfall is located in a retaining wall on the bank of the Saranac River (Figure 5).

- When the PB11 outfall was first visited on July 29, 2020, a wastewater odor was noted, the specific conductance was quite high (5000 µS/cm), and OB was detected.
- A follow-up test on August 27, 2020 confirmed presence of OB at the outfall.
- The outfall was inaccessible in 2021 due to construction. On August 5, 2021, samples were collected for *E. coli* and TP analysis at MH01, located at the end of Cornelia Street. This is the

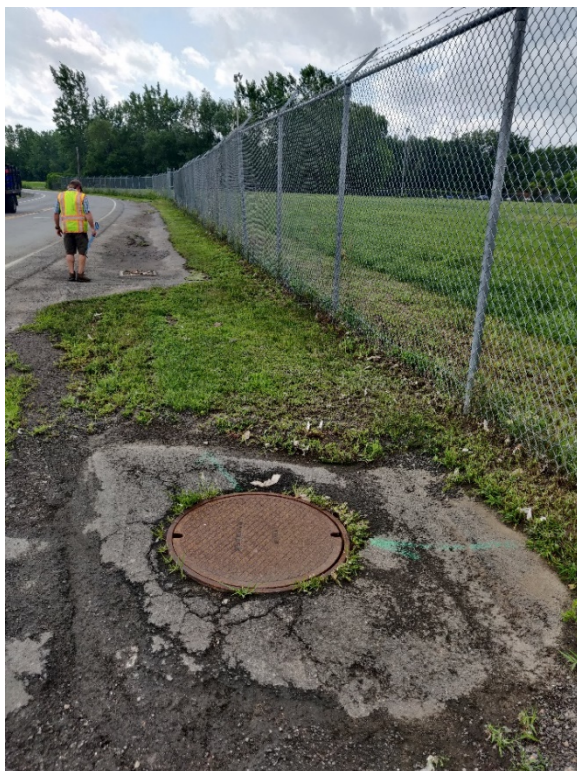
Figure 6. Sanitary manhole SAM01

- This system was first visited on August 11, 2020. A representative from the City of Plattsburgh accompanied the visit. Upon arrival, it was apparent that a sanitary sewer overflow had occurred during a recent storm. The cover of sanitary manhole SAM01 (Figure 6; Appendix C, Map 7) was ajar, sanitary paper was seen on the surrounding ground, and a wastewater odor prevailed. More sanitary paper was visible on the grate of catchbasin CB01, indicating that wastewater had entered the PB19 system at this point (Figure 7).

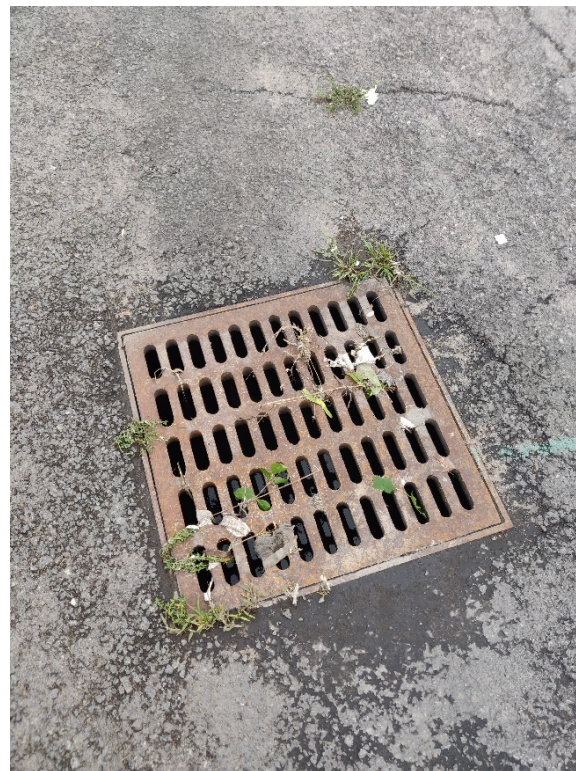
Figure 7. Toilet paper on catchbasin CB01 grate following sewer overflow event

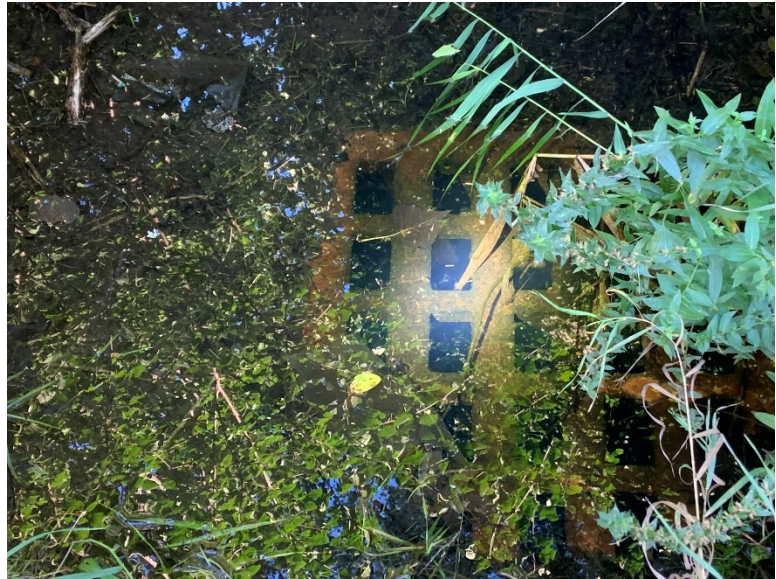
- The system is mis-mapped. The main line appears to enter catchbasin CB02 and flow toward CB03 and then CB01. It is unclear whether the structure labeled MH01 is connected with this system. We have assumed that catchbasins CB04 and CB05 are connected.
- The high MBAS and ammonia concentrations at CB01 were confirmed a week later, on August 5, 2021 (Table 12), and the *E. coli* concentration was very high, 2,420 MPN/100 mL (Table 13). A foul odor was noted and CB02 was flooded.
- There were no similar indications of wastewater contamination on two dates in 2022. No optical brightener was at CB04 and CB05 on September 29, 2022. On October 6, the lower portion of the system was flooded, and negligible *E. coli* were measured at CB01 (1 MPN/100 mL).
- The prevalence of iron staining at CB01 and CB02 suggests contaminated groundwater from historic uses on the oval enters the stormdrain.

Figure 8. Flooded catchbasin CB01

Conclusion: After repeated visits and testing throughout the system, we have tentatively concluded that there is no current illicit discharge in this system. We are not sure how to explain the apparent change between the 2021 and 2022 sampling events. It is possible there was a sanitary wastewater leak or accidental discharge to the stormdrain that was corrected. This system will be revisited in 2023 to confirm there is no current illicit discharge.
