# New Mexico Environment Department

## Oversight of Installations, Modifications, and Repairs – Why is it Important?

Joe Godwin, Manager, Prevention Inspection Program  
September 23, 2025

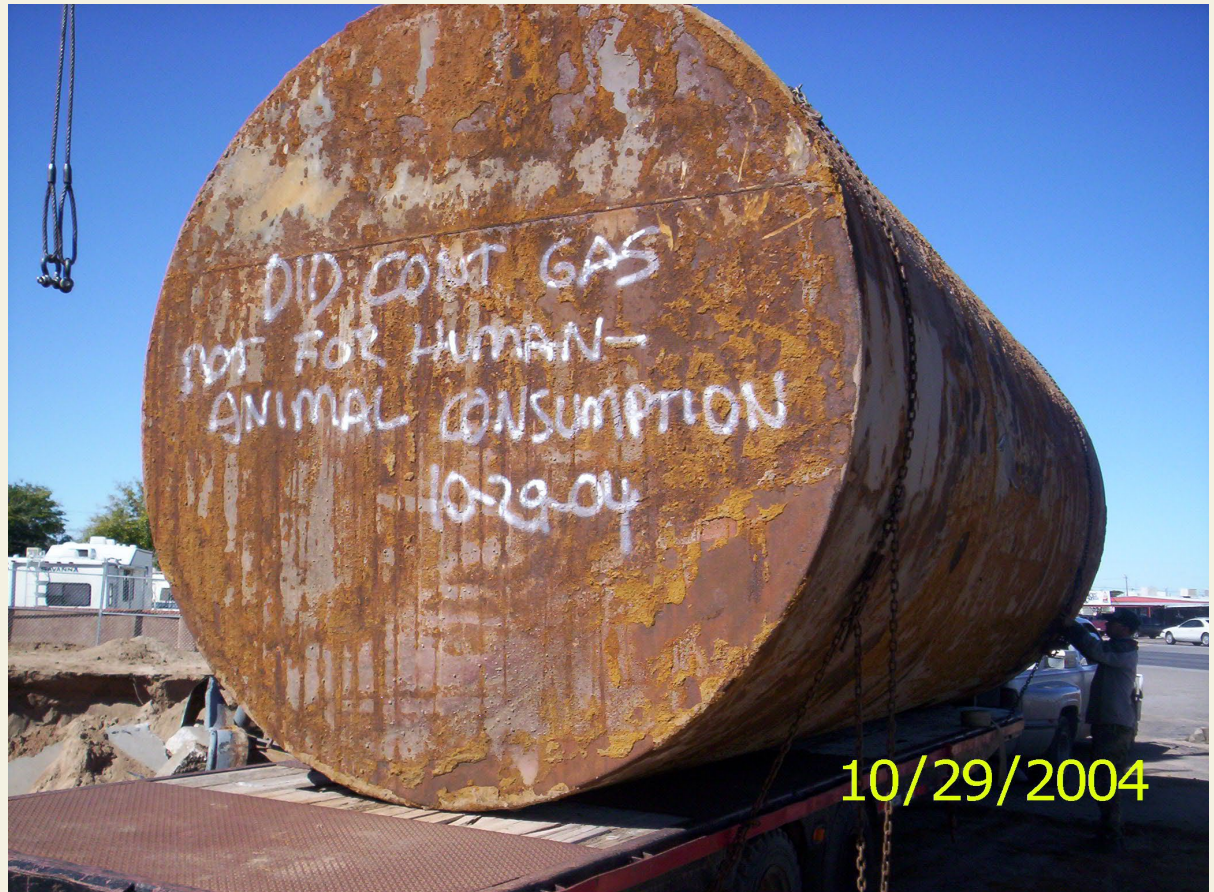
UST was originally registered in 1990 as a fiberglass clad steel tank, but later, records were discovered that the tank was actually installed in 1967 and the facility had been sold three times before 1990. Current owner had no clue as to what type of tank was in the ground.

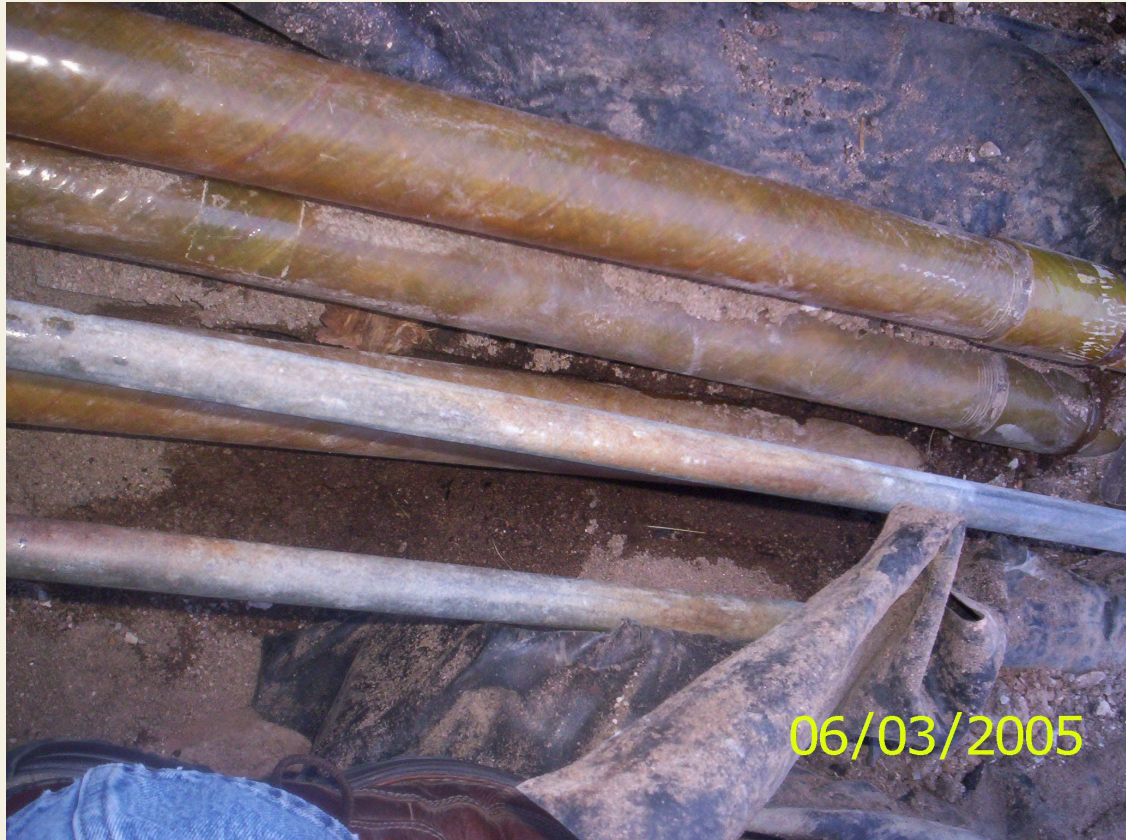
The piping was installed in 1996 but without a state inspector present due to the owner not providing notification as required and using a contractor not certified in New Mexico.

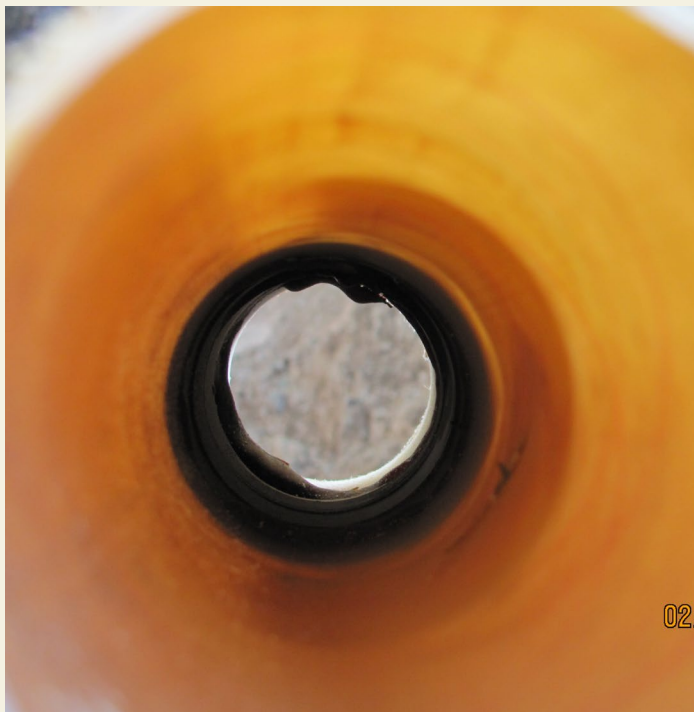
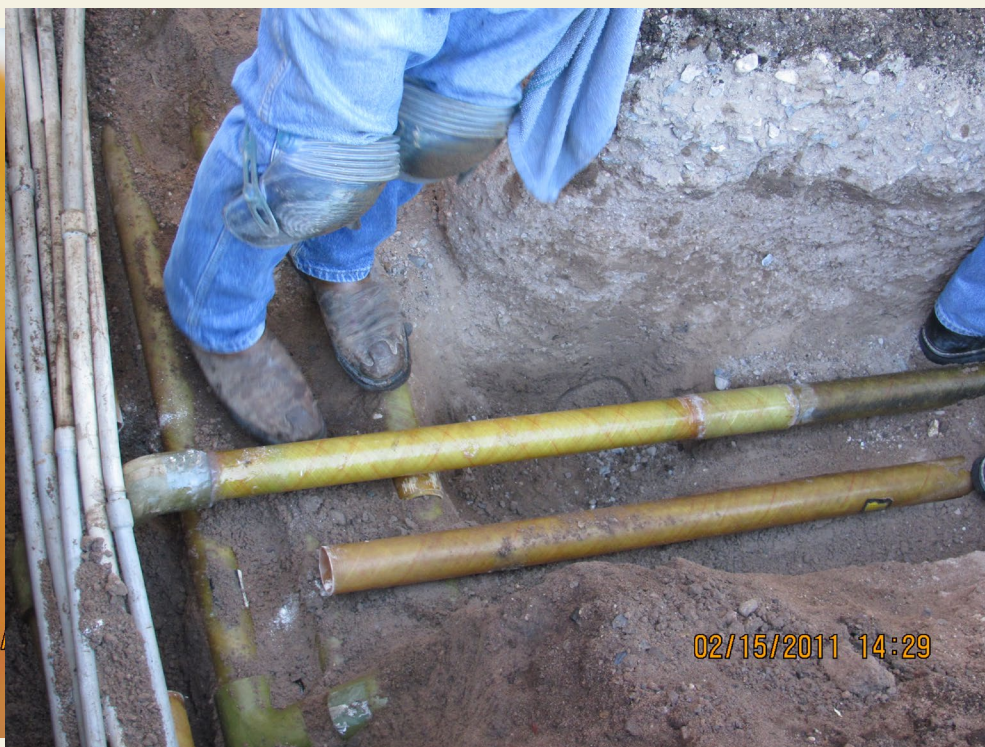
High throughput facility where the underground piping had been modified heavily over the years and at one point the super unleaded piping was replaced. The super unleaded fiberglass reinforced plastic piping was laid right on top of the diesel piping. After several years, the diesel pipe rubbed a hole in the bottom of the super unleaded piping causing a release to the environment.

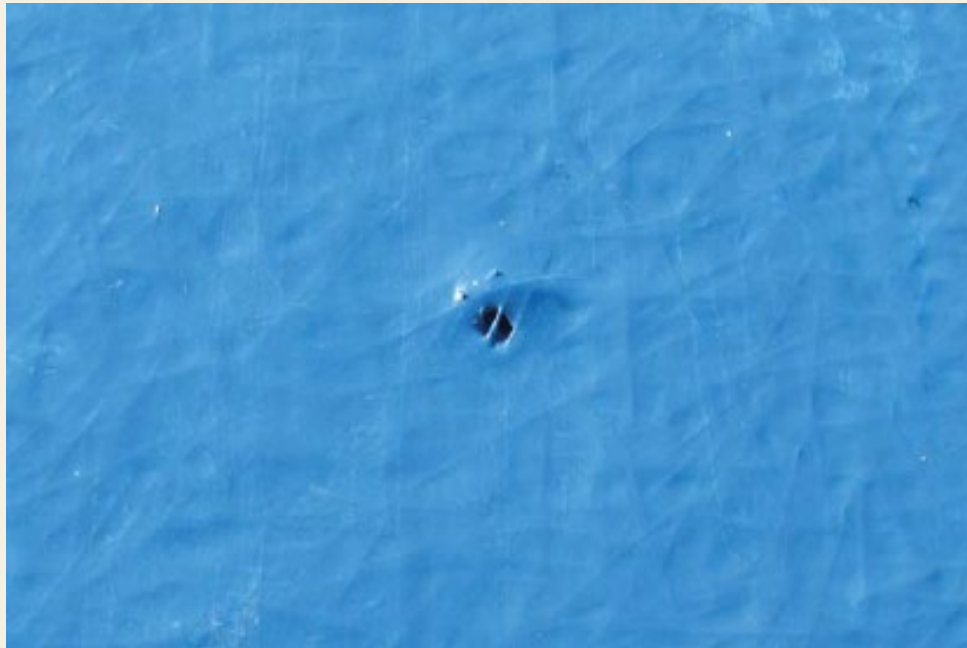
New 12,000-gallon double walled ACT-100 UST arrived on-site in Las Cruces with a 1/4 inch holiday in the FRP cladding in the lower quadrant of one end of the tank. Contractor asked if that should be repaired because the tank would probably not fail for at least 20 years.

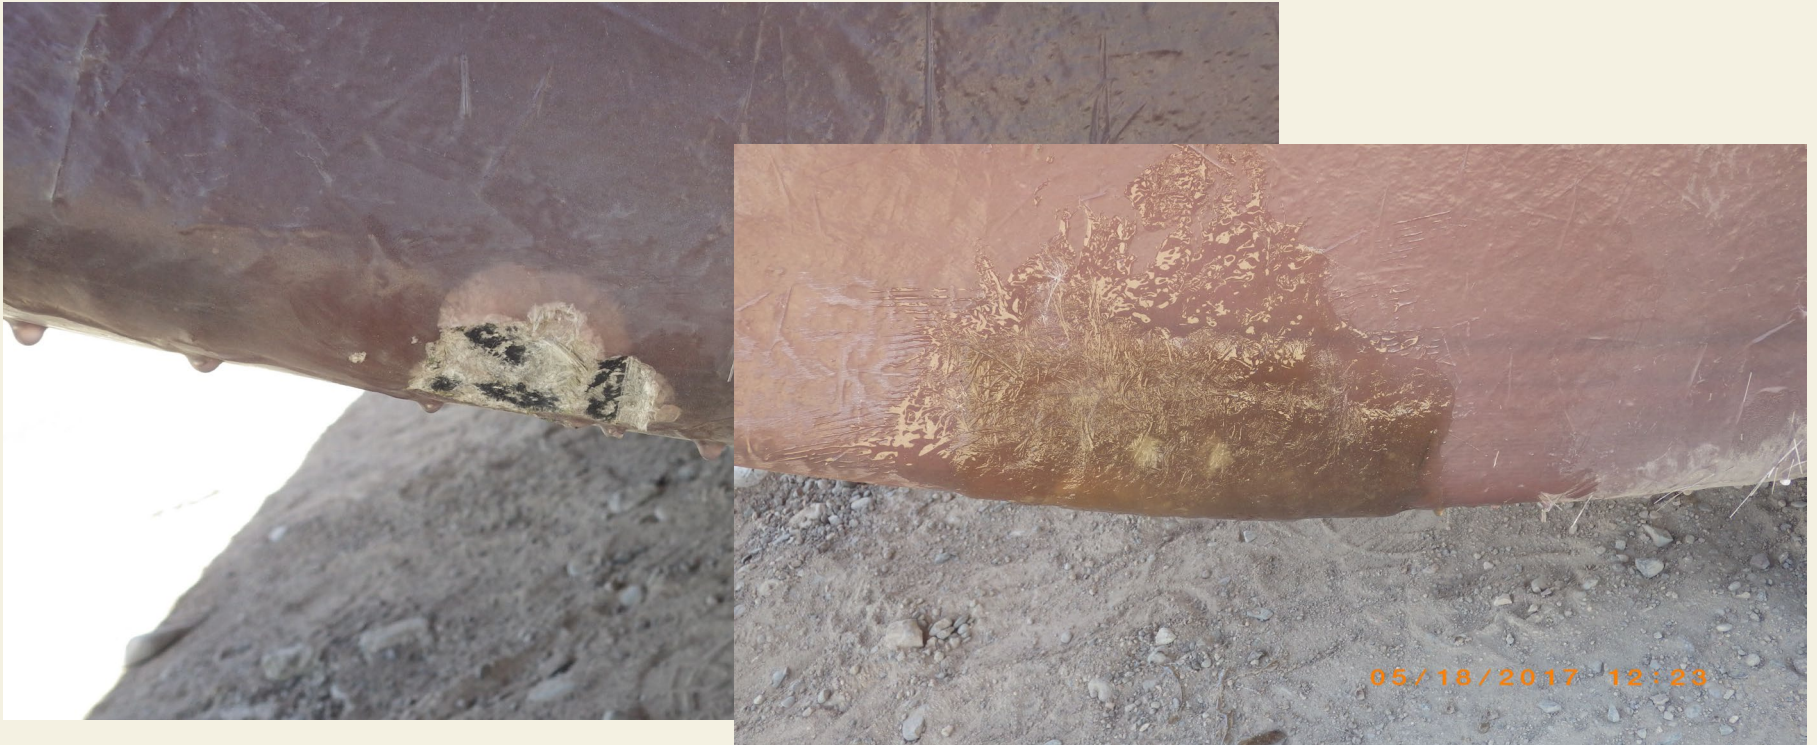
20,000-gallon double walled Permatank arrived at a site in Deming, New Mexico in 2017 with damage to the bottom of one end that compromised the integrity of the secondary of the tank. Owner asked if they could install the tank as a single walled tank and said, if a state inspector had not been there that it would have been installed without being repaired.

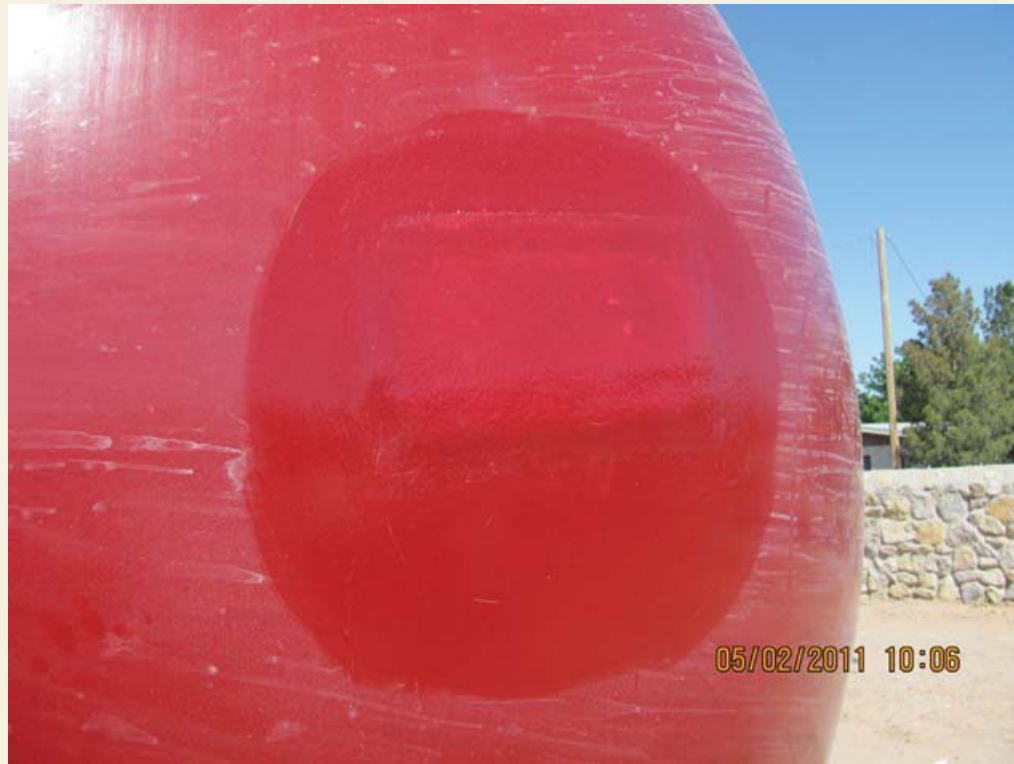
A new 12,000-gallon dual compartment fiberglass reinforced plastic UST was hit by the crane operator as the tank was being unloaded and a first the contractor was stating the damage was insignificant. Tank was repaired after it failed to pass tightness tests.

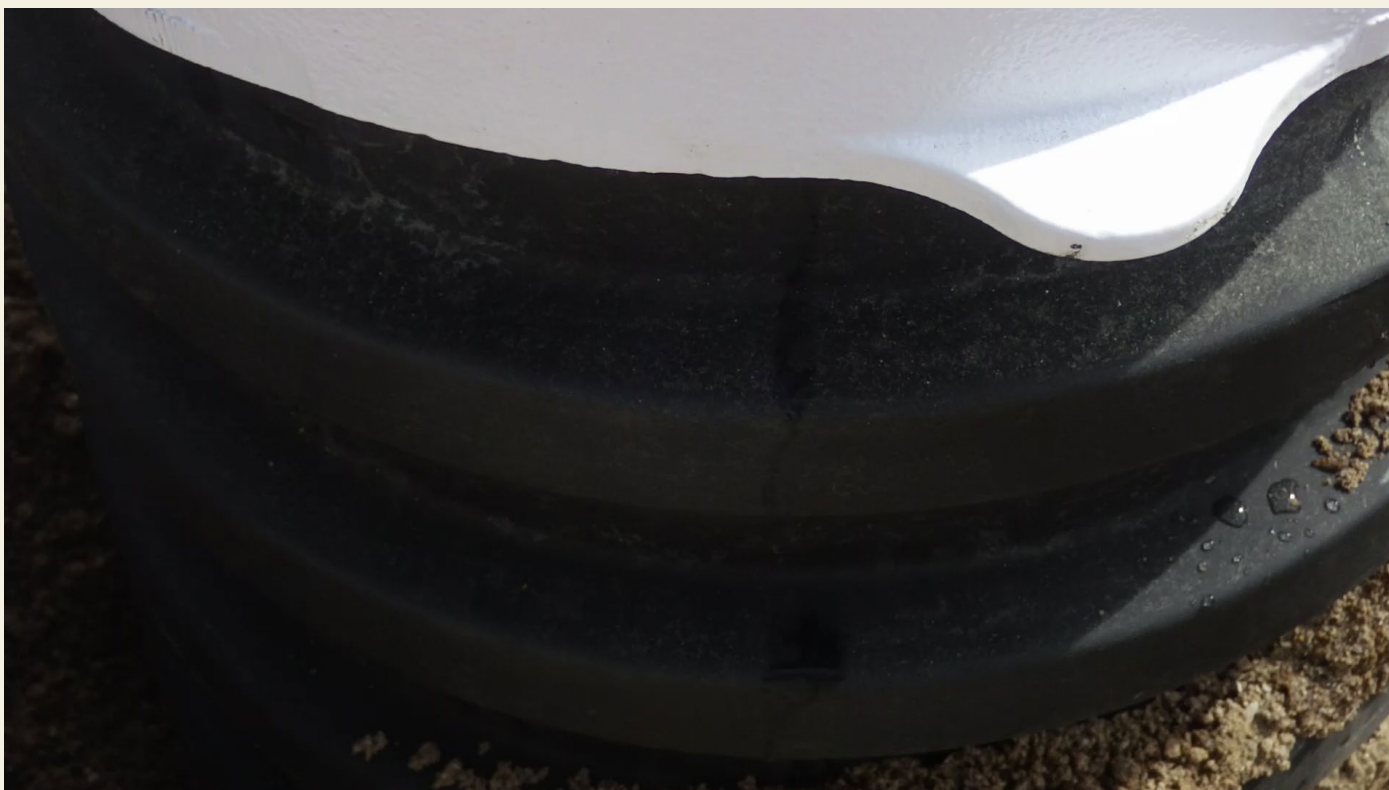
New double walled spill prevention equipment was replaced on regular unleaded UST in 2016 and it discovered during the initial hydrostatic test on the primary that water was leaking through both walls.

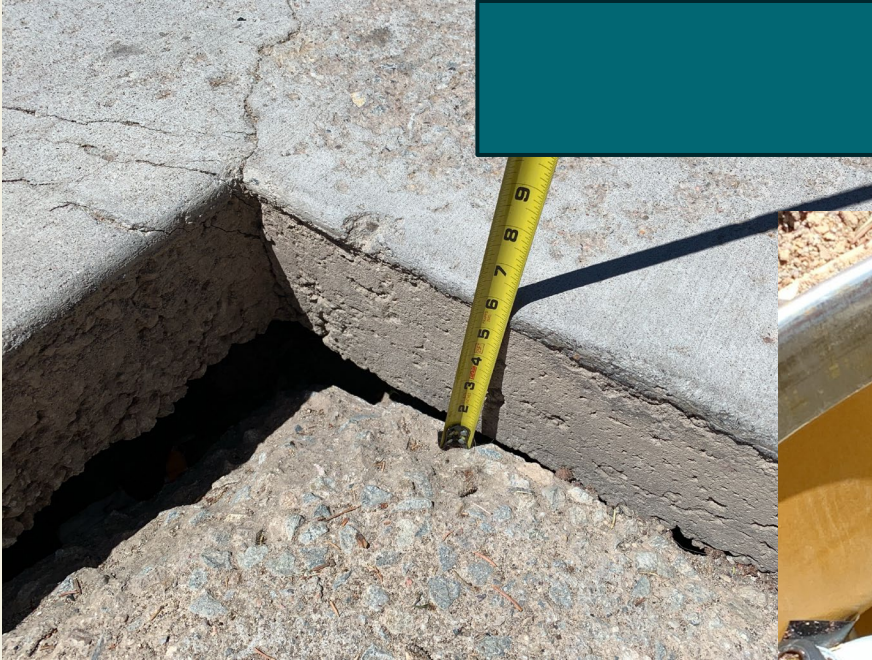
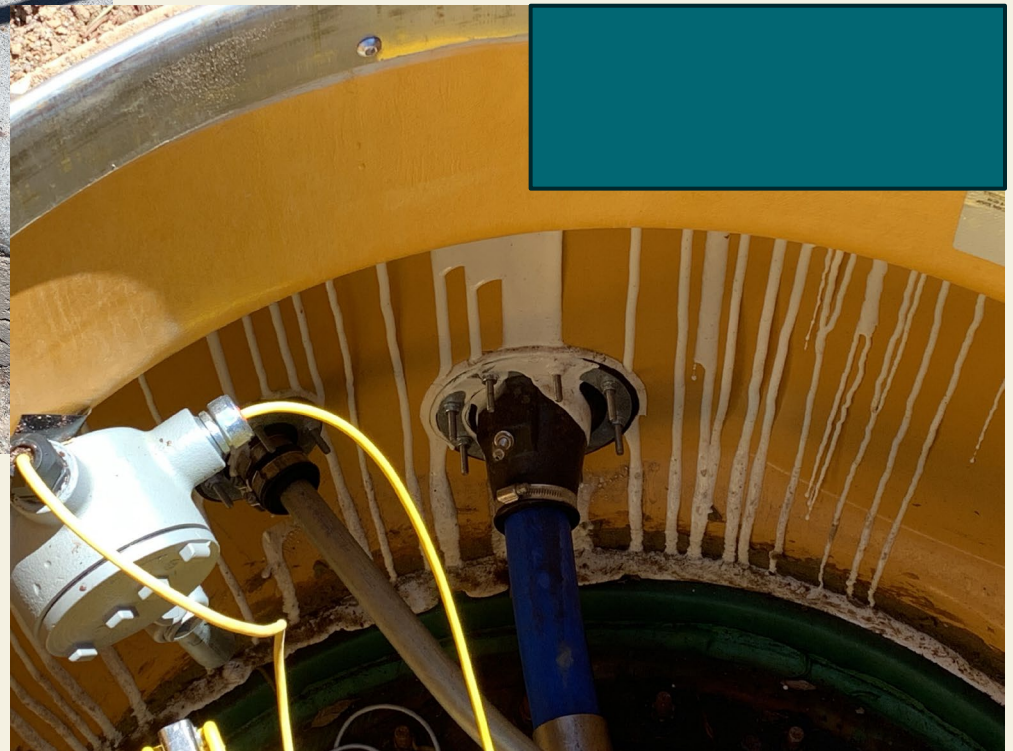
Concrete pad on top of UST was sinking on one corner.

STP Containment Sump not installed per manufacturer's installation instructions

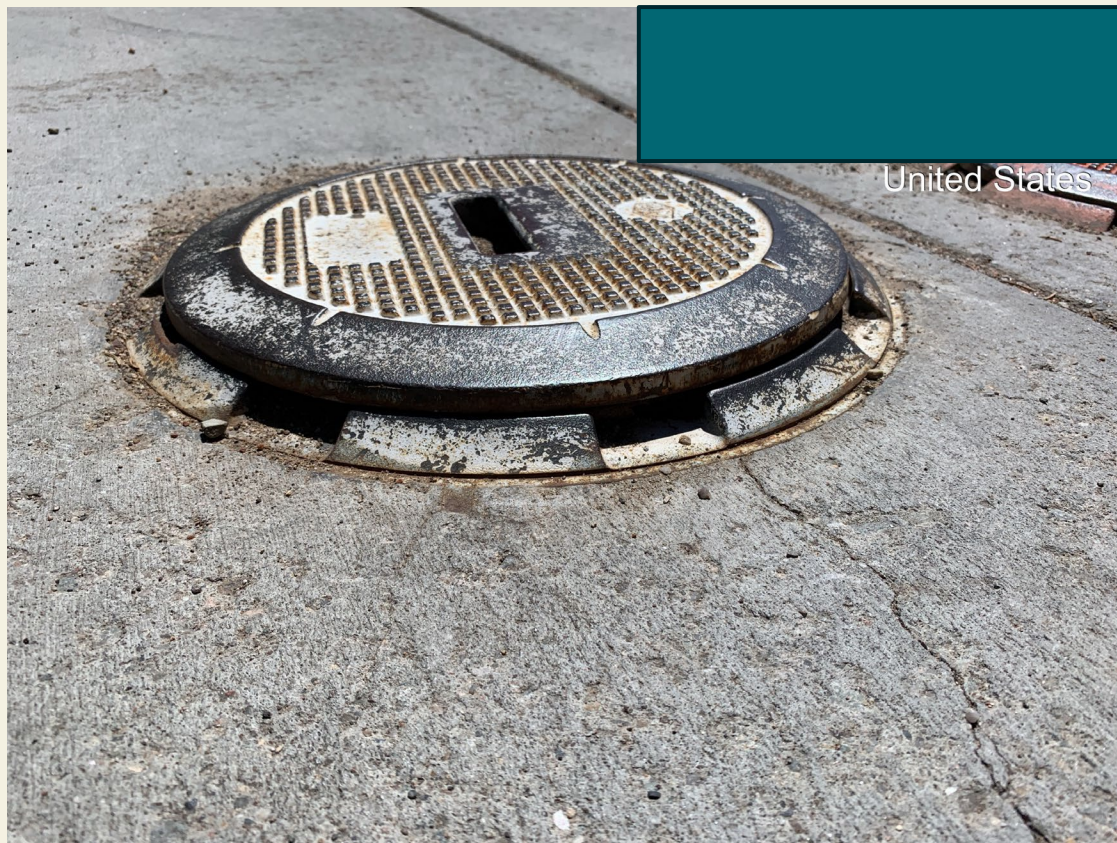
Fill riser is too tall and with the tank in a traffic area it is a matter of time before tank is damaged.

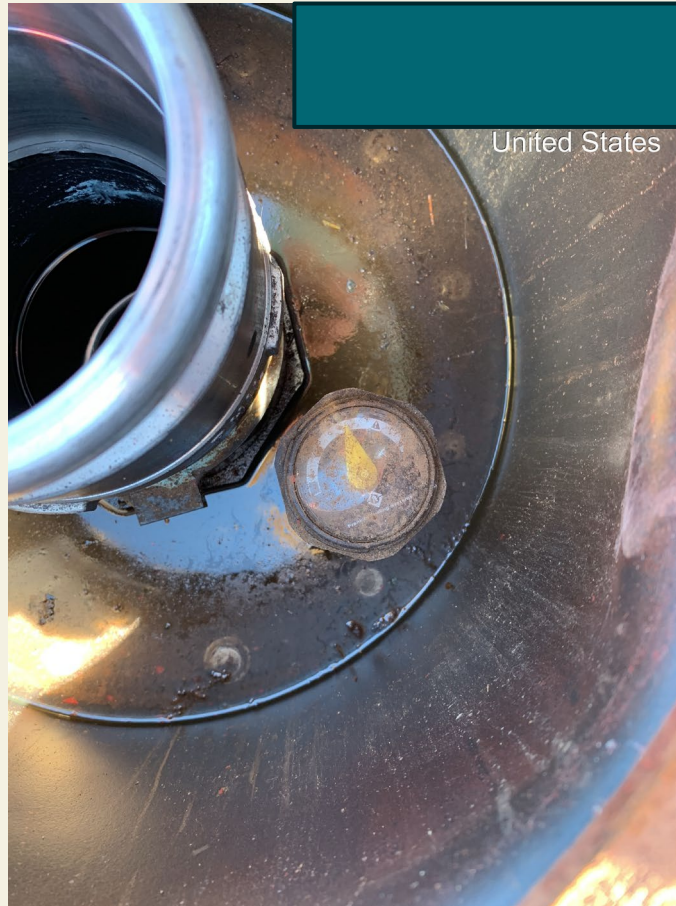
- ❑ Double Walled Spill prevention had fuel and water in the interstice because float gauge was not tight.
