# ON THE FRONT LINES: FAILED SUMP INSPECTION INITIATIVE

# INSPECTION SCHEME - MASSACHUSETTS

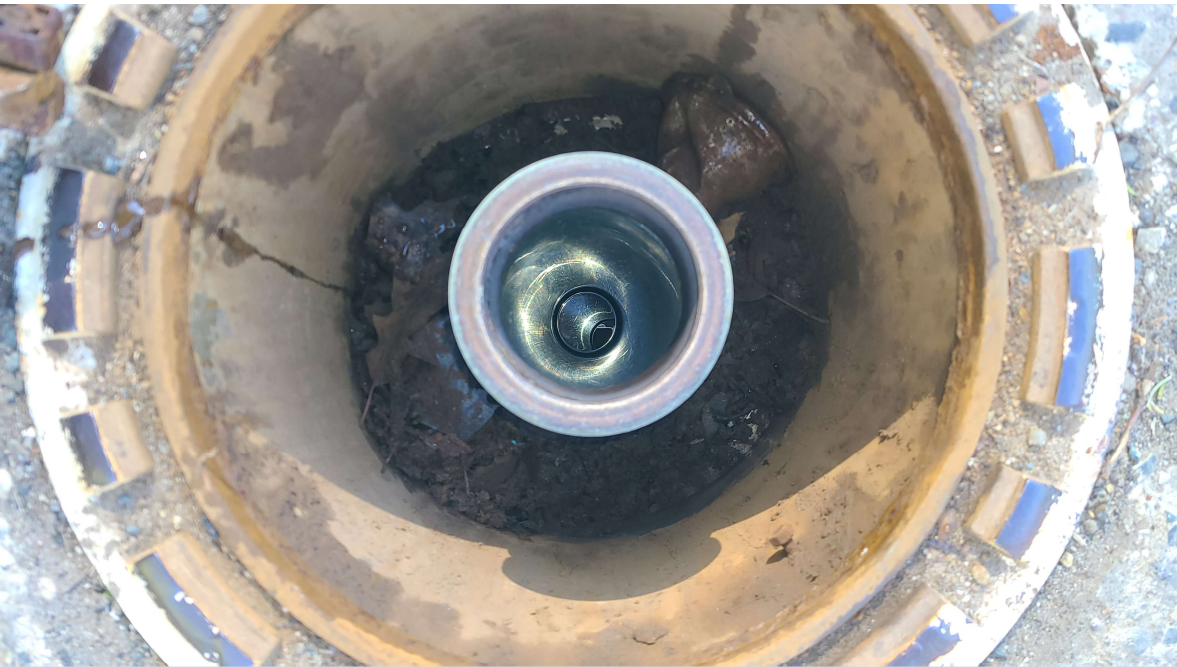
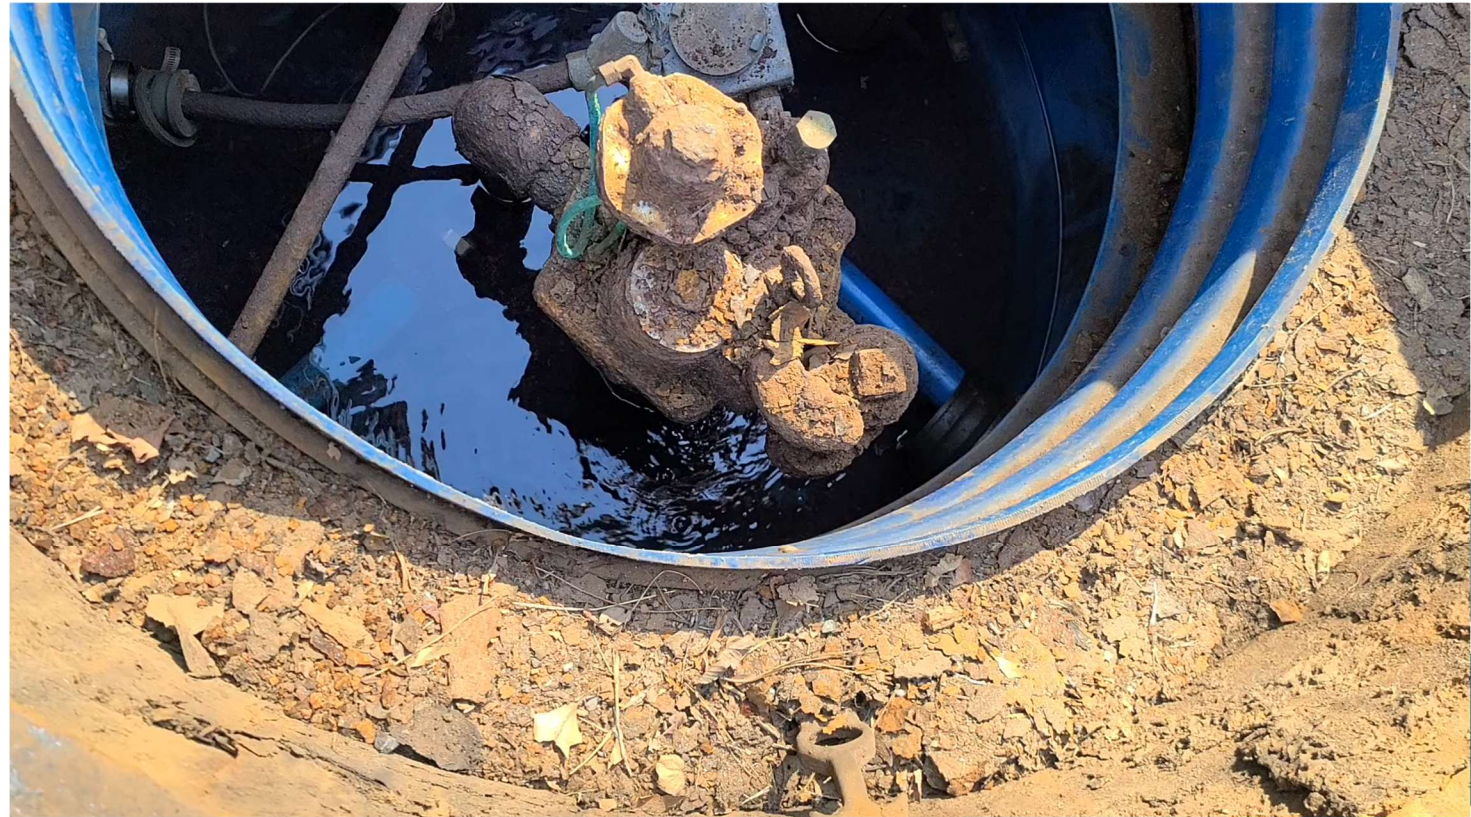
- Petroleum odors identified at wastewater treatment plant. Jan 2021
- Traced back to gas station in Athol with historical overfills and a faulty turbine sump. Mar 2021

- Turbine sump entry boots, conduit in sump, and overflow prevention (ball floats to automatic shut-off) were replaced.
- Old equipment in MA: UST was installed in 1995.
- LNAPL and impacted soil and groundwater discovered. Clean-up is ongoing.

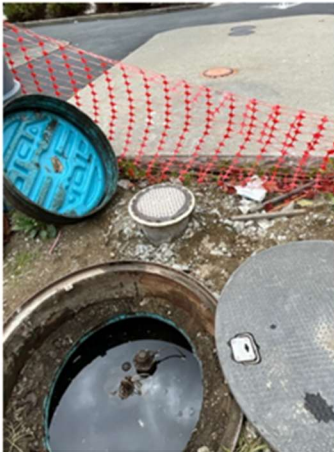
RUL STP sump filled to top with water and bottom is filled with dirt and debris due to contractor never coming back to finish work.

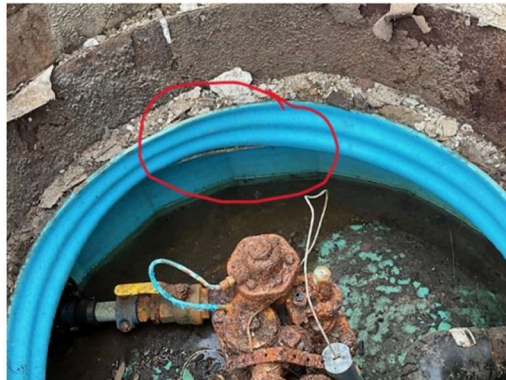
T-13B SUL STP SUMP HAS A CRACK IN PLASTIC AT TOP OF SUMP AND ALSO LEAKED 7" IN AN HOUR BELOW CRACK AS WELL, WATER WAS LEFT IN SUMP OVER NIGHT AND ALL WATER LEAKED OUT.

ALL DISPENSER SUMPS ARE VISUAL FAILS, ALL SECONDARY BOOTS AND CLAMPS ARE LOOSE, NEED TO BE POSSIBLY REPOSITIONED AND TIGHTENED. DISPENSERS WOULD NEED TO BE REMOVED FROM ISLANDS TO PROPERLY BE ABLE TO TIGHTEN ALL LOOSE CLAMPS ON EVERY SECONDARY TEST BOOT, JUST TO BE ABLE TO CONDUCT A HYDROSTATIC TEST OF DISPENSER SUMPS.

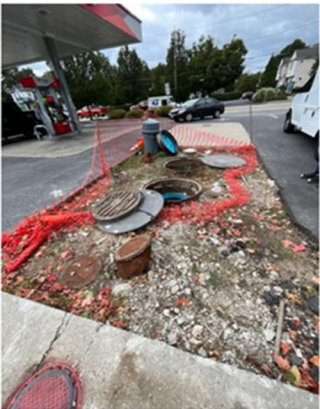
Sump area is wide open on both RUL STP sump and SUL STP sump due to contractor never coming back to finish work.

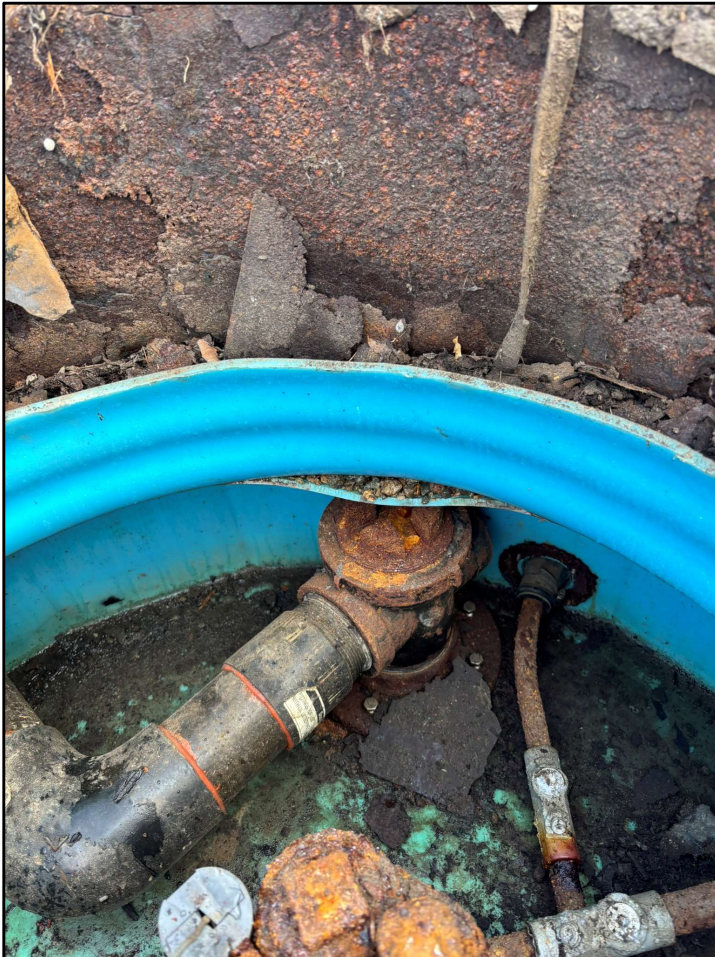
Crack in premium gasoline turbine sump

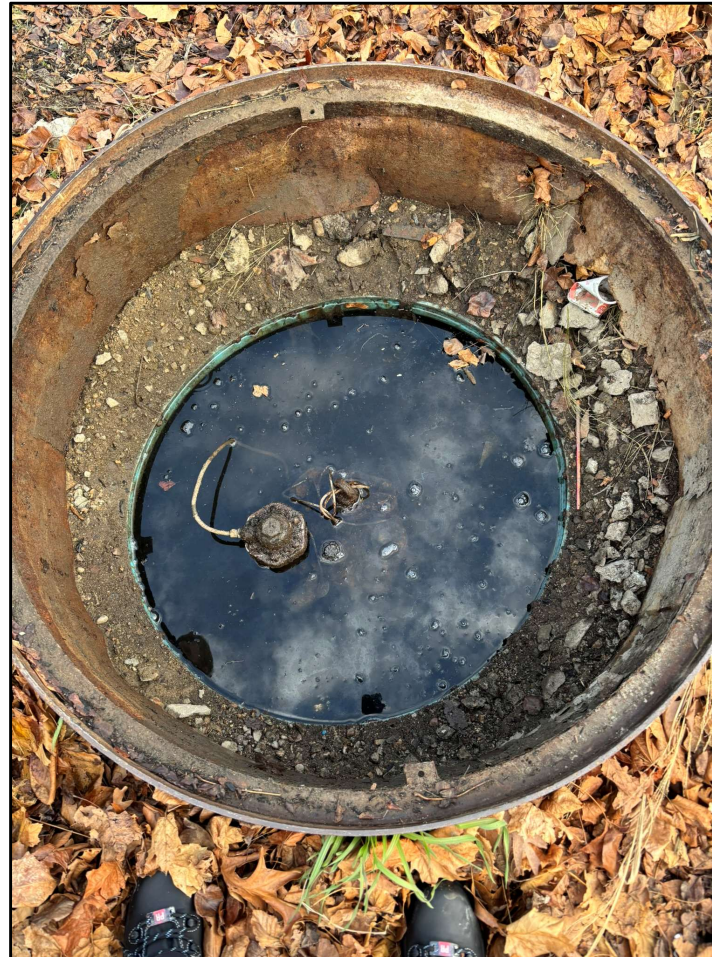
12 inches of water in regular gasoline turbine sump

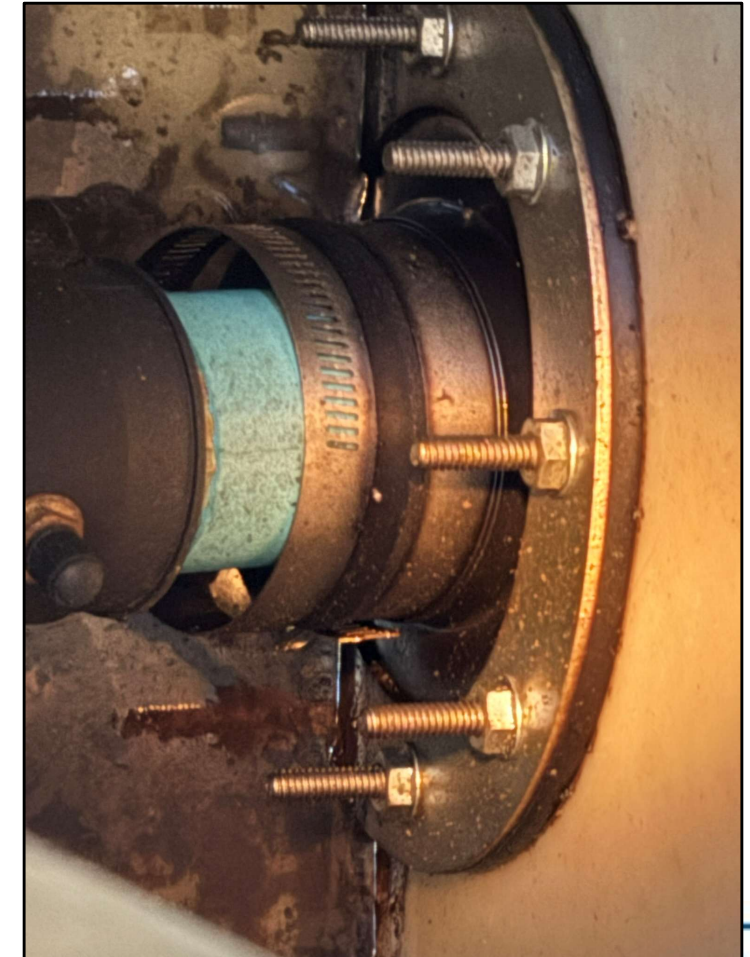
Loose secondary containment boots and clamps in dispenser sump

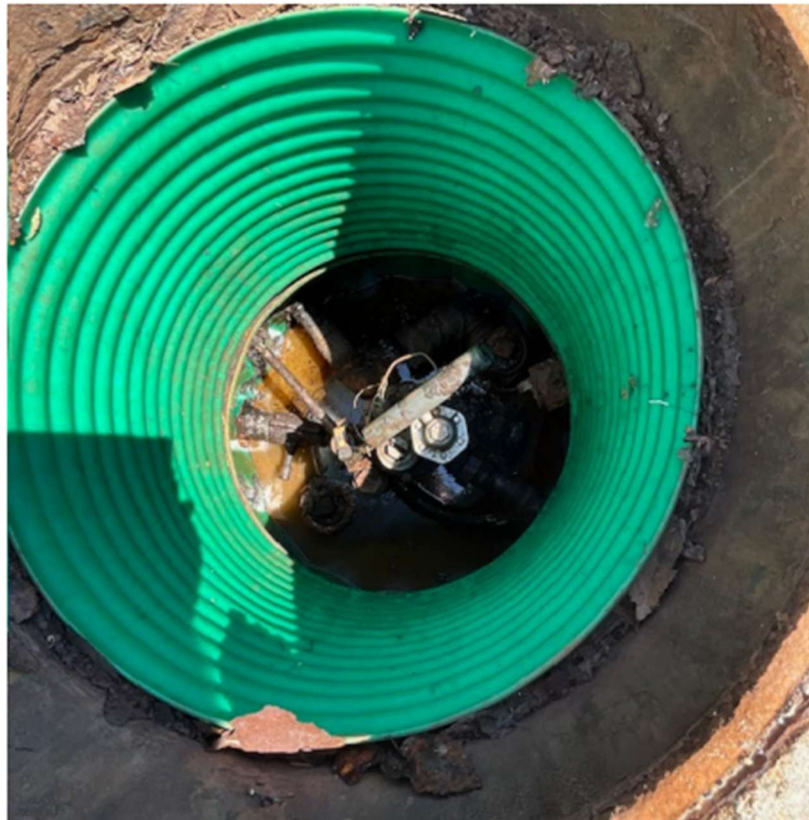
DSL STP sump also has a crack in bottom of sump.

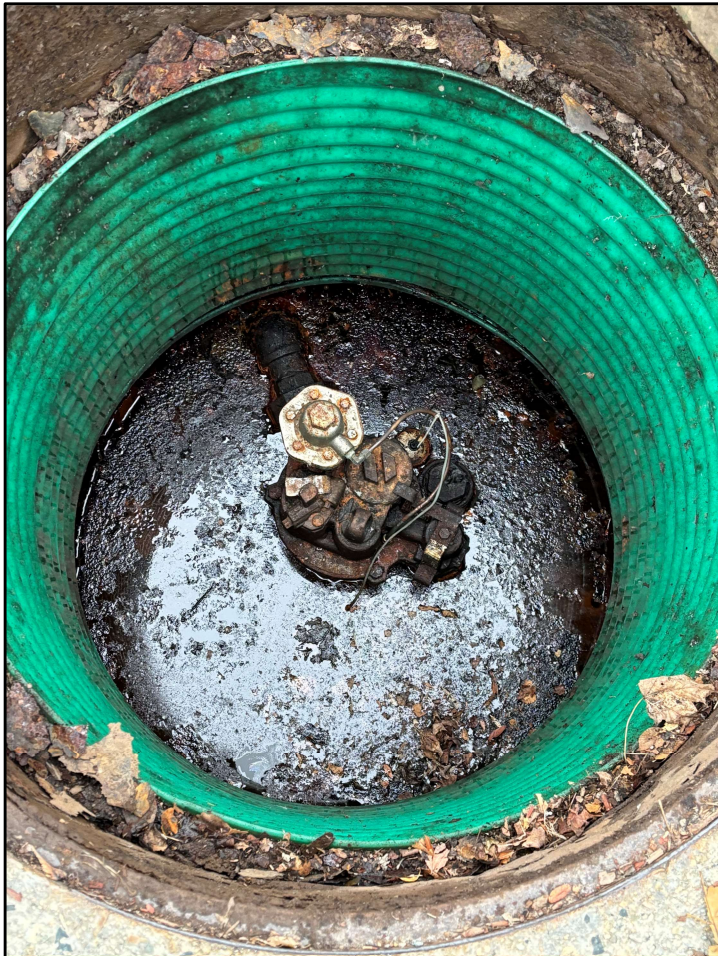
Approximately, 20 inches of water in regular gasoline turbine sump

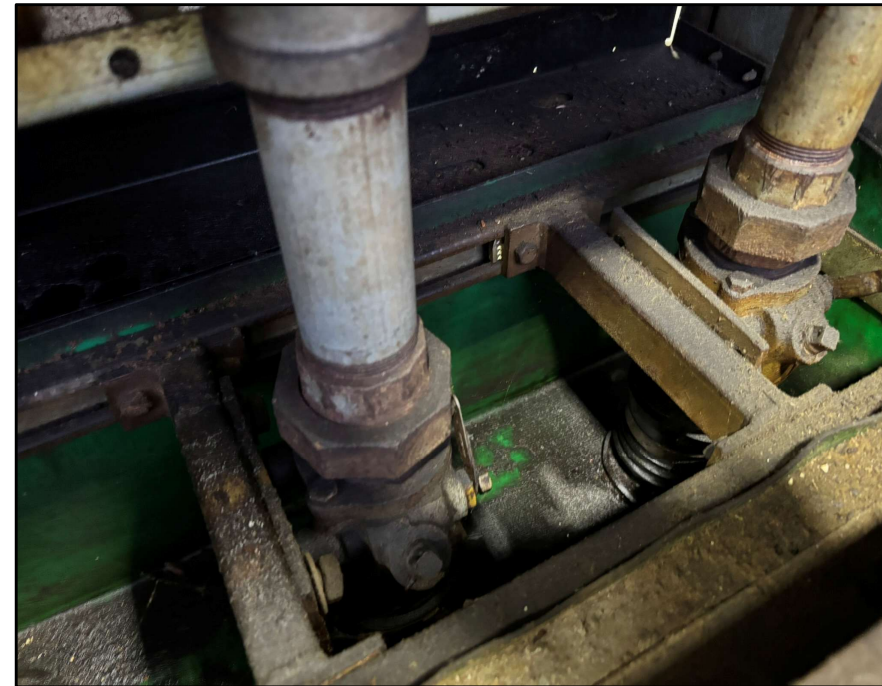
Solid debris and trace amounts of fuel in dispenser sump

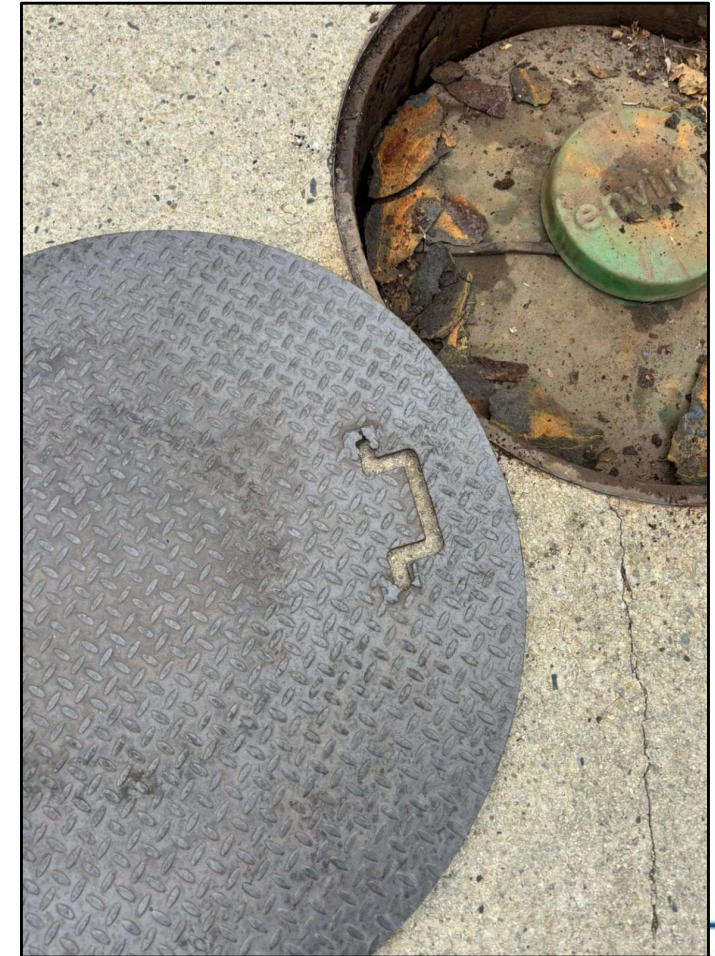
Holes in turbine sump manhole cover, allowing water to infiltrate sump

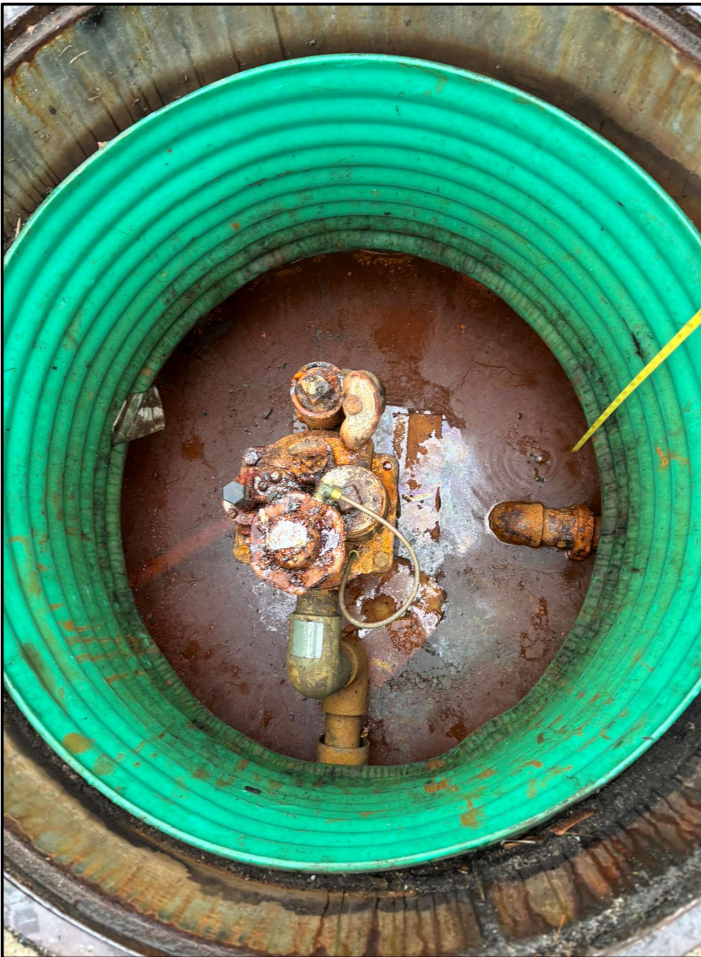
6 inches of water in regular gasoline turbine sump

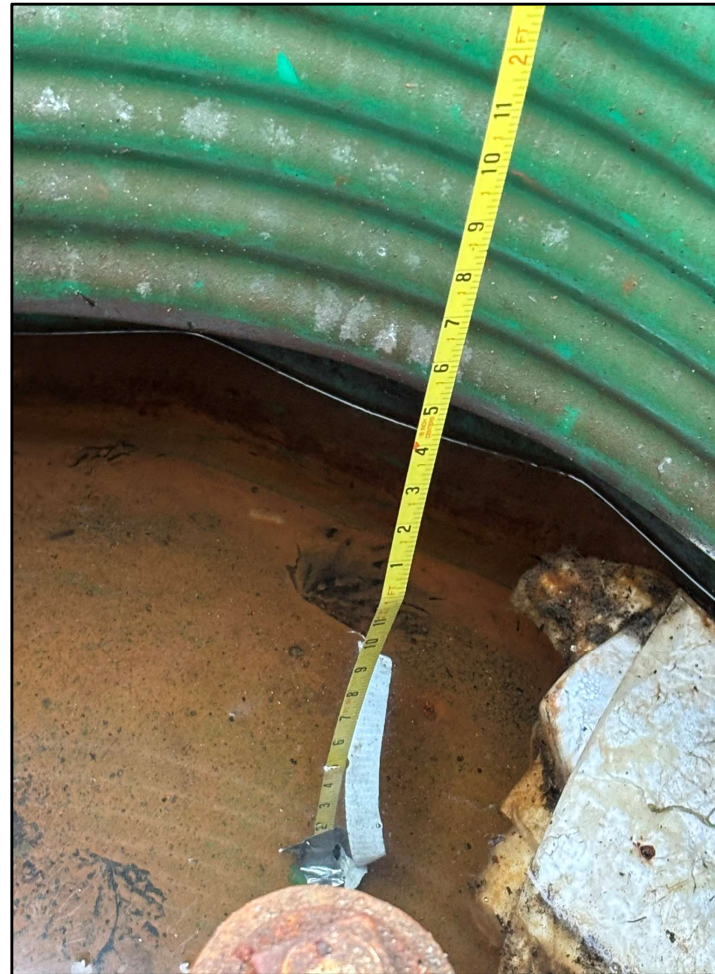
5 inches of water and solid debris in super gasoline turbine sump

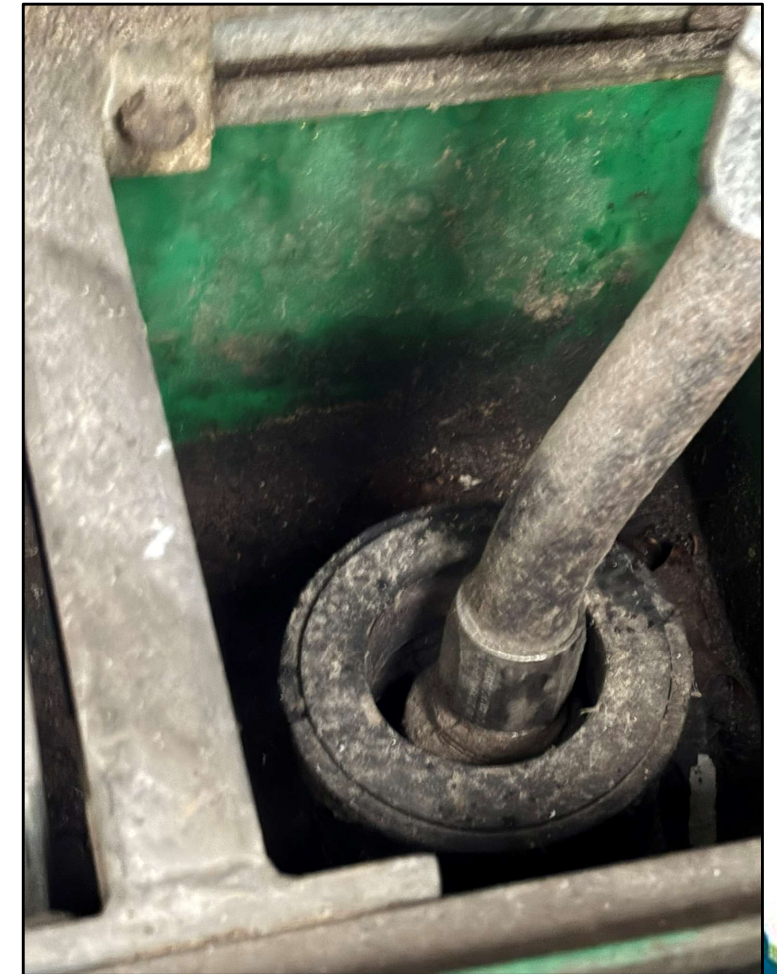
Loose secondary containment boots and clamps in dispenser sump

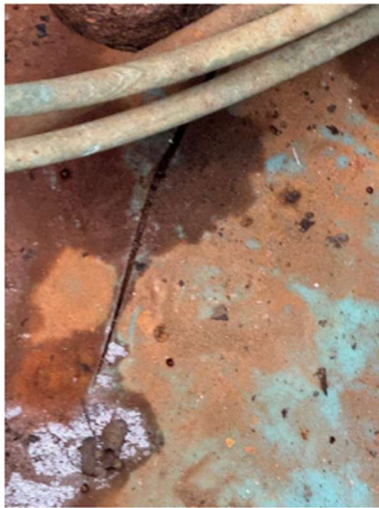
Sump is cracked at bottom, needs to be repaired and or replaced. Syphon line Copper tube hole wide open, it was tested together with RUL-S sump but still failed integrity testing.

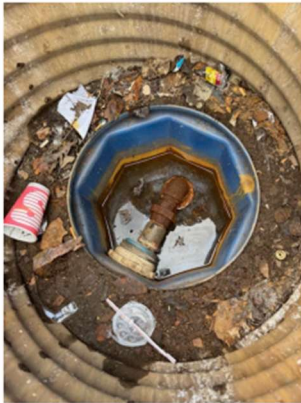
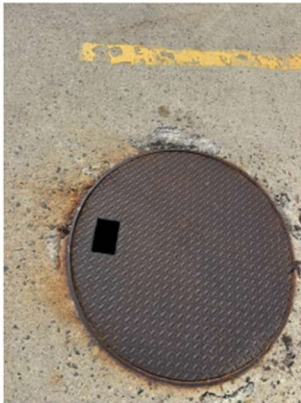
Sump manhole covers have holes from old handles that need to be repaired by welding closed or replaced with new covers.

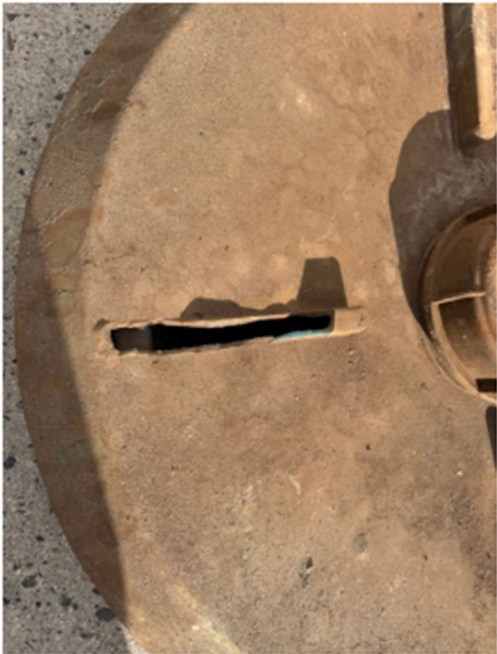
Sump cover needs to be replaced.

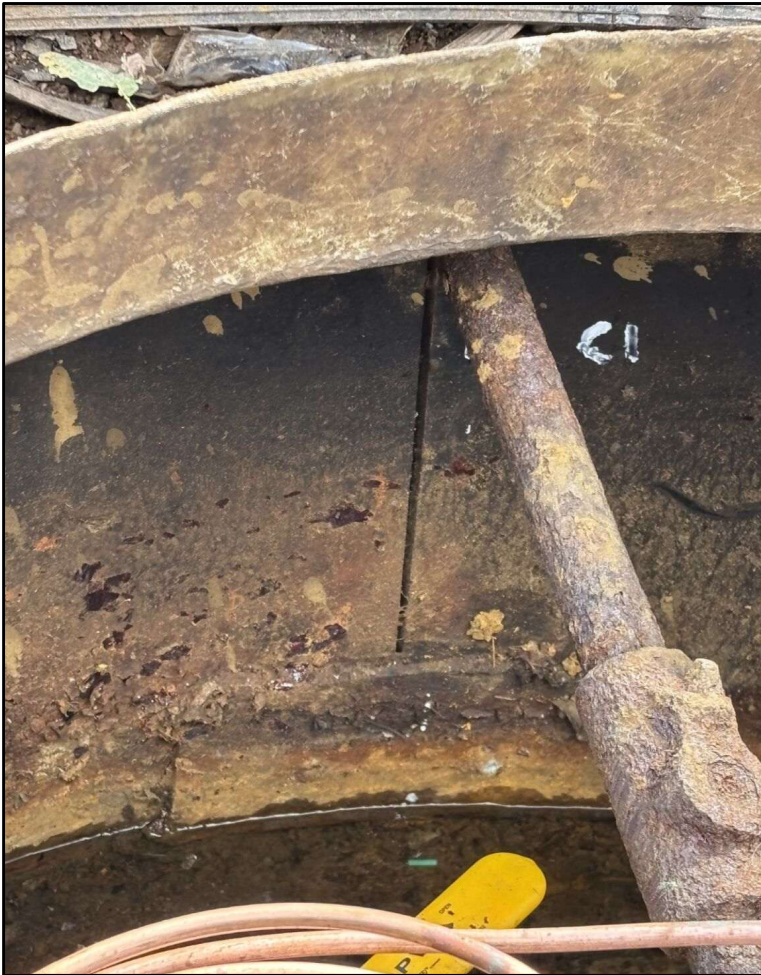
Crack in regular gasoline turbine sump

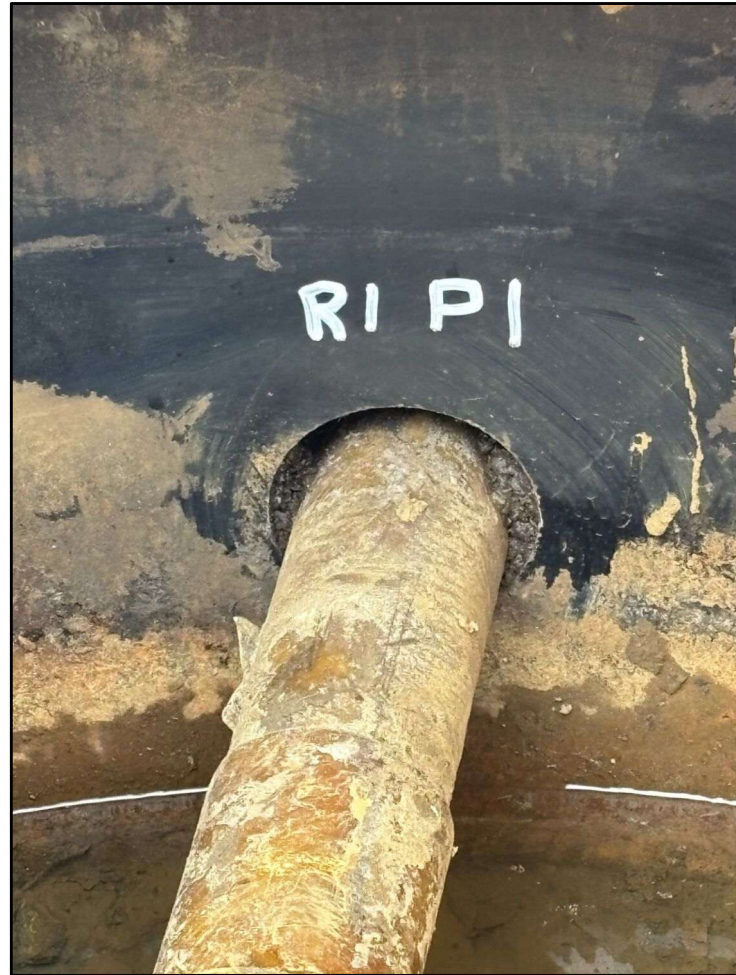
Hole in regular gasoline turbine sump where piping enters

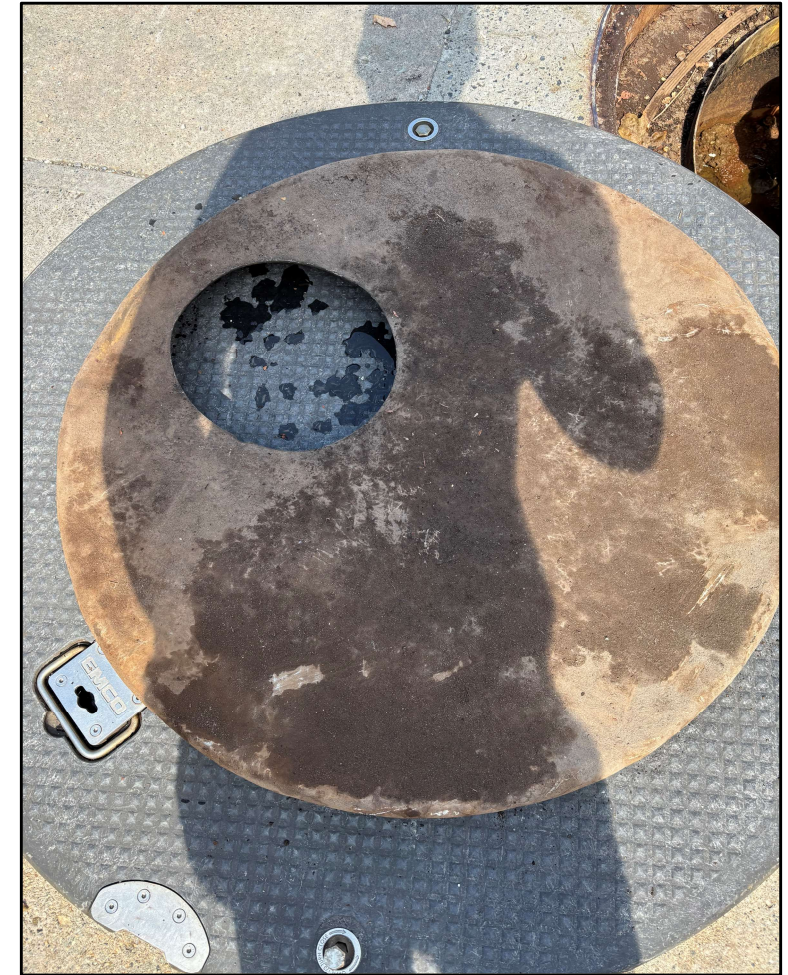
Hole in turbine sump covers
