# Feasibility Study for Anadromous Fish Passage

Blackamore and Cranberry Ponds  
Cranston and Warwick, Rhode Island

Project No. P310-000  
Revised March 3, 2017

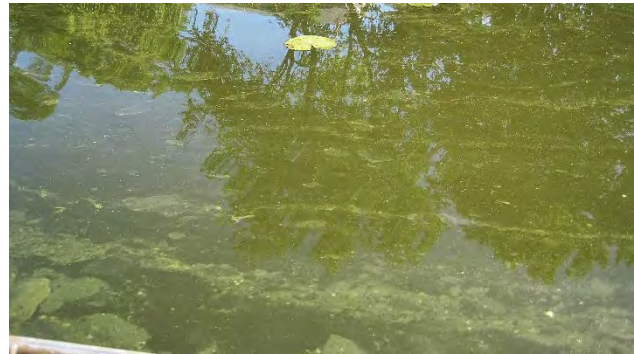
Additionally, excessive algal growth was observed at Blackamore Pond, including a cyanobacteria bloom at the time of sampling. Cyanobacteria blooms have been observed at this pond in prior years (ESS 2013), indicating that this is a recurring issue. Species observed in the blooms (such as *Aphanizomenon* spp., *Woronichinia naegeliana*, *Microcystis* spp., and *Dolichospermum* spp.) are known to be potentially toxigenic and the Rhode Island Department of Health (RIDOH) and RIDEM have issued health advisories for the pond multiple times since 2012.

*Surface scums of cyanobacteria were observed at Blackamore Pond.*

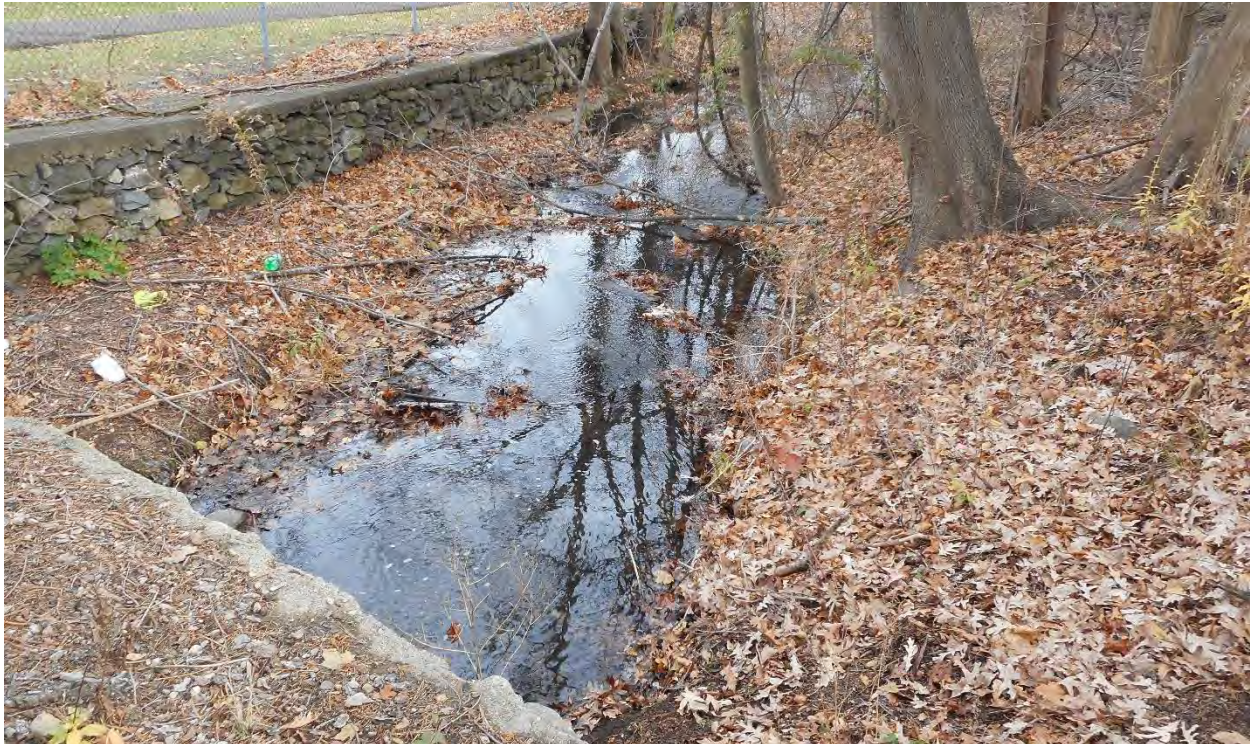
This highly modified portion of the Blackamore outlet stream scored a 106 out of 200, indicating sub-optimal habitat conditions. Sediment deposition and lack of pool variability were among the lowest-scoring instream habitat elements. Channelization was also identified as a sub-optimal element of instream habitat. Riparian habitat elements, such as vegetative protection and riparian zone width were also considered marginal. See the completed habitat assessment forms in Appendix B for a detailed evaluation of stream morphology immediately downstream of Blackamore Pond.

*Assessed reach of the Blackamore Pond outlet stream, looking downstream. Budlong Pool is behind fence at upper left.*

Stream daylighting is currently recommended at one location associated with the Blackamore Pond system (Budlong Park). In this case, daylighting would likely involve the removal of concrete panels that currently cover a short channelized section of the outlet stream behind Budlong Pool. This section of the stream currently contains slots for stoplogs, presumably to allow diversion of the stream into the low-lying “pond” just south of the baseball fields at Budlong Park, which may serve both a flood storage and recreational purpose. Therefore, daylighting of the stream at this location would require additional coordination with the owner and operator of the structure to ensure that it is compatible with current uses.

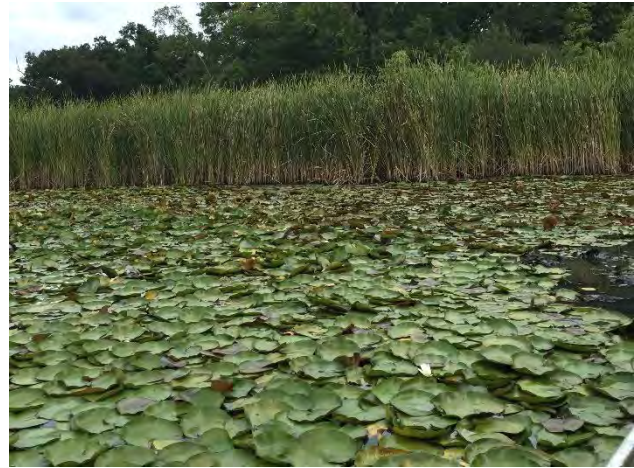
*Water lilies (foreground) and broadleaf cattail (background) formed nearly monotypic beds at Cranberry Pond.*

In Cranberry Pond, excessive growth of water lilies, naturally low water clarity, and lack of clean sand, gravel, or other coarse substrates suggests that habitat is marginal for alewife spawning and recruitment.

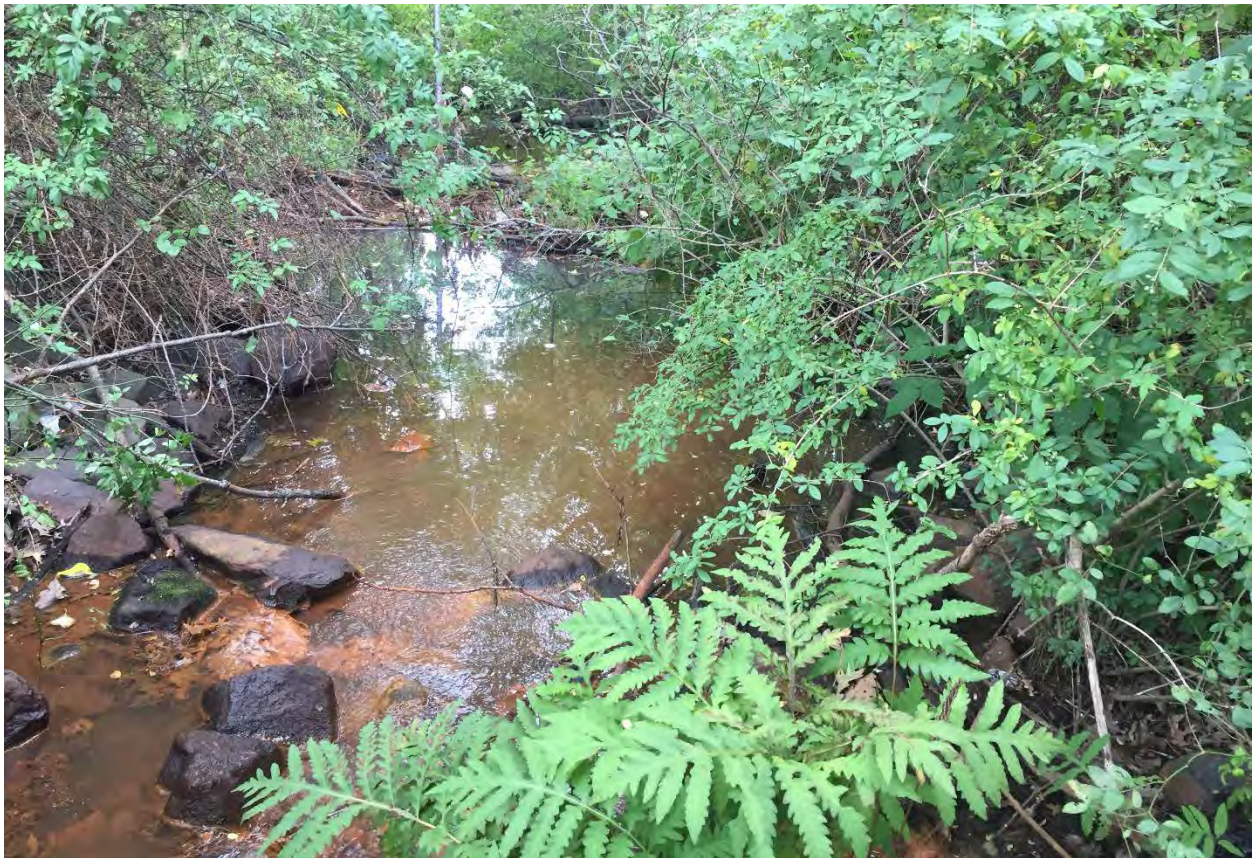
This uppermost portion of Cranberry Brook scored a 117 out of 200, which reflects sub-optimal habitat conditions. Pool variability and channel sinuosity were the instream habitat elements characterized by marginal scores. Riparian zone width was also marginal at this location. See the completed forms in Appendix B for a detailed evaluation of stream morphology immediately downstream of Cranberry Pond.

*Cranberry Brook, looking downstream from Mowry Avenue*

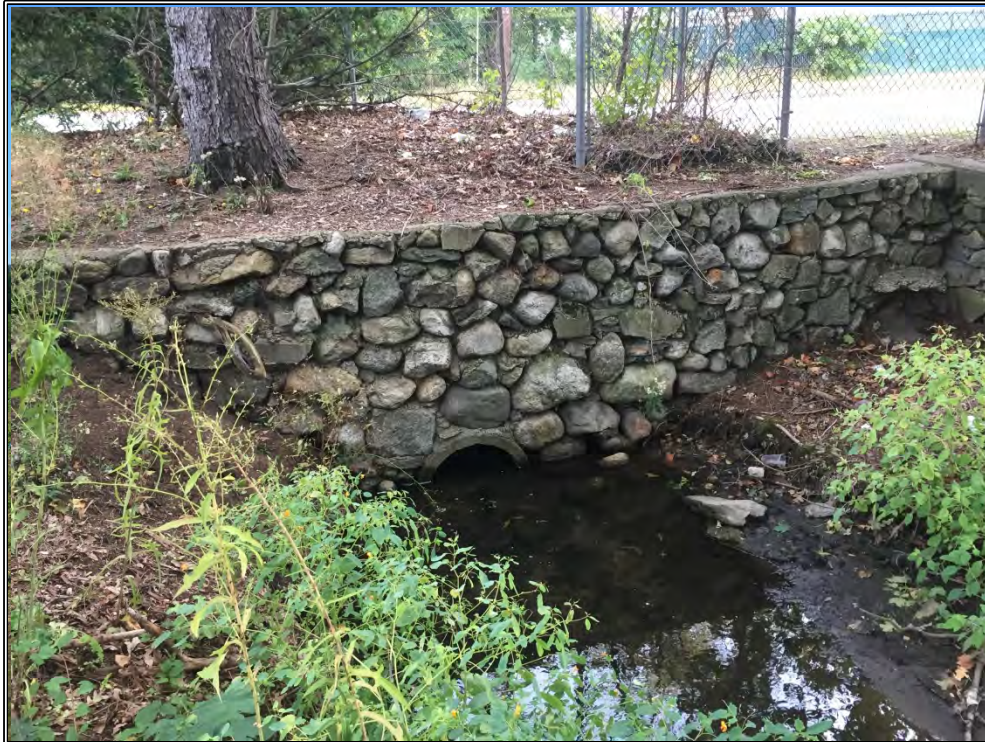
**B-1: Blackamore Pond outlet culvert under Aqueduct Road, downstream side – September 30, 2016**

Culvert retrofit is recommended as an interim measure to improve fish passage for at least one location associated with Blackamore Pond (Aqueduct Road). Due to the low openness ratio (area to length) of the culvert at this location, much of the existing pipe is dark, which may discourage fish passage. The addition of supplemental lighting within the culvert, such as solar powered waterproof LED strip lighting, is one low-cost retrofit option to address this issue.

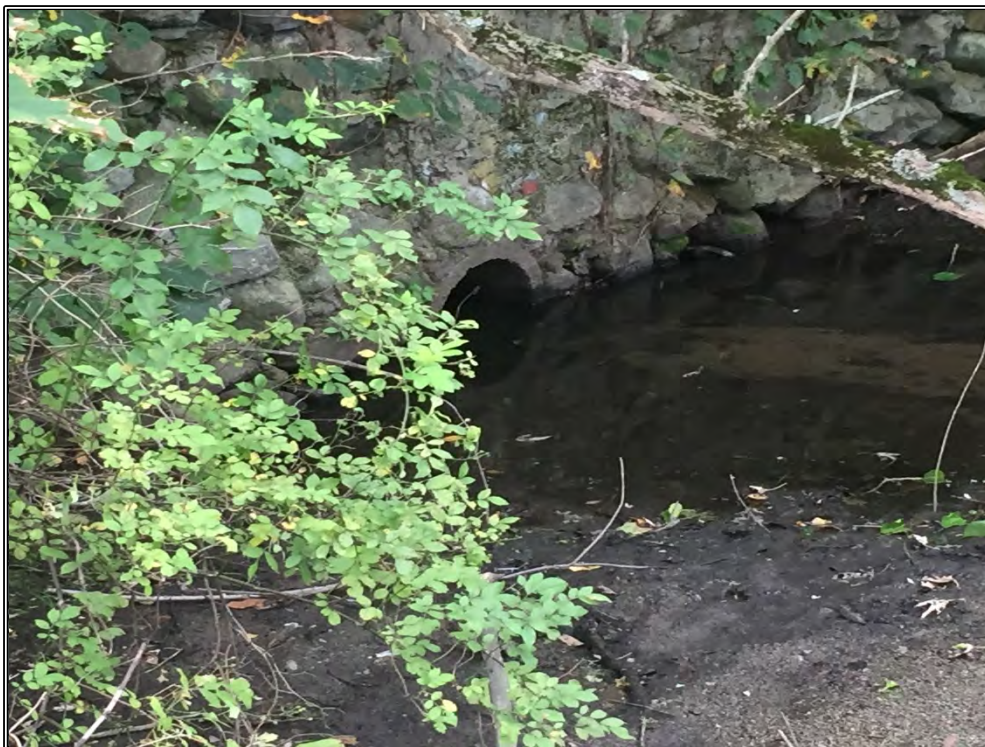
**B-1: Blackamore Pond outlet culvert under Aqueduct Road, upstream side – September 30, 2016**

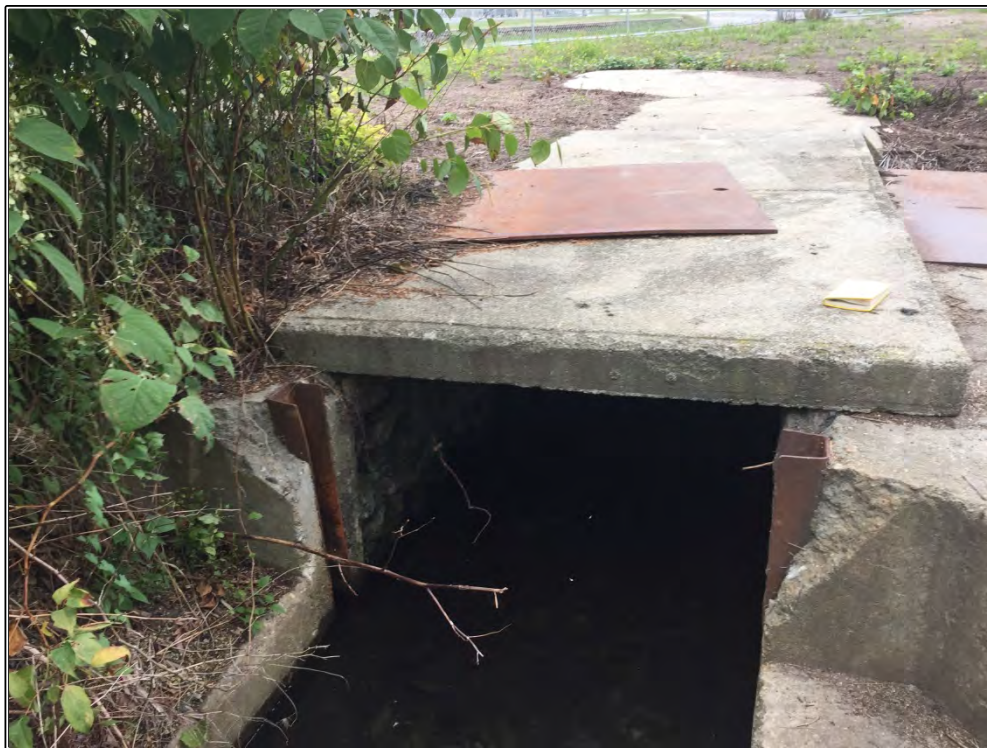
**B-2: Culvert/underpass behind Budlong Pool facility, downstream end – September 30, 2016**

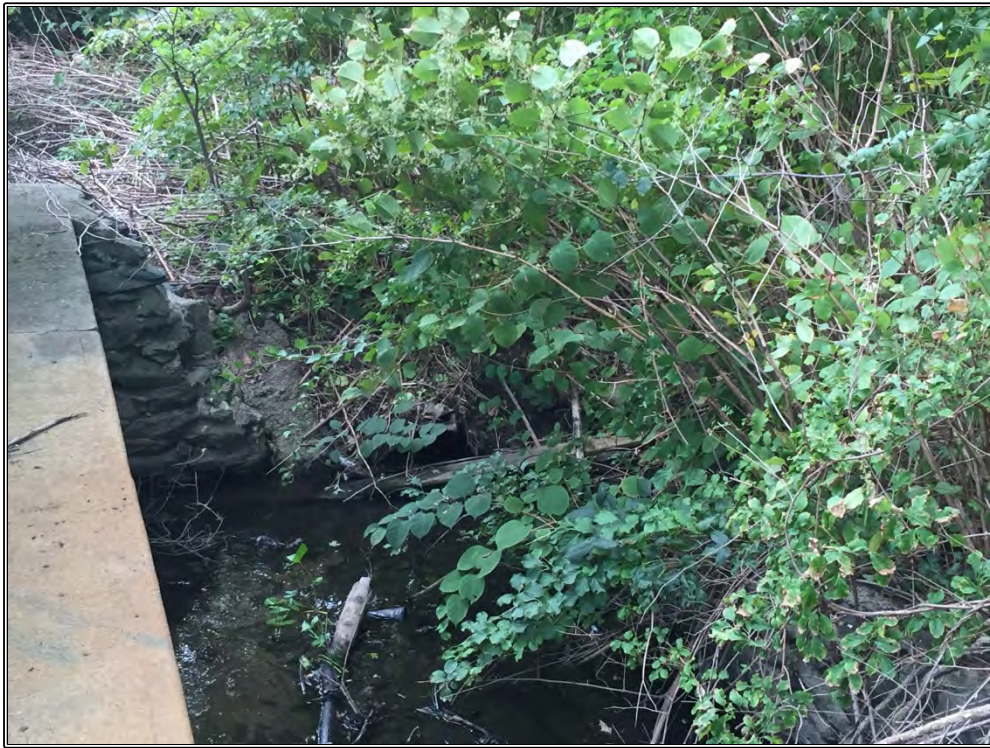
**B-2: Upstream entrance to culvert/underpass behind Budlong Pool facility – September 30, 2016**

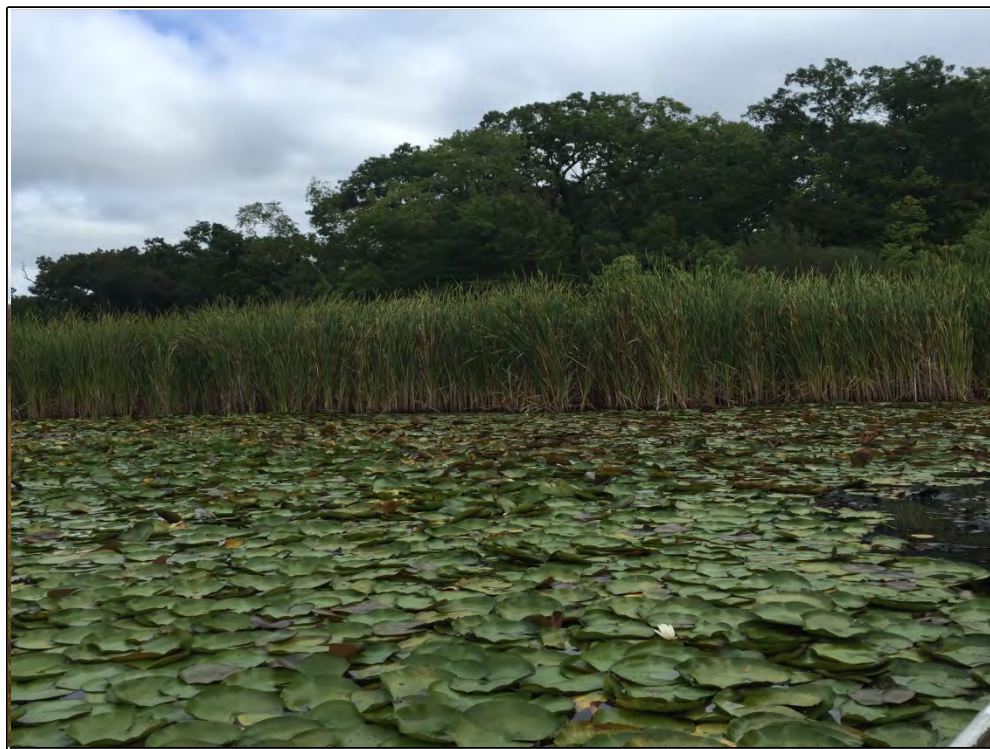
**Cranberry Pond densely vegetated shoreline – September 29, 2016**

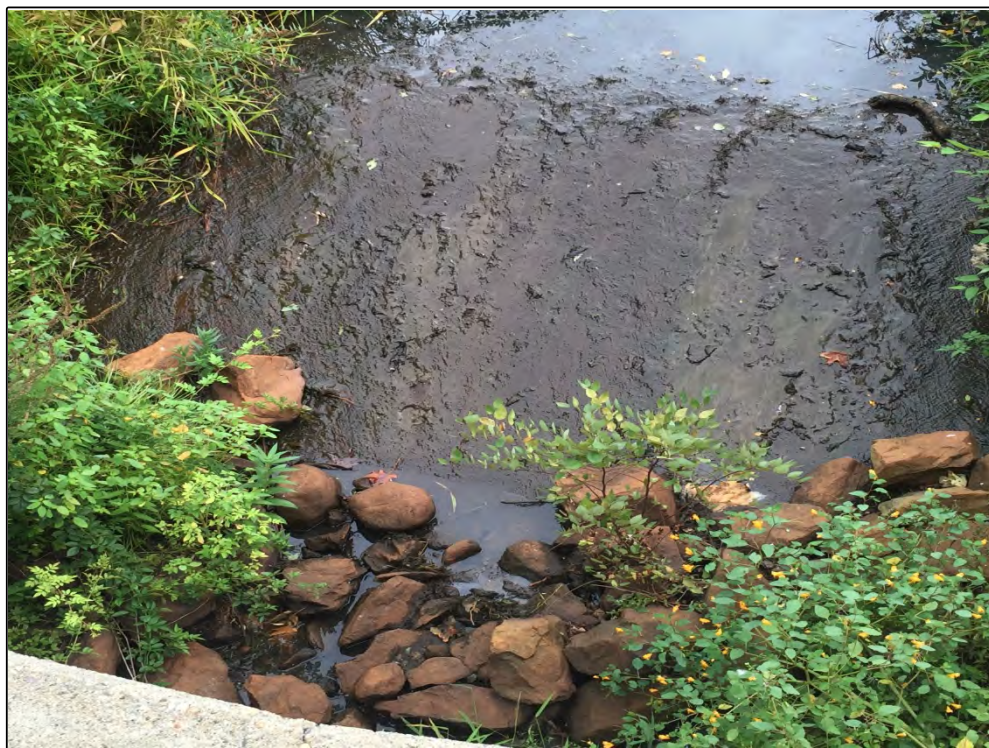
Approximately 150 feet downstream of Cranberry Pond, a small concrete structure impedes flow immediately upstream of the Mowry Avenue crossing. This structure is a ramp that is built into the streambed and creates an obstruction that is approximately 3 to 4 feet in height and 5 feet in length. This feature severely constricts flow under low water conditions, resulting in a very shallow water depth that may impede migration of fish into or out of the pond. Once flow passes over this impoundment, it enters an adjacent culvert beneath Mowry Avenue. Table I below includes culvert dimensions and photos are included in Appendix C.

**C-1 Obstruction at Cranberry Pond outlet – September 30, 2016**

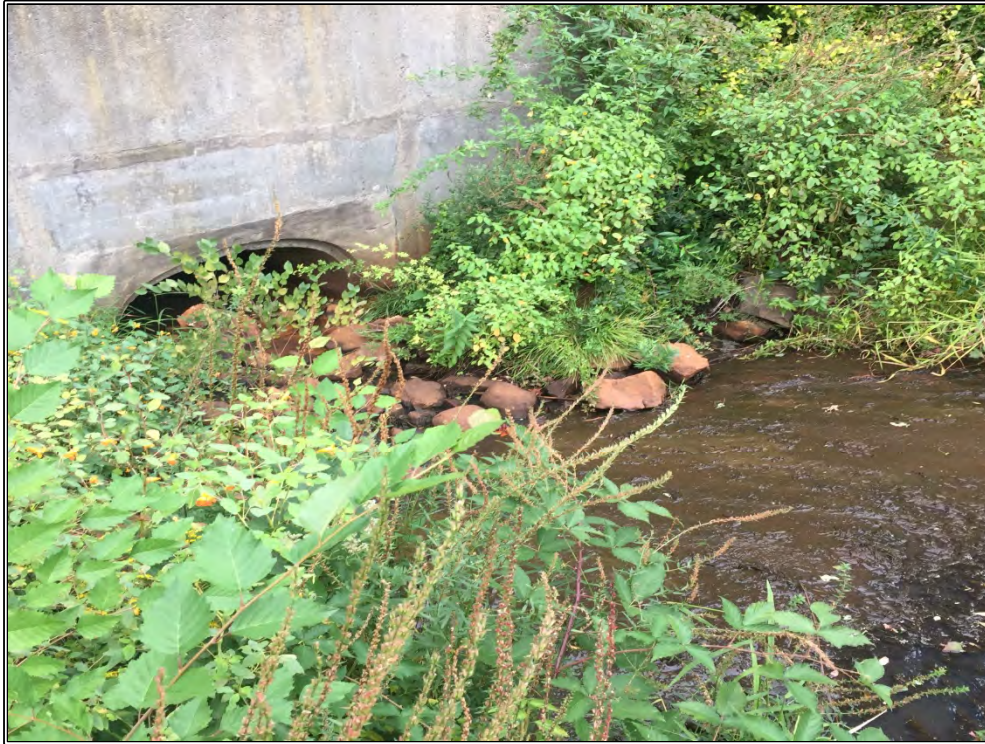
**C-1: culvert under Mowry Ave directly downstream from spillway -- September 30, 2016**

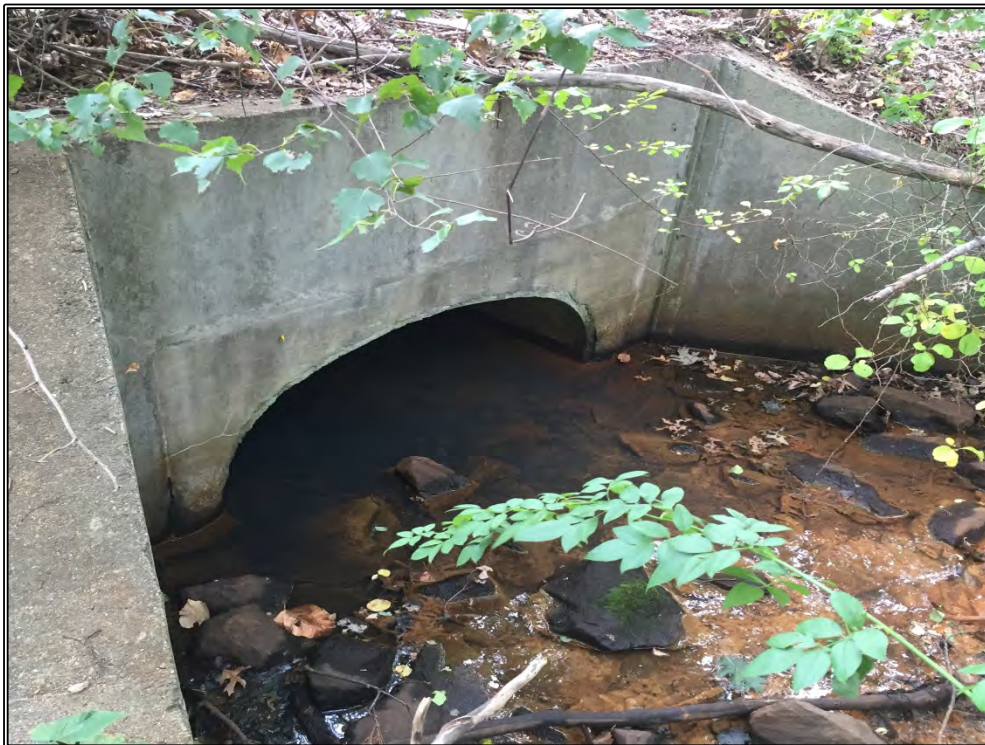
**C-1: downstream side of culvert under Mowry Ave -- September 30, 2016**

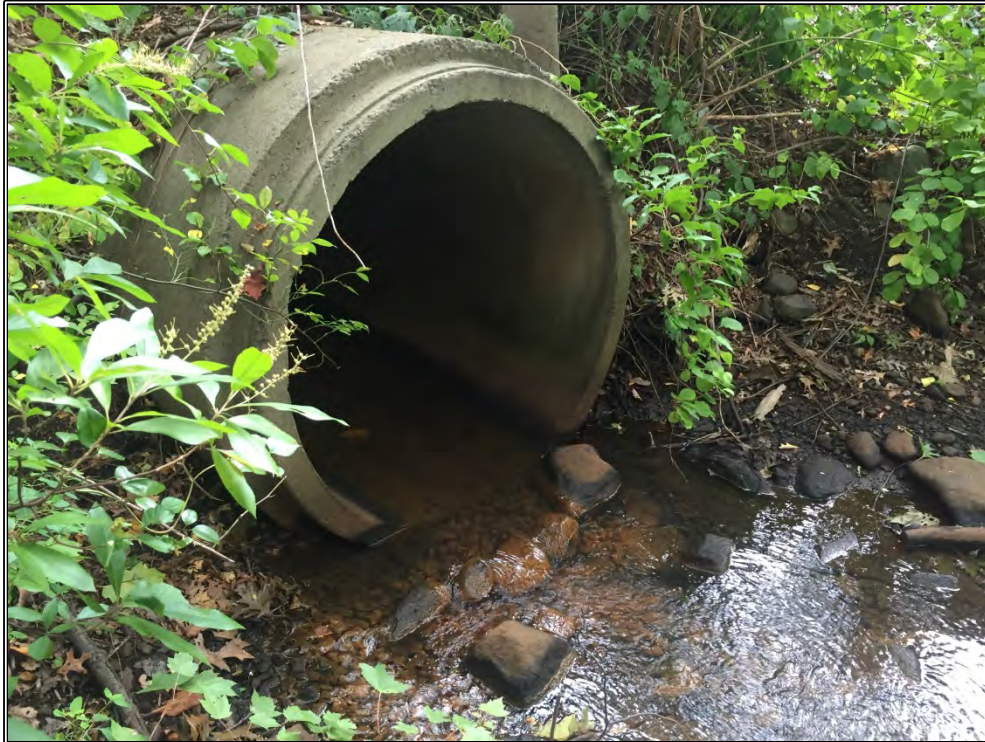
**C-2: extended culvert under Fifth Ave, downstream end – September 30, 2016**

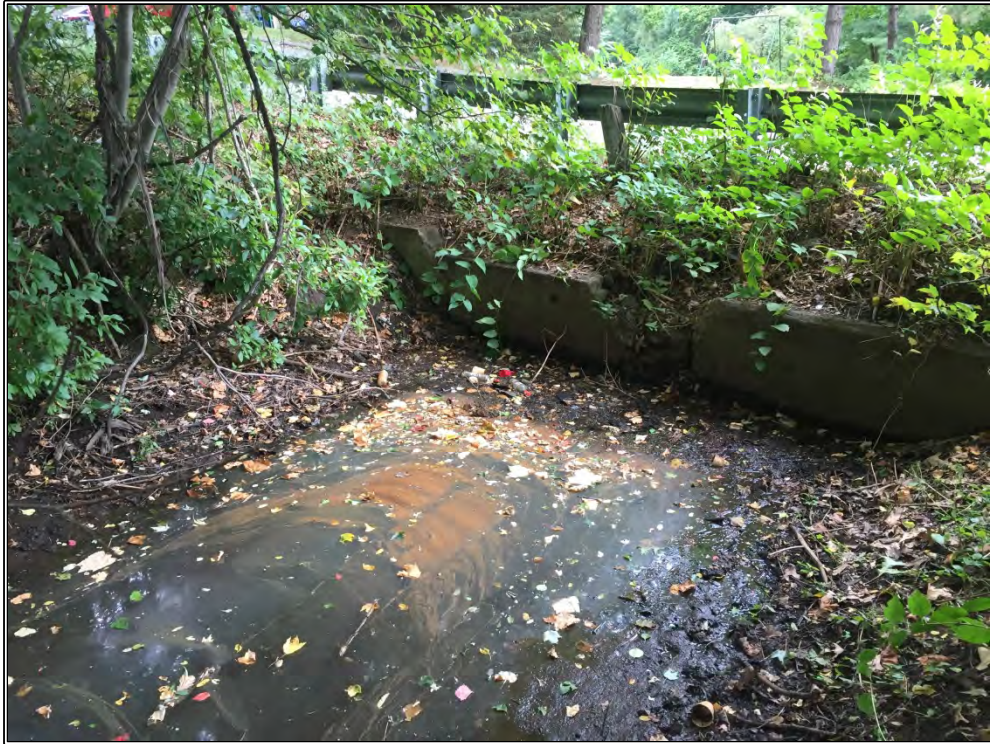
**C-3: Underpass at the intersection of Sumner Ave and Pawtuxet Ave, upstream side -- September 30, 2016**

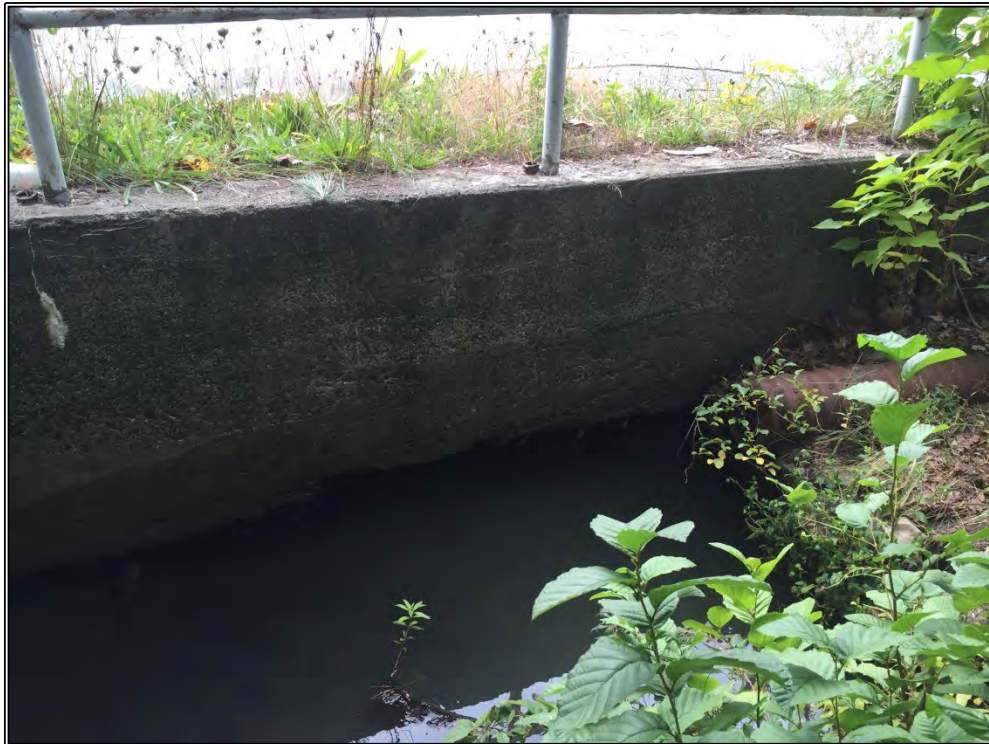
**C-3: Underpass at the intersection of Sumner Ave and Pawtuxet Ave, downstream side -- September 30, 2016**

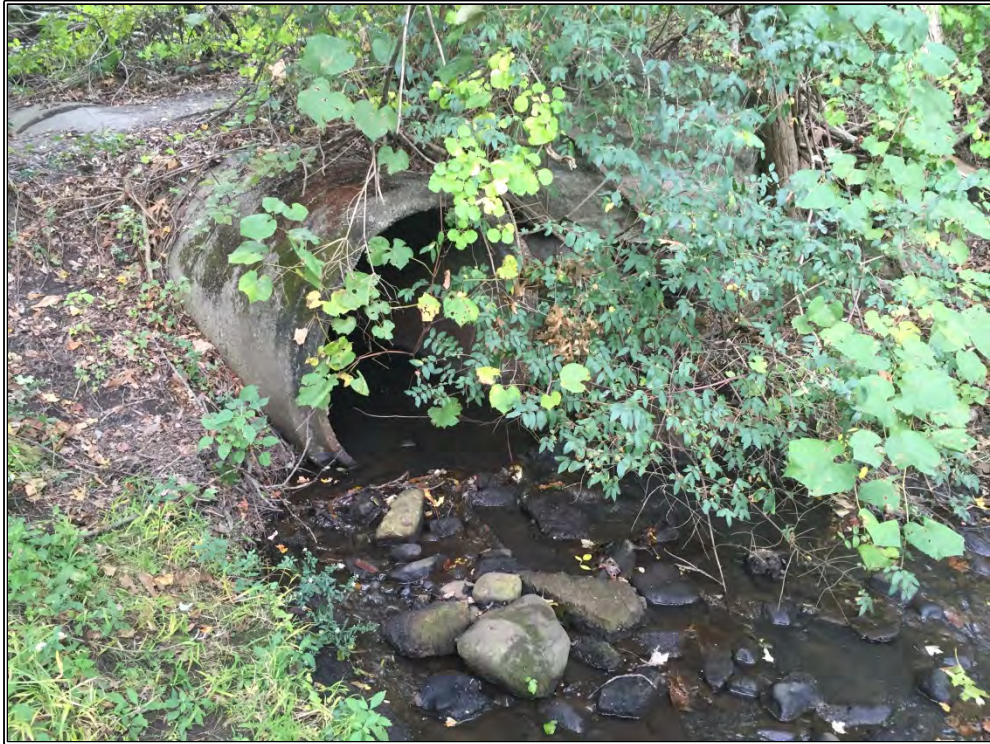
**C-4: Culvert underneath trail at the confluence of Cranberry Brook and Pawtuxet River – September 30, 2016**
