Managing a catastrophic release to achieve rapid decision making and minimize long term impacts

September 12, 2018

Petroleum Program

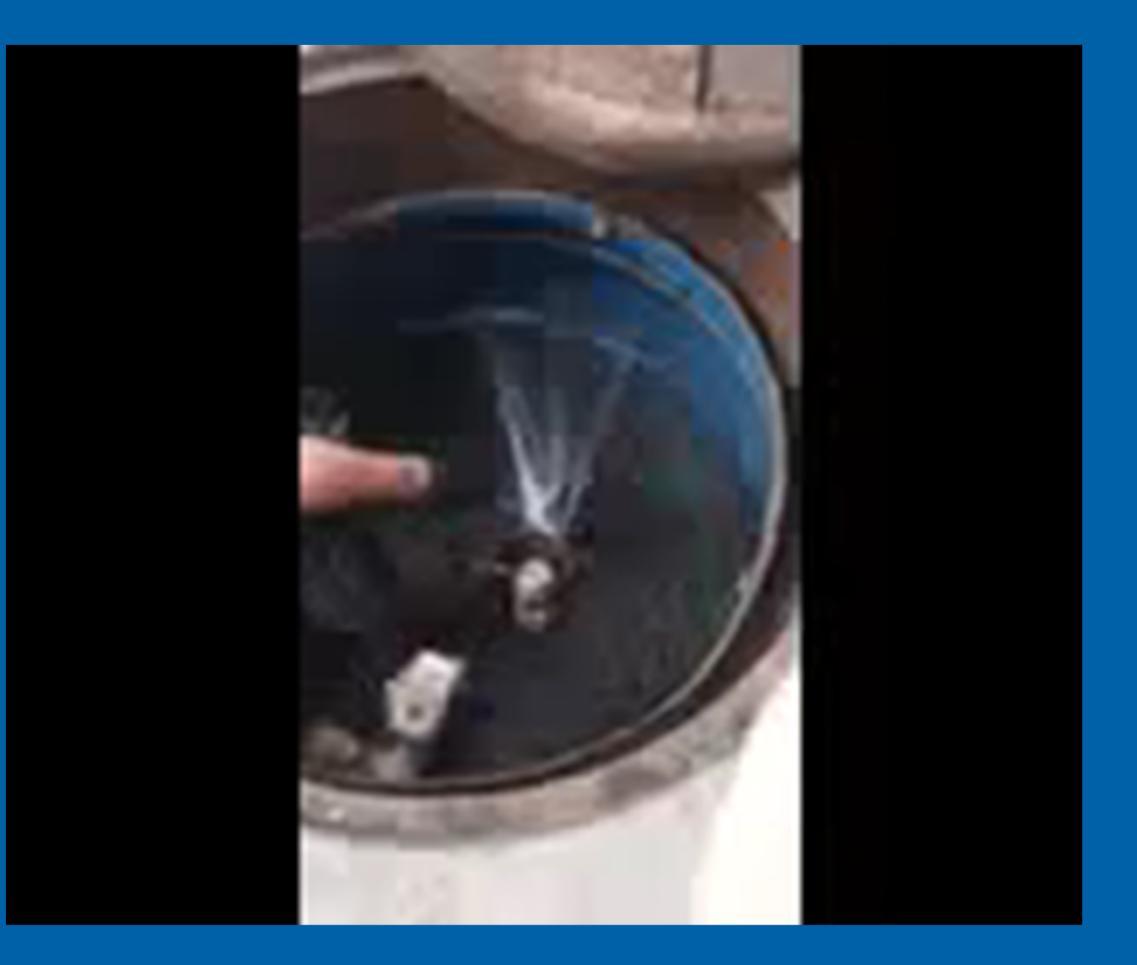
- Estimated 5,600 gallons released over four days after repairs on September 15
- Sump liquid sensor alarm on
- Leaked through STP sump
- 1982 system

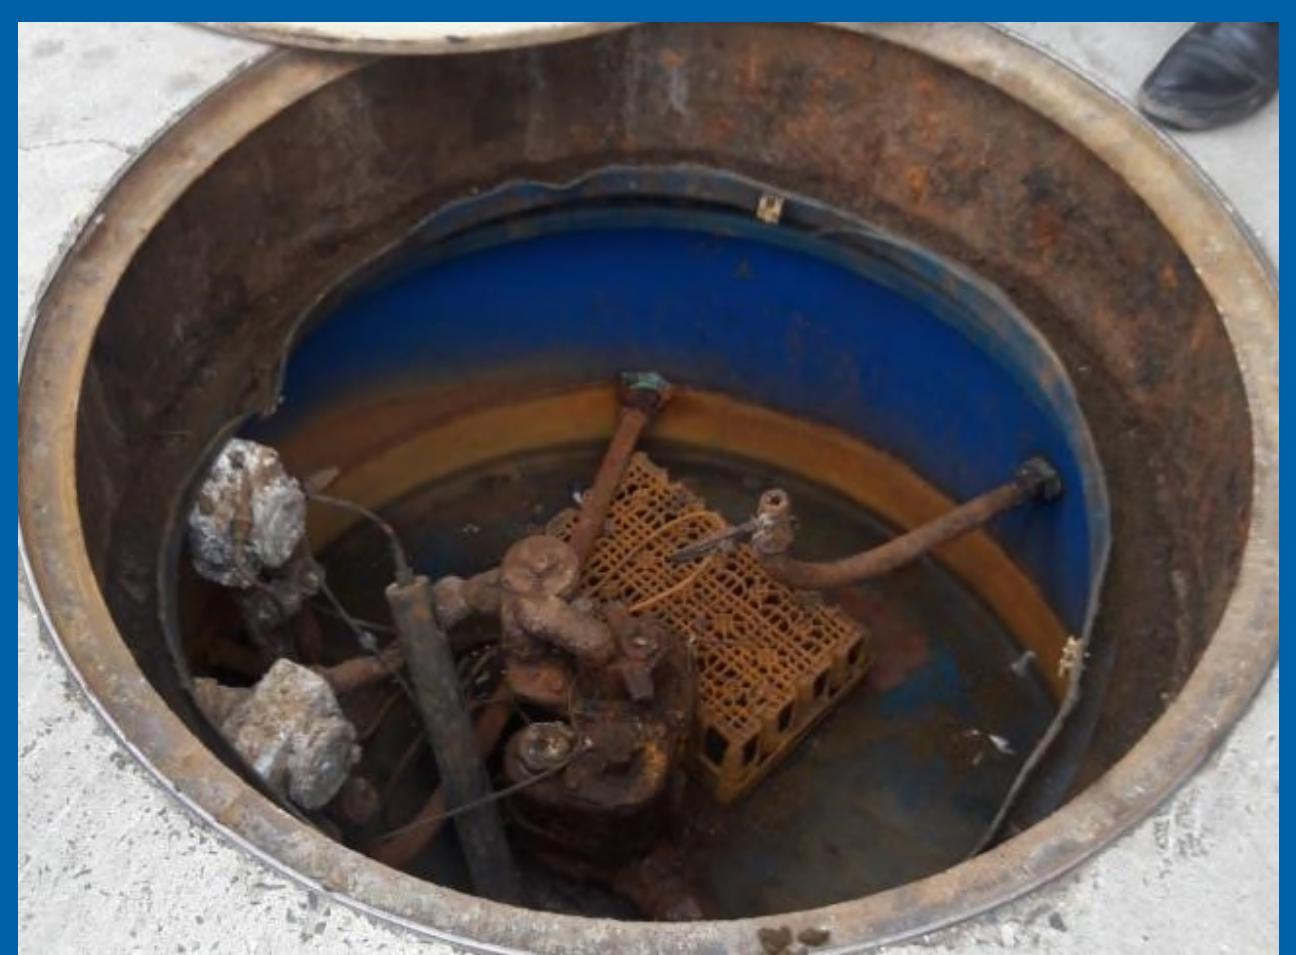
- Free phase gasoline identified in two subsurface dewatering sumps
- Next door subsurface gym closed due to petroleum vapors
- Lowest underground parking level on nearest apartment building evacuated. Odors in stairwells and lower floor corridors

Third apartment building with slight petroleum odors in lowest garage level but no restrictions needed

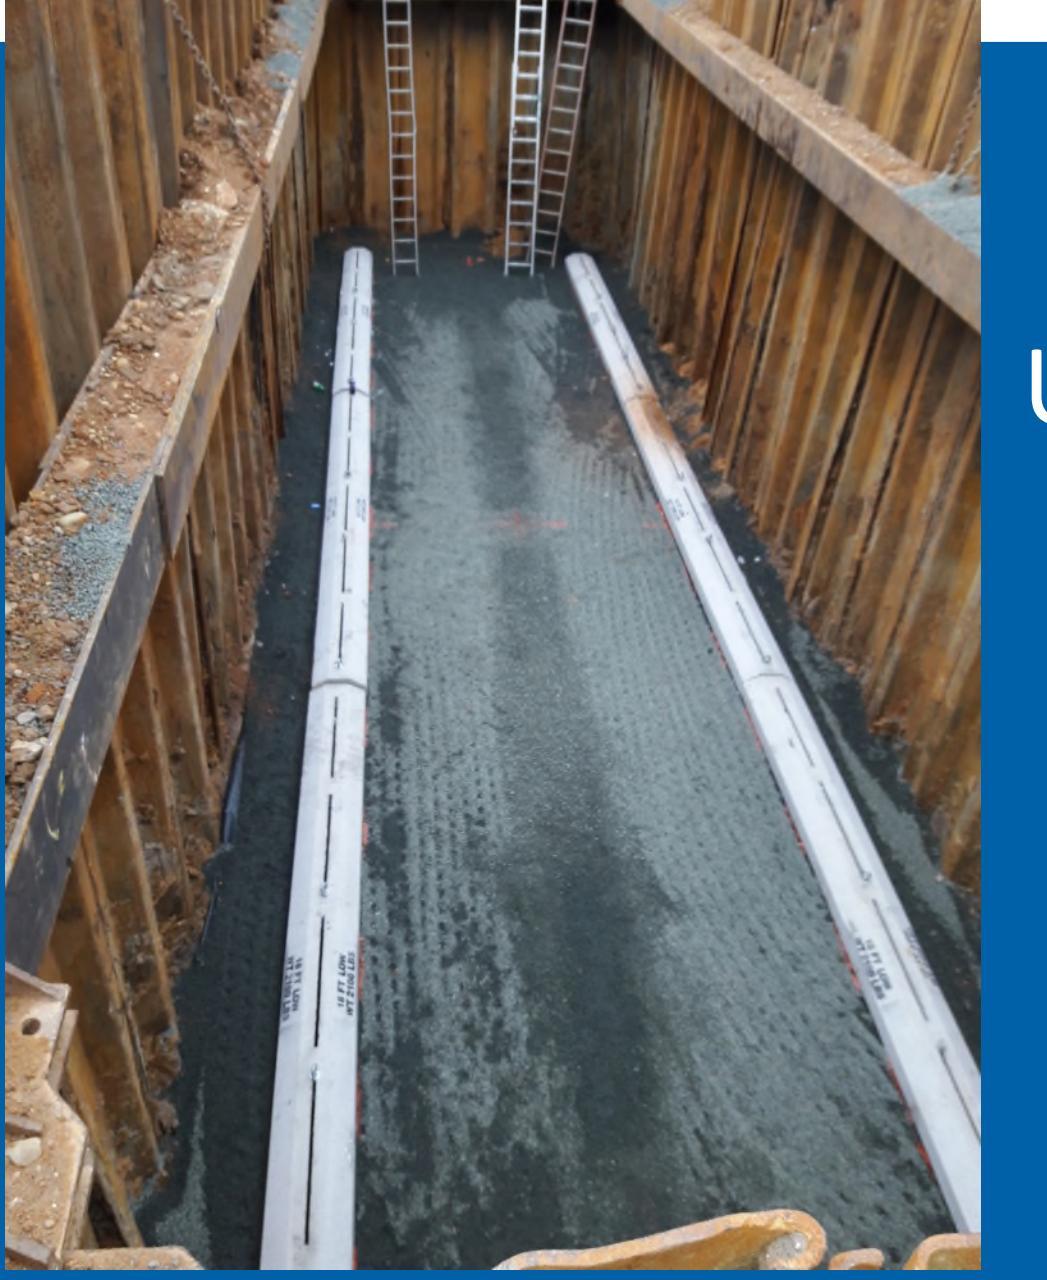
UST excavation ready

Reg Mid Prem 86100 UST Ready to lift in place

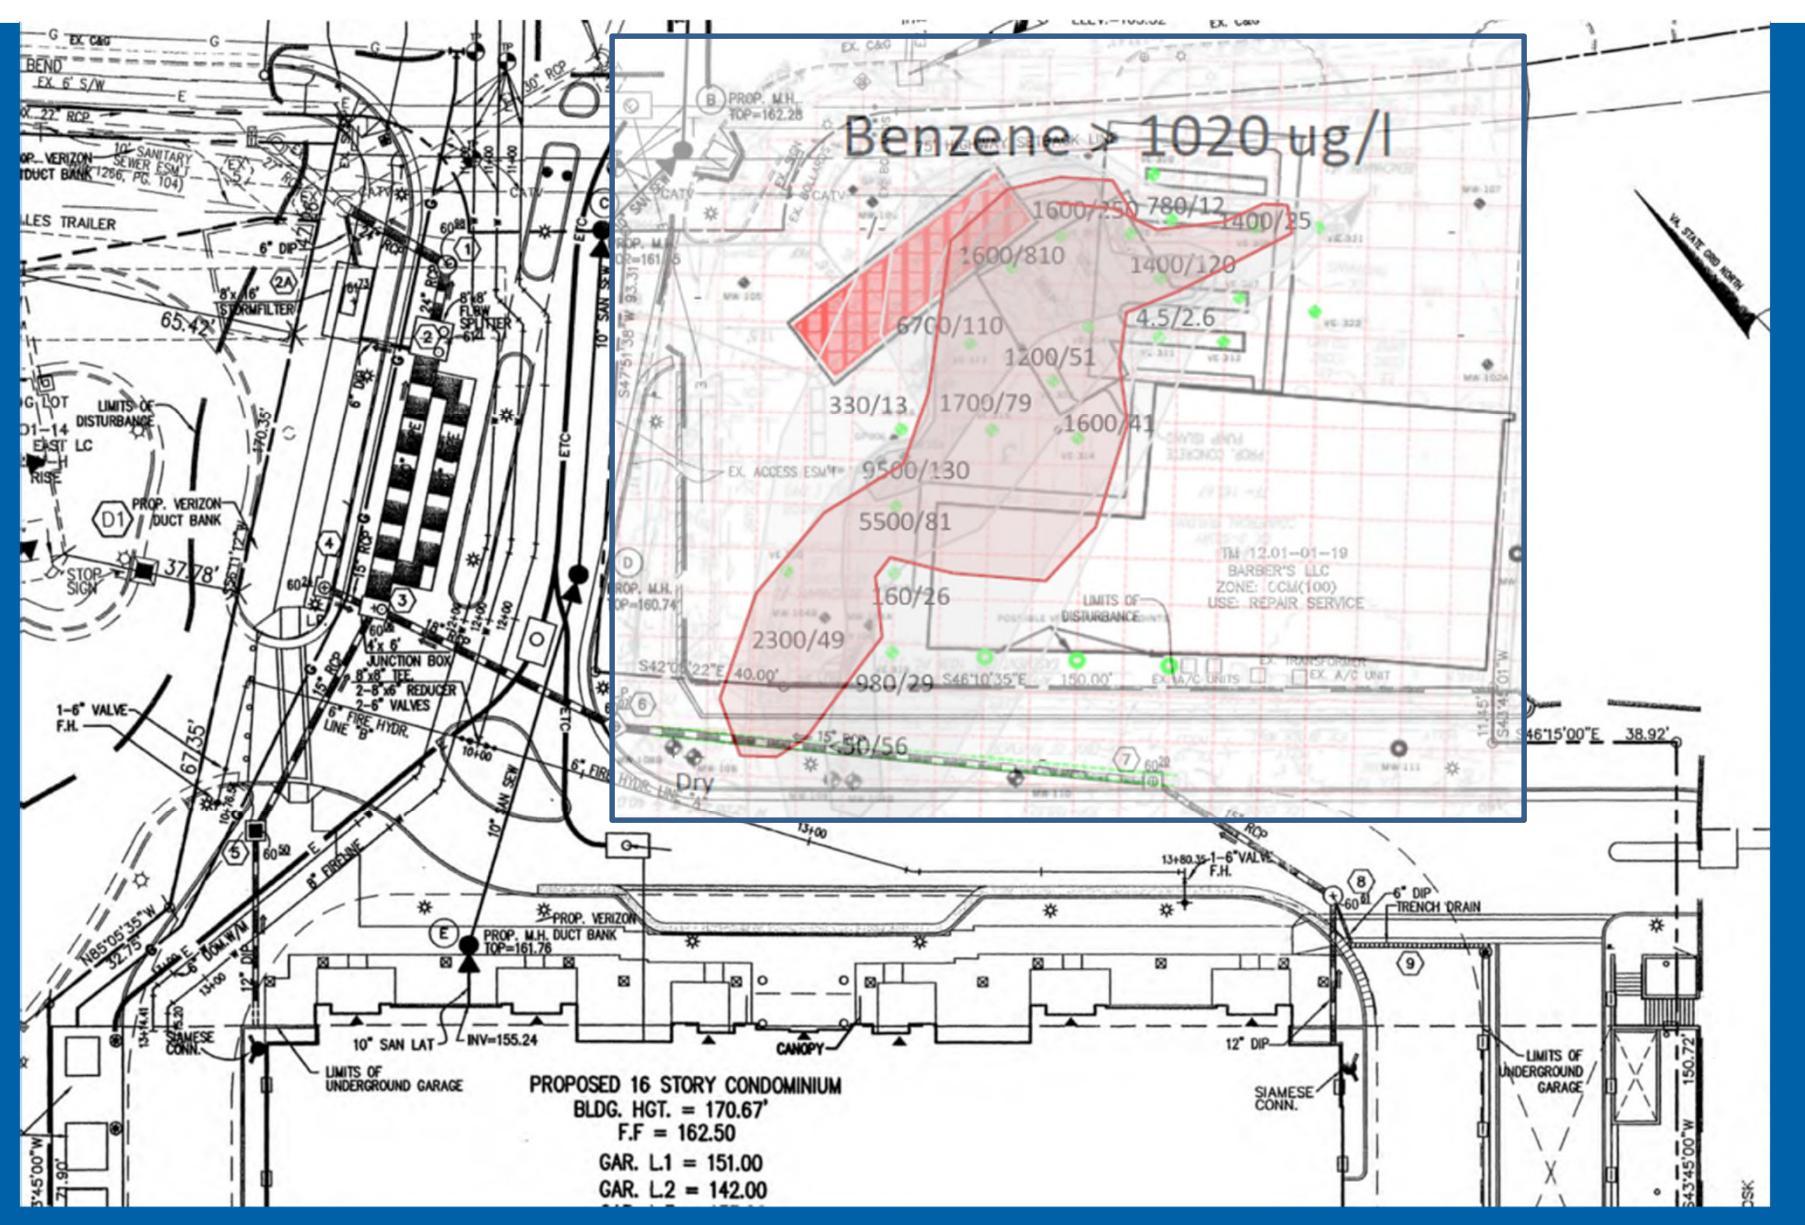
Shallow Groundwater Plume

Shallow Groundwater Depths 8 -18'

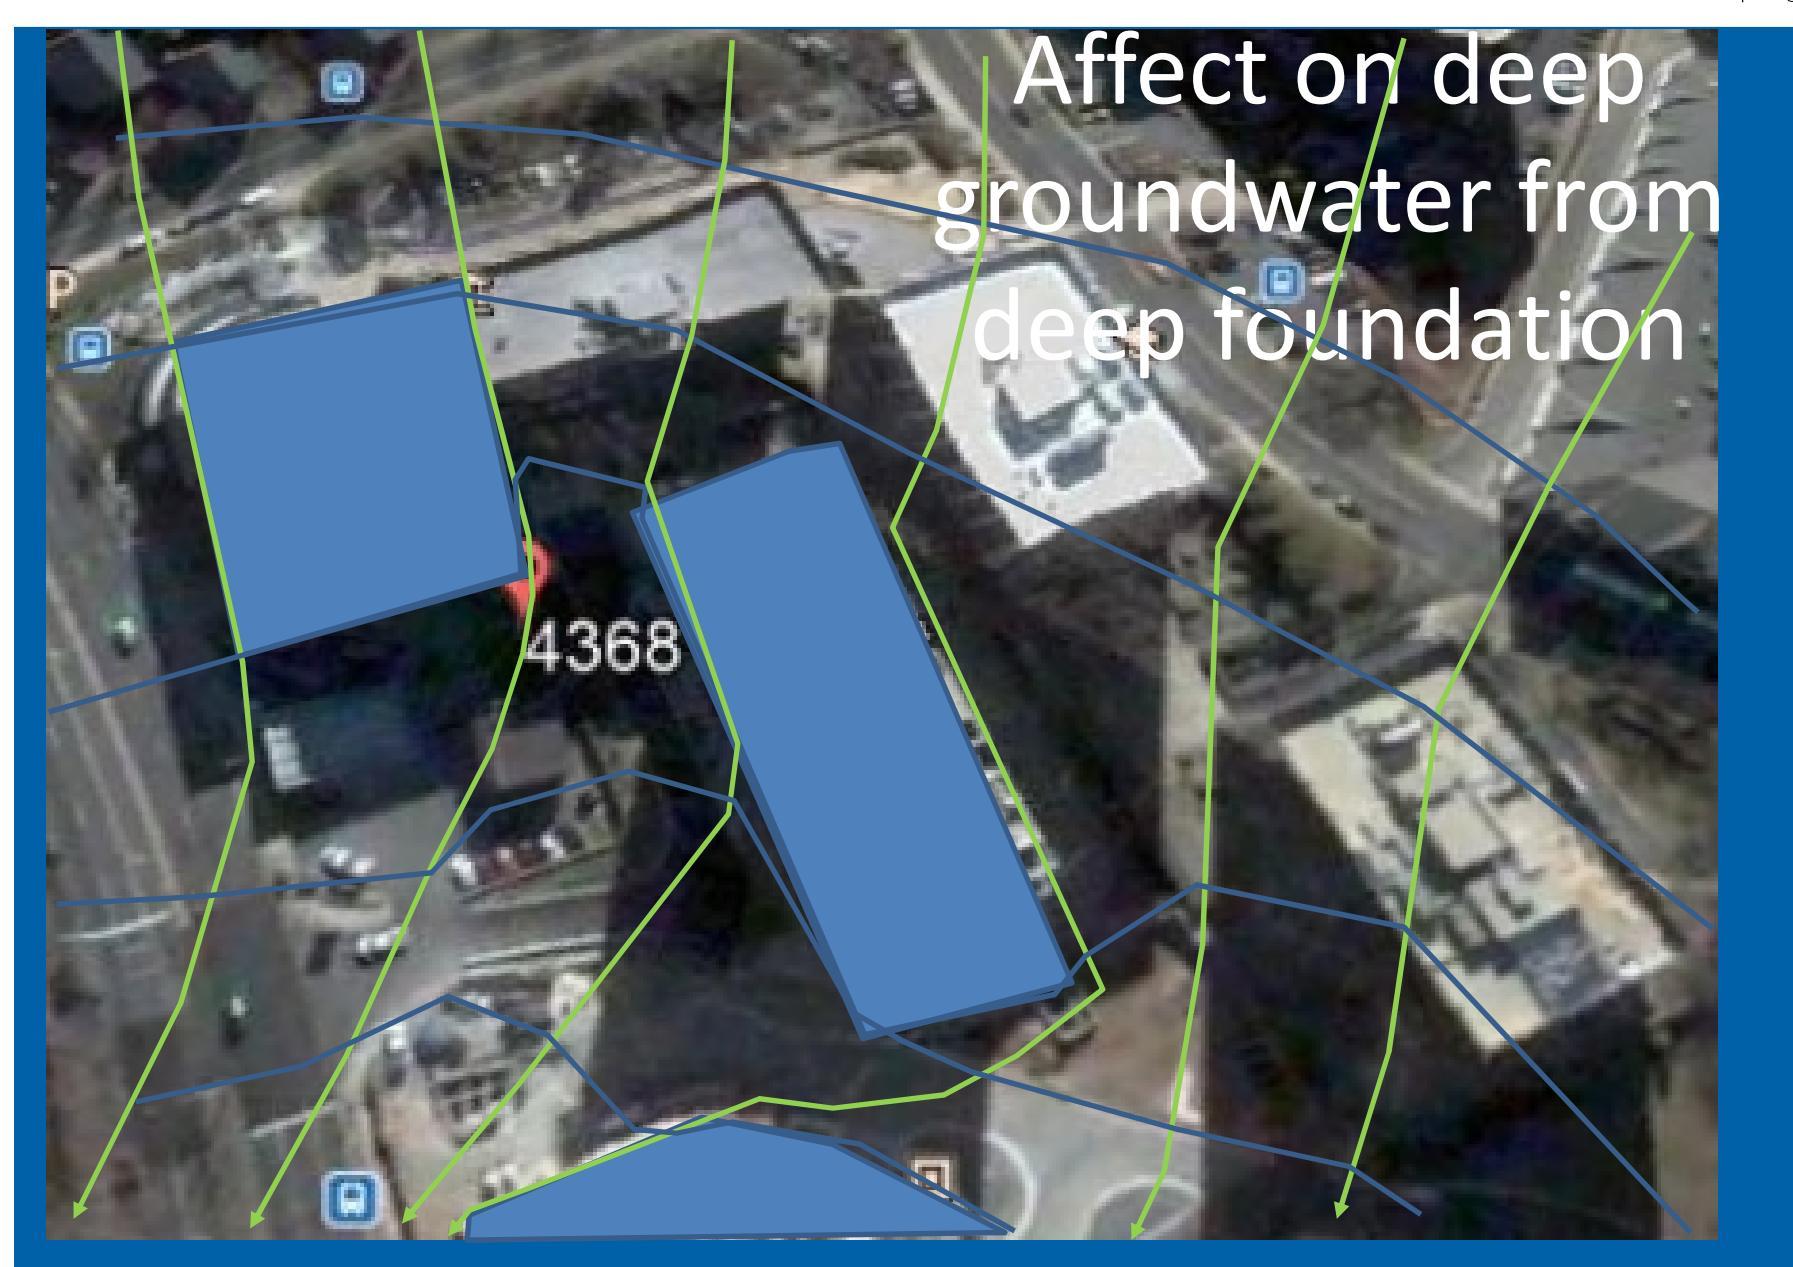
New Impacts to neighbors, August

- Residents complaining of odors in lobby, elevators and ground floor residences
- Discovered roof storm drain with vents within building with petroleum vapors
- Influenced by rising shallow groundwater?
- Apparent communication failure as complaints went unreported to DEQ
