As part of the first phase of infrastructure evaluation, the Arizona Department of Environmental Quality (ADEQ) conducted internal inspections on 79 school-owned fuel

## AN INSIDE VIEW OF ARIZONA'S UNDERGROUND STORAGE TANKS

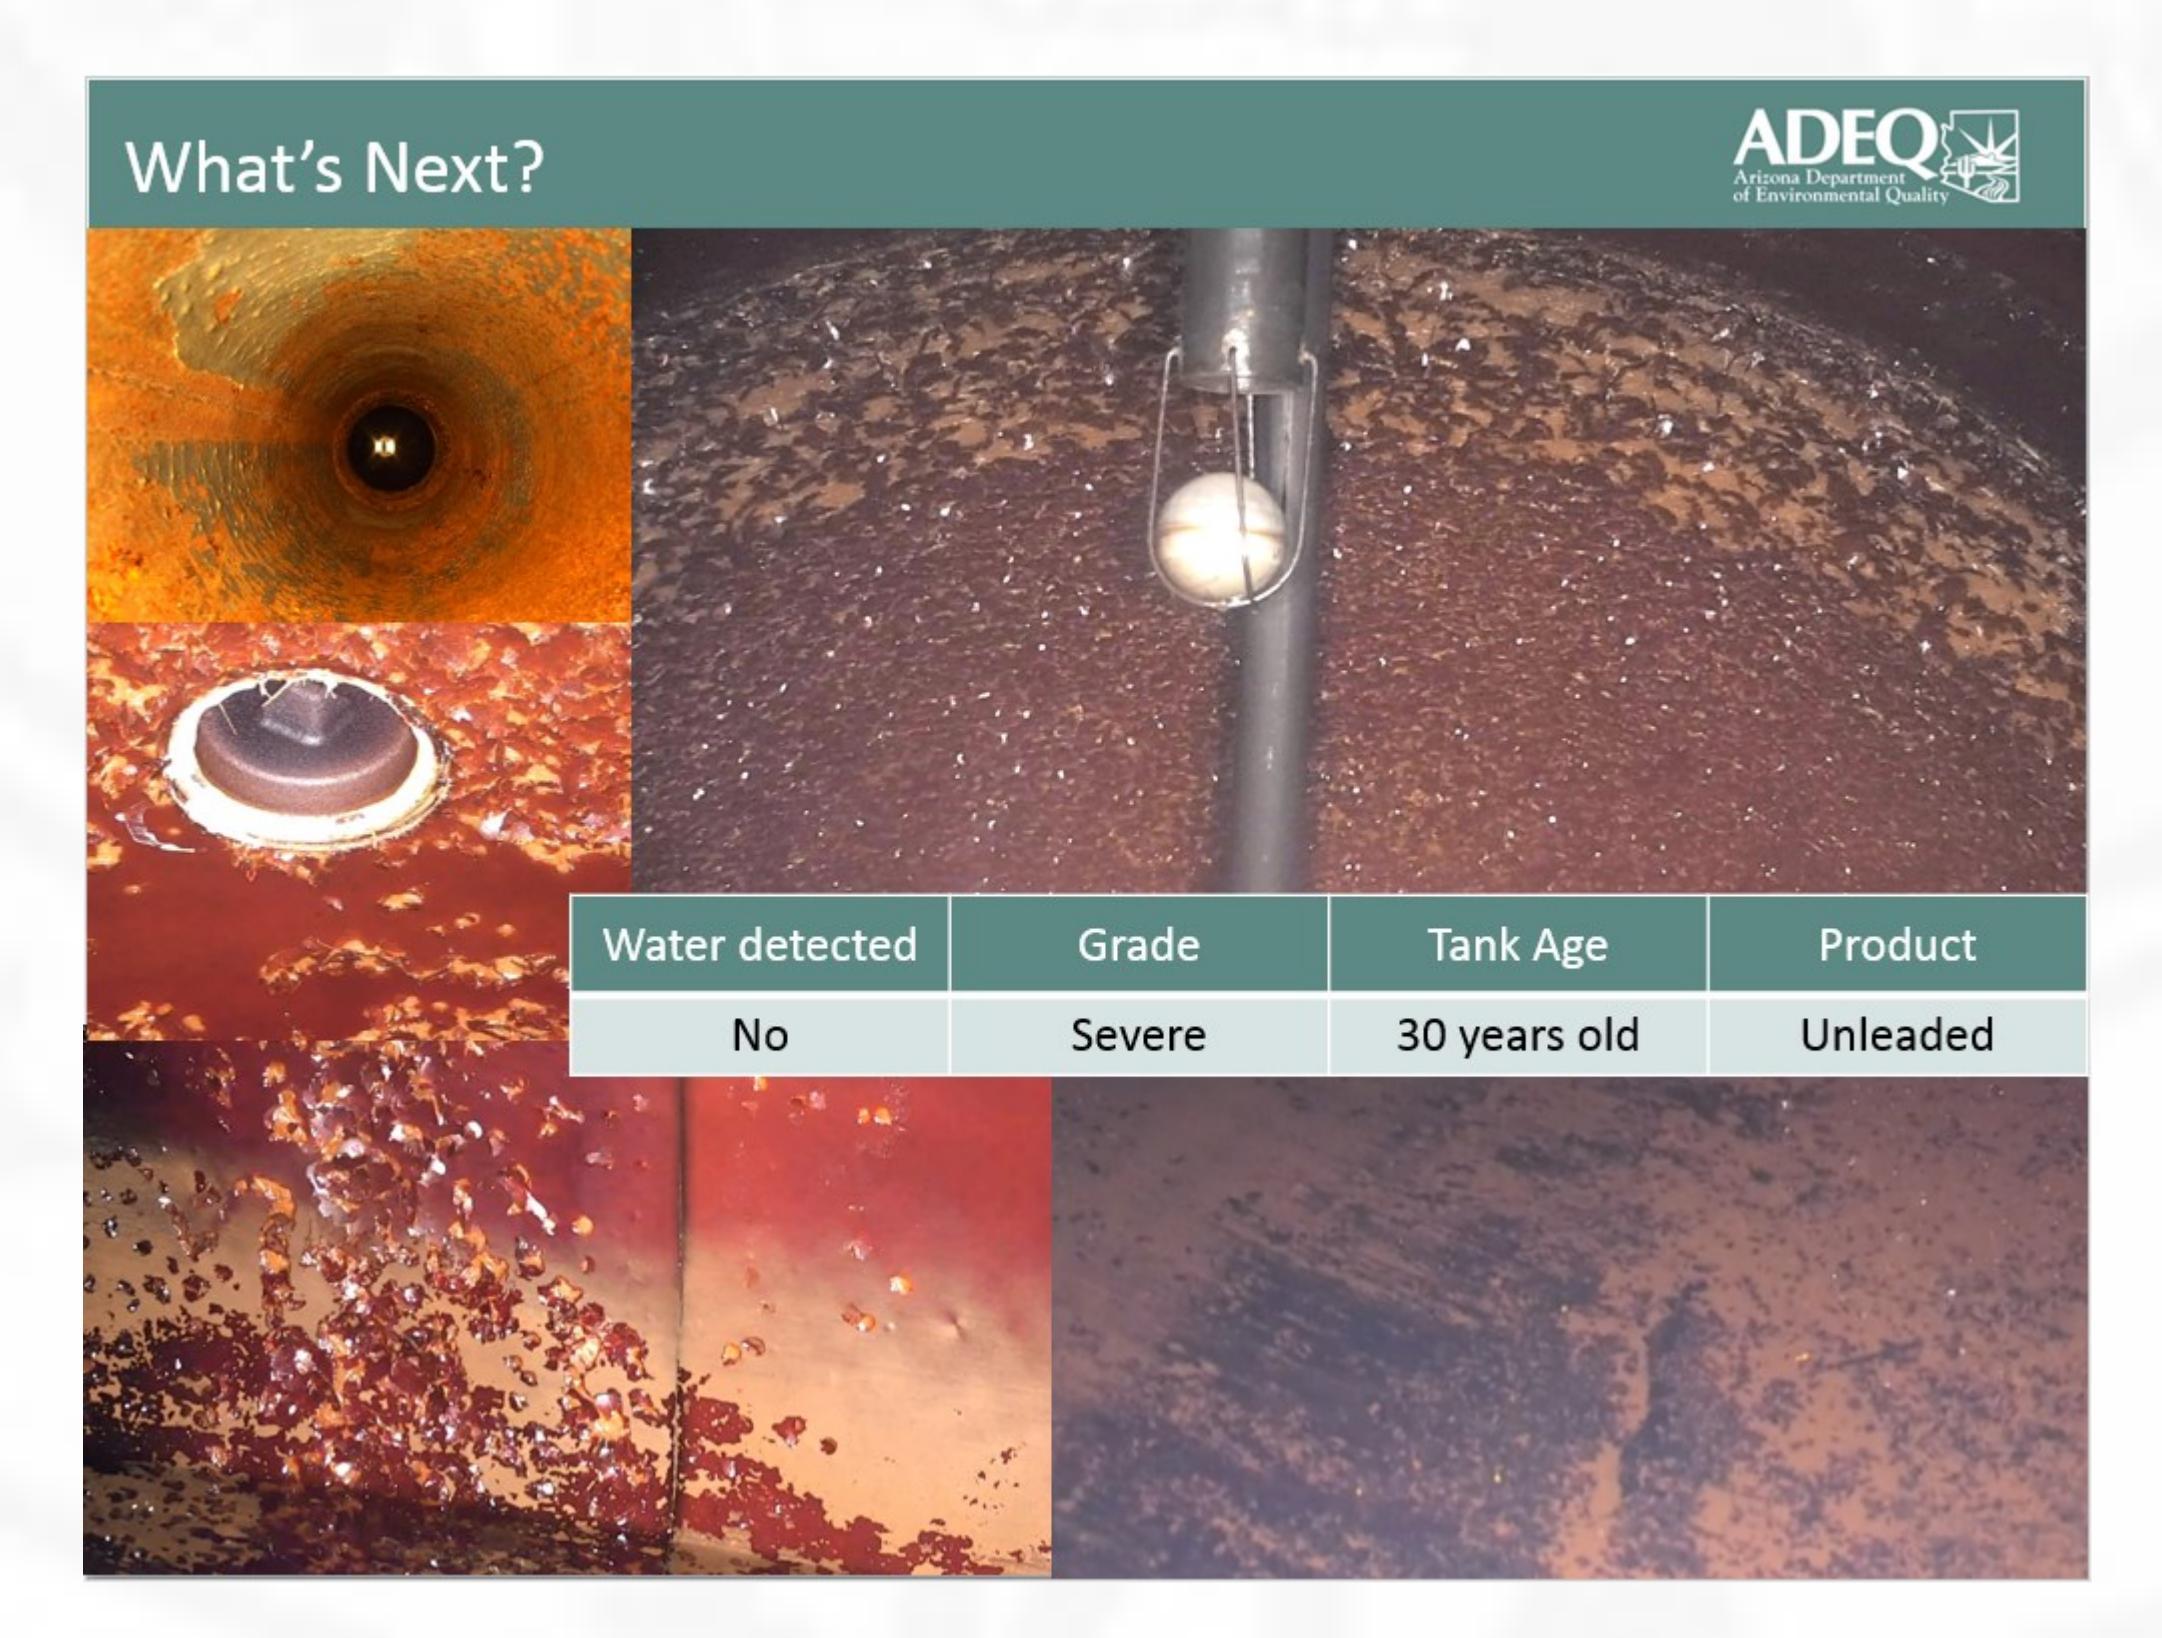
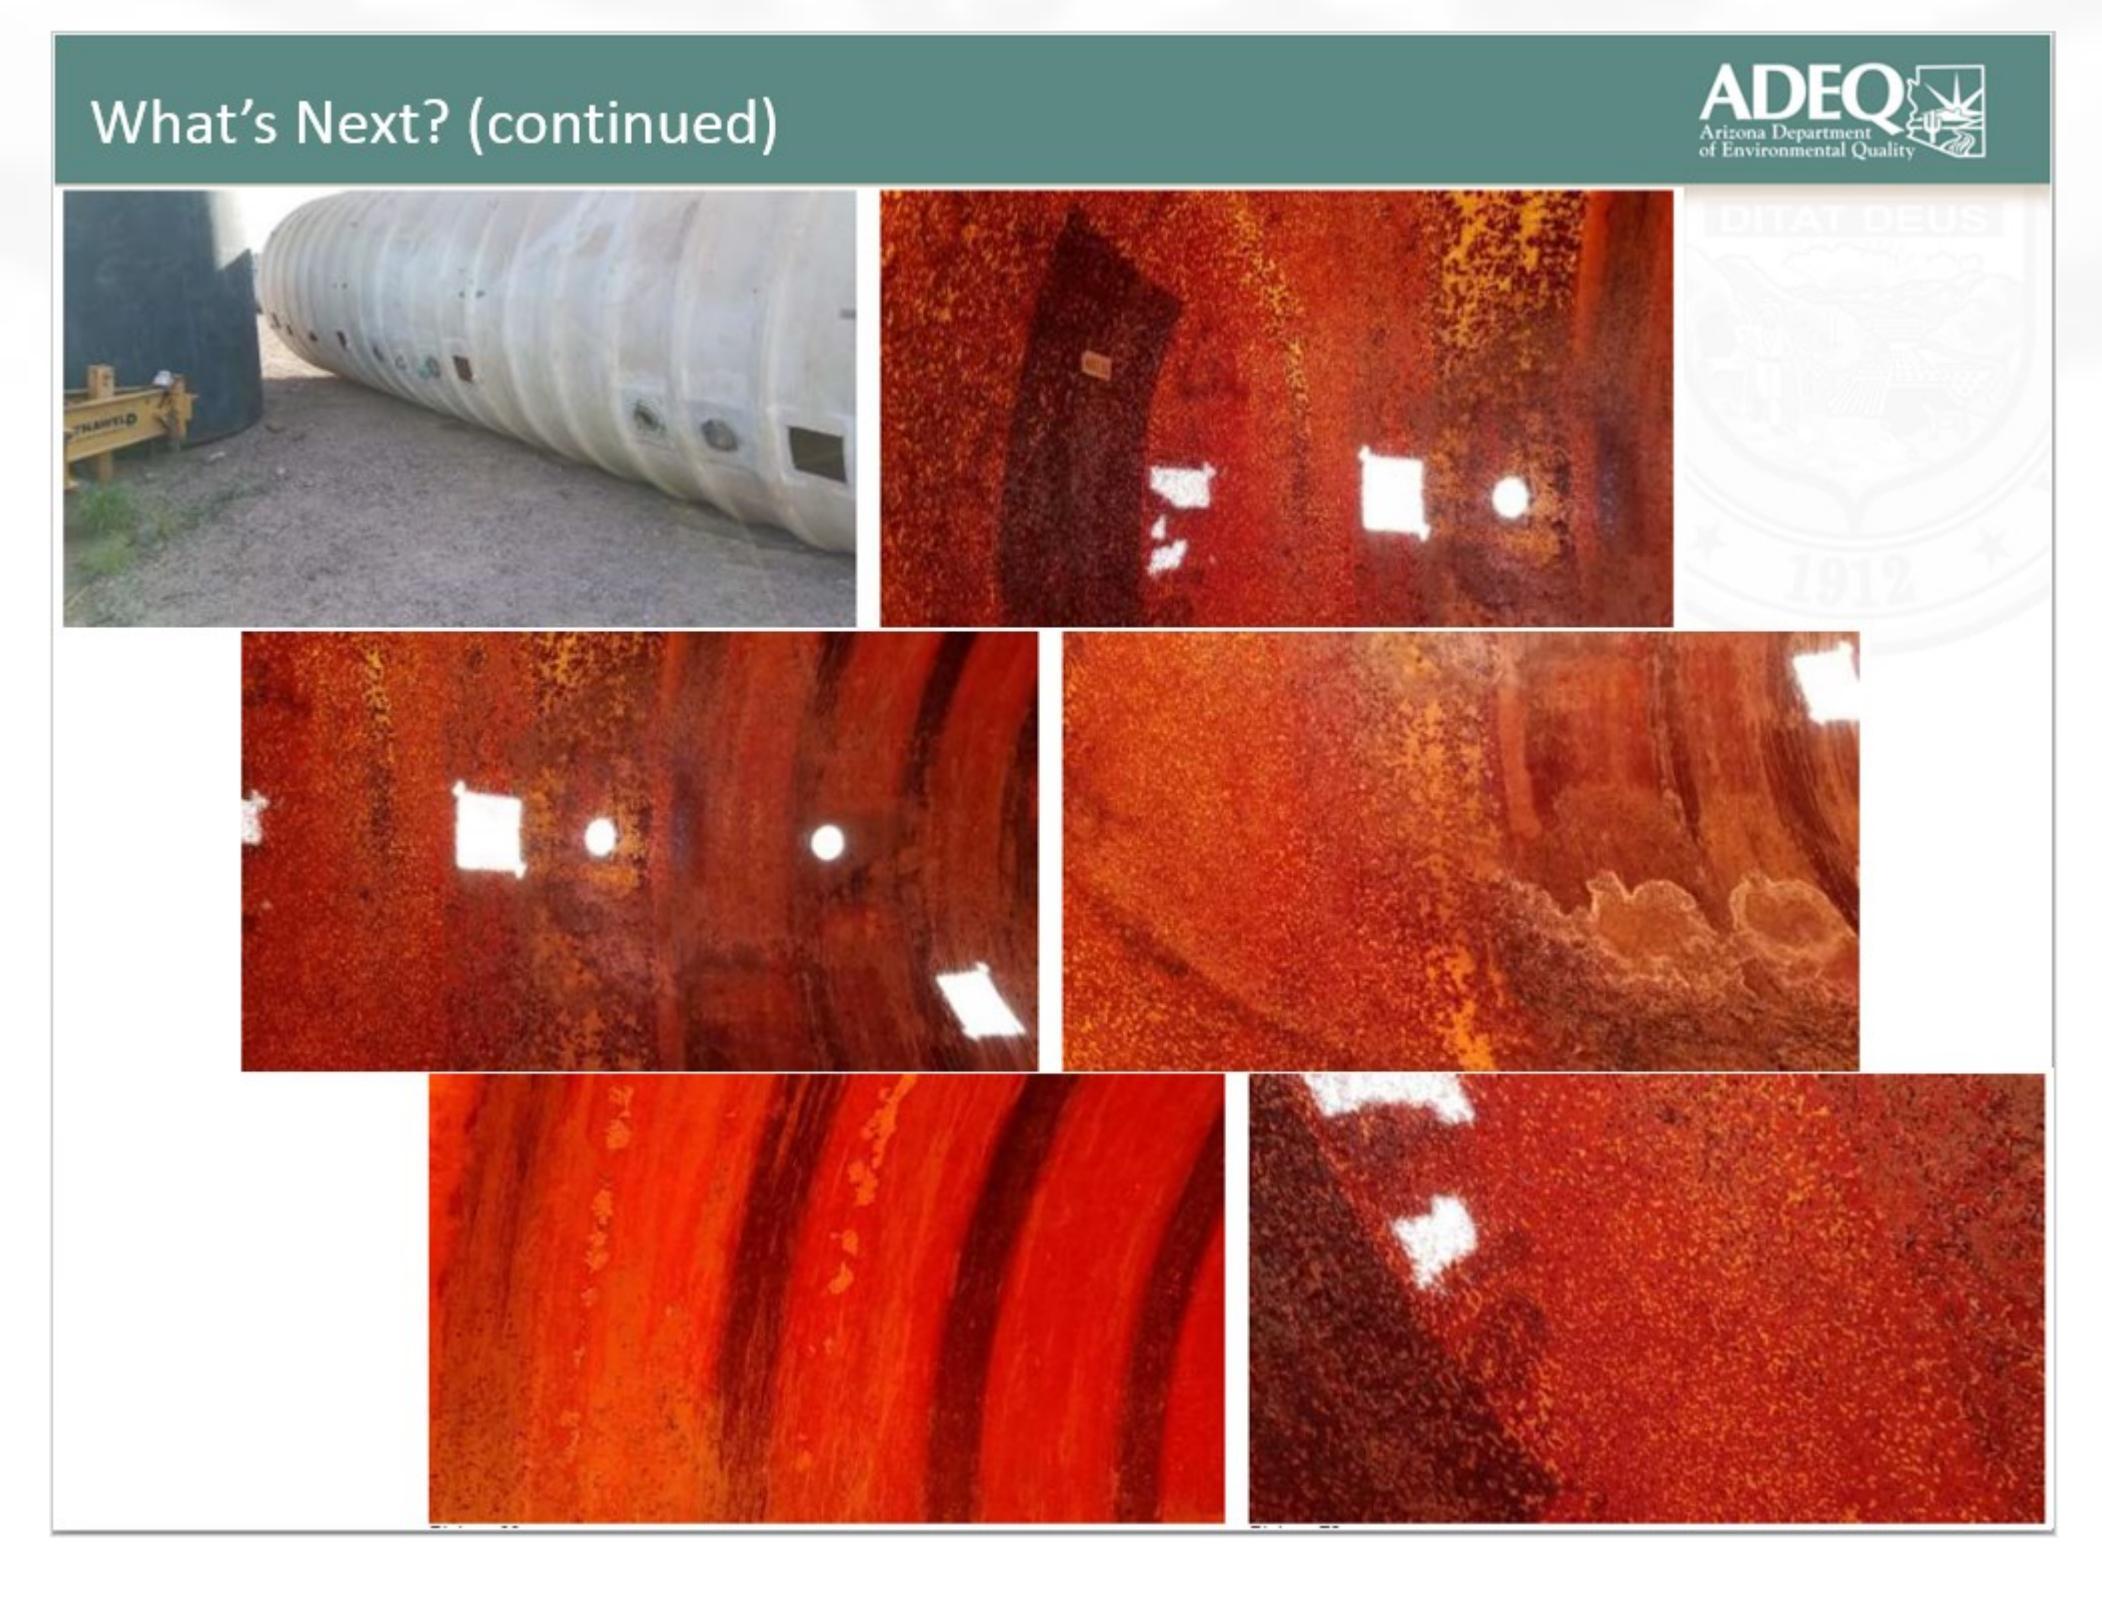
Two schools who had their tanks scoped also elected to have their tanks removed through ADEQ:

Release confirmed and subsequently closed based on sampling results

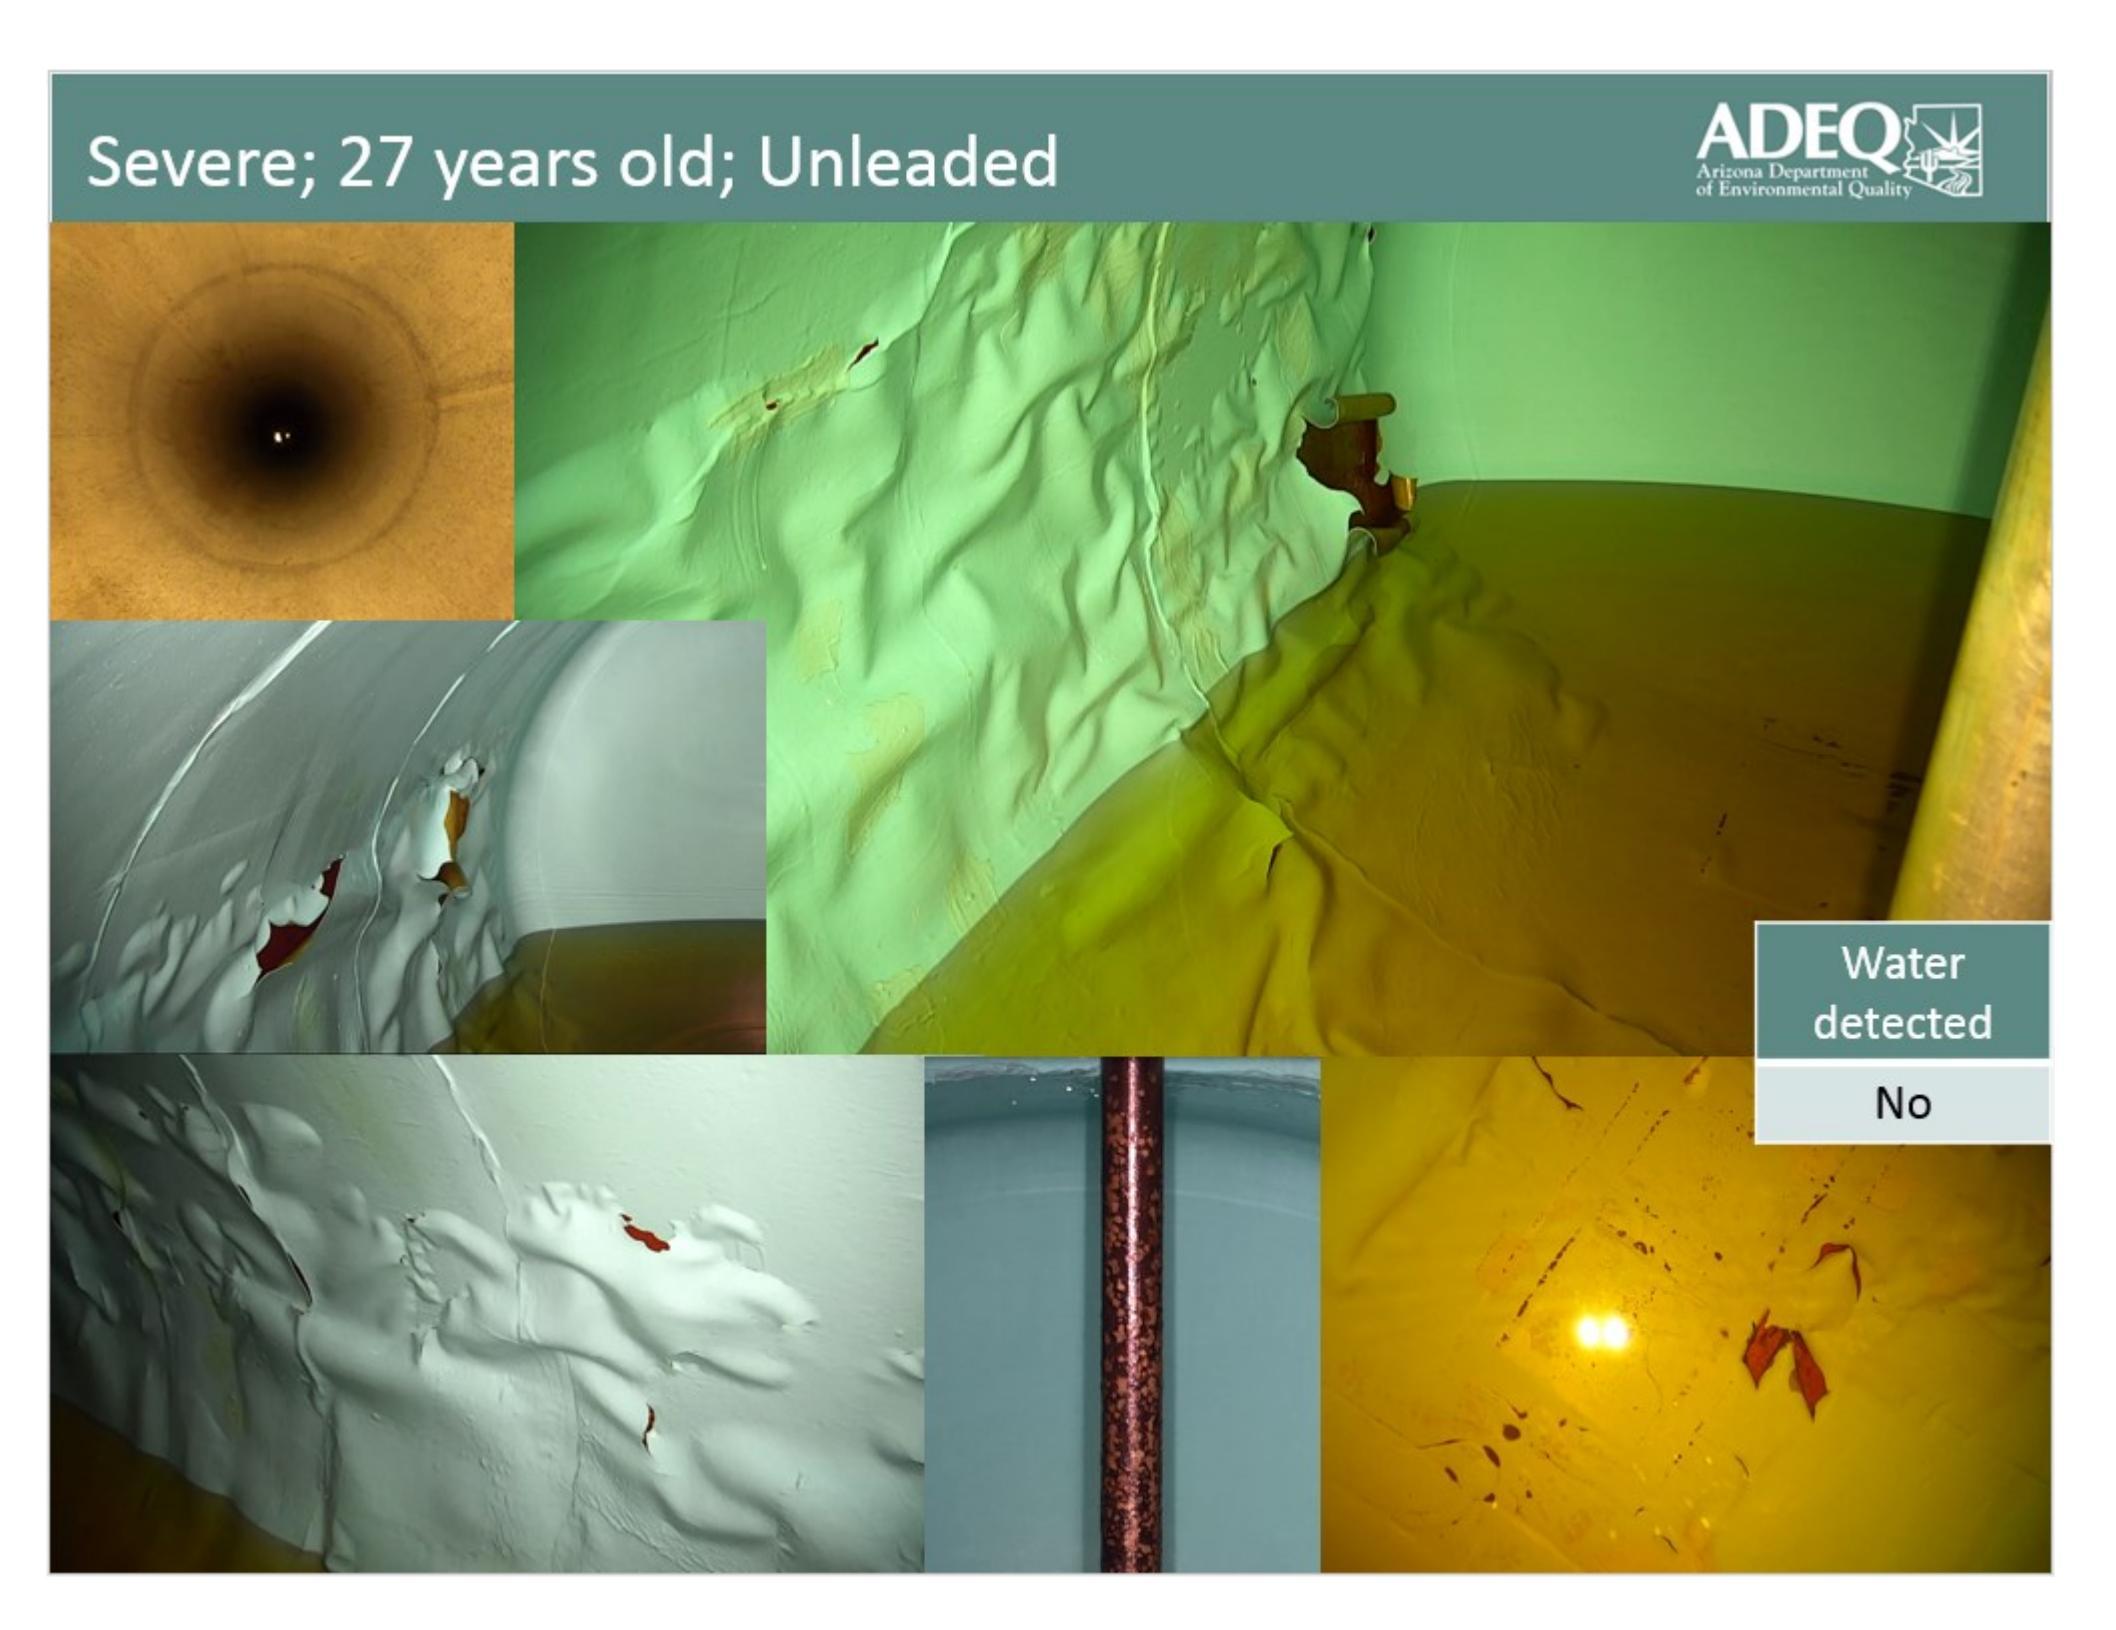
Lining approximately 2 years old No release confirmed
