Photographic Documentation of Equipment and Components Pulled from Removed USTs Used to Evaluate Trends in Interior Degradation and Corrosion for USTs Formerly Storing Biodiesel B98, Diesel (Clear and Dyed), Ethanol E99, and Regular E10 in Lawrence, Kansas.

Photographic Documentation of Equipment and Components from Removed USTs Storing Biofuels

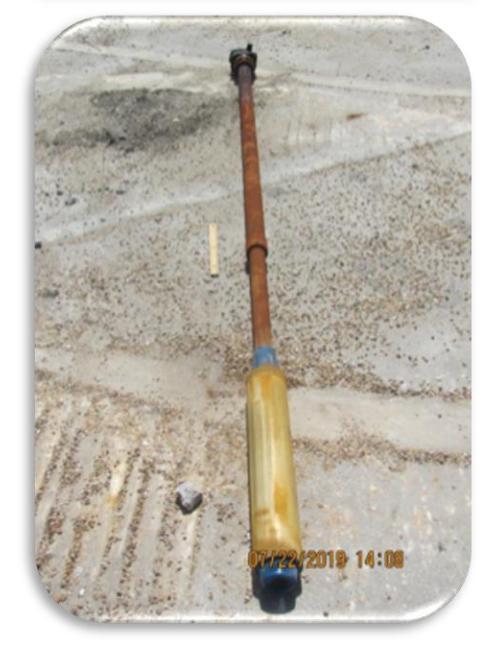
U006: Severe

Corrosion

Figure 2: Minimal to severe corrosion occurred on submersible turbine pump (STP) shafts pulled from designated USTs. Corrosion rating criteria appearing in the 2016 EPA Diesel Corrosion Study were used to make these determinations

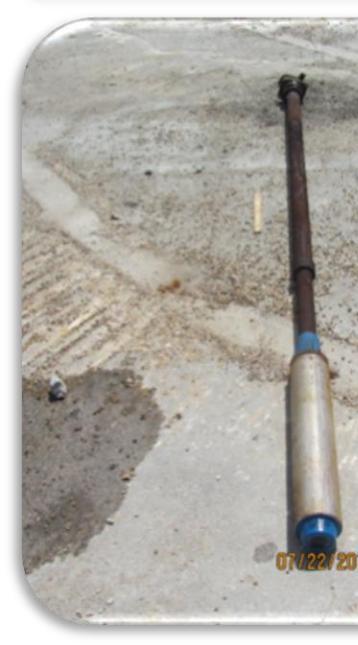
> U007: Severe U008: Severe Corrosion

Corrosion

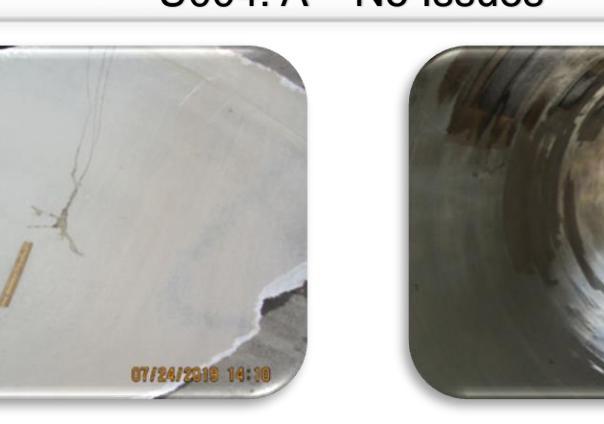
U006: B – Minimal to Moderate Issues

Figure 3: Photographs of endcaps and barrels of designated, removed single-wall Containment Solutions USTs show a range of staining remaining behind after removers used detergent to clean out the sludge. The condition of these tanks ranged from "A - No Issues" to having "B - Minimal to Moderate Issues" using criteria developed for the 2018 Arizona Tank Scoping Study. Foot-long (30-centimeter) ruler

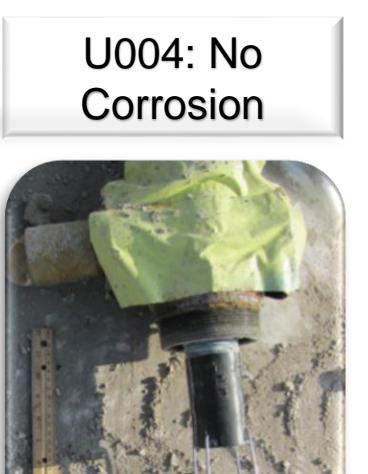
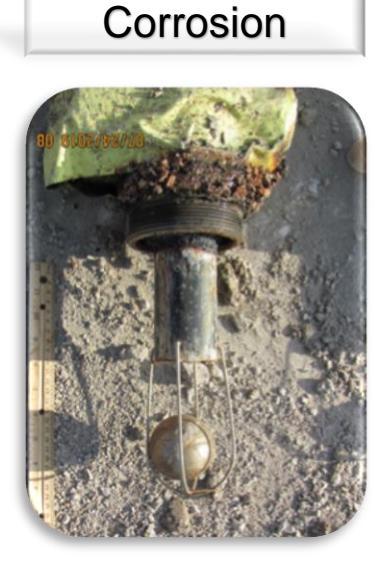
Ball Float Valves

Figure 4: Heavier corrosion occurred on the ball float valve extractor and cages for the designated USTs installed to contain diesel fuels than the ones that contained Gas Ethanol E99 and Gasoline Unleaded E10. Proposed corrosion ratings for BFV are presented on this poster.

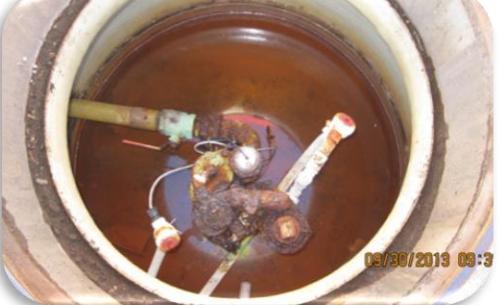
Tank U004: 2013

Figure 6: Pronounced corrosion of metallic components in contained STP sumps took place in designated USTs between 2007 and 2013. Treatment of the sumps reduced the rate of corrosion between the time of treatment and 2019. Tank U004 stored Gas Ethanol E99 throughout its service life. Storage in U005 switched from Biodiesel B98 clear to Diesel Dyed Off Road.

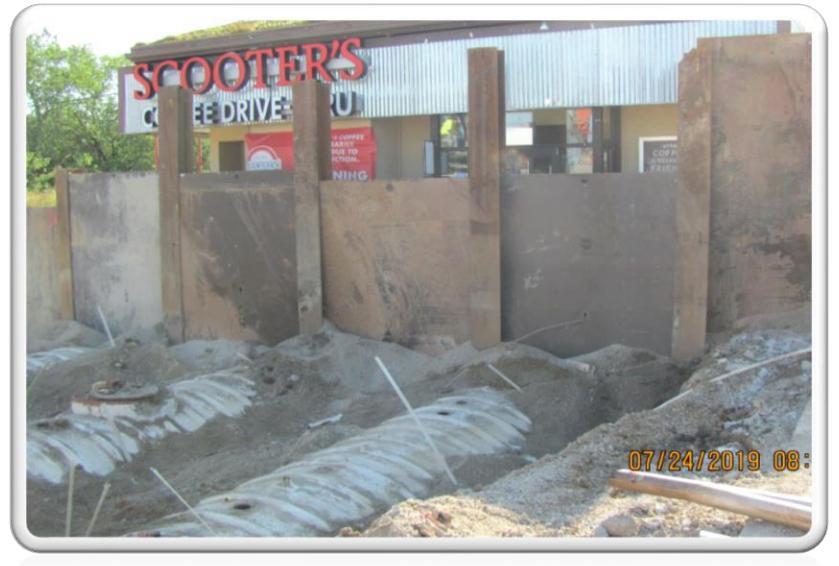
Figure 7a: UST removers installed shoring to keep the drive-thru coffee shop from collapsing into the excavation.

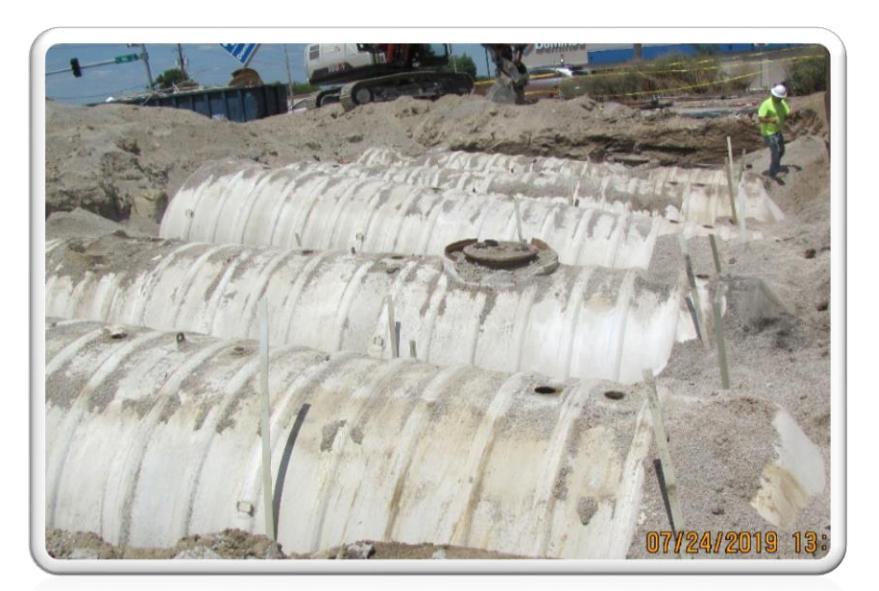
Figure 7b: From front to back, Tanks U008 U007, U006, U005, and U004 are exposed and ready for removal on 7/24/2019

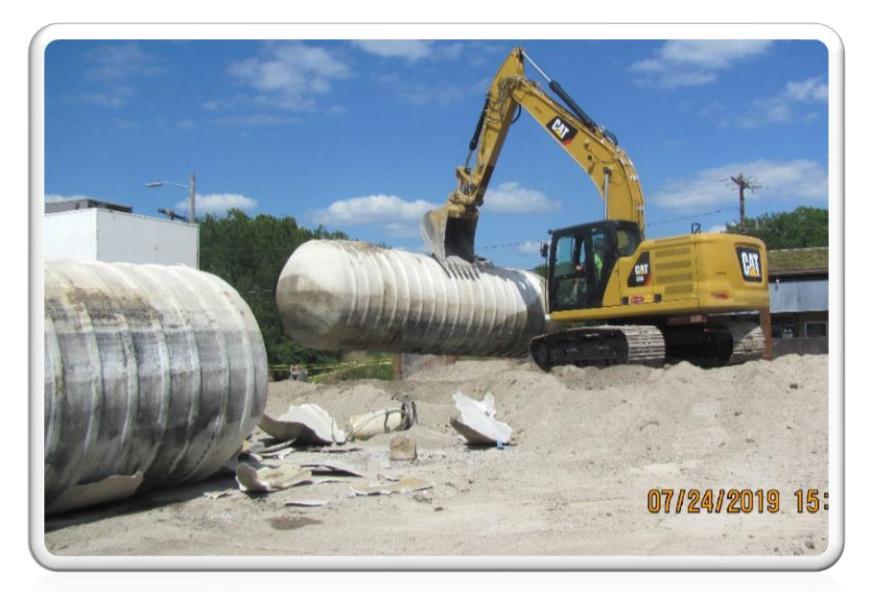
Figure 7c: The track hoe has lifted Tank U004 from the tank excavation. Tank U003 (foreground) has had the endcaps removed
