Lower Charles River Demonstration Project

Gunderboom® Beach Protection System™

2002

April 2003

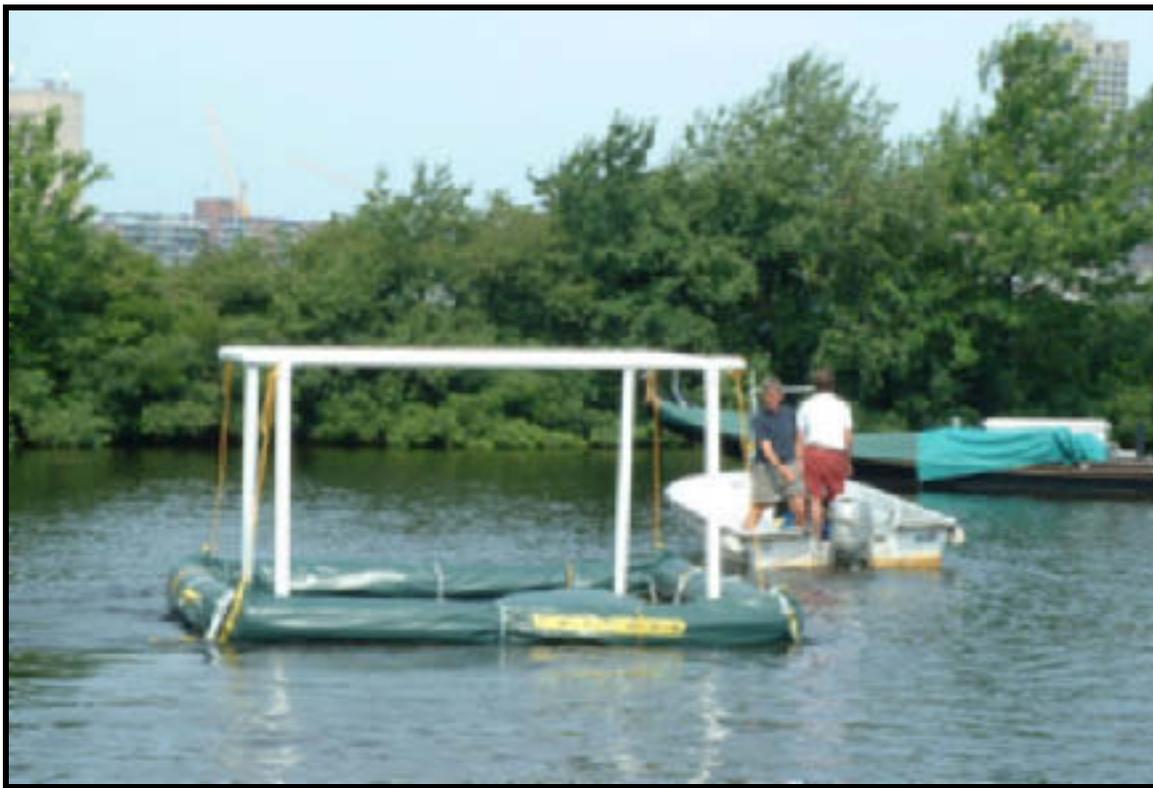
Figure 3. Reefed test system with exposed PVC frame being towed into position.

The test system was set up and deployed from the Metropolitan District Commission (MDC) dock on the lagoon adjacent to the Hatch Shell on the Boston side of the Charles River. Set-up included inserting the system flotation billets into the hood, assembly and placement of the PVC frame inside the test system, and reefing the filter fabric to the flotation to place the test system in its towing configuration. When ready, the test system was pushed off the dock into the water and towed to the first sampling location in the vicinity of site CRBLA8 (Figure 3).

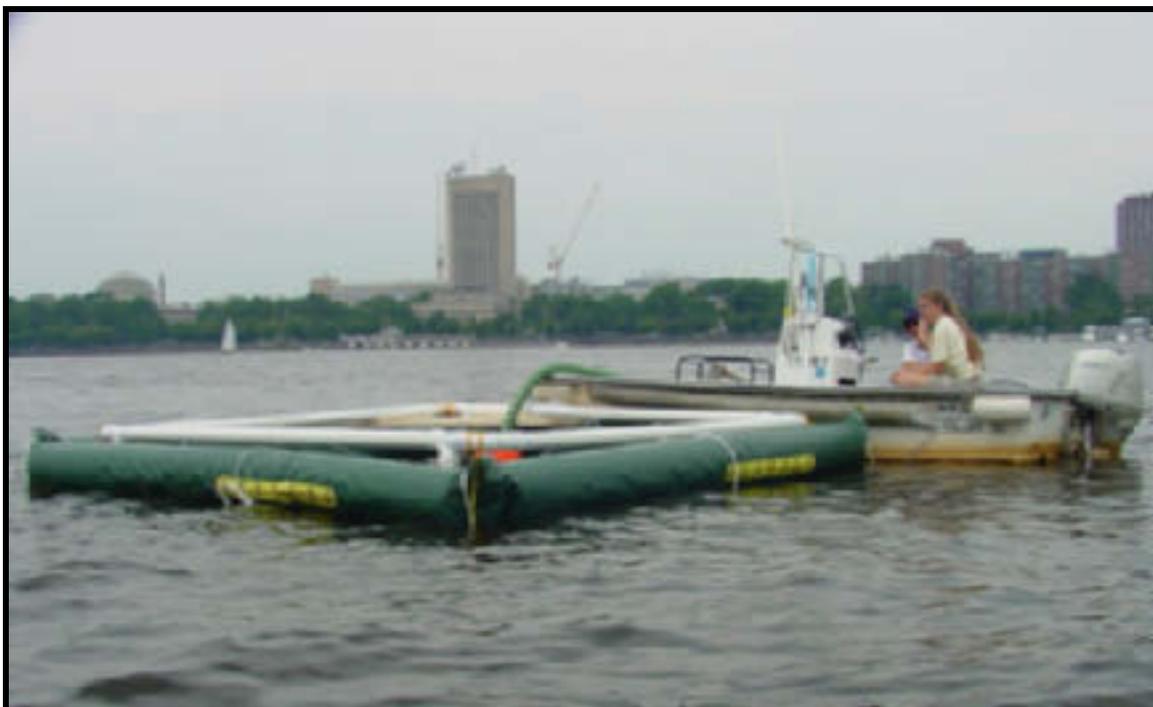
Figure 4. Deployed BPS™ test system with PVC frame submerged.

Concurrent with test system set up 4, 40-pound Danforth anchors, complete with marker buoys, anchor chain, and line, were deployed and set. Once the test system was towed into position, the anchor lines were attached to the top anchor points. When all anchor lines were secured, the reefing lines on the test system were released and the PVC frame pushed down to stretch the system to a six-foot depth, to complete the deployment of the system (Figure 4).

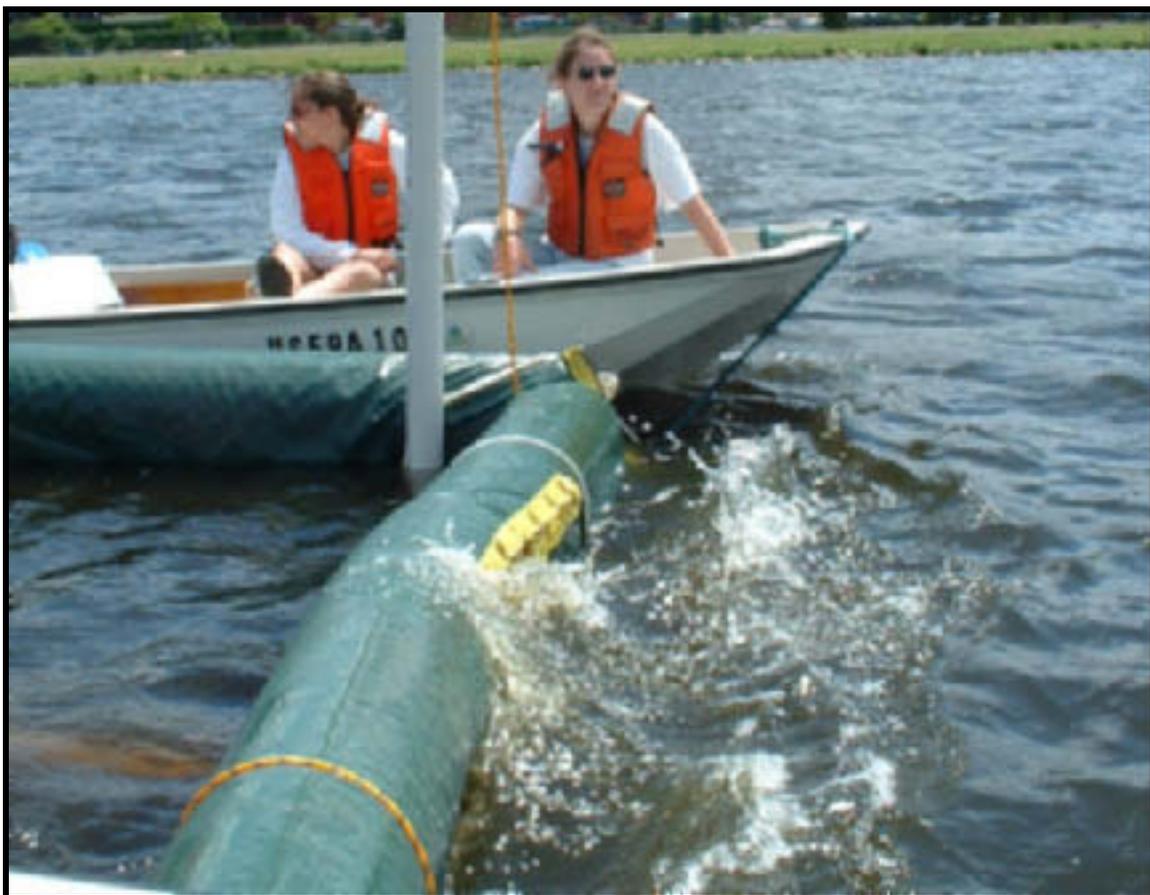
Figure 5. Towing of reefed boom between sites; note splash over on leading edge of boom.

There was one occurrence that raised an issue regarding the effectiveness of the test system and sampling protocol for direct application of results to future full-scale applications. On the final day of testing, initial improvements in water quality were reversed immediately following the passage of a commercial tour boat in close proximity to the system creating a substantial wake, twice, within a five minute period. Researchers conjectured that over the three days of testing, a substantial amount of fine sediment had settled out, inside the test chamber, coating the PVC frame and bottom of the system; the sediment was re-suspended by the passing boat wake. Additionally, the amount of sediment inside the boom was most likely elevated as a result of towing the boom on 7/16/02, as the floatation was frequently breached and water filtered from inside out, leaving particulates inside the test system (Figure 5).

Initially, researchers believed that the decrease of water quality might be due to a damaged portion of the boom. However, as described above, the post-deployment, onshore inspection of the test system indicated no system failures. This same onshore inspection confirmed a high level of sedimentation on the inside of the test chamber.

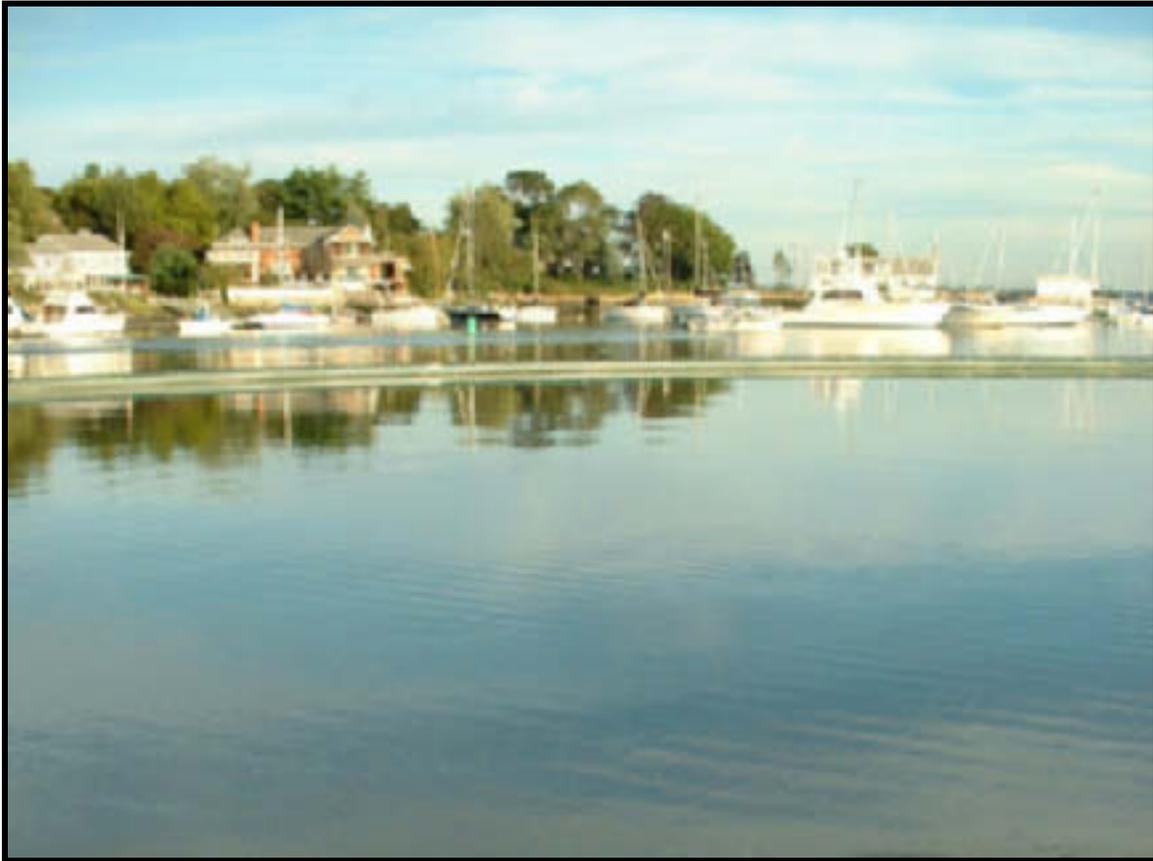
Figure 32. The successful Harbor Island BPS™ at Mamaroneck, NY

The most recent and applicable full scale BPS™ application to date is the Harbor Island deployment at Mamaroneck, New York, deployed in the late summer of 2002 (Figure 32). A replacement for the successful Mamaroneck Harbor Island Beach BPS™ described above, this system incorporated many additional design updates from the original, including an enhanced anchoring system and updated structural materials. The initial data were collected and analyzed by the town to determine the effectiveness of the system at providing a safe swimming area (Table 5). Data from 9/16/02 was taken closely following the deployment of the boom. One week later, 9/24/02, the BPS™ brought the water quality at the beach into full compliance with the New York State Standards for safe swimming (2400 MPN Total Coliforms, 200 MPN Fecal Coliform).

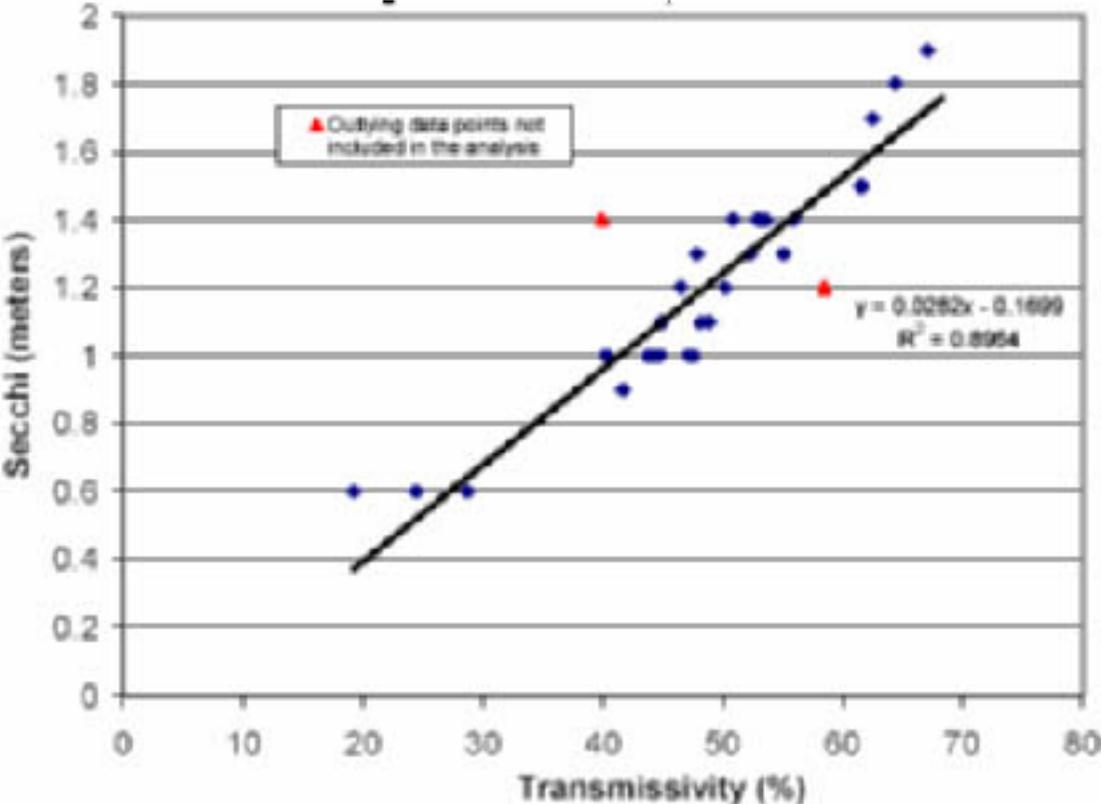
Appendix 2. Secchi depth vs. transmissivity in the Charles River as presented by EPA, using data collected at multiple locations and dates

Transmissivity is another measure of water clarity; it is a measurement of the percent of ambient light transmitted through a water column. Secchi depth is a *subjective* measurement of water clarity, while transmissivity is an *objective* measurement. A historical comparison of Secchi depth and transmissivity in the Charles River is provided in Appendix 2.
