Design of a Sustainable Shorelines Demonstration Project at Nutten Hook

FINAL REPORT

BLUESHORE ENGINEERING LLC & CREATIVE HABITAT CORPORATION

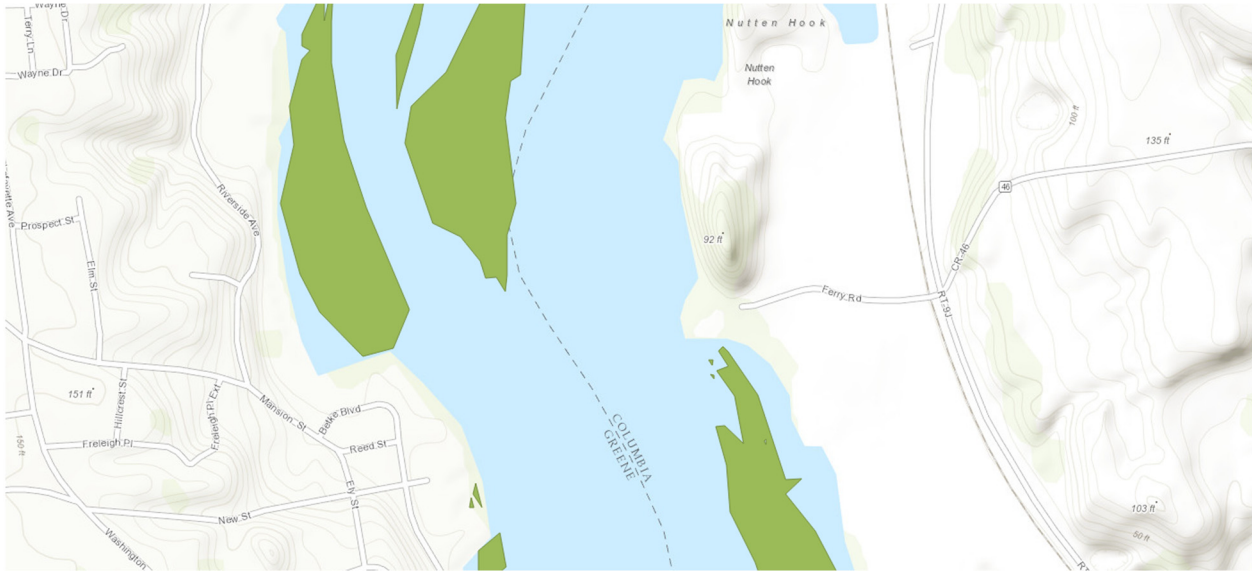
Figure 15. Documented SAVs

Submerged aquatic vegetation (SAVs) have been documented to the south of the Nutten Hook site being discussed herein (see Figure 15). The closest SAV habitat documented in the past 20 years is approximately 140 feet from Nutten Hook's southern shoreline. This documented SAV data, last revised in August 2013, was obtained from the NYS GIS Clearinghouse database. The data was produced in collaboration of the Institute of Ecosystems Studies (IES), the NYSDEC, Cornell University and the NOAA Coastal Services Center and is a combination of 1997, 2002 and 2007 datasets, representing a culmination of all areas where SAV habitat has been documented.

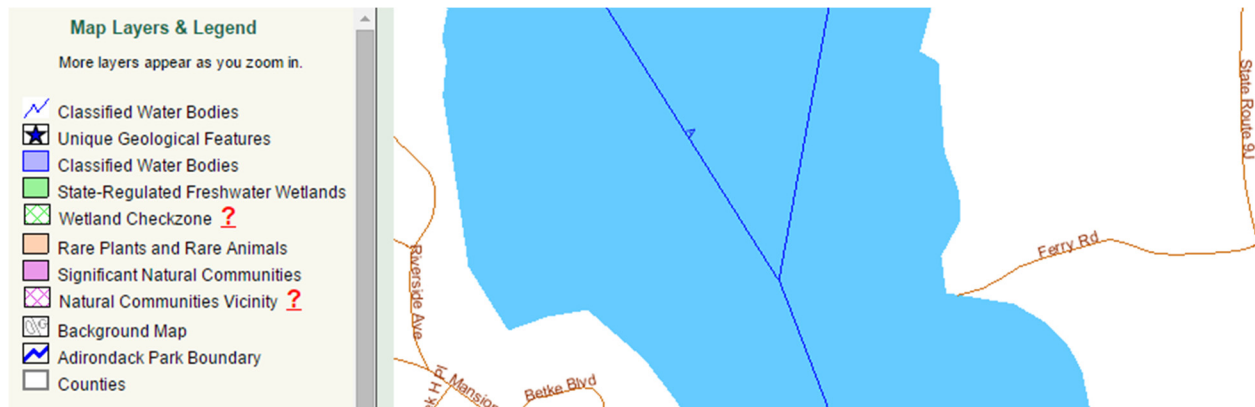
Figure 17. Classified water bodies map

body (see Figure 17). The water body has an 'A' classification, which the NYSDEC assigns to waters used as a source of drinking water.

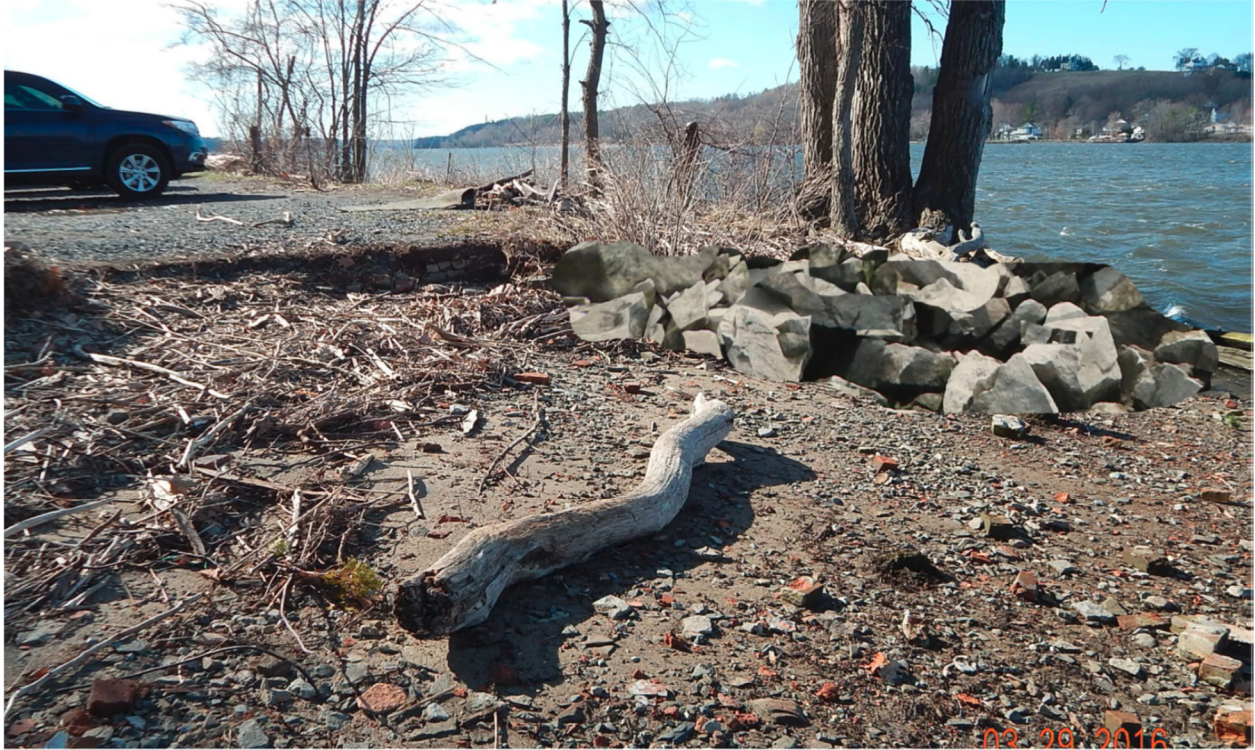
Photo 1. Visualization of tree root protection at northern poplars

Stabilizing the tree clusters (see Photo 1) will preserve habitat value generated by these trees. Removing trees at the seawall will prevent further damage of the seawall by tree roots, enhance the stability of the seawall and presumably increase its life expectancy. Reinforcing the shoulder of the road with rock and grasses as vegetative treatment (see Photo 2) will aid in preserving access to the site by helping to protect the road from wave action at elevations above MHW given sea level rise. Stone with plant reinforcement above MHW along the escarpment line will aid in armoring the shoreline to protect against further erosion without causing an increase in wave energies in the channel. Plants' roots will have the ability to remain anchored and retain soil fines.

Roots at the northern and southern tree clusters shall not be cut or damaged at any time during construction work. Sand should be washed into place to fill the voids between and underneath the tree roots. The tree clusters shall then be surrounded with rock fill that will act as armor to aid in stabilizing the undermined clusters. Live stakes shall be installed into washed-into-place sand, between tree roots.

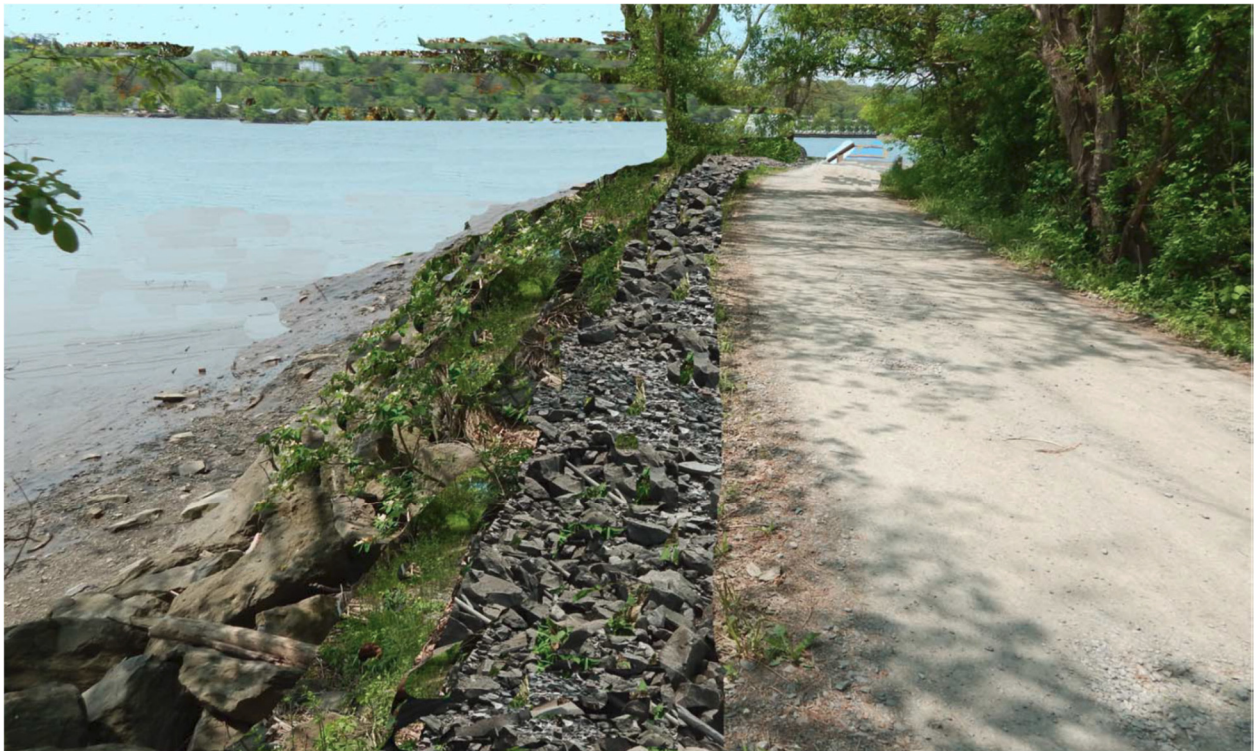
Photo 2. Visualization of road base armor (using stones and grasses)

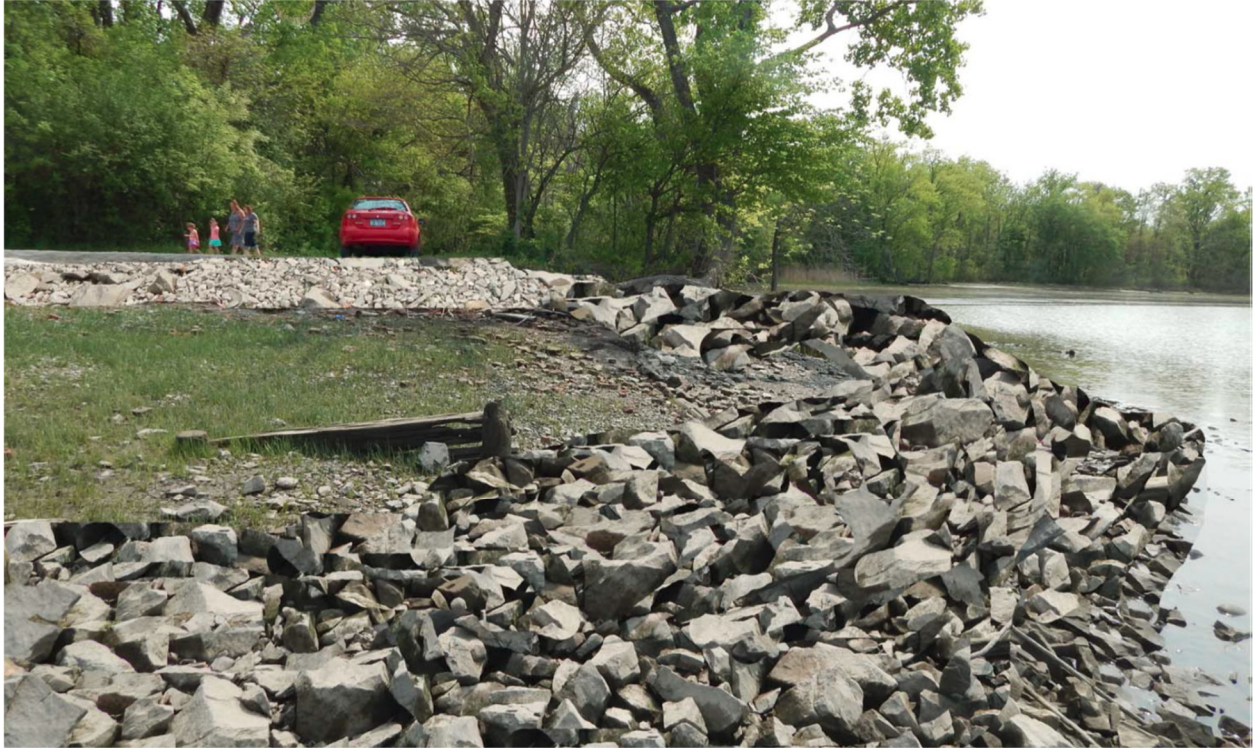
Photo 3. Visualization of submerged stone sill, combined with escarpment reinforcement

Slope armoring via rock sills (see Photo 3) will involve armoring the slope using submerged, well-graded rock/stone fill below MHW on top of the shoreline at areas experiencing significant erosion. This alternative should help break waves before they reach the shoreline and will reinforce existing structures to better protect the site from erosion caused by ice, current and wave action. However, this alternative can also destroy some of the shoreline’s intertidal zone, though not nearly as significantly as the net-zero fill alternative discussed below. Because the sills are made from rock/stone, fisherman and other visitors can walk on the sills without adversely affecting them.

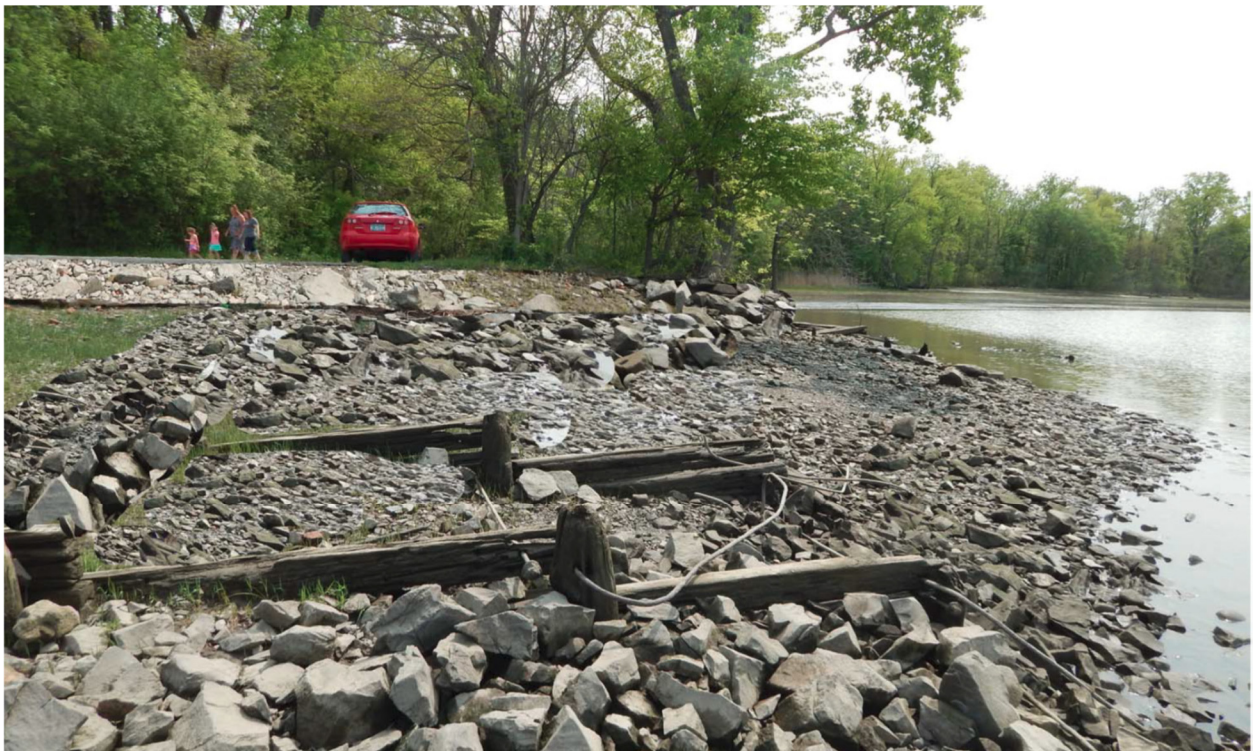
Photo 4. Visualization of net-zero fill, combined with escarpment reinforcement

Slope armoring via net-zero fill (see Photo 4) was considered as an additional “add-alternative” design. This option would involve excavating at areas experiencing significant scarping and placing stone in excavated areas to achieve net-zero fill below MHW. This alternative would help to break waves that wash over the shoreline to better protect the property from erosive forces. However, this alternative would heavily impact and destroy most of the shoreline’s intertidal zone and habitat value, particularly its potential to support rare plant species that rely on eroding surfaces. Plant species (such as the existing rushes) at these areas that are currently helping to hold together the shoreline would be destroyed. Therefore, we determined that this option was not a suitable shoreline stabilization strategy for the site.

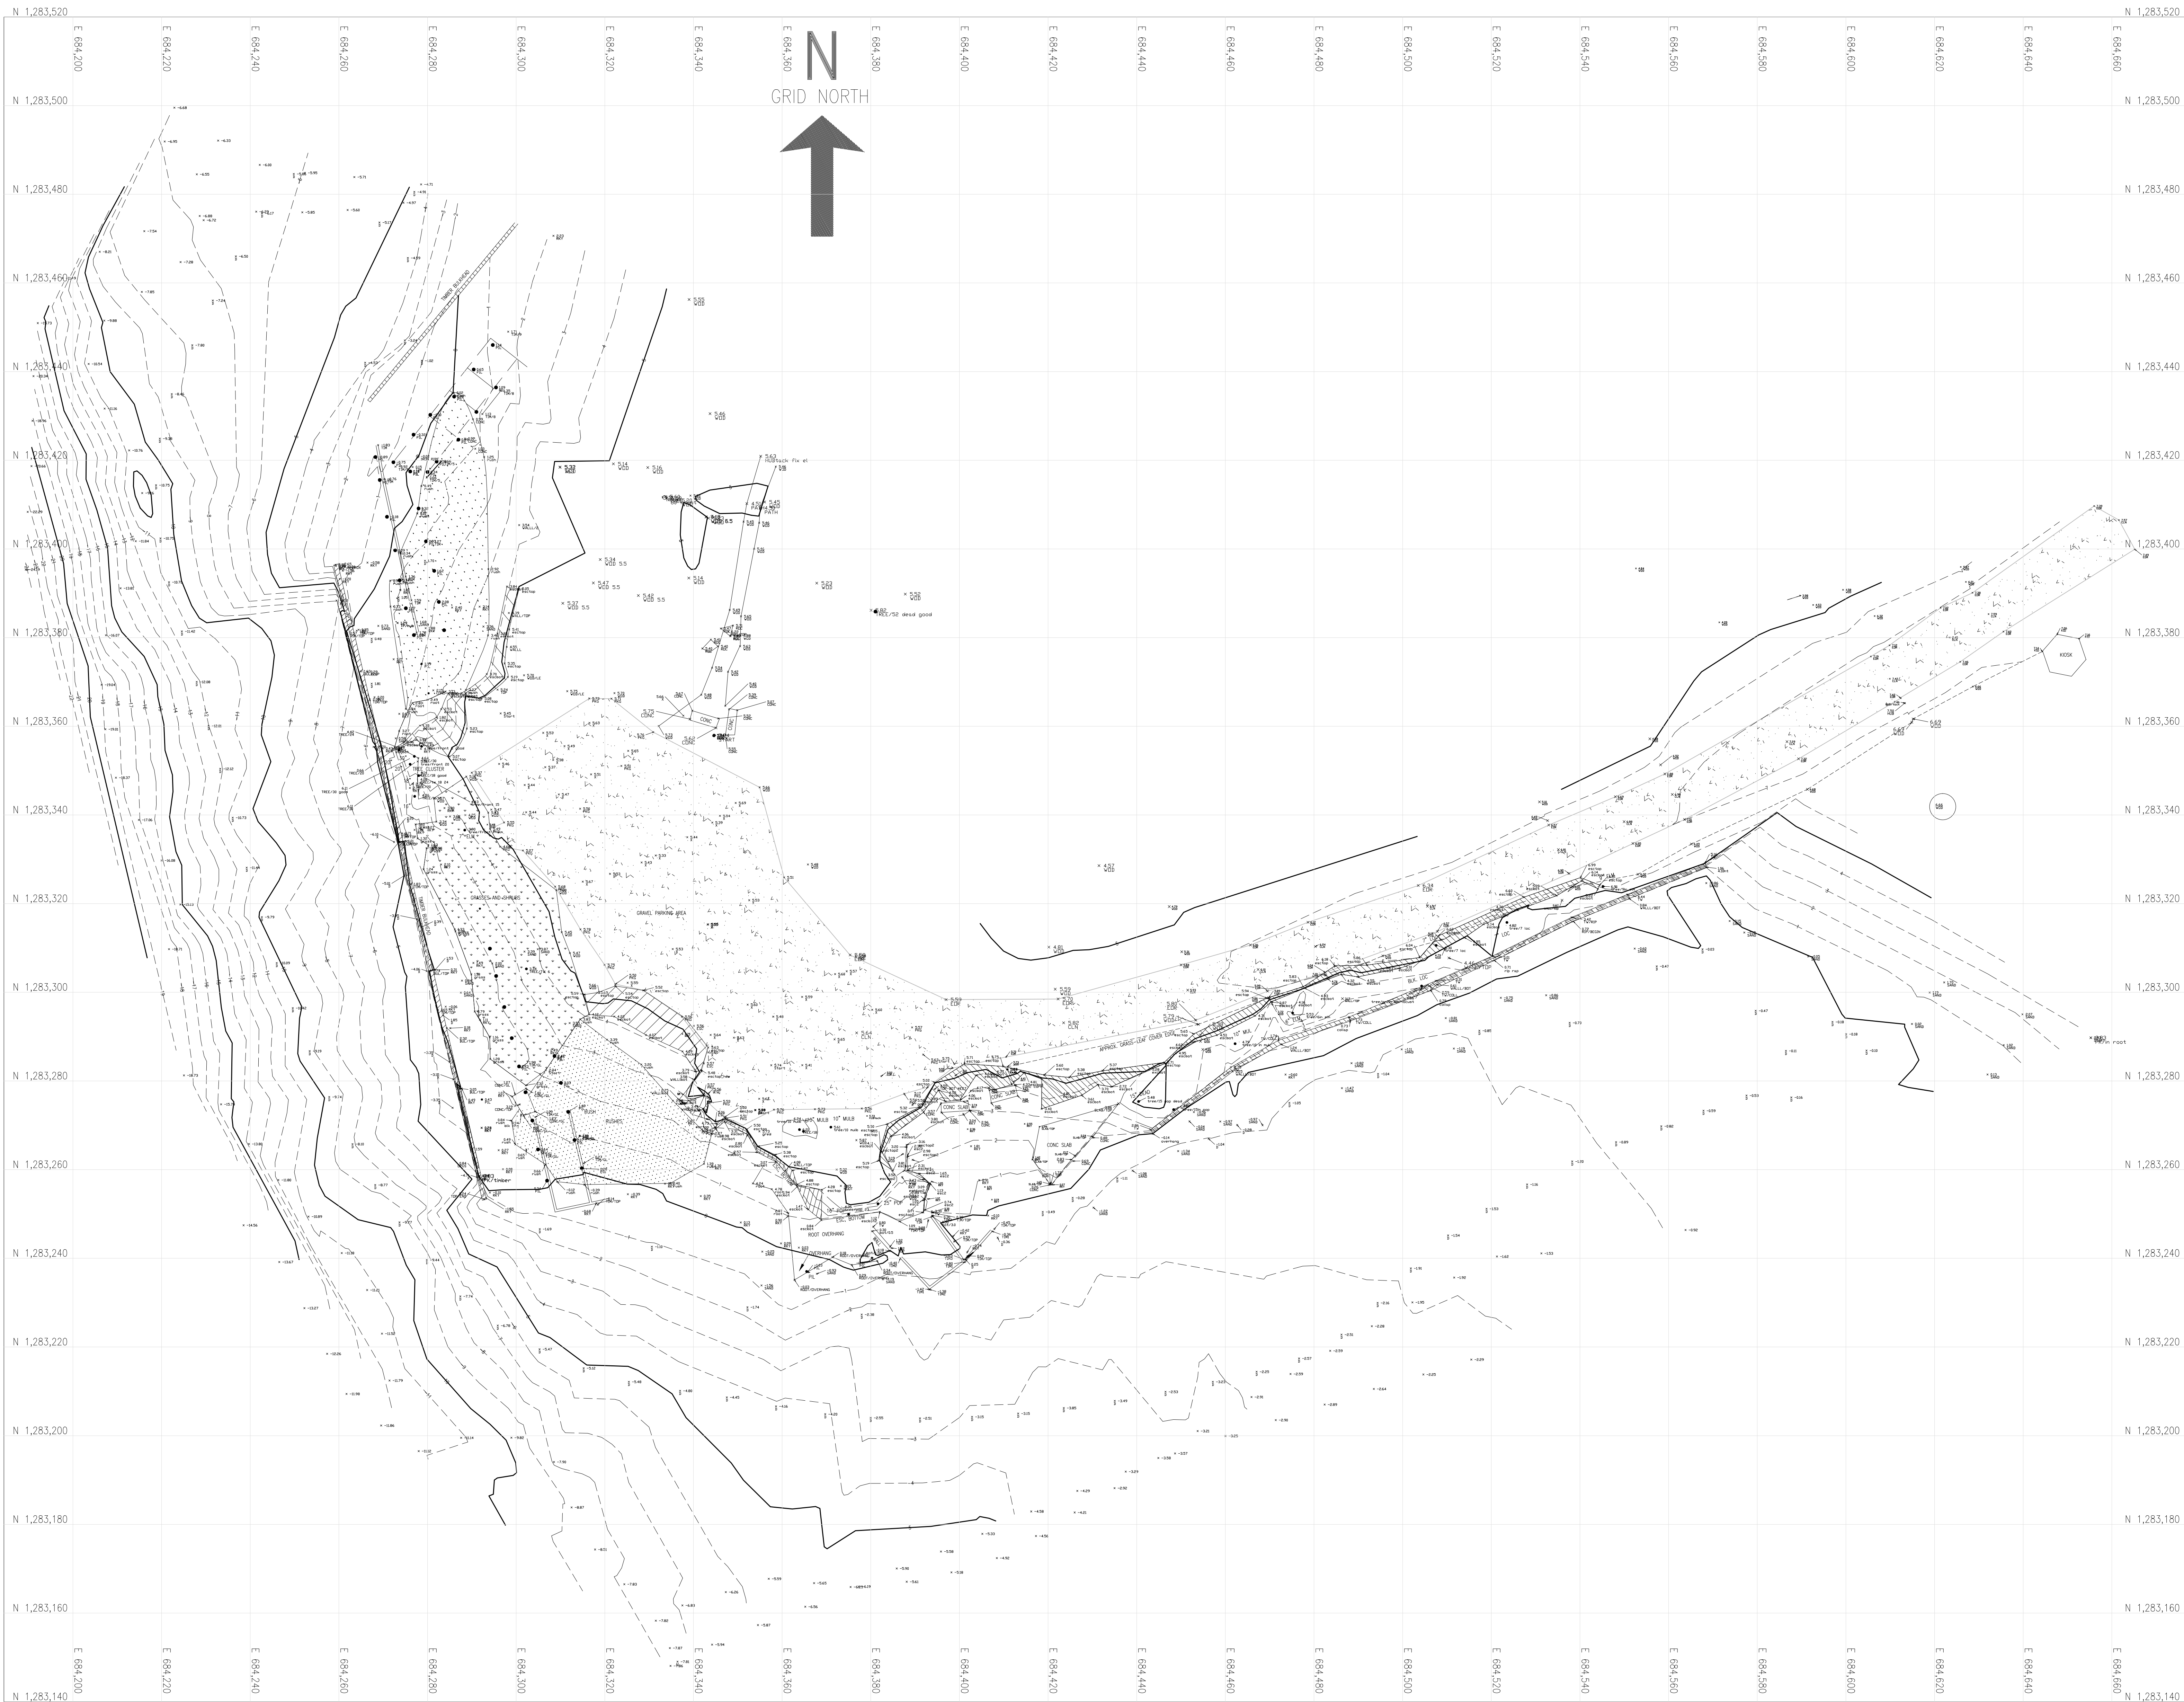
Nutten Hook
 at the end of Ferry Road
 Town of Stuyvesant
 Columbia County, NY

SURVEY NOTES:
 1. HORIZONTAL CONTROL IS REFERENCED TO NAD83
 OPUS OBSERVATIONS CONDUCTED AS PART OF THIS
 SURVEY AND DISPLAYED IN THE NEW YORK EAST
 COORDINATE PROJECTION SYSTEM.
 2. ELEVATIONS ARE BASED ON NAVD88 OPUS GPS
 OBSERVATIONS CONDUCTED AS PART OF THIS SURVEY.
