CASE STUDY – COMPARISON OF MULTIPLE LINES OF EVIDENCE

CASE STUDY – DISSOLVED PHASE PLUME

Survey Locations	Figure 1
Lee County DOT #4 Salem, AL	March 2017
High-Resolution Assessment

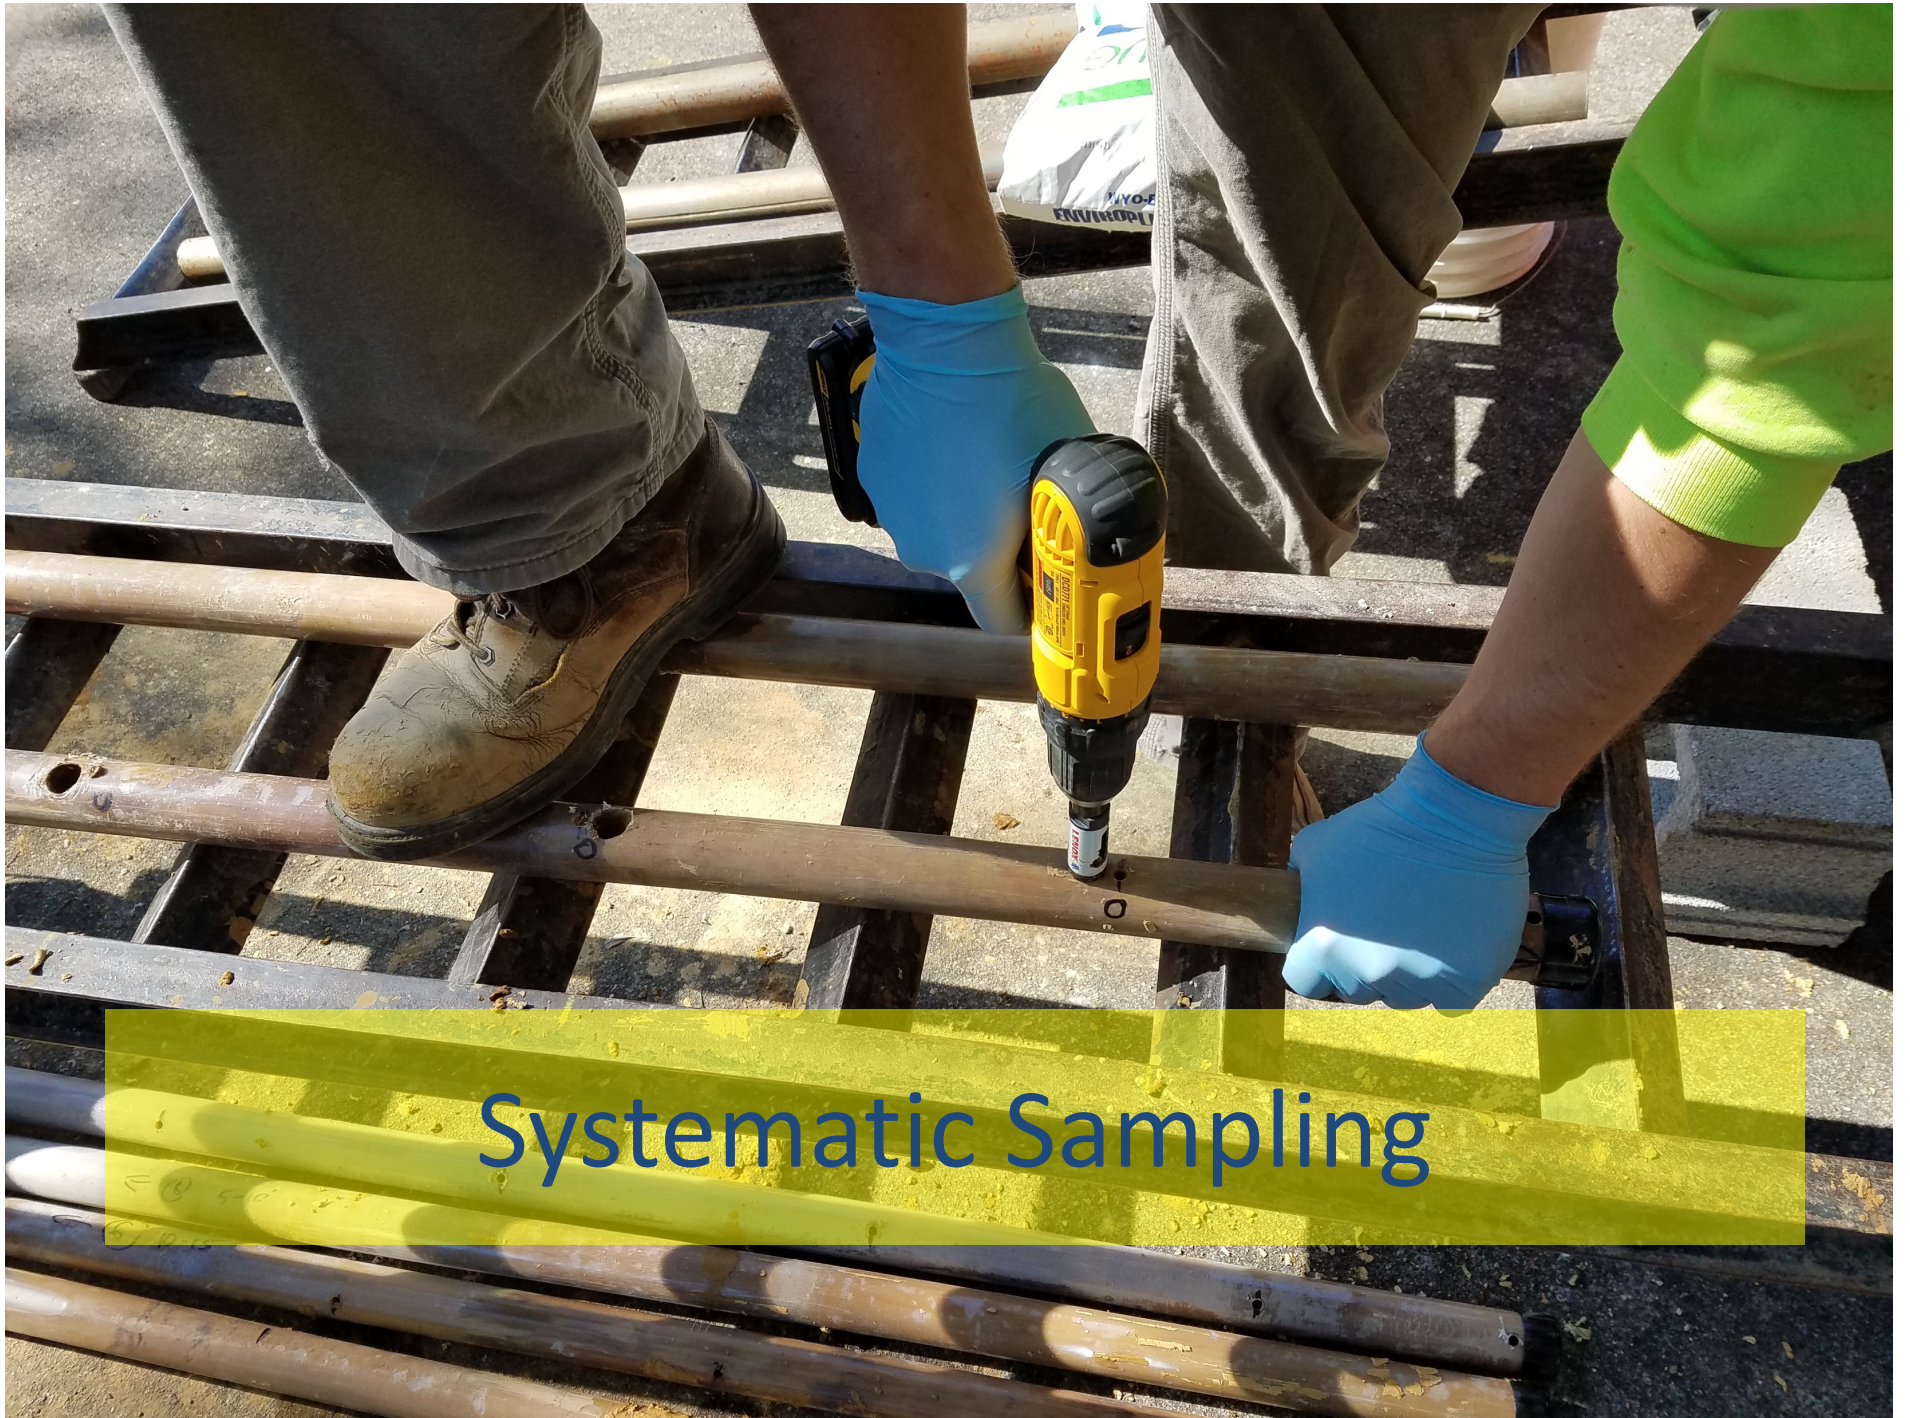
Systematic Screening

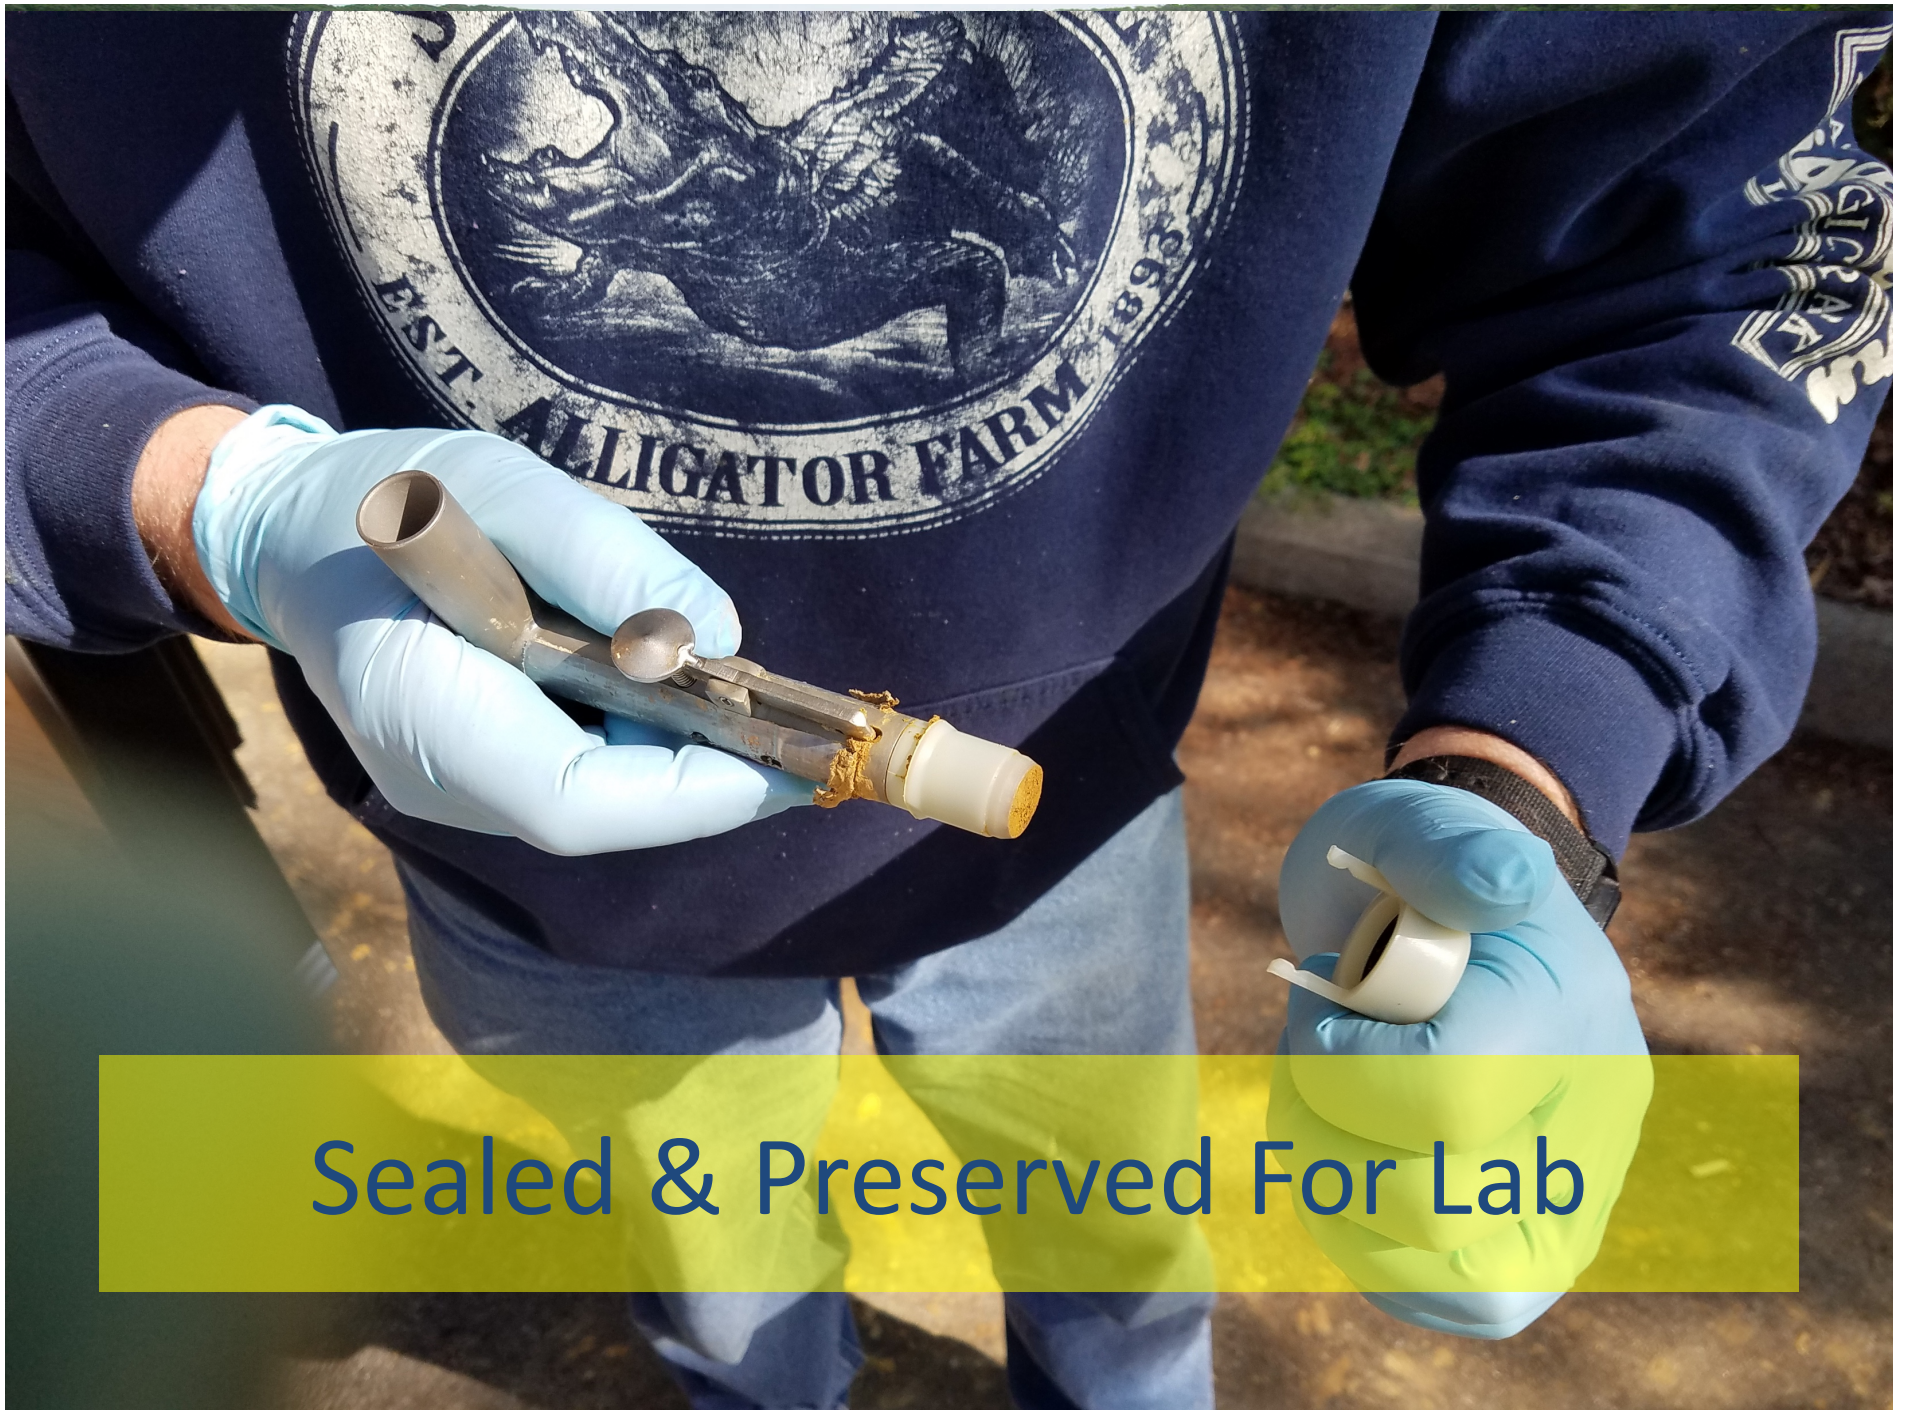
Systematic Sampling

Sealed & Preserved For Lab

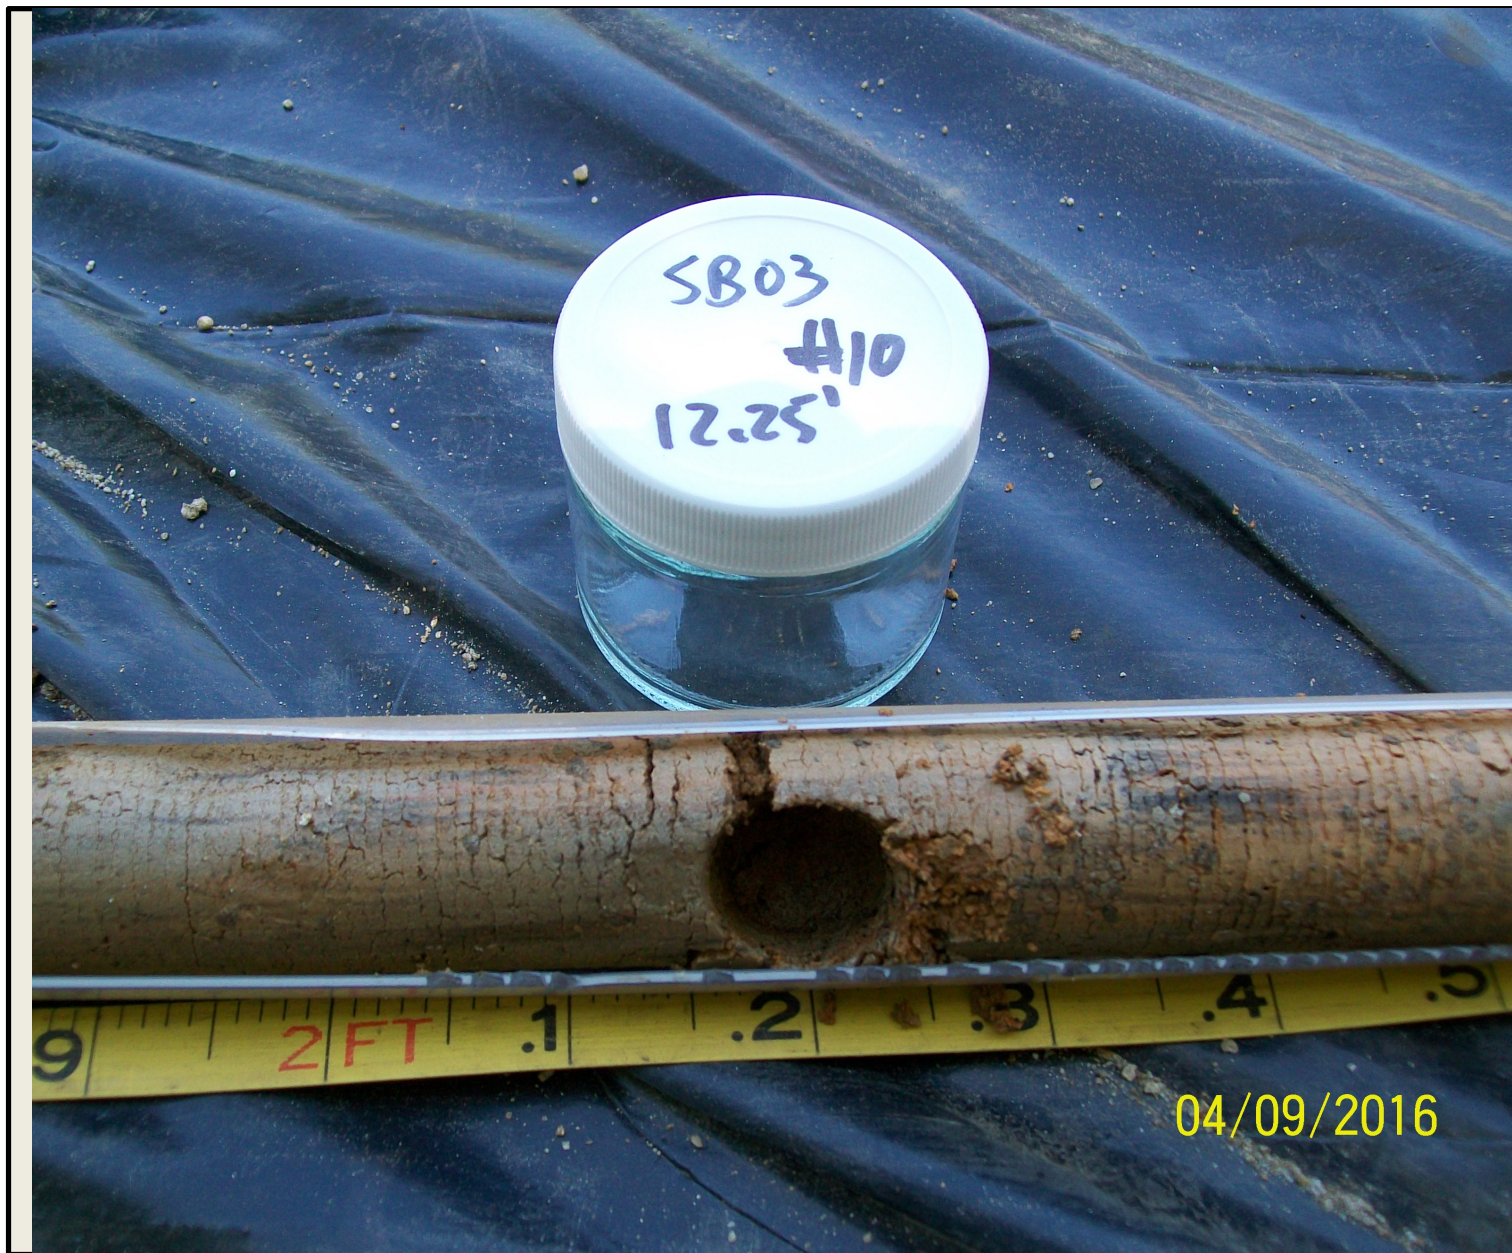
Lee County DOT #4 Salem, AL	Discrete Soil Sample Plug
	High-Resolution Assessment	March 2017
		Figure 6

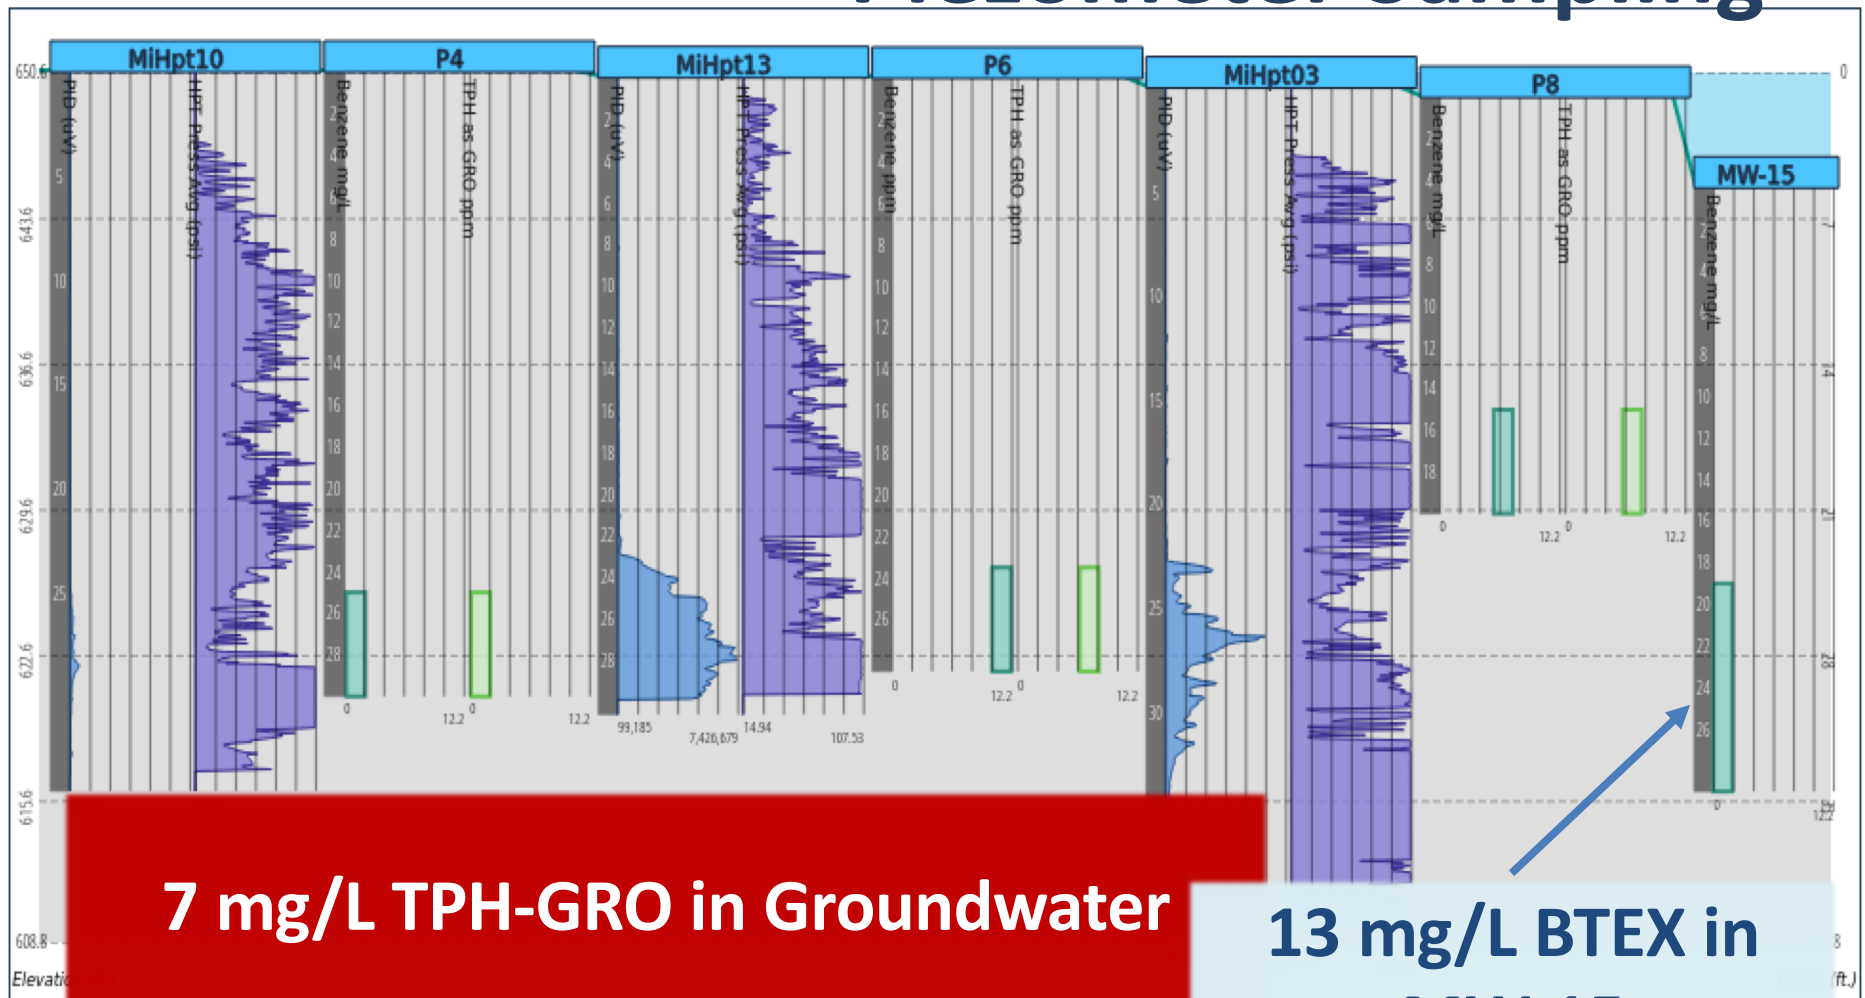
Piezometer Sampling

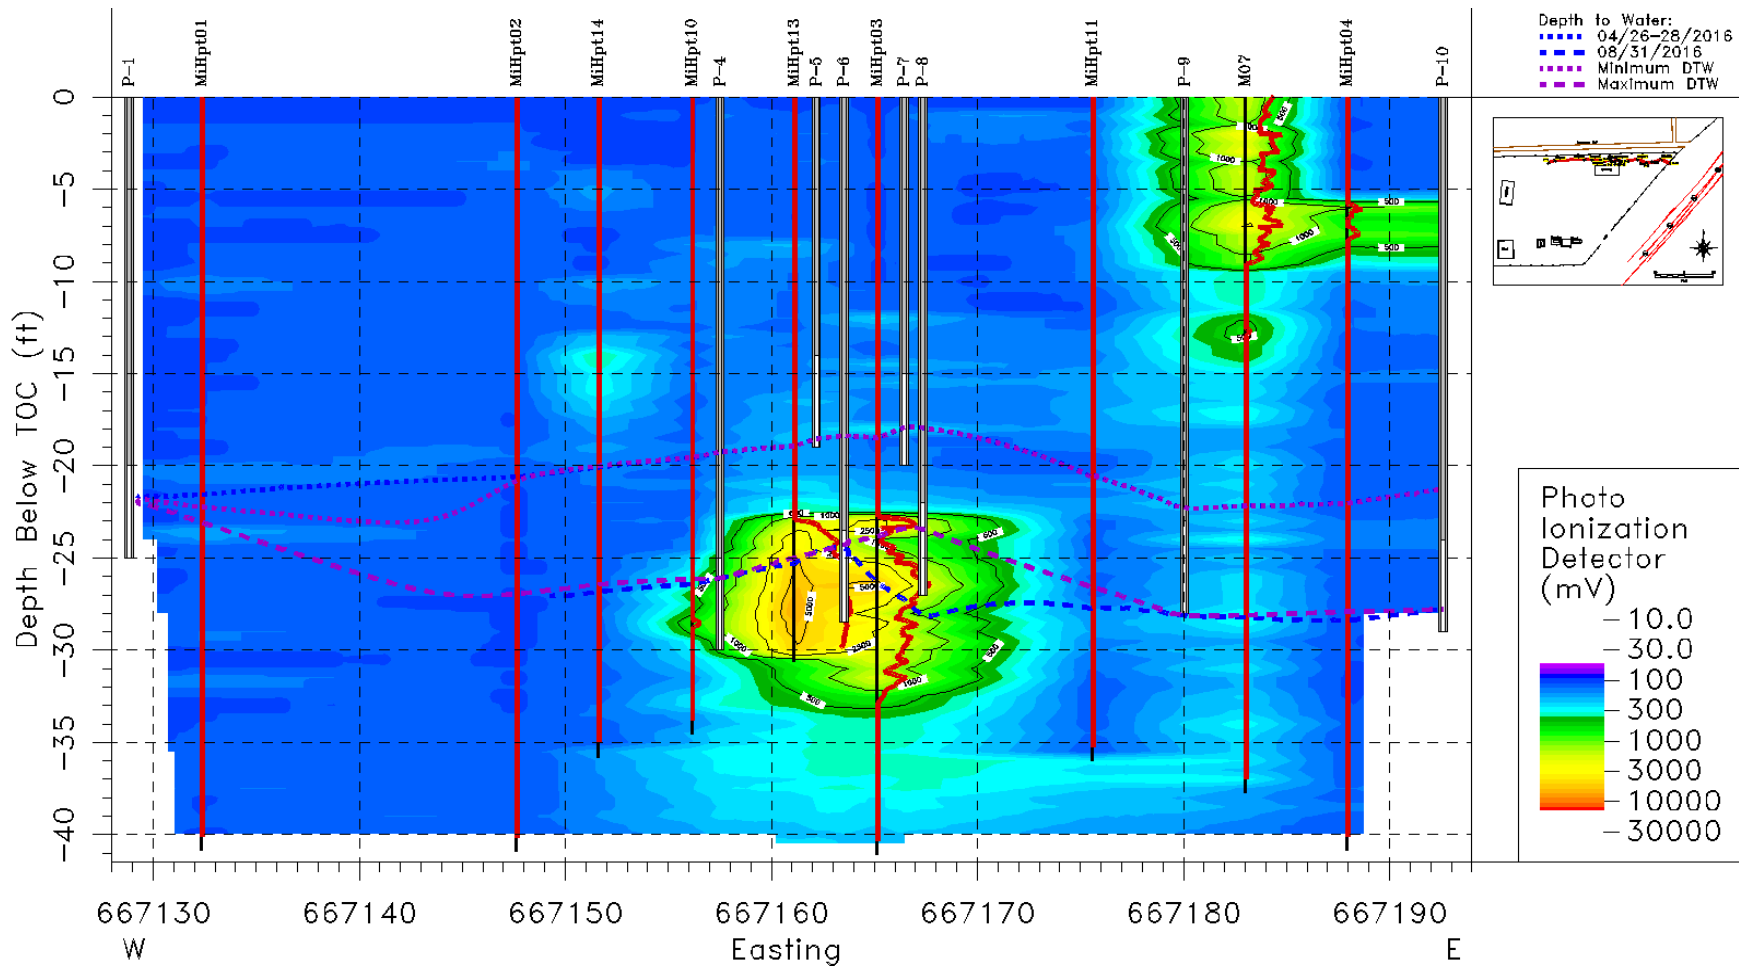
Mass Transport Diagram

- Dissolved phase contamination will result from residual LNAPL mass in saturated zone
- Cleanup goals for groundwater are not going to be achieved if LNAPL mass remains onsite – *“if you have a water problem, you have a soil problem”*
- Transport pathways will likely result in 80-90% of the dissolved phase mass moving through 10-20% of the vertical plane
- Scale appropriate measurements are need to identify the mass transport pathway
