# L.U.S.T.LINE

A Report On Federal & State Programs To Control Leaking Underground Storage Tanks

## 30 YEARS OF FEDERAL UST REGULATION Looking Back; Going Forward

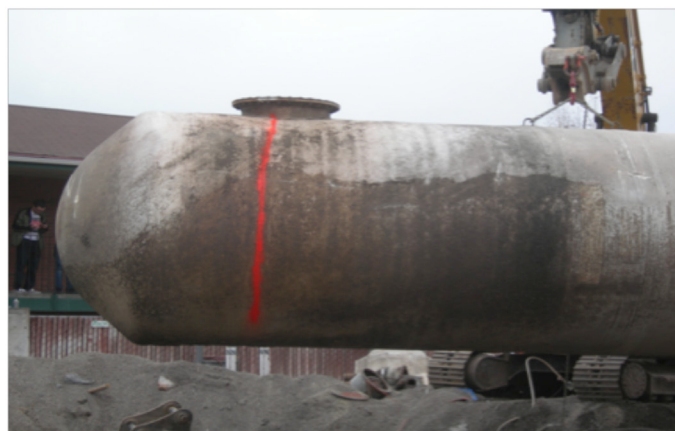
**Figure 2.** 10,000-gallon double-walled fiberglass UST with red paint on the crack.

The UST that failed was a 10,000 gallon double-walled Owens Corning UST installed in 1989, prior to the existence of the state oversight program for UST installations. On April 2, 2018, the UST was removed and a large, nearly vertical crack was observed near one end. Although records of construction details were not available, it appears that a few factors may have contributed to the failure of the UST.

At the time of the UST removal, it was observed that the burial depth of the UST was somewhat shallower than we see in current installations. The surface immediately above the end of the UST was also the junction of concrete and asphalt paving and happened to be where the fuel delivery trucks would drive, and sometimes park, to fill the USTs. Although we may never know for certain, the thin overburden, location of surface stress points, and possible issues with compaction may have contributed to stresses that led to the crack in the UST.

In late February, the crack appears to have extended downward until it ran along nearly the entire height of the tank as shown in Figure 2. At this time the leak rate became high enough that the ATG registered a "No Idle Time" alarm. At this facility, the ATG was located in a cabinet in the middle of the C-store, rather than in a back room where employees would be more likely to observe an alarm.

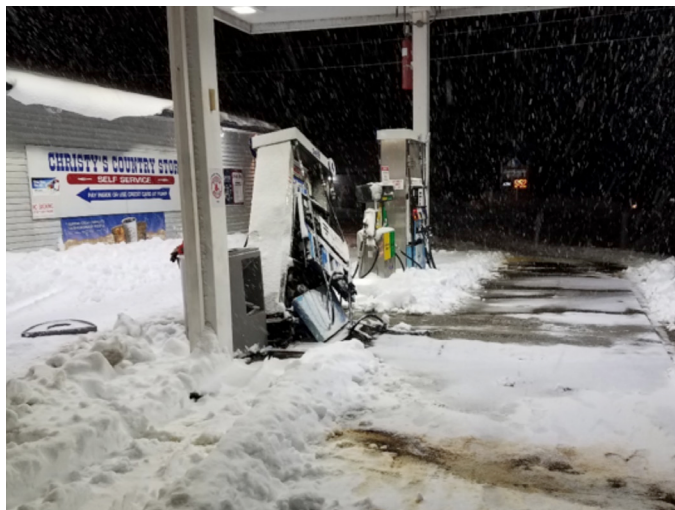
*Dispenser when it was found by the fire department. Notice the streams of fuel.*

When the fire department arrived, fuel was still flowing out of the broken crash valve that had not completely closed. When MDEP Response Services staff arrived, they stopped the flow with a formable plug. Then they hired a cleanup company to scoop up the snow and gasoline into roll off dumpsters. The free product and saturated slushy snow were recovered by a vacuum truck with a "liquid ring" pump rated for flammable liquids.

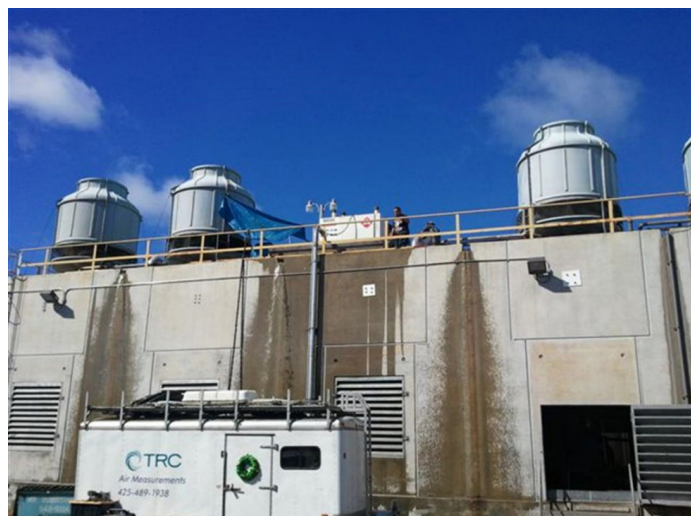
**Figure 2.** An example of what can happen when a day tank on a building lacks appropriate overflow prevention and tank-rupture controls that would prevent the automatic emptying of the main storage tank onto or into the building. The visible staining on the front of this building is diesel fuel. [Photo Courtesy of Guam EPA]

On October 13, 2010, building service workers in New Hampshire were wondering what the red liquid was dripping from the ceiling in the third-floor boiler room of a county nursing home. It turns out that it was heating oil from the 20,000-gallon UST that automatically supplied a day tank located in the third floor boiler room and that was vented up through the roof of the building. The day tank was lacking any overflow alarms or controls other than an overflow return pipe to the UST, which had started to clog. Luckily only a few hundred gallons of heating oil had been discharged onto the roof before it was observed and the transfer pumps could be manually shut down, thereby avoiding a fire catastrophe.
