# L.U.S.T.LINE

A Report On Federal & State Programs To Control Leaking Underground Storage Tanks

## Goodbye Tank Farm, Hello Wind Farm

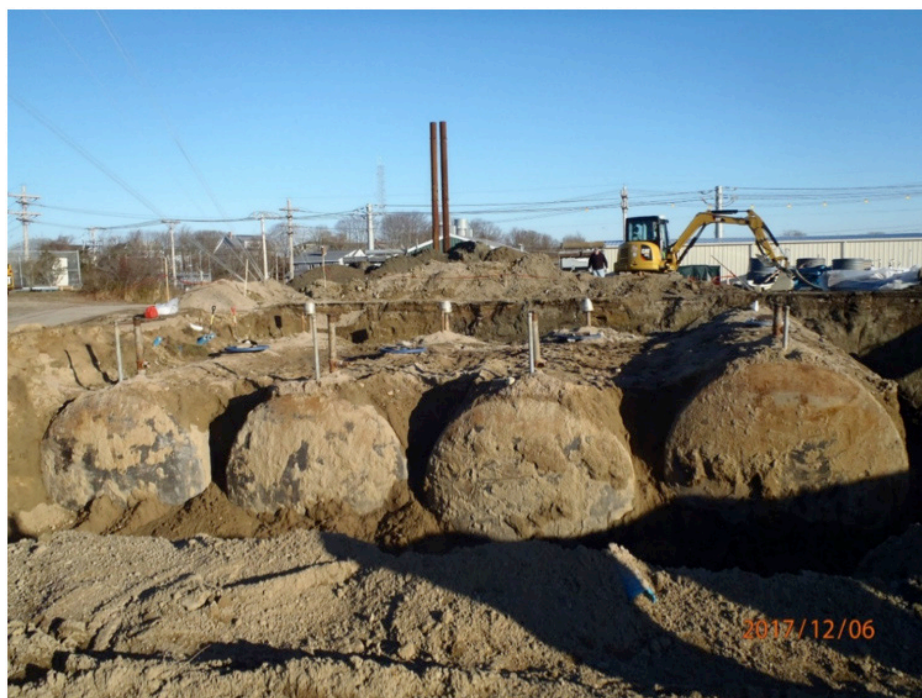
**Figure 2.** Northerly view of tanks 007, 008, 009, and 010 (right to left) prior to being excavated in December 2017.

The tank removals took place a week later. On former rail tank cars, the tanks were brought to the island in 1960 and positioned against each other beneath a mounded area in the southern area of the property. According to the contractor that emptied the product from the tanks, these single-walled USTs had an interior coating to prevent corrosion. Prior to our arrival, a local contractor exposed the tanks and opened the eastern side of the mound. In delicately choreographed maneuvers, an excavator and a bulldozer were used to slowly “roll-out” the tanks from the “excavation.” All five tanks, removed in one day, were in fair condition, with some scaling and rusting, but no discernible major holes or cracks. We all cheered the excellent work of the contractors and consultant for the efficiency of this closure, and for BIPCo having met the 2017 single-walled deadline.

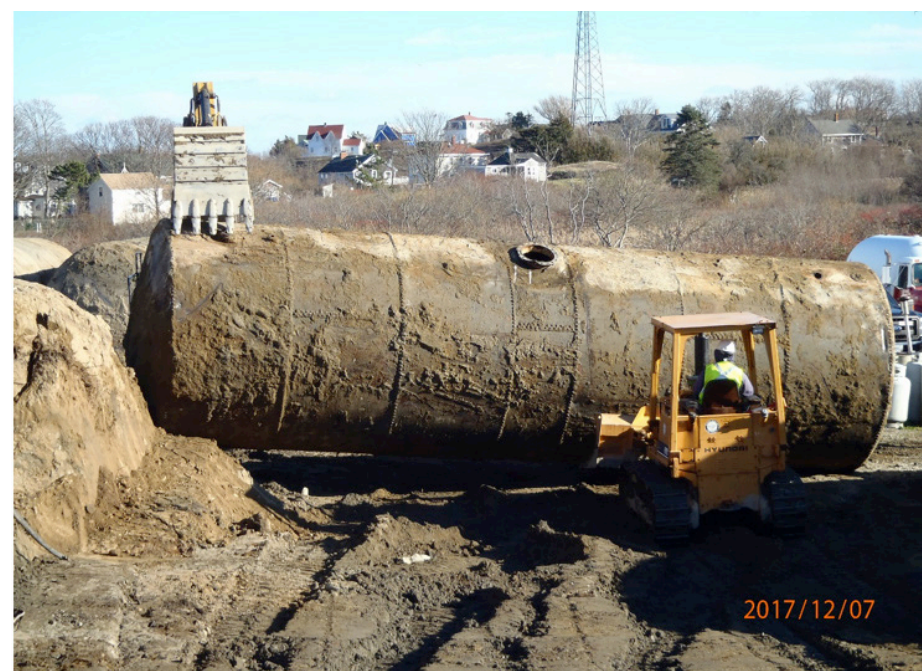
**Figure 3.** Last 20,000-gallon diesel tank being removed from the southern tank farm at BIPCo site.

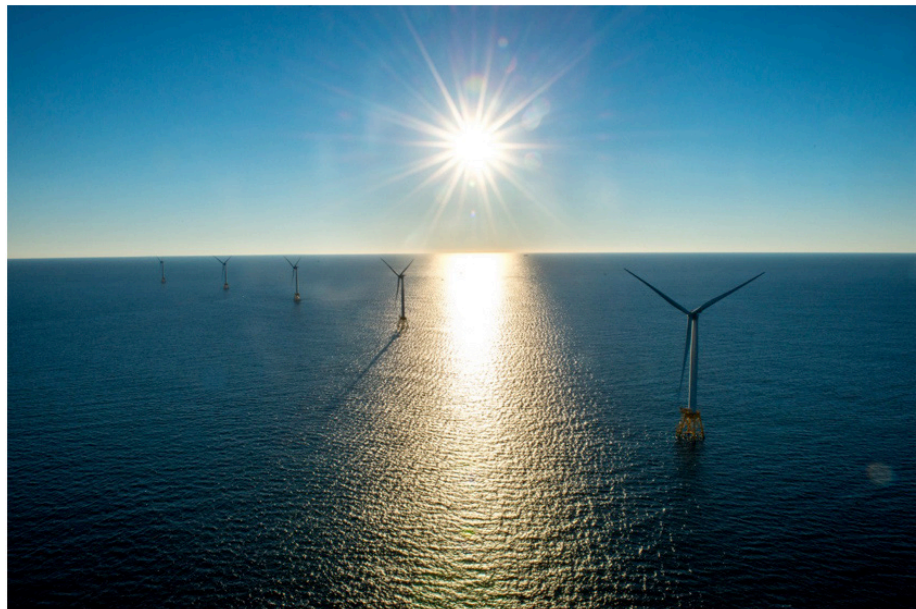
**Figure 4.** Photograph of the Block Island Wind Farm (<http://dwwind.com/project/block-island-wind-farm/>)

At the same time, a major event was taking place on Block Island. The first offshore wind farm in the United States was being built approximately 3.8 miles southeast of the island. Between 2015 and 2016, a five-turbine, 30-megawatt capacity known as the Deepwater Wind Block Island Project was developed. On May 1, 2017, BIPCo switched from diesel power to wind power at 5:30 a.m. Electricity is now being harnessed by wind power!

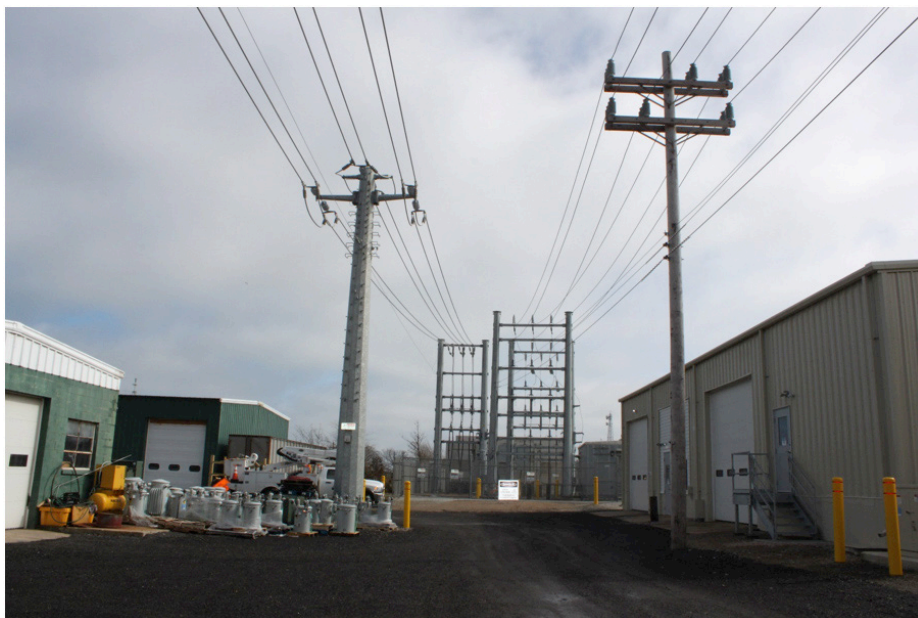
**Figure 6.** View of National Grid / Deepwater Wind substation located in the “Alternative A” study area at the far end of this photograph. Existing BIPCo buildings are in the foreground. This picture was taken in February 2019.

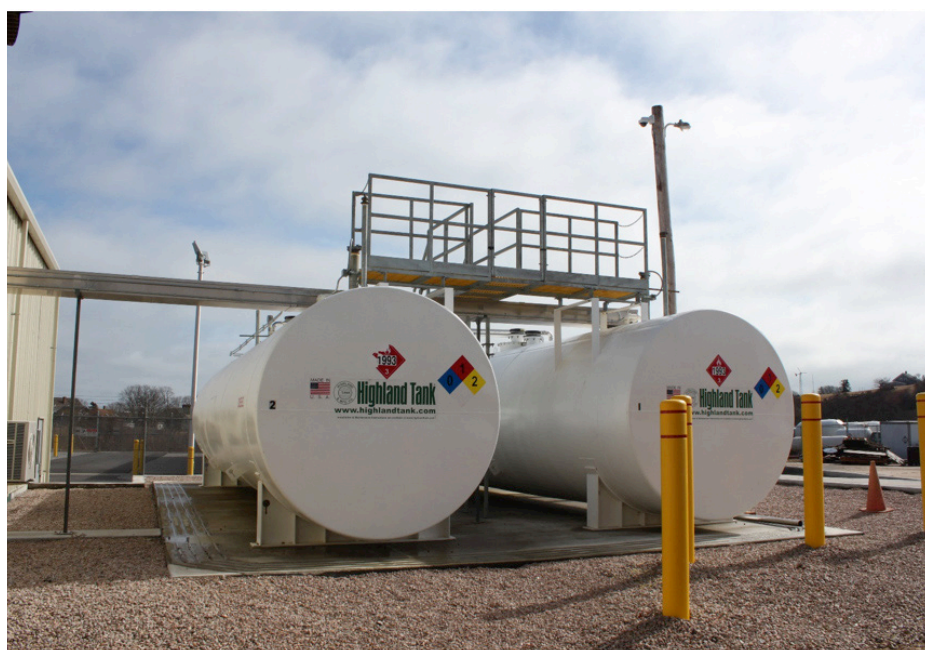
**Figure 7.** View of two on-site above-ground diesel tanks used for emergencies (February 2019)

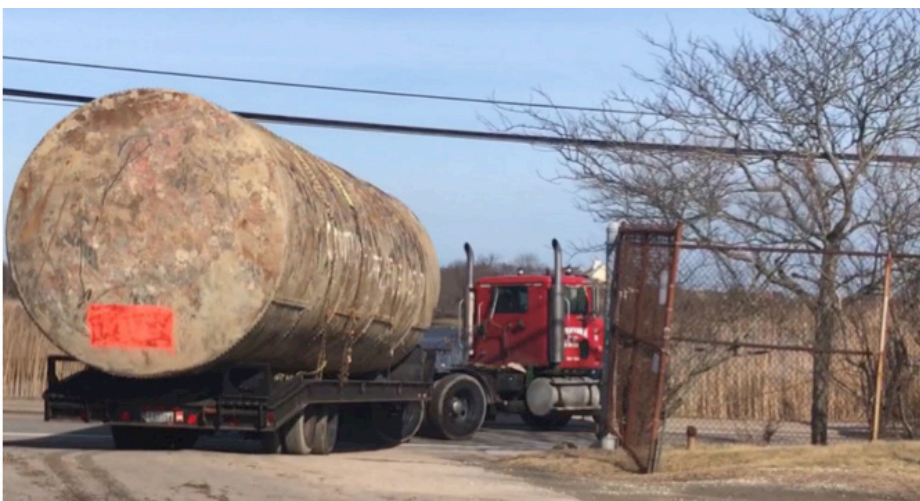
**Figure 8.** The last 20,000-gallon diesel tank leaves the BIPCo premises to be loaded on the Block Island Ferry for disposal on the mainland.

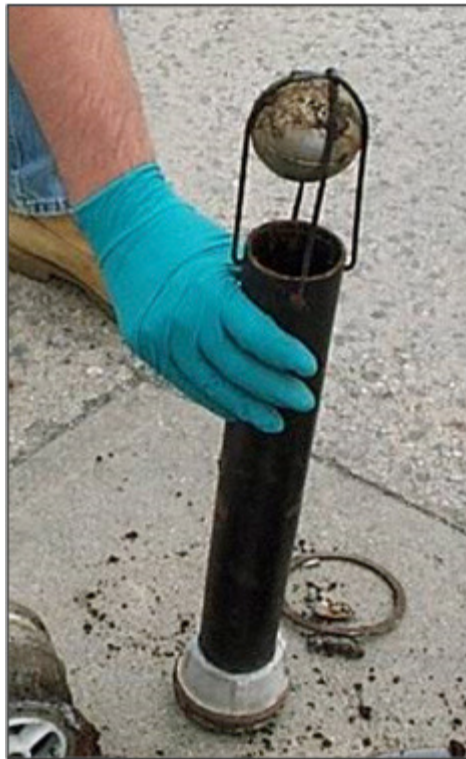
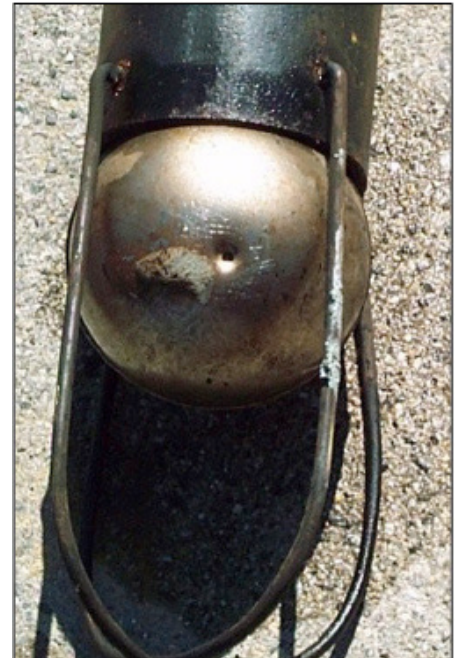
**Figure 1.** Removing overfill devices may reveal damage that is not otherwise obvious. Close inspection is required to detect ball floats that are stuck in their cages (left photo) or punctured so that they don’t float (right photo). Photos courtesy of Spruce Wheelock.

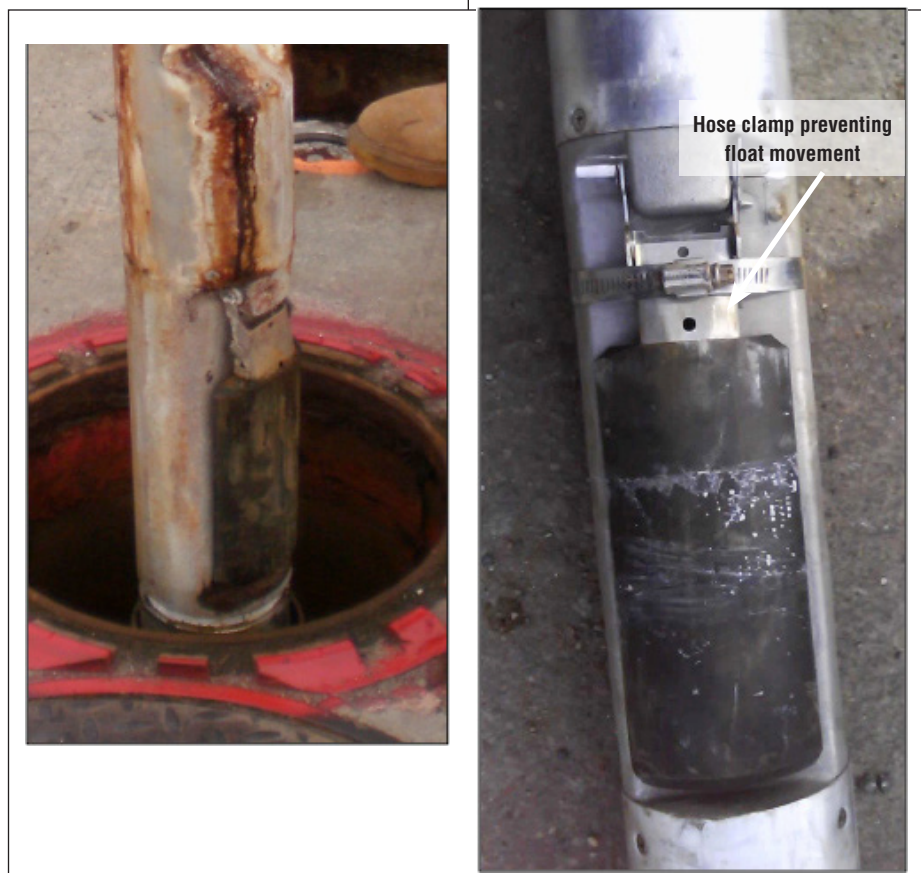
**Figure 3.** Movable floats on drop tube shutoff devices may not move. This may be due to corrosion (left photo) or human interference (right photo). Photos courtesy of Spruce Wheelock.

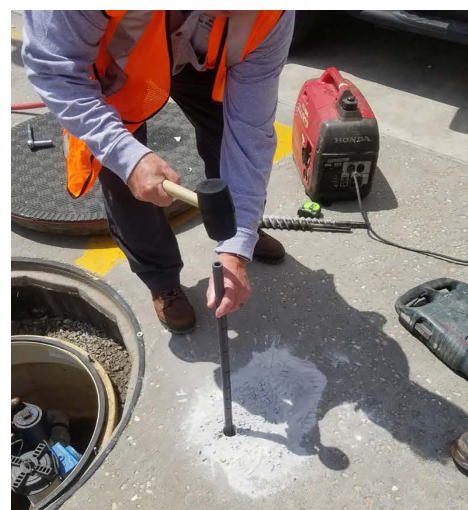
**Figure 1.** In the Dri-Sump method of sump testing, Vapor Stimulating Tubes (VSTs) are first driven into holes drilled in close proximity to the sump(s) to be tested. During the test, a vacuum is applied to these tubes. If any holes are present in the sump, the aerosol is drawn through the hole, into the backfill, into the VST, and then into a box where a laser beam reveals the presence of the aerosol.

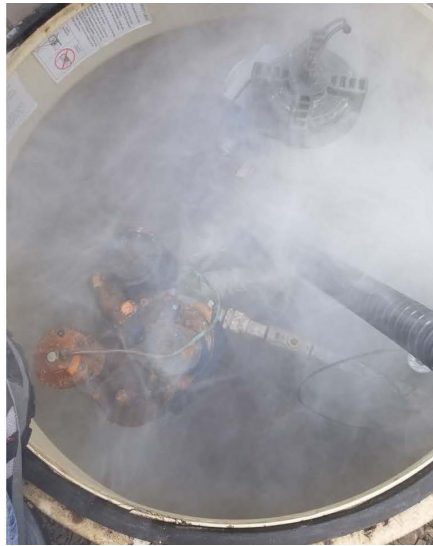
**Figure 2.** *In the Dri-Sump method of sump testing, the sump is filled with a cloud of dense aerosol.*

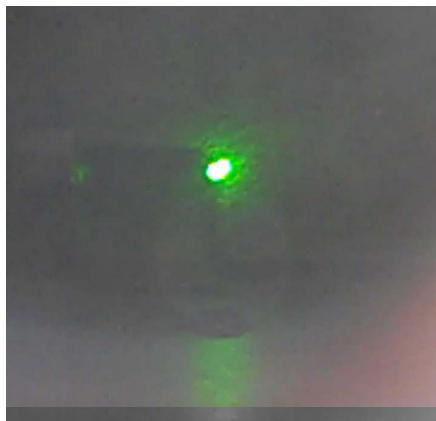
**Figure 3.** *The view inside the Dri-Sump black box. A vacuum draws air from the VSTs into the black box. A green laser pointer beam is directed through a viewing port into the box. In the absence of any aerosol, the laser shows up as a dot on the wall inside of the box (left photo). When aerosol is present, the laser shows up as a beam (right photo).*

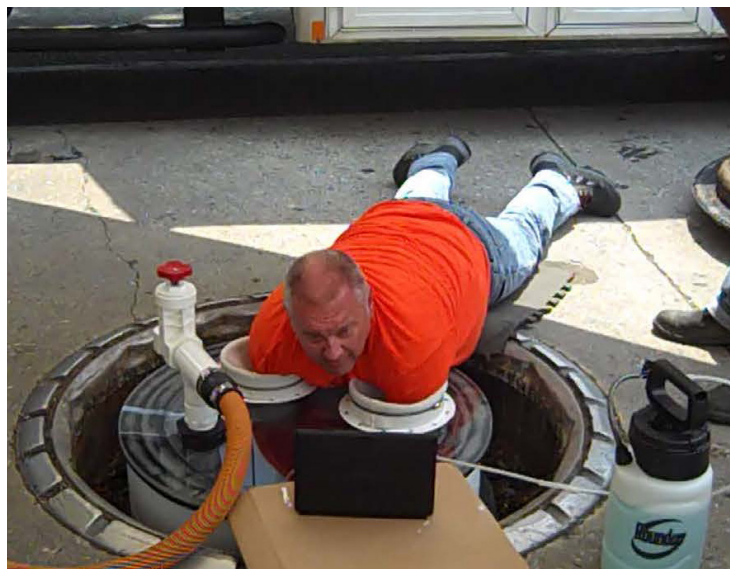
**Figure 5.** During the Leak Detection Technologies test, a vacuum is maintained in the sump while a technician sprays a soap solution on the sump wall and sump fittings with one hand and maneuvers a video camera in the other hand. The video image is transmitted to a screen that the technician (that's Ed in this photo) watches closely to see if any bubbles appear.

hand. An aboveground video screen, which can be a laptop computer or TV monitor, is connected to the video camera in the tester's hand inside the sump and is observed by the tester. The tester then systematically sprays the entire surface of the sump and each penetration fitting with the soap solution and then points the camera at the area he has just soaped to see if bubbles appear on the video screen in front of him. The presence of bubbles (or the ingress of water if groundwater is present outside the

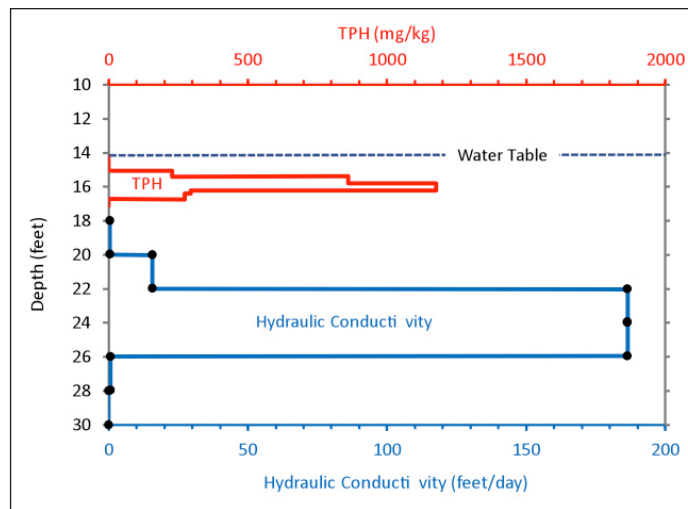
**Figure 3.** Vertical distribution of TPH and Hydraulic Conductivity at the location with the highest concentration of TPH.

sampled by Wilson and Kampbell (1993) is identified by a red triangle in Figure 2. Data from this location is provided in Figure 3 and Table 2. A considerable amount of residual LNAPL hydrocarbons (TPH) remained at the site after active remediation. However, detectable concentrations were confined to a narrow interval between depths of 15 and 17 feet in the clay and silt overburden.

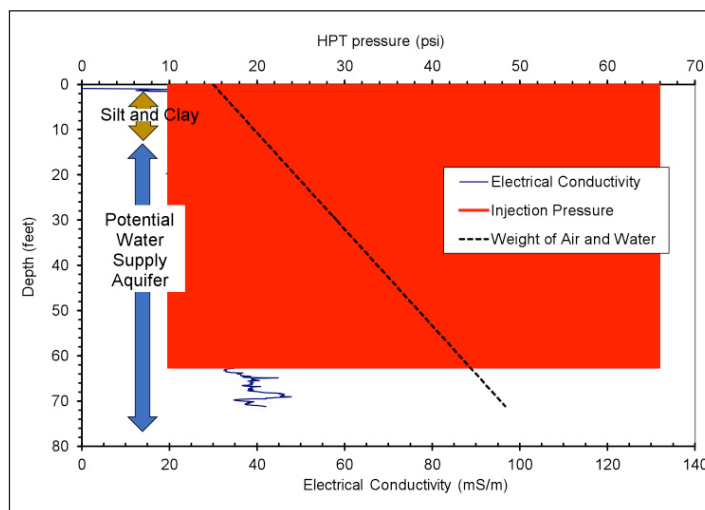
**Figure 5.** An example of the data provided by modern tools to distinguish clay and silt from sand and gravel and determine the vertical distribution of hydraulic conductivity. Courtesy Wes McCall, Geoprobe Systems®.
