Corrosion of Copper and Steel Alloys in the Presence of *Acetobacter* sp. in a Simulated UST Sump Environment

Jeffrey Sowards & Elisabeth Mansfield

Applied Chemicals and Materials Division, NIST – Boulder, CO

Problem: Rapid UST Corrosion

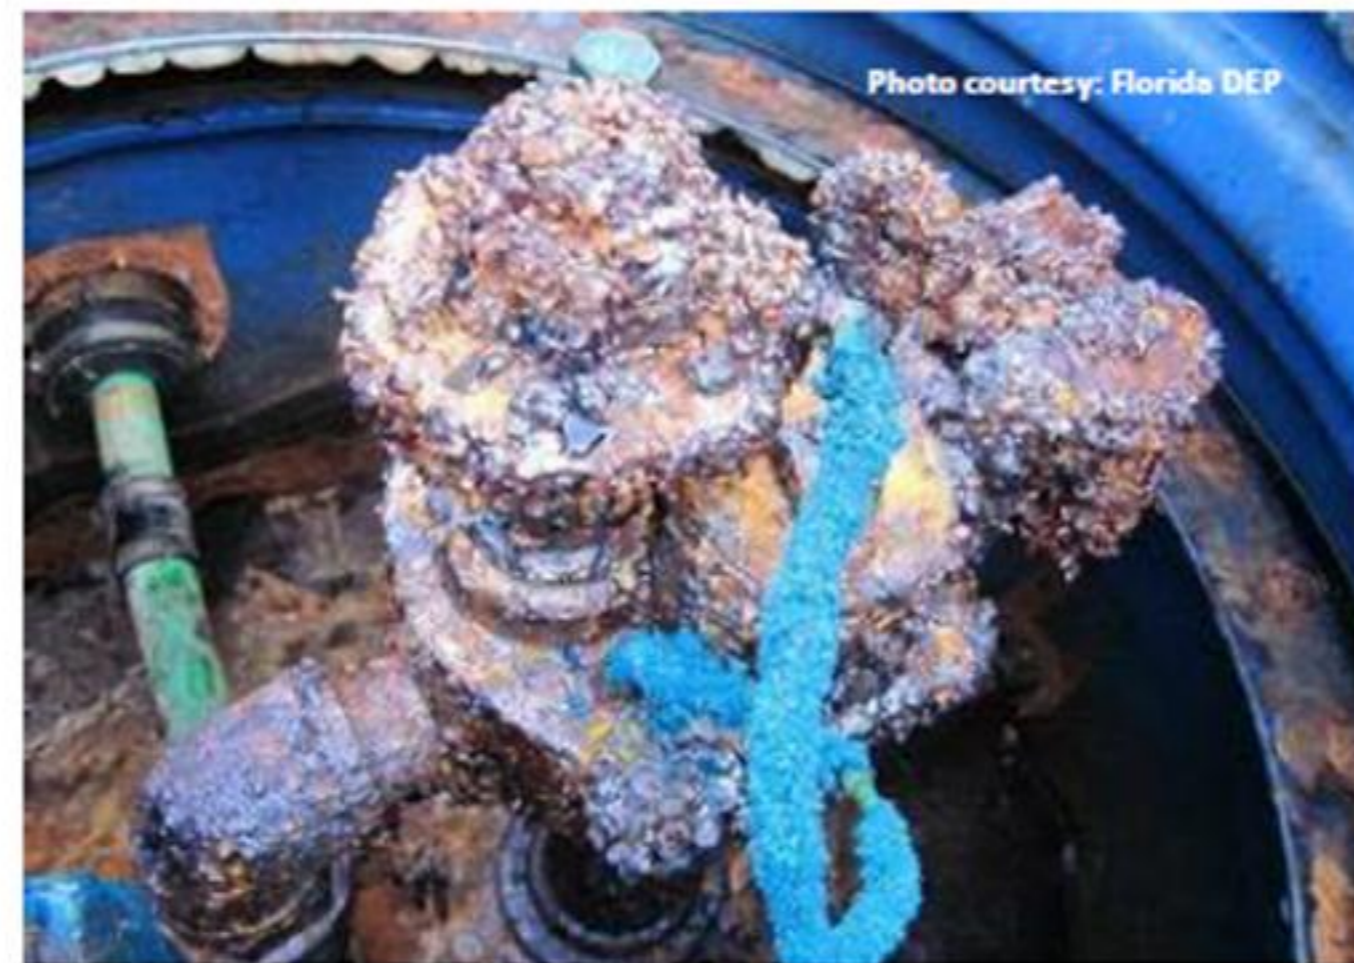
E10 STP, unknown grade (Florida) – Feb. 2011

Inspectors of USTs have noticed rapid corrosion and a vinegar-like odor when accessing the sumps. Microbiologically influenced corrosion (MIC) is suspected of contributing to the accelerated damage of UST systems dispensing ethanol-blended fuels.

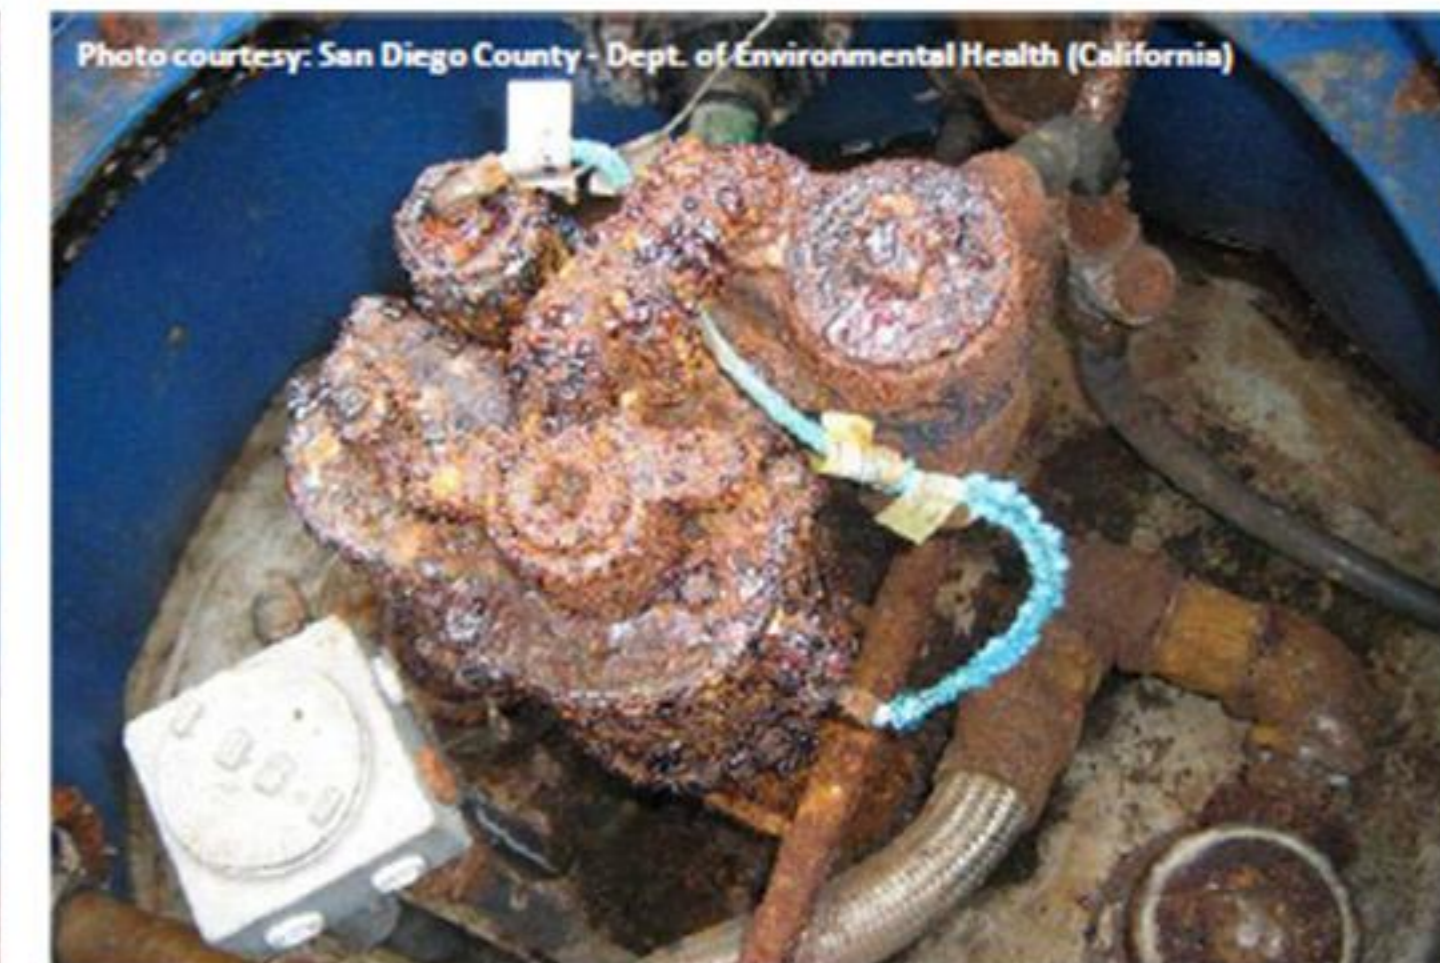
91 octane STP (California) – August 2010

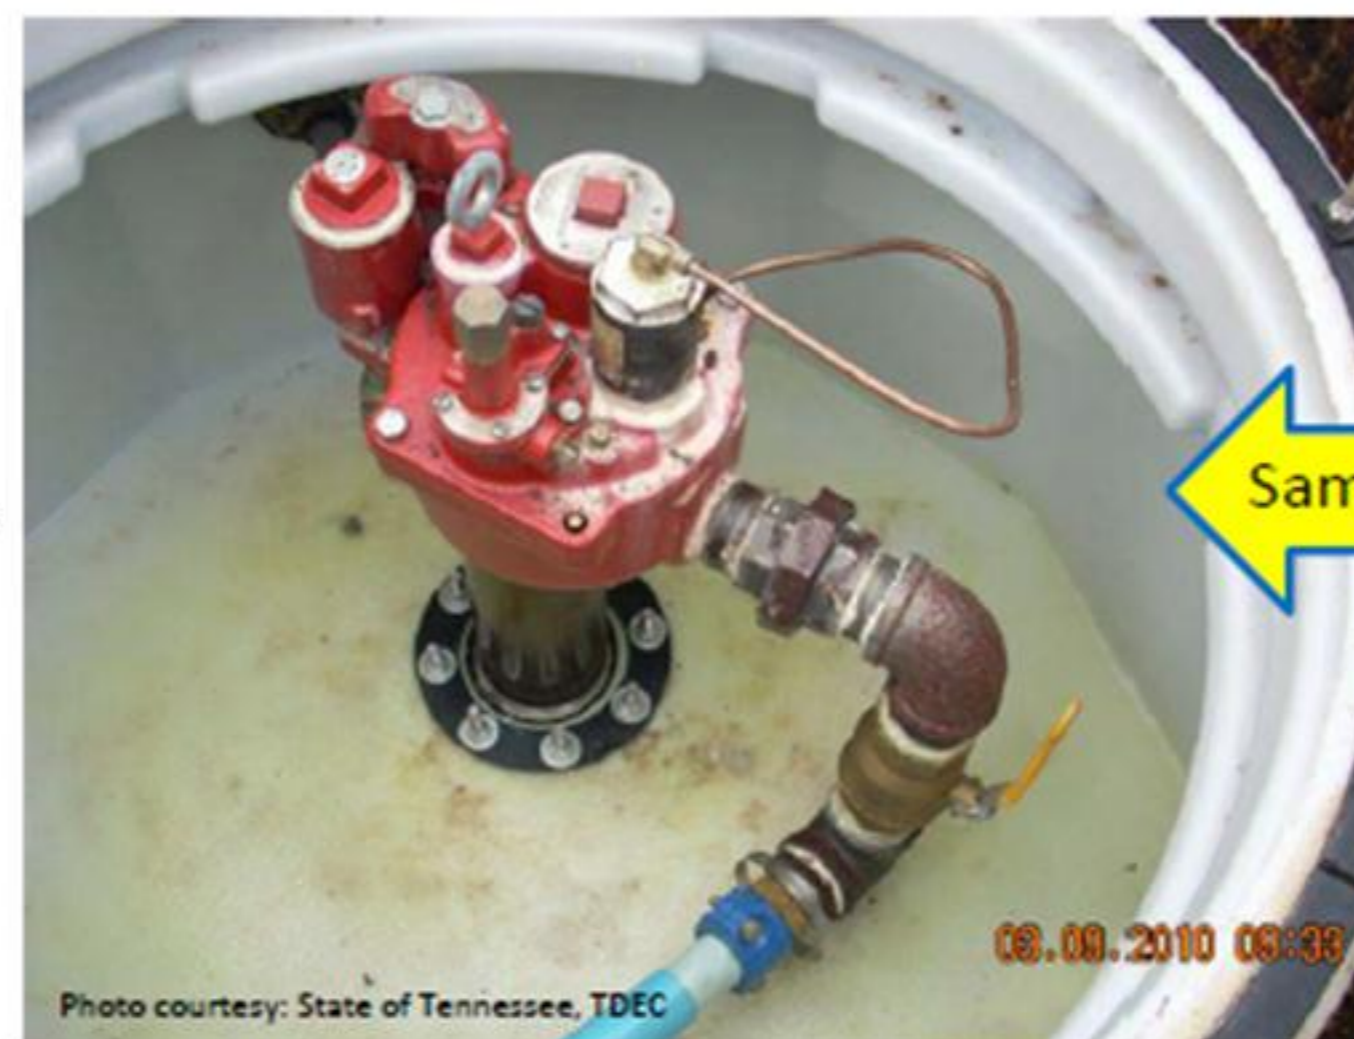
Premium/E10 STP (Tennessee) – March 2010

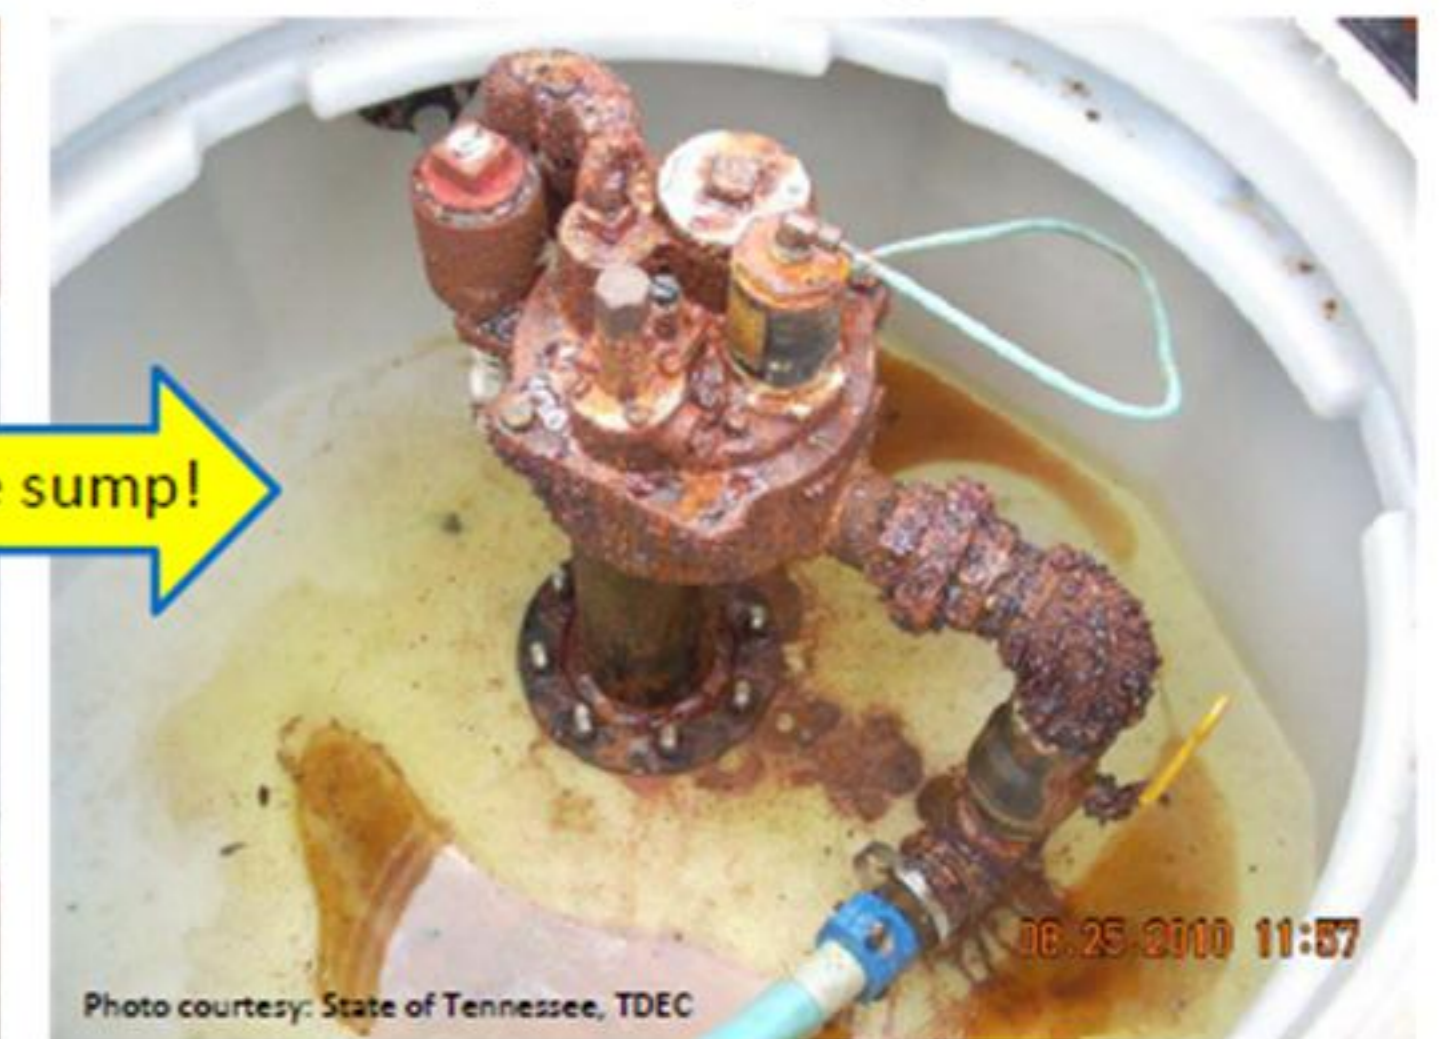
Premium/E10 STP (Tennessee) – August 2010

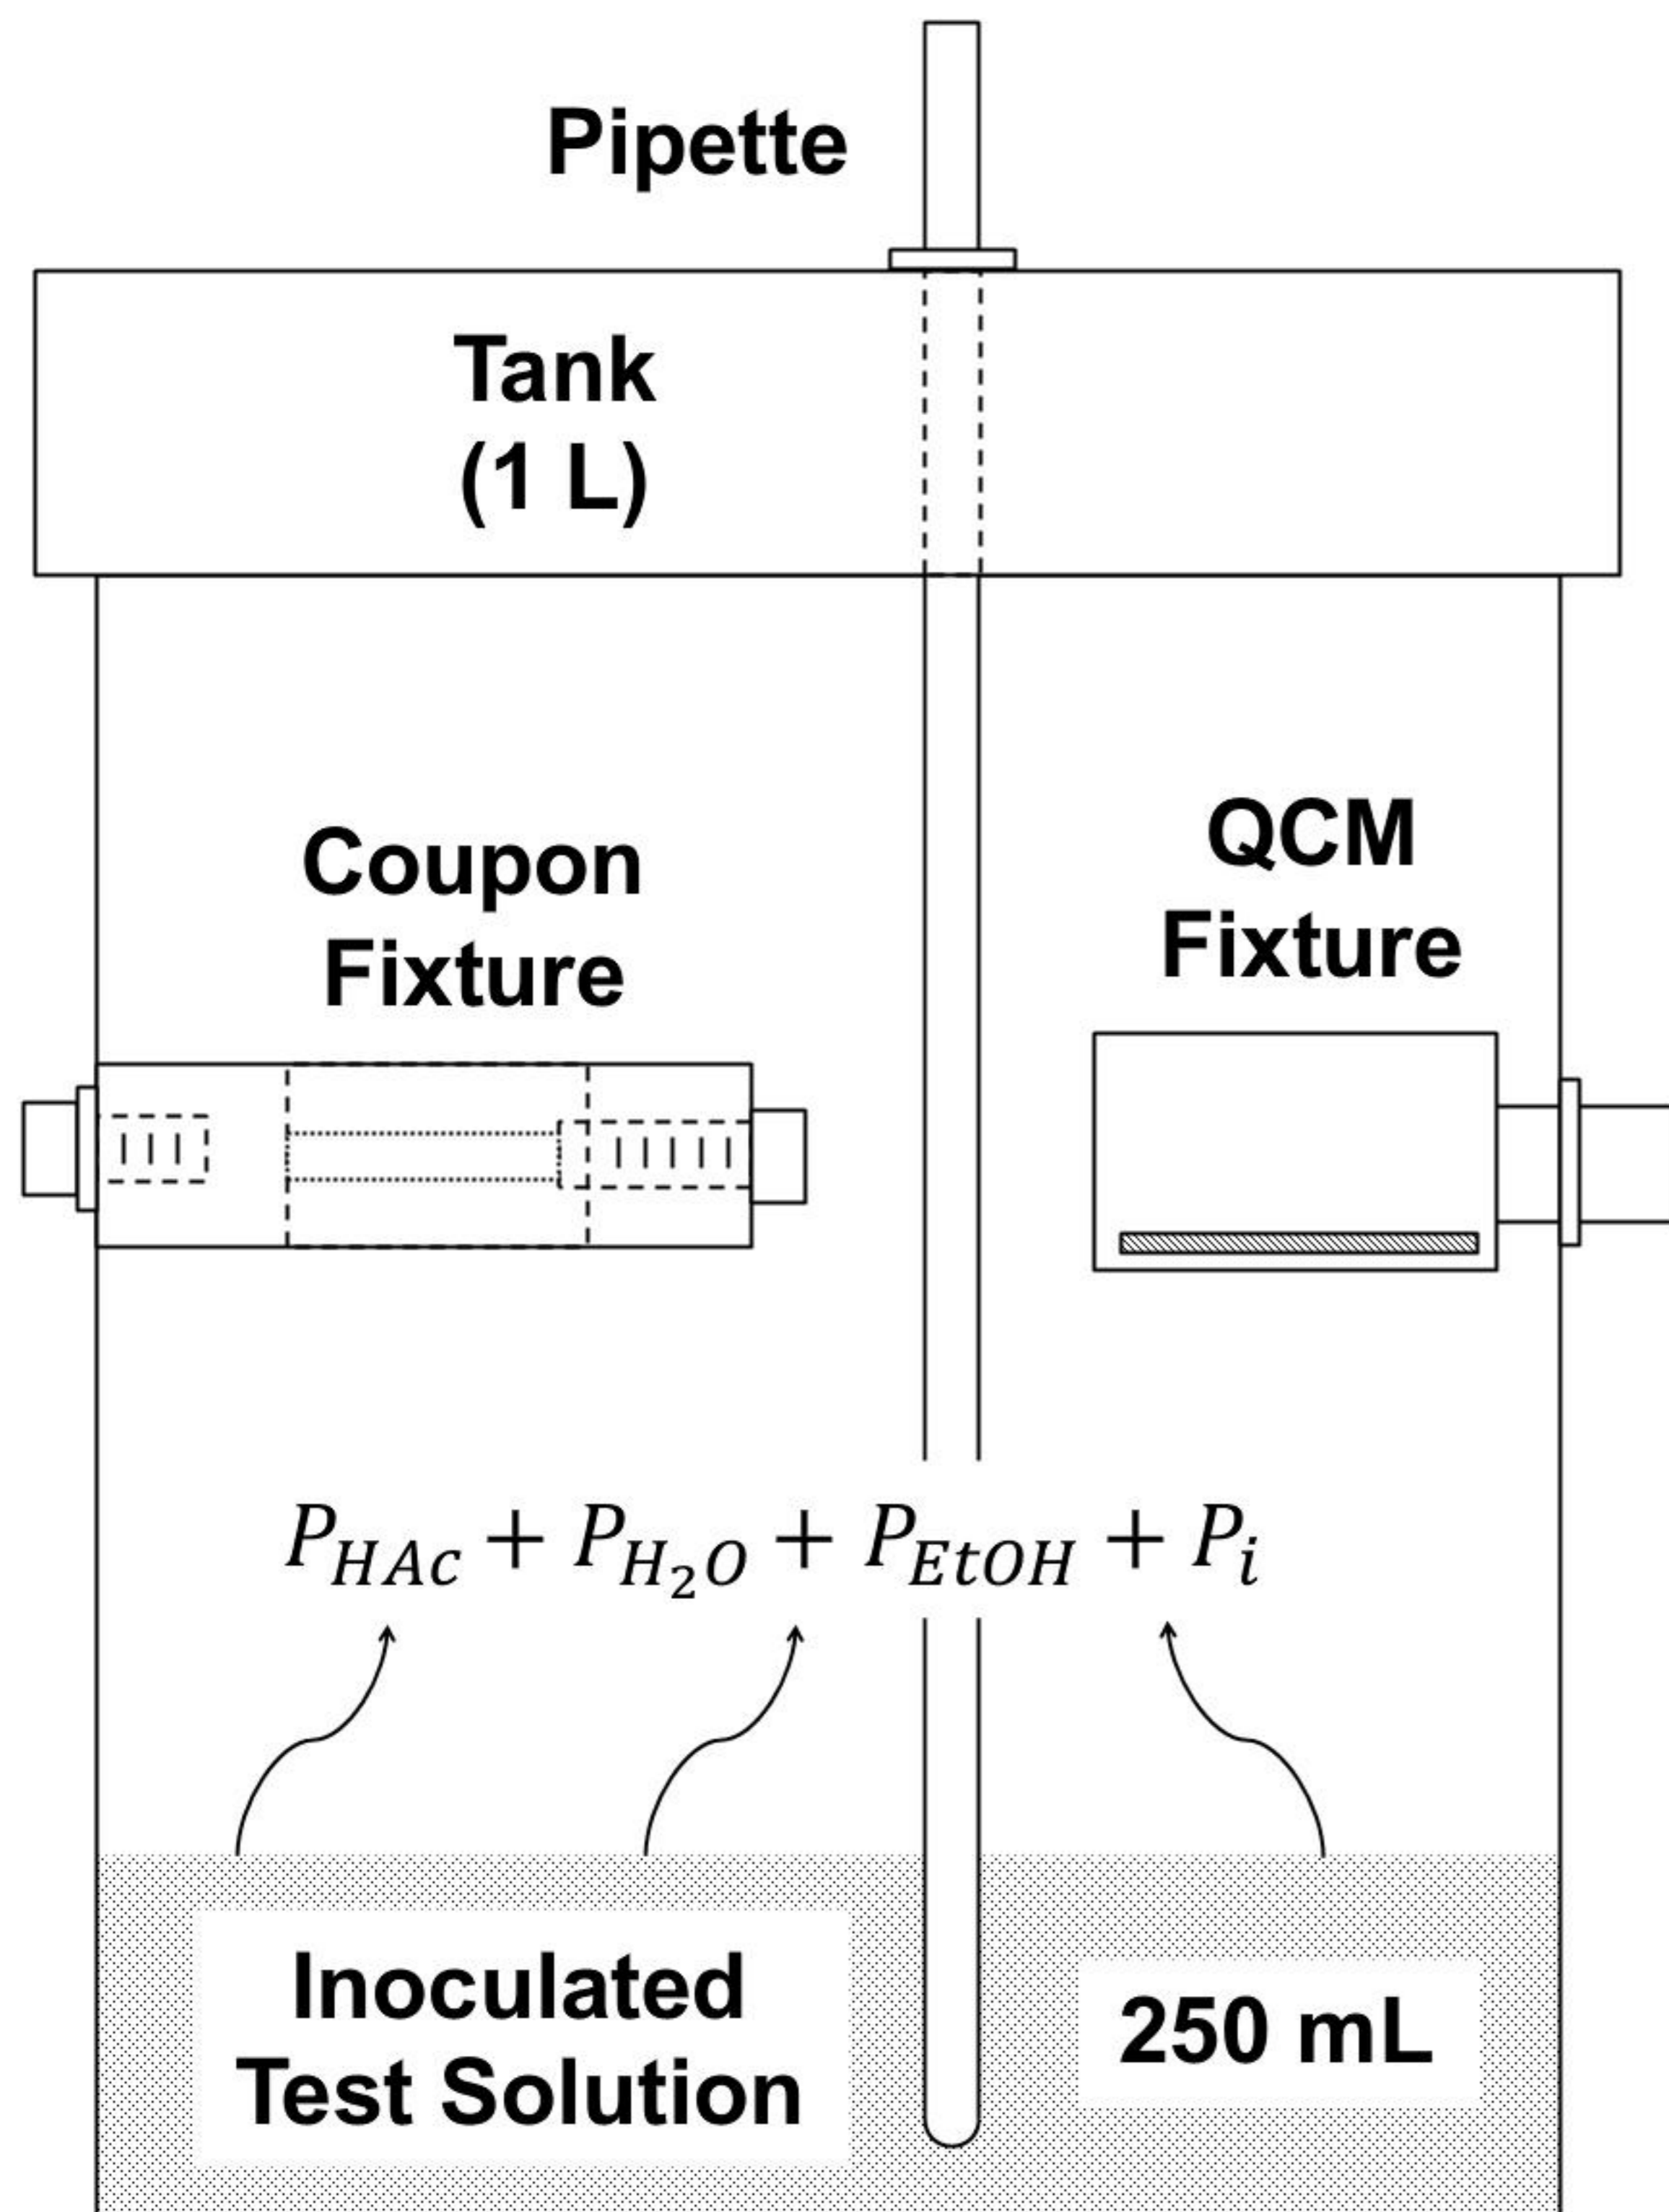
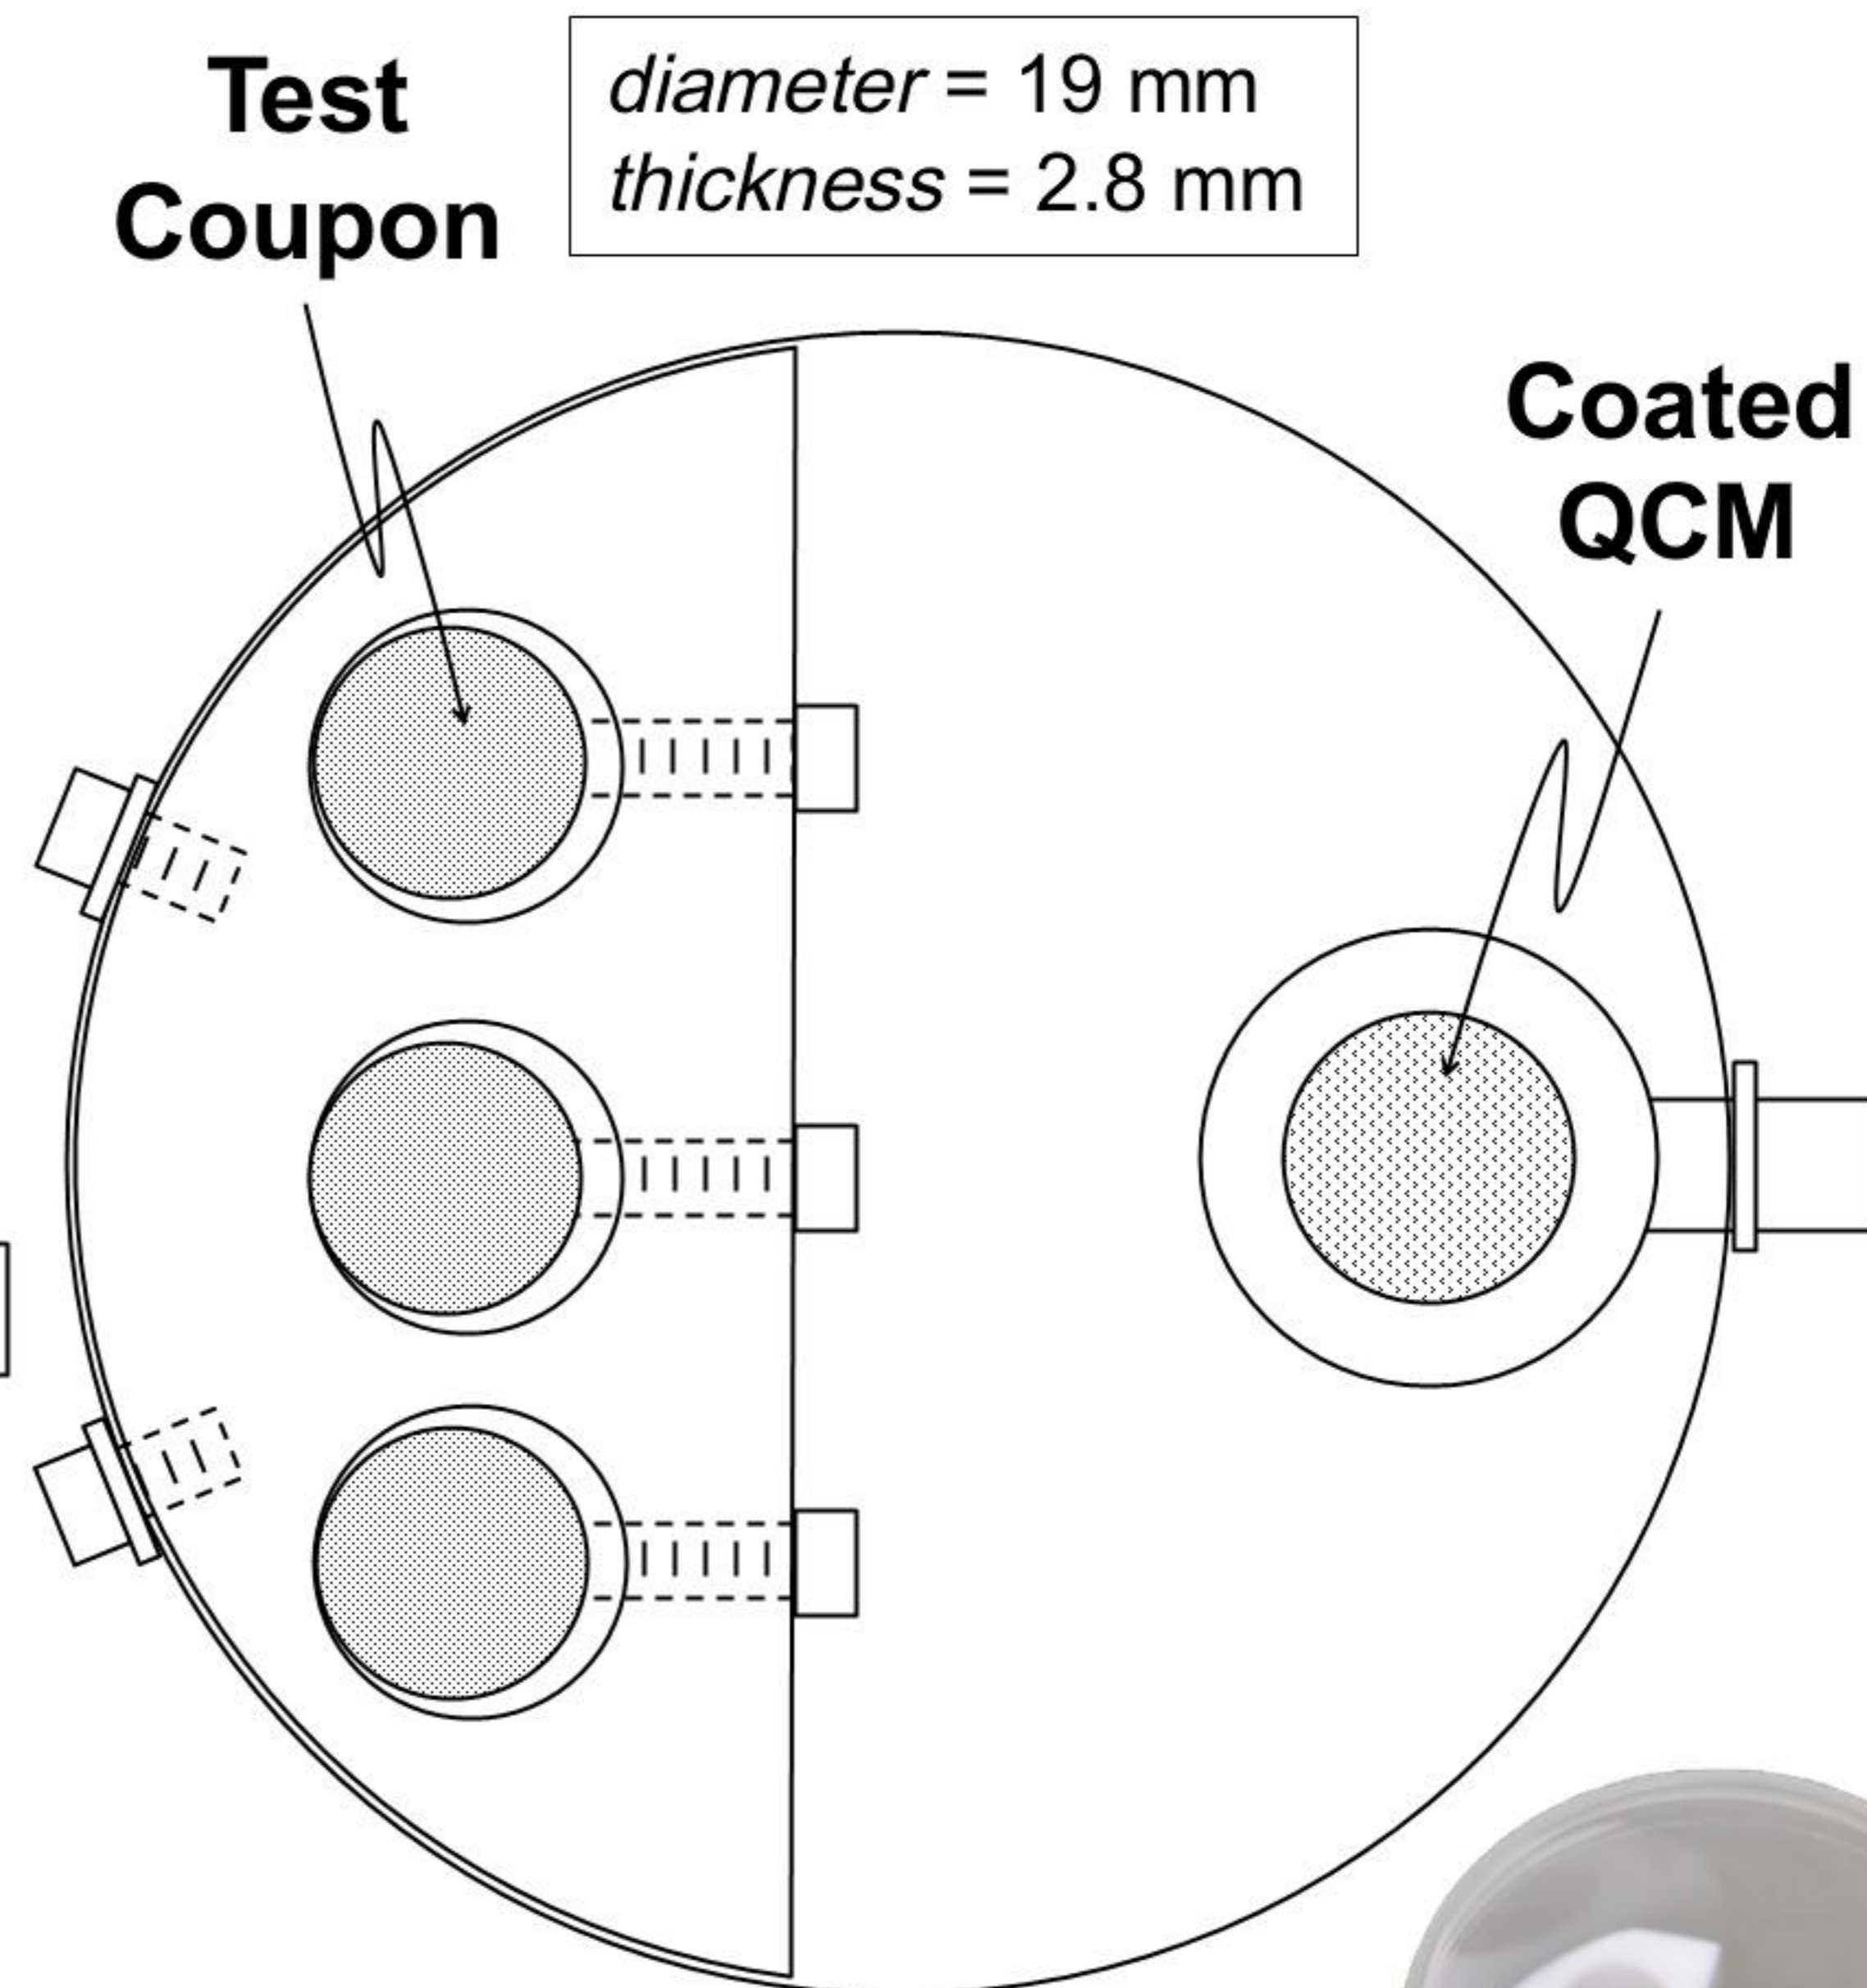
Headspace Corrosion Test Setup

Headspace Corrosion	Aqueous-Ethanol Immersion Corrosion
<ul style="list-style-type: none">• Inoculate 250 mL of Test Media with <i>Acetobacter sp.</i>• Expose metal coupons to the vapor phase only• Expose Fe and Cu quartz crystal microbalances (QCM) and monitor frequency shift (\propto mass change)	<ul style="list-style-type: none">• Inoculate 500 mL of Test Media with <i>Acetobacter sp.</i>• Fully immerse alloy coupons in the liquid phase Test Media
<ul style="list-style-type: none">• Pull coupons at regular intervals to investigate transient corrosion behavior• Maintain culture by periodic feeding with fresh Test Media• Monitor the solution acidity (pH meter) and solution absorbance with UV-Visible Spectroscopy:<ul style="list-style-type: none">• Absorbance$_{\lambda = 600 \text{ nm}} \propto$ bacteria cell count• Perform tests in triplicate

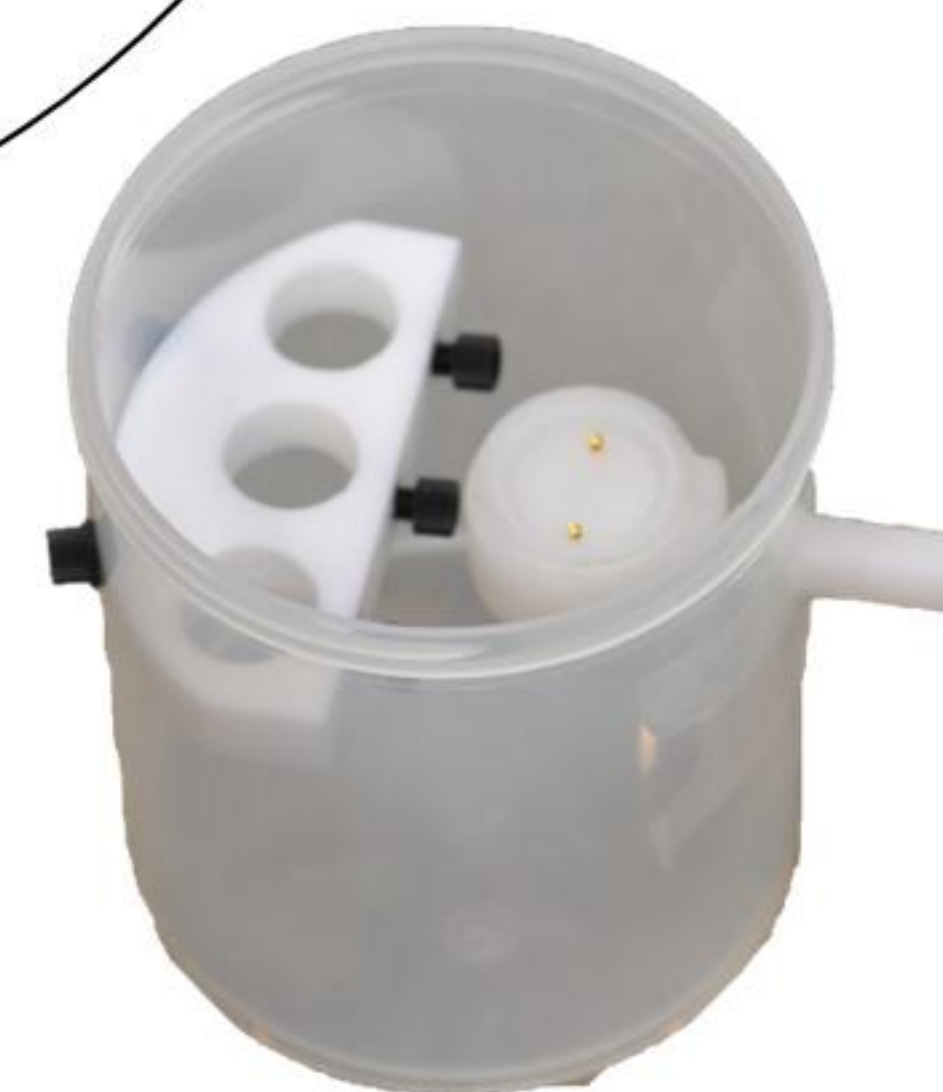
View looking UP
from Tank Bottom

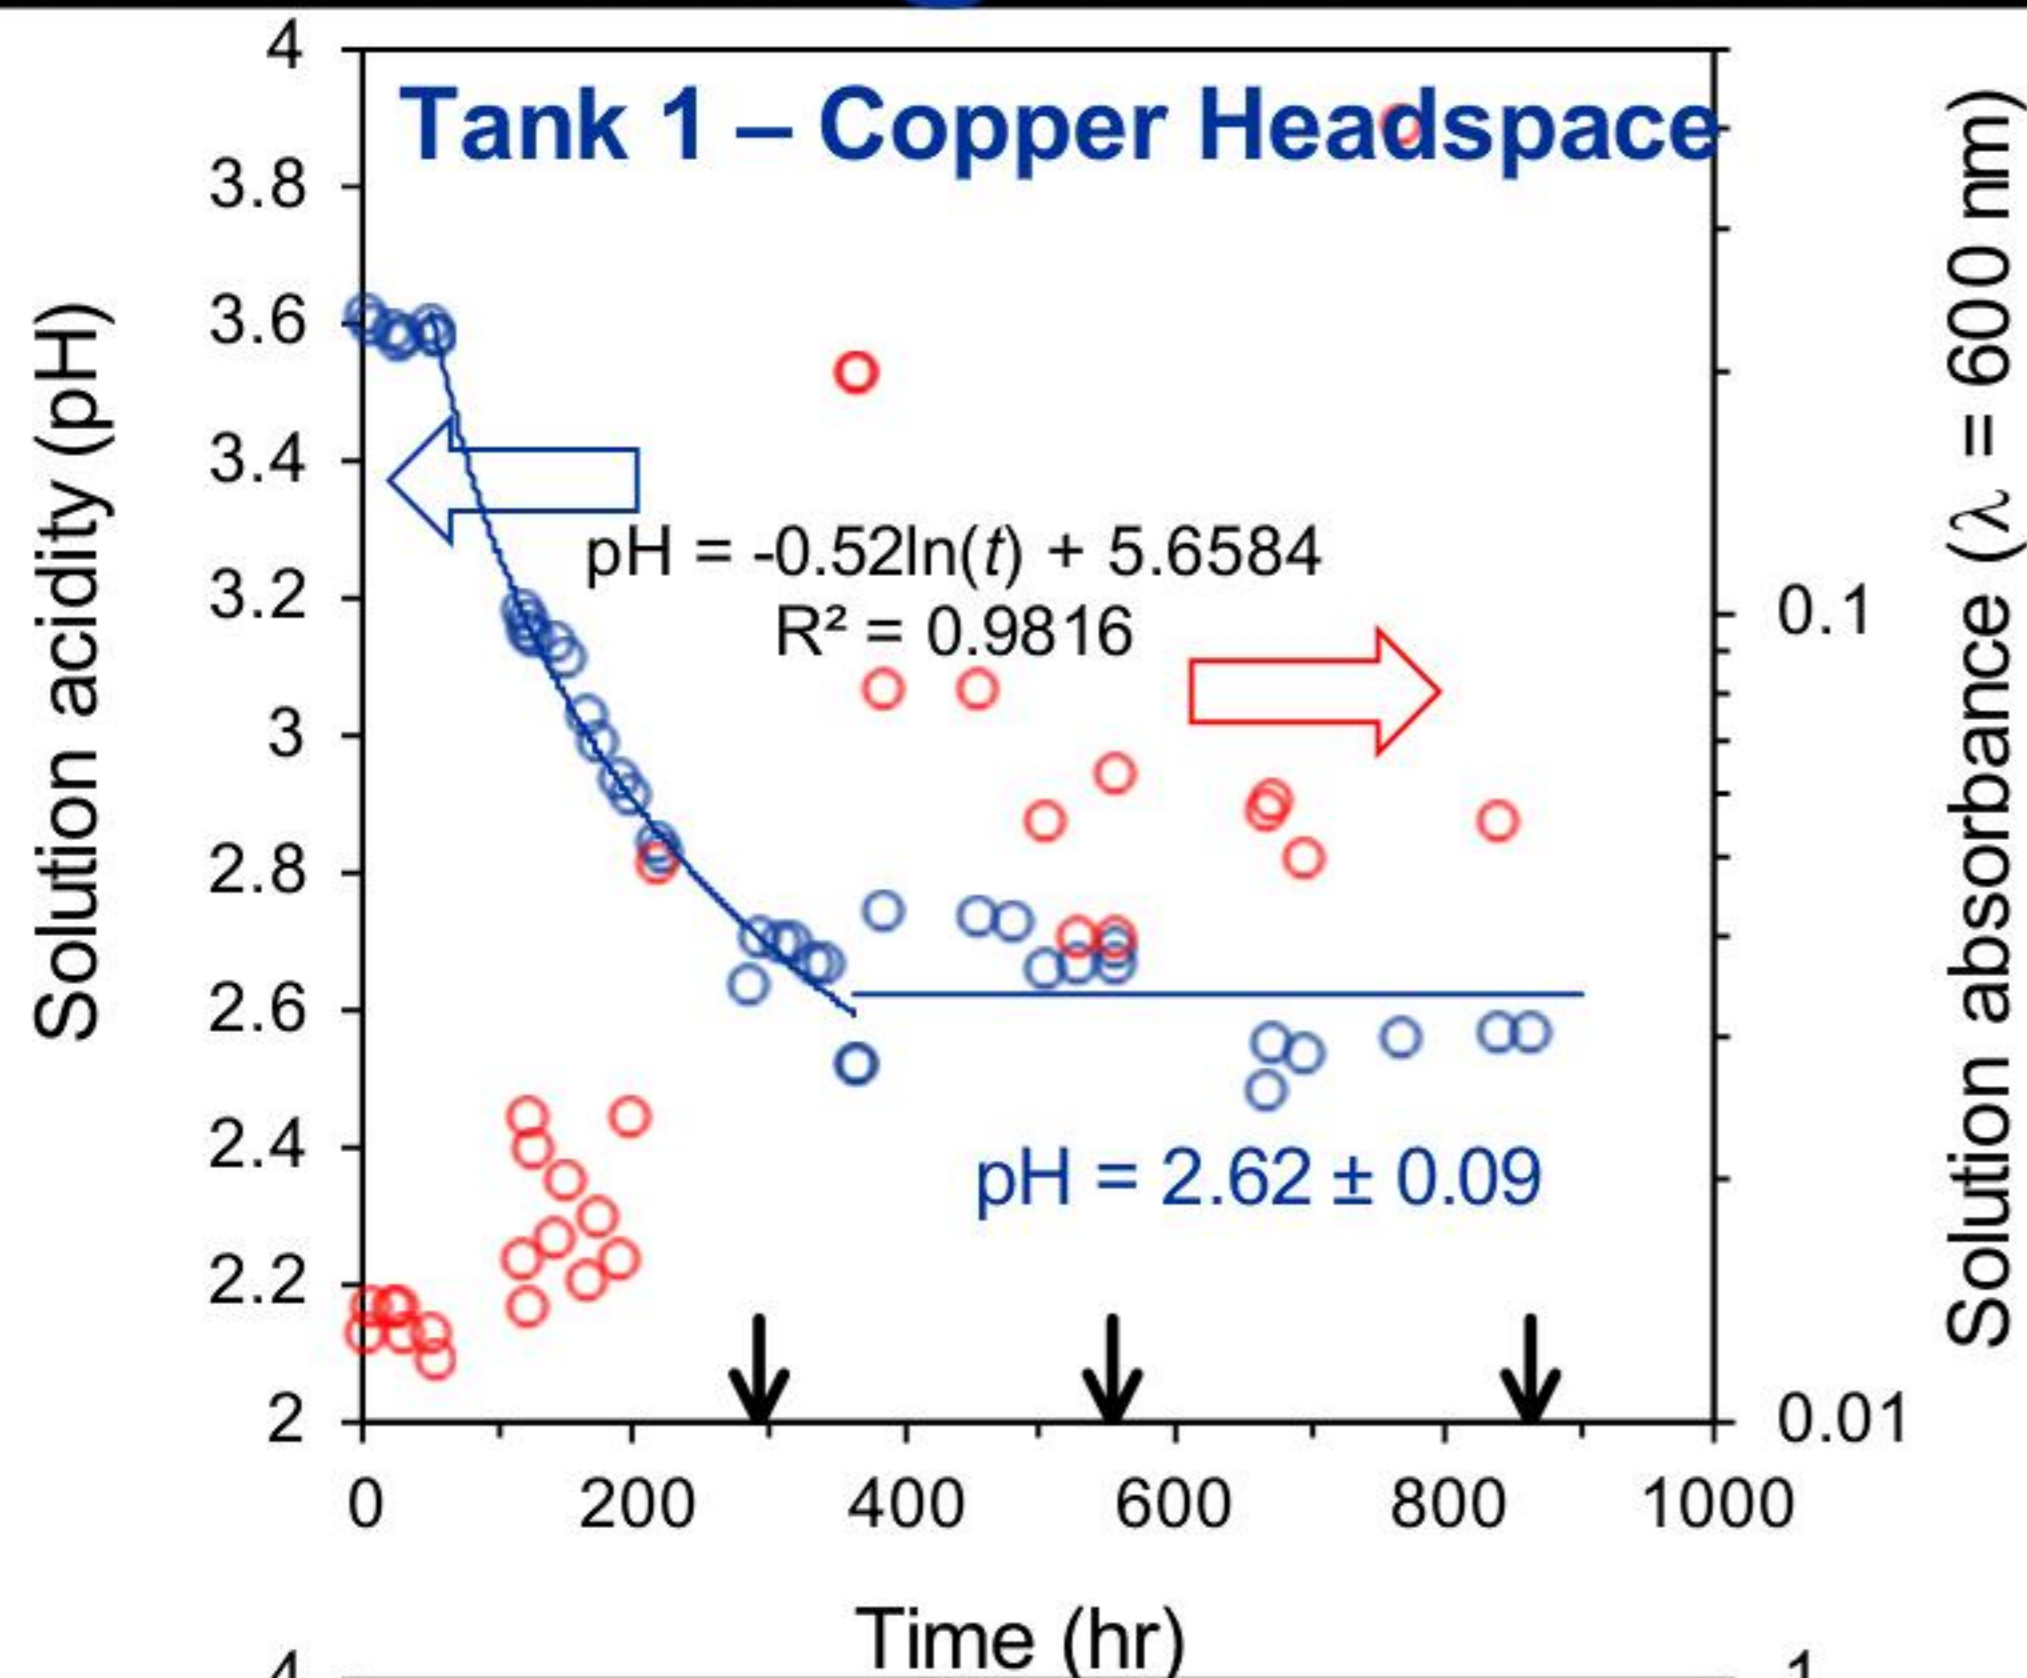
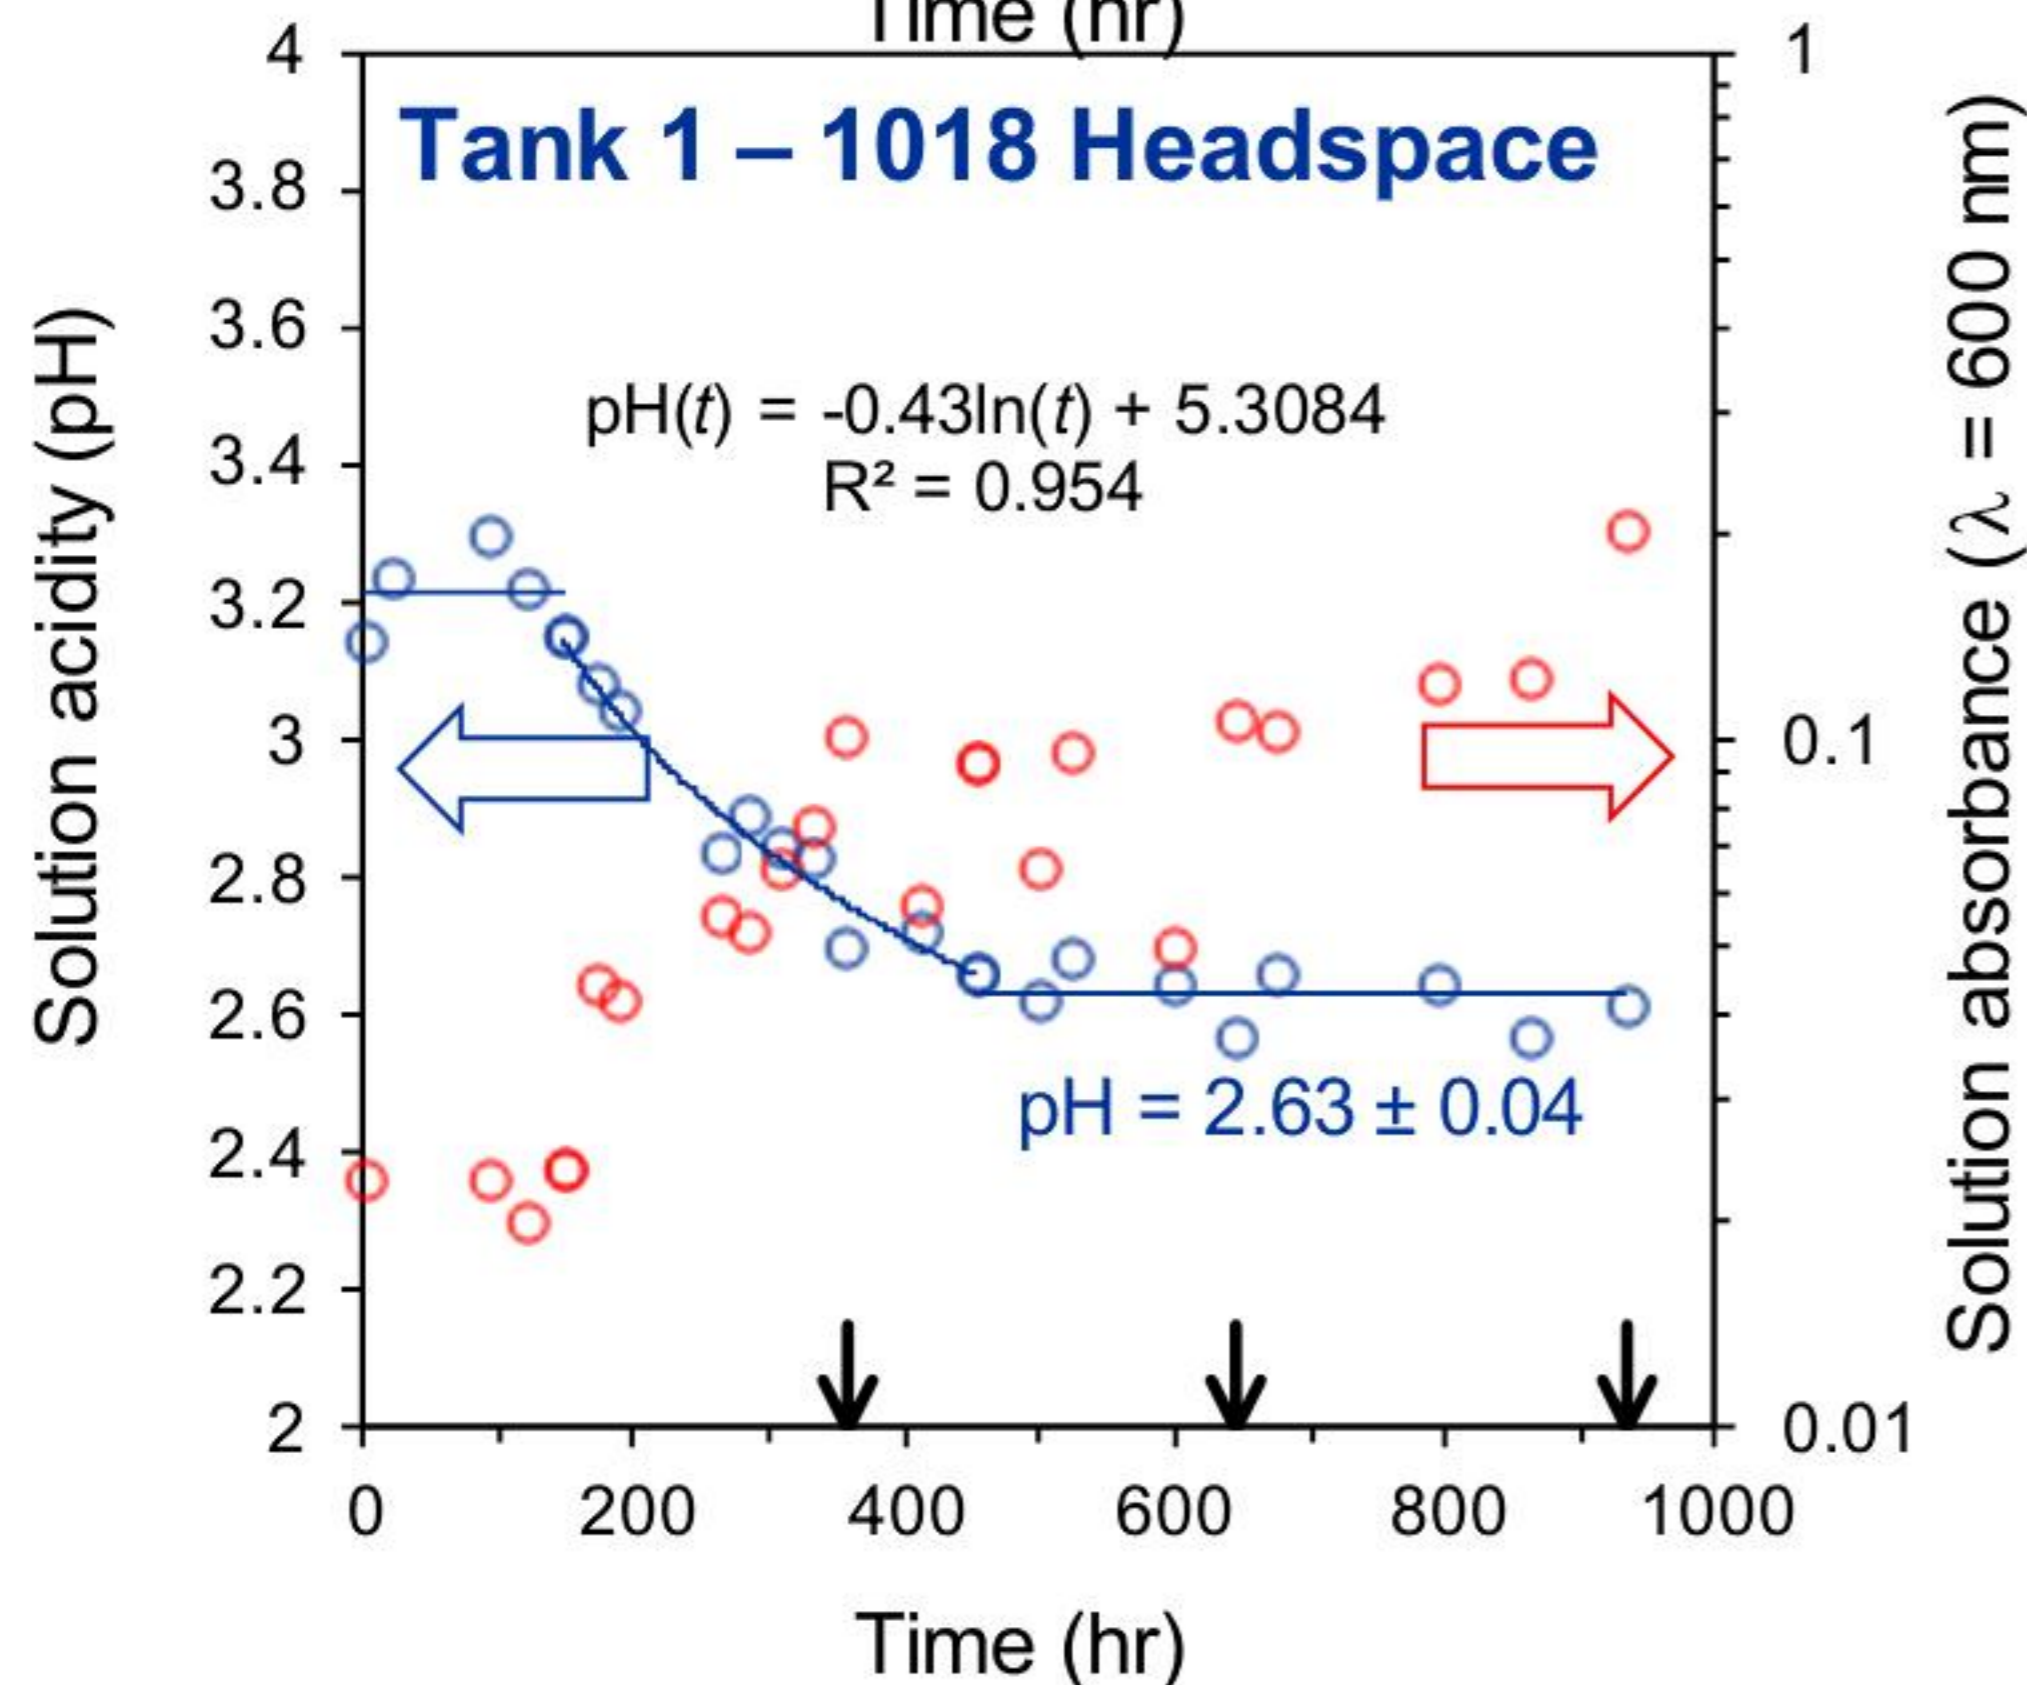
Measuring Bacteria Kinetics

Liquid samples were collected from the tank bottoms daily and acidity and *Acetobacter* cell density were measured.

- The tanks produced repeatable bacteria behavior in copper and steel corrosion tests.
- The initial pH was slightly higher in the copper tests; however, both series of tests decayed to similar pH levels in the solution.
