Corrosion of Copper and Steel Alloys in the Presence of *Acetobacter* sp. in a Simulated UST Sump Environment

Jeffrey Sowards & Elisabeth Mansfield

Applied Chemicals and Materials Division, NIST – Boulder, CO

Problem: Rapid UST Corrosion

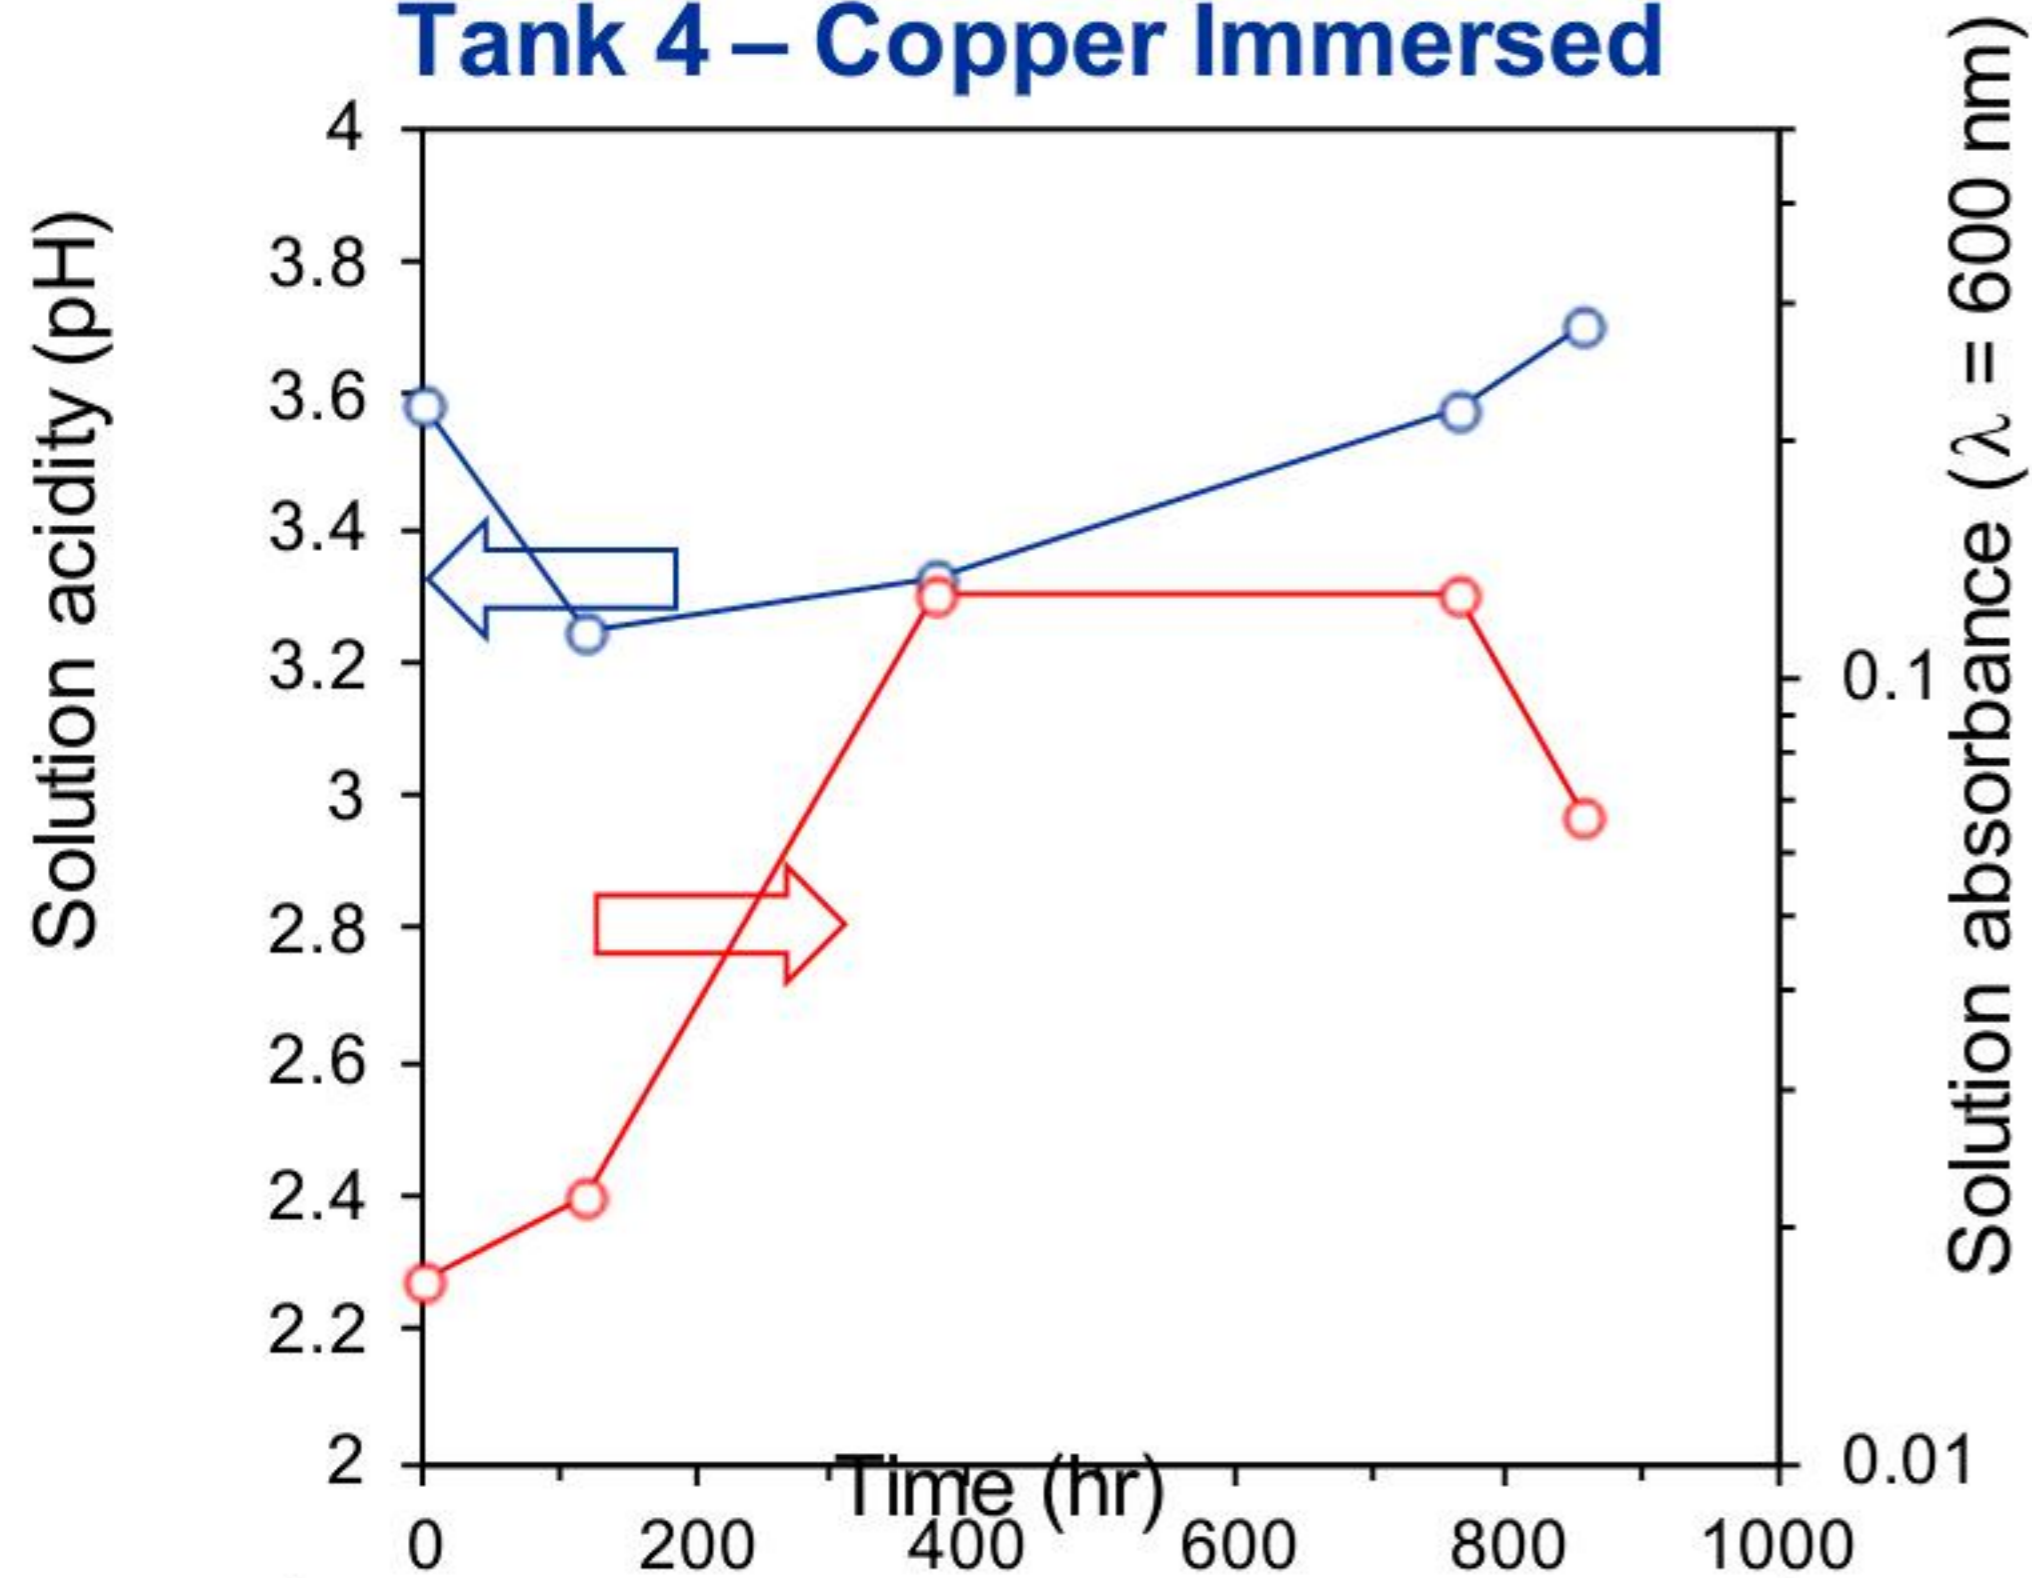
Tank 4 – Copper Immersed

Liquid samples were collected from the tank bottoms and acidity and *Acetobacter* cell density were measured.

- When copper coupons were immersed in the test solution, the pH increased over time and bacteria tended to clump in an unusual morphology. Copper has some antimicrobial properties.
- When steel coupons were immersed, the bacteria kinetics were similar to the headspace tests.

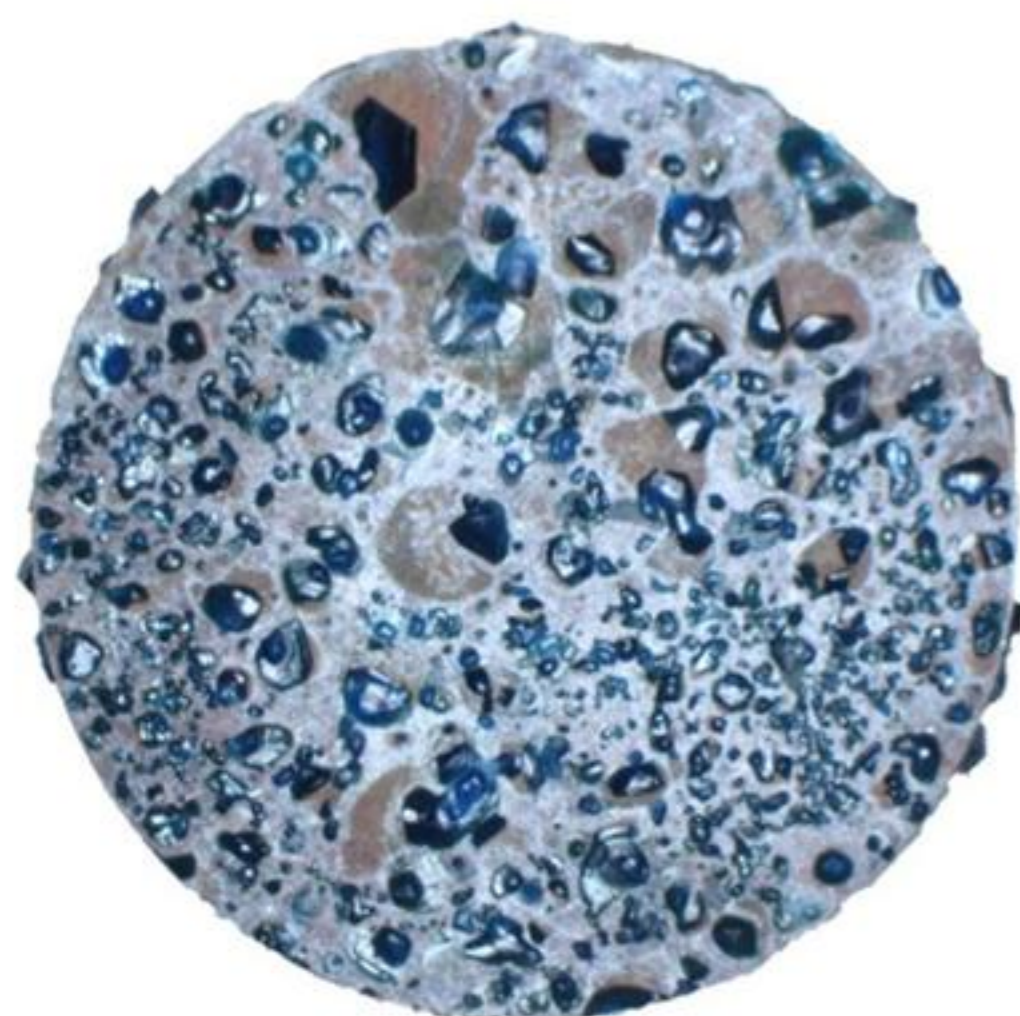
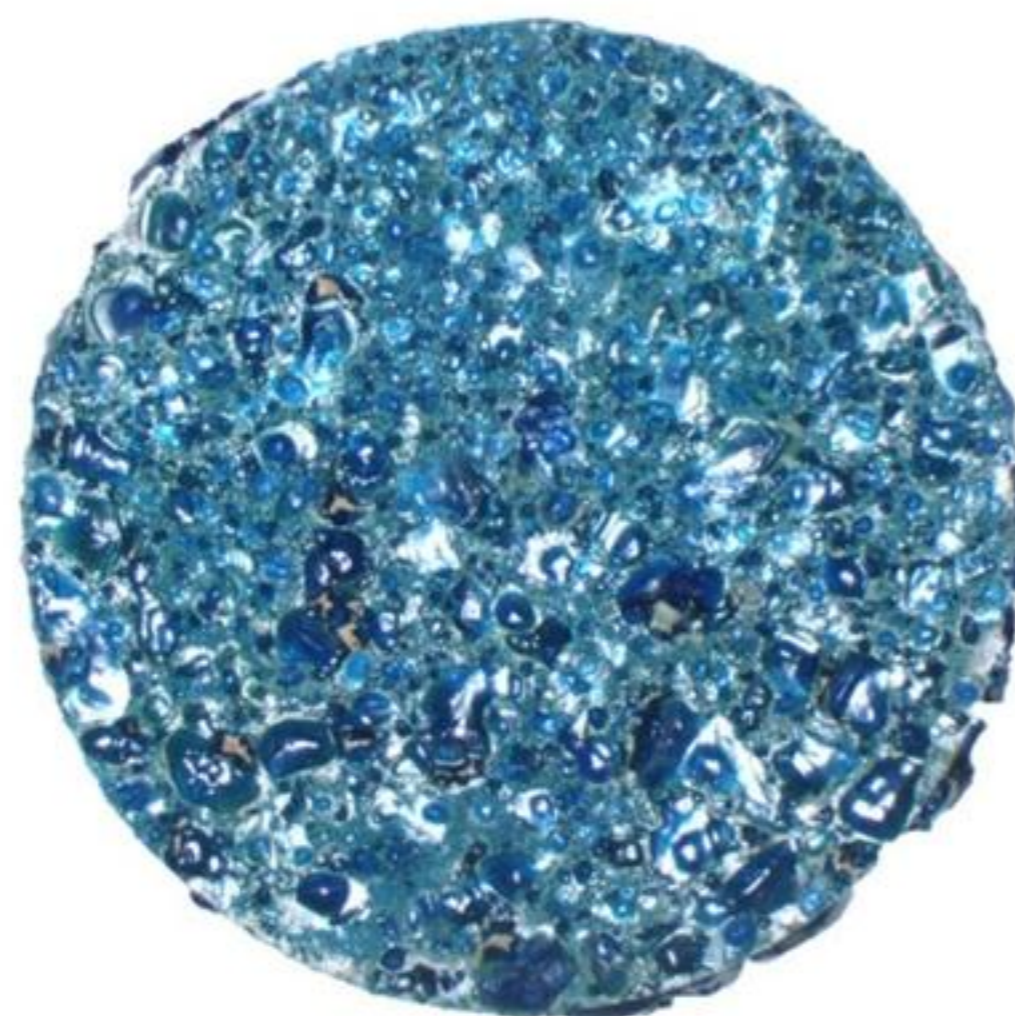
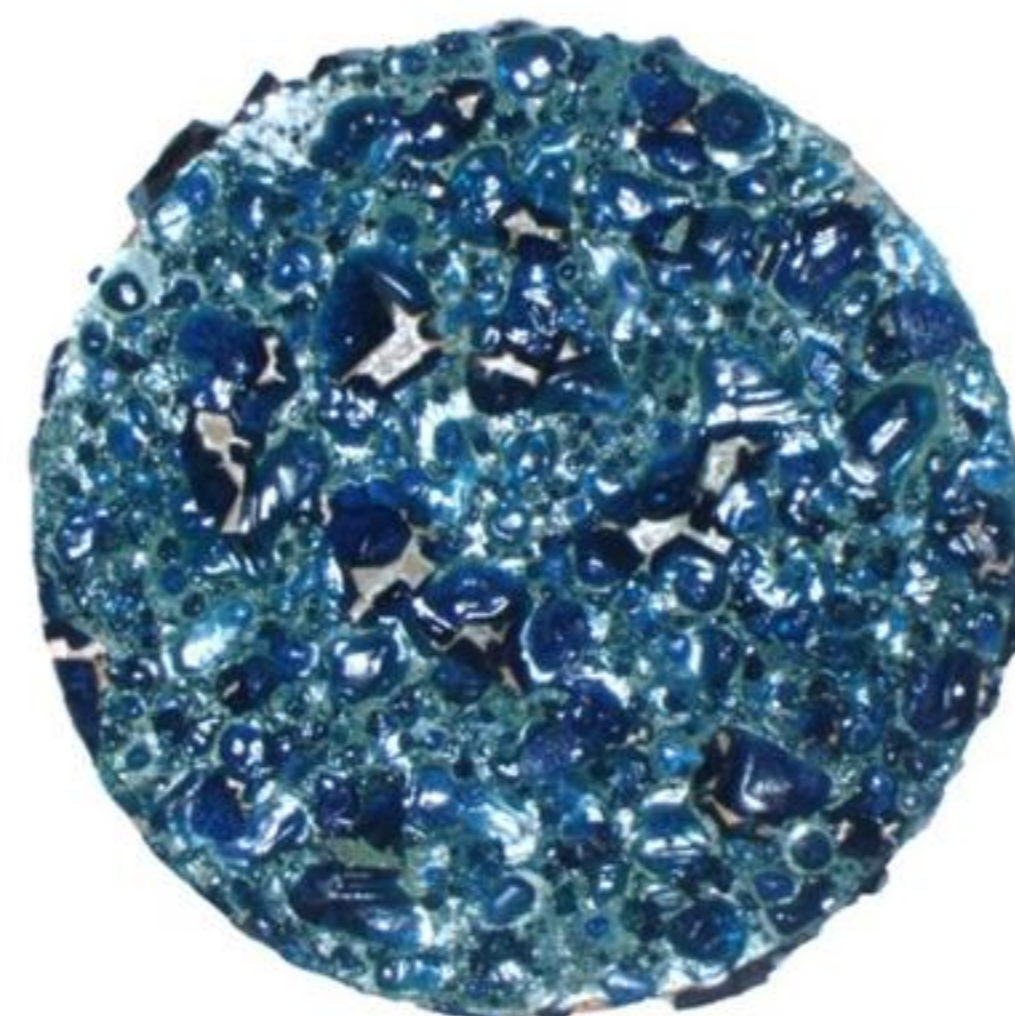
Copper Corrosion After Headspace Exposure

292 hr

550 hr

863 hr

X-Ray Diffraction (XRD) was used to identify corrosion products:

- Copper acetate dihydrate
- Copper hydroxide acetate
- Cuprite

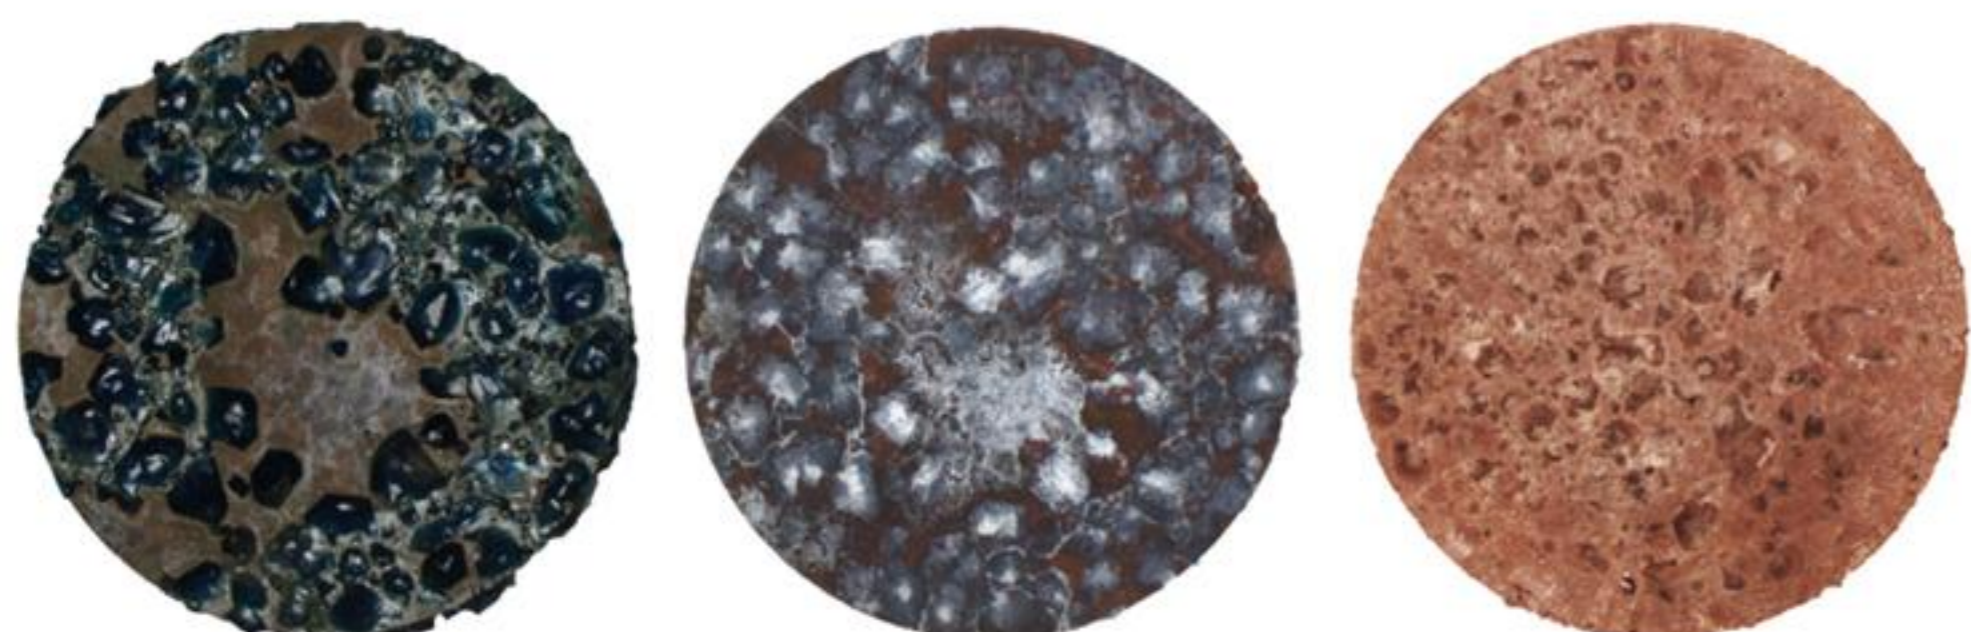
As-tested condition
removed from Tank 2

Sonicated for 3 minutes
in Deionized Water

Brushed for 4 minutes
in HCl/H₂O Solution

- Blue crystals are removed with sonication
- Silver-colored corrosion product is more tenacious, and is removed mechanically and chemically by brushing in HCl/H₂O Solution

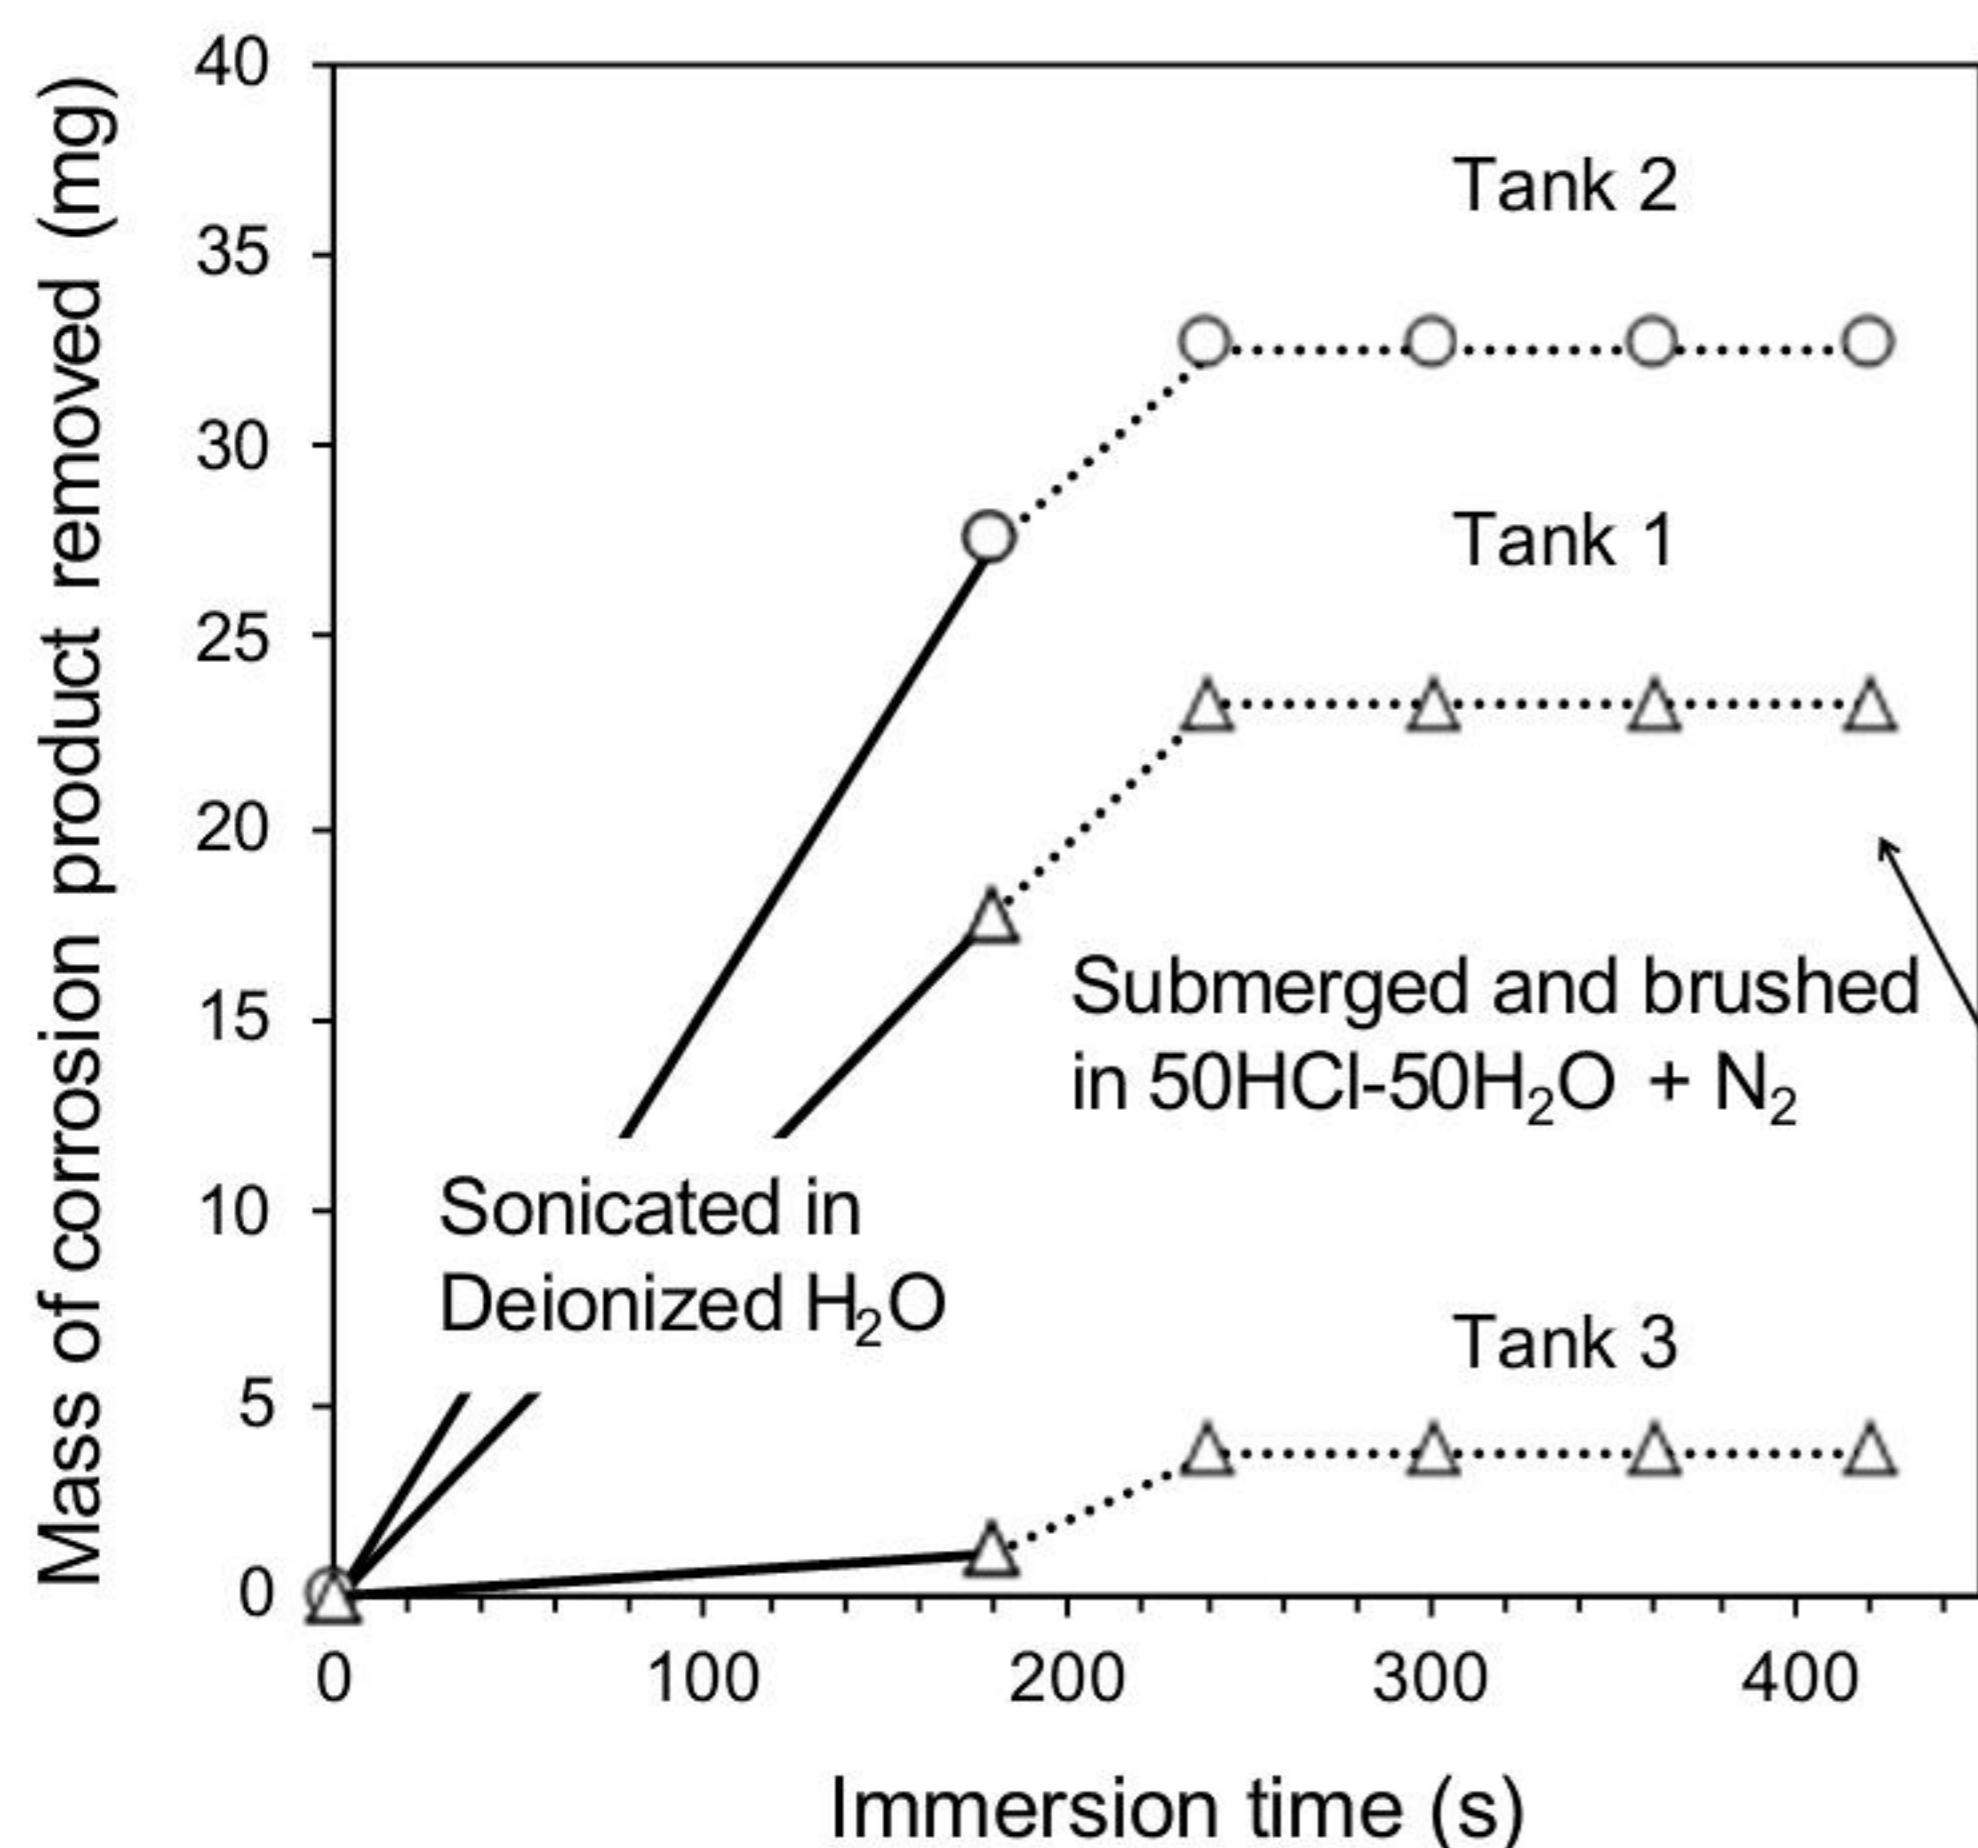
Removal of corrosion product reveals extensive pitting corrosion underneath the corrosion product.

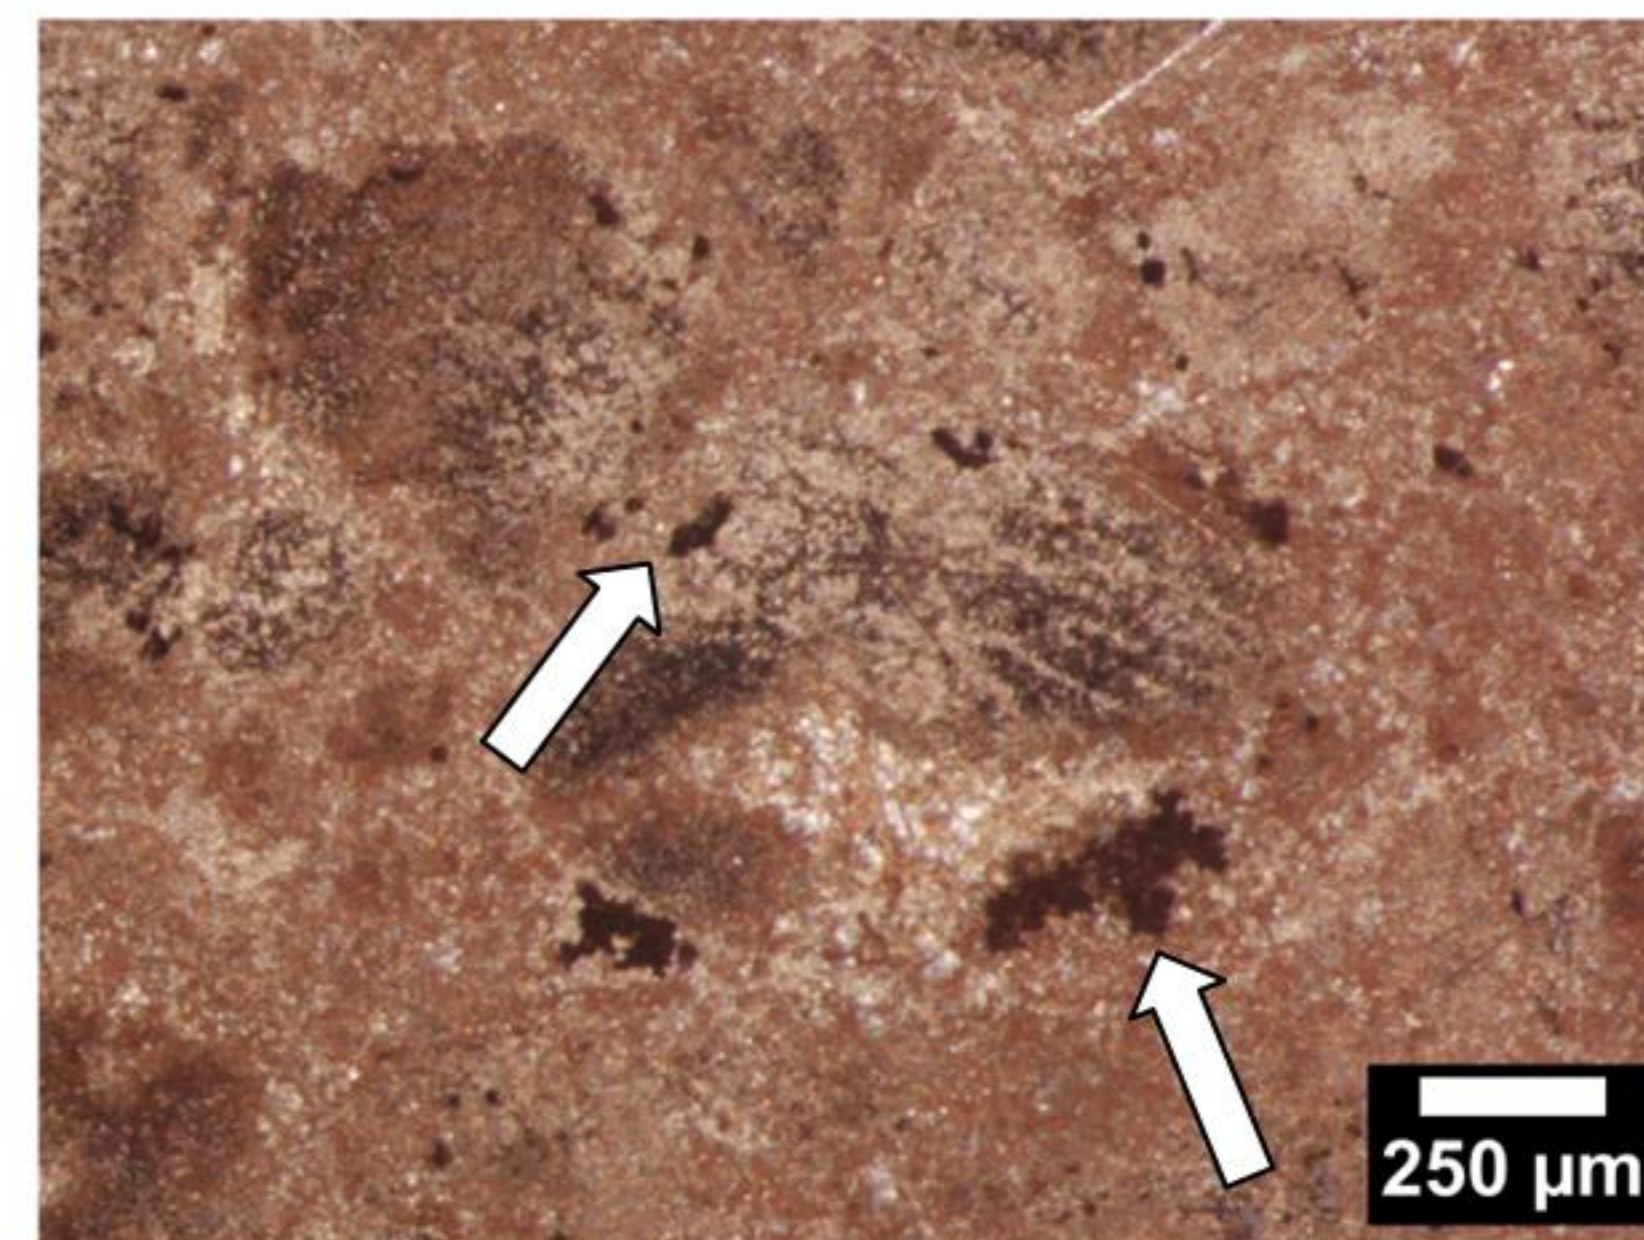
The cleaning process removes the corrosion product but does not corrode the underlying metal.

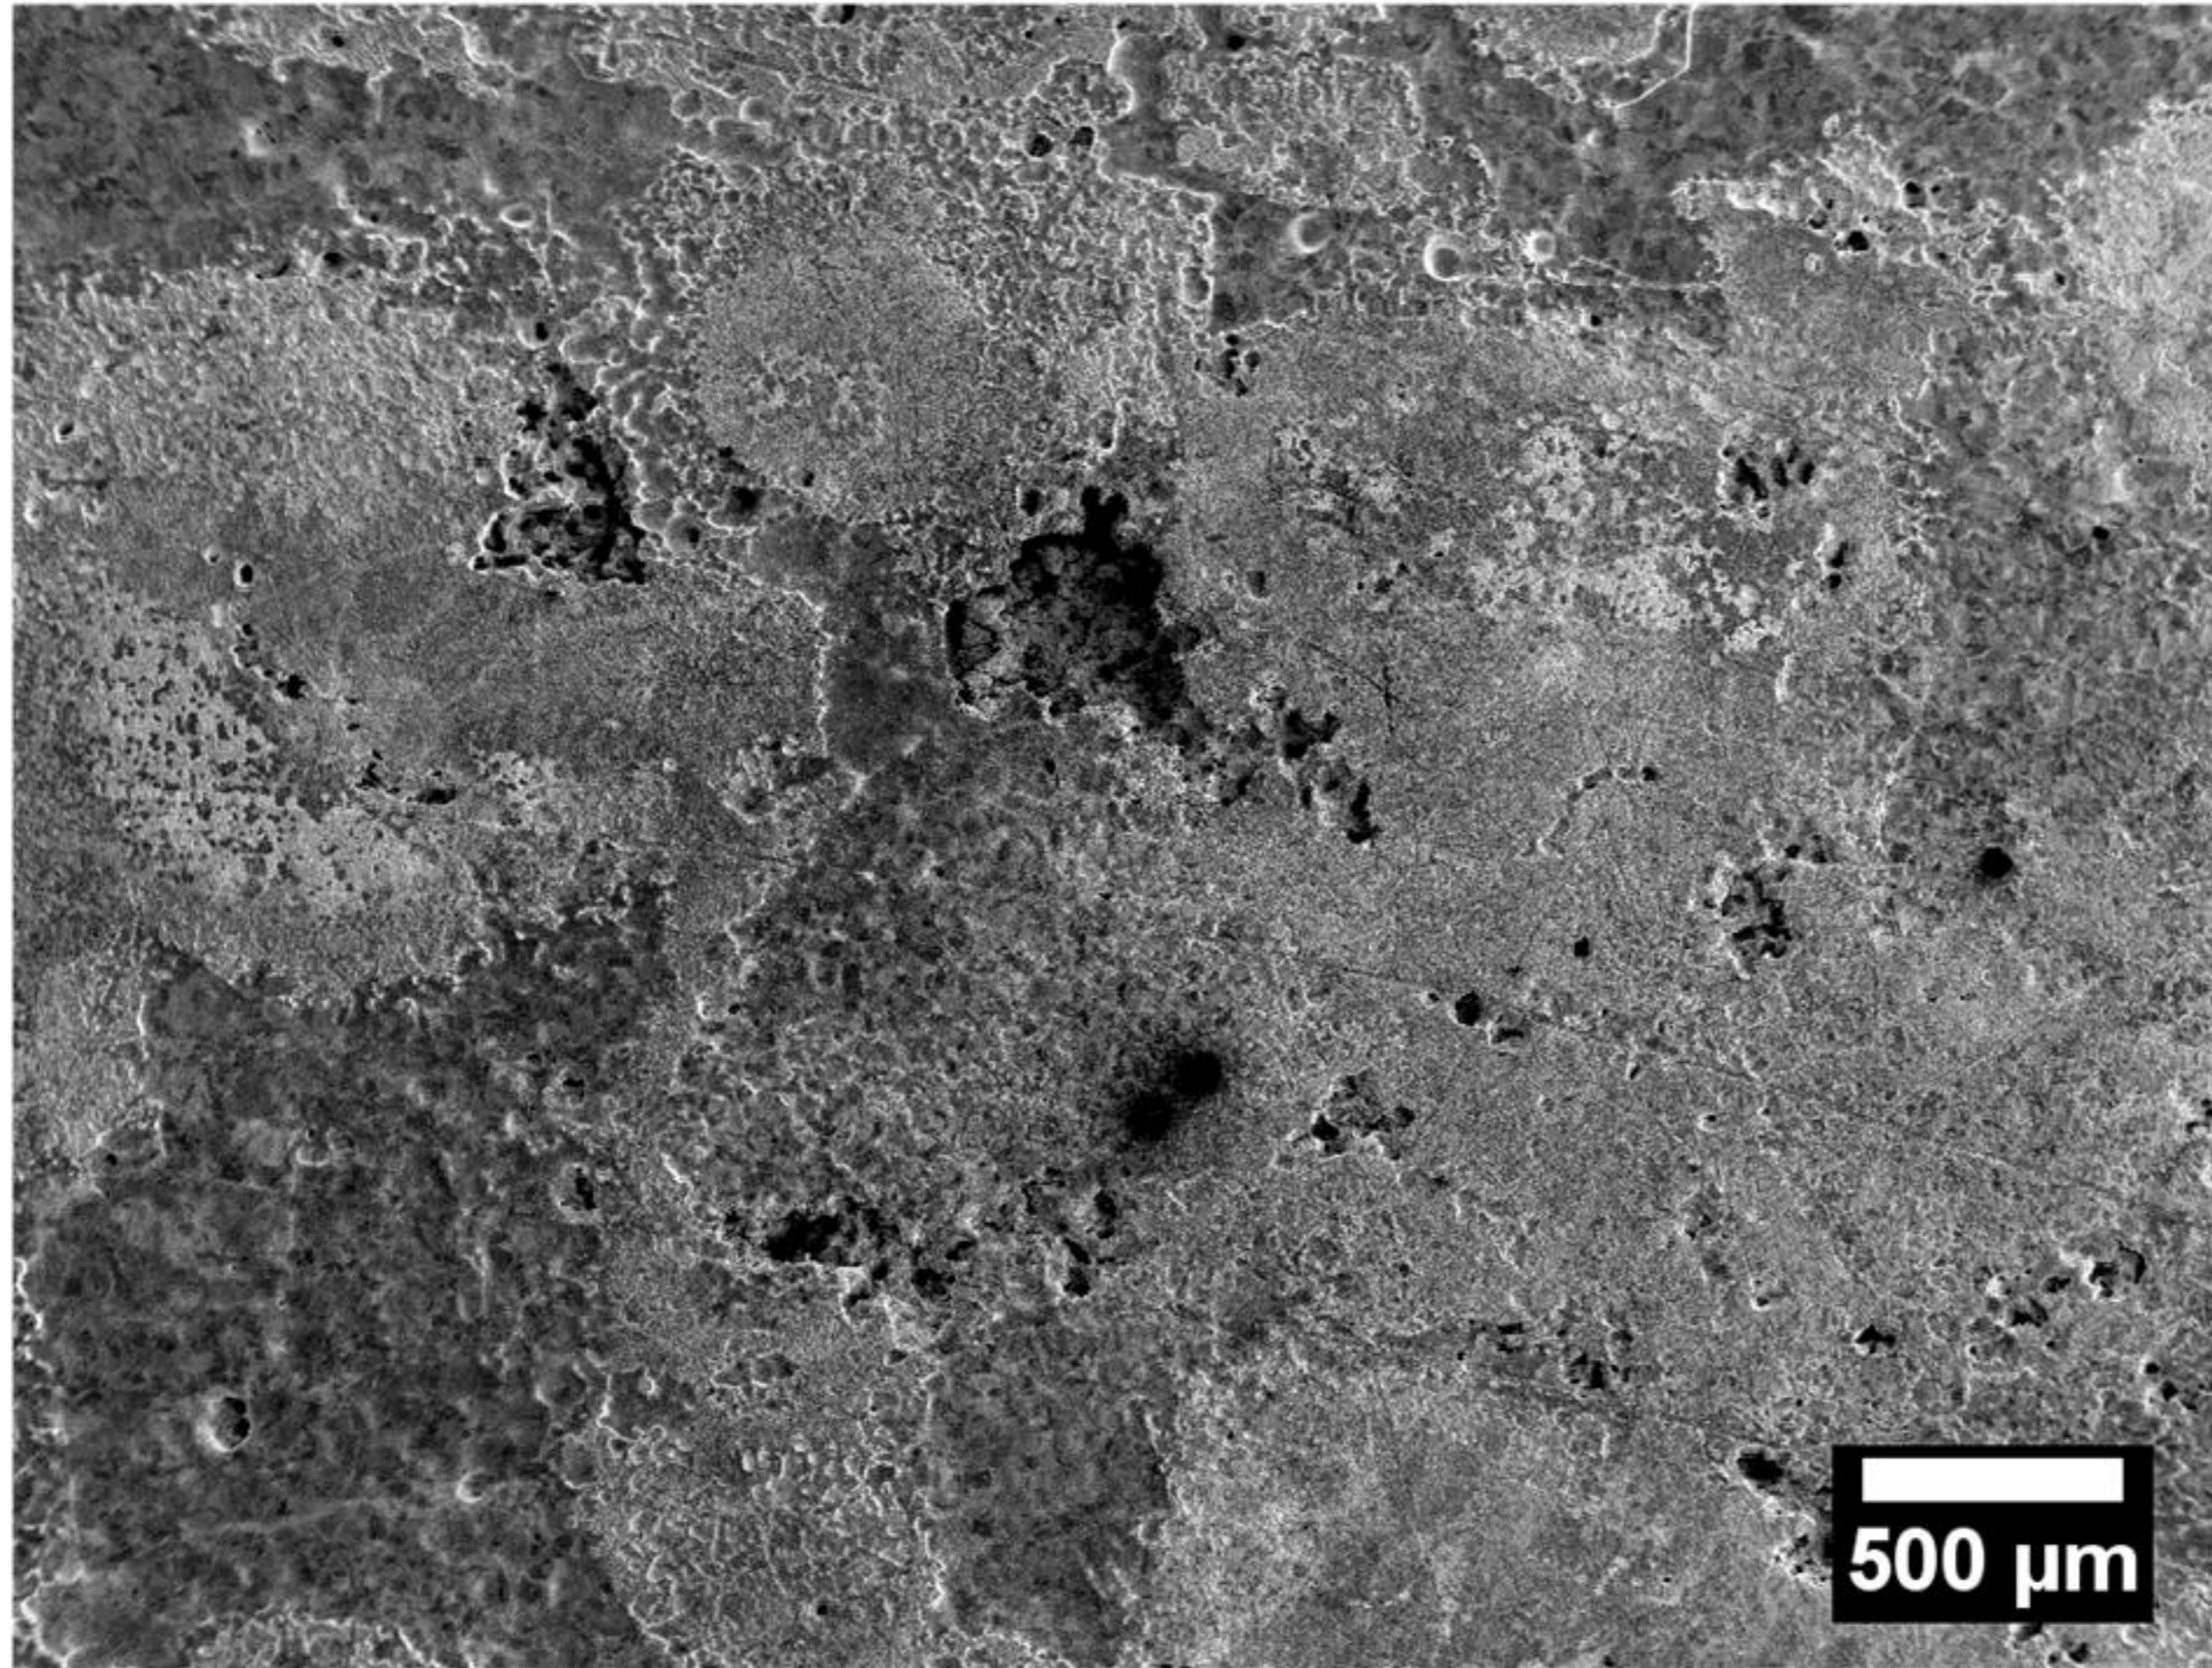
Headspace Corrosion Morphology NIST

Removal of copper acetate revealed that general corrosion and pitting corrosion occurred under the crystals.

Small pits coalesced into larger pits with a wide, shallow appearance.

Pit Depth: Pit Width \approx 1:2

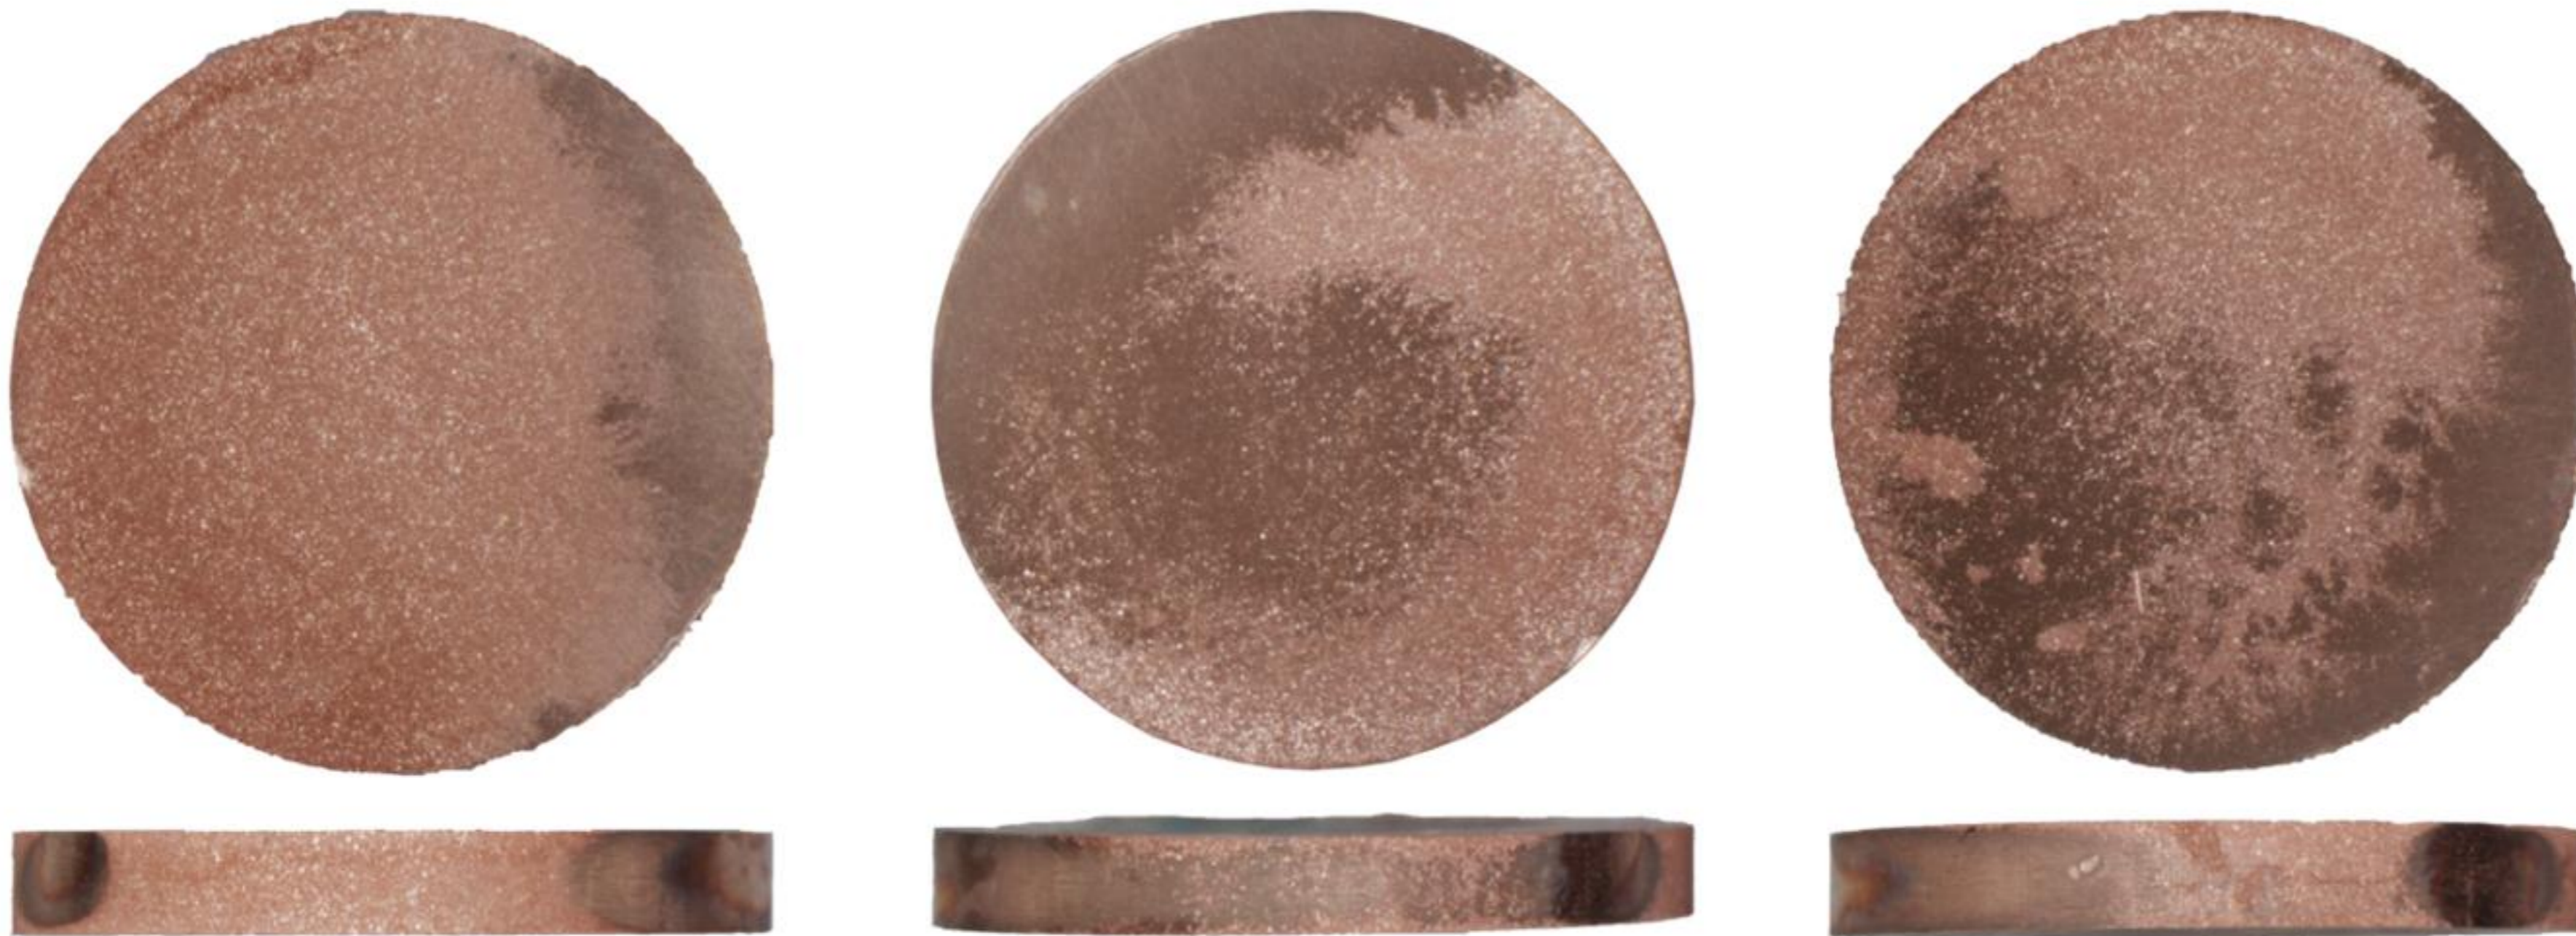
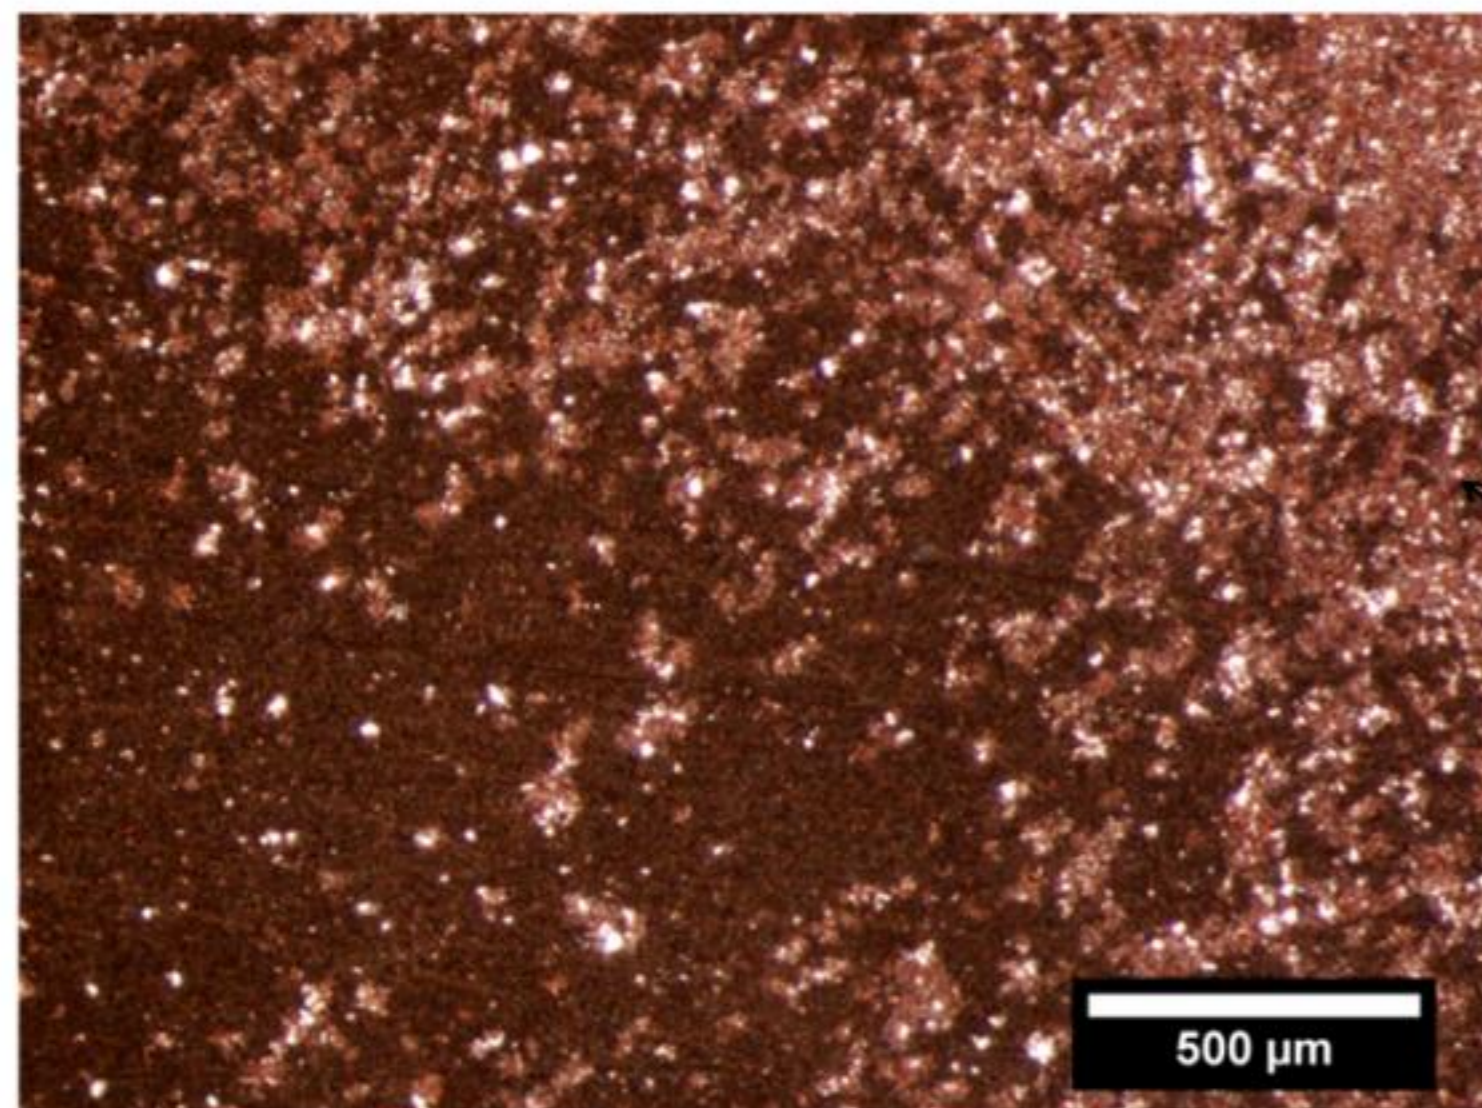
Copper Corrosion After Immersion

Surface Pitting

Corrosion was not as extensive on the immersion coupons as compared to the headspace coupons. Pit morphology exhibited a shallow and coalesced appearance. The test solution notably turned a blue color during testing, indicating the presence of dissolved copper acetate.
