Corrosion of Copper and Steel Alloys in the Presence of *Acetobacter* sp. in a Simulated UST Sump Environment

Jeffrey Sowards & Elisabeth Mansfield

Applied Chemicals and Materials Division, NIST – Boulder, CO

Problem: Rapid UST Corrosion

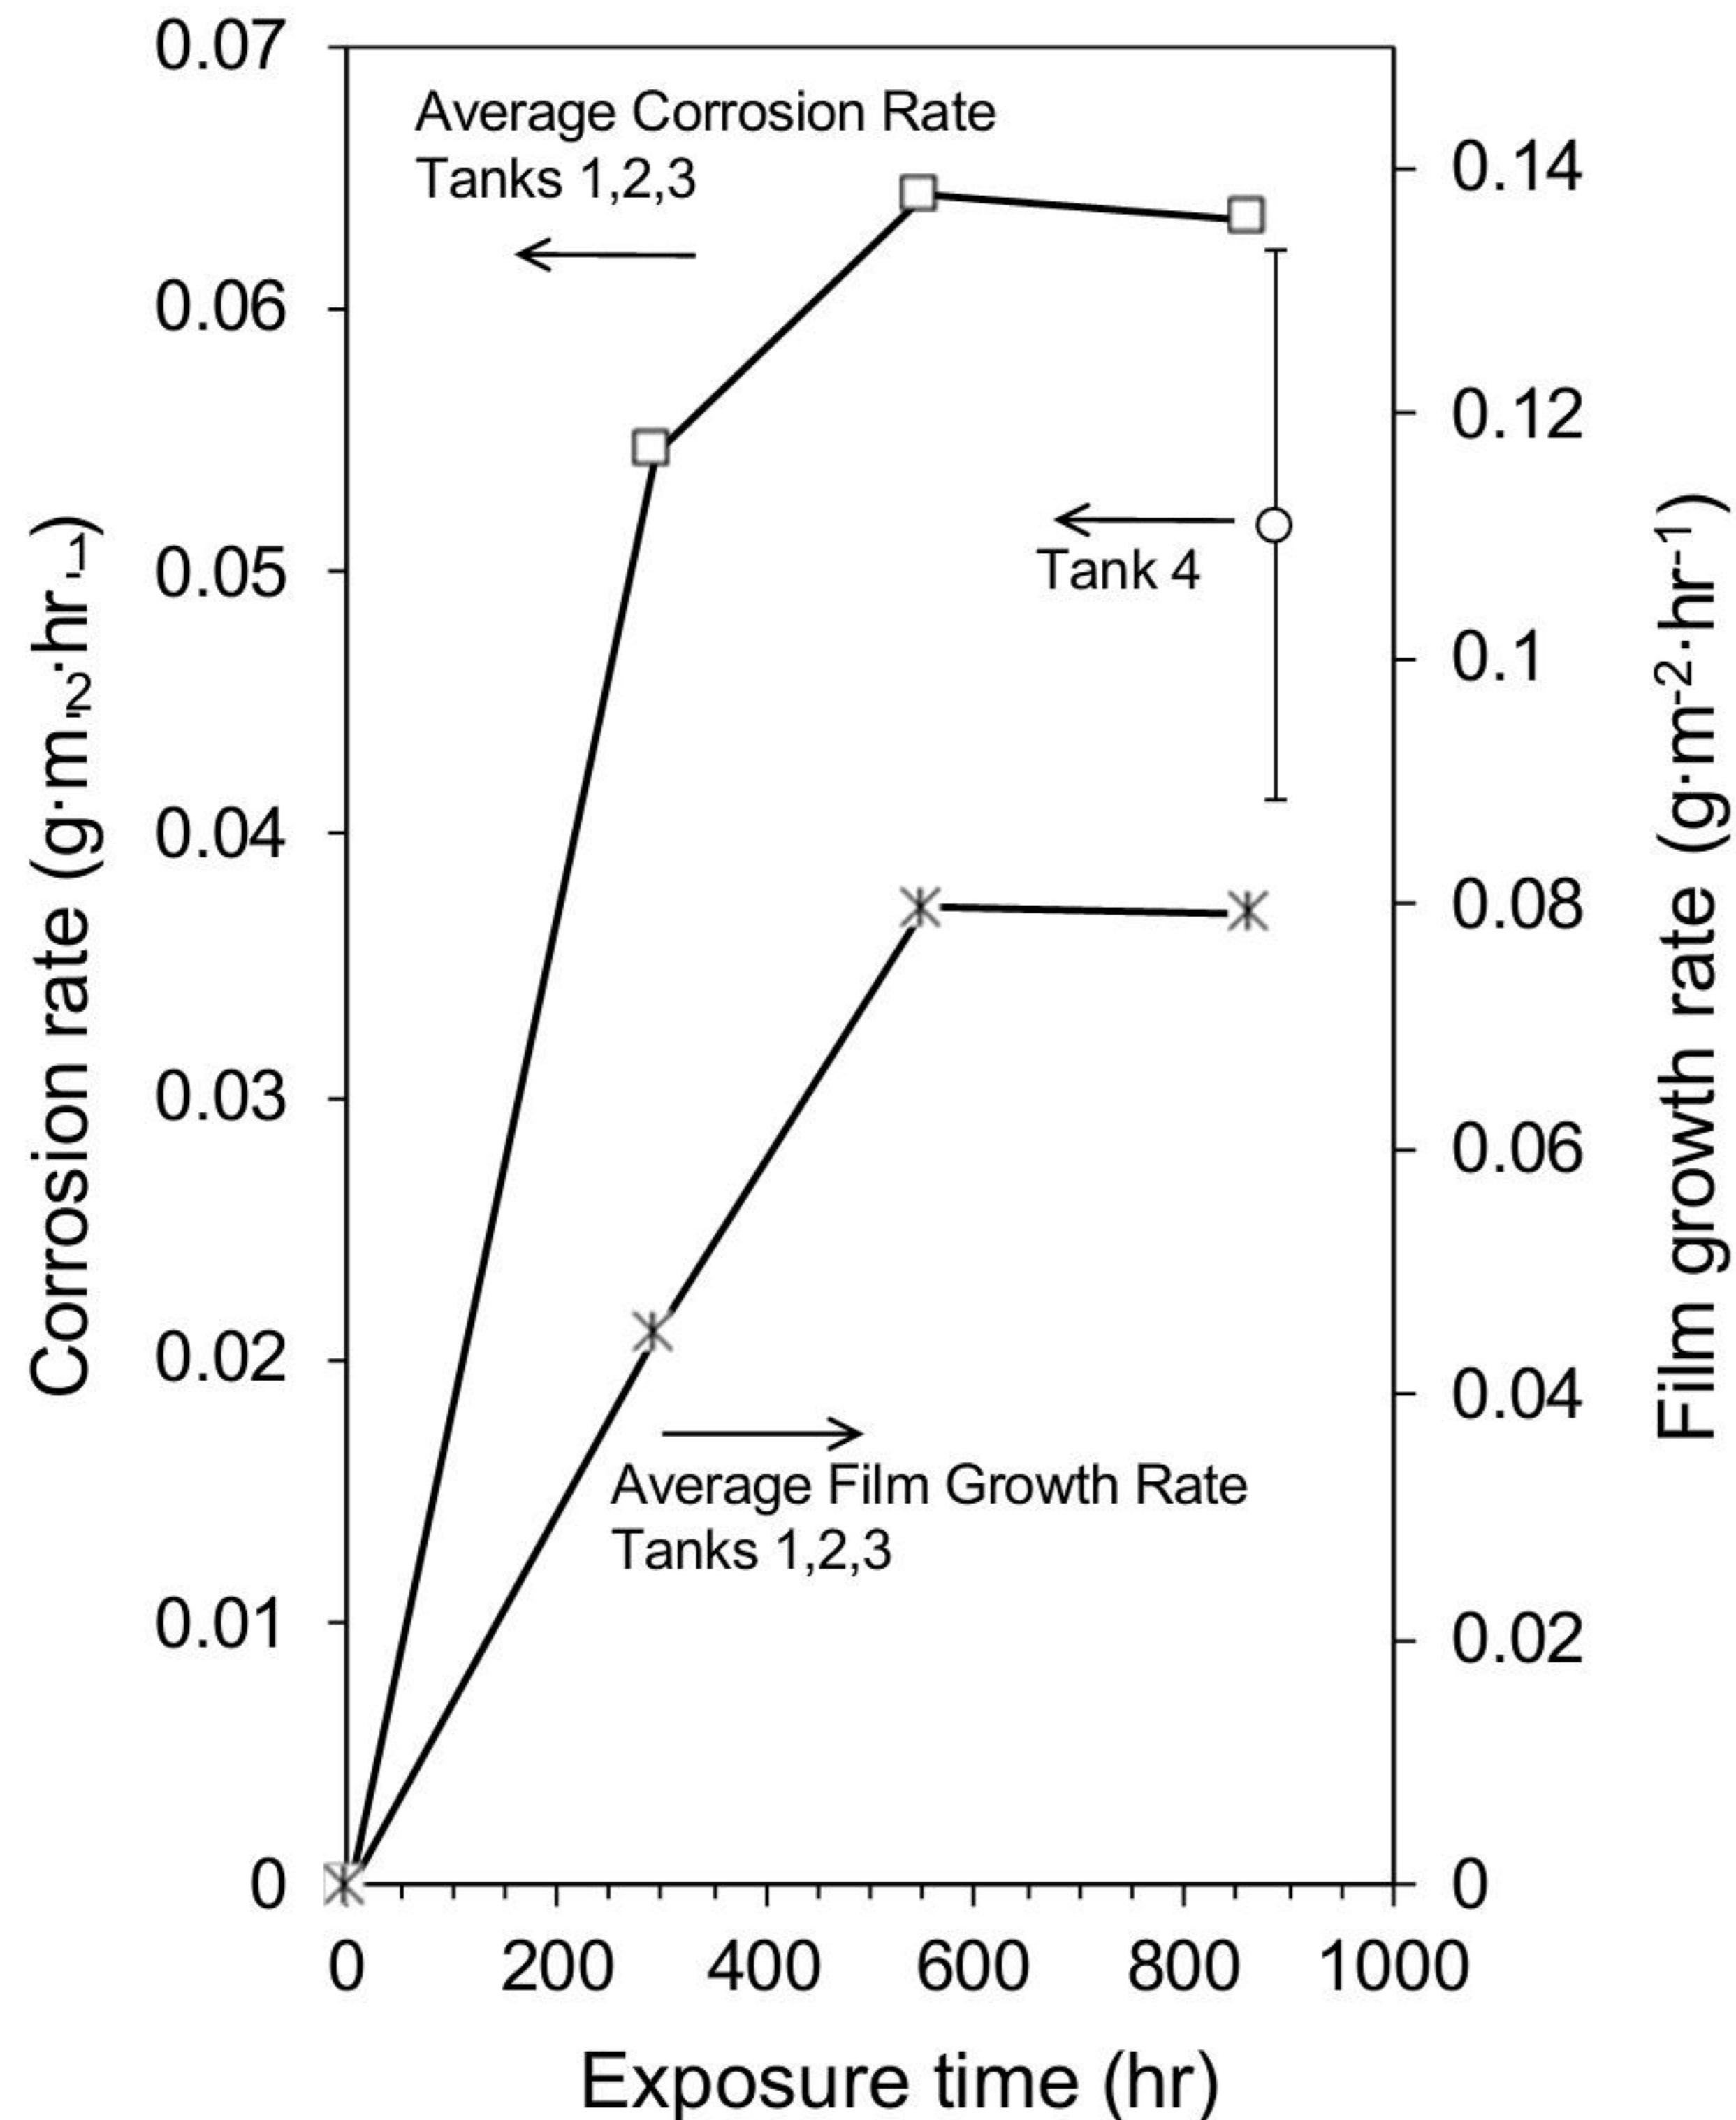
Copper Corrosion Rate

Corrosion rate and film growth rate in the headspace (Tanks 1, 2, 3) exhibit a plateau above a certain exposure period. This suggests that the copper corrosion rate increased until coupon surface was covered with the bluish corrosion product (i.e., a *steady-state* condition was achieved).

- Film growth rate is slightly higher than corrosion rate since mass is added to the system when acetate is captured at the copper surface.
- Immersed coupons (Tank 4) exhibited slightly lower corrosion rates compared to the headspace coupons.
- A typical corrosion rate of copper in water is about ~ 0.0025 mm/y (~ 0.1 mpy)
- An “acceptable” corrosion rate of copper in an open-loop system is typically less than 0.025 mm/y (< 1.0 mpy)
- Corrosion rate of copper here is ~ 0.08 mm/y (~ 3.3 mpy)

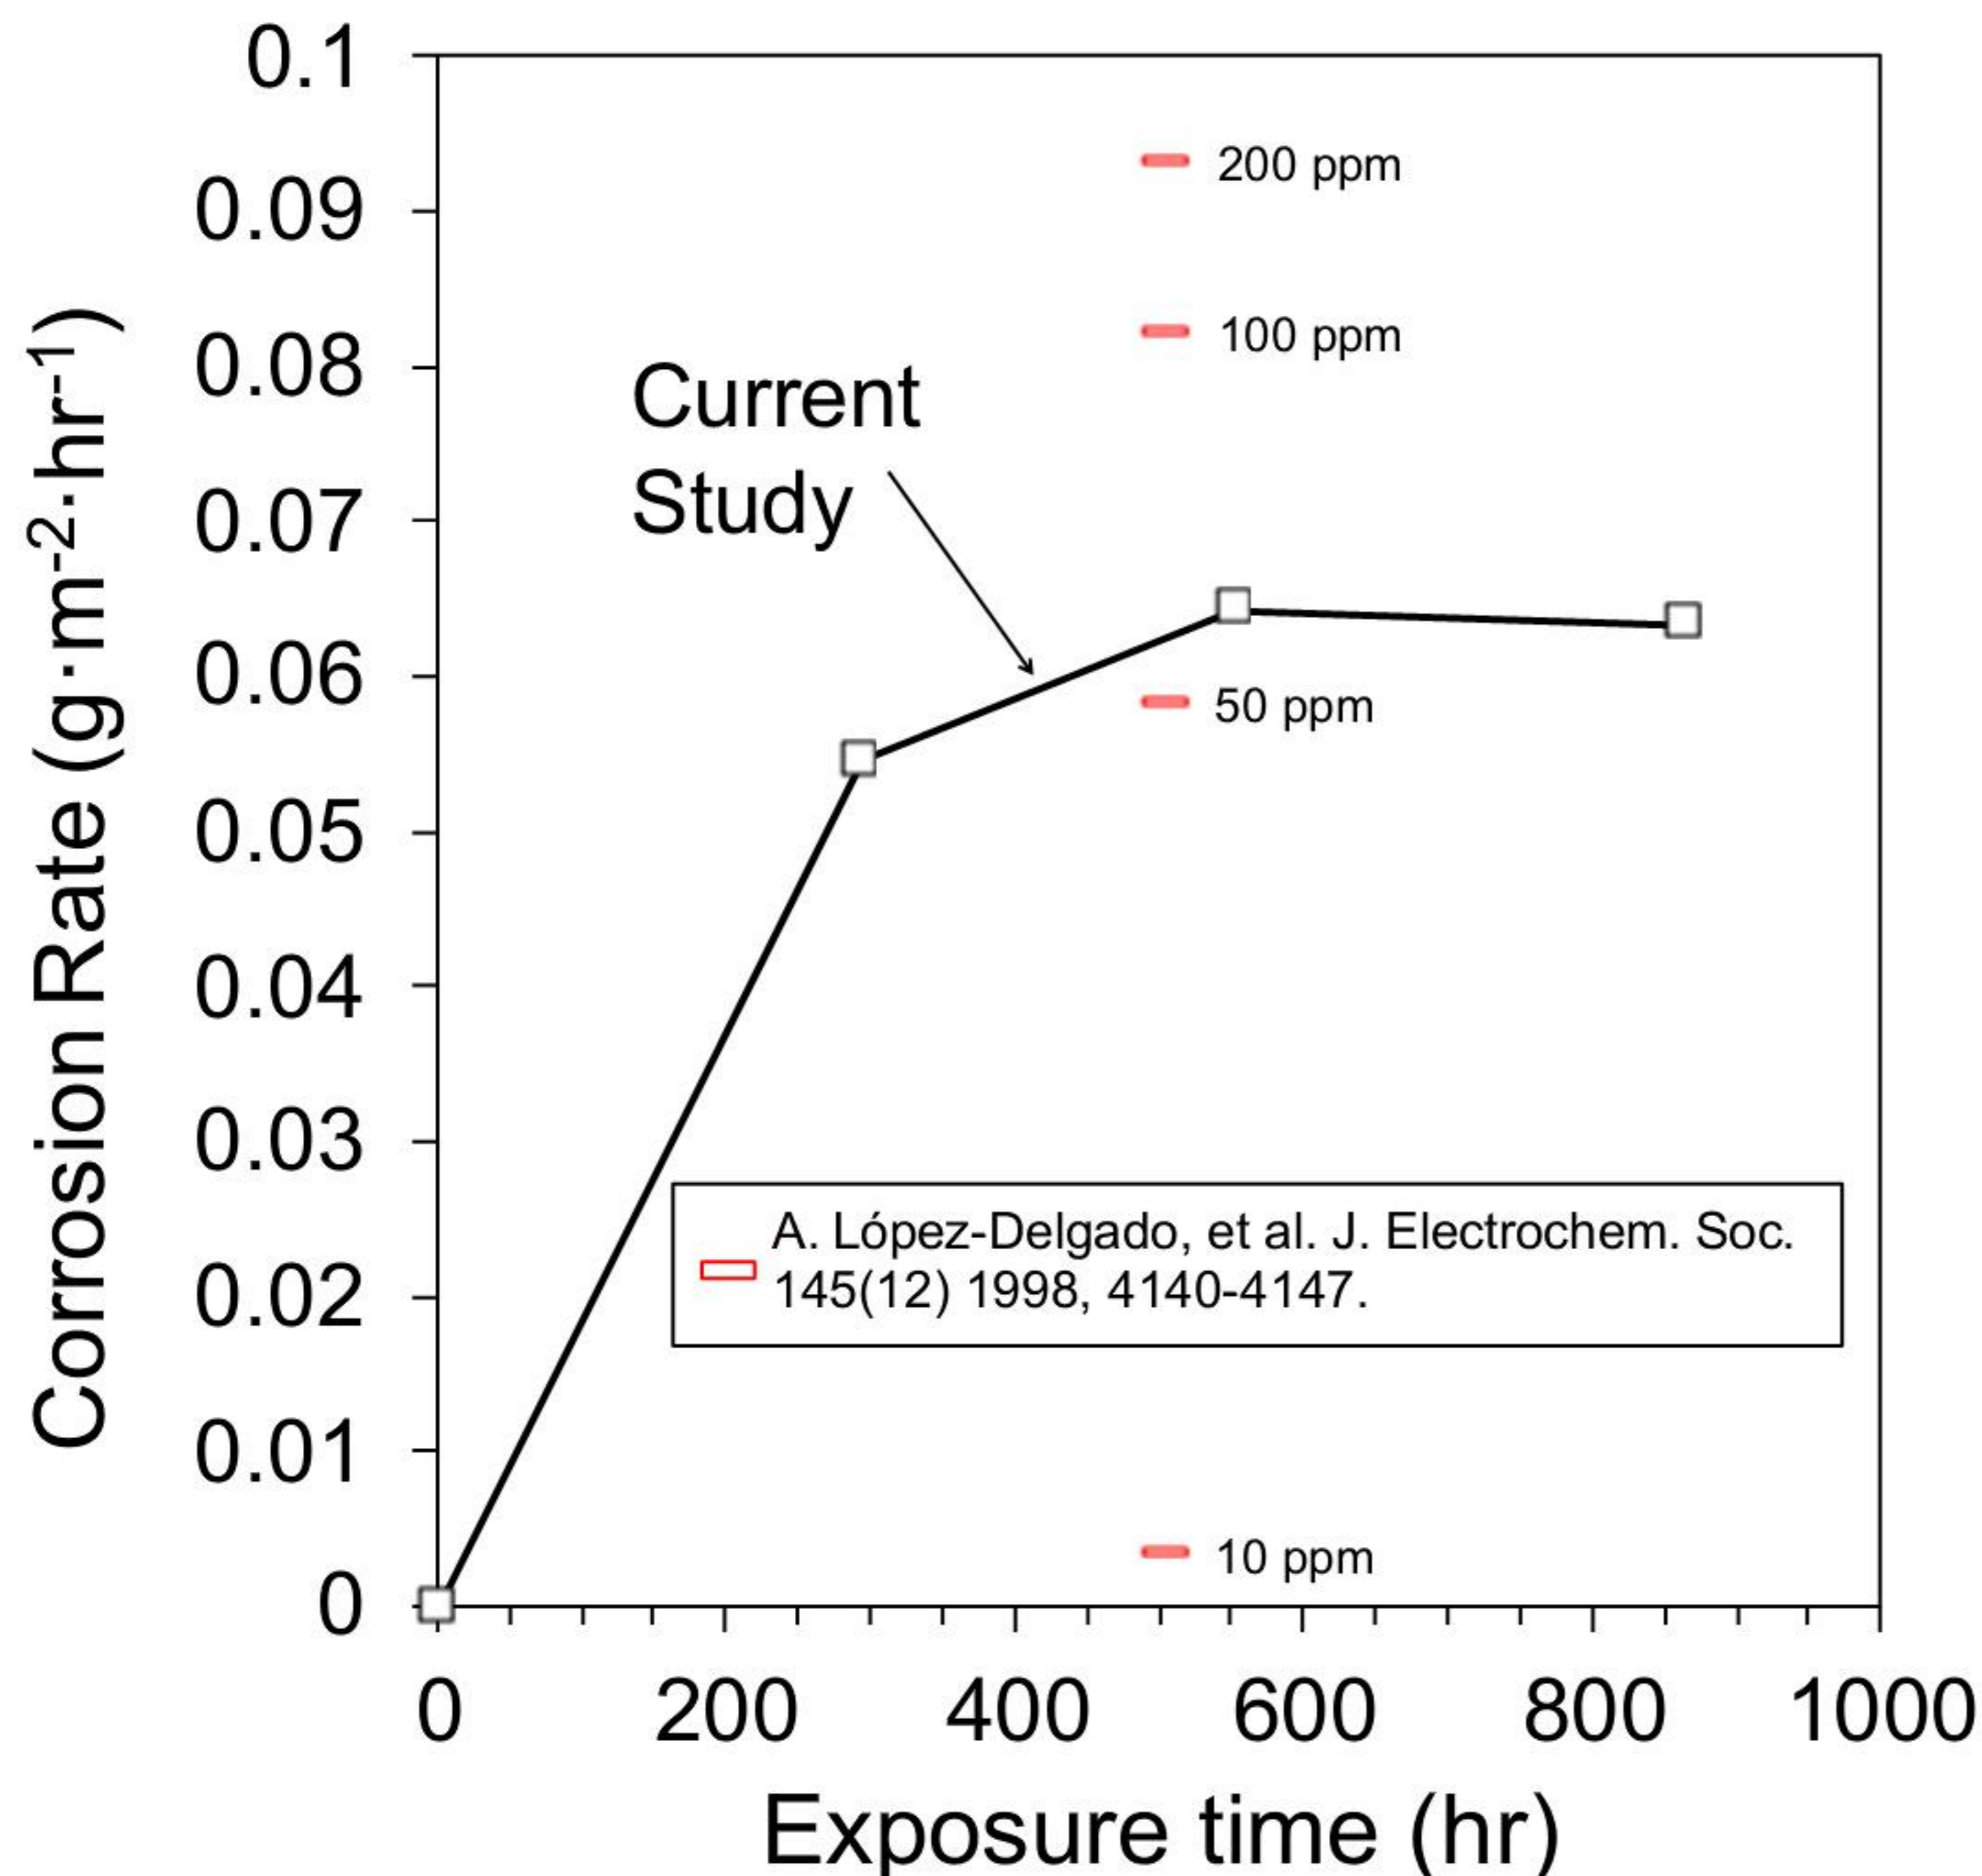
A comparison with abiotic acetic acid corrosion of copper is made here. Estimates based on this comparison suggest bacteria could produce acetic acid vapor concentrations in the range of 50 to 100 ppmw although calculated values suggest we may have significantly higher levels.

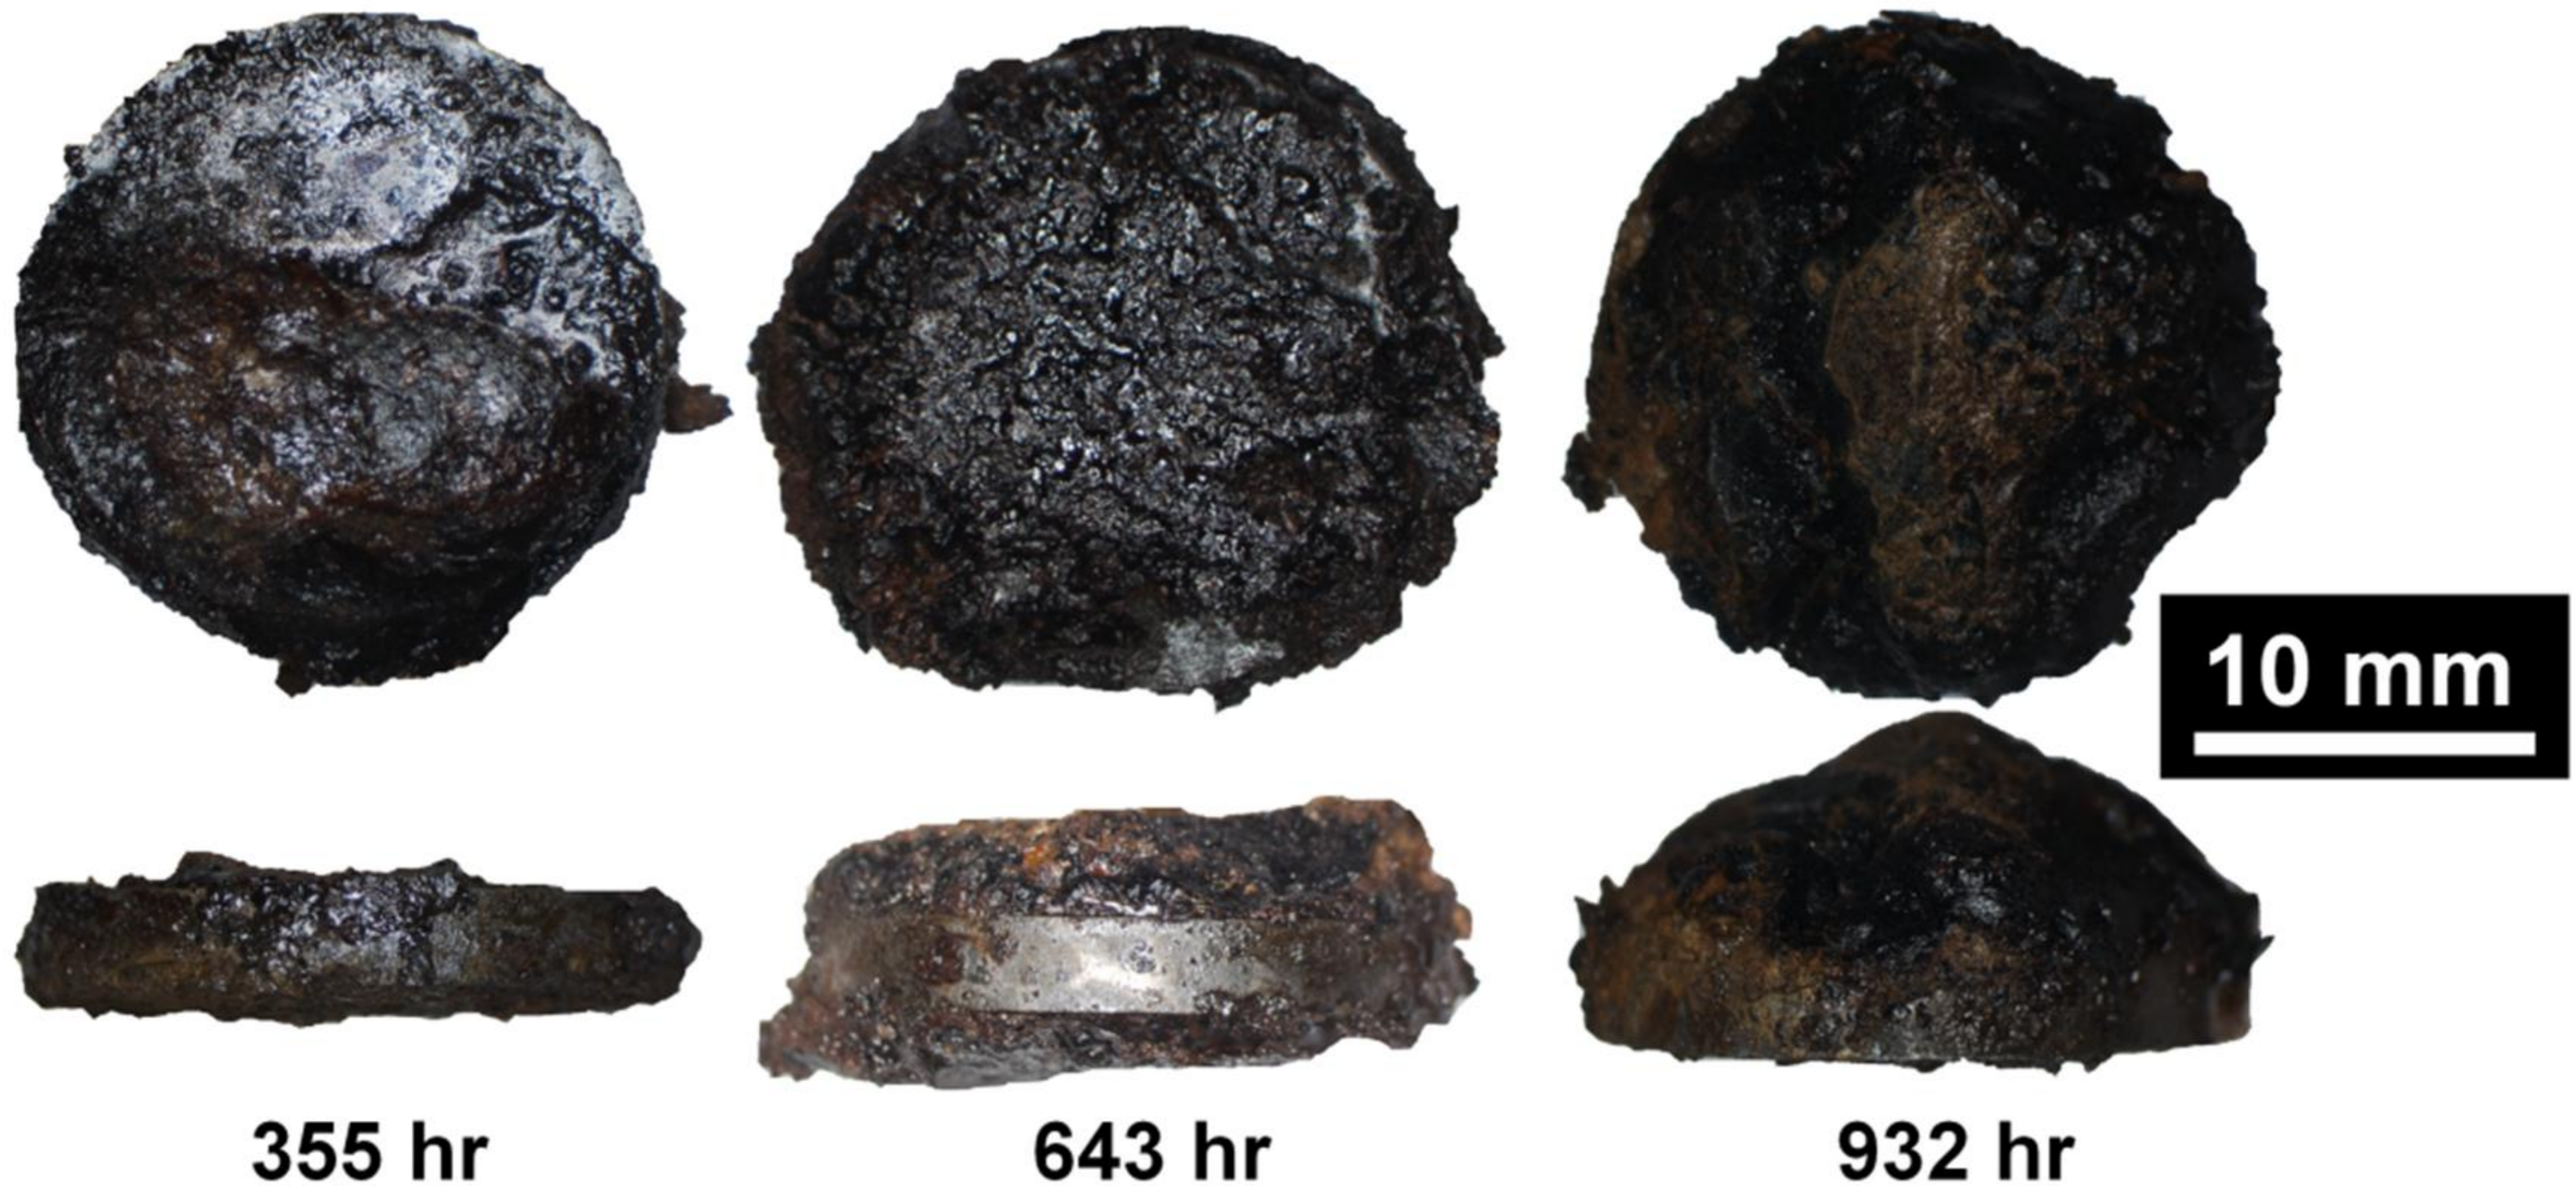
Corrosion product on the steel grew in thickness with longer exposure periods, and flaked easily from the coupons.

XRD was used to identify corrosion products:

- Iron oxides
- Iron hydroxides

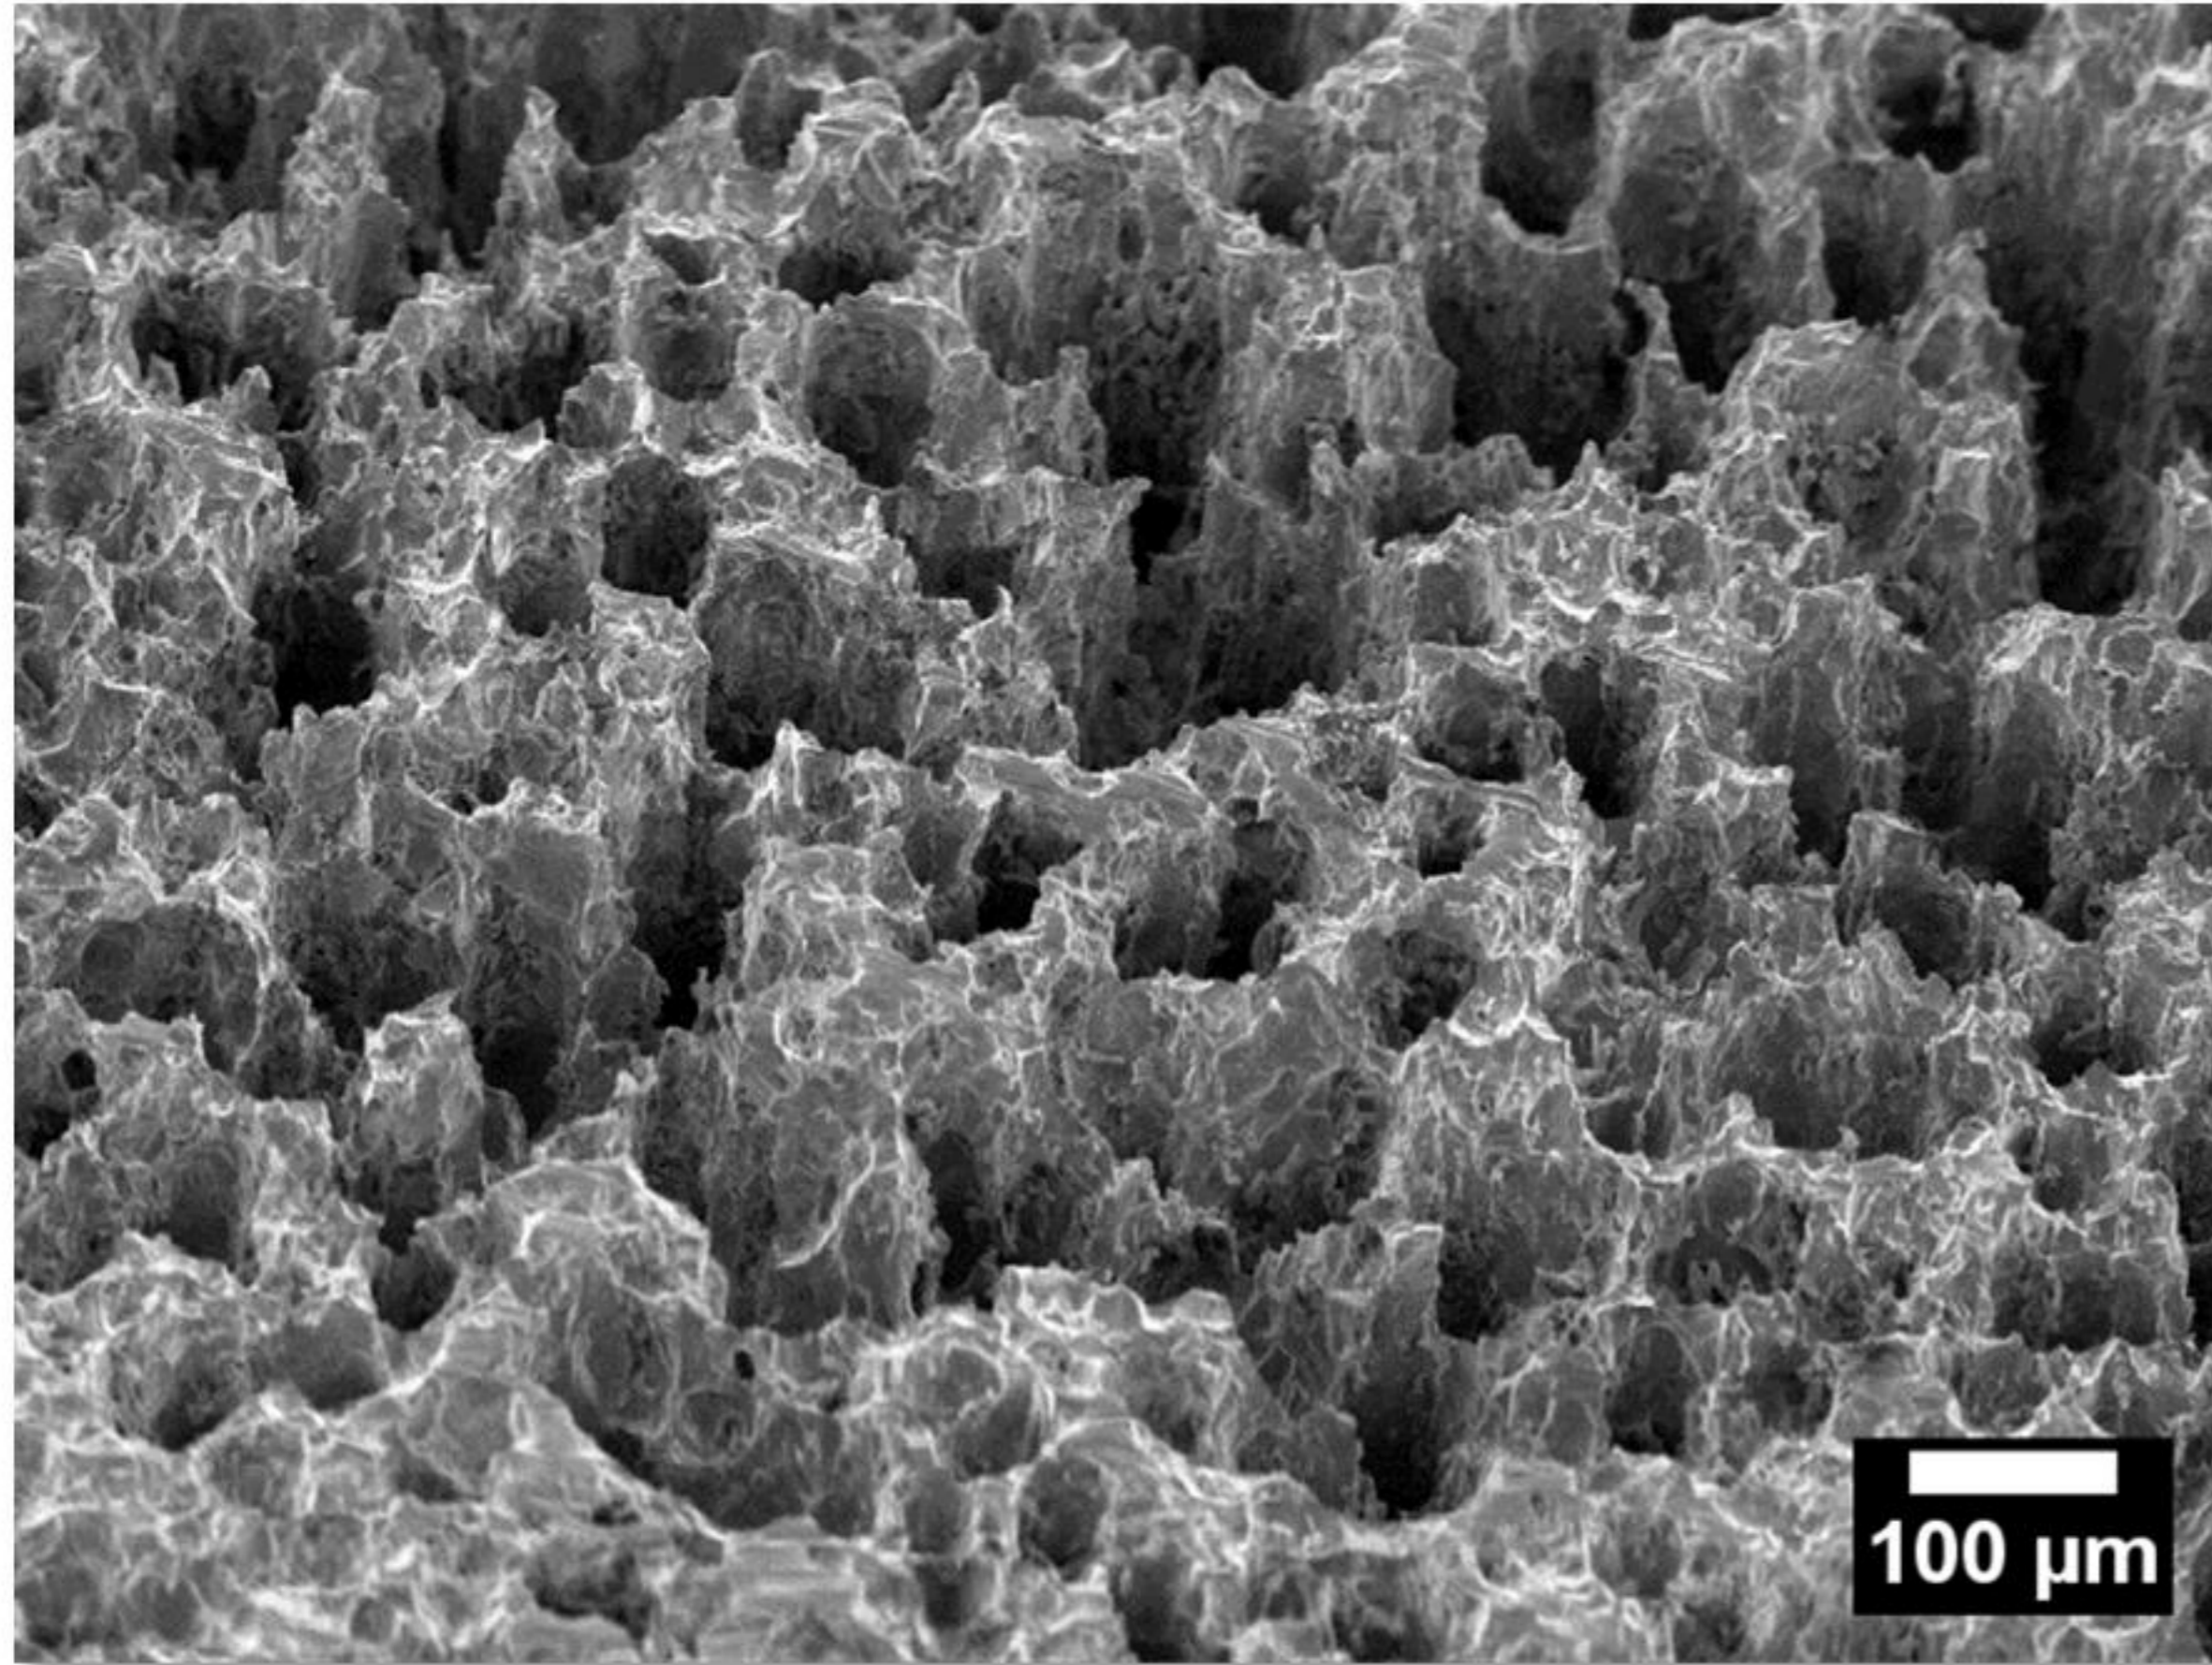
Headspace Corrosion Morphology **NIST**

Removal of iron oxidation products revealed that general pitting corrosion occurred underneath.

Pit density varied spatially about the radial direction of the coupons.

Pit initiation appear to be associated with non-metallic inclusions (e.g. MnS); therefore, alloy sulfur content may play an important role in pitting.

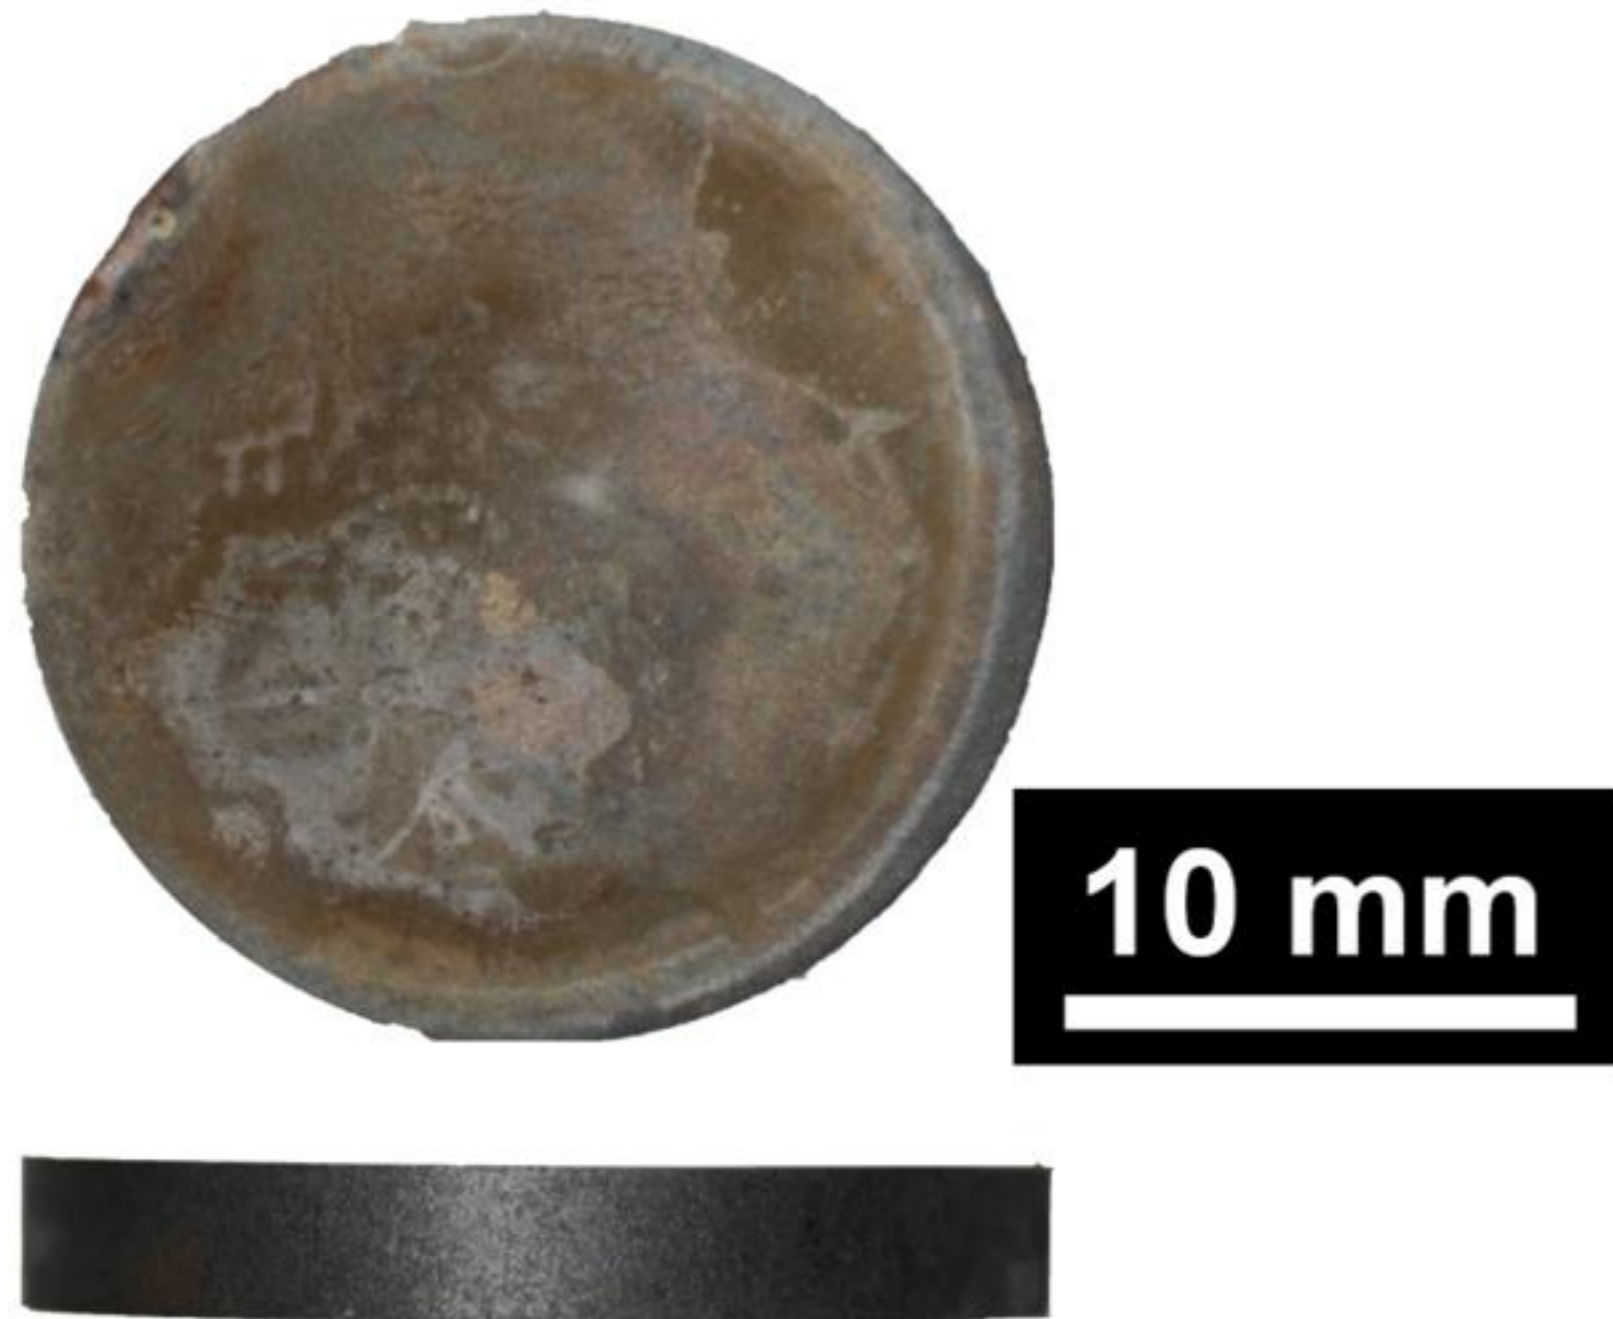
Steel Coupon Appearance After Immersion

Corrosion rate was comparable to the copper headspace coupons and copper immersion coupons. This low rate may be related to bacterial attachment to the steel surface, which could protect the steel by a passivation mechanism. However, the surface was still covered with a deep pitting attack. Pits were predominantly found within ferrite grains, although some attack at ferrite-pearlite boundaries was noted.

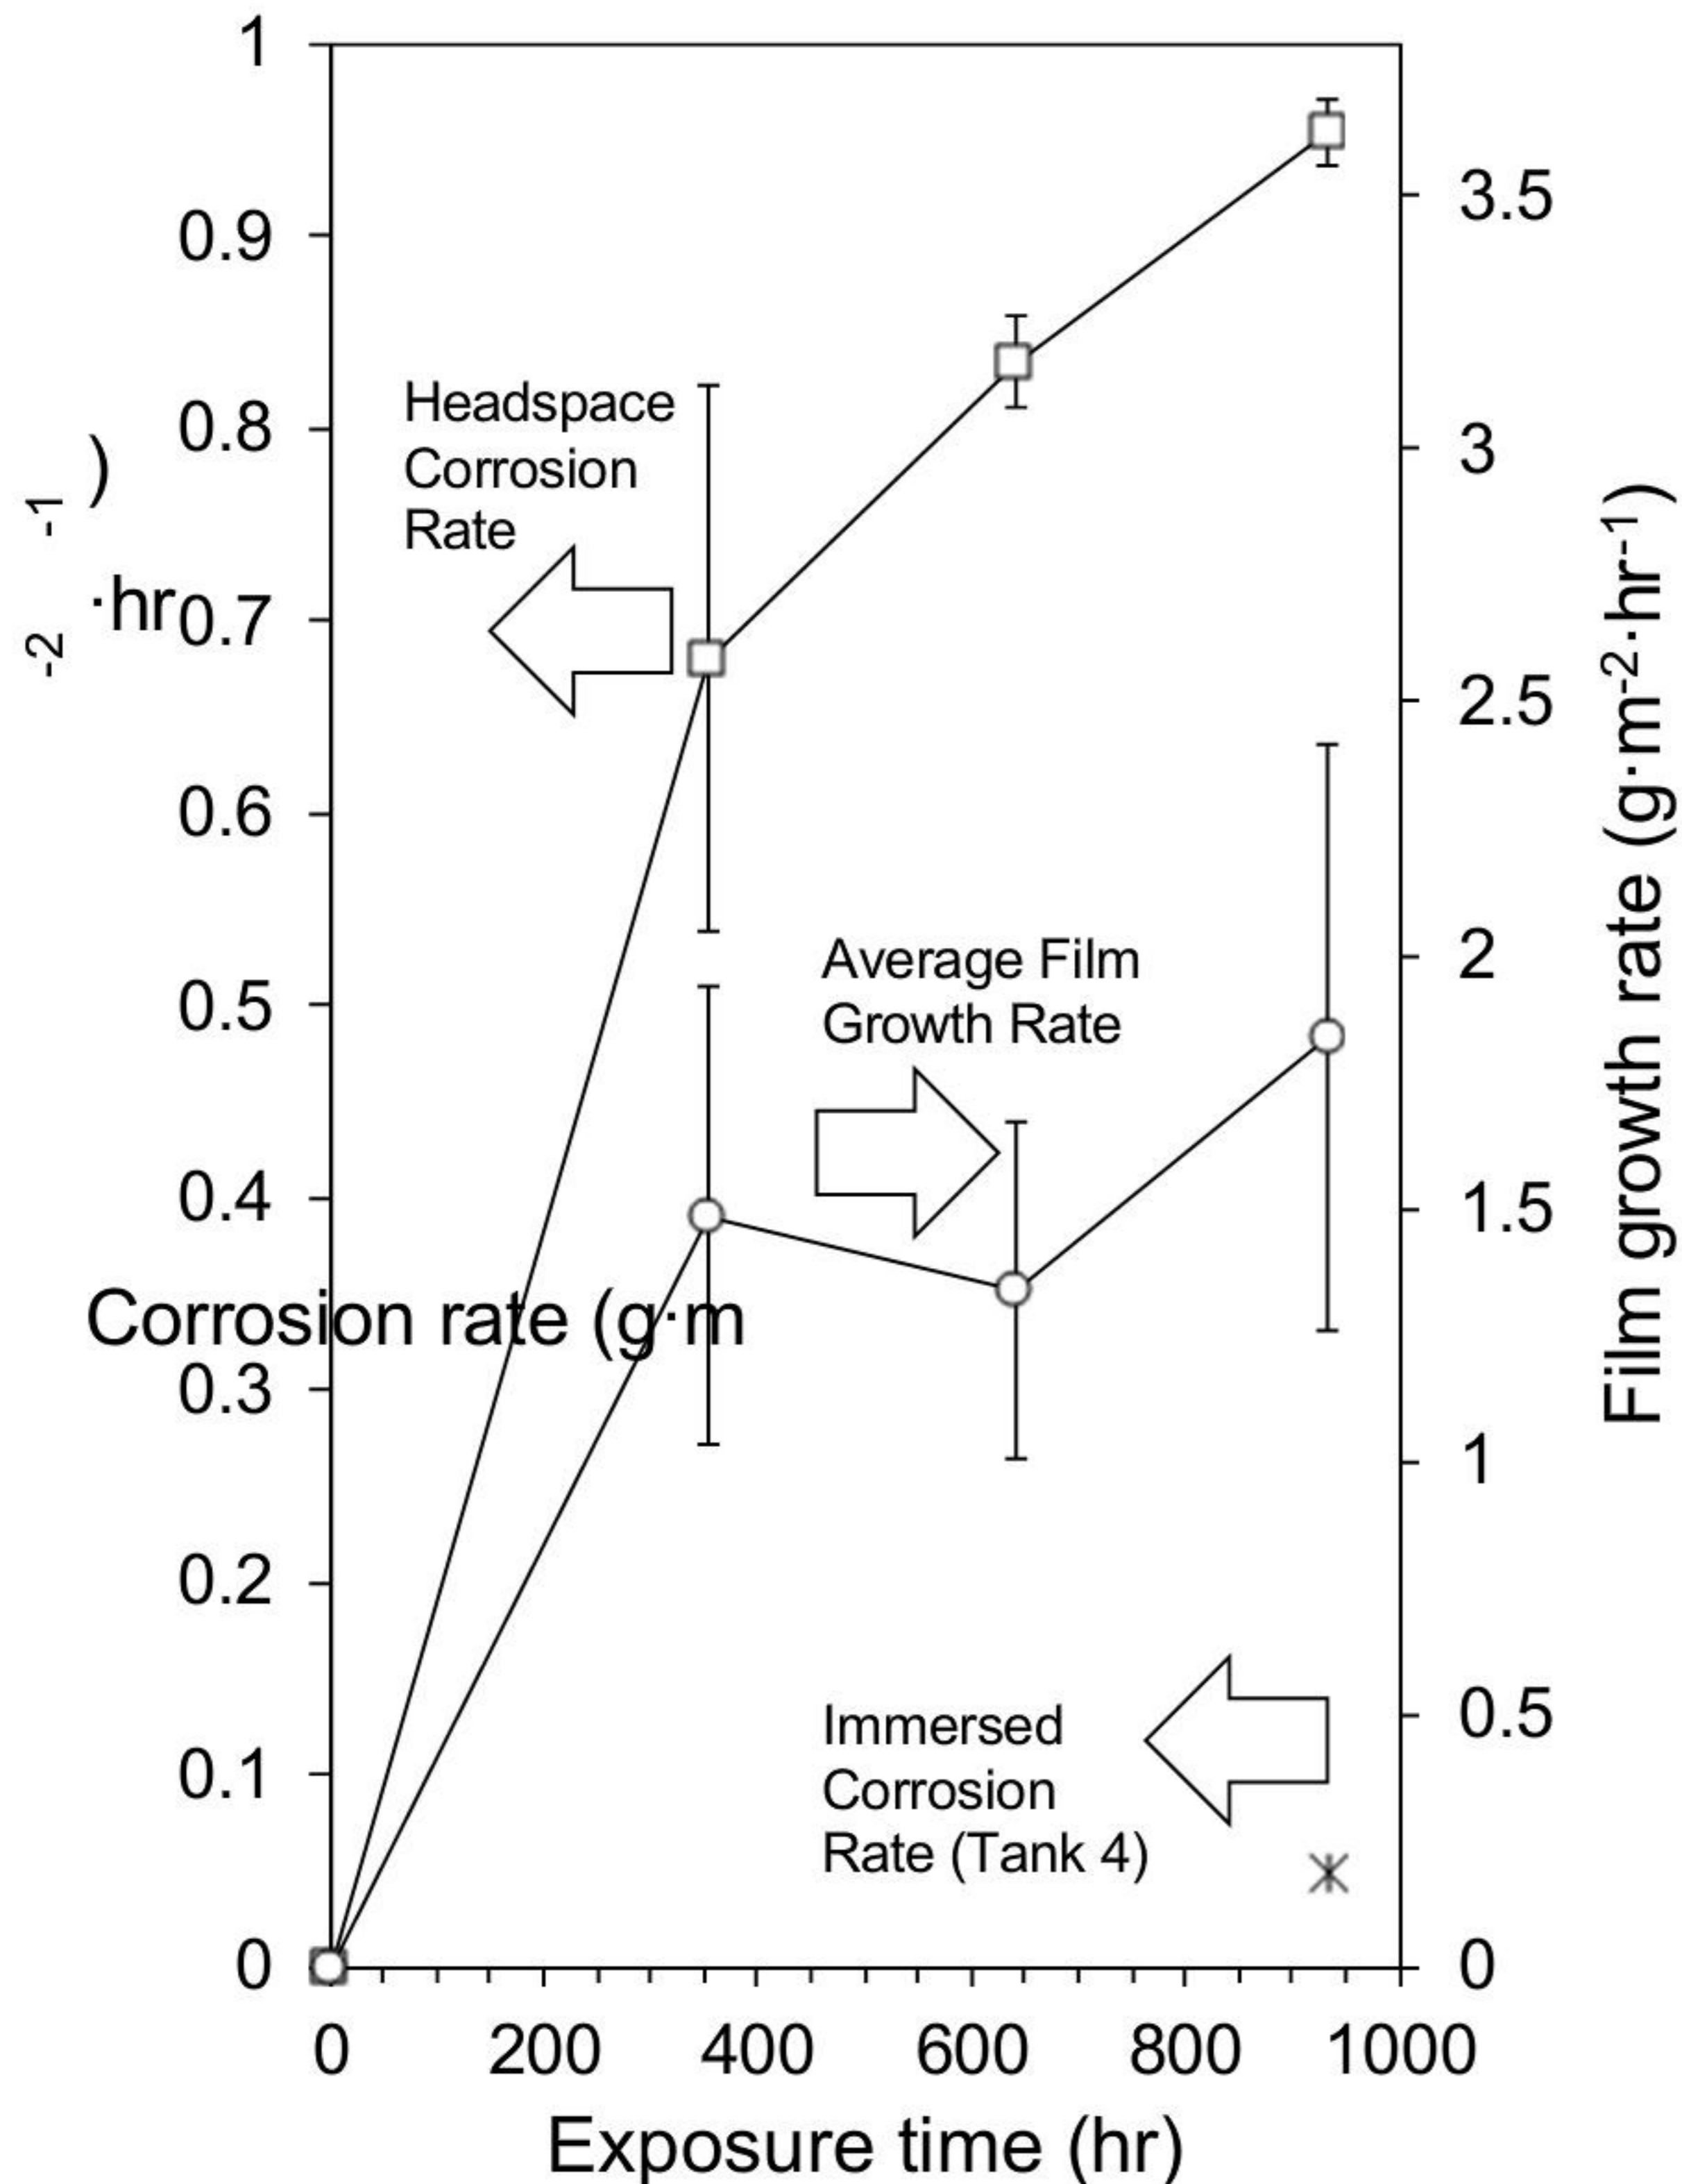
Steel Corrosion Rate

Corrosion rate likely has some dependence of the film growth as seen in the copper corrosion.

- Corrosion rate of 1018 steel coupons exposed to headspace was an order of magnitude greater than copper in the headspace and continuously increased with exposure time. (> 1 mm/y !!!)
- Film-growth rate on headspace coupons is higher since mass is added to the system when iron oxidation products are captured by the steel surface.
- Immersed coupons exhibited significantly lower corrosion rates than in the headspace. Microbial attachment (formation of a biofilm) may play a role in this behavior.
