Corrosion of Copper and Steel Alloys in the Presence of *Acetobacter* sp. in a Simulated UST Sump Environment

Jeffrey Sowards & Elisabeth Mansfield

Applied Chemicals and Materials Division, NIST – Boulder, CO

Problem: Rapid UST Corrosion

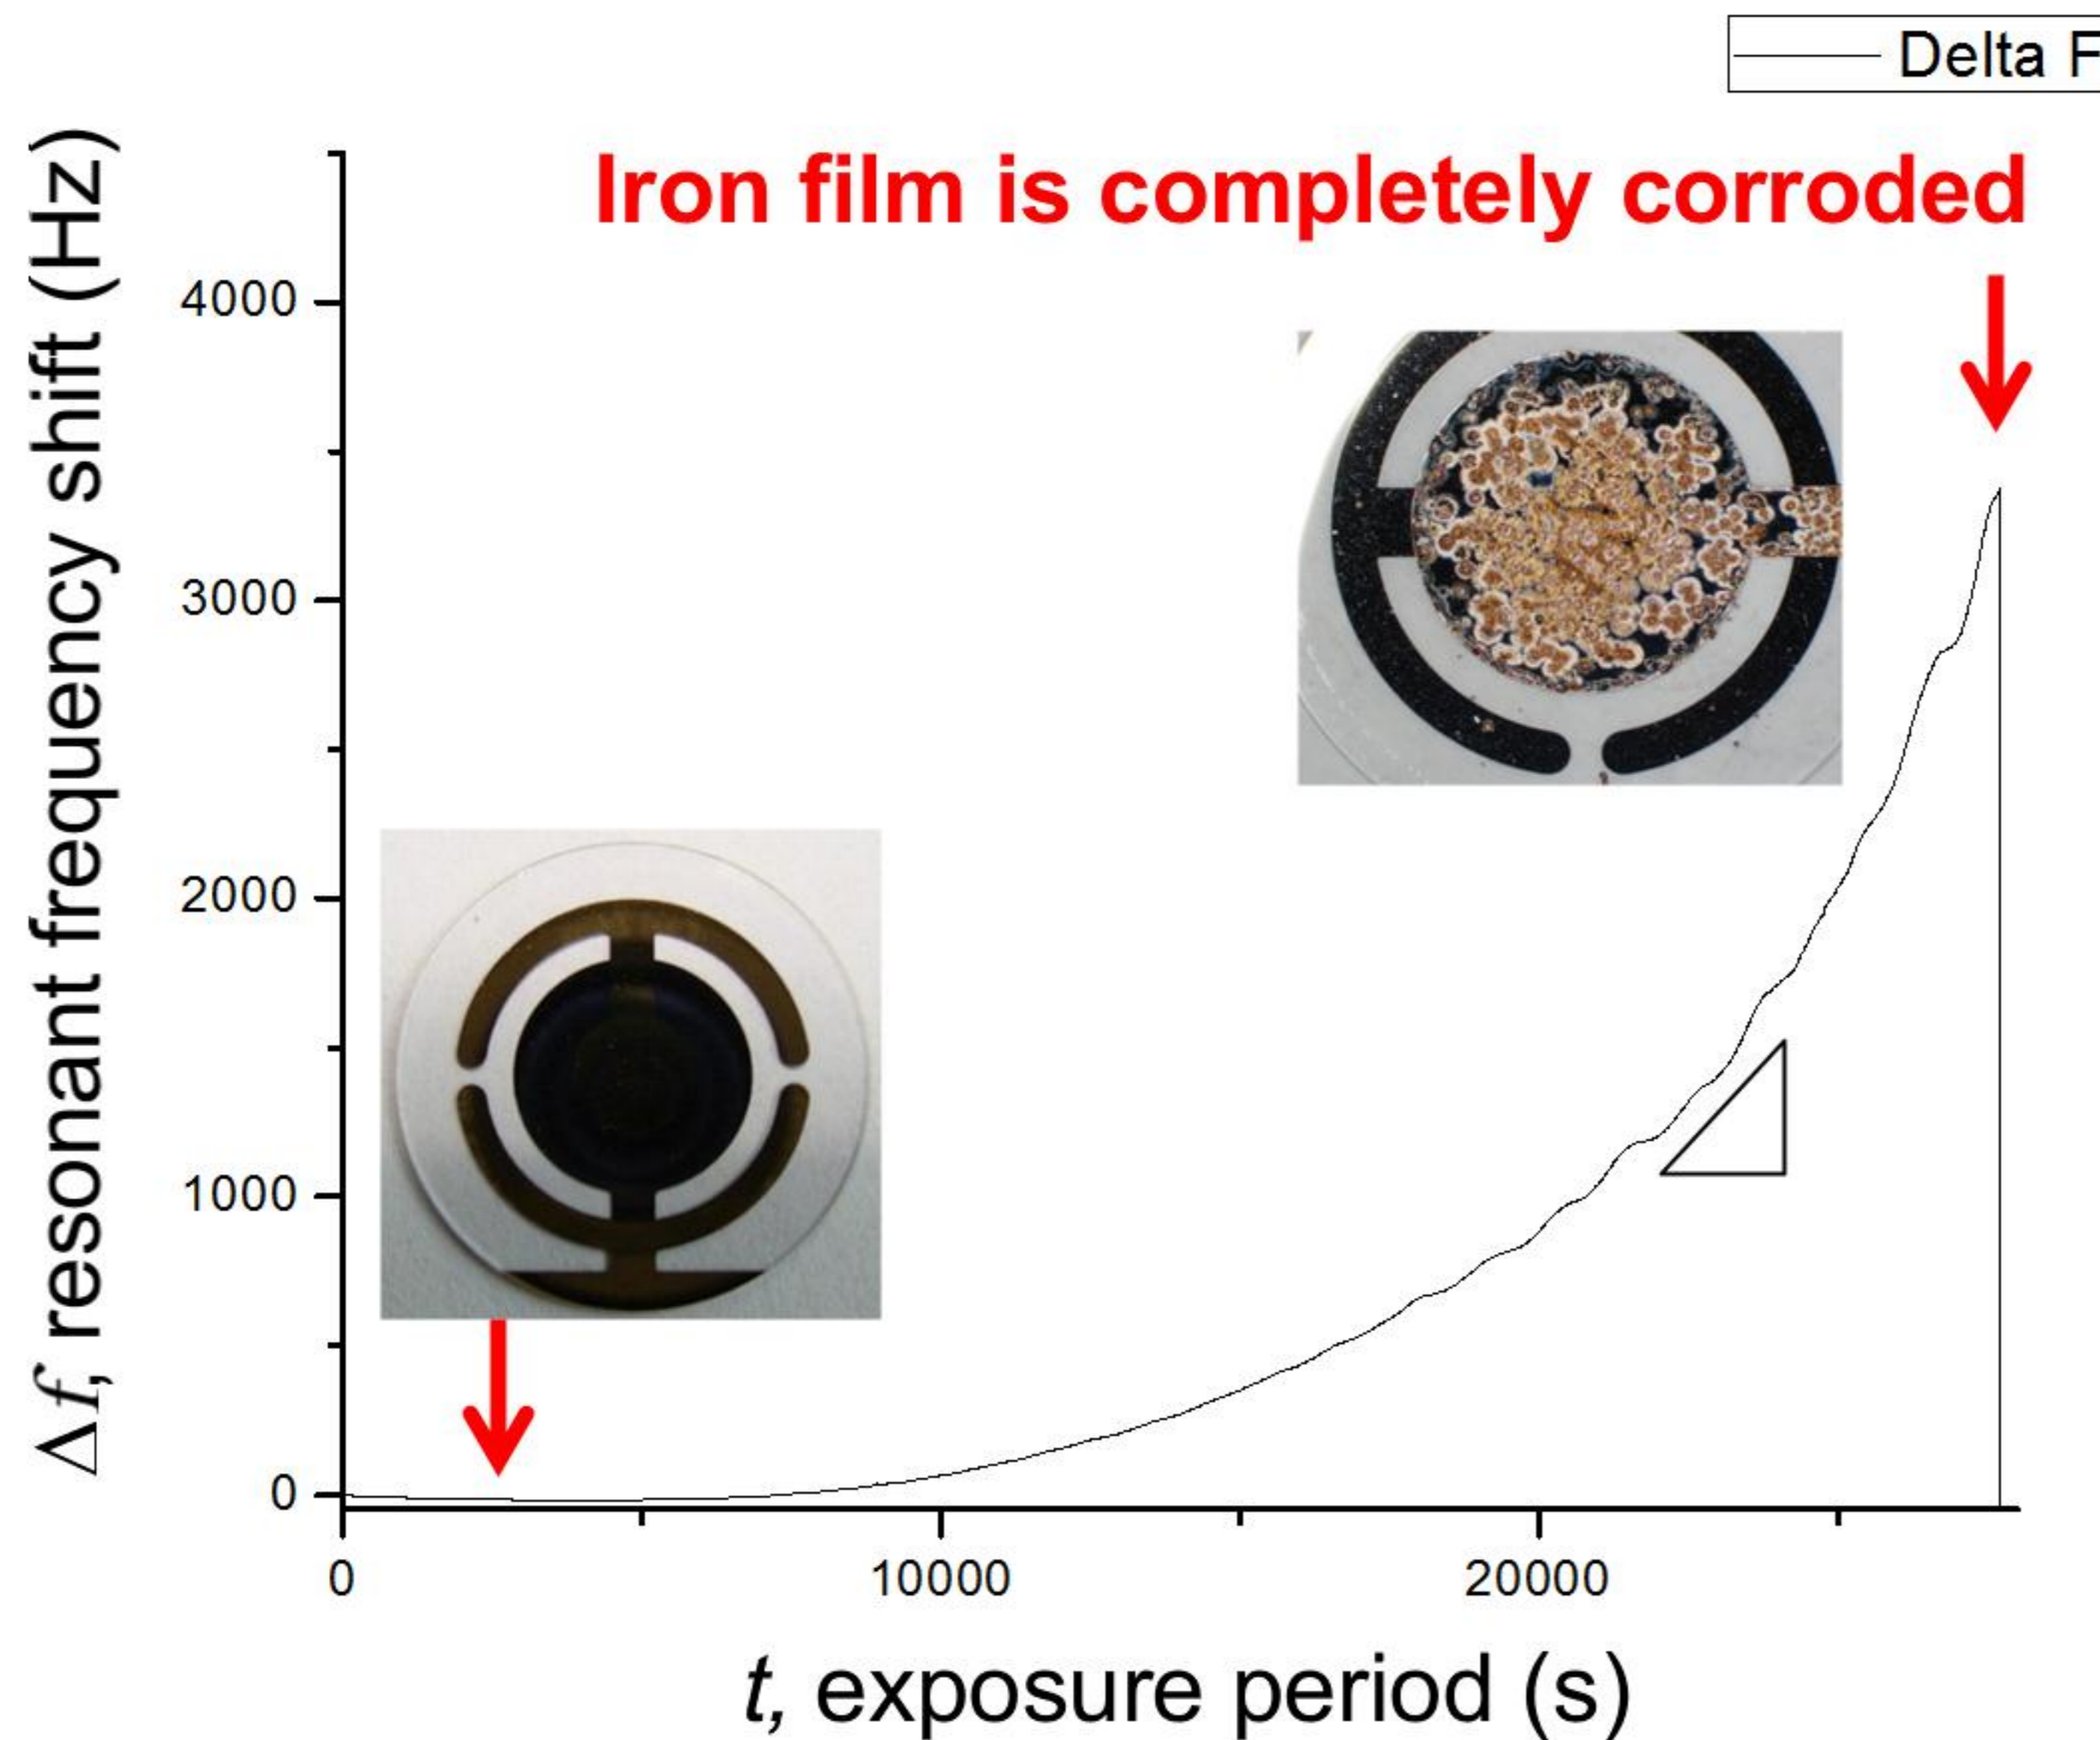
Corrosion of Fe Thin Film Sensor NIST

We deposit thin Fe films onto quartz crystals. The crystals are excited with an oscillating voltage so that they vibrate at their resonant frequency. The mass of the crystal can be measured real-time by monitoring the shift in the resonant frequency.

Mass change occurs due to oxidation of the thin iron layer as evident by the frequency shift.

Sensor technology could be used as an early warning system for the onset of corrosion or to study corrosion in the field.

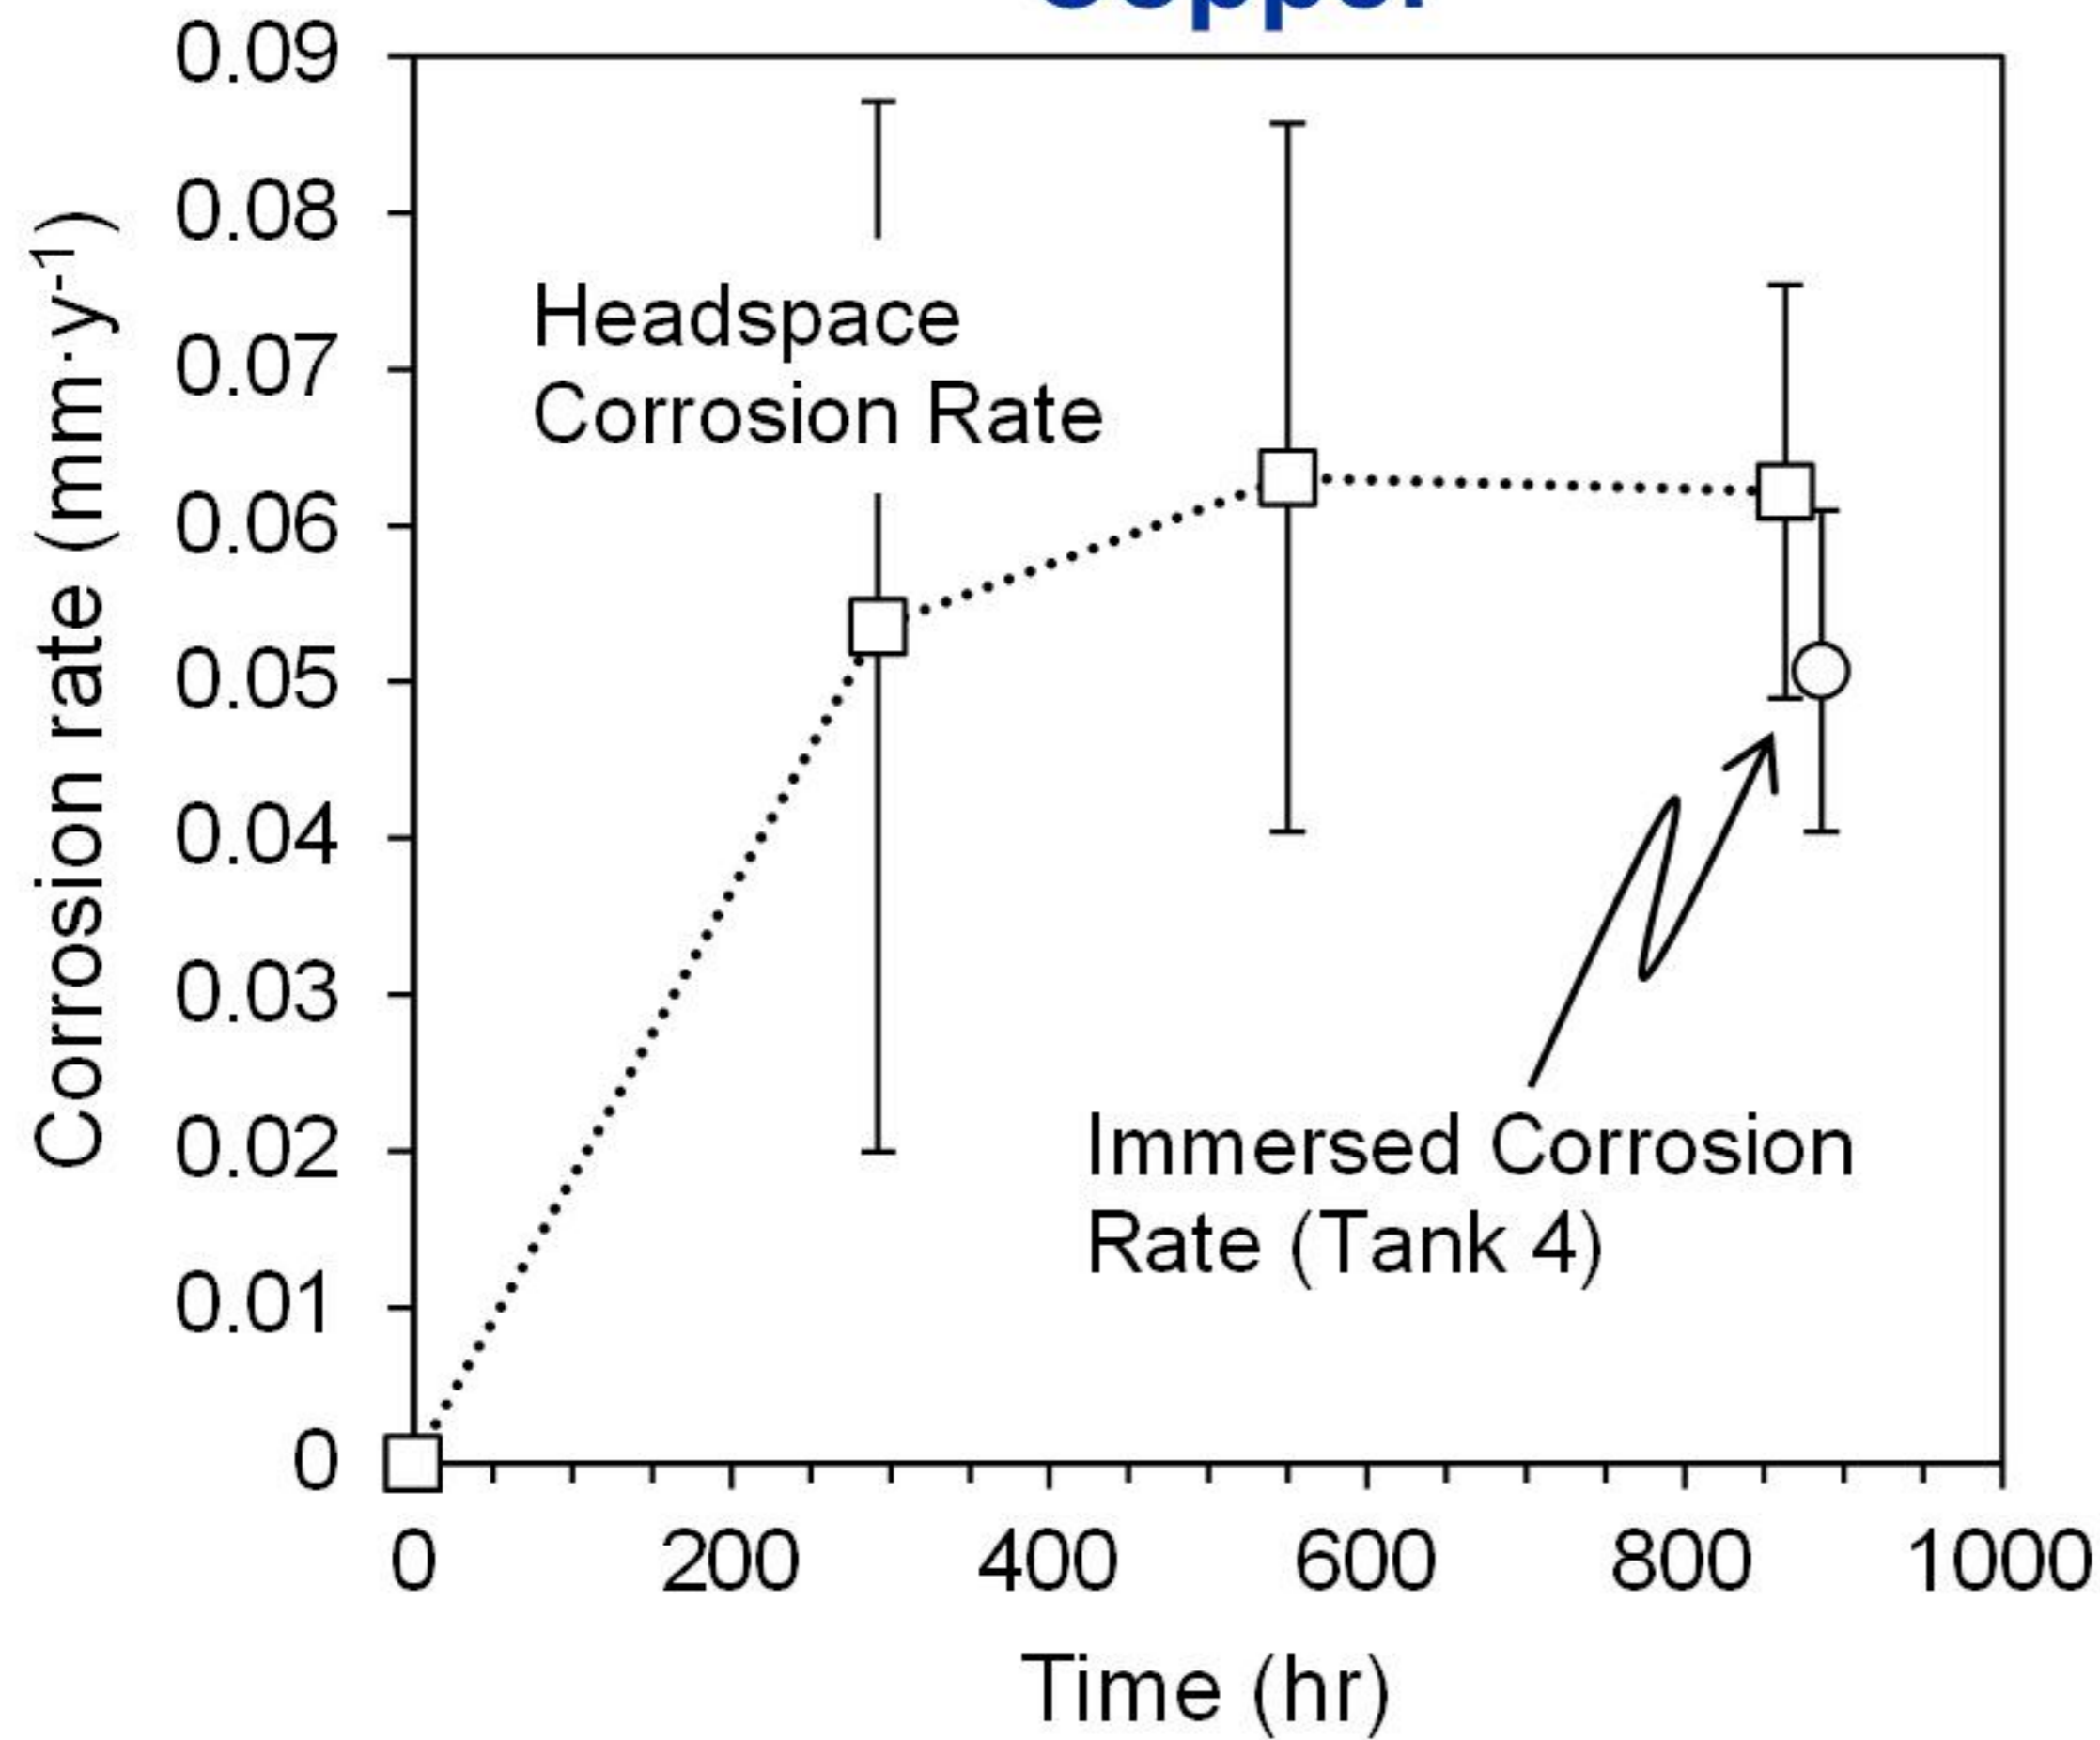
- Copper corrosion rate was up to ~0.08 mm/y in the headspace. It would take 15 years to corrode through copper tubing with 1.2 mm wall thickness.
- Deep grain-boundary attack was observed on the cold-worked copper immersed in solution!
- Stress-corrosion cracking is a likely concern, which would likely reduce the tubing life and lead to leakage of fuel into the environment and into the sump.

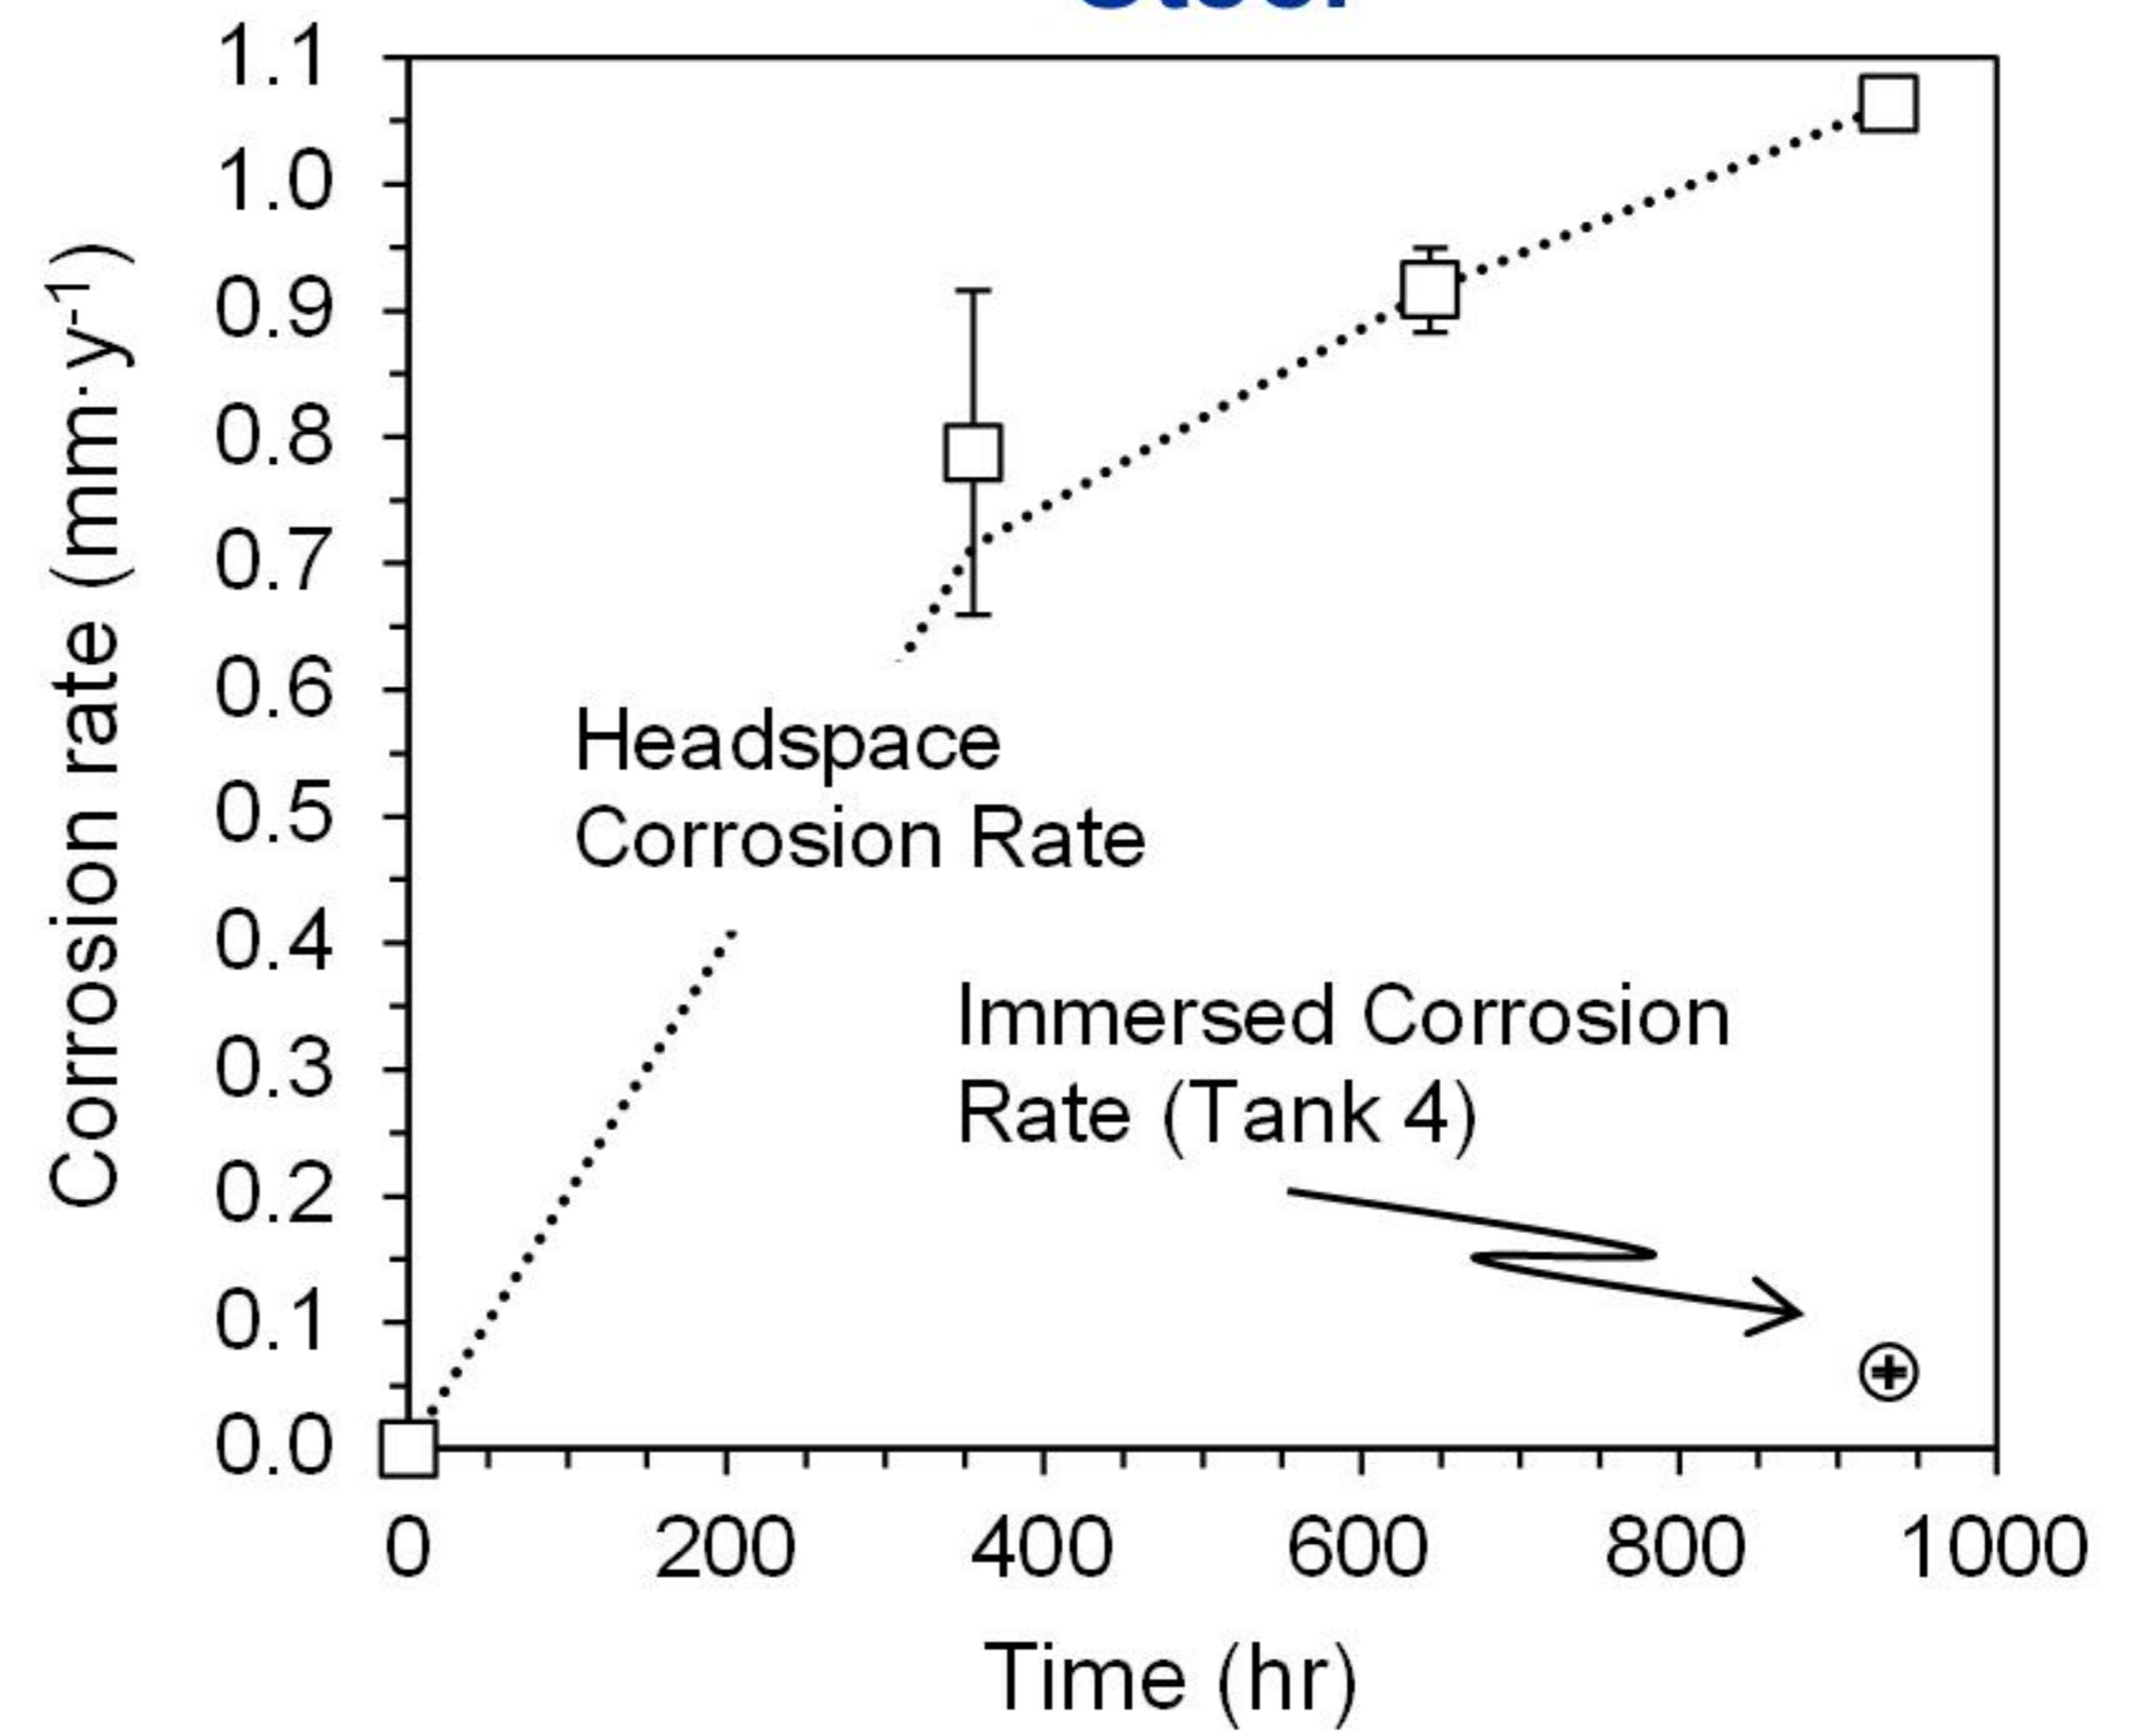
- Steel corrosion rate was above 1.0 mm/y in the headspace! This is an order of magnitude higher than that of the copper.
- Corrosion rate was lowest when the steel was immersed into the bacteria solution (~0.06 mm/y). This may be related to biofilm attachment on the steel corrosion coupons.
