L.U.S.T.LINE

A Report On Federal & State Programs To Control Leaking Underground Storage Tanks

SPECIAL APPENDIX to

Mississippi UST Facilities Impacted by Hurricane Katrina: A Photo Essay

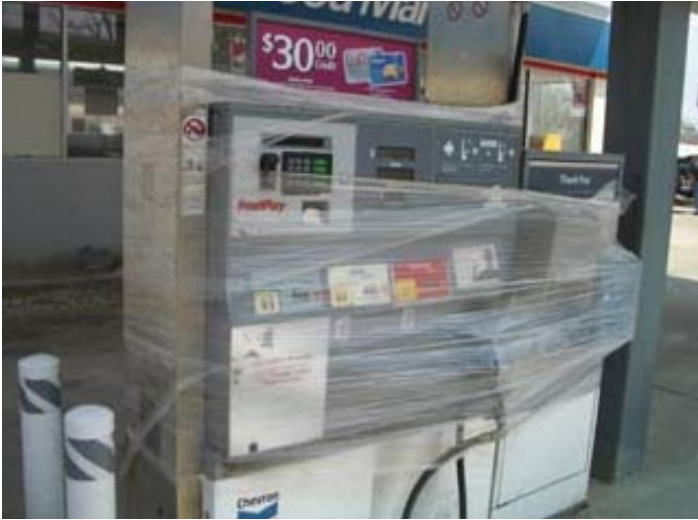
Gas-N-Save Pascagoula - Shrink wrap applied in preparation for the storm was of little use when the store was submerged by 8 feet of flood water.

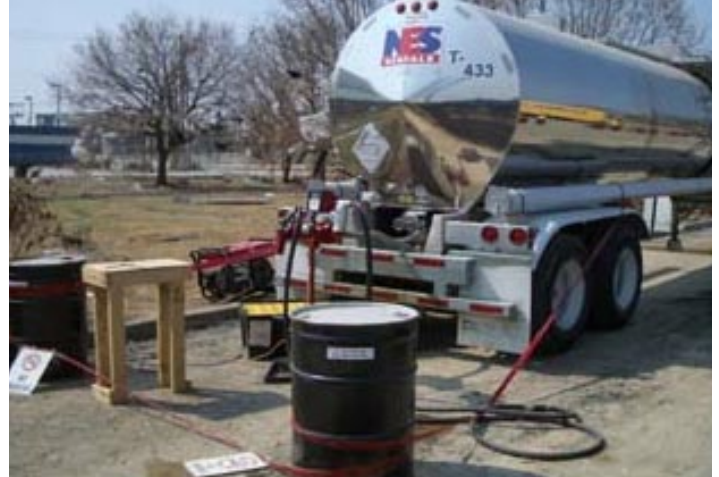
Cadet Marina, Biloxi - Tractor/Trailer tank also utilized for emergency vehicle fueling in the parking lot of the Point Cadet Marina.

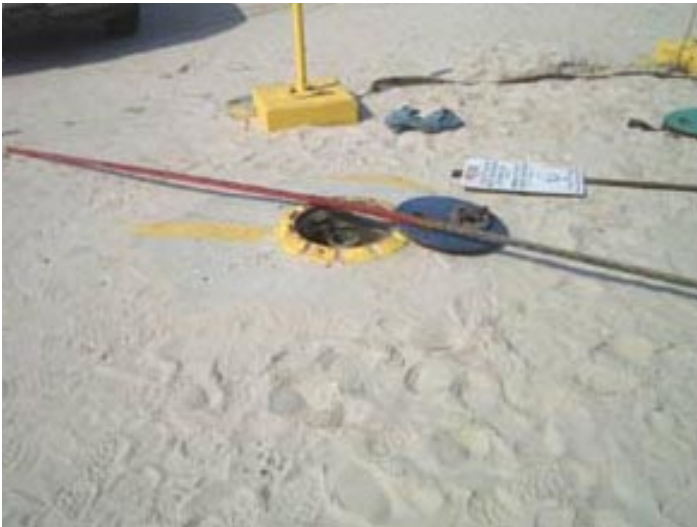
Point Cadet Marina, Biloxi – Gauging the tanks confirmed that floodwater had filled the tanks (note red color of water finding paste on gauging stick).

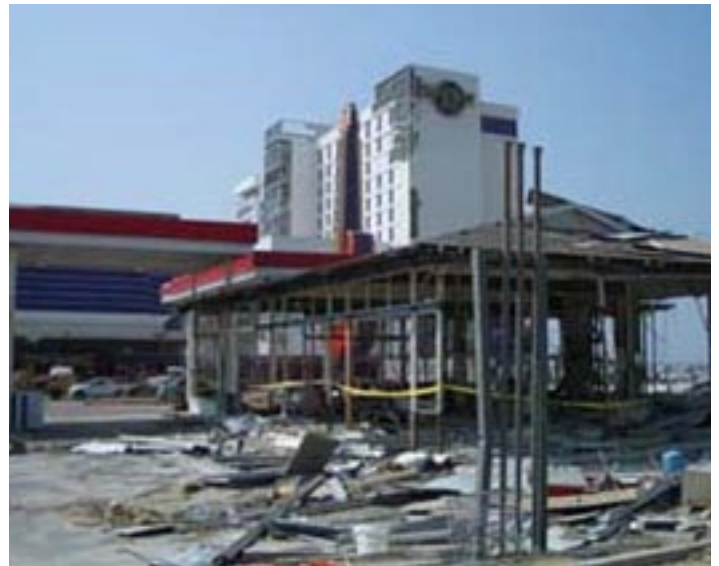
Fast Trac - Store building was blown out by storm surge. Hard Rock Casino in background was to have its grand opening the day after the storm hit.

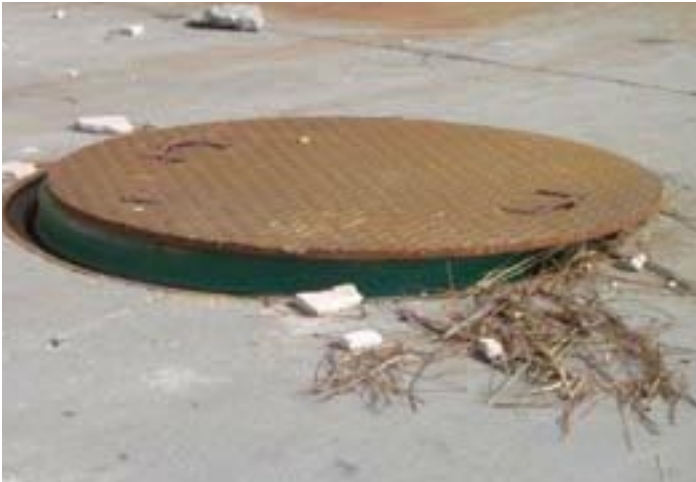
Beau Rivage Marina, Biloxi - "Easy-off" man way lids facilitated by sunken concrete pad.

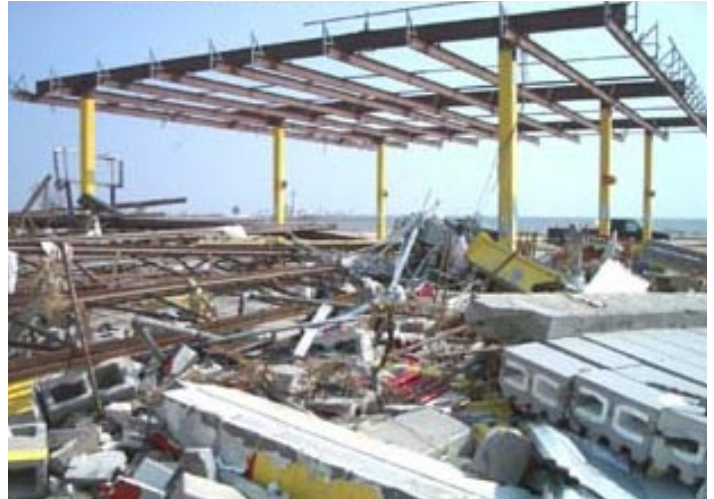
Pantry, Biloxi - Store building completely destroyed by the storm. Broadwater Marina can be seen in the background.

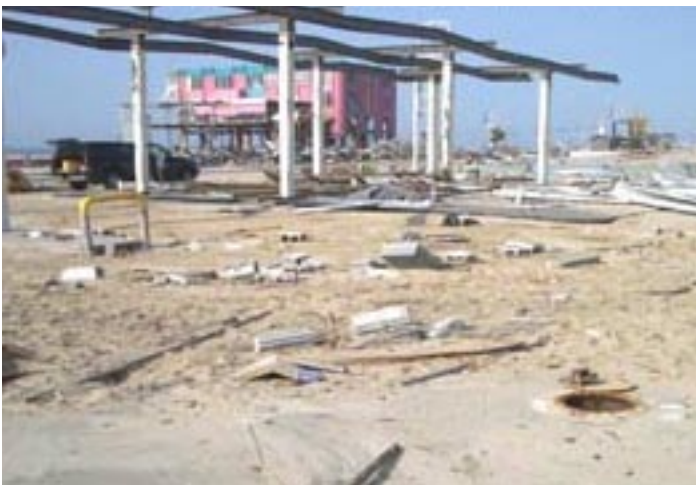
P & L Quick Mart, Biloxi - Store after the storm. Only one tank could be accessed here due to the sand/debris covering the parking lot.

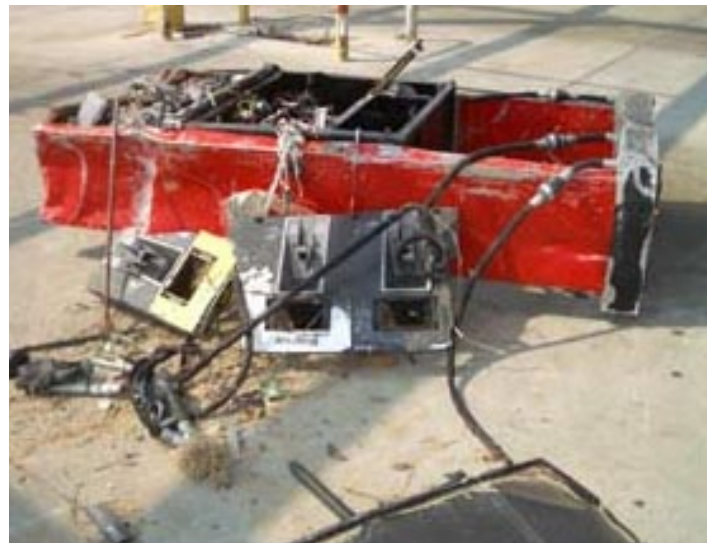
Pantry, Biloxi - The dispenser cabinets were found up to 1/4 mile away.

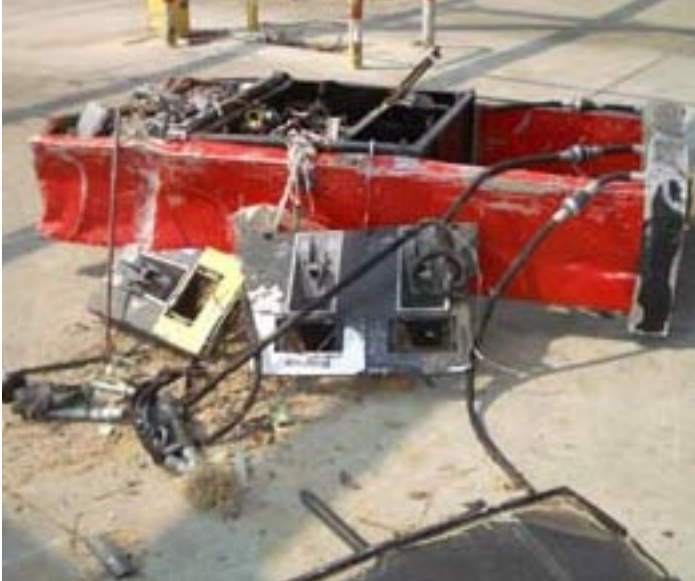
Pantry, Biloxi - The dispenser cabinets were found up to 1/4 mile away.

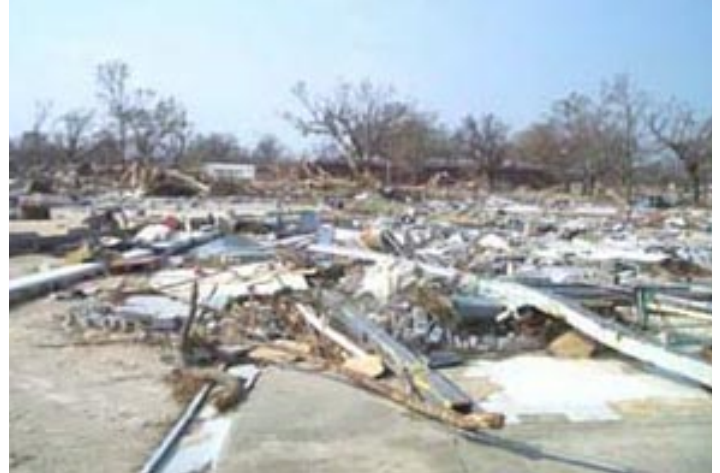
Dixie Gas #10, Gulfport - Store completely demolished by the storm. Note the barge and shipping containers (this store was near the port in Gulfport) in the background that probably contributed to the complete destruction in this area.

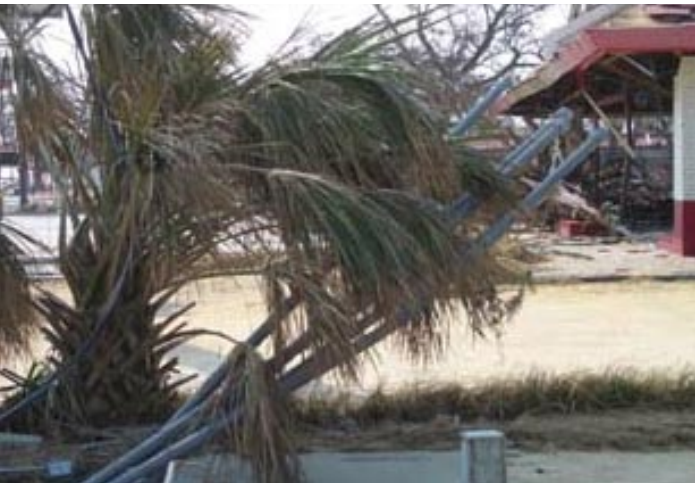
Edgewater Chevron, Gulfport - Store building was completely destroyed but the tank vent lines although badly bent, remained standing. The building to the right in the photo was a McDonald's restaurant immediately adjacent to the Chevron.

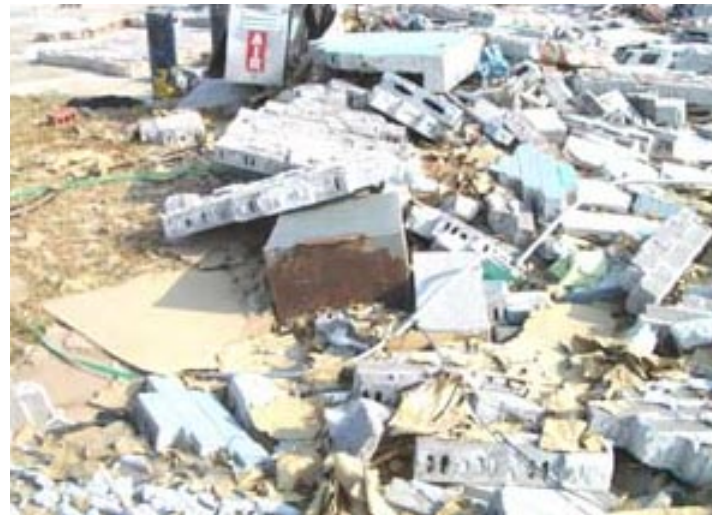
Dixie Gas, Gulfport - Cathodic protection system rectifier (face down) and air compressor were about the only things recognizable at this store.

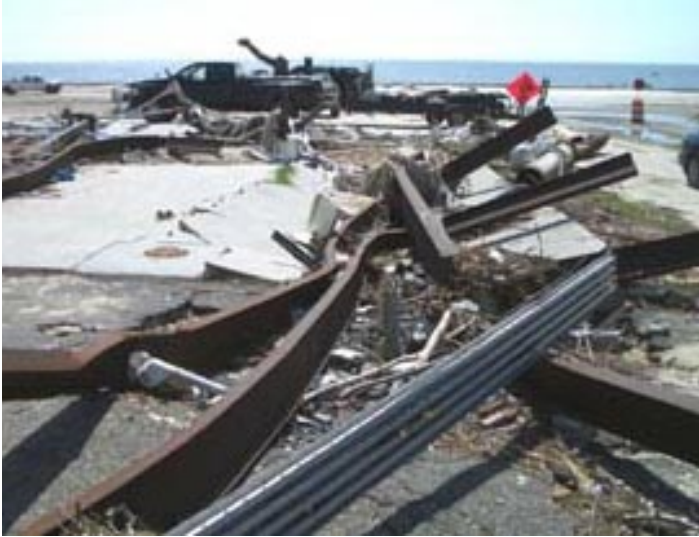
Walco Mart, Gulfport - View of the tank pit showing the "regular unleaded" tank. Apparently, the tank backfill materials were scoured out by the storm surge and the weight of the steel I-beams caused the concrete pad to collapse.

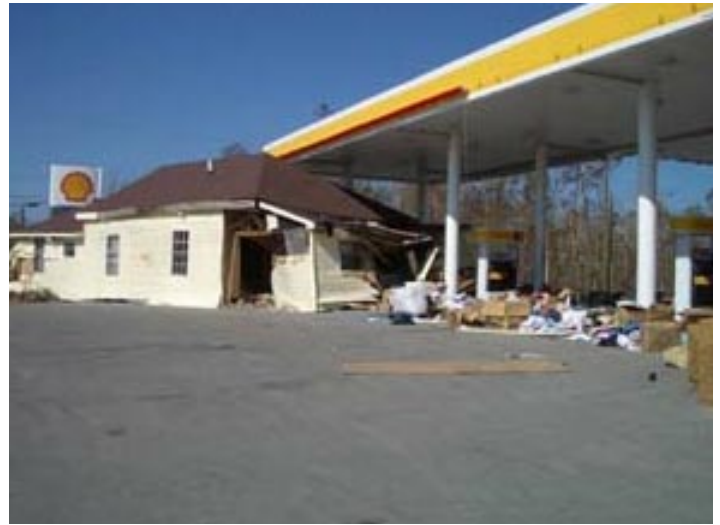
C & J Shell, Pass Christian - This store where a home "floated" up to the dispenser islands is several miles from the coast.

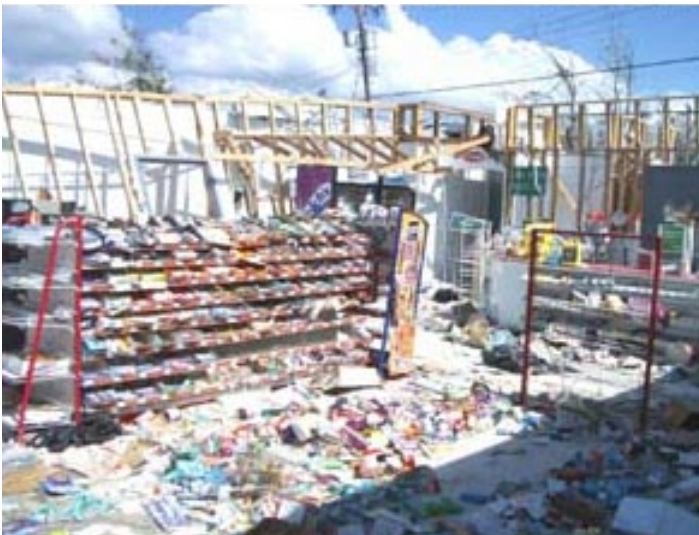
Ben's Chevron, Long Beach - This store was several miles from the coast and no flood waters reached it. This damage was caused by the 120+ mph winds.

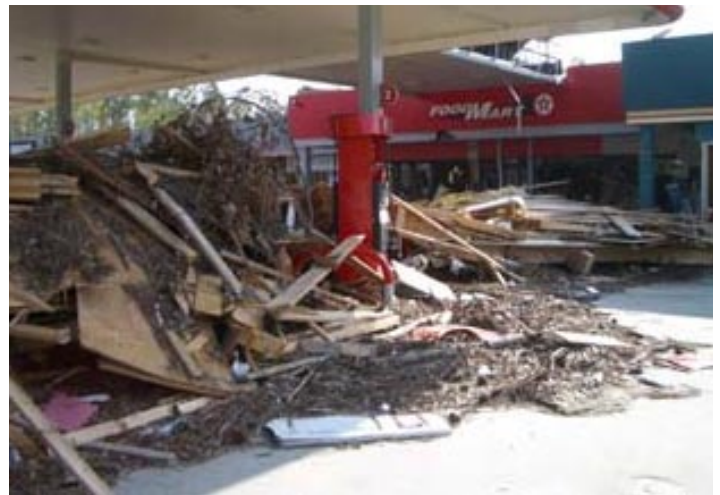
Two Jacks Texaco, Diamondhead - Huge pile of debris left at the dispenser islands of this store.

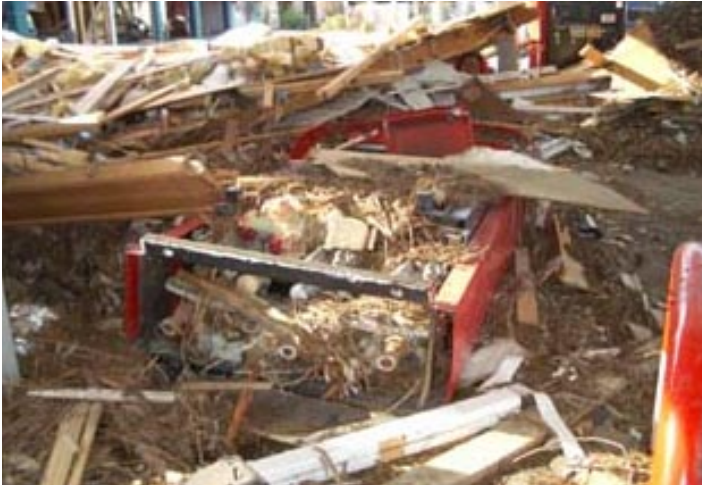
Two Jacks Texaco, Diamondhead - Dispenser cabinet buried amid the debris.

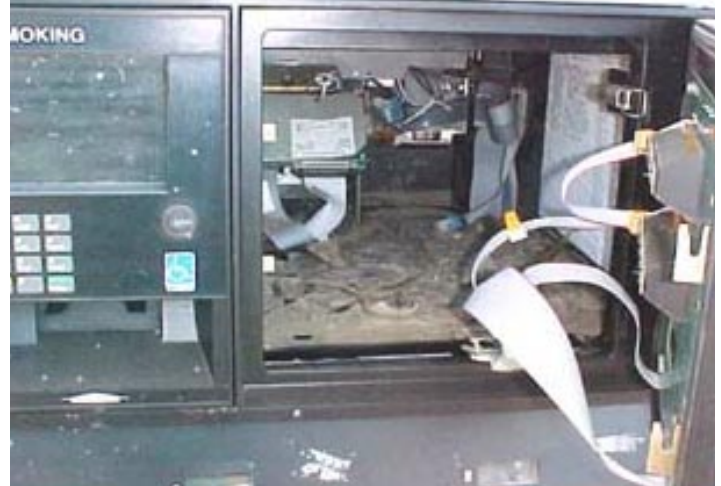
Gas-N-Go, Bay St. Louis - Mud inside brand new dispensers indicates floodwaters ruined all the electronics in these dispensers.

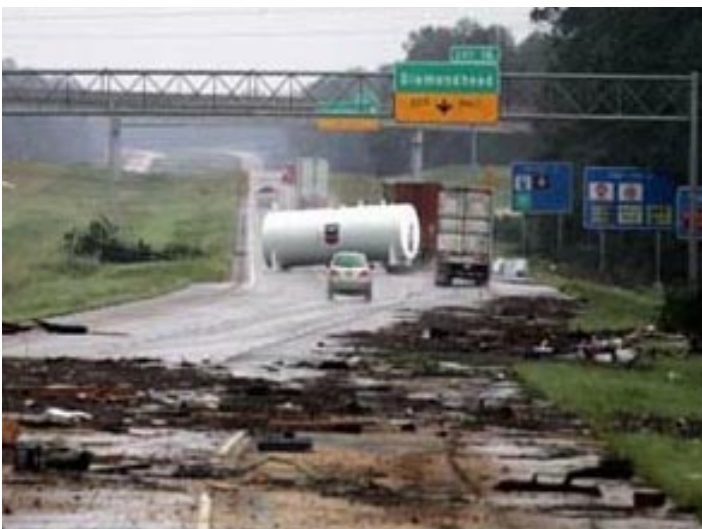
Private Airport, Diamondhead - 4000 gallon AvGas tank tore itself from anchoring and floated down the runway winding up right in the center of I-10 eastbound.

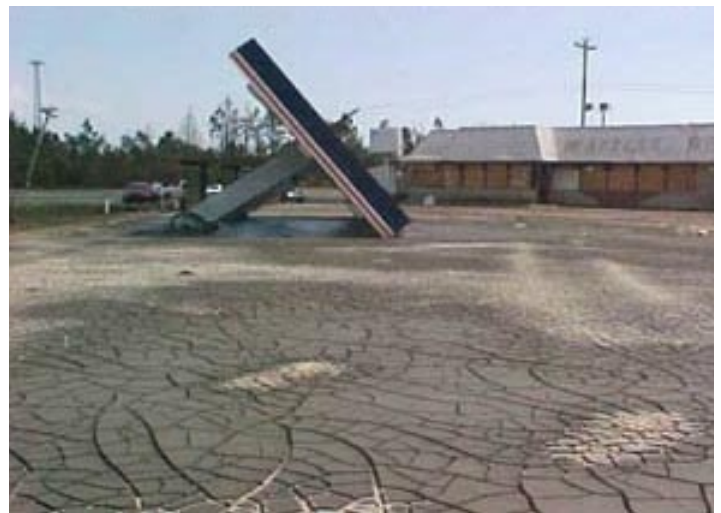
Pure, 13031 Hwy. - Store is 5 miles from the coast. Floodwaters deposited mud and wind knocked canopy down. Tank vent lines were broken when the canopy fell and tanks filled with water. Tank fills are two light spots in foreground.

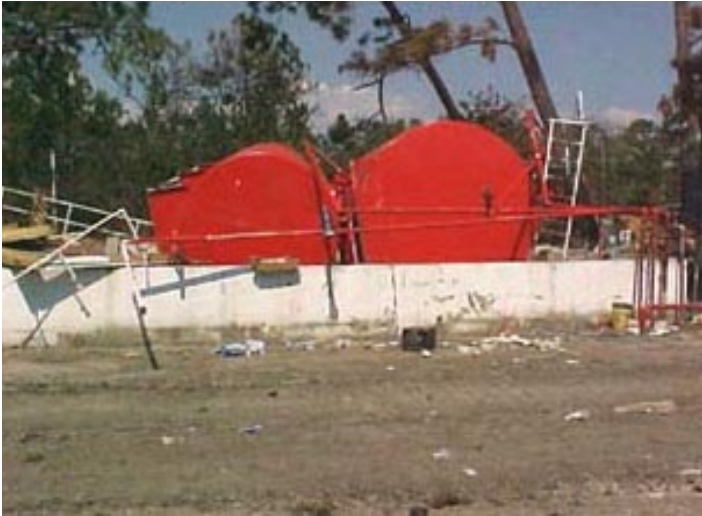
Todd's, Bay St. Louis - These AST's all broken loose from the product lines and rolled over. One of the three tanks is missing from the tank farm.

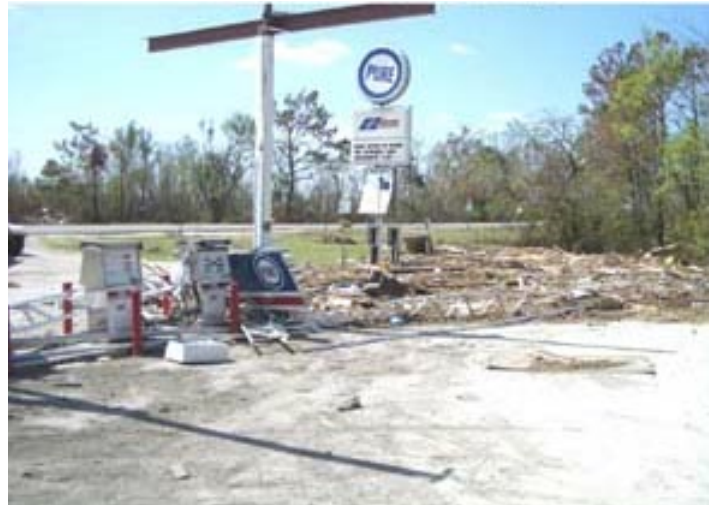
EZ Serve, Pearlinton - No access to the tank at this store as they are all underneath the debris and rubble.

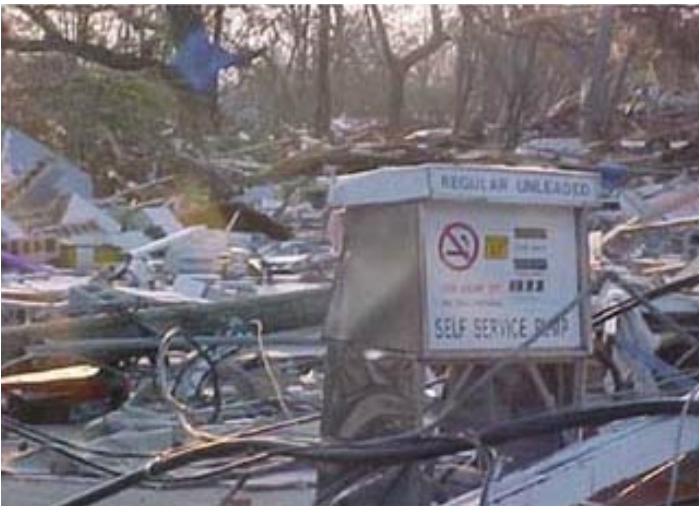
Wavemart, Waveland - Store as it appeared after the storm.

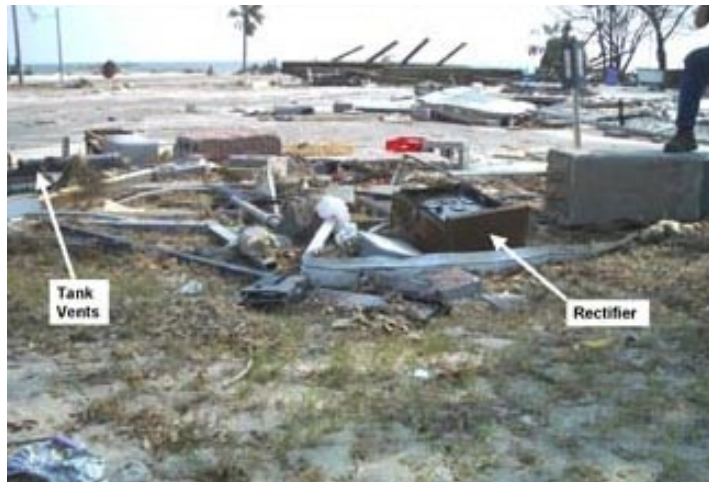
Shell, Gulfport - Impressed current cathodic protection system rectifier remained on site, tethered to anode lead wires.
