Sparkill Creek – Citizen Science Pathogen Indicator Project

Sparkill Creek Watershed Alliance

Final Report

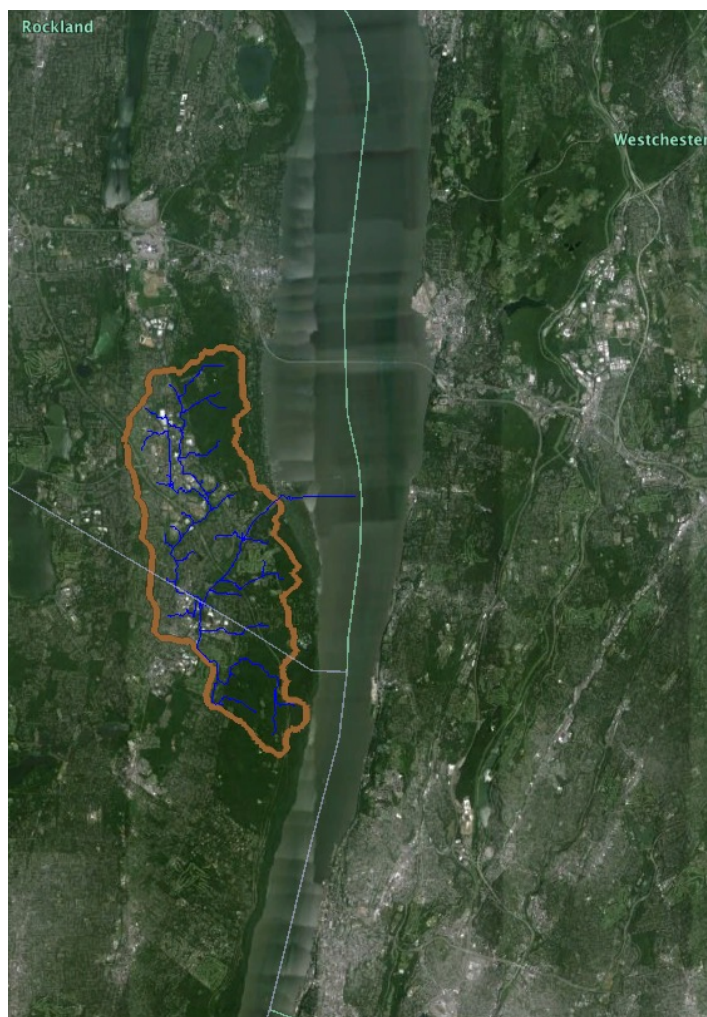
Figure 1: The Sparkill Creek Watershed. Note the NY/NJ border crossing the watershed, the Tappan Zee Bridge to the north, and the confluence of the creek with the Hudson River at Piermont

The Sparkill Creek watershed occupies the southeastern portion of Rockland County, NY plus a smaller section in Bergen County, NJ totaling almost 12 square miles (Figure 1). In many respects it is a typical suburban stream, with several apparently pristine parkland areas, residential areas and more heavily developed light industrial and commercial strips. There are no significant agricultural areas in the watershed.

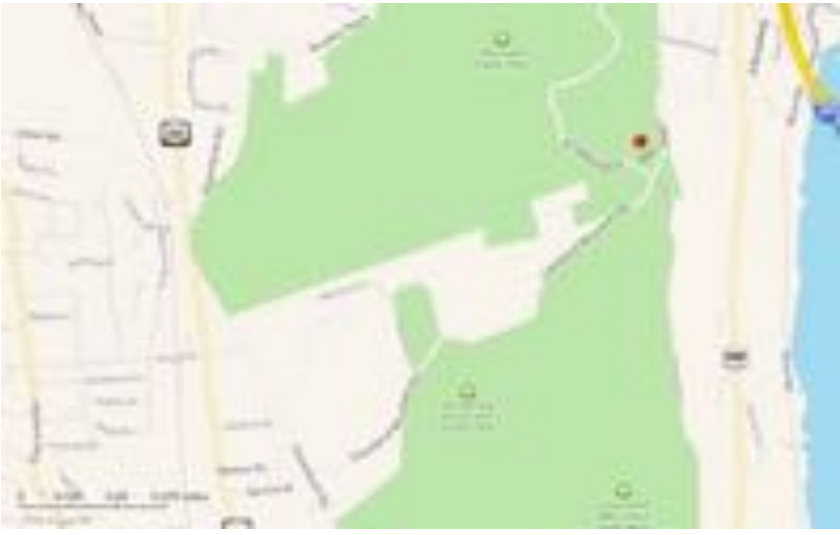
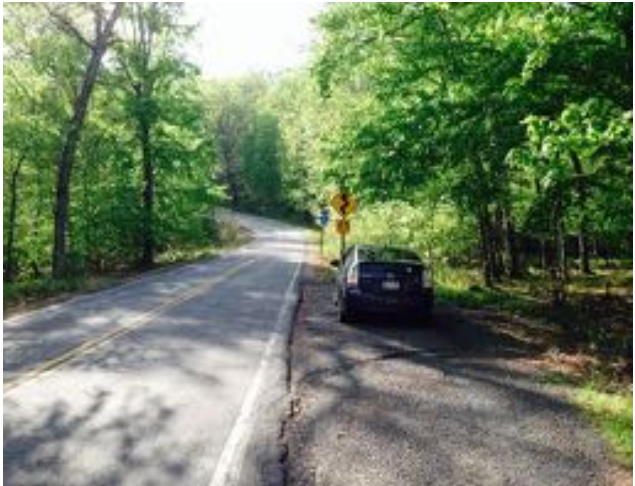
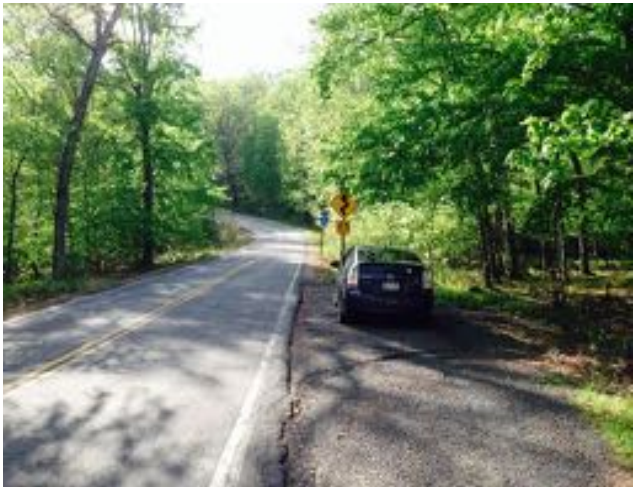
Location ID SPC-01 Location Description Tweed

Latitude 41.070922° Longitude -073.928047°	
Directions NE on Clausland Mtn Rd. Left (N) at stop sign (Tweed). Park immediately on Right.	
Safety Traffic is light here but motorists are not expecting pedestrians. Cyclists appear from north noiselessly.	
Site Site is on right side of road and a hundred feet down Tweed from parking.

Notes The site is on State Park land. This tributary originates to the east of the road in a wet area at the edge of the watershed. If there is no flow during dry conditions, seek water further east. Note that though this site is fairly remote, drainage from at least some part of one residential property across Clausland Mountain Rd. does enter the wet area that feeds this site.

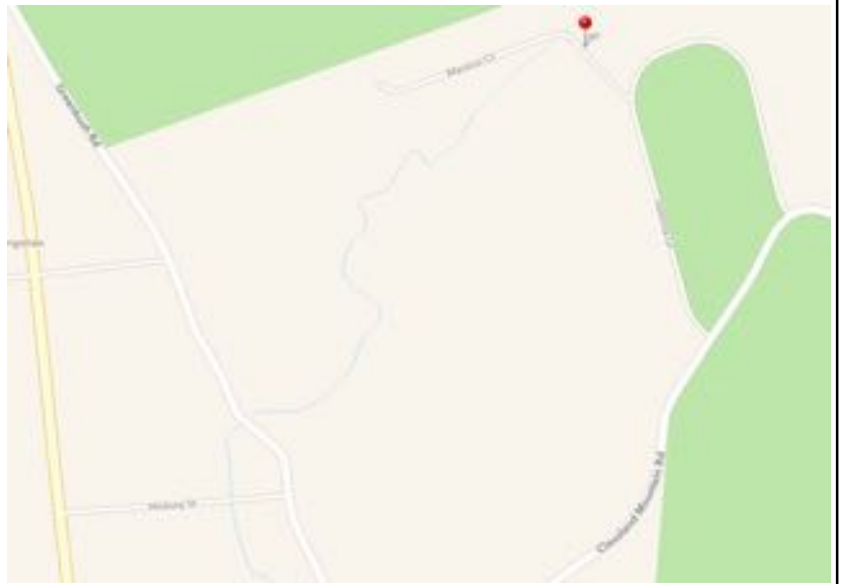
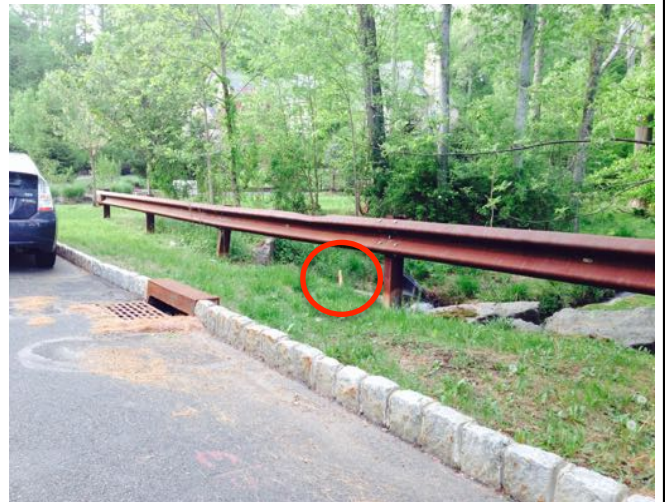
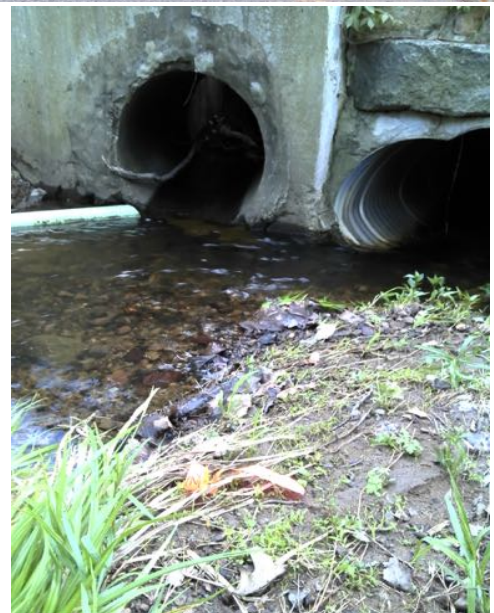
Location ID: SPC-02
Location Description: Marsico

Site Access via driveway to left of stream. Sample near culvert (upstream of road, north side). Include confluence of both the small stream and input from black culvert entering at this site.

Notes Also sampled for Riverkeeper program. This site is downstream of SPC-01 Tweed but the area in between has several small ponds/reservoirs. Some undoubtedly flow to this site but note inflow further up Marsico into this former wetland area. Note sewage pump station just up Marsico on right. Immediate neighbors interested in this project and are friendly.

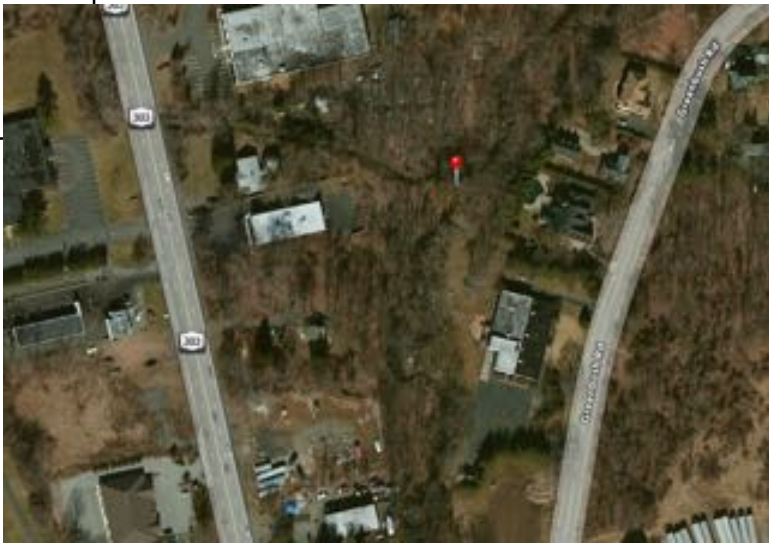
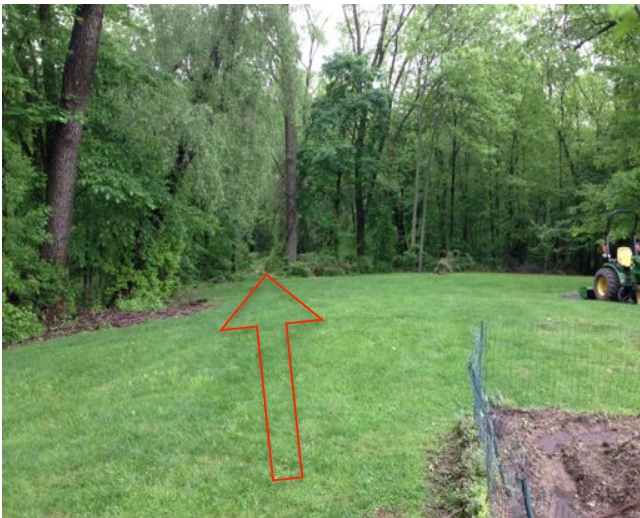
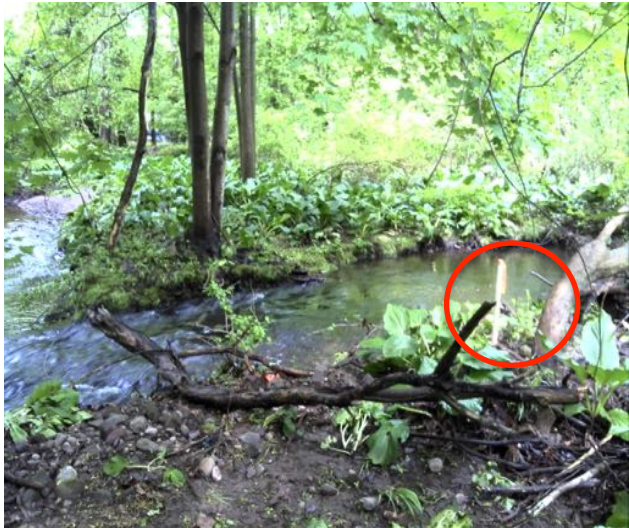
Location ID:	SPC-03

Location Description:	Inertia Switch (main stem)	
Latitude Longitude	41.054469° -073.945072	
Directions	South on Greenbush Rd. to Inertia Switch. Right into parking lot. Sample at both SPC-03 and SPC-04 at this location.	
Safety	Parking lot is an active work site. Be aware of trucks. Sampling site may be flooded during heavy rains. Wear at least knee high boots for wading to adjacent sample site (SPC-04)	
Site	Walk north across lawn with stream on your left. Site is upstream 100' into wooded area on eastern bank. Sample above confluence of Blauvelt arm. Site SPC-04 is on this arm at left of photo.

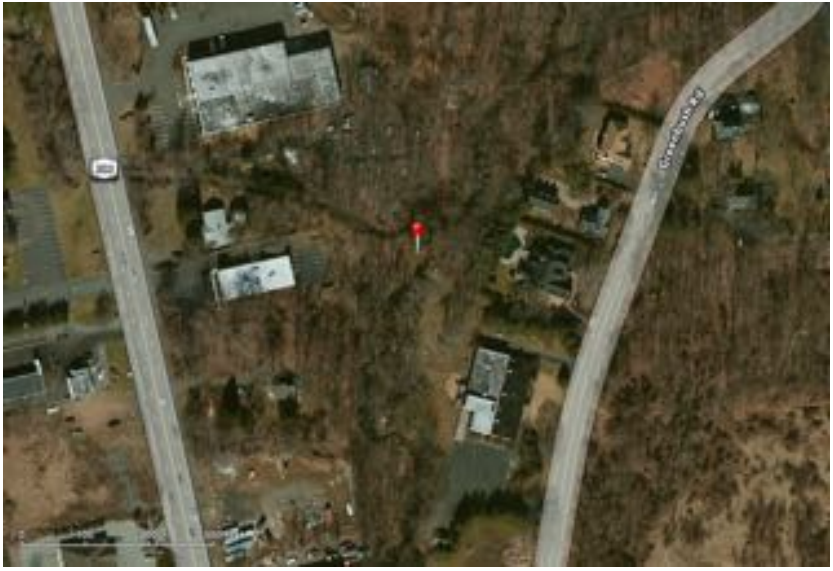
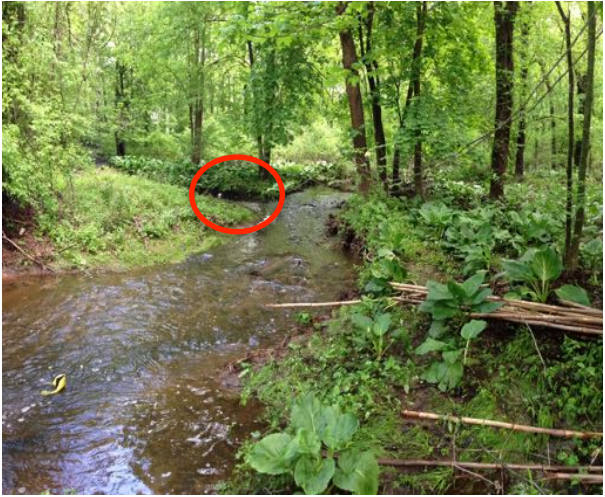
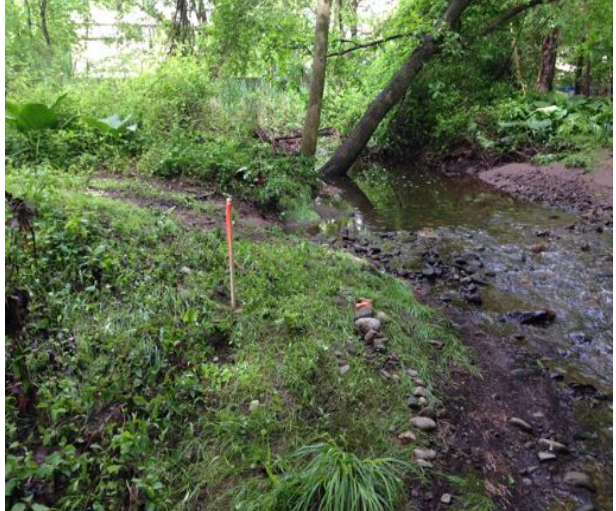
Location ID:	SPC-04

Longitude	-073.9451500°	
Directions	As in SPC-03. From SPC-03, wade across shallow section of creek to access this incoming tributary.

Safety	As for SPC-03. Main stem of Sparkill is shallow above SPC-03 sample point even with moderate rain effect. Some deeper portions (3-4 ft.) at confluence. Blauvelt Arm also shallow. Knee high boots will ordinarily be sufficient.	
Site	Sample best at SW corner of this confluence. Photos are looking upstream.	
Notes	Under flood conditions this site may be better accessed from parking lot of building on Rt. 303 (Approximately 523 Rt 30, Orangeburg NY) - see path in photo here to back of building.

1 Mean enterococcus counts at the Upper Blauvelt Arm (SPC-04) are substantially higher than any other site during dry weather. This site has two unusual factors: 1- it is fed from a small storm water detention basin from the Blauvelt area, 2- a sewage transfer pump is located very nearby. Sewage overflow at this pumping station or at adjacent pipes was noted within the last several years.⁹ Another site with somewhat elevated counts is Closter Rd (SPC-12) this may also require follow up though no obvious source is evident. These results will be presented to the Orangetown Sewer District authorities for further investigation.

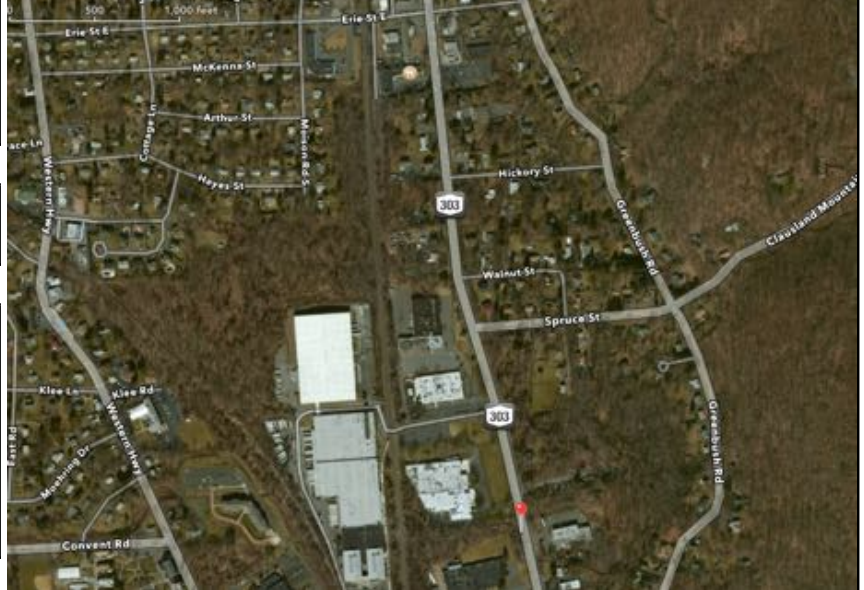
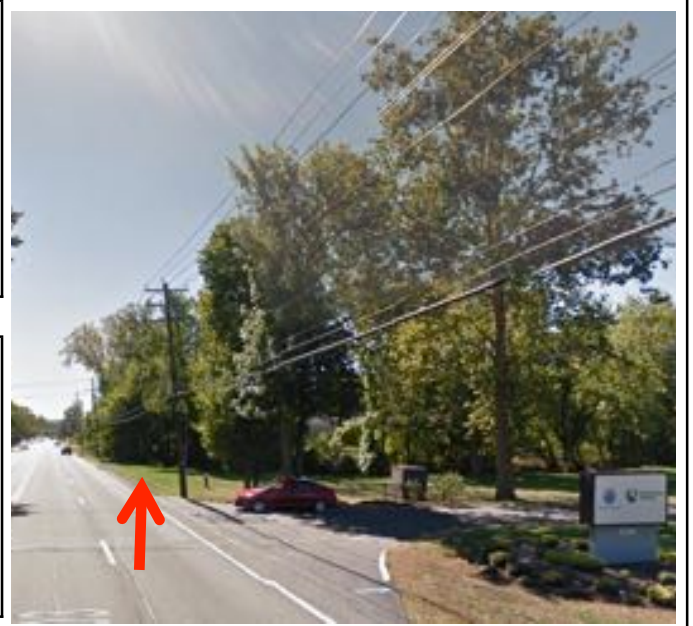
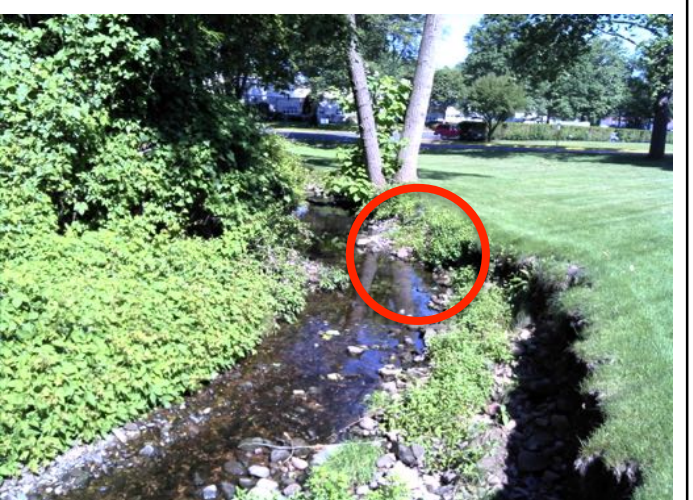
Location ID: SPC-05 Location Description: Blauvelt Arm at 303

Latitude 41.05515 Longitude -073.94725	
Directions South on Rt 303 past Glenshaw, park just past Instrumentation Laboratory entrance. Sample point is just off 303 on right down bank.	
Safety Take care on busy Rt. 303. Park on 303 Right of Way - not parking lot.

Site Site is small tributary just west of Rt. 303 down bank just downstream the bend	
Notes The original intent was to sample upstream of this location near the RR tracks however, access is Instrumentation Laboratory who declined (Jeanette DeGennaro EHS Compliance Manager, 845-365-8044). As a result the sample point is just downstream of the main Rockland County sewer line to the treatment plant. Elevated access covers visible on across stream from sample point.

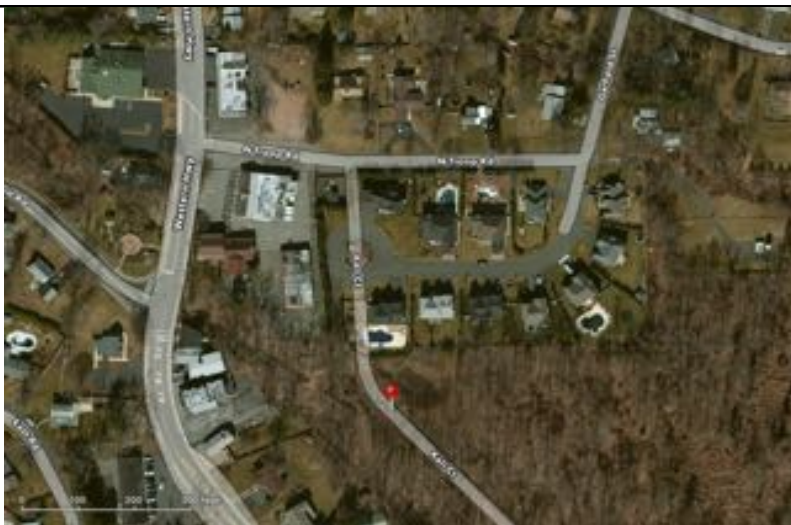
Location ID:	SPC-06

Location Description:	Blauvelt Arm Upstream	
Latitude	41.0590167°	
Longitude	-073.9560667°	
Directions	From Western Hwy N, right on N Troop Rd then right on Murphy Ct to 2/3 around circle to access road in photo. Park on Murphy. Walk down road past gate.	
Safety	Many children play on this dead end street. Some concern by neighbors of transients at adjacent empty stores.	
Site	The access road joins the former railroad right of way now the Clarke Rail Trail. Site at outflow to the left of the trail past the detention pond in back of the house (photo at right taken from the trail).	
Notes	Kali Ct shown on the map above <u>does not exist</u> . Note sewer pump station at Murphy Ct circle. John Hayes (cell 917 676 4817) at 14 Murphy Ct is aware of our work; use him as a reference if issues arise. This is on the Clarke Rail Trail, public property. Alternative access is from the left of Wally's Ice Cream on Western Hwy at end of parking lot at Trail sign. Modeled flow shows this site feeding SPC 05 but exact flow uncertain

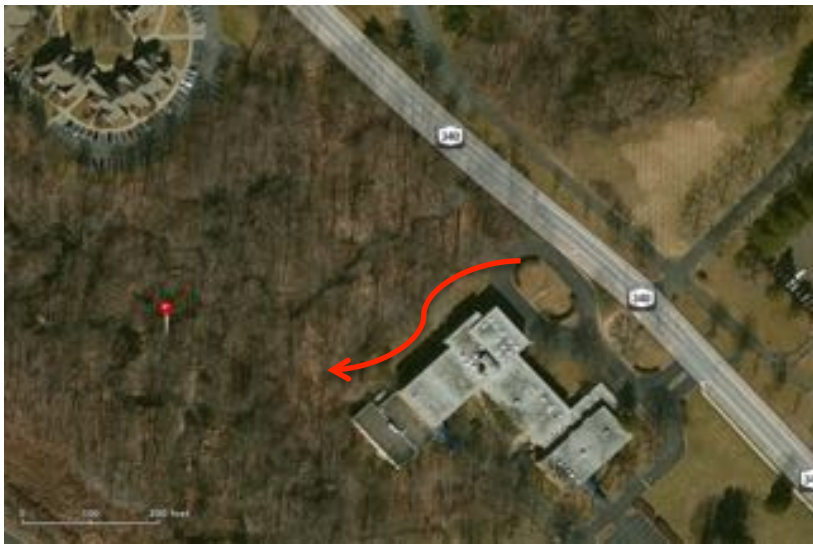
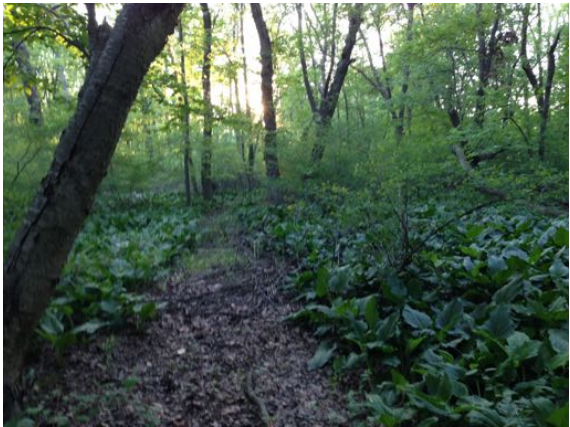
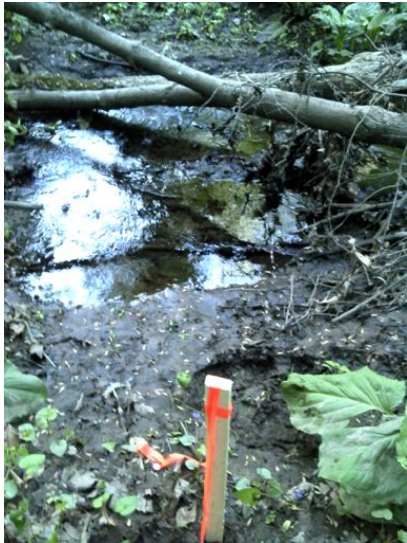
<p>Location ID: SPC-07</p> <p>Location Description: Trib 9a at confluence</p>

<p>Latitude 41.0390333°</p> <p>Longitude -073.9372667°</p>	
<p>Directions NW on Rt. 340; turn rt to access road across from LIU building. (Park here for SPC-08 too). Walk across 340 past end of traffic circle and along NW side of building.</p>	
<p>Safety Route 340 is a relatively busy road. Take care. This site is accessed by a trail which is often muddy or even submerged. Rubber boots mandatory. Poison ivy is prevalent.</p>

<p>Site Walk next to the LIU building to the end of the grass and into the woods. Follow an old trail 100 yards until the tributary is visible. Sample site is ~20 yard from the confluence with the Sparkill.</p>	
<p>Notes Alternative access from the rail trail at the Orangeburg WWTP. This requires wading the Sparkill. The LIU building is rented from the Venture Center. Mark Lukens at Camp Venture has granted us access with the cooperation of the site manager Diana Delollio (845 365 1316). Calling her a day before testing will help. We may get parking on the driveway circle.</p>

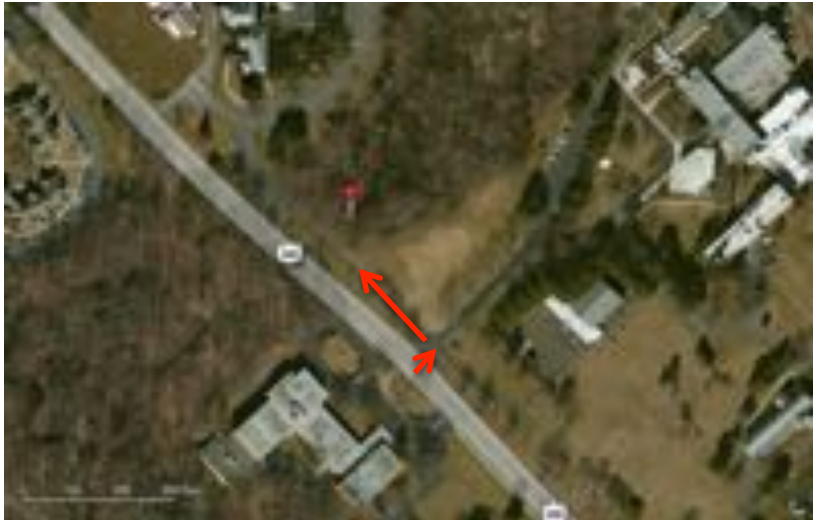
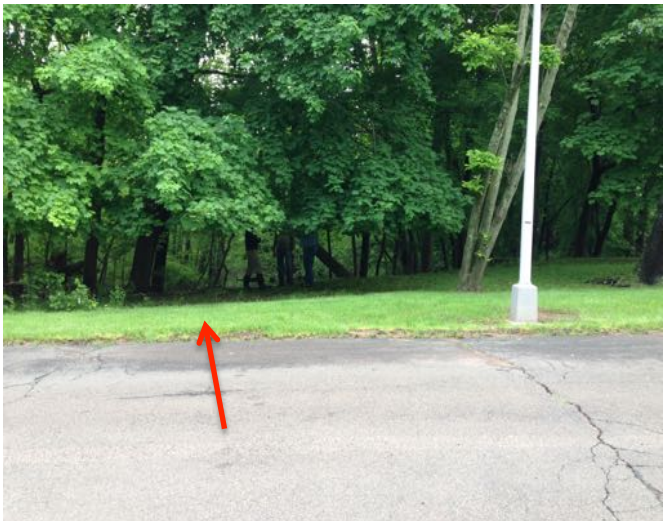
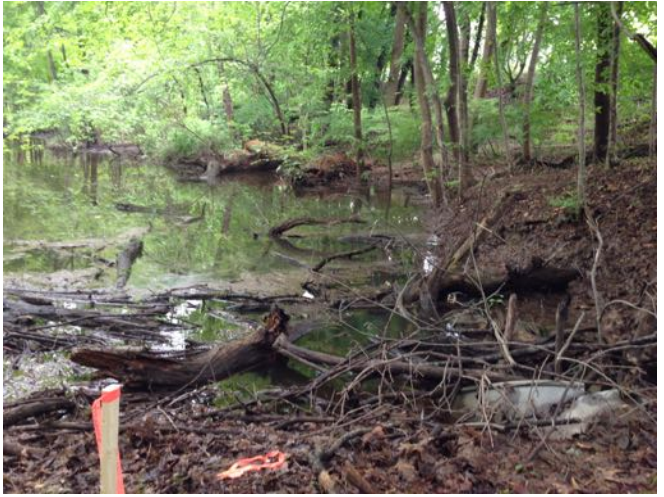
<p>Location ID: SPC-08</p> <p>Location Description: Trib 9a at 340</p>

<p>Latitude 41.03998</p> <p>Longitude -073.93517</p>	
<p>Directions Route 340 to Dominican Convent entrance across from LIU . Park along the parallel access road for this site and SPC-07</p>	
<p>Safety Poidon Ivy is prevalent though low at beginning of season. This site is muddy. Recent storms have brought many downed trees; flow is restricted. Sampling may be easier to the left along the shore. Use of a pole will help avoid problems with the muddy bank.</p>

<p>Site Site is across access road into the woods on the left (west) side.</p>	
<p>Notes This site is on border of the college and the convent. Messages to buildings manager are yet to be returned. This stream is directly downstream of SPC-09. Note clogged culvert in photo. When assessed in winter 2014 this site was more free flowing. Subsequently, blockage to the pond outfall has restricted the flow considerably.</p>

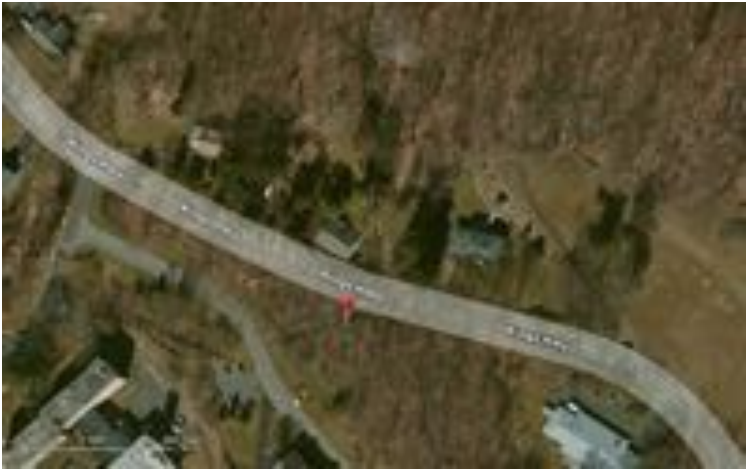
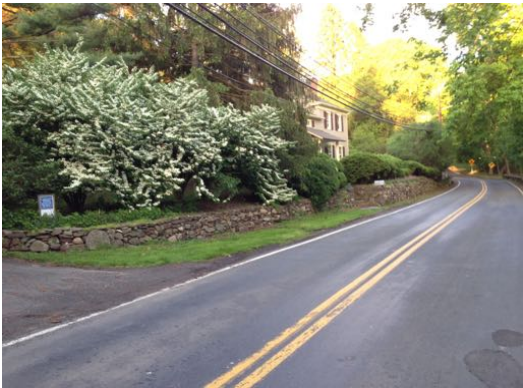
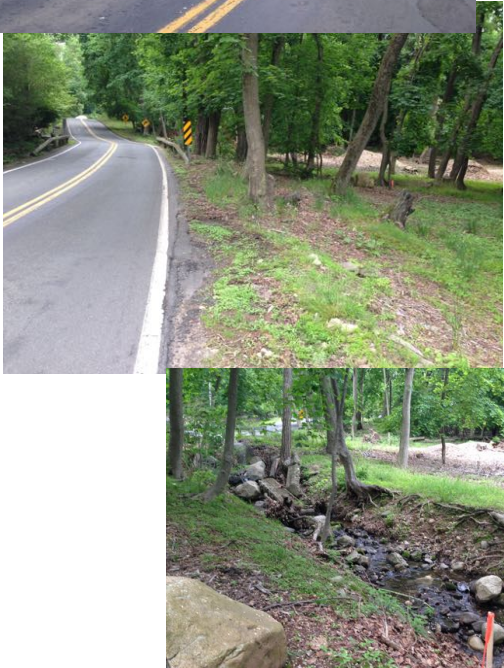
Location ID: SPC-09 Location Description: Trib 9a at Kings Hwy

Latitude 41.04150 Longitude -073.93101	
Directions Kings Hwy from either Rt 303 or Rt. 340 to Dowling Gardens driveway (turn south) across road from 171 King's Hwy then immediate left to small lot right.	
Safety This road has minimal traffic but the curve and rise present limited visibility. This is a senior citizen facility.

Site Site is back up the stream between the driveway and Kings Hwy. Approach from the left side (west).	
Notes This site is fed by a small pond in back (north) of 171 Kings Hwy. In the dry parts of the season when flow is low this pond may be substantially if not totally fed by a drinking water well overflow. Septic input higher up the watershed seems unlikely though some houses are situated there.

Areas with only septic systems feed two sites, Trib 9a at Kings Hwy (SPC-09) and Ferdon Outfall (SPC-16). As noted above for these sites, enterococcus counts can be high here in wet weather. During dry periods, counts are among the lowest of the study.

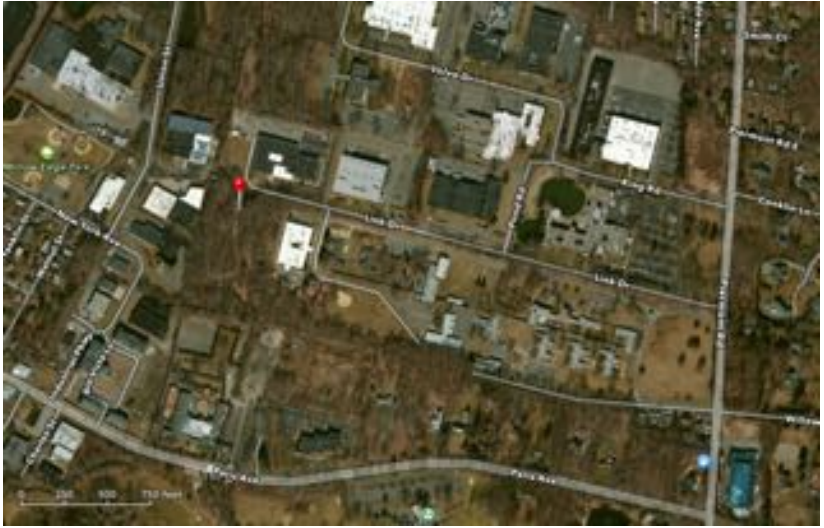
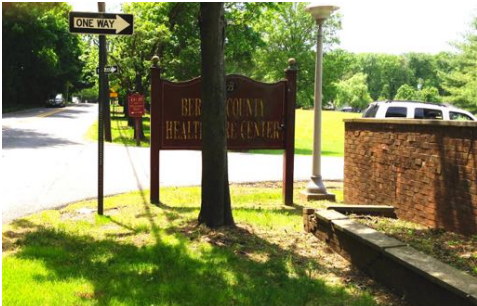
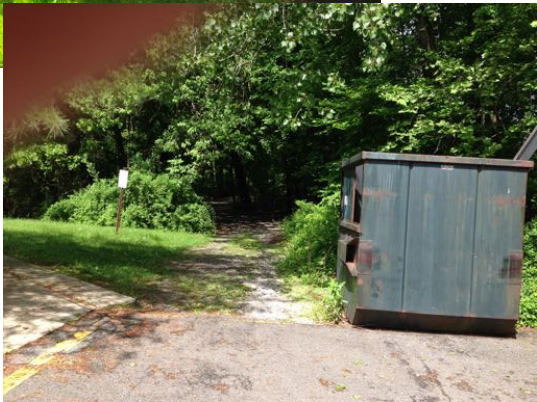
Location ID:	SPC-10

Site	Walk down trail past dumpster to Sparkill Brook. Site is on the near bank to the left of the bridge. Sampling done here for Riverkeeper project (blue circle). Plan on taking sample more conveniently from upstream side of bridge with pole (red circle).

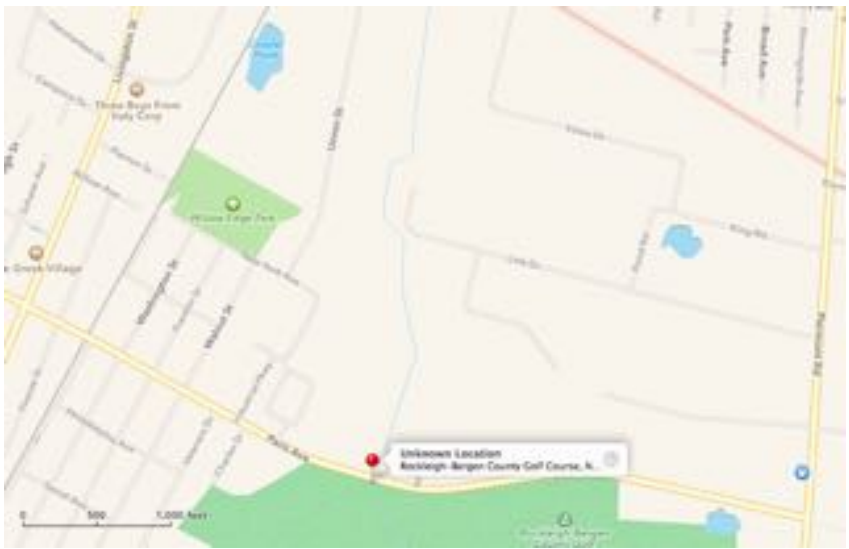
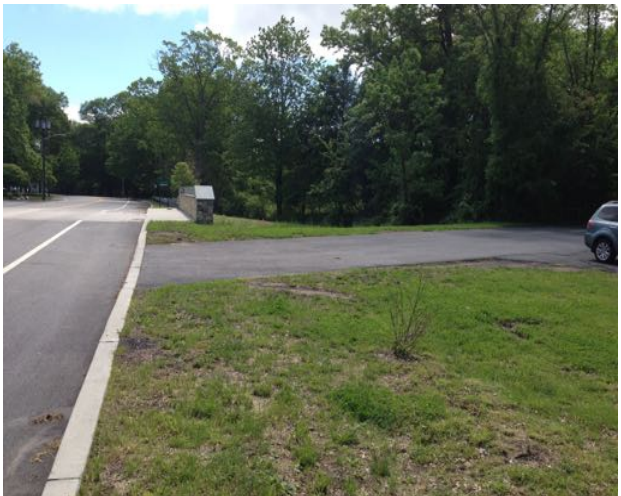
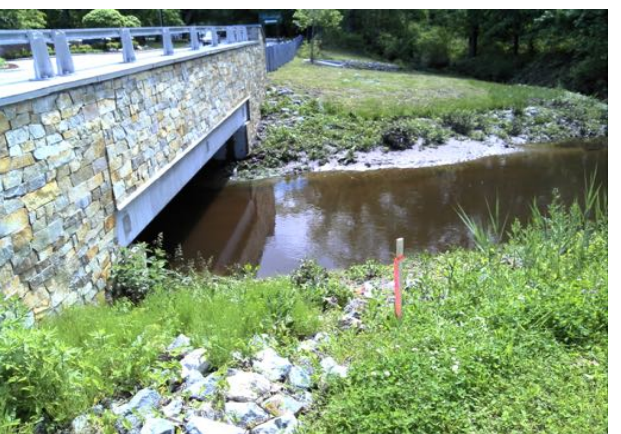
Location ID:	SPC-11

Location Description:	Sparkill Brook at Paris Ave	
Latitude Longitude	41.00341 -073.94065	
Directions	Take Paris Ave. East from Livingston for about half mile. Take driveway right before Sparkill Brook bridge to park.	
Safety	Slope is somewhat steep but access next to bridge where purchase is possible.

Site	Site is directly down the bank next to bridge.	
Notes	The stream flows from the Rockleigh Golf Course.

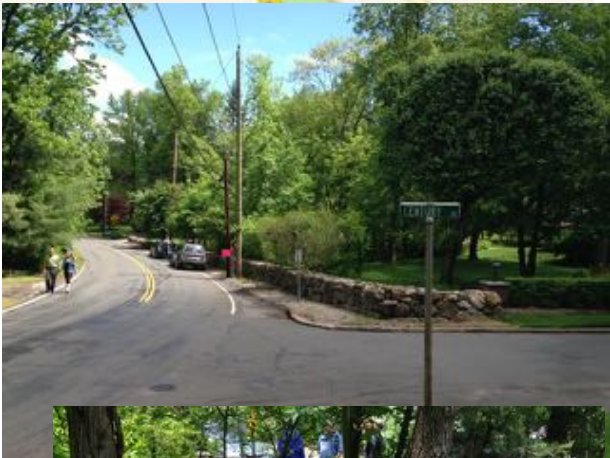
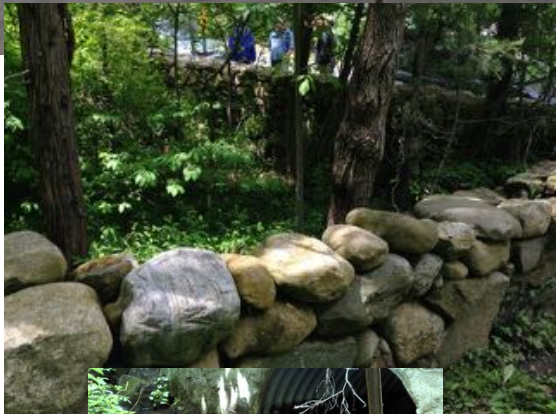
<p>Location ID: SPC-12</p> <p>Location Description: Closter Road</p>

<p>Latitude 41.00822</p> <p>Longitude -073.91865</p>	
<p>Directions From Oak Tree Rd take Closter Rd south or from Piermont Rd north take Willow; turn left Closter to vicinity of Century Road for best parking. See Note</p>

<p>Safety Virtually no walkway on this narrow road between cars and the stone wall. Park on Willow. Care must be taken with the walls but they are low and ground relatively even.</p>	
<p>Site Site is over rock wall on east side of road at catch basin. Best access is from adjacent driveway to the north where the stone wall is easy to get over. Note whether the sample represents both small streams or only one. Alternatively could be taken from road with pole.</p>

<p>Notes Will attempt communication with neighbors with driveway. This area has sewers in the street but little upstream of the site. Watershed ends approximately at Rt. 9W to the east. <u>Note</u> that Willow Ave is one way (eastbound) during the morning hours so this site is best sampled after the NJ sites.</p>

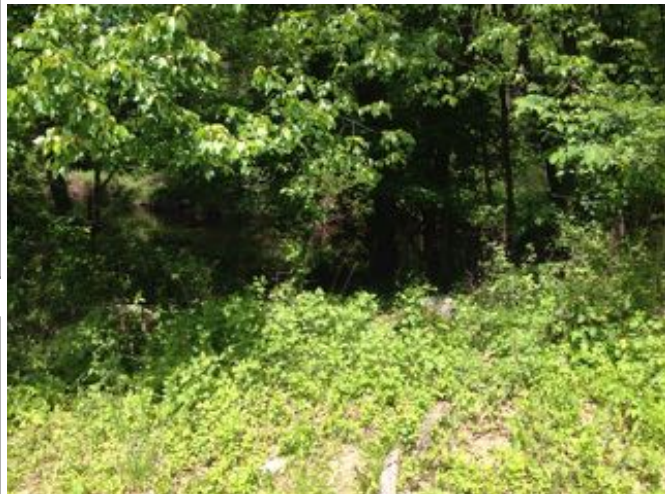
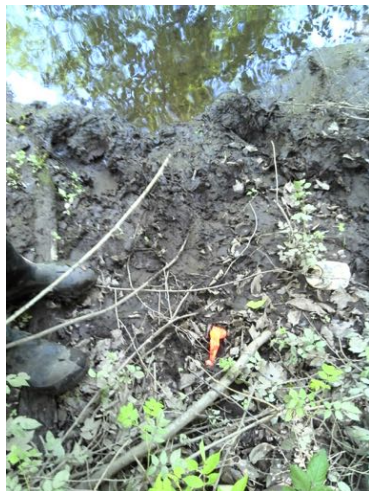
Location ID:	SPC-14
Location Description:	Graney Gardens

Location Description:	Rt. 340 Sparkill		
Latitude Longitude	41.02576 -073.92716		
Directions	Rt 340 south past firehouse and group of houses. Turn right (west) into bare parking area. Site is accessed at north end of the lot through trees (photo).		
Safety	Poison Ivy abounds in the short distance from parking lot to stream. Stream bank is very muddy.		
Site	Site is directly adjacent to the parking area with eroded muddy banks. This site may be easier sampled with a pole especially during wet periods.		
Notes	Parcel owned by Town of Orangetown. Slightly upstream of SPC-14 outfall. This site is sampled for the Riverkeeper project.

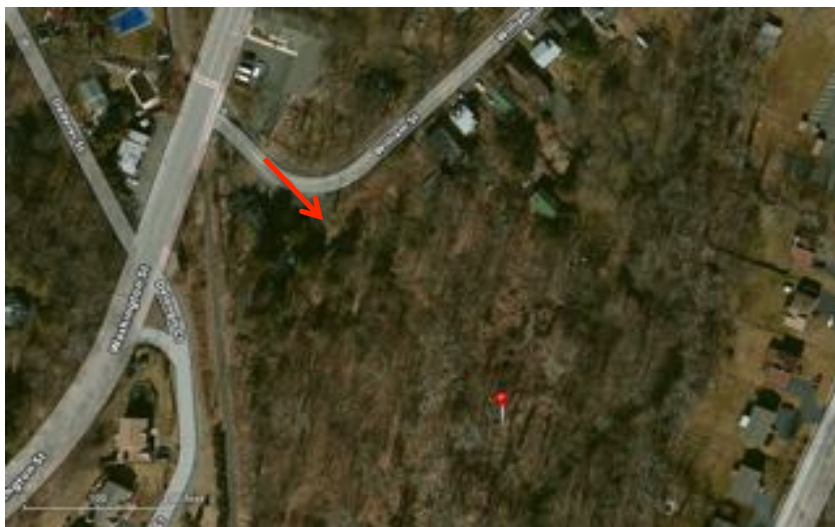
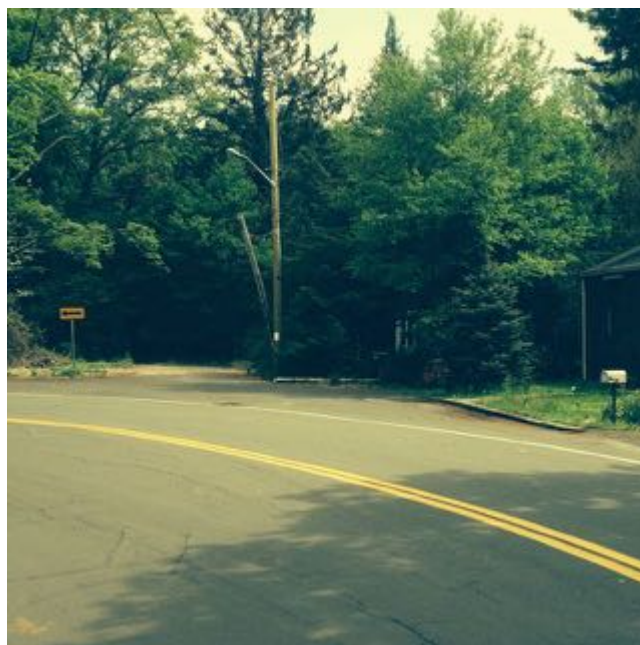
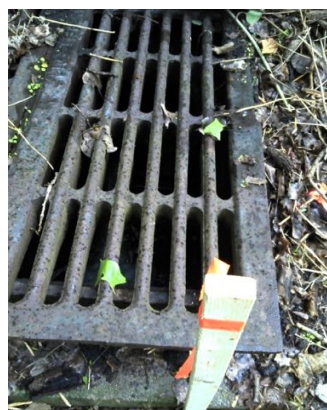
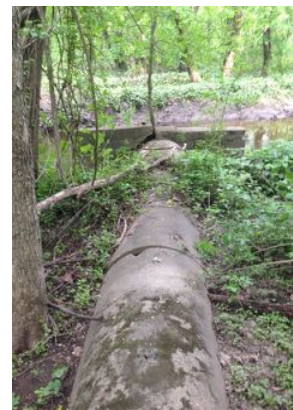
Site	Follow path to a bowl, frequently filled with water. Going around it to right to avoid much poison ivy. Exit bowl area two thirds of the way around (about 10 o'clock) via swale leading to stream. Site is a catch basin to left of swale 20 yards along. Listen for constant water falling. Sample this catch basin using pole.
-------------	---

Notes	This catch basin (photo near right) feeds a second large pipe that empties into the stream (photo far right) where sampling would be difficult. Plus, in flood, the stream is above the pipe. Note after sampling season: the approach to this site has been cleared for development. This approach will be a street.
--------------	---

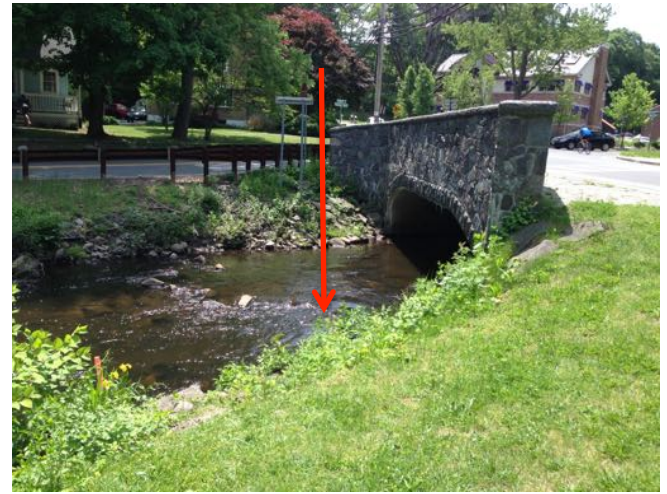
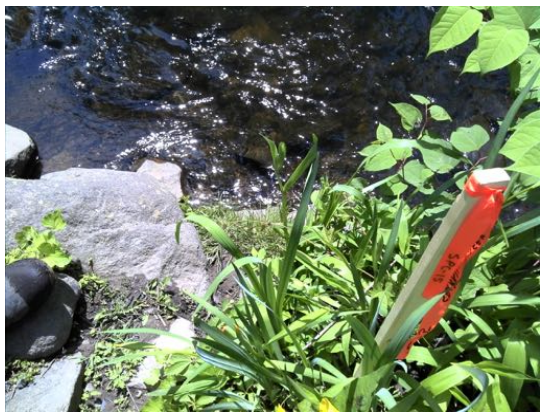
Latitude 41.02931 Longitude -073.92541	
Directions North on Rt. 340 to stop sign in Sparkill. Bear left on 340, pass Ferdon Ave. Immediately pass over bridge and turn right to park.	
Safety Relatively high traffic area at this intersection. Frequent cyclists. Water may be high after rain. Careful of sharp rocks.

Site Site is just down stream of bridge on North bank.	
Notes This is likely the most sampled and tested site on the Sparkill, having been part of most studies in the last decade. Administered by Village of Piermont, the pond is property of United Water; possibly same for this site.

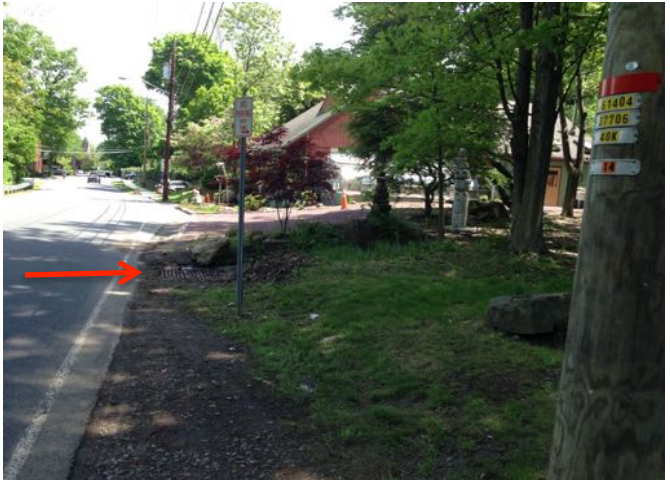
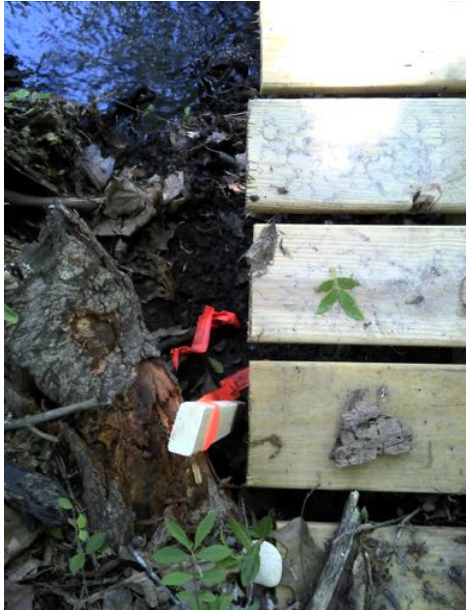
Latitude 41.03429 Longitude -073.91965	
Directions NEast on Ferdon from Rt 340 toward Piermont. Site is on right just prior to Rockland rd and bridge and before Outside Inn Gallery. Park on right before site.	
Safety Busy local road.

Site The streamlet feeds the catch basin at right side of road from the right (south). Sample slightly upstream at the small footbridge.	
Notes This streamlet source is surface water from the homes along Rockland Rd. and Tallman park. It is small and may not be running in late summer - check upstream for more flow.
