AN OVERVIEW OF THE SITE CHARACTERIZATION AND LNAPL MASS REDUCTION

MEMPHIS SHELL LUST SITE

Larry Kinsman

ORIN Technologies, LLC

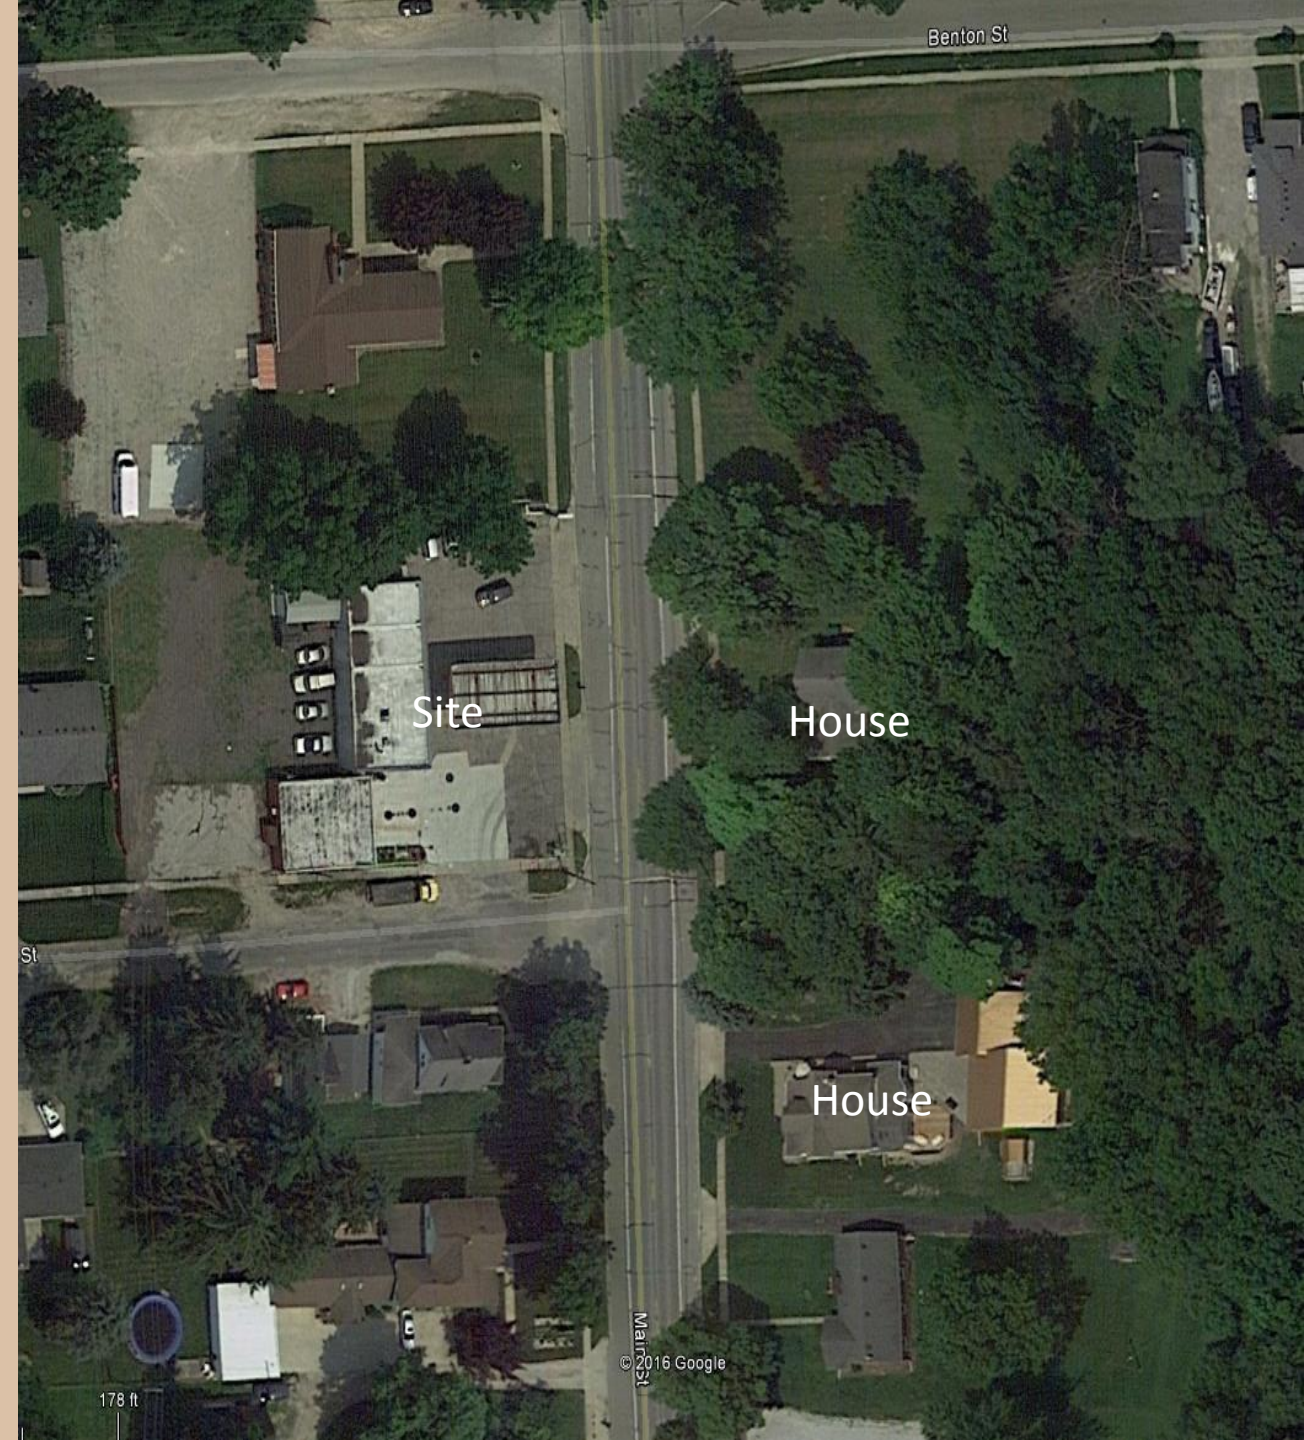
ZOOM IN...

- “Site” on west side of M-19 (Main Street)
- Former (and current) UST basin
- Residential dwellings, with basements, on east side of M-19
- Sparse residential and wooded land to east

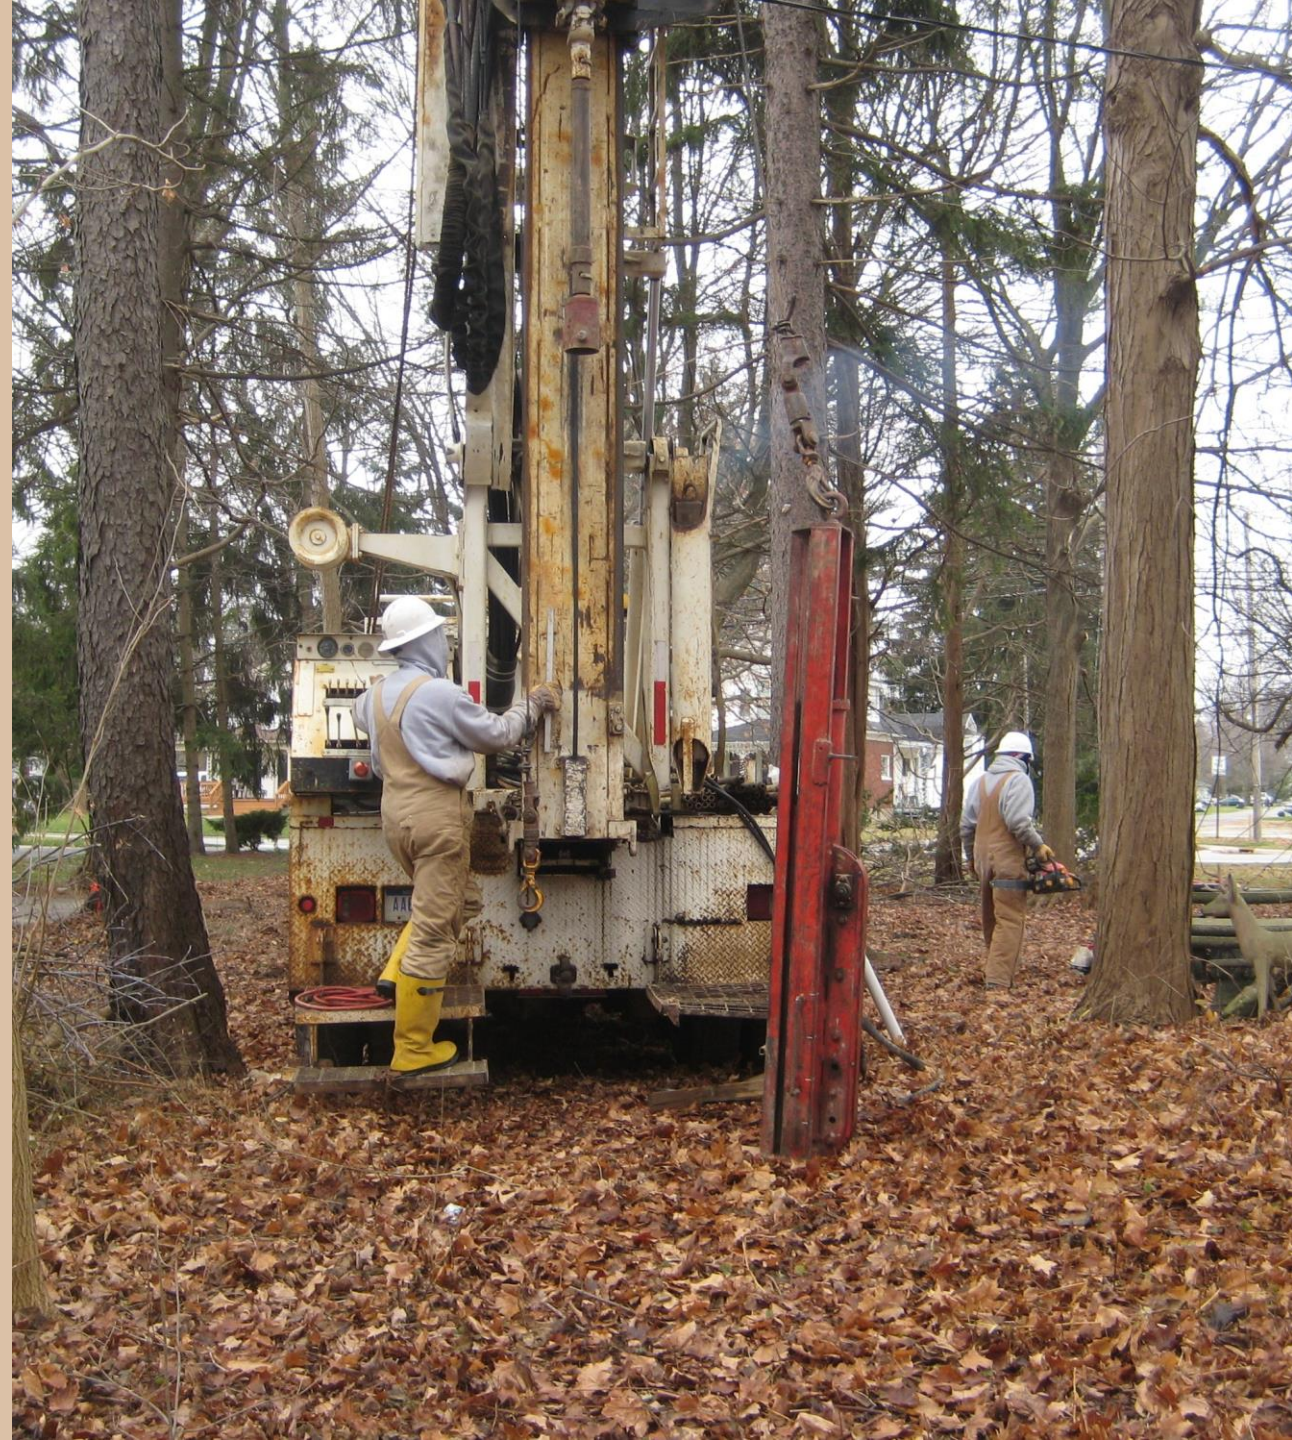
- MDEQ took over in 2013
- Contracted RI/FS
- 10 additional soil boring/monitoring wells (MW-16 thru MW-25) installed on east side of M-19 at residential properties
- LIF for LNAPL Delineation Soil Gas Survey for Vapor Intrusion
- Periodic monitoring

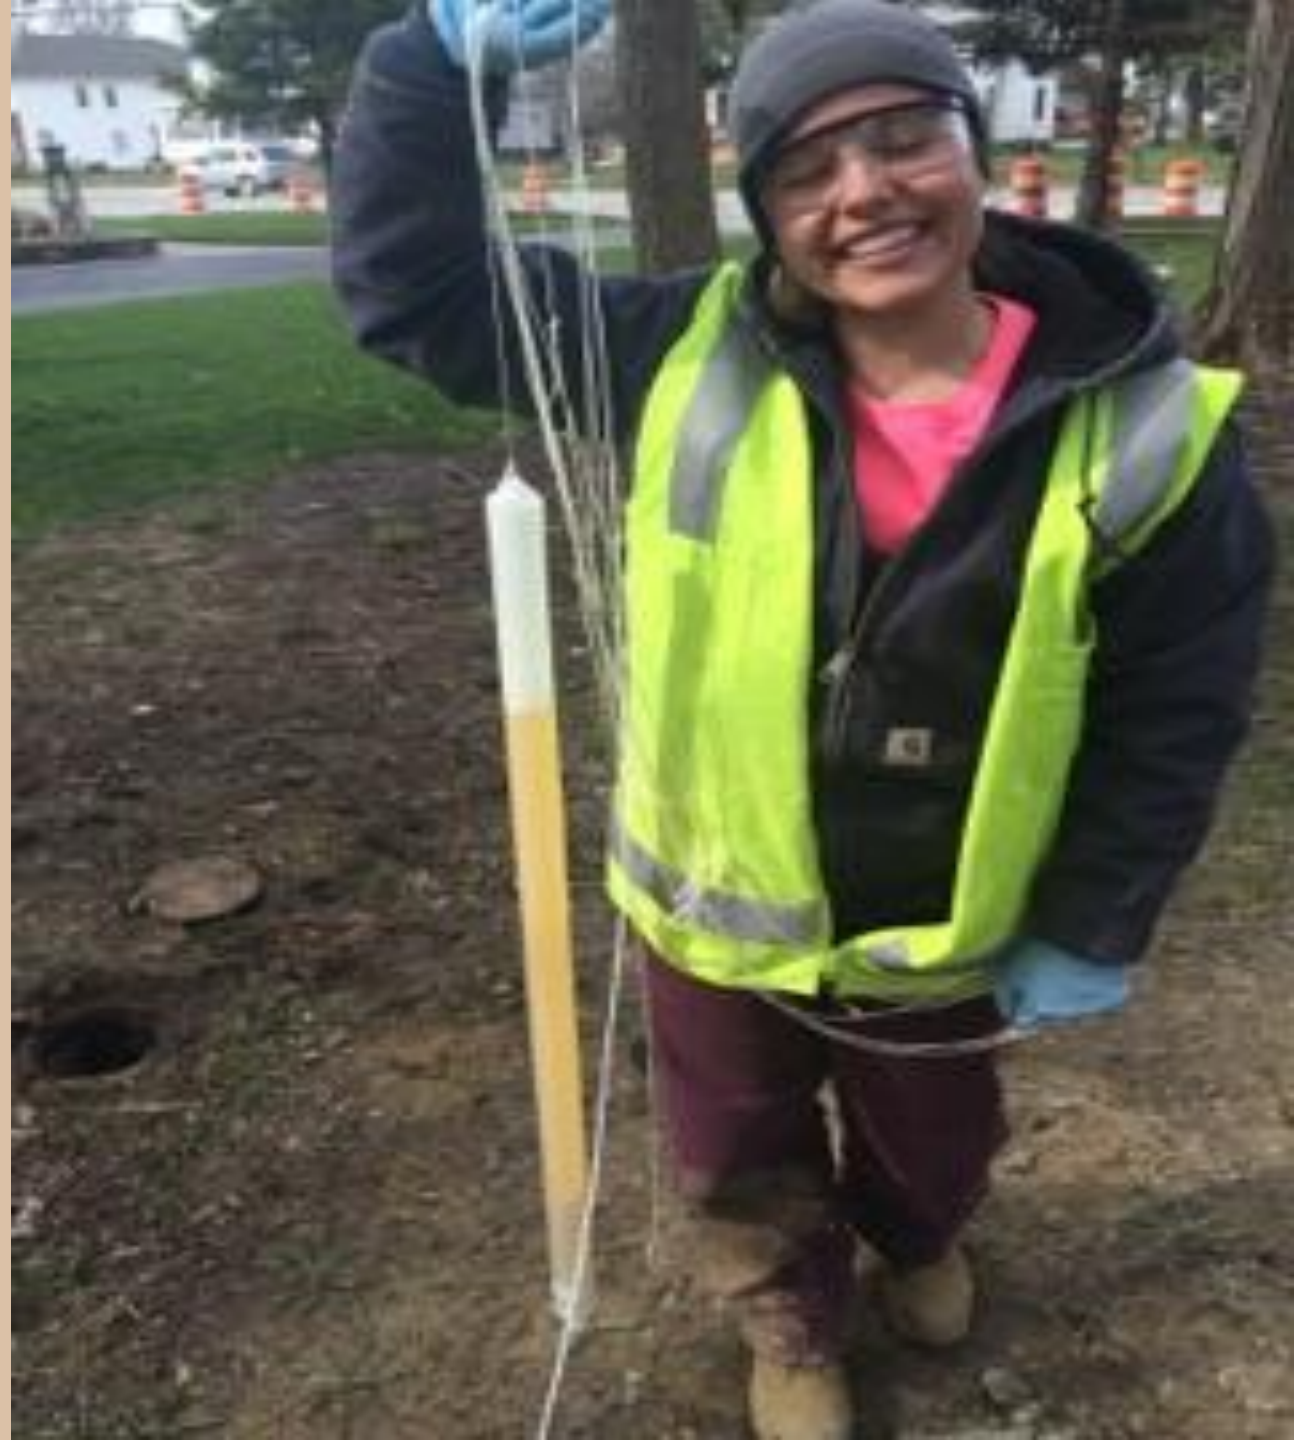
OCCURRENCE OF LNAPL

- MW's 01, 02, and OW's 01, 02 on west side
- MW's 10, 12, **18**, 19, 23 on east side
- Up to 2.5 feet thick in wells 10 and 18
- Migrating

- Highest thickness of LNAPL was observed in MW-18 in March 2016.
- More than 90% decrease in LNAPL thickness in MW-18 (from 1st ISCO injection to the 2nd injection)
- Indicates an excellent reduction in LNAPL

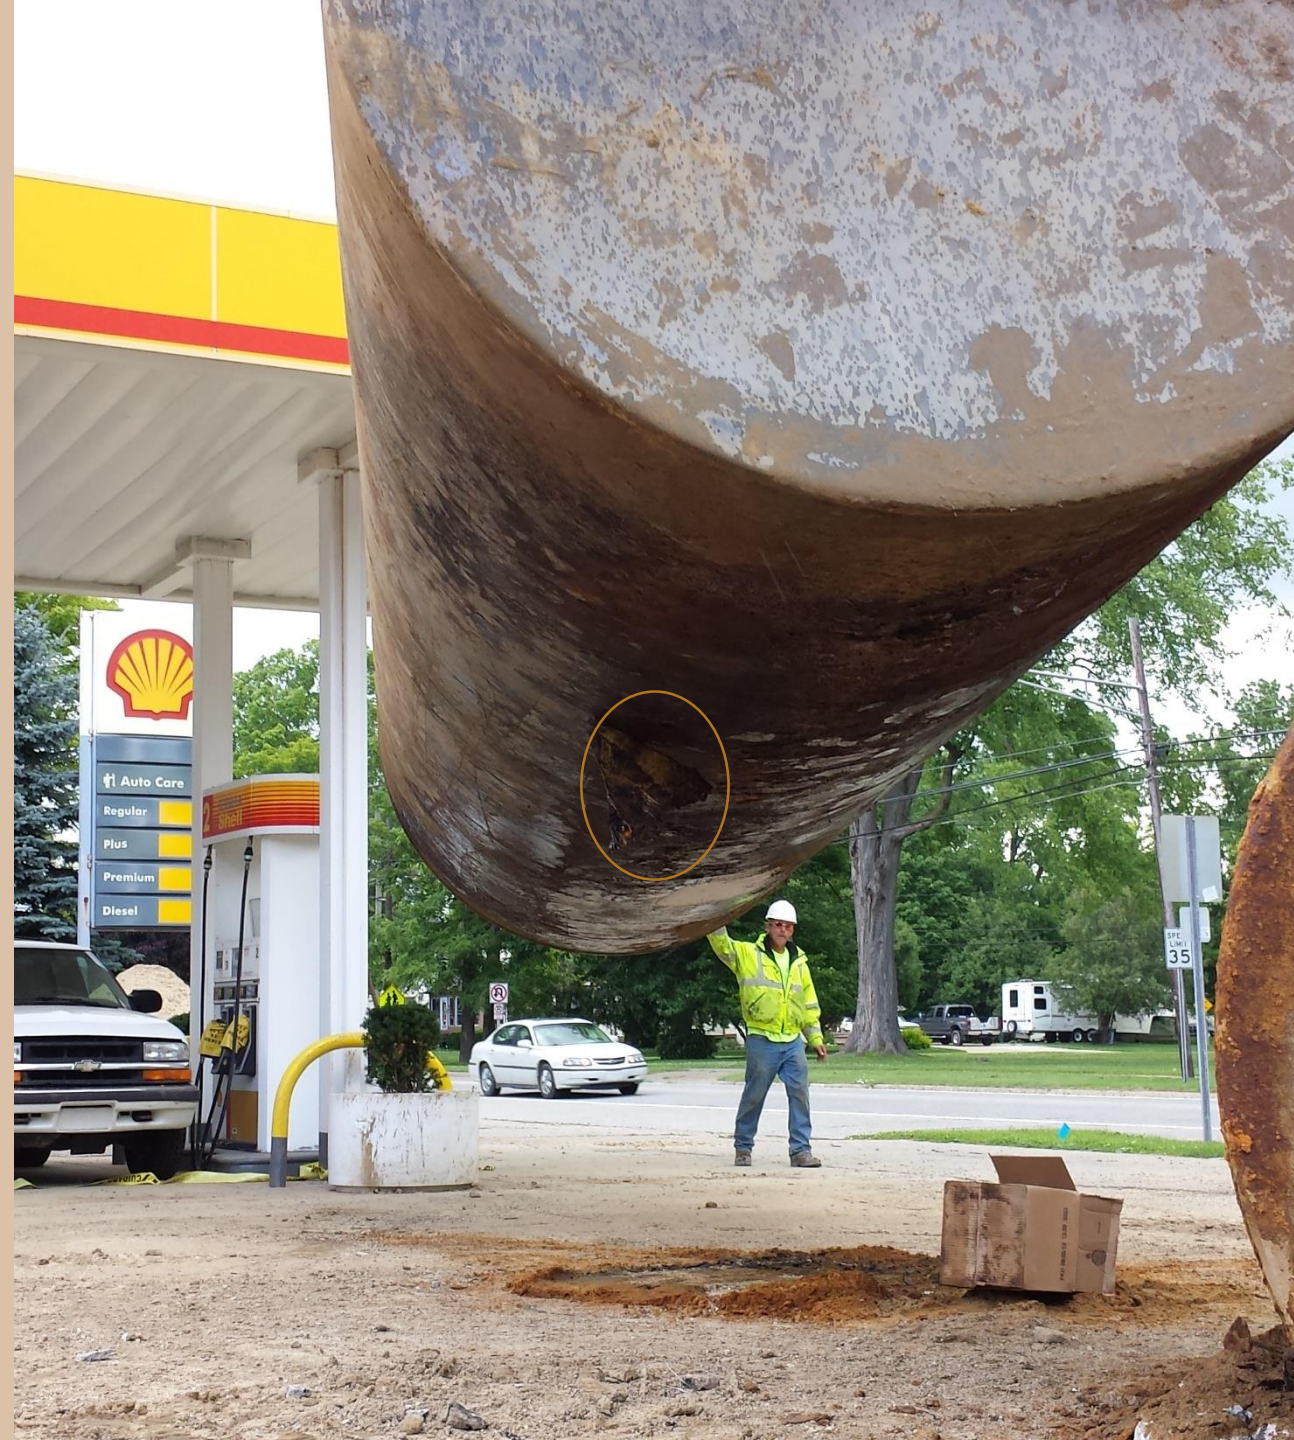
- July 2014
- Three fuel and one used oil
- Tanks pitted and holes
- Removal coincided with UST replacement
- 200 tons of soil removed

THERE'S your
problem...

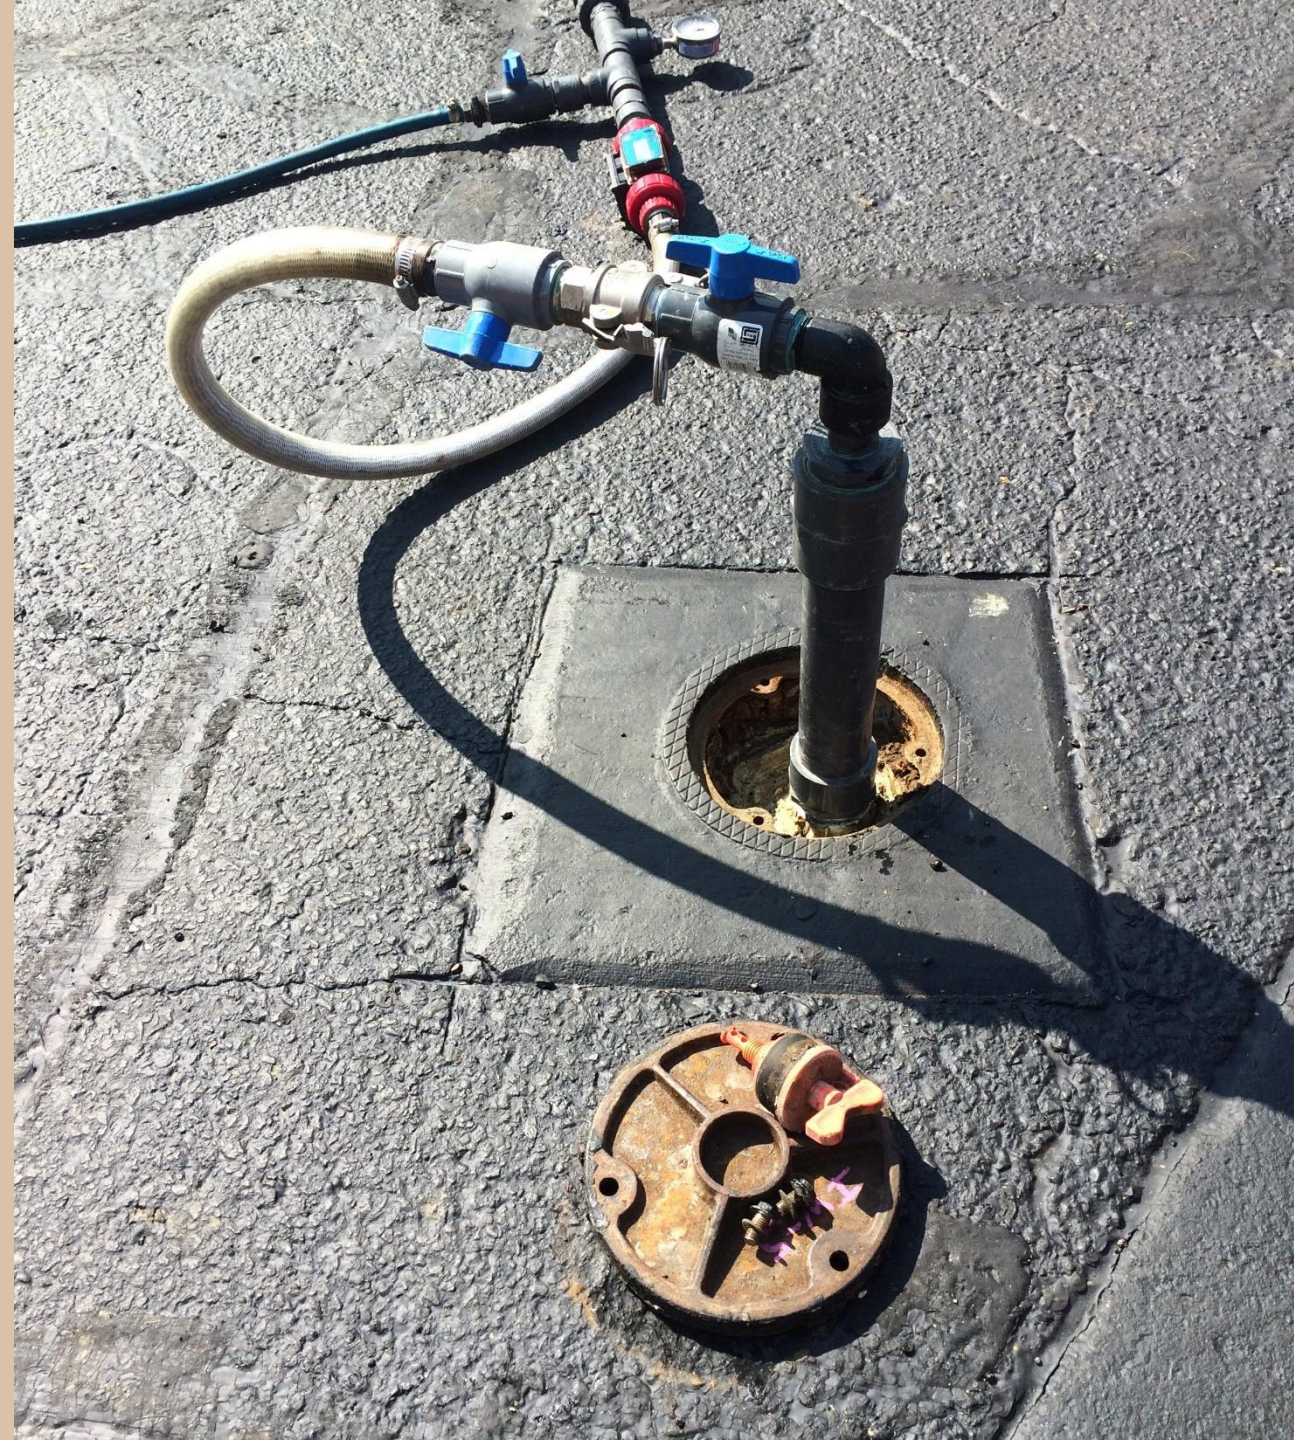
- The most expedient and cost effective method for this Site
- Pilot study in 2015
- Two events conducted in March and August 2016

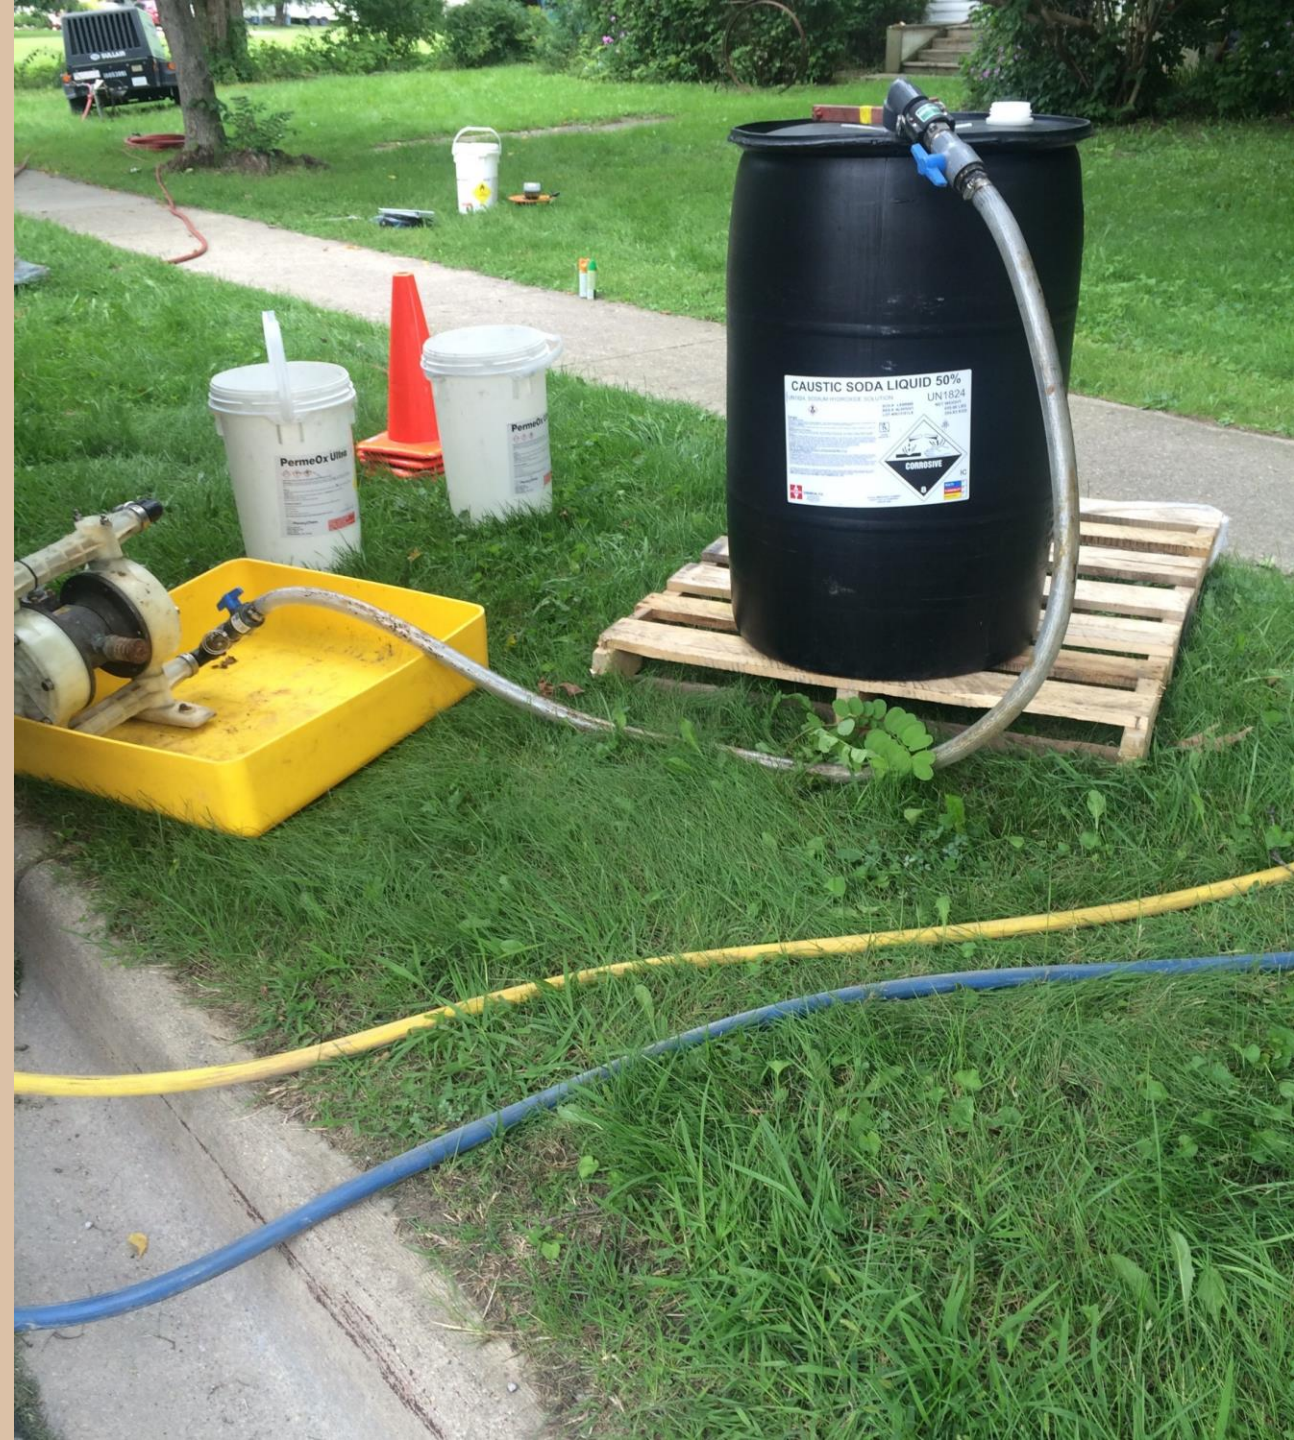
CHEMICAL APPLICATION

- Injection of Klozur - sodium persulfate catalized with sodium hydroxide
- Capable of oxidizing a broad range of recalcitrant compounds and LNAPL
- Injected using direct push technology (DPT) and/or injection wells, with simultaneous extraction from nearby wells
- “Pulls” chemicals through the formation

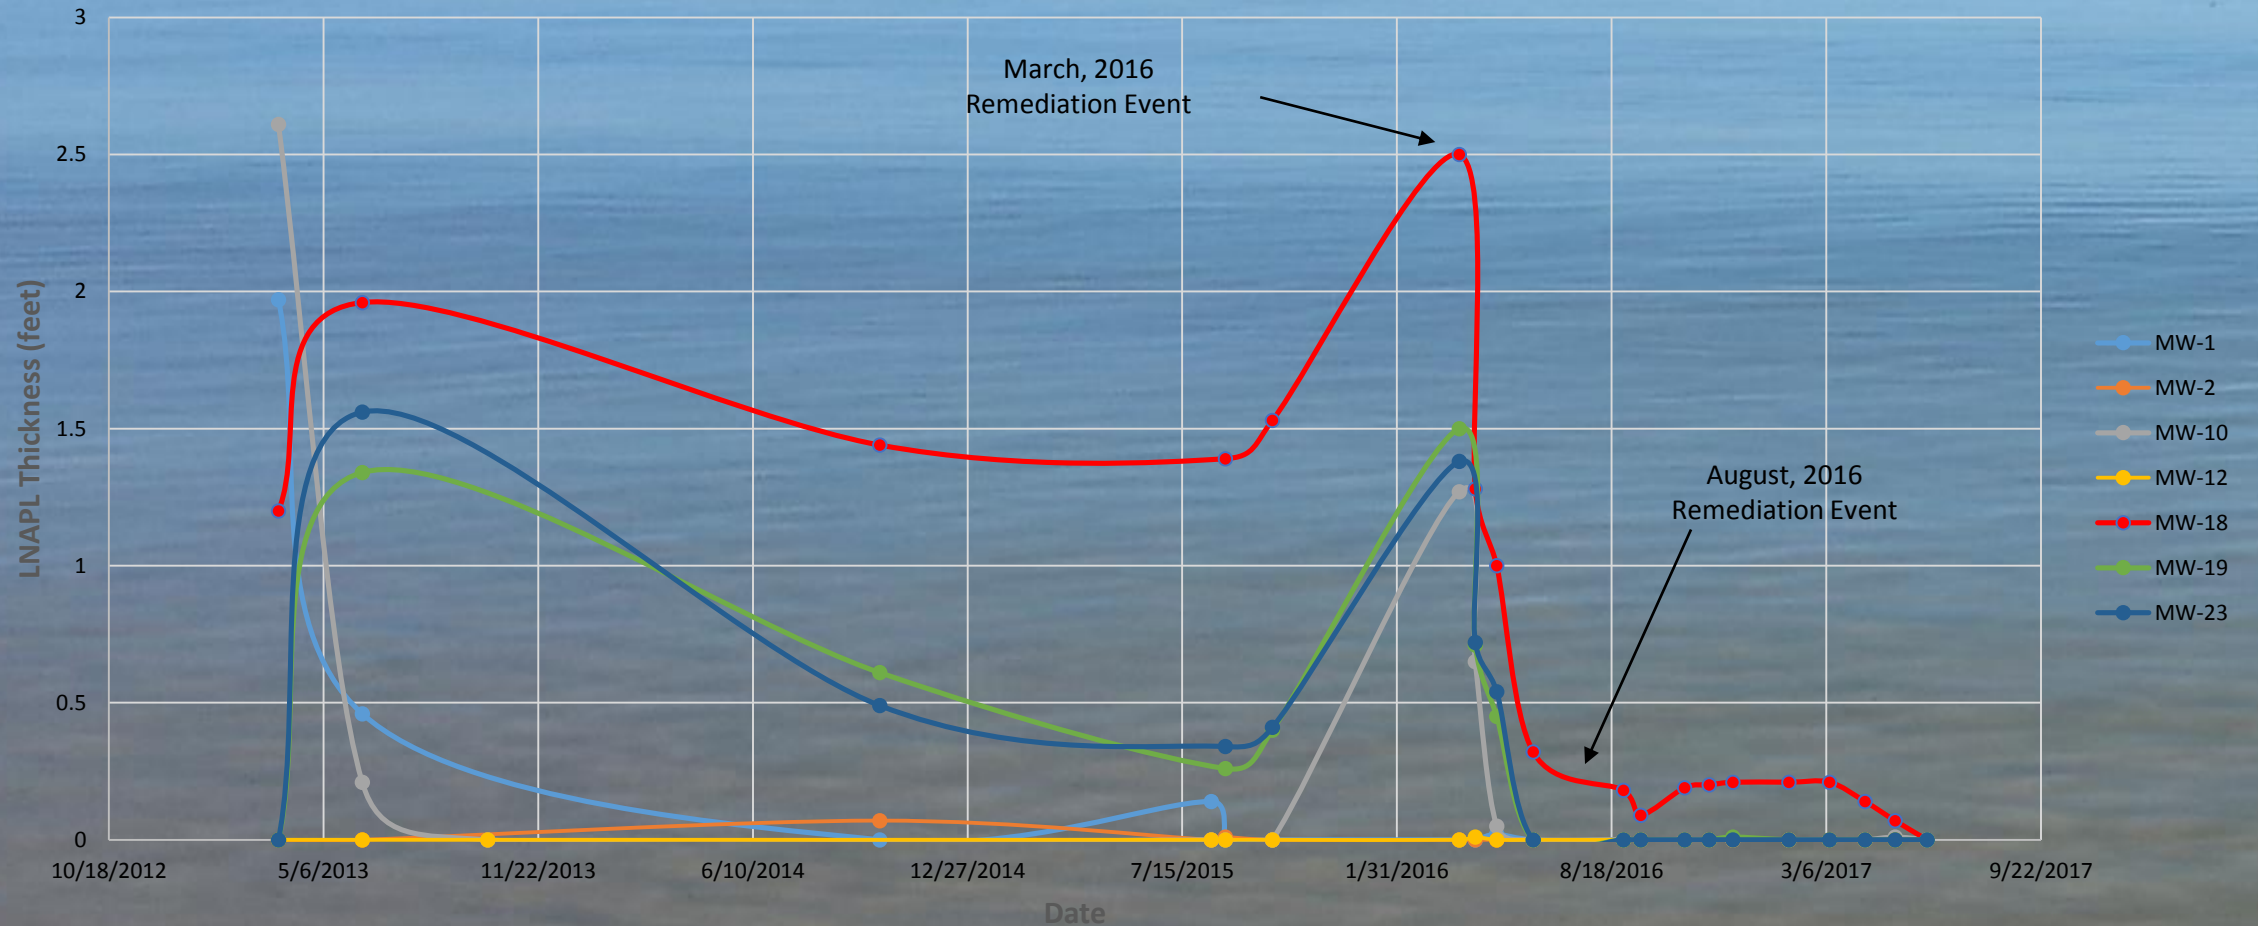
LNAPL Thickness Over Time in Monitoring Wells

Well ID	Date	Depth to Water (ft.)	DEPTH TO LNAPL (ft.)	LNAPL THICKNESS (ft.)
MW-01	3/25/2013	--	43.06	1.97
	6/11/2013	43.62	43.16	0.46
	10/7/2015	42.95		
	3/29/2016	44.1	43.40	0.70
	4/13/2016	43.54	--	--
	5/3/2016	43.23	43.21	0.02
	6/6/2016	42.96	--	--
	7/9/2016	42.77	--	--
	8/10/2016	42.69	--	--
	8/29/2016	42.69	--	--
	9/14/2016	42.71	--	--
	10/25/2016	42.84	--	--
	11/17/2016	42.95	--	--
	12/9/2016	43.02	--	--
	1/30/2017	43.10	--	--
	3/9/2017	43.09	--	--
	4/11/2017	42.96	--	--
	5/6/2017	42.47	--	--

Well ID	Date	Depth to Water (ft.)	DEPTH TO LNAPL (ft.)	LNAPL THICKNESS (ft.)
MW-10	3/25/2013	47.1	44.49	2.61
	6/11/2013	45.56	44.35	1.21
	10/6/2014	44.27	--	--
	8/24/2015	44.32	--	--
	10/7/2015	44.35	--	--
	3/29/2016	45.88	44.61	1.27
	4/13/2016	45.17	44.52	0.65
	5/3/2016	44.47	44.42	0.05
	6/6/2016	44.22	--	--
	7/9/2016	44.03	--	--
	8/10/2016	44.01	--	--
	8/29/2016	43.97	--	--
	9/14/2016	44.03	--	--
	10/25/2016	44.25	--	--
	11/17/2016	44.31	--	--
	12/9/2016	44.35	--	--
	1/30/2017	44.38	--	--
	3/9/2017	44.33	--	--
	4/11/2017	44.23	--	--
	5/6/2017	43.69	--	--

Well ID	Date	Depth to Water (ft.)	DEPTH TO LNAPL (ft.)	LNAPL THICKNESS (ft.)
MW-23	6/11/2013	45.57	44.01	1.56
	10/6/2014	44.43	43.94	0.49
	8/24/2015	44.36	44.02	0.34
	10/7/2015	44.46	44.05	0.41
	3/29/2016	45.70	44.32	1.38
	4/13/2016	44.98	44.26	0.72
	5/3/2016	44.66	44.12	0.54
	6/6/2016	43.99	--	--
	7/9/2016	43.80	--	--
	8/10/2016	43.78	--	--
	8/29/2016	43.79	--	--
	9/14/2016	43.02	--	--
	10/25/2016	46.27	--	--
	11/17/2016	44.09	--	--
	12/9/2016	44.19	--	--
	1/30/2017	44.13	--	--
	3/9/2017	44.11	--	--
	4/11/2017	43.98	--	--
	5/6/2017	43.45	--	--

Well ID	Date	Depth to Water (ft.)	DEPTH TO LNAPL (ft.)	LNAPL THICKNESS (ft.)
MW-19	6/11/2013	46.96	45.62	1.34
	10/6/2014	46.08	45.47	0.61
	8/24/2015	45.83	45.57	0.26
	10/7/2015	46.00	45.60	0.40
	3/29/2016	47.16	bailed	1.50
	4/13/2016	46.63	45.92	0.71
	5/3/2016	46.10	45.65	0.45
	6/6/2016	45.50	--	--
	7/9/2016	48.31	--	--
	8/10/2016	45.35	--	--
	8/29/2016	45.30	--	--
	9/14/2016	45.37	--	--
	10/25/2016	45.56	--	--
	11/17/2016	44.61	--	--
	12/9/2016	45.71	45.7	0.01
	1/30/2017	45.69	--	--
	3/9/2017	45.64	--	--
	4/11/2017	45.52	--	--
	5/6/2017	44.95	--	--

Well ID	Date	Depth to Water (ft.)	DEPTH TO LNAPL (ft.)	LNAPL THICKNESS (ft.)
MW-18	3/25/2013	46.57	45.37	1.2
	6/11/2013	46.80	44.84	1.96
	10/6/2014	46.11	44.67	1.44
	8/24/2015	46.11	44.72	1.39
	10/7/2015	46.28	44.75	1.53
	3/29/2016	47.15	bailed	2.50
	4/13/2016	46.31	45.03	1.28
	5/3/2016	45.92	44.92	1.00
	6/6/2016	45.14	44.82	0.32
	7/9/2016	44.82	44.66	0.16
	8/10/2016	44.81	44.65	0.16
	8/29/2016	44.83	44.65	0.18
	9/14/2016	44.81	44.72	0.09
	10/25/2016	45.10	44.91	0.19
	11/17/2016	45.15	44.95	0.20
	12/9/2016	45.26	45.05	0.21
	1/30/2017	45.22	45.01	0.21
	3/9/2017	45.18	44.97	0.21
	4/11/2017	45.02	44.88	0.14
	5/6/2017	44.32	--	--

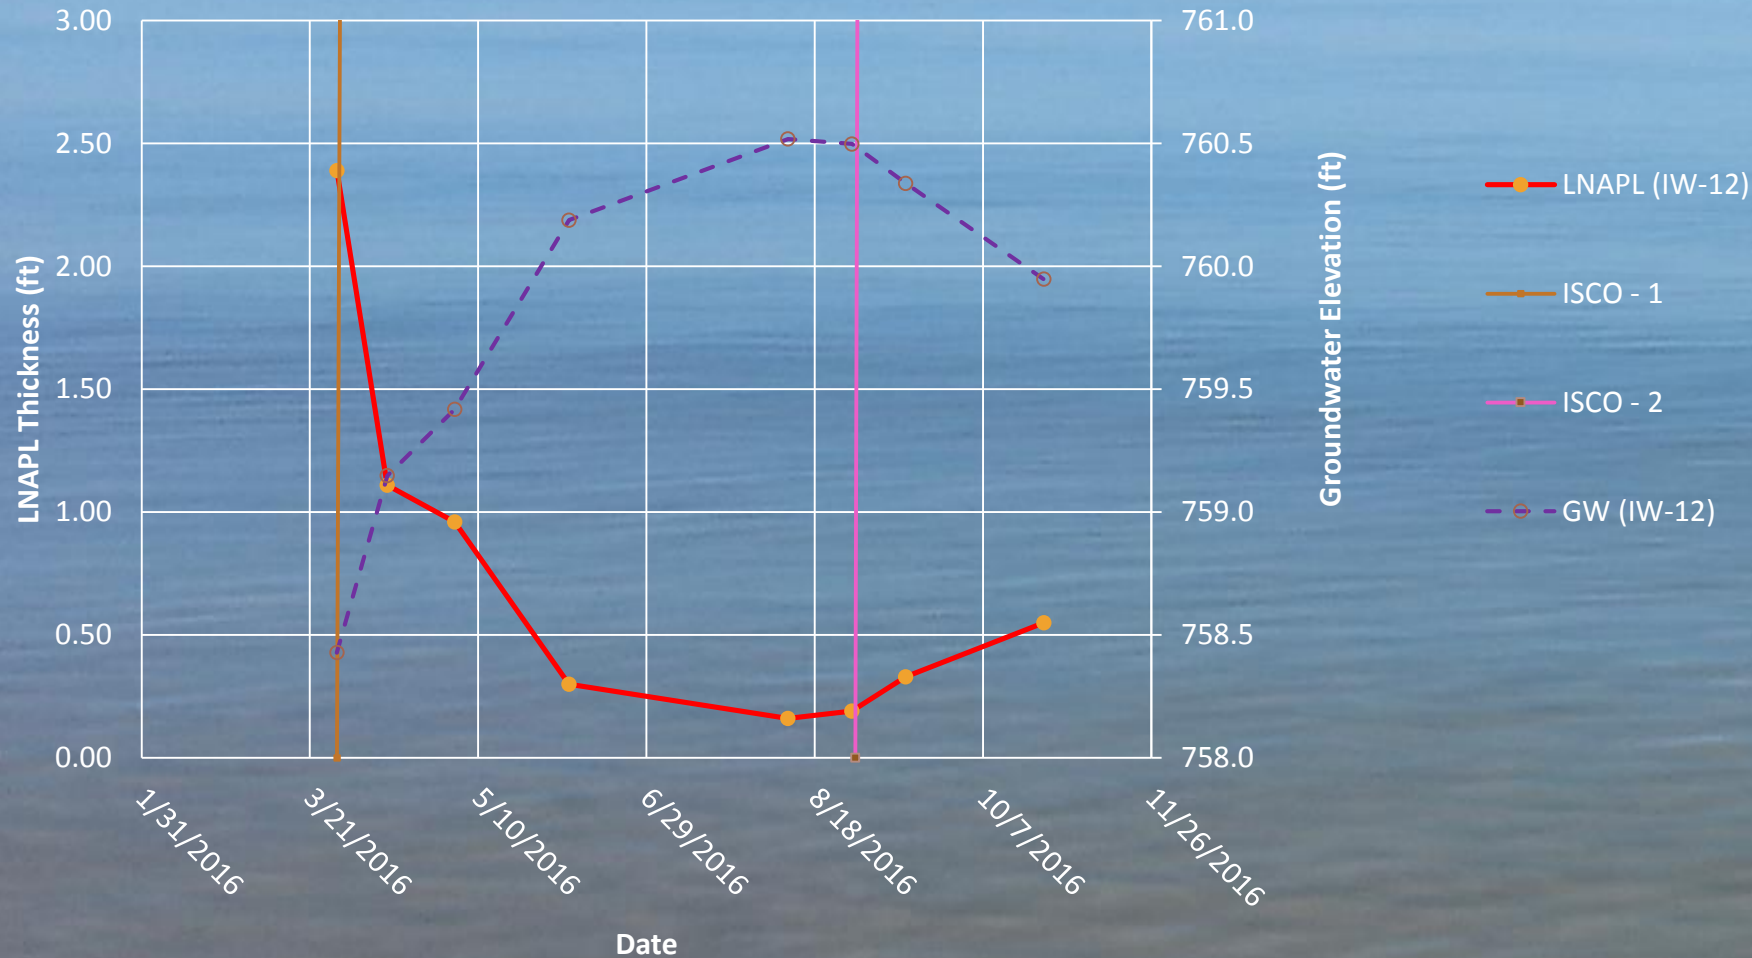
IW-12 POST INJECTION

- IW-12 is located approximately 45 feet NW of MW-18.
- More than 90% decrease in LNAPL thickness in IW-12 (from 1st ISCO injection to the 2nd injection)
- Indicates an excellent reduction in LNAPL throughout the Site

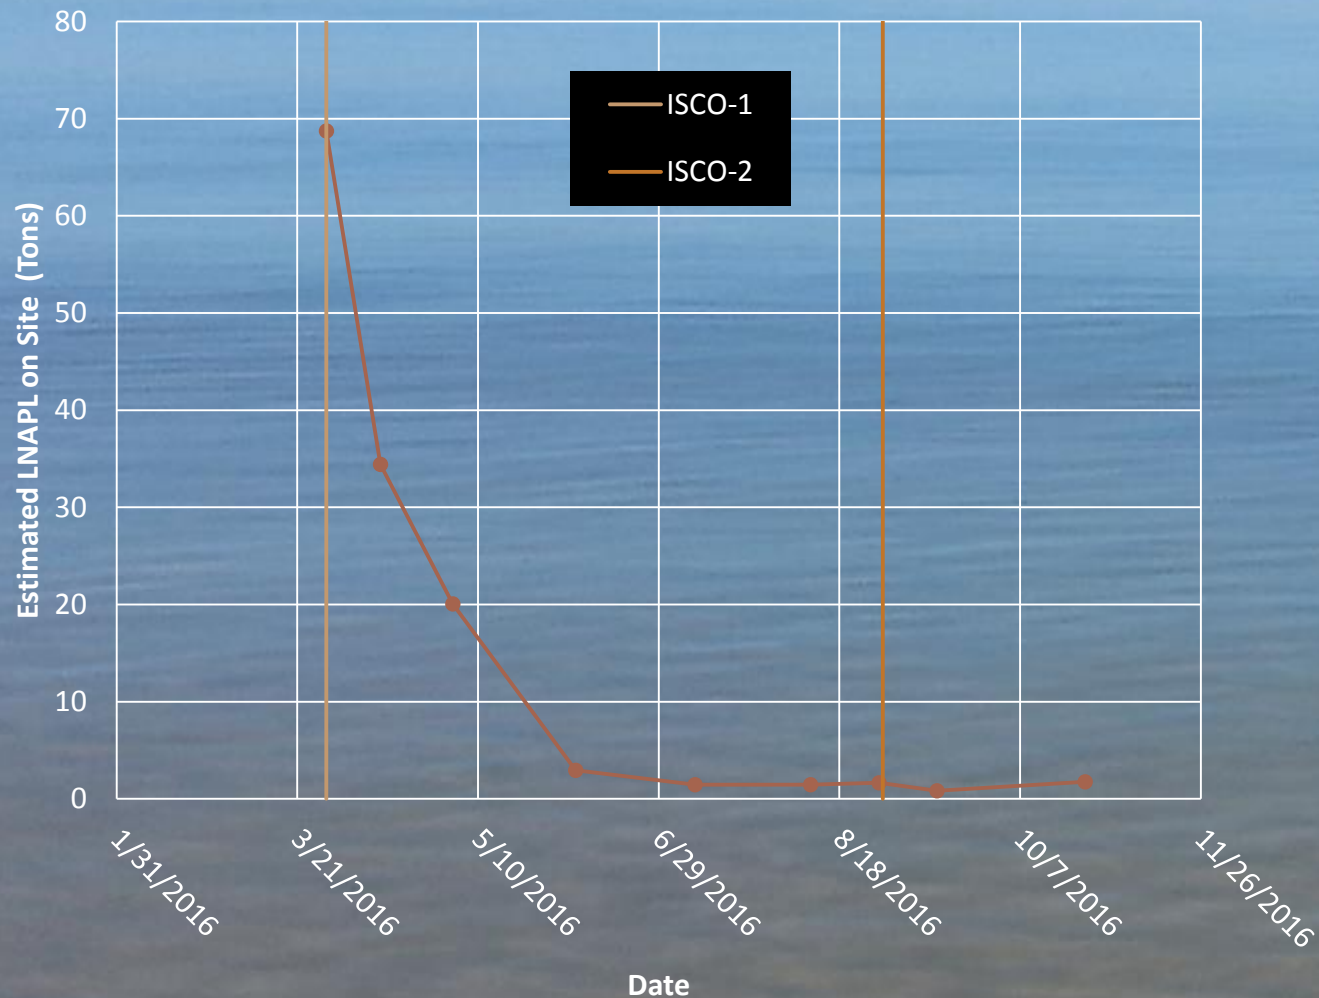
ESTIMATED MASS OF LNAPL ON SITE

- Mass of LNAPL was estimated based on the LNAPL thicknesses measured at monitoring wells.
- More than 90% of LNAPL has been removed from the 1st ISCO injection to the 2nd injection.
- Indicates an excellent reduction in LNAPL throughout the Site.

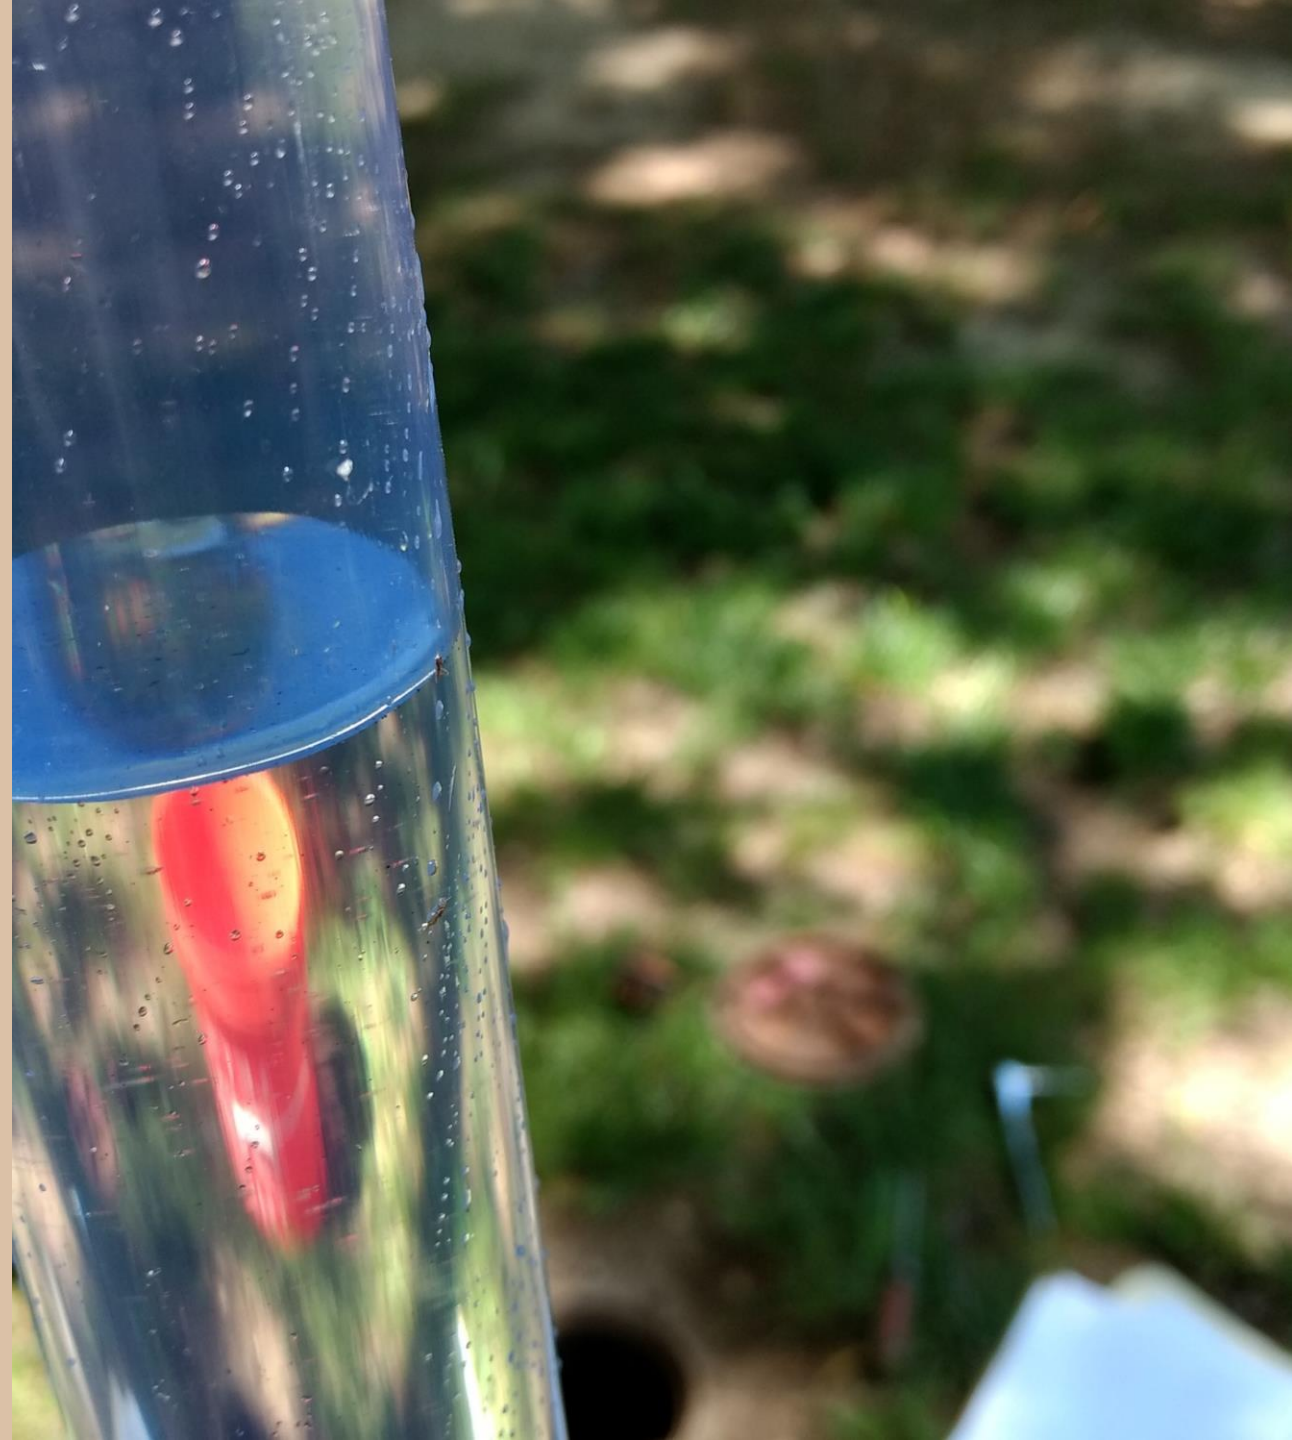
MW-18

Good enough to drink!

Maybe not....
