Accelerated Corrosion of UST Equipment (an ethanol hangover) Inspection Concern to Professional Research

Steve Pollock
EPA Biofuels Series
June 20, 2013

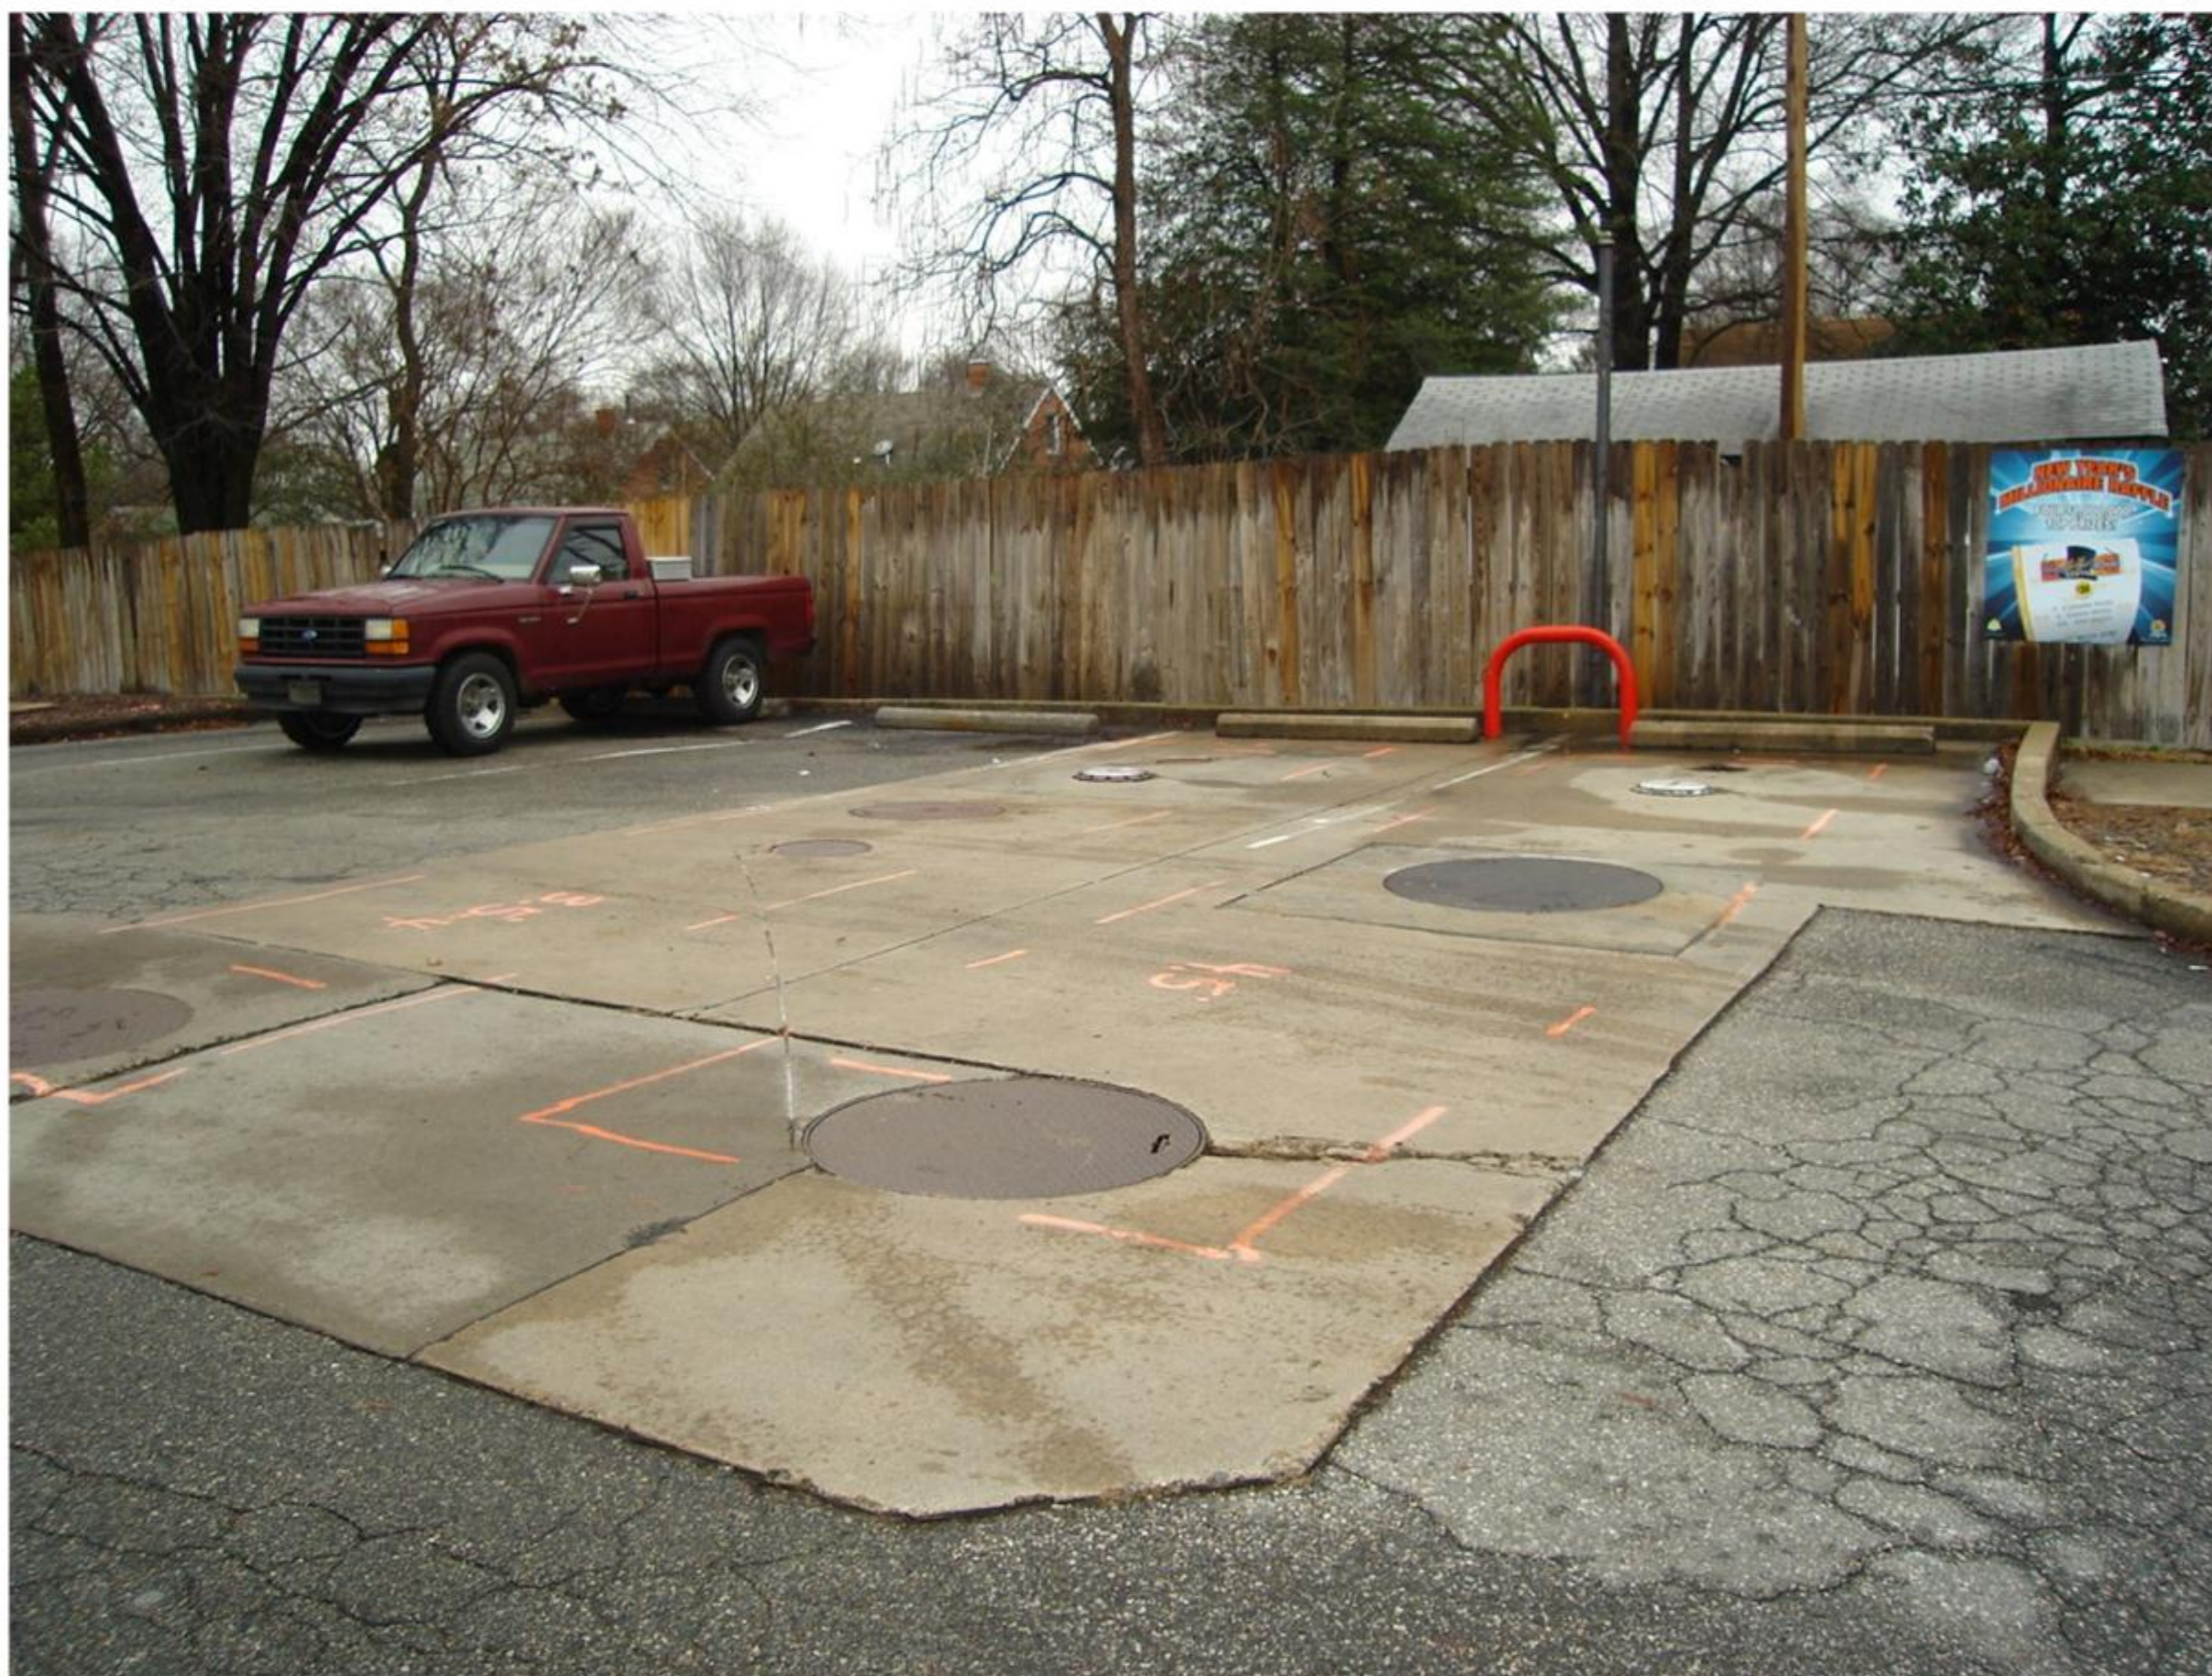
An everyday inspection

Wed 12/17/2008 4:30 PM – I ran across this mess in a sump today. I've seen similar messes, but this was just a little different. [The environmental consultant I was with] had never seen anything like it either. Kind of mounded, with recently active looking bubbles (Hydrogen gas?) on top. Sort of like the sulfur reducing bacteria crud we sometimes find, but somehow a little more pillowy. [The consultant] knocked it around a little, and I was waiting for the whoosh of rotten egg smell. Instead, it was a **vinegar smell – acetic acid**. Maybe in the presence of E-10, our native soil/water bacteria now prefer to chomp on the ethanol first as Acetobacters or just opportunistic bacteria loving an easier chain (the alcohol) to digest, creating acetic acid. You know, like wine going bad. Or, in the presence of E-10, these are the first bacteria to feast at the buffet, then the vultures, then the oil metabolizers.

Anyway, the acetic acid, bacteria and some funky mold (or yeast?) is tearing up the steel, too. Also note that supposedly the **line leak detector was replaced this past February** ...But if it's new as of Feb '08, it has had a hurting put on it. Oddly, the next door STP sump was also full of water, but not this mess. And it was clear that the LLD had been replaced.

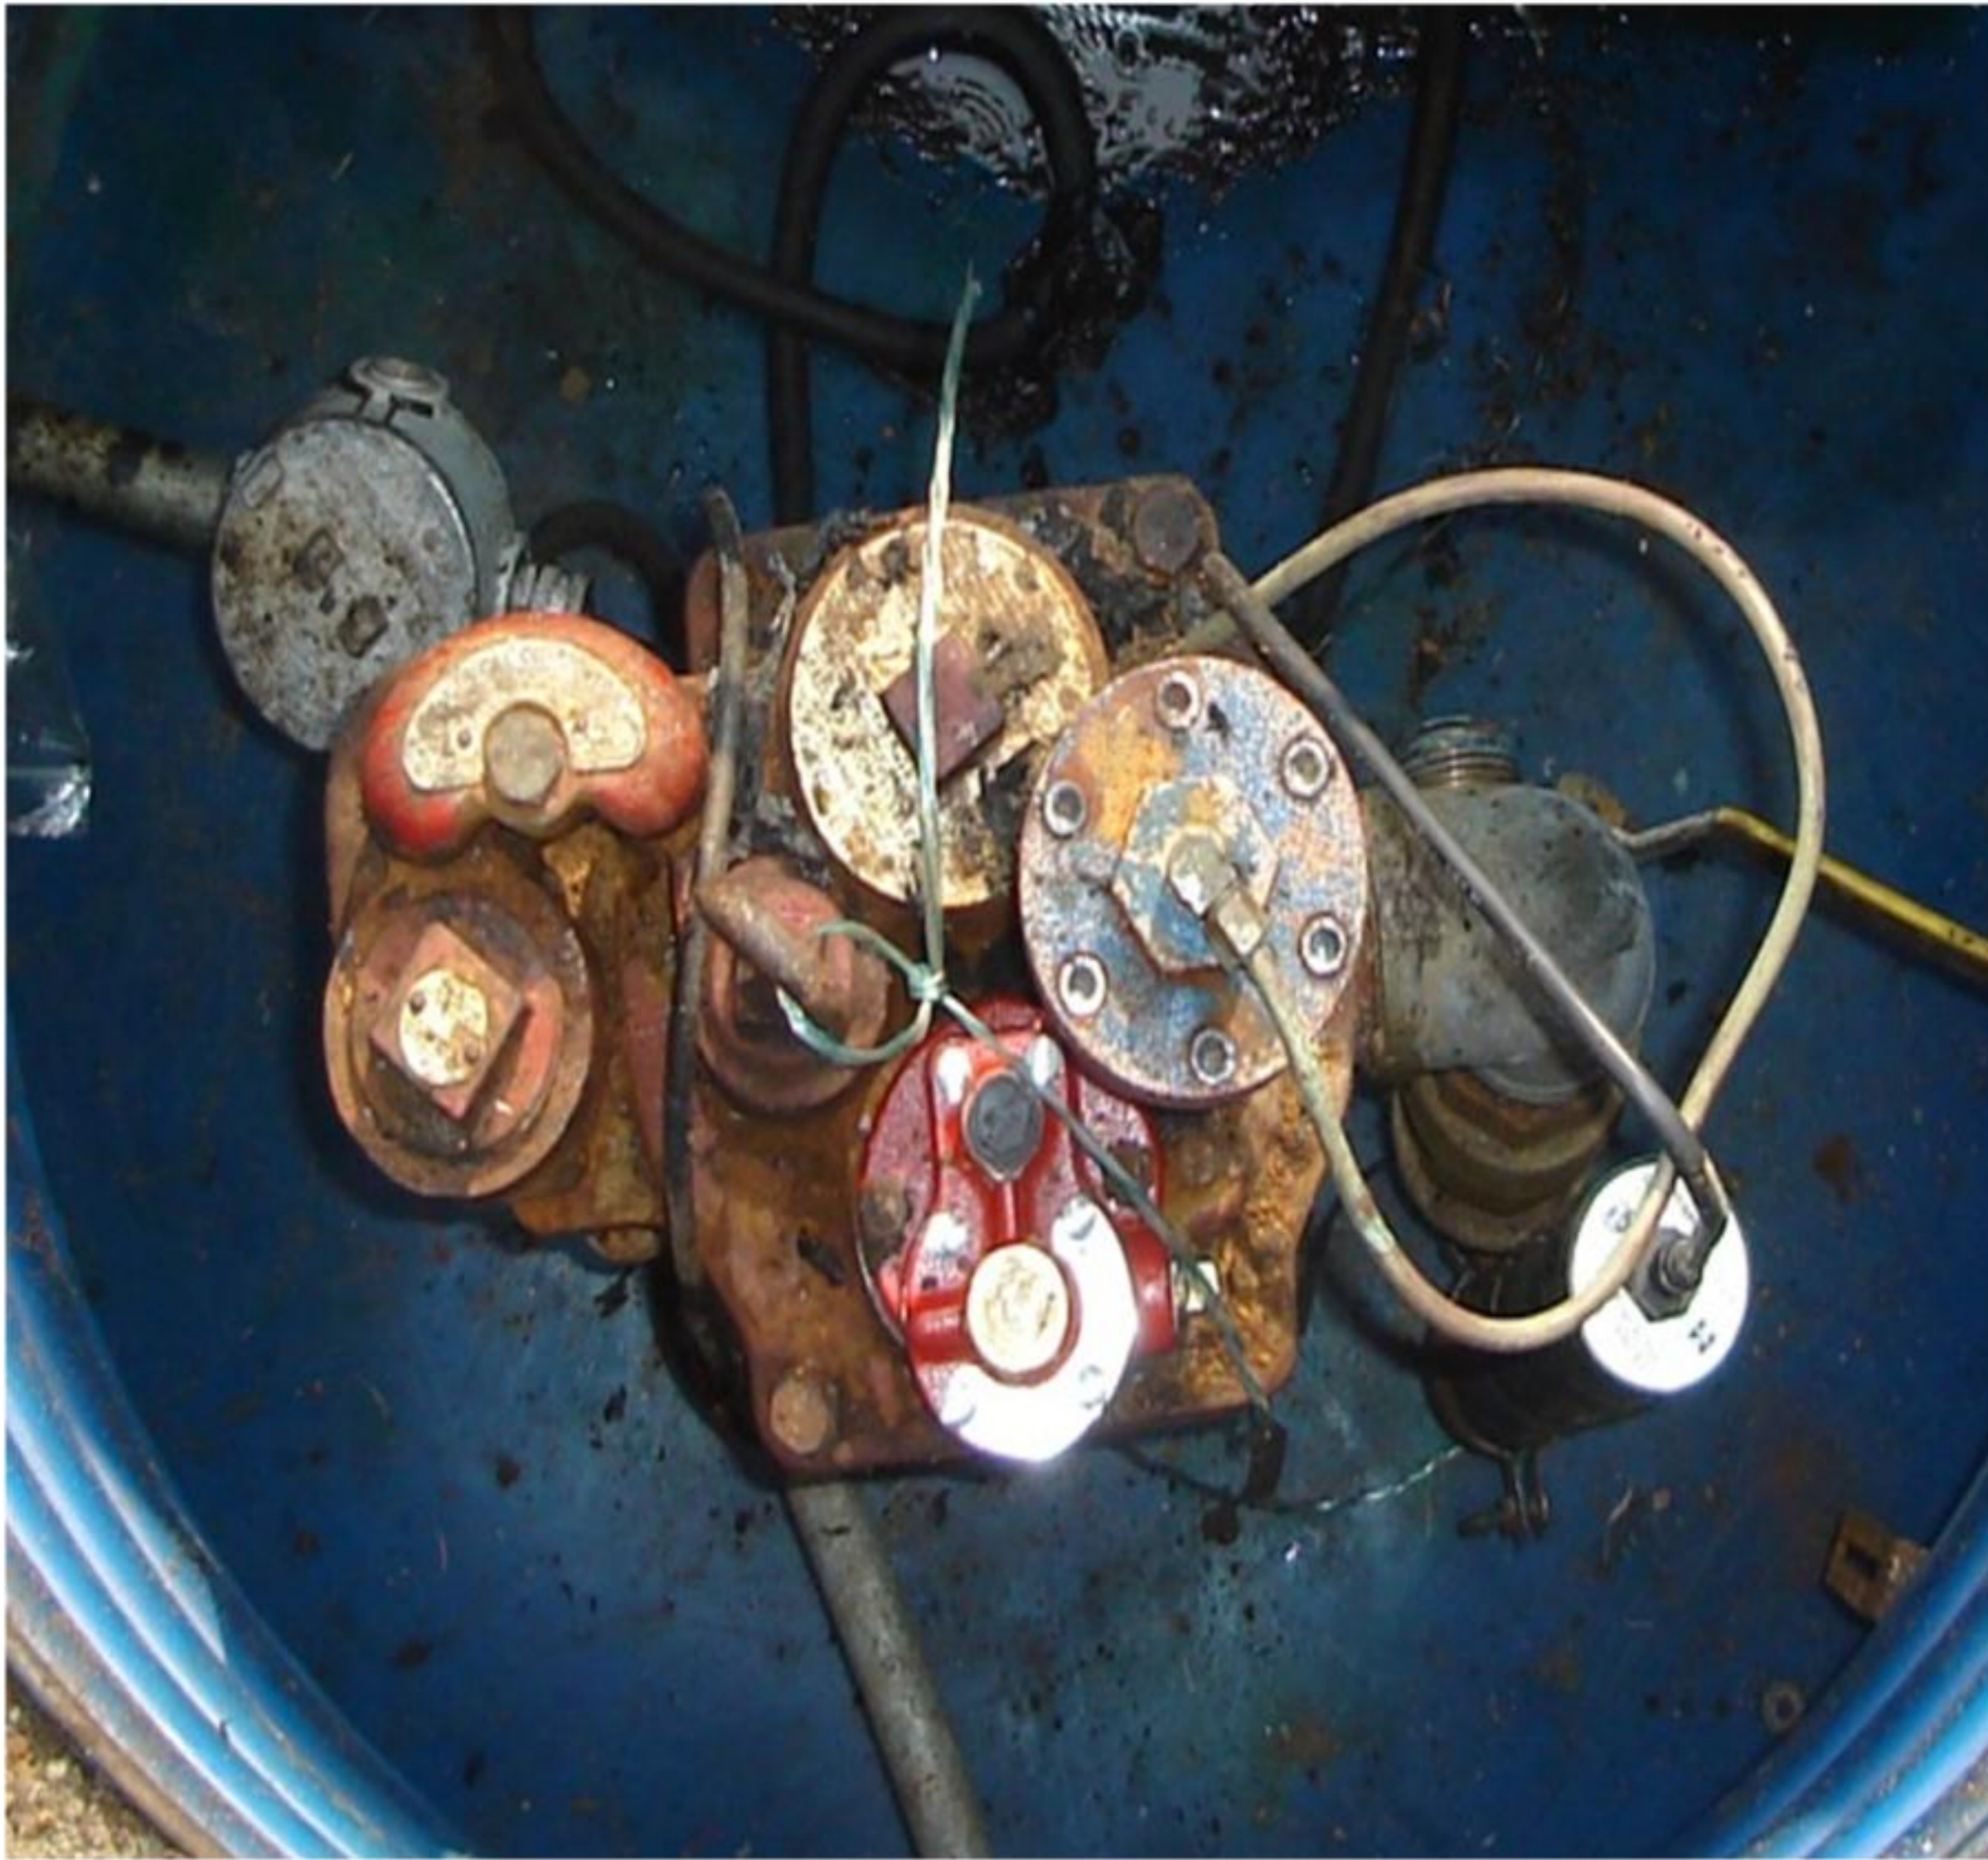
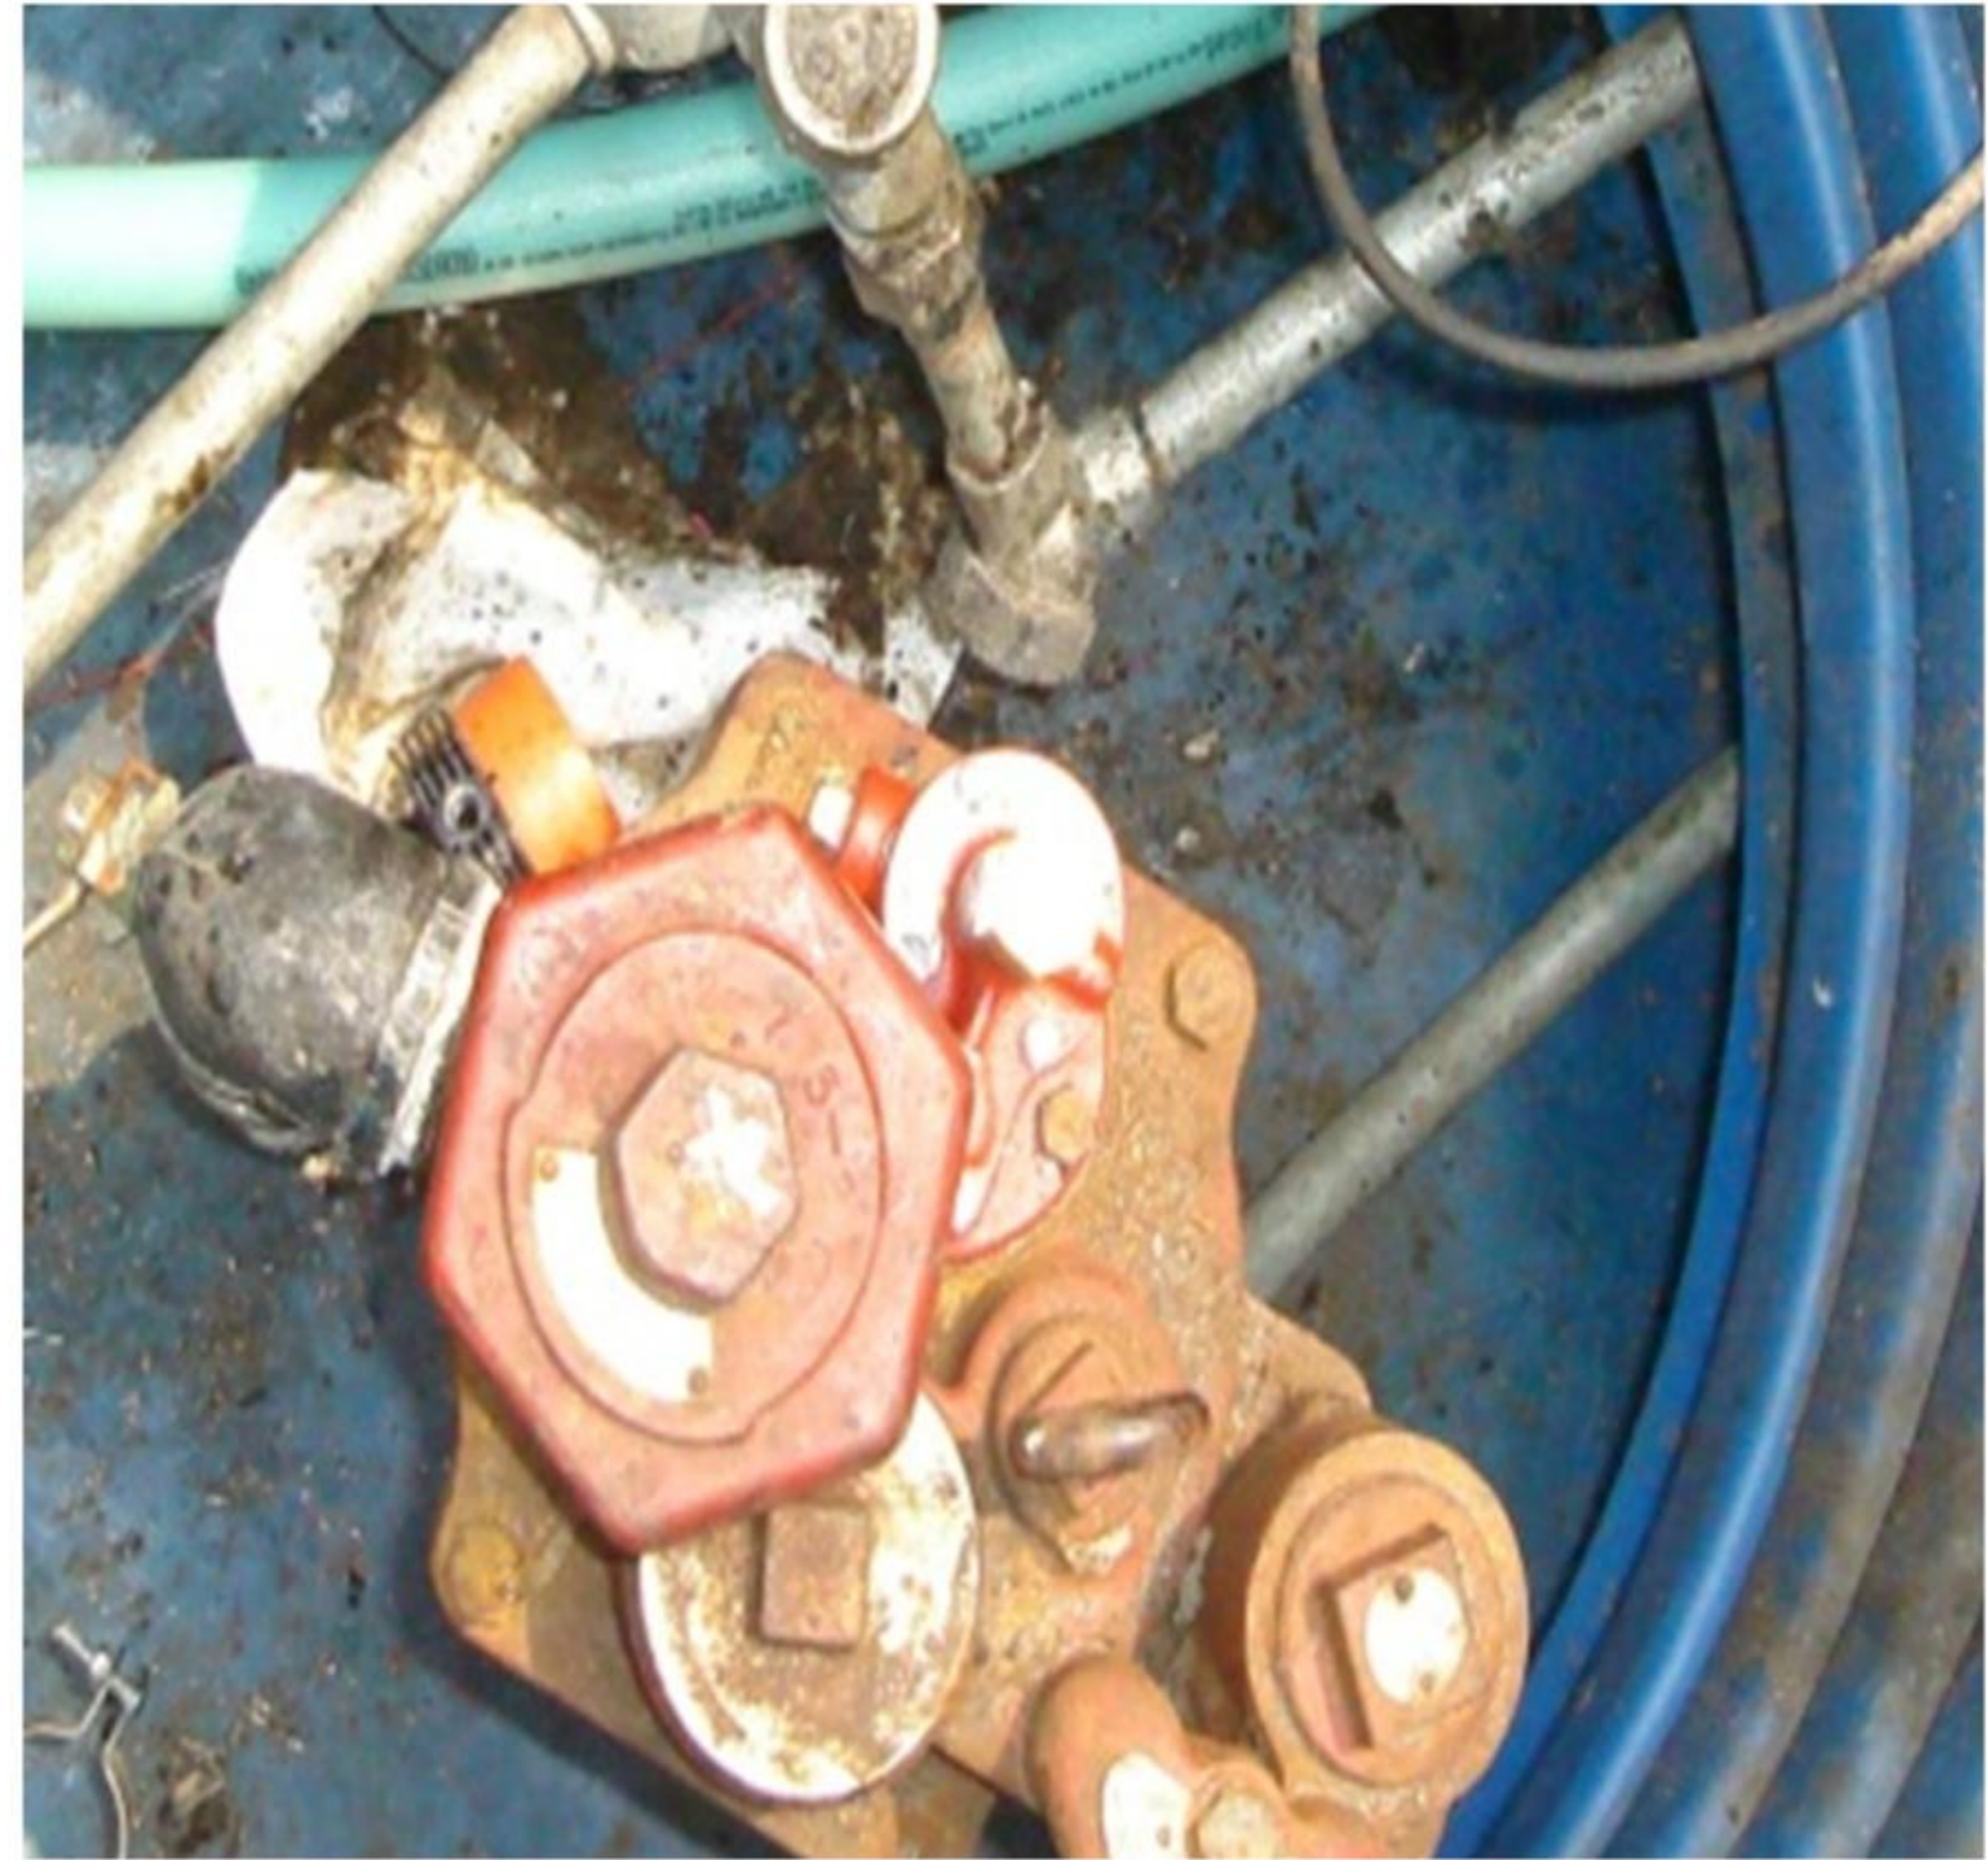
Old Familiar Corrosion

Photos prior to E-10; UST's in ground 20 years

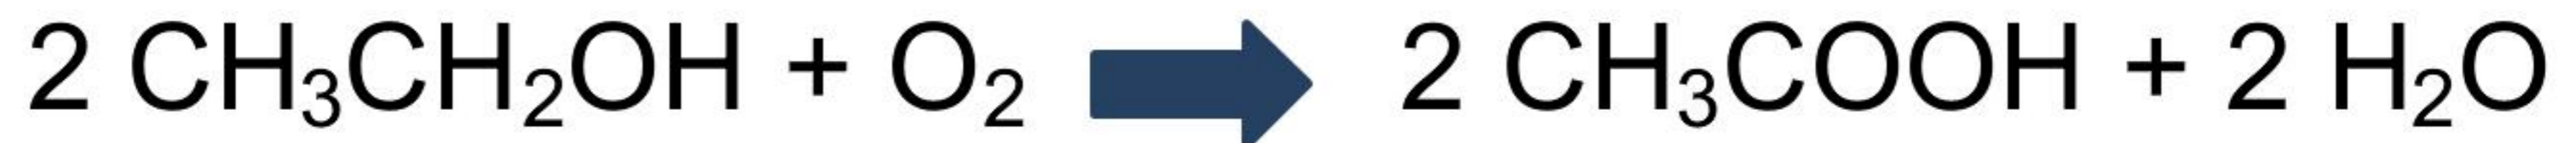
- A new environment primed for biological activity is created
- Acetic acid bacteria use oxygen from the atmosphere to rapidly transform the ethanol to acetic acid:

- **The acetic acid produced by biological degradation of ethanol can facilitate the corrosion of metals.**

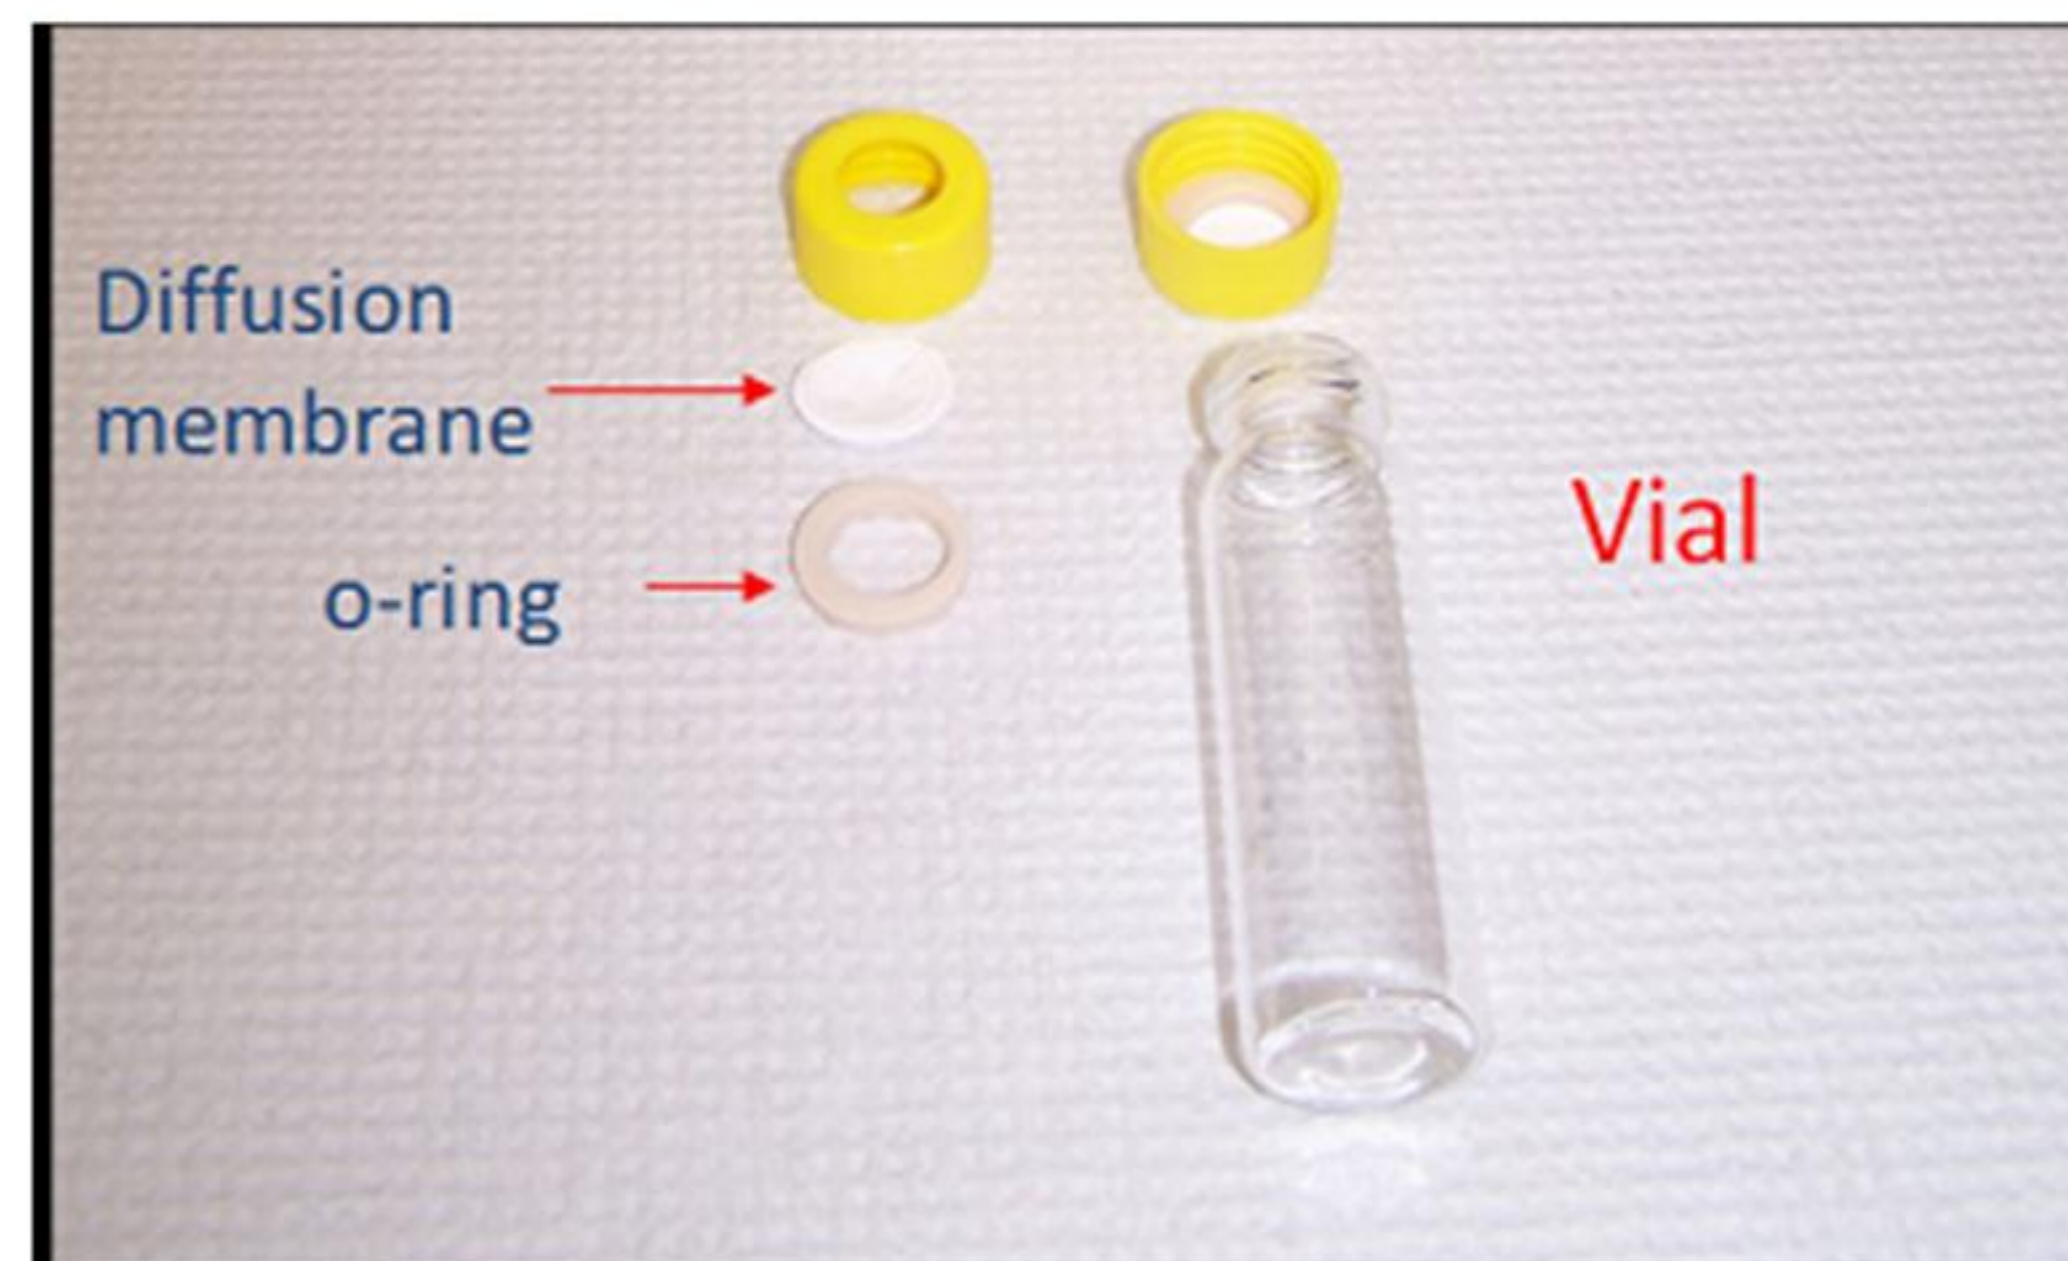
Vapor samplers were 40 mL VOA vials filled with water containing trisodium phosphate (a preservative).

- The vapors enter the sampler by passing through a nylon filter.
- One sampler was kept as a field blank and sent back with the others.
- To test pH of standing water, ORD included pH test strips.
- When possible, a sample of the liquid in the sump was obtained.
- All samples were sent to EPA's Kerr Center in Ada, Oklahoma, for analysis

- Volunteers installed **two vapor samplers** under every STP cover at the facility, and left them there for approximately **one month**.

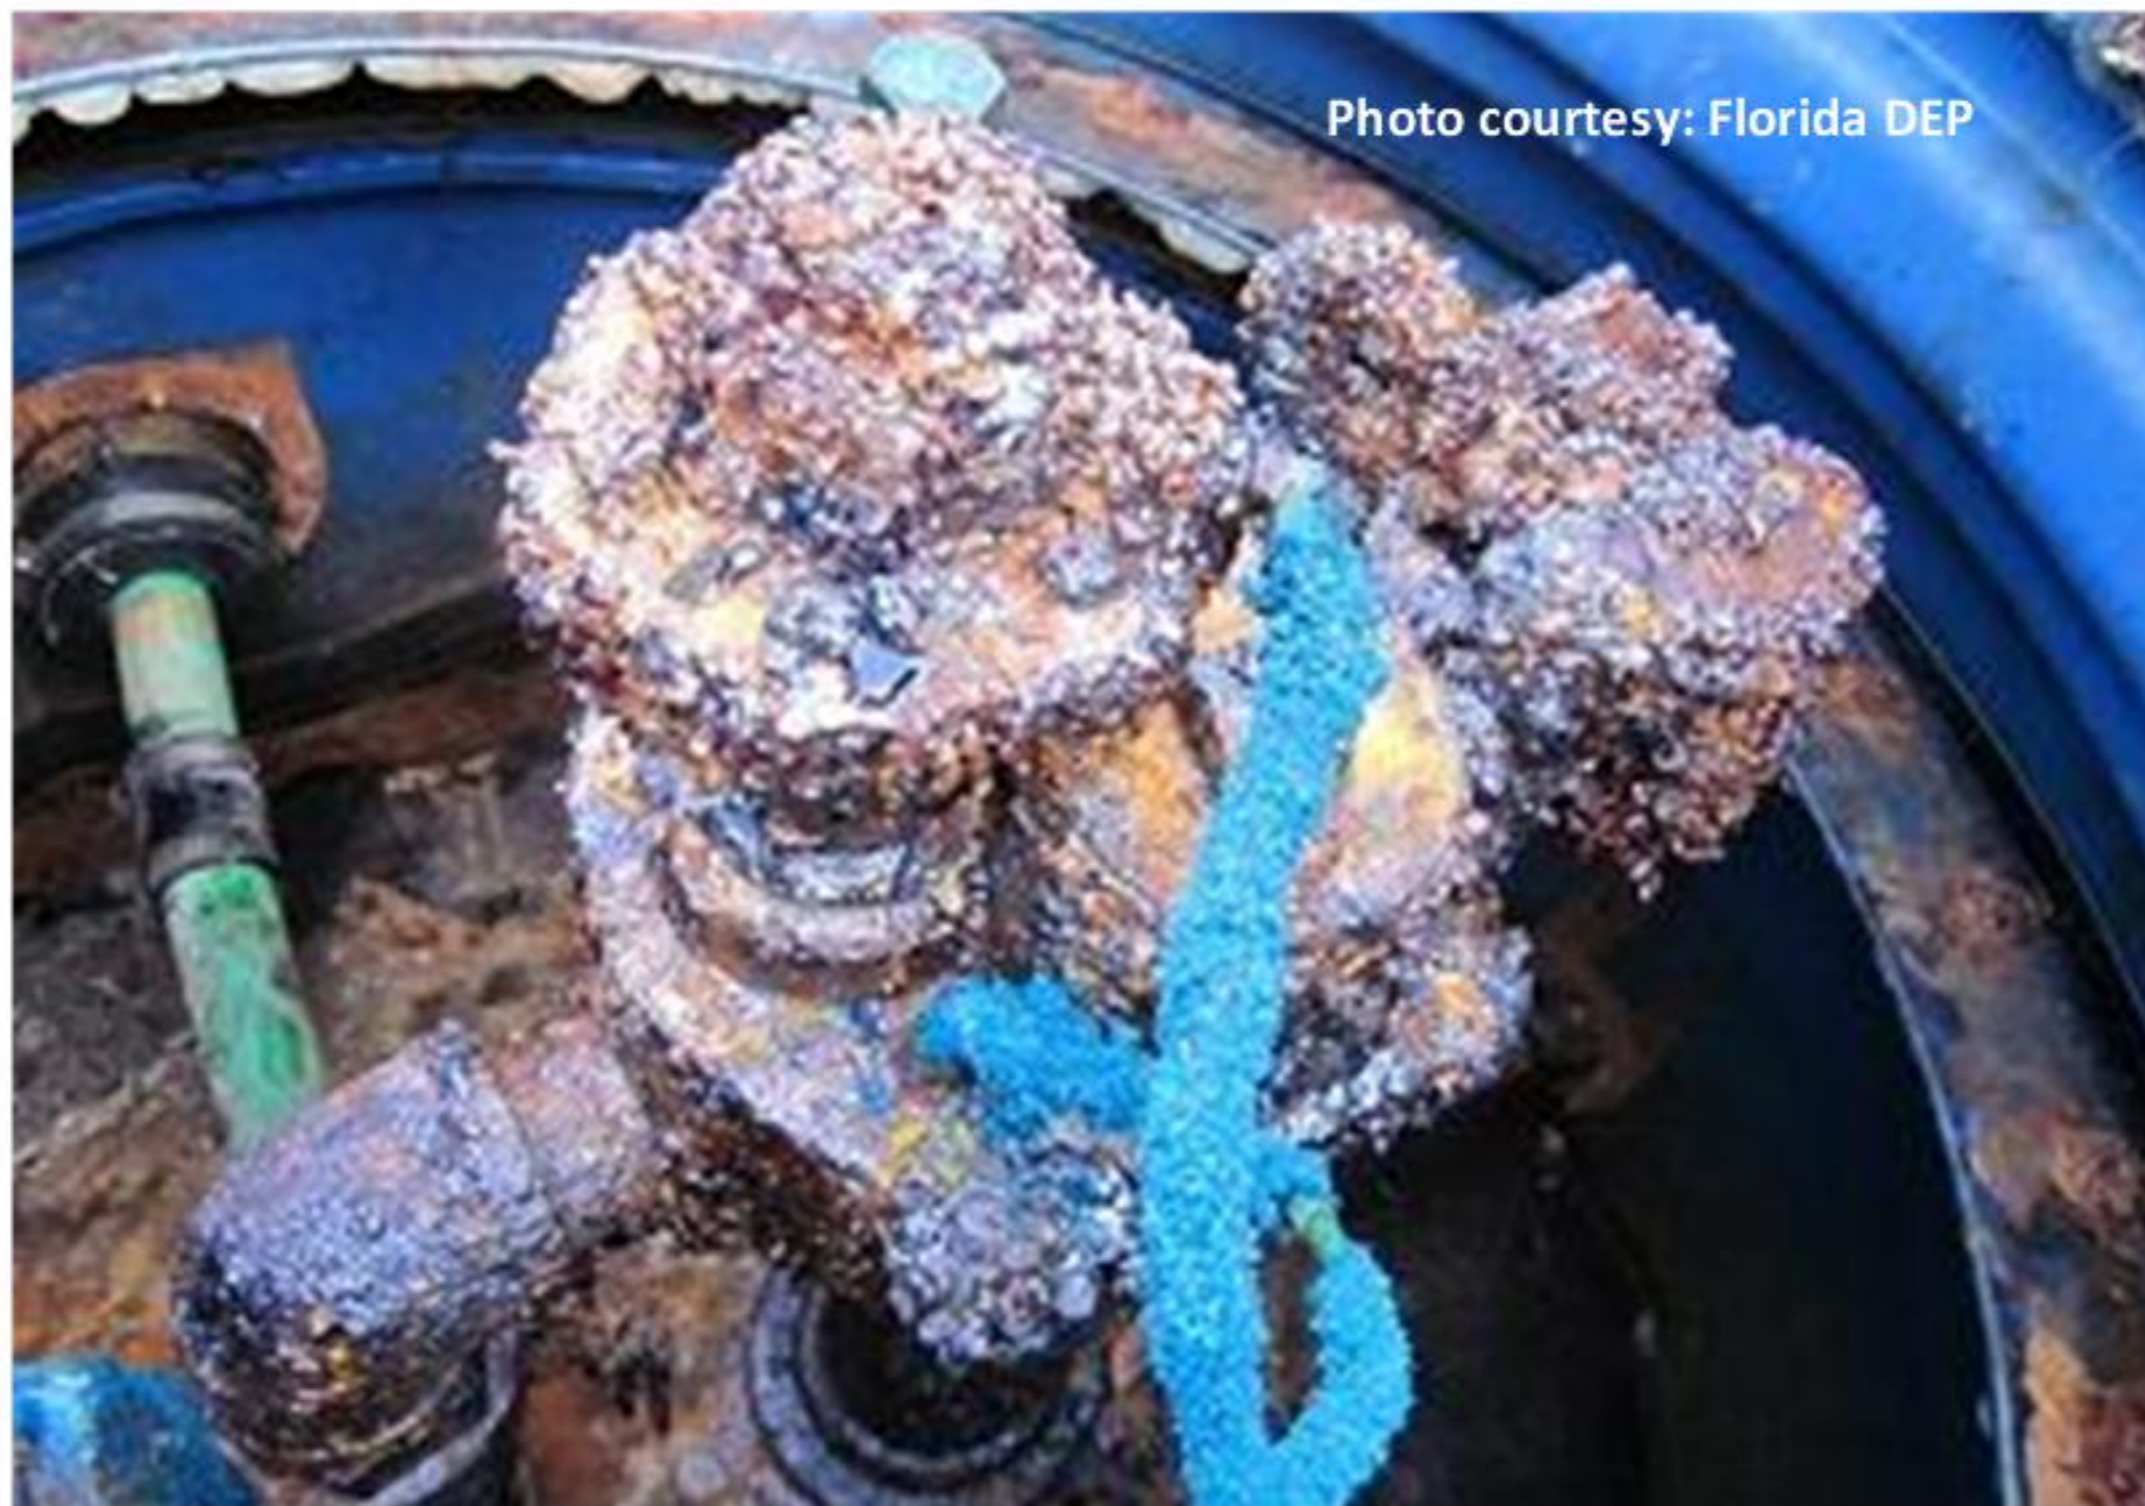
Photo courtesy: Florida DEP

E10 STP, unknown grade (Florida) – Feb. 2011

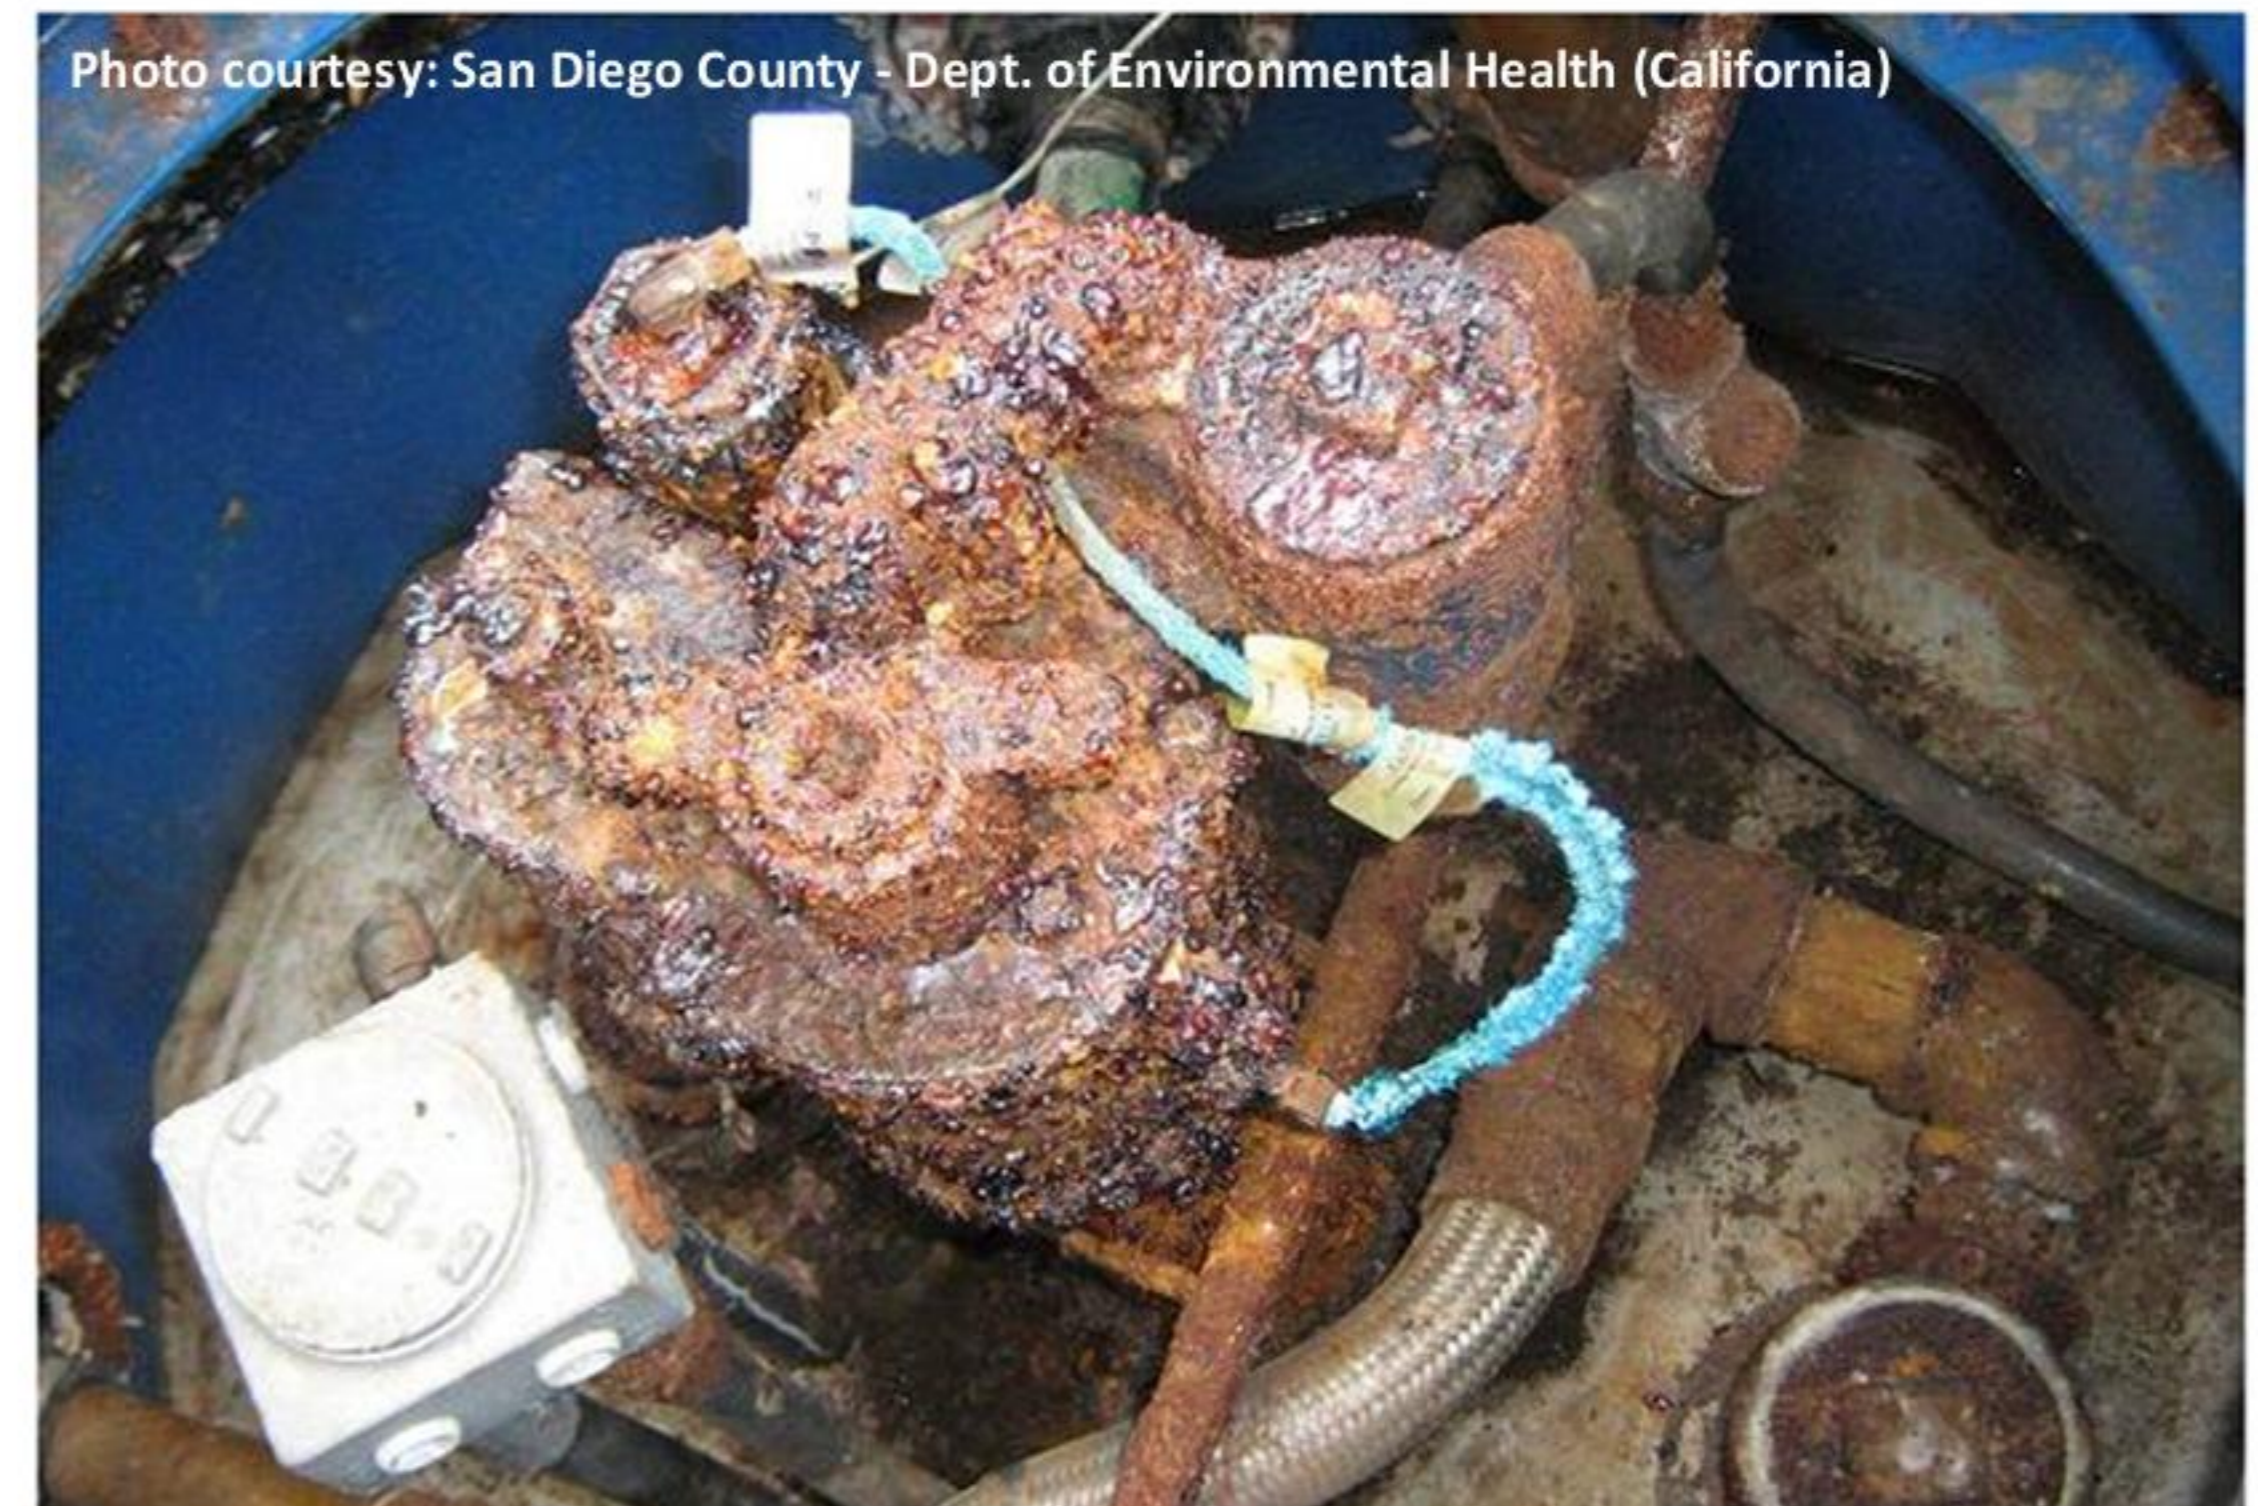
Photo courtesy: San Diego County - Dept. of Environmental Health (California)

91 octane STP (California) – August 2010
