Accelerated Corrosion of UST Equipment (an ethanol hangover) Inspection Concern to Professional Research

Steve Pollock
EPA Biofuels Series
June 20, 2013

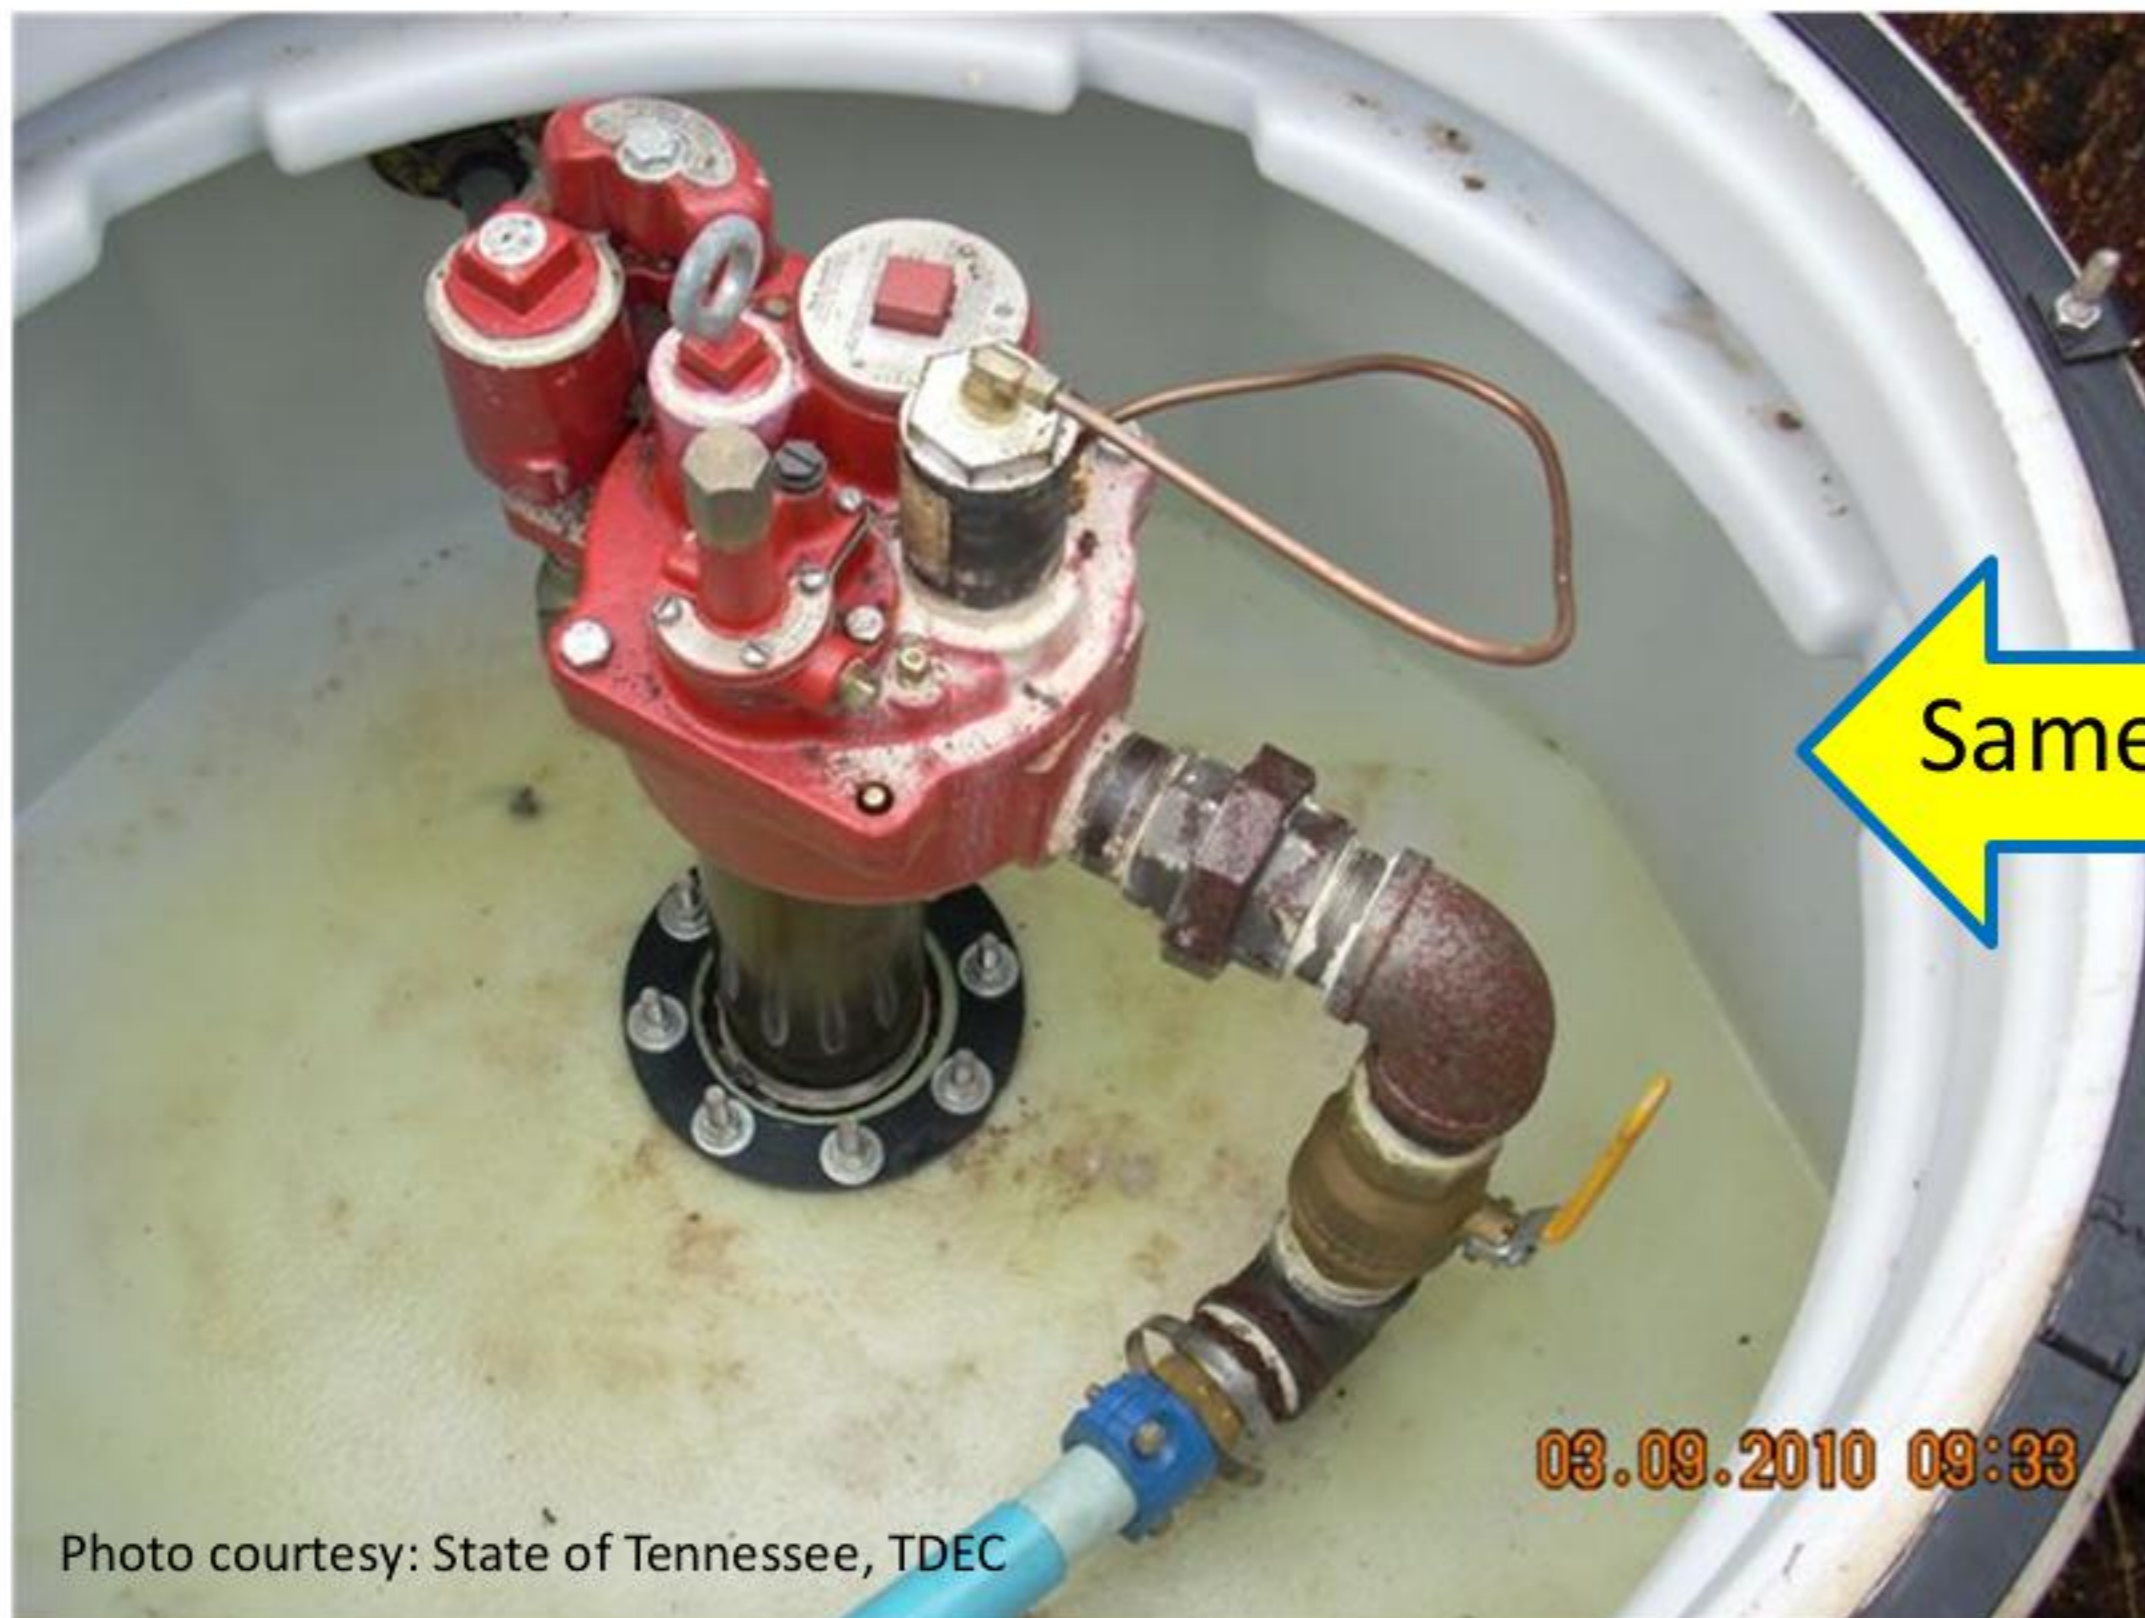
Photo courtesy: State of Tennessee, TDEC

Premium/E10 STP (Tennessee) – March 2010

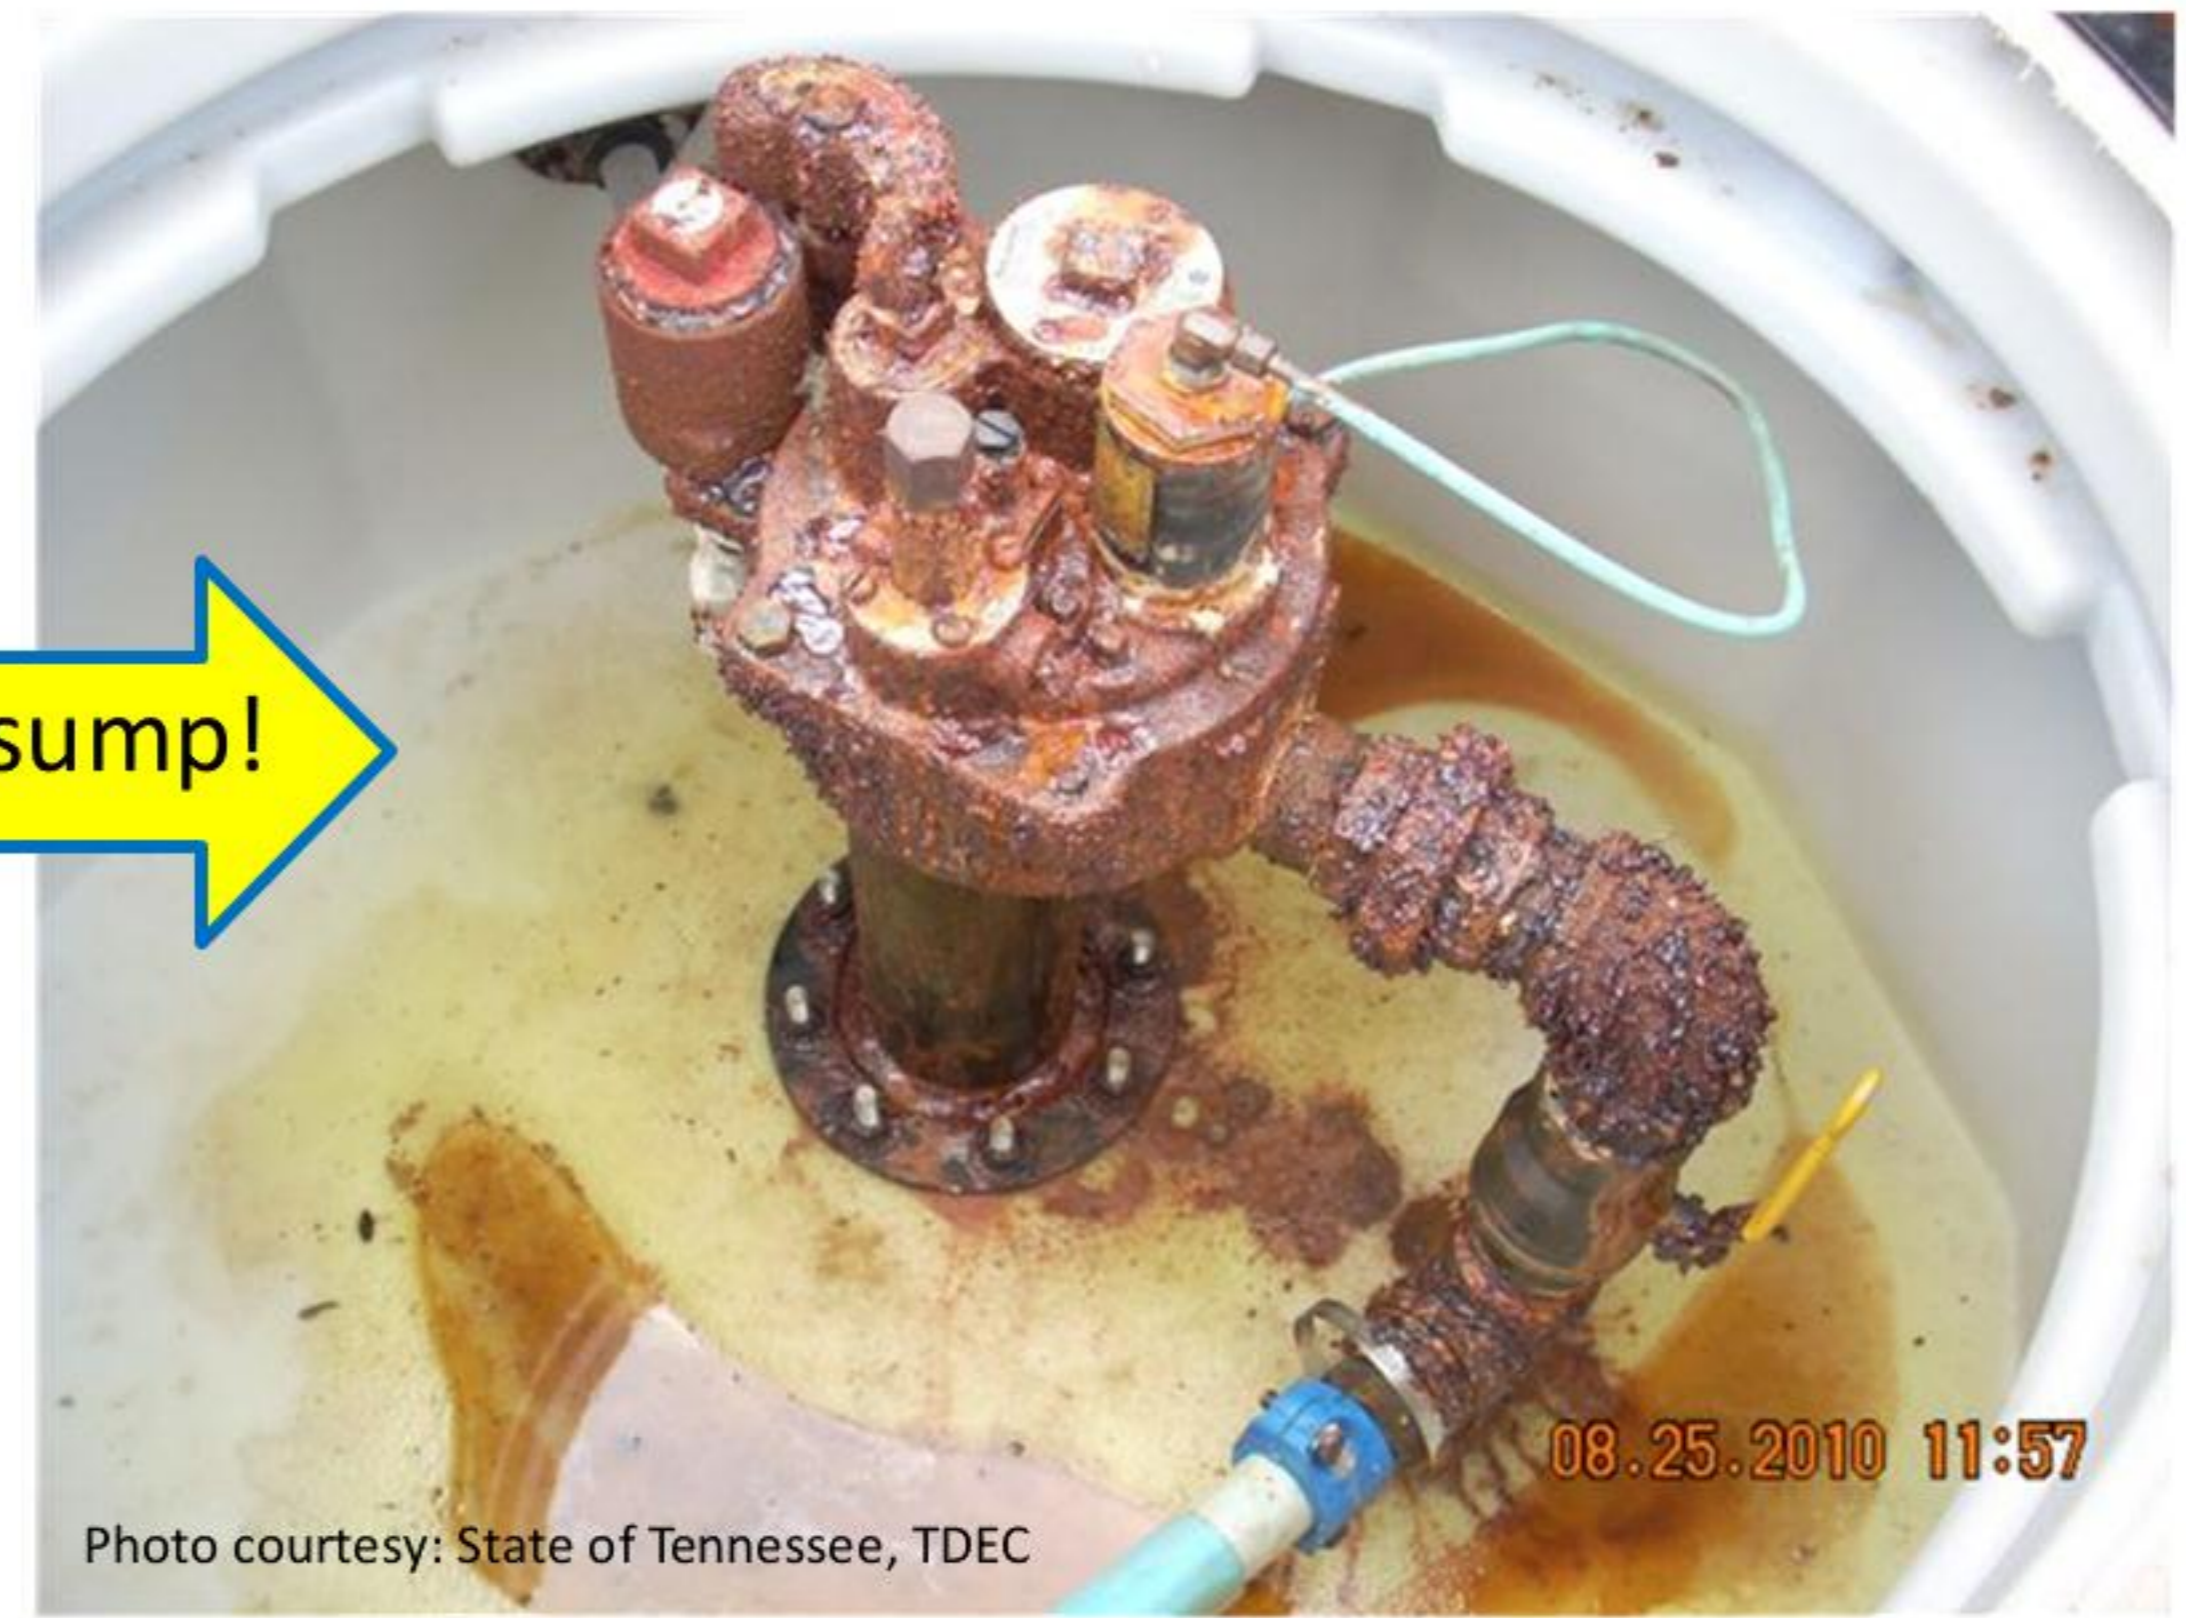
Photo courtesy: State of Tennessee, TDEC

Premium/E10 STP (Tennessee) – August 2010

Same sump!

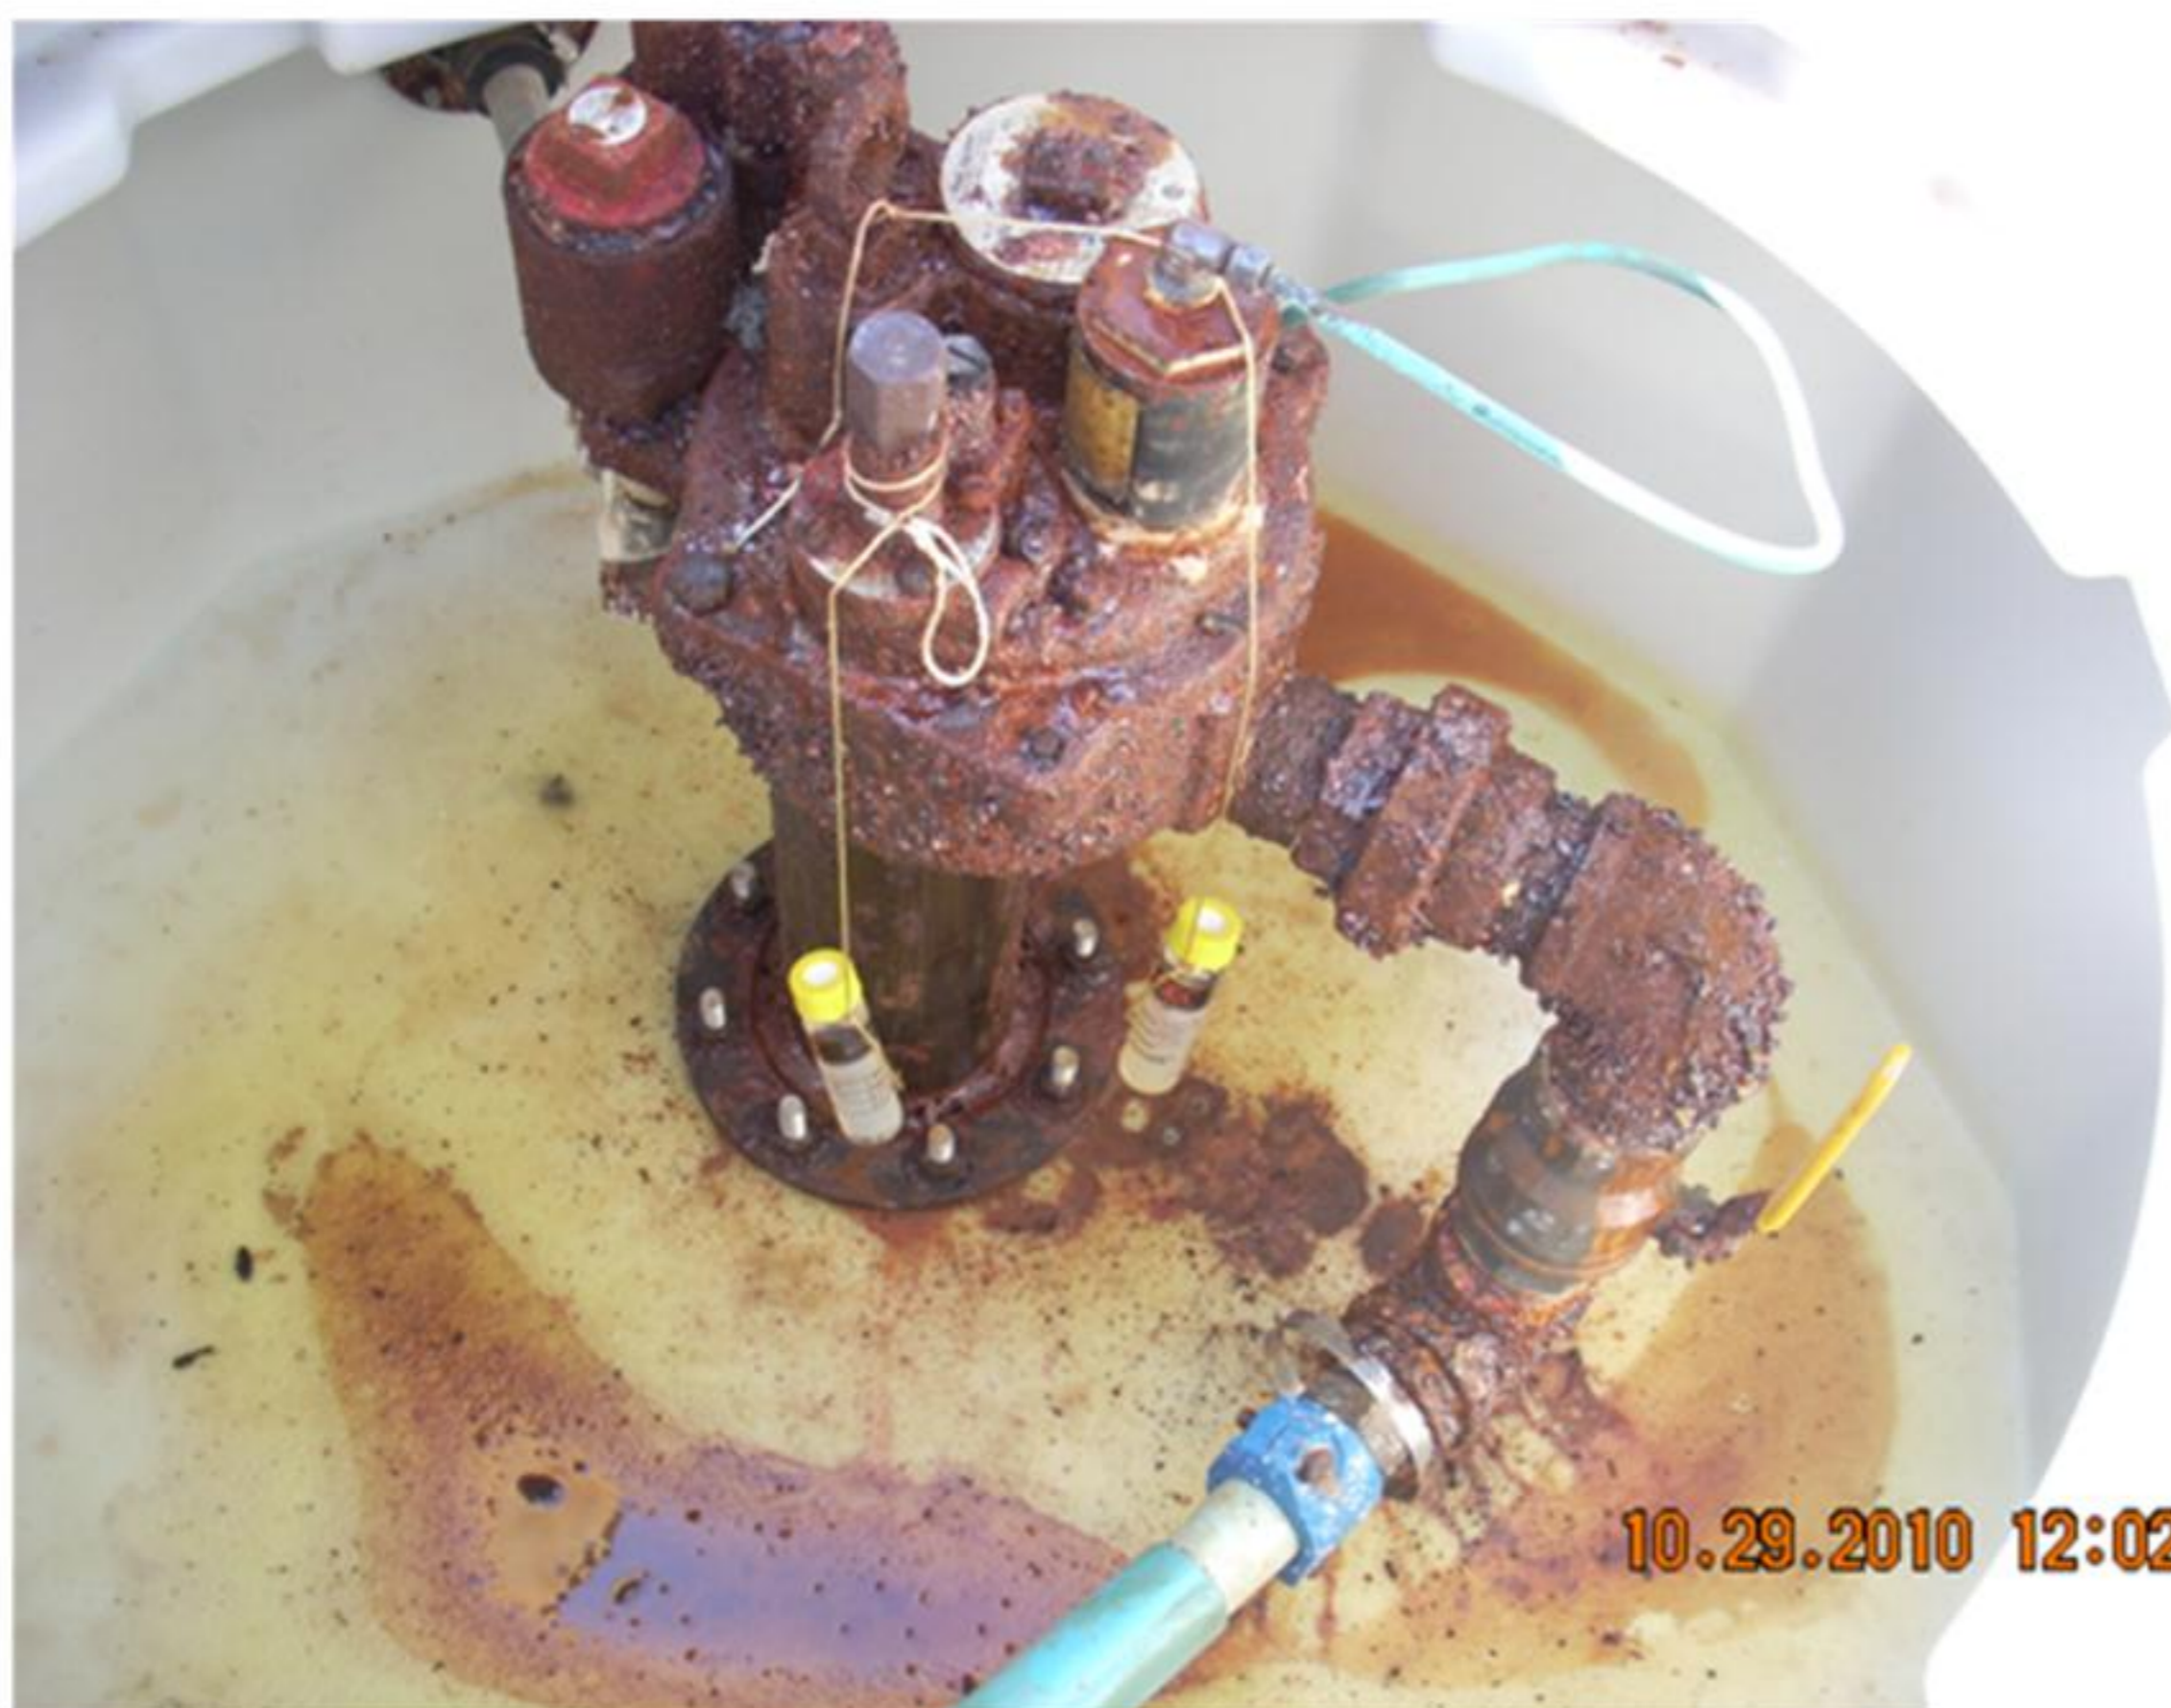
Ample ethanol in vapors
 Water condensing on fixtures
 Ample production of acetic acid
Extensive corrosion

800023 Premium	Sump Water	Vapor Samplers
	(mg/L)	(mg/L)
Ethanol	No Sample	14850
Acetic acid	No Sample	125
Benzene	No Sample	1
Total BTEX	No Sample	21
no standing water, STP 2 years old , pH condensate 5.3

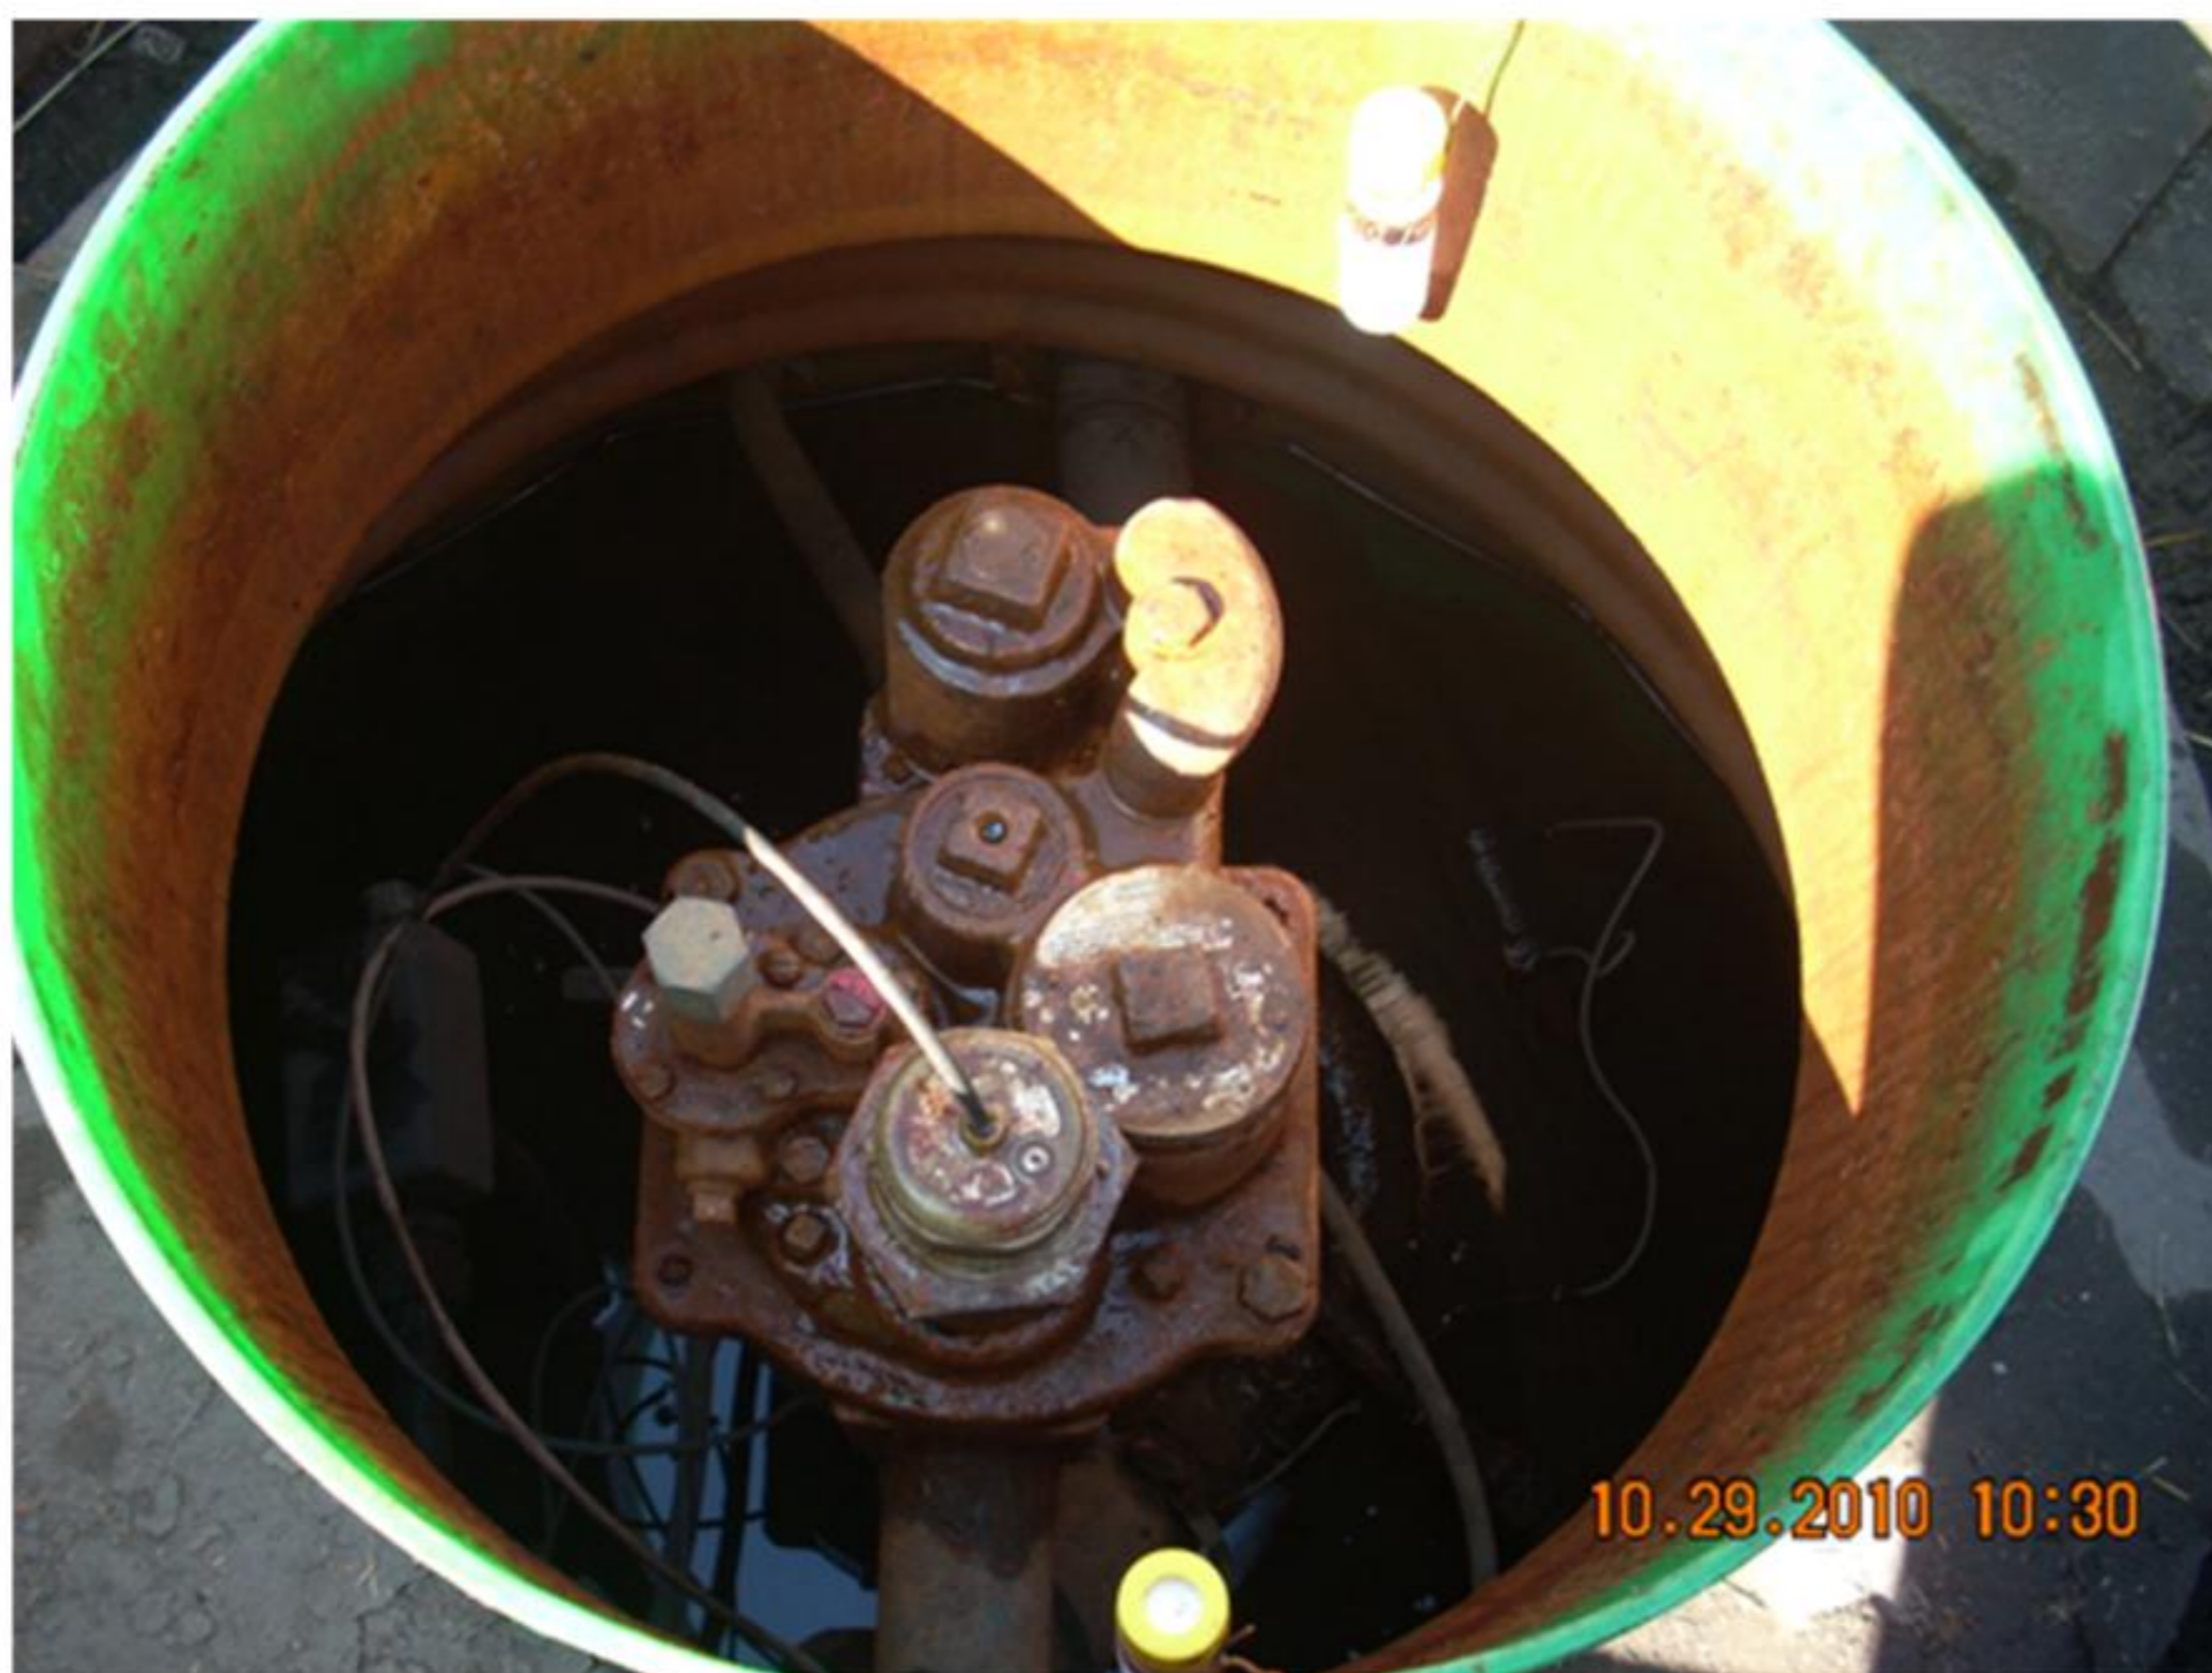
Minimal ethanol in vapors

Adequate water

Concentration of acetic acid not above trip blank (0.77 mg/L)

No evidence of corrosion

4-560089 Regular	Sump Water	Vapor Samplers
	(mg/L)	(mg/L)
Ethanol	ND	8.49
Acetate or Acetic acid	0.35	0.99
Benzene	0.09	0.04
Total BTEX	0.98	0.69
19" water, STP 5+ years old , pH 5.3

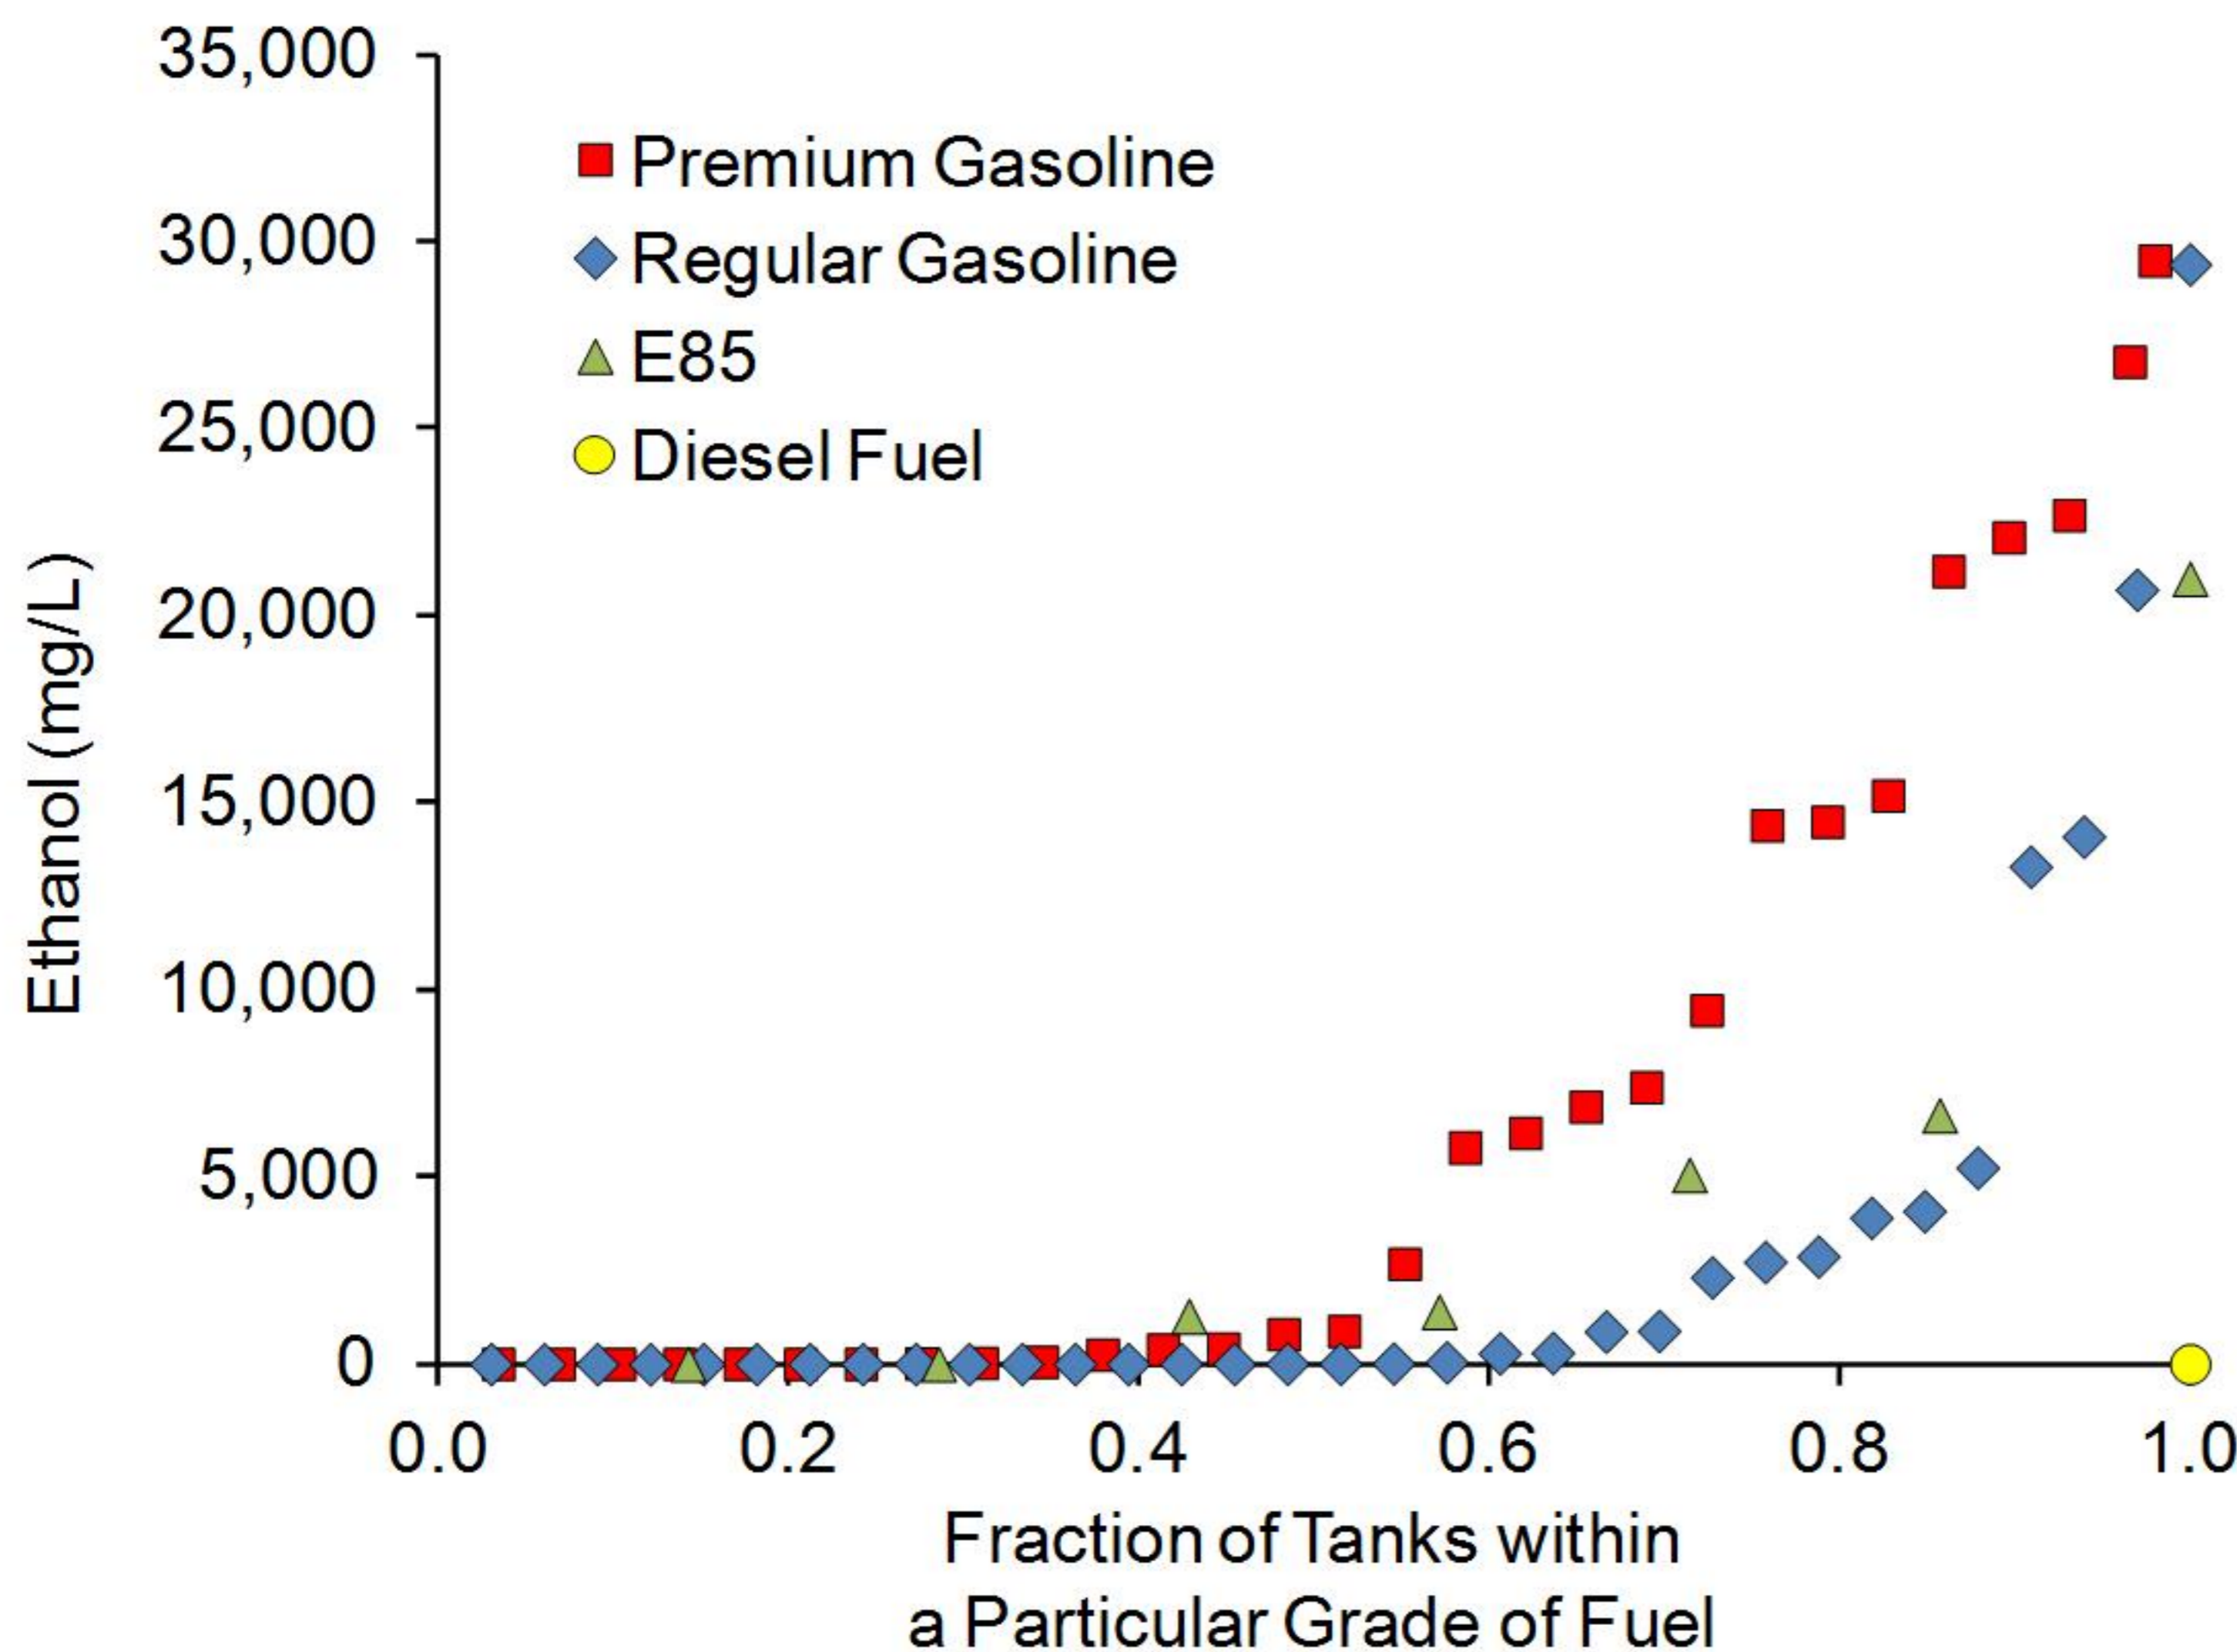
Concentration of ethanol in vapor samplers

- Many sumps had high concentrations of ethanol
- Once the presence of ethanol in the vapor was established, ORD measured acetic acid (in the form of acetate)
- ***New graphs soon!***
