Accelerated Corrosion of UST Equipment (an ethanol hangover) Inspection Concern to Professional Research

Steve Pollock
EPA Biofuels Series
June 20, 2013

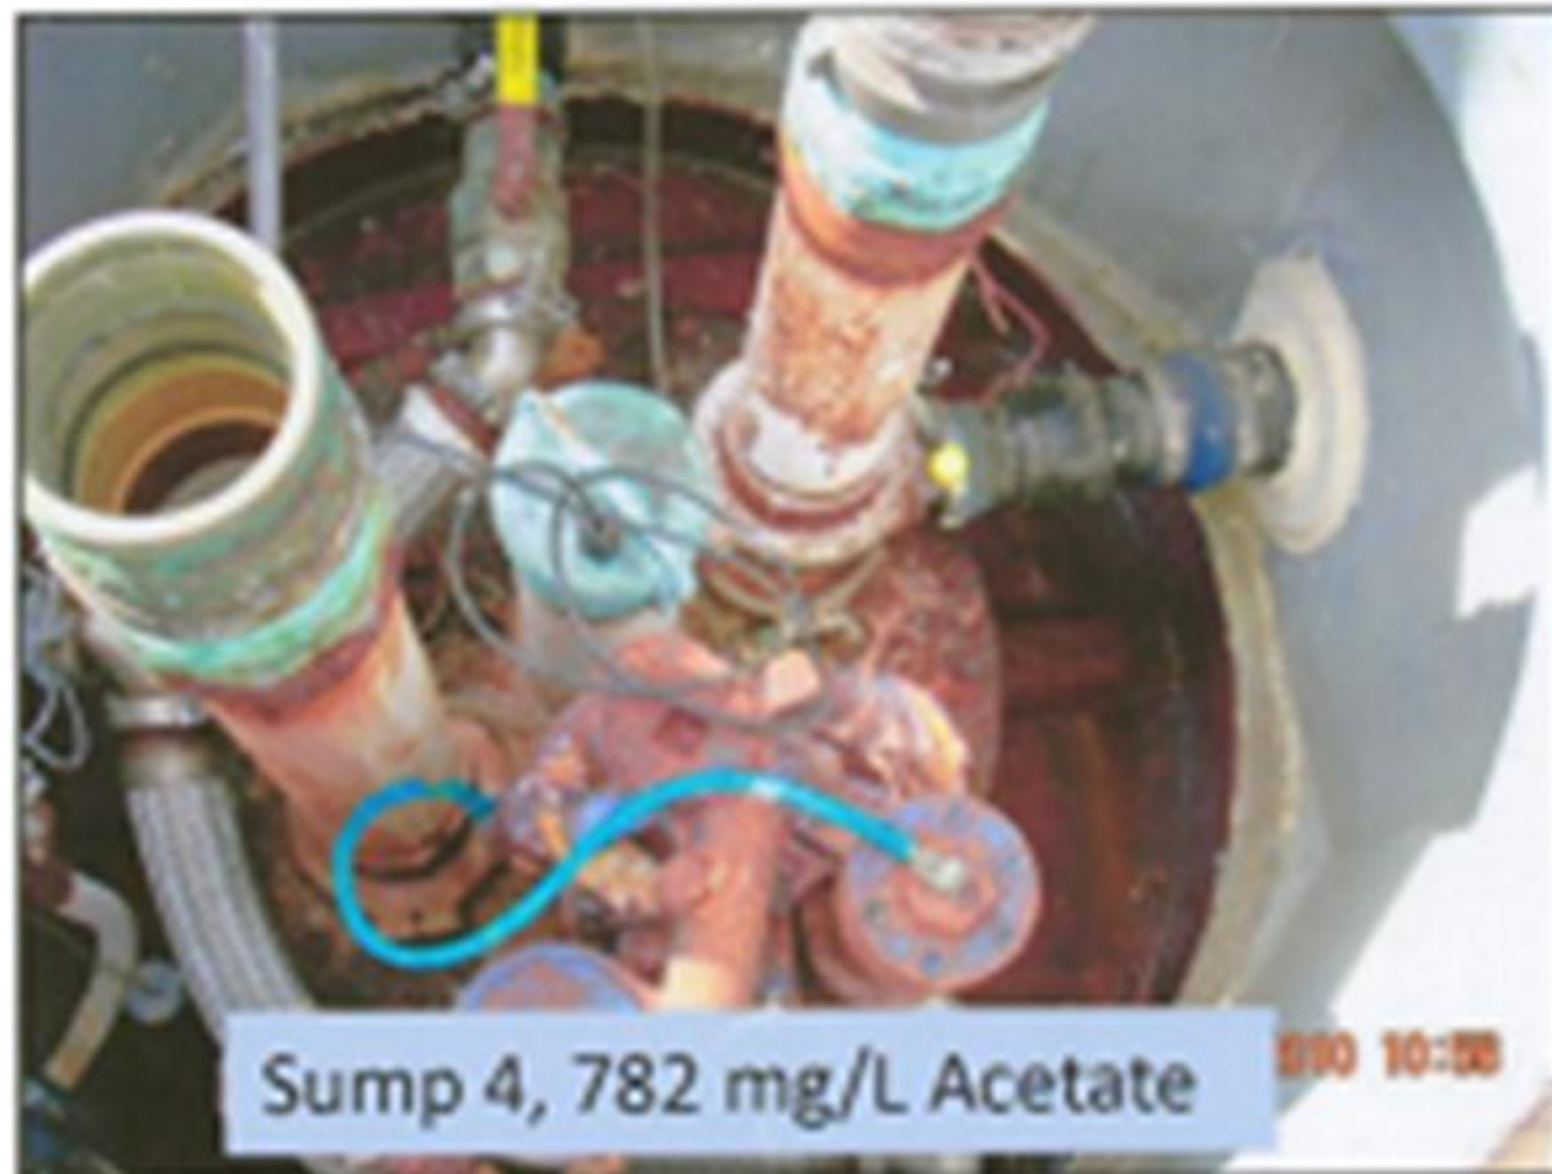
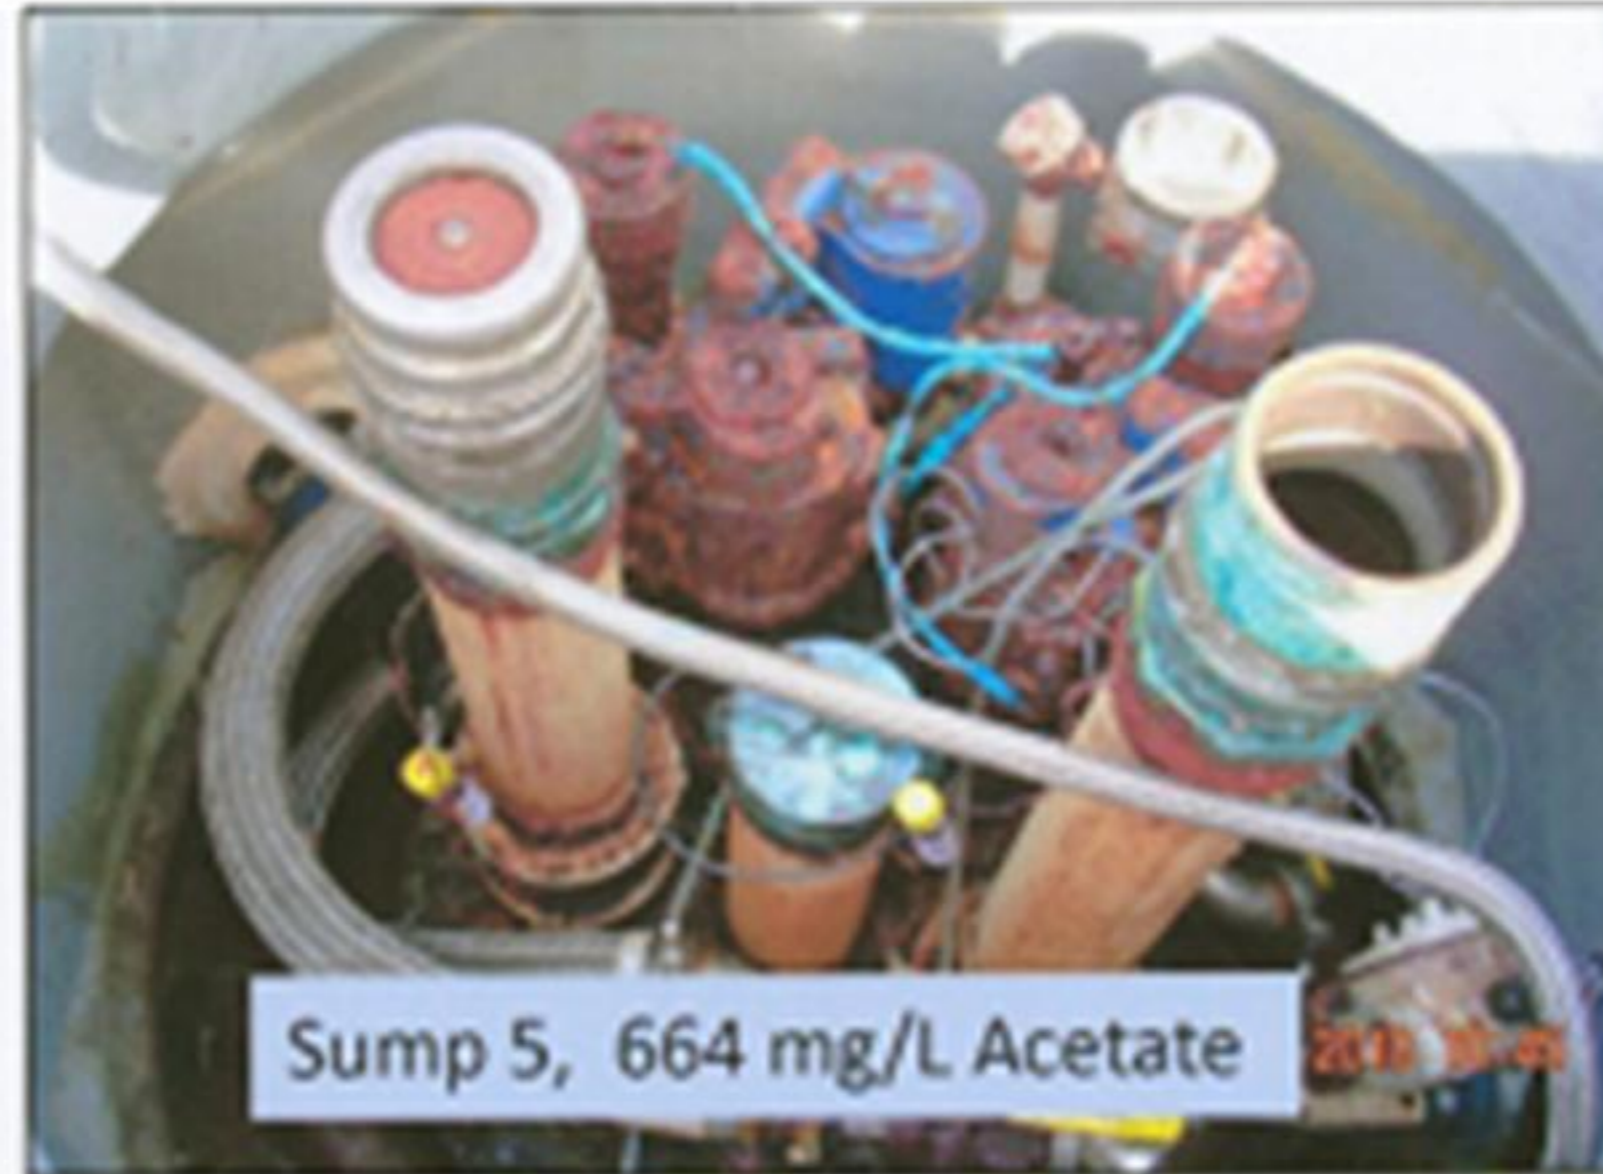
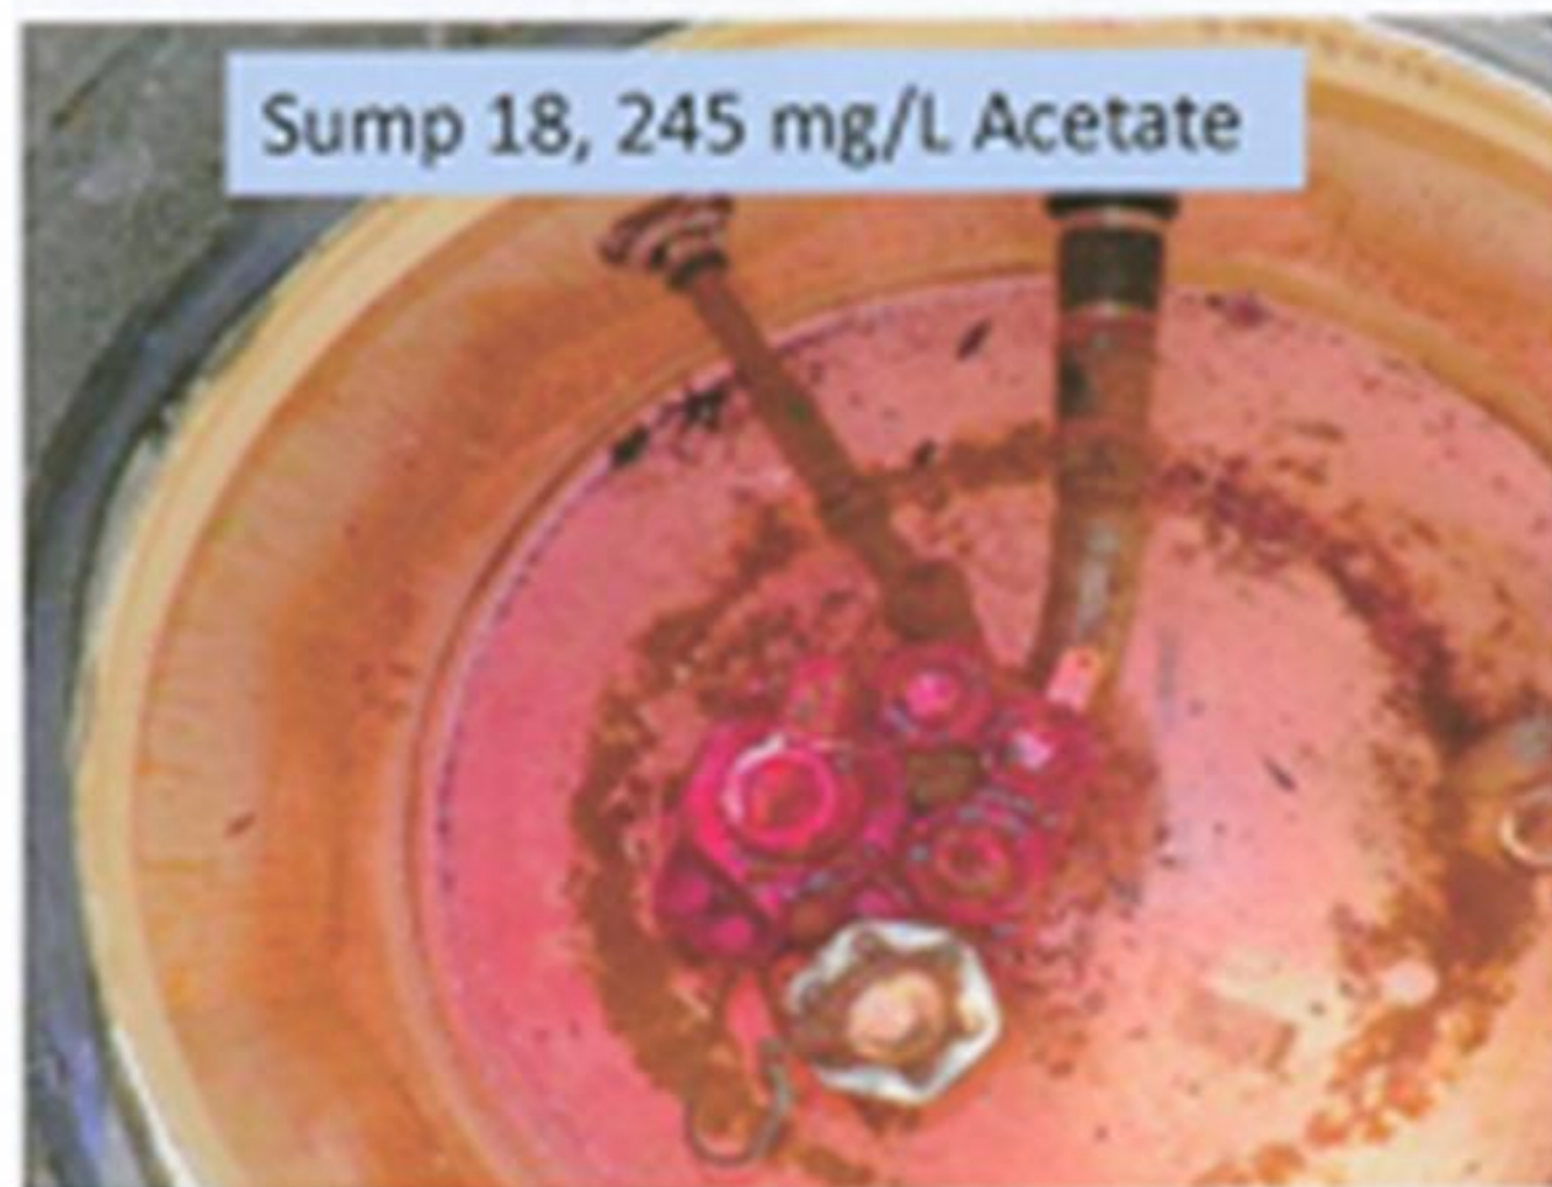
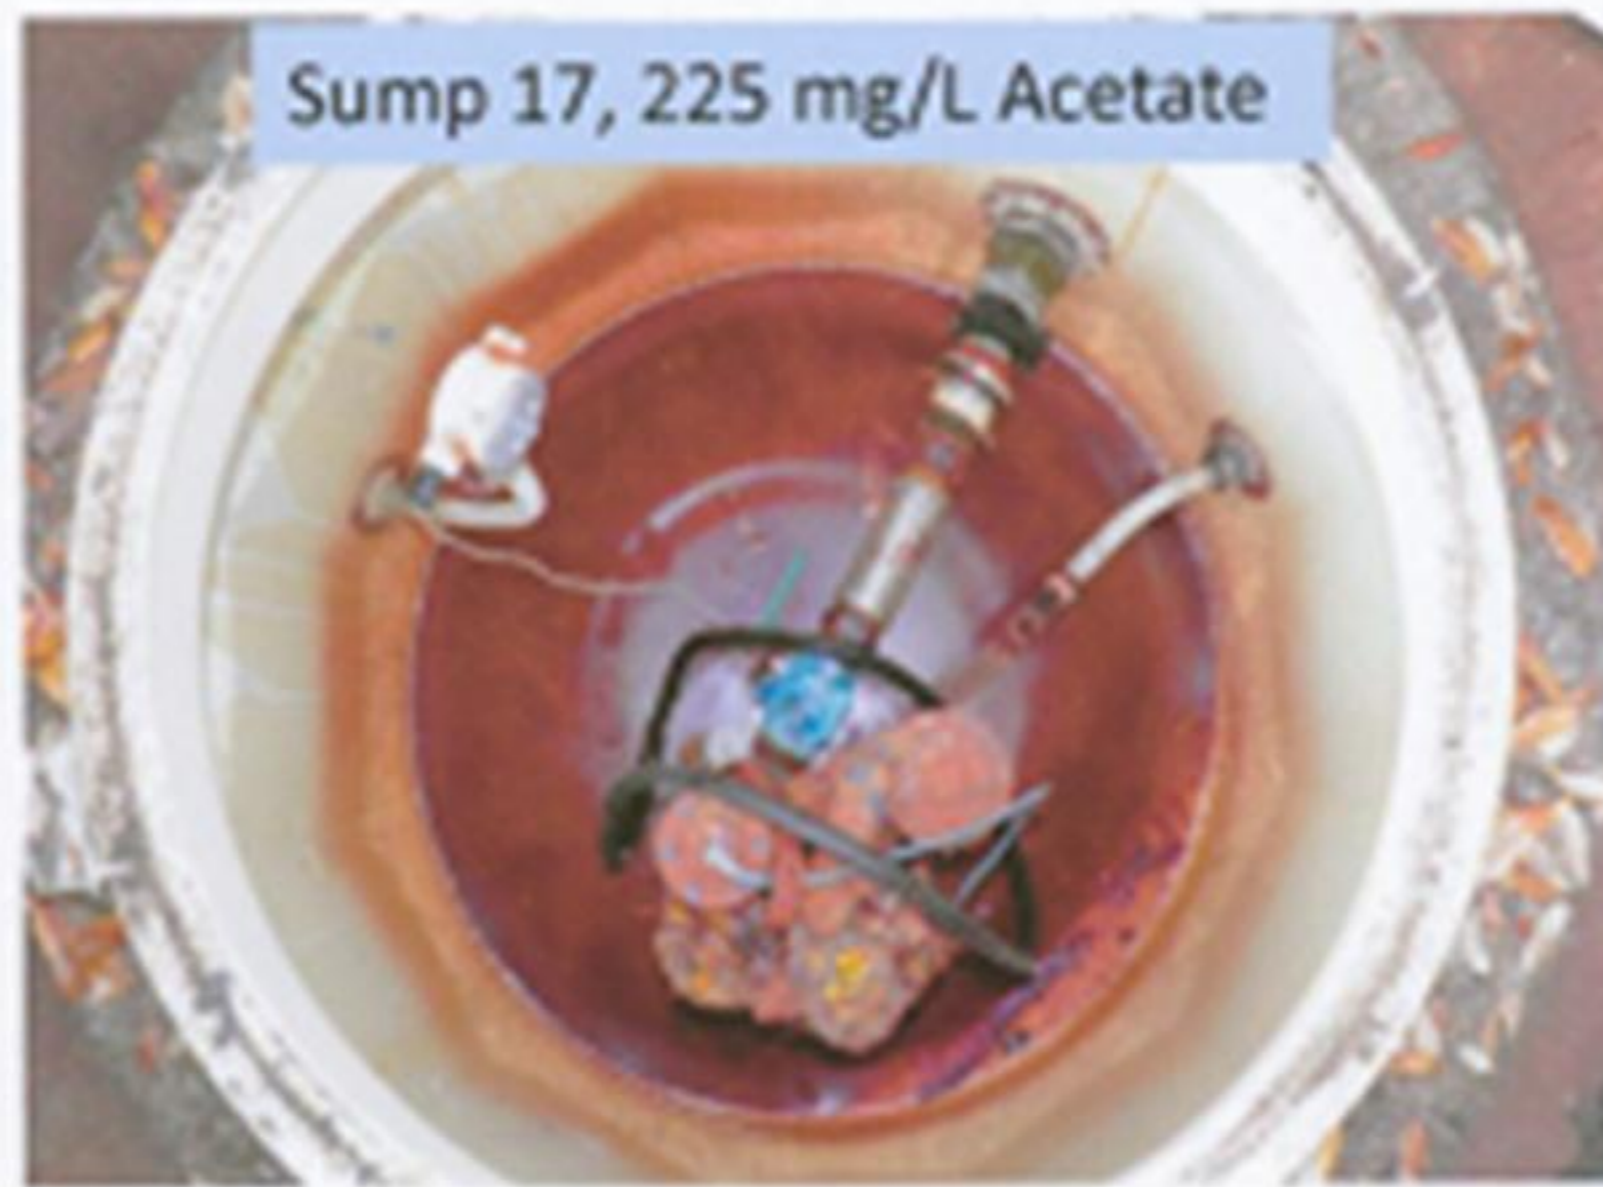
In general, there was more observable corrosion in sumps with high and intermediate concentrations of acetate measured in the vapor samplers.

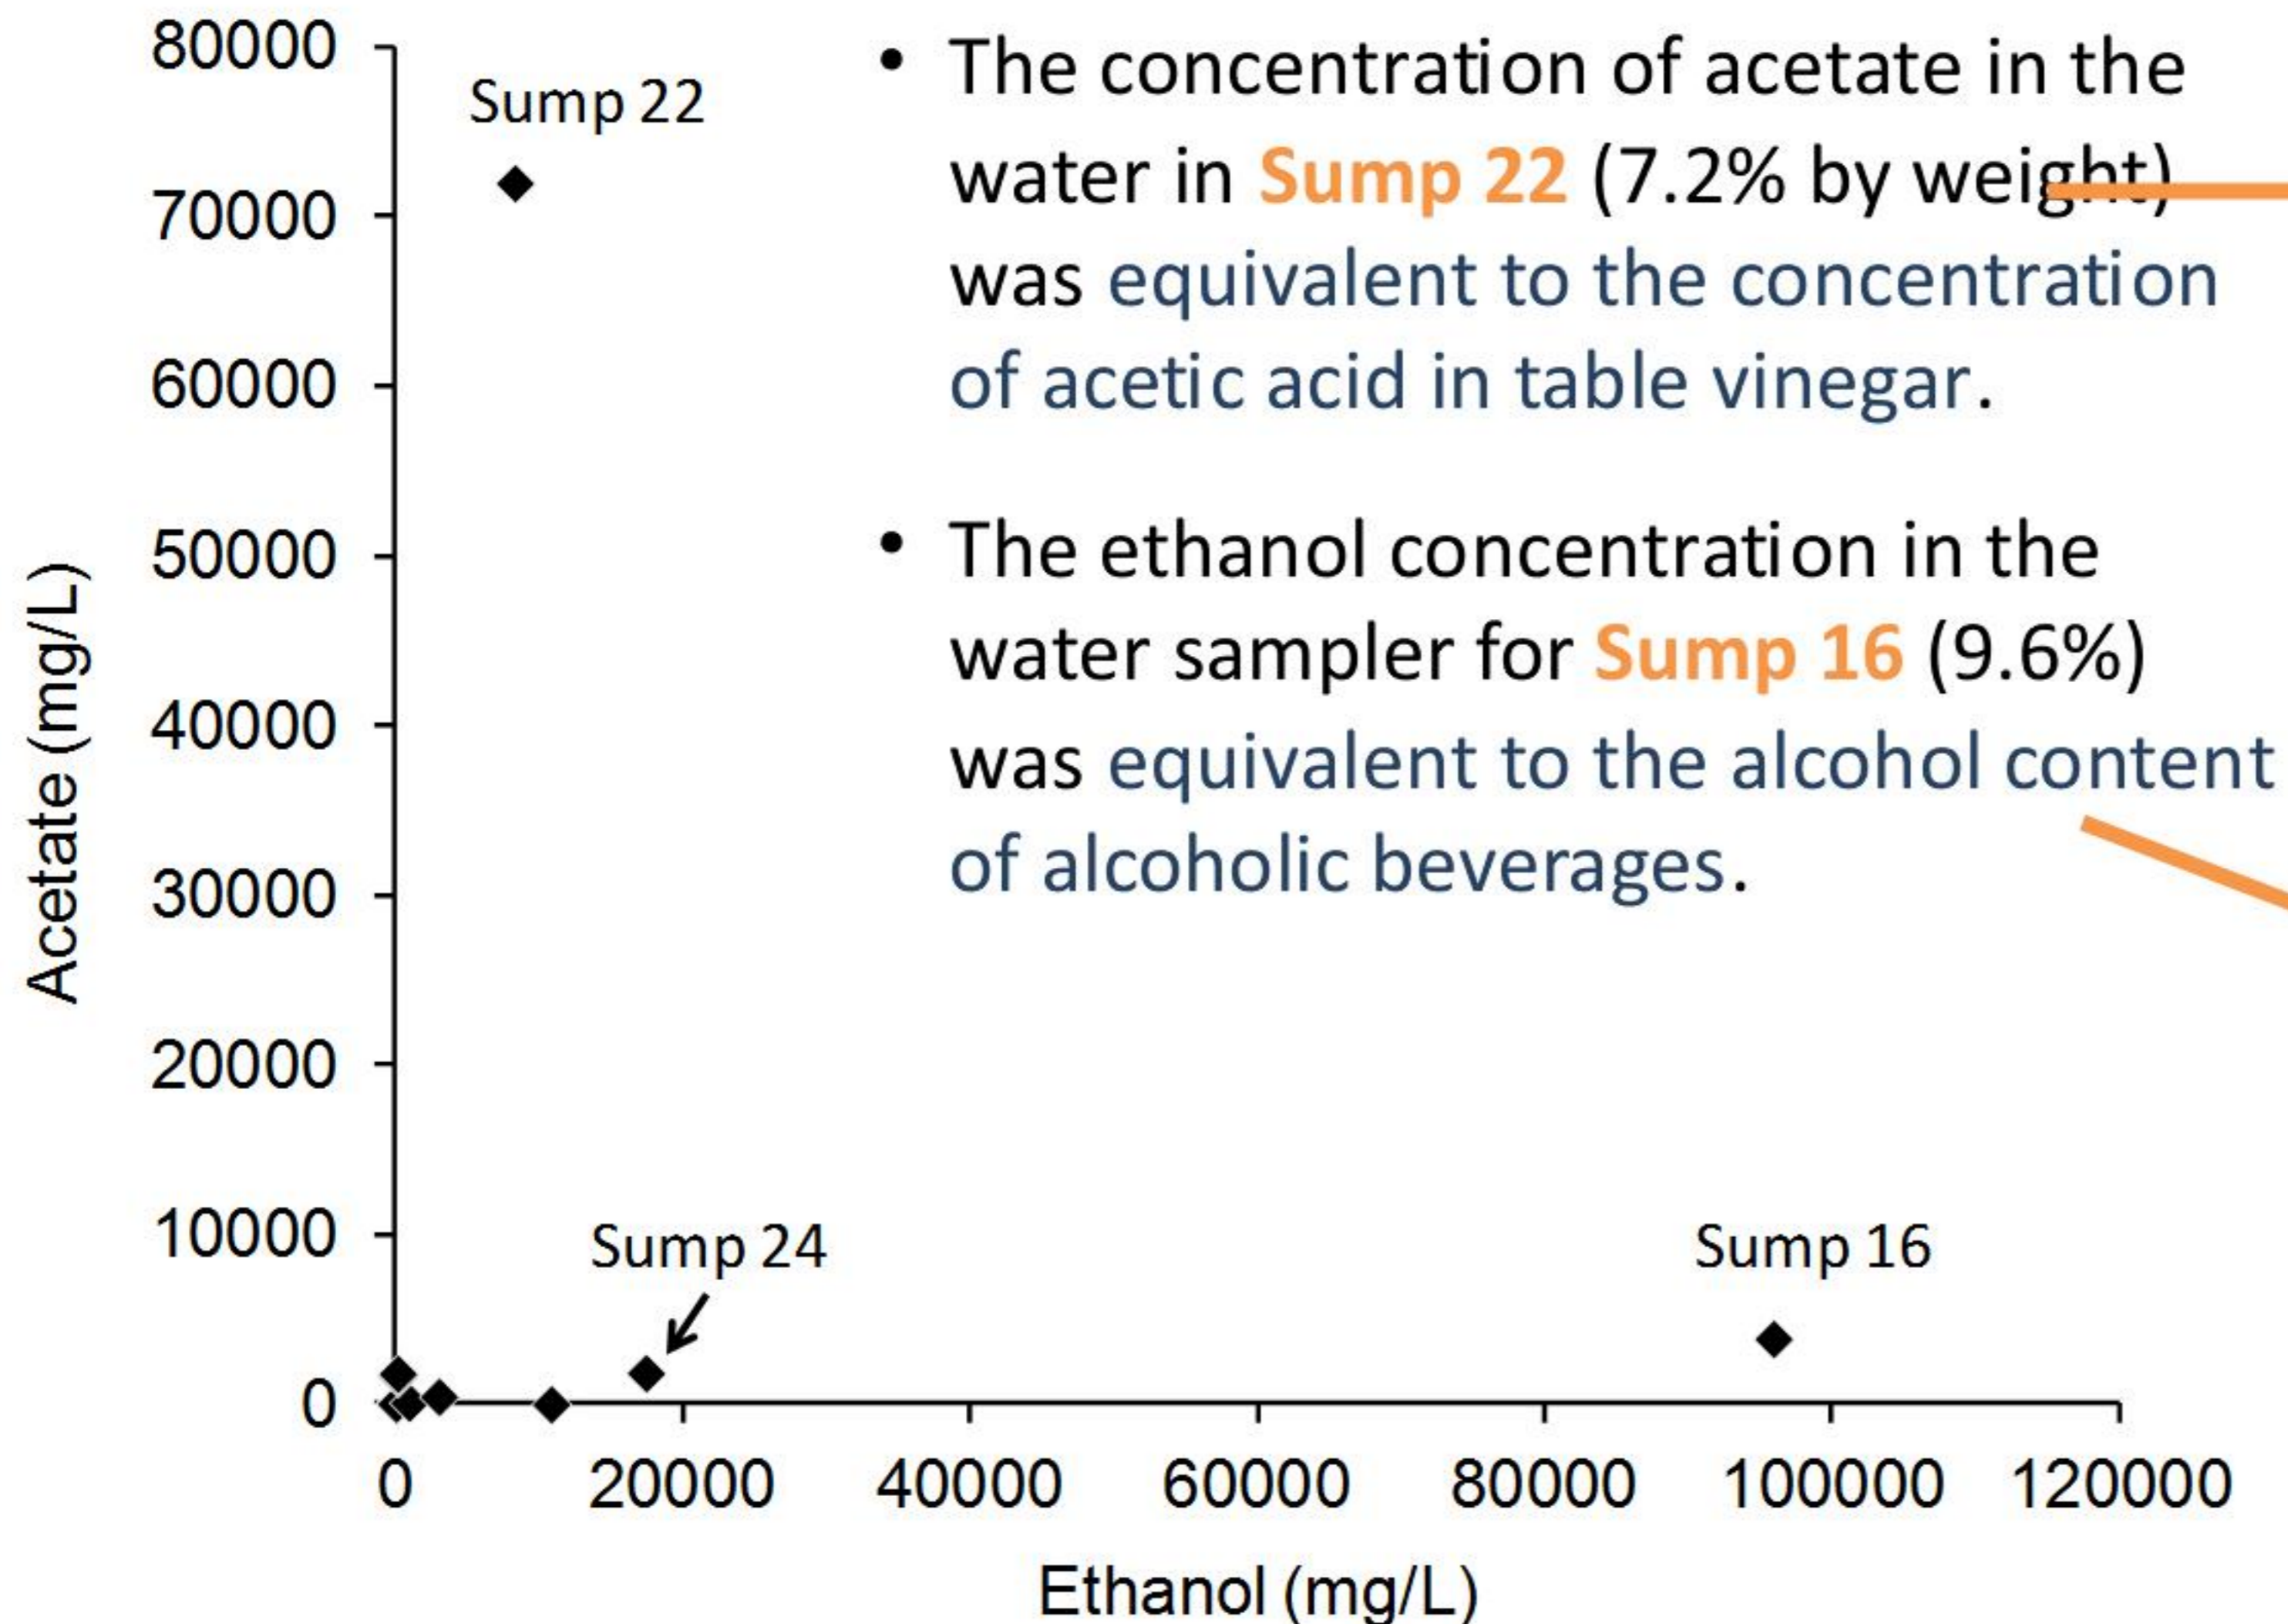
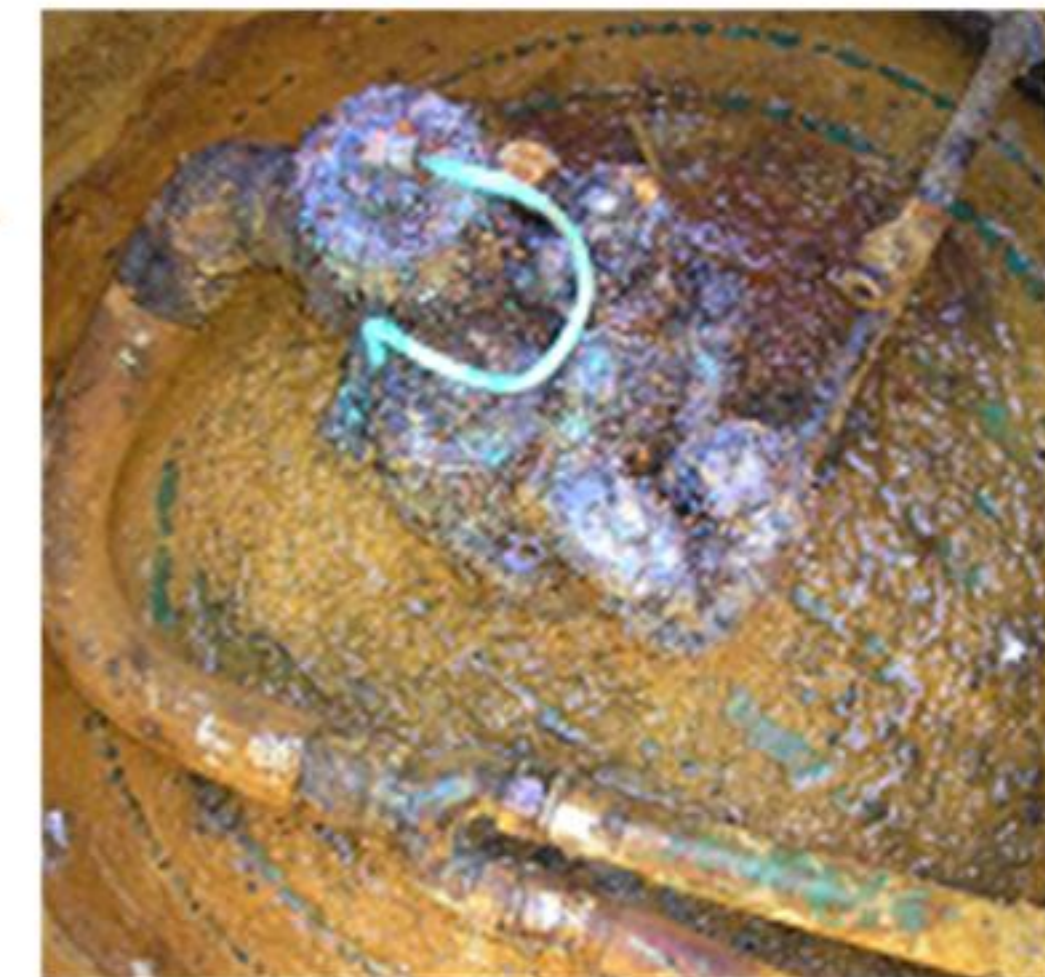
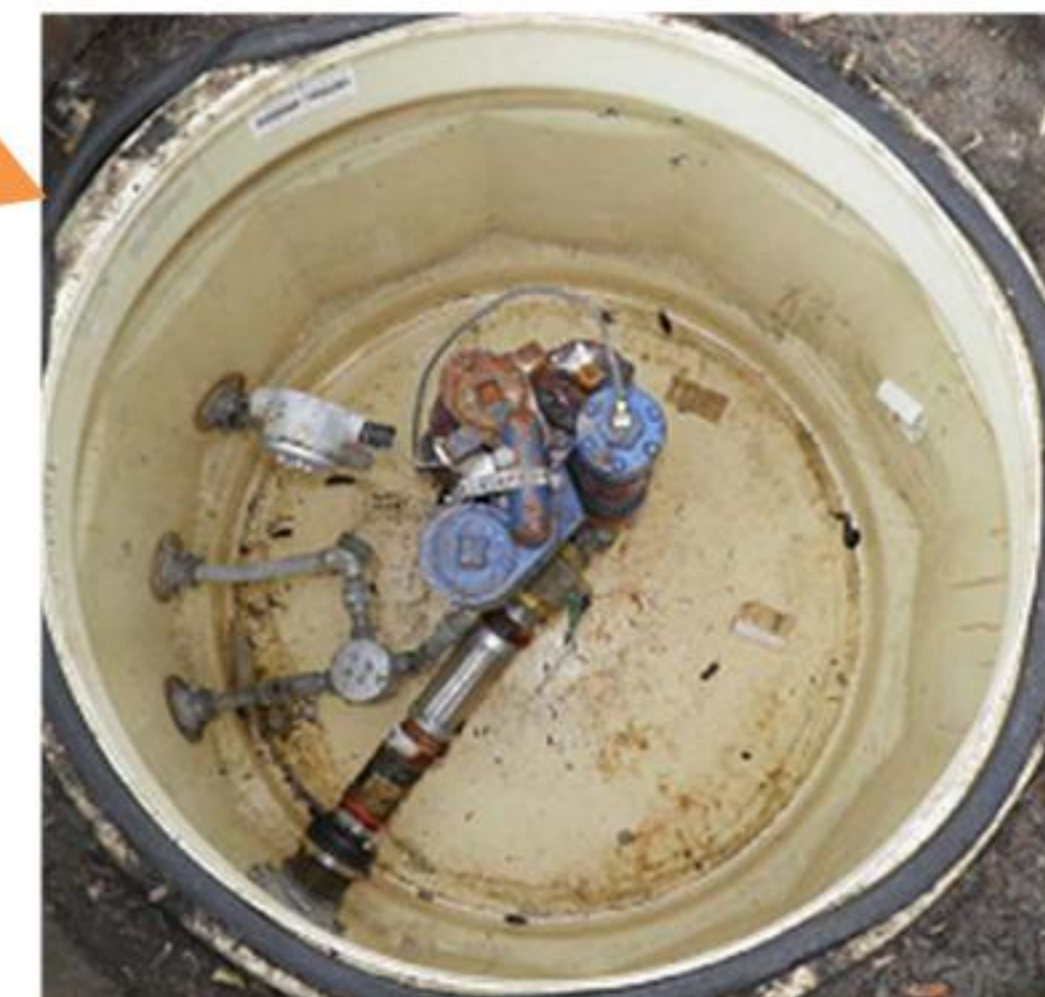
Concentration of ethanol in sump water

Water in 3 sumps had very high concentrations of either ethanol or acetate. Sumps 22 and 16 are particularly notable because:

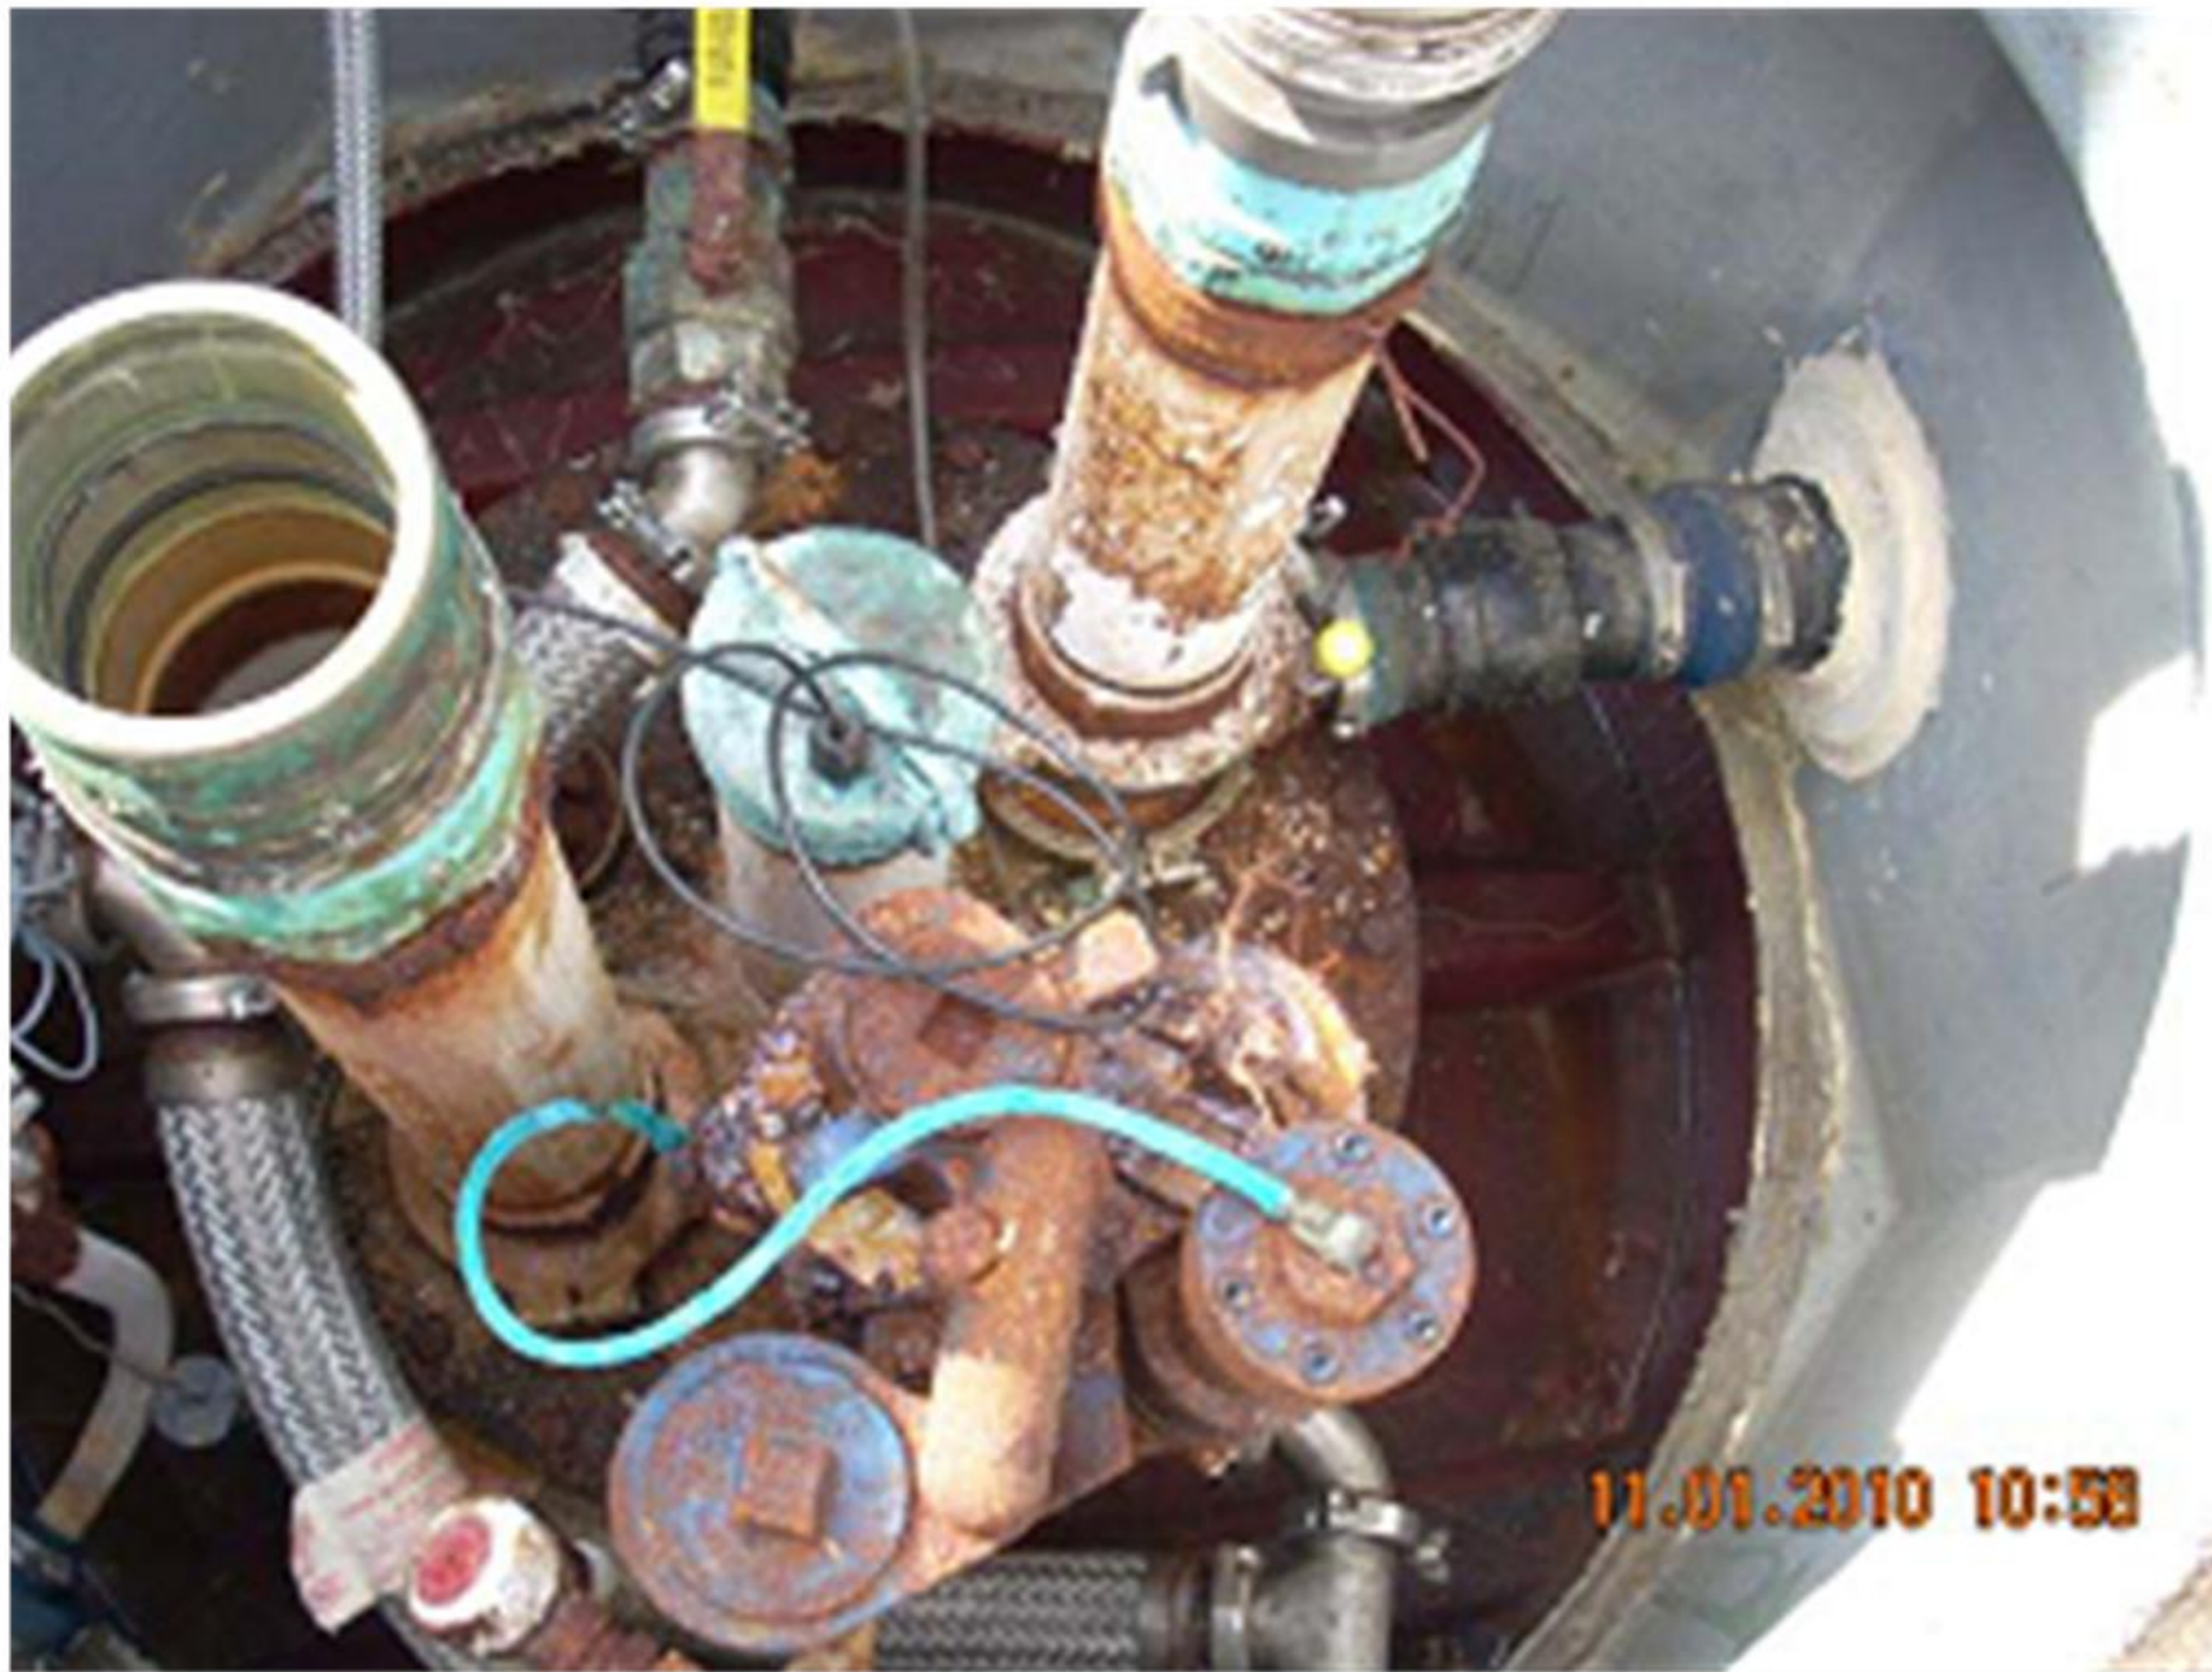
Chemical analysis of corrosion products

As expected, the red-brown corrosion were iron oxides (rust).

Most of the blue-green corrosion product was copper and acetate.

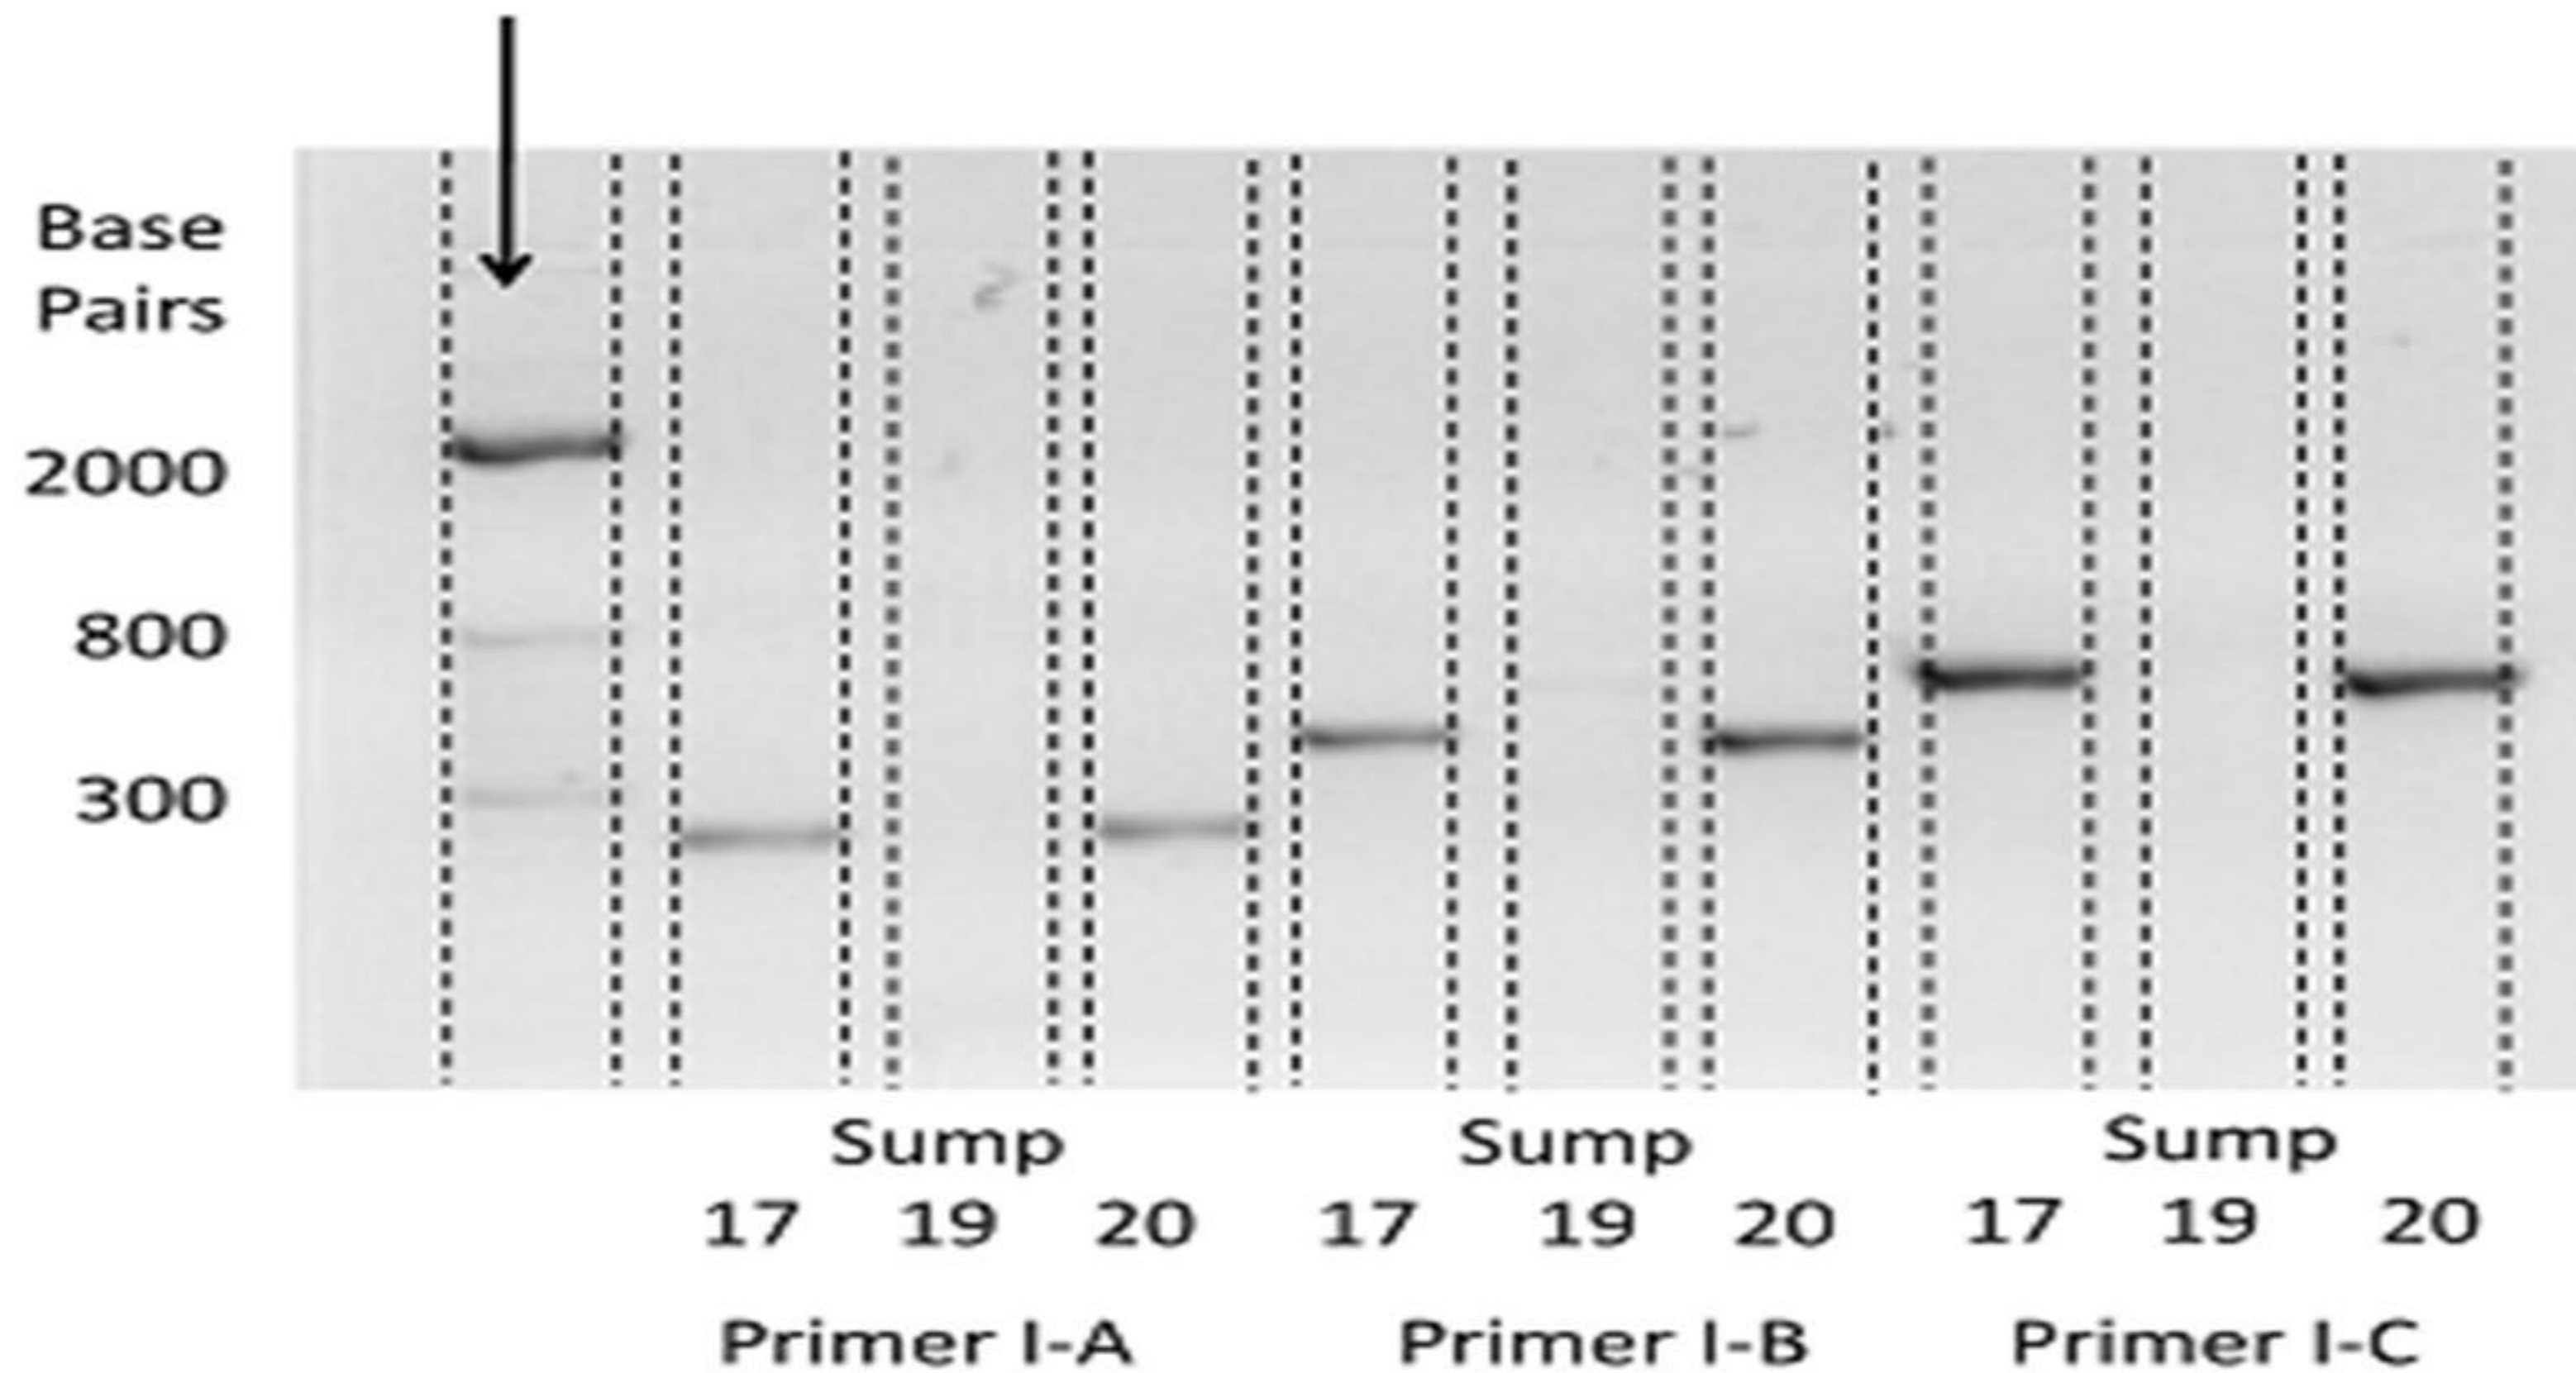
Acetobacter DNA in sump water

DNA to Calibrate the Gel

Sump #	17	19	20
Conc. Acetate	225 mg/L	<0.1 mg/L	30 mg/L
DNA detected?	Yes	No	Yes
