Accelerated Corrosion of UST Equipment (an ethanol hangover) Inspection Concern to Professional Research

Steve Pollock
EPA Biofuels Series
June 20, 2013

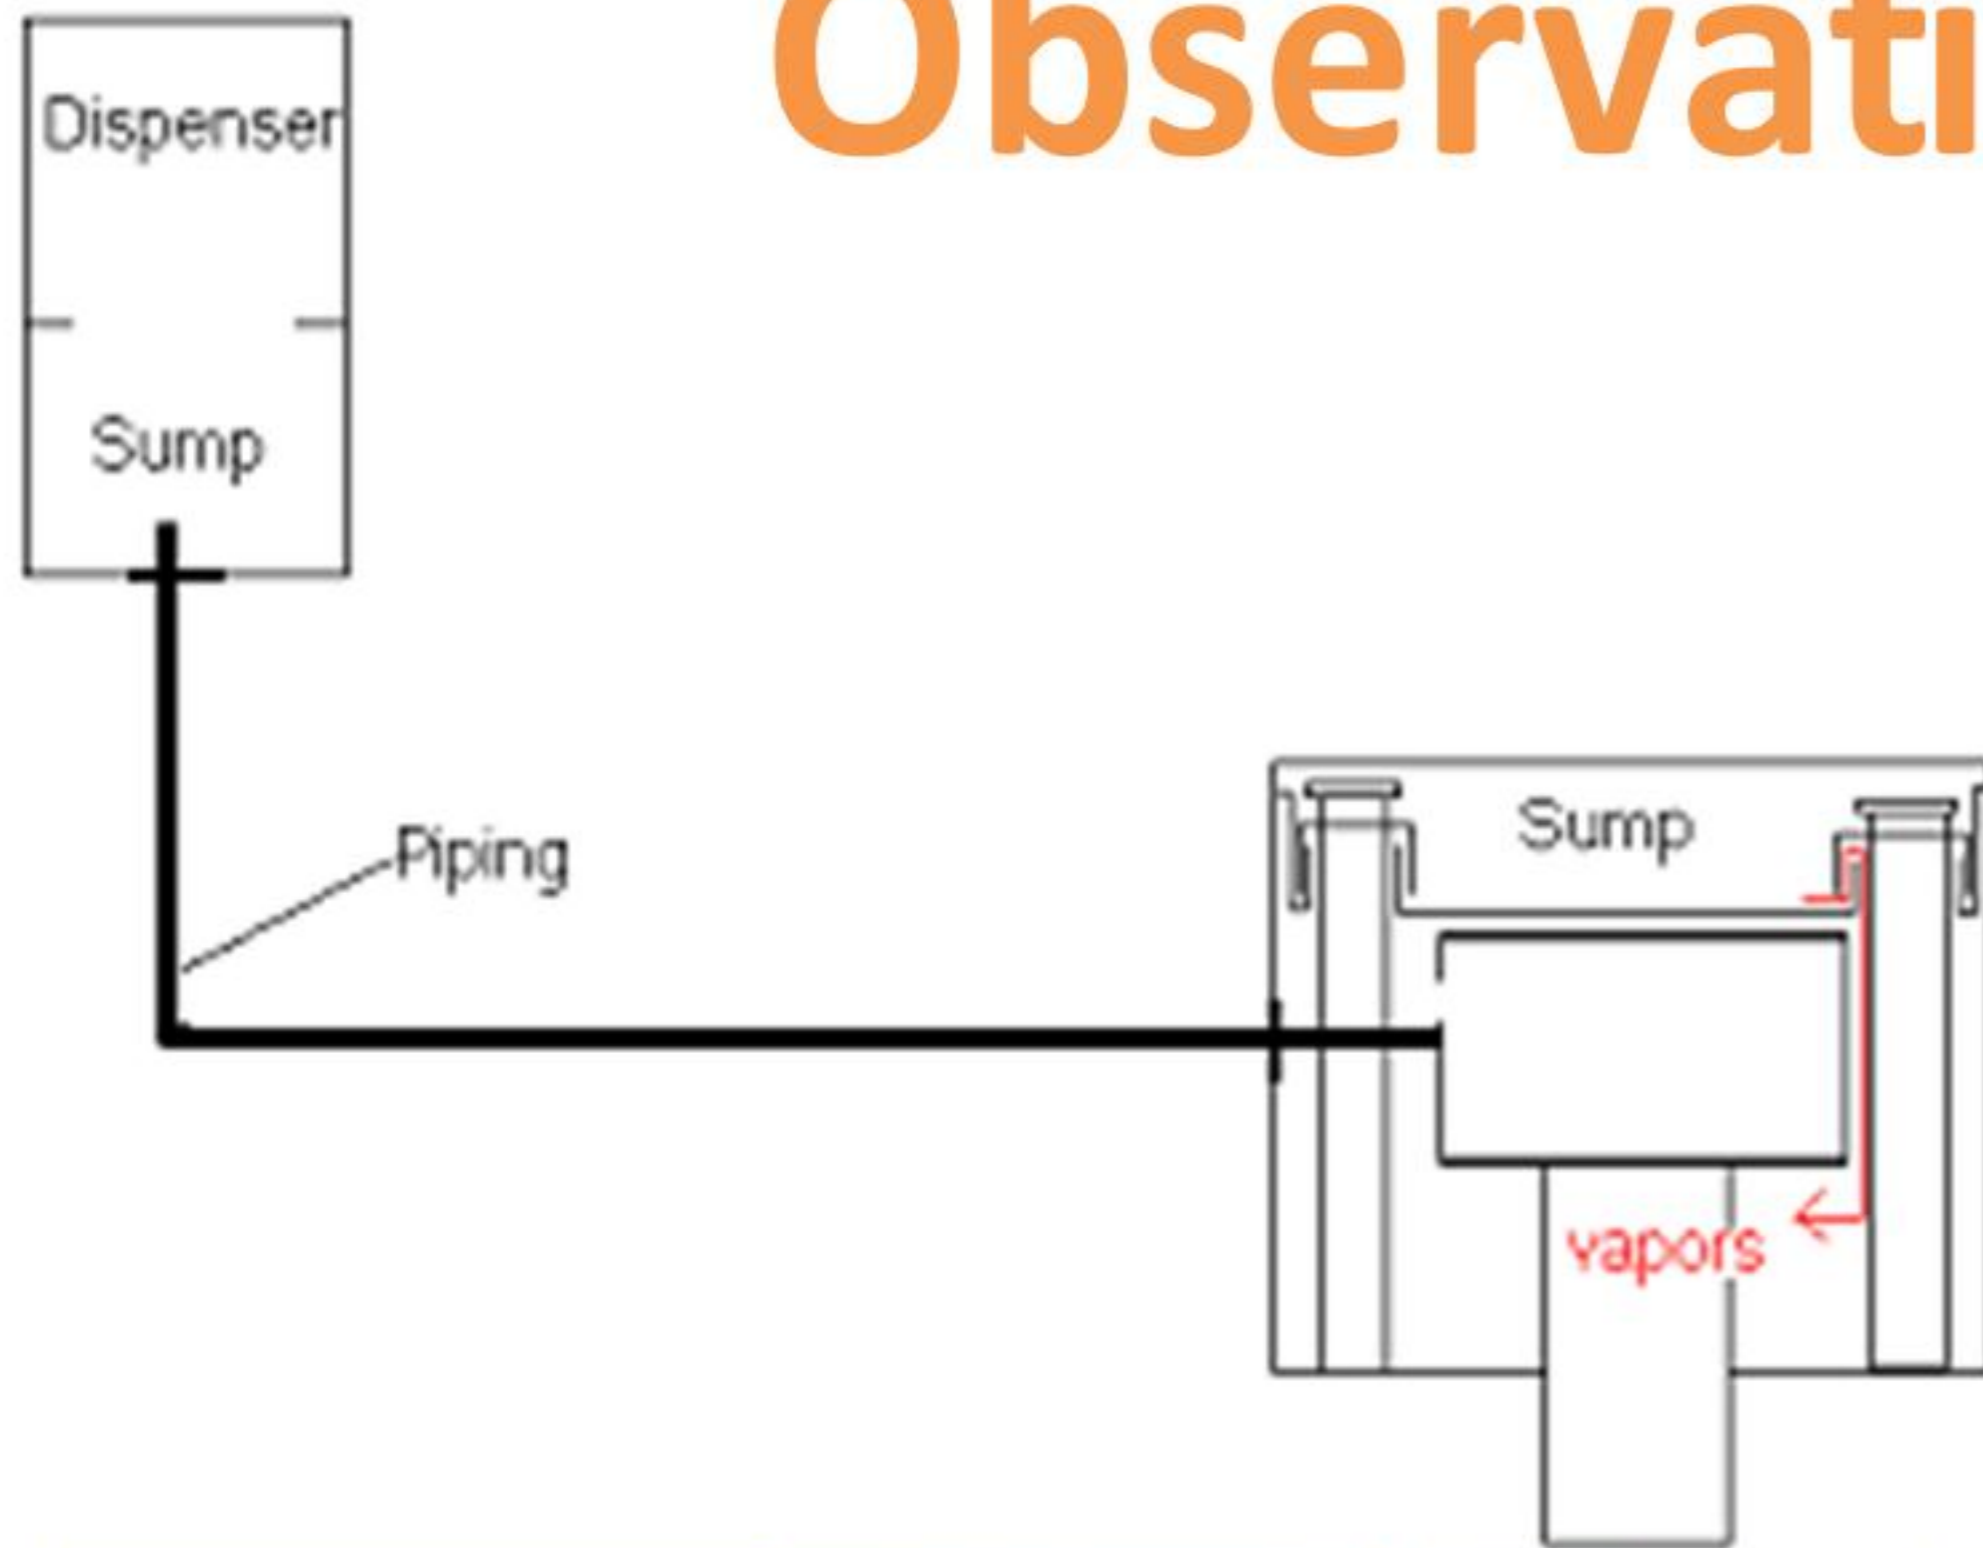
Certain “all-in-one sumps” do not allow vapors to escape and were more likely to have high ethanol vapor concentrations and therefore experience corrosion.

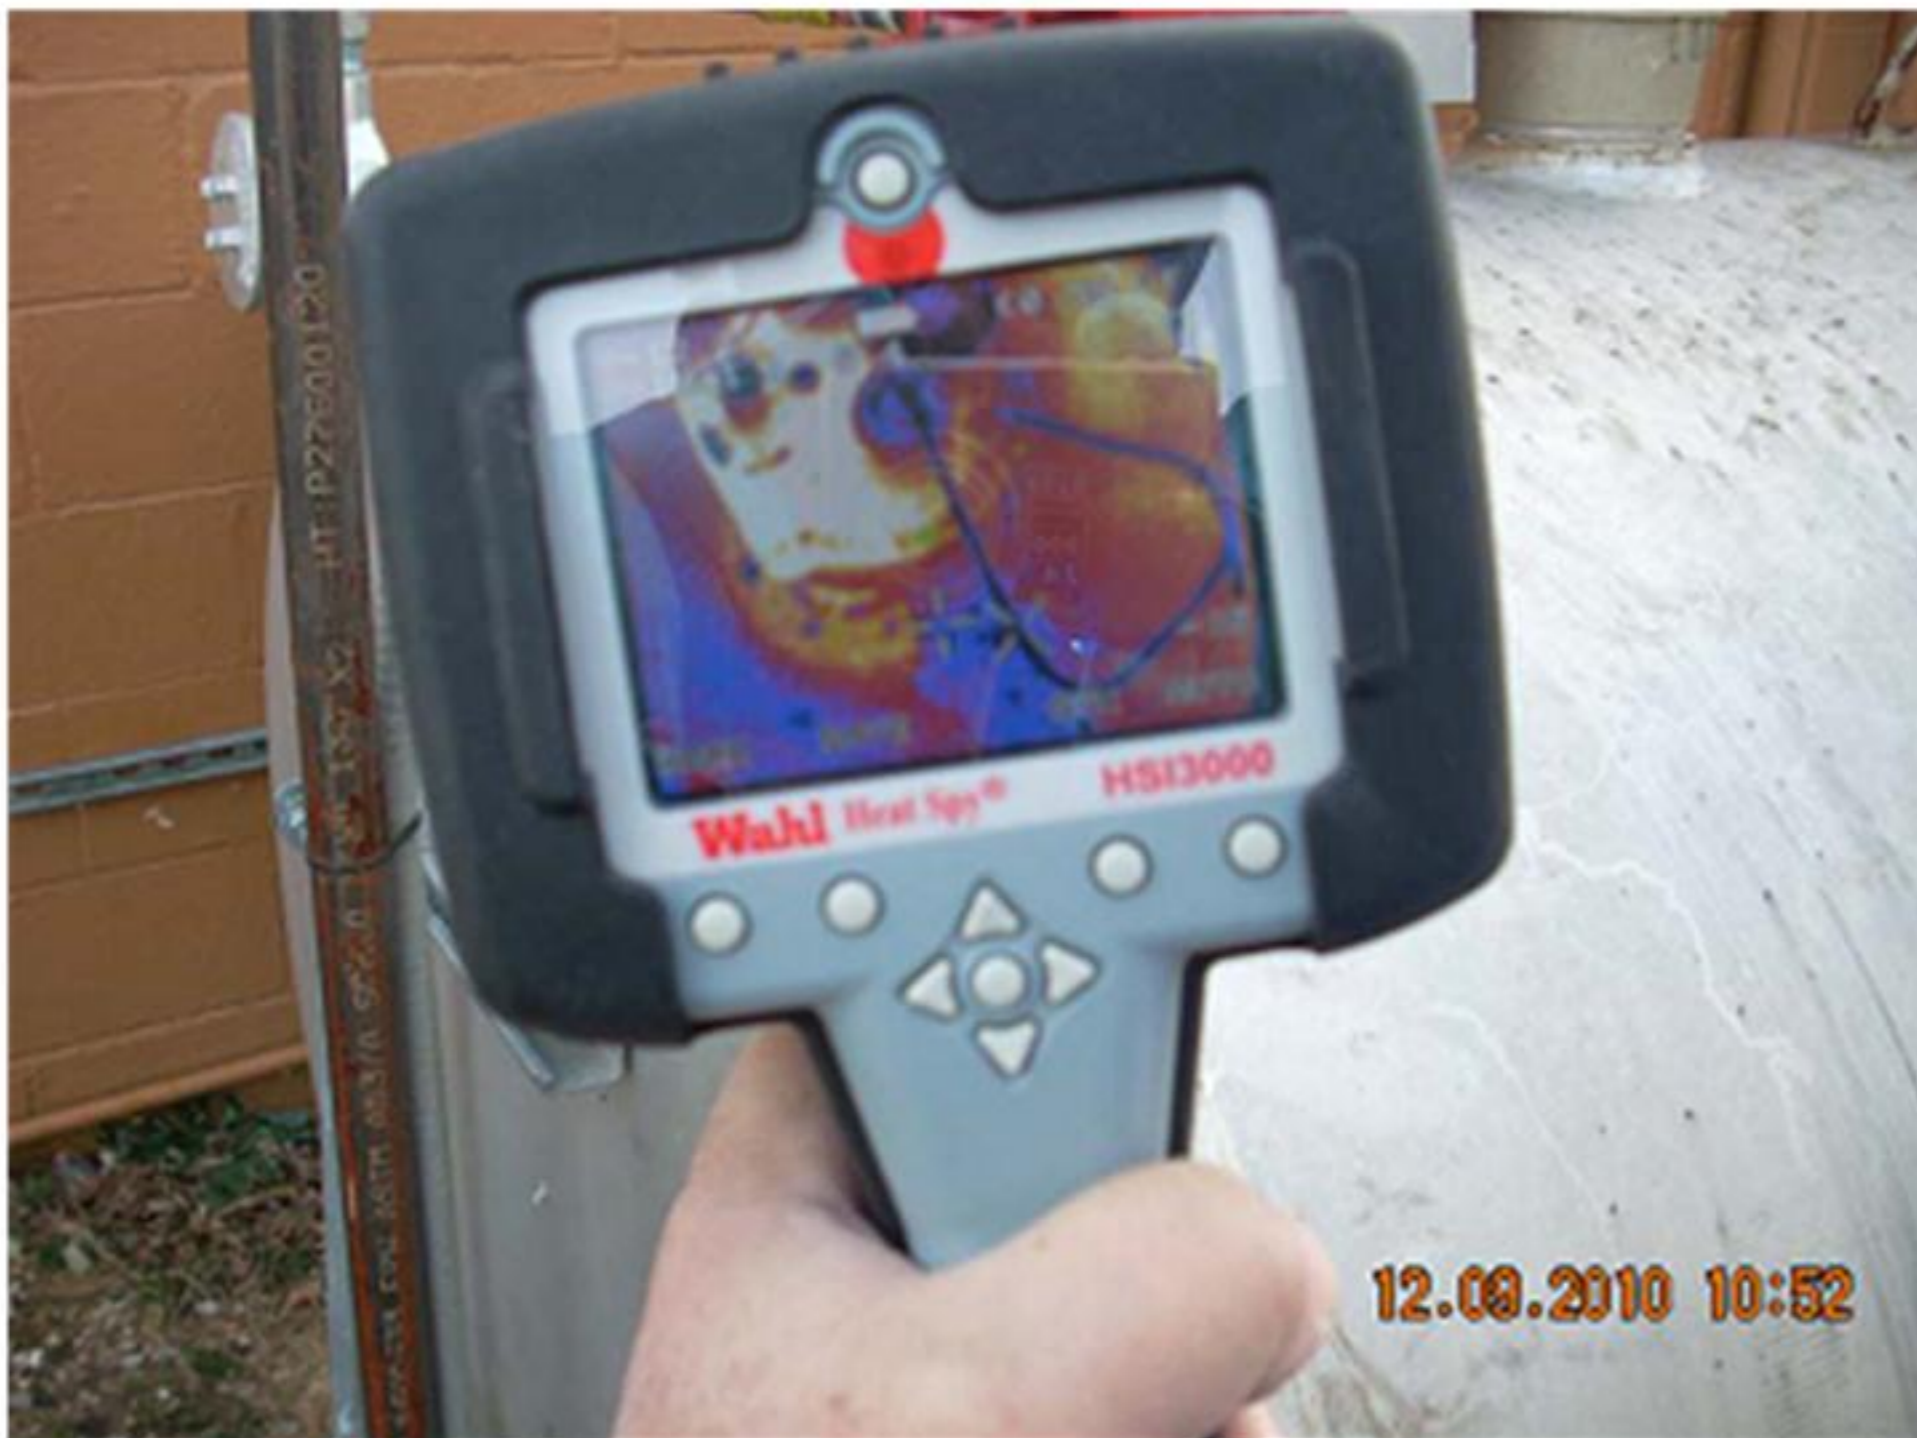
TN used an infrared detector to see if there was a detectable vapor leak.

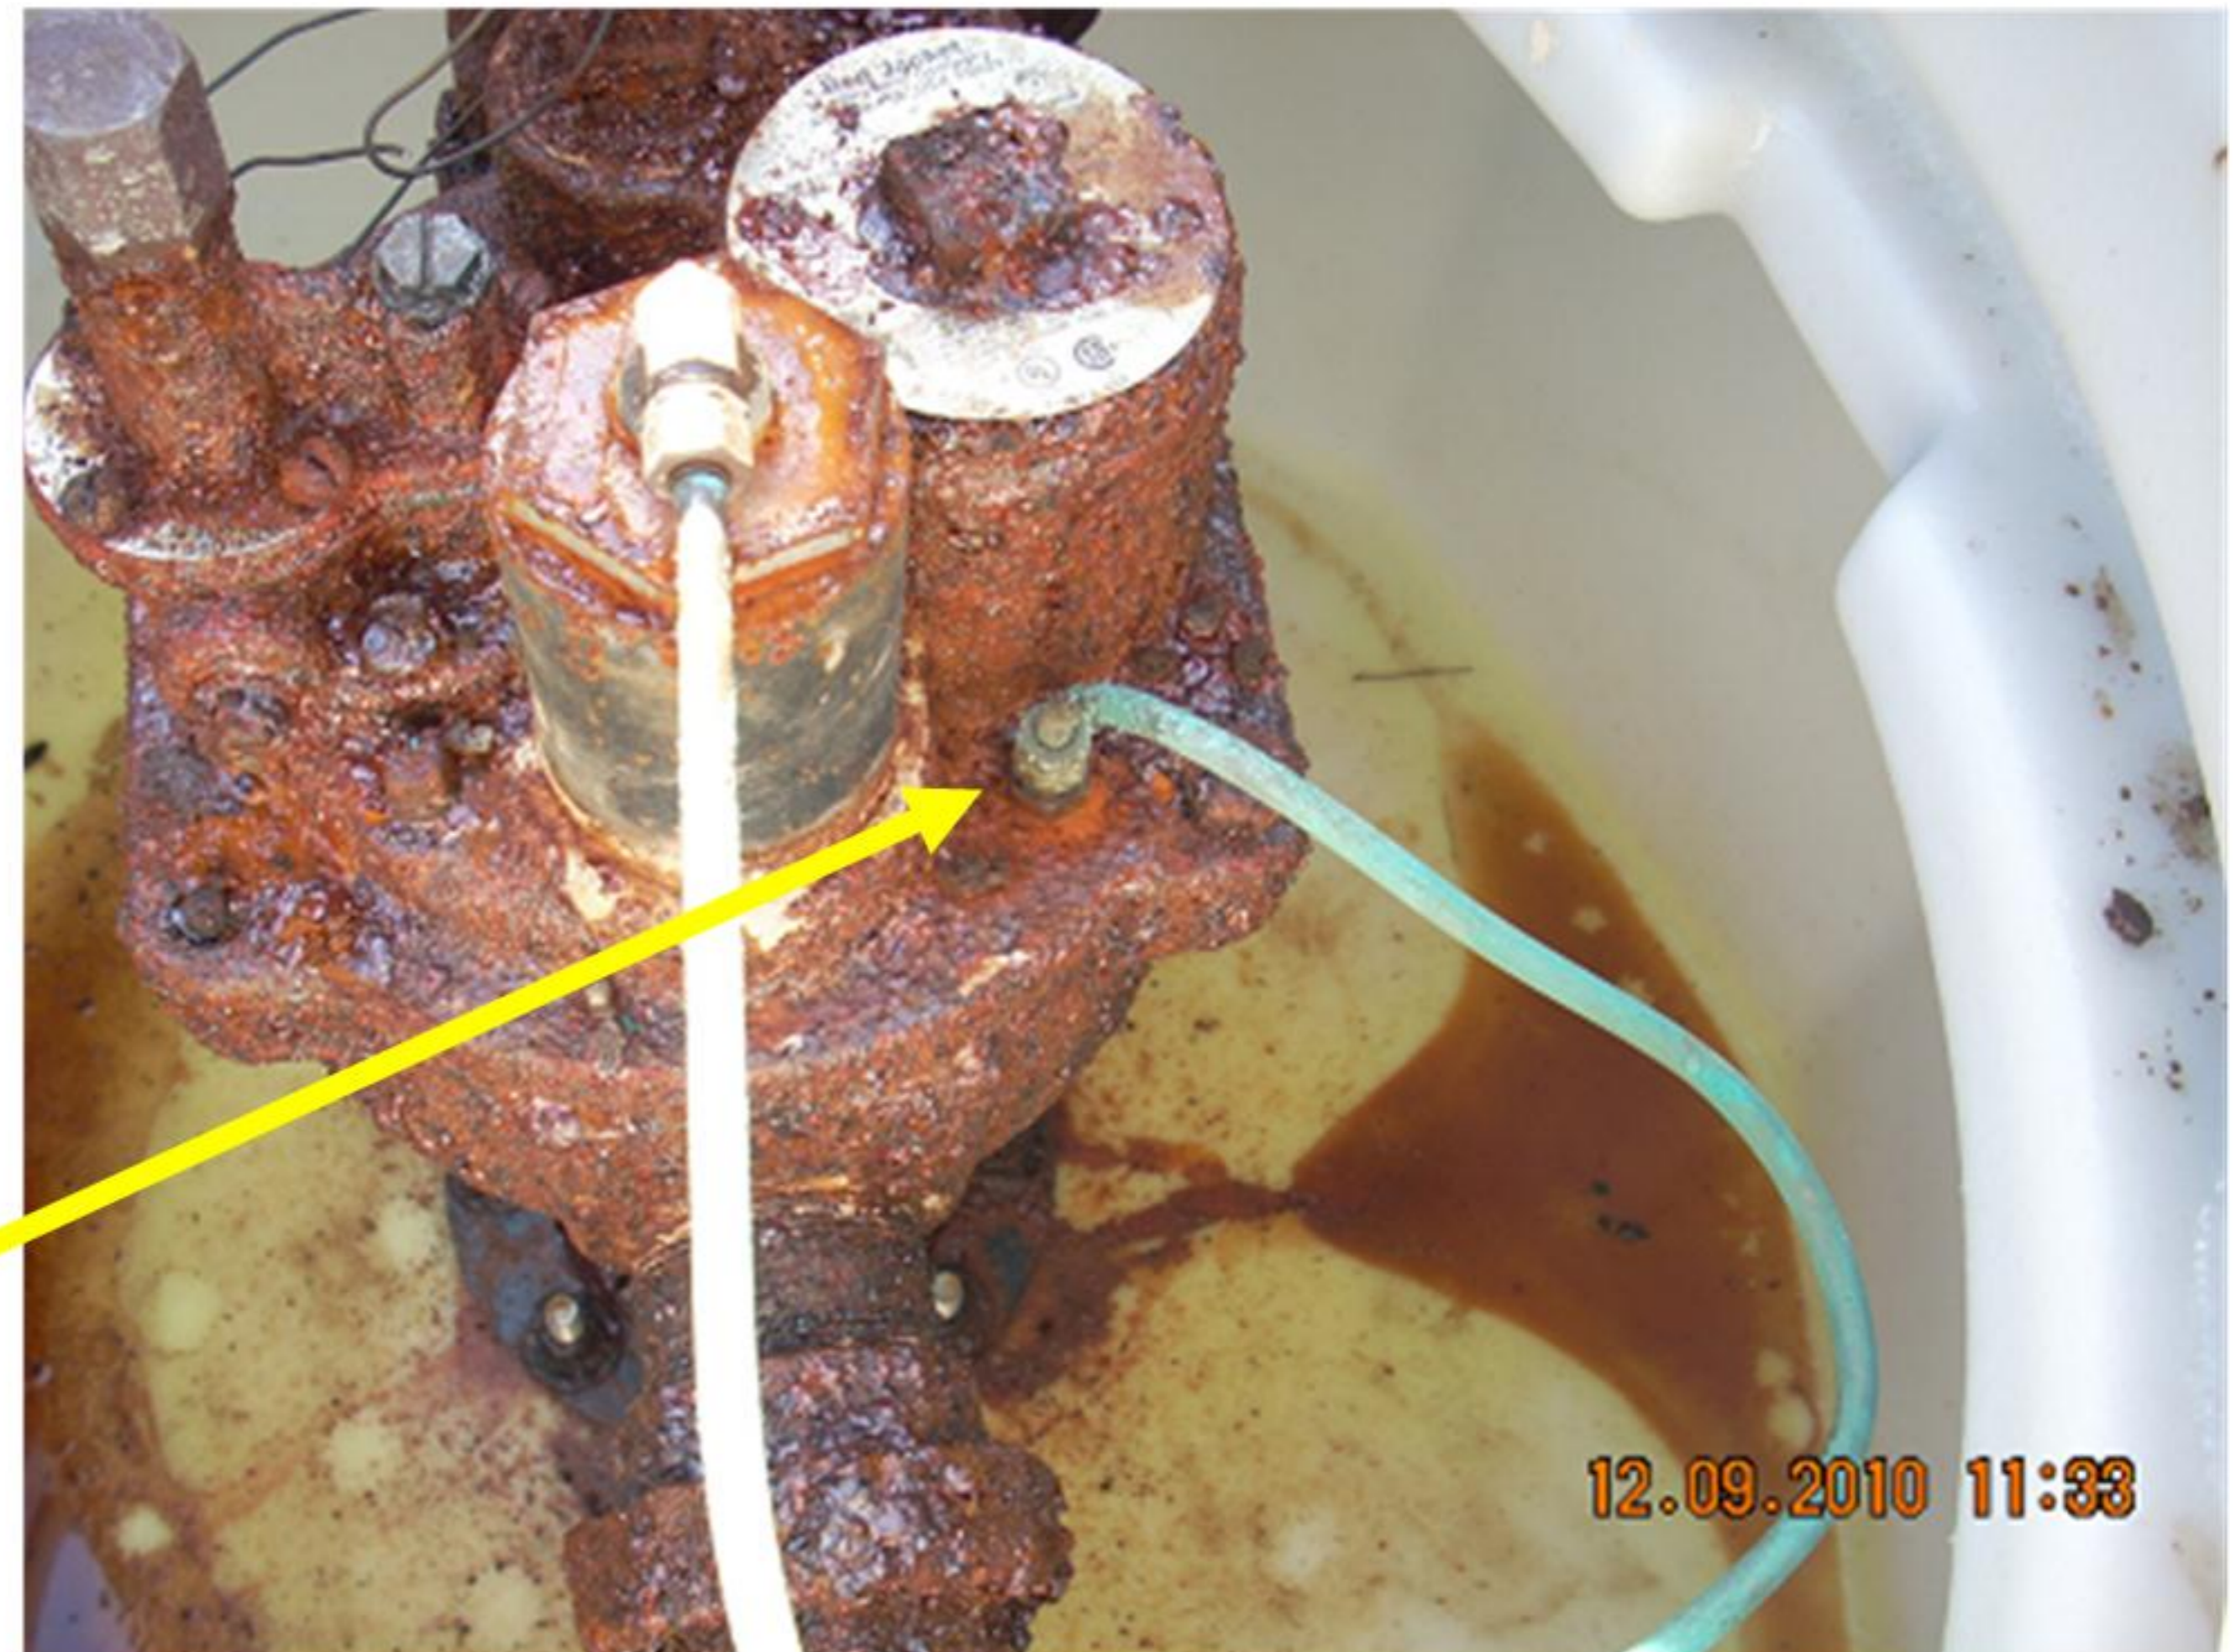
They found a vapor leak here

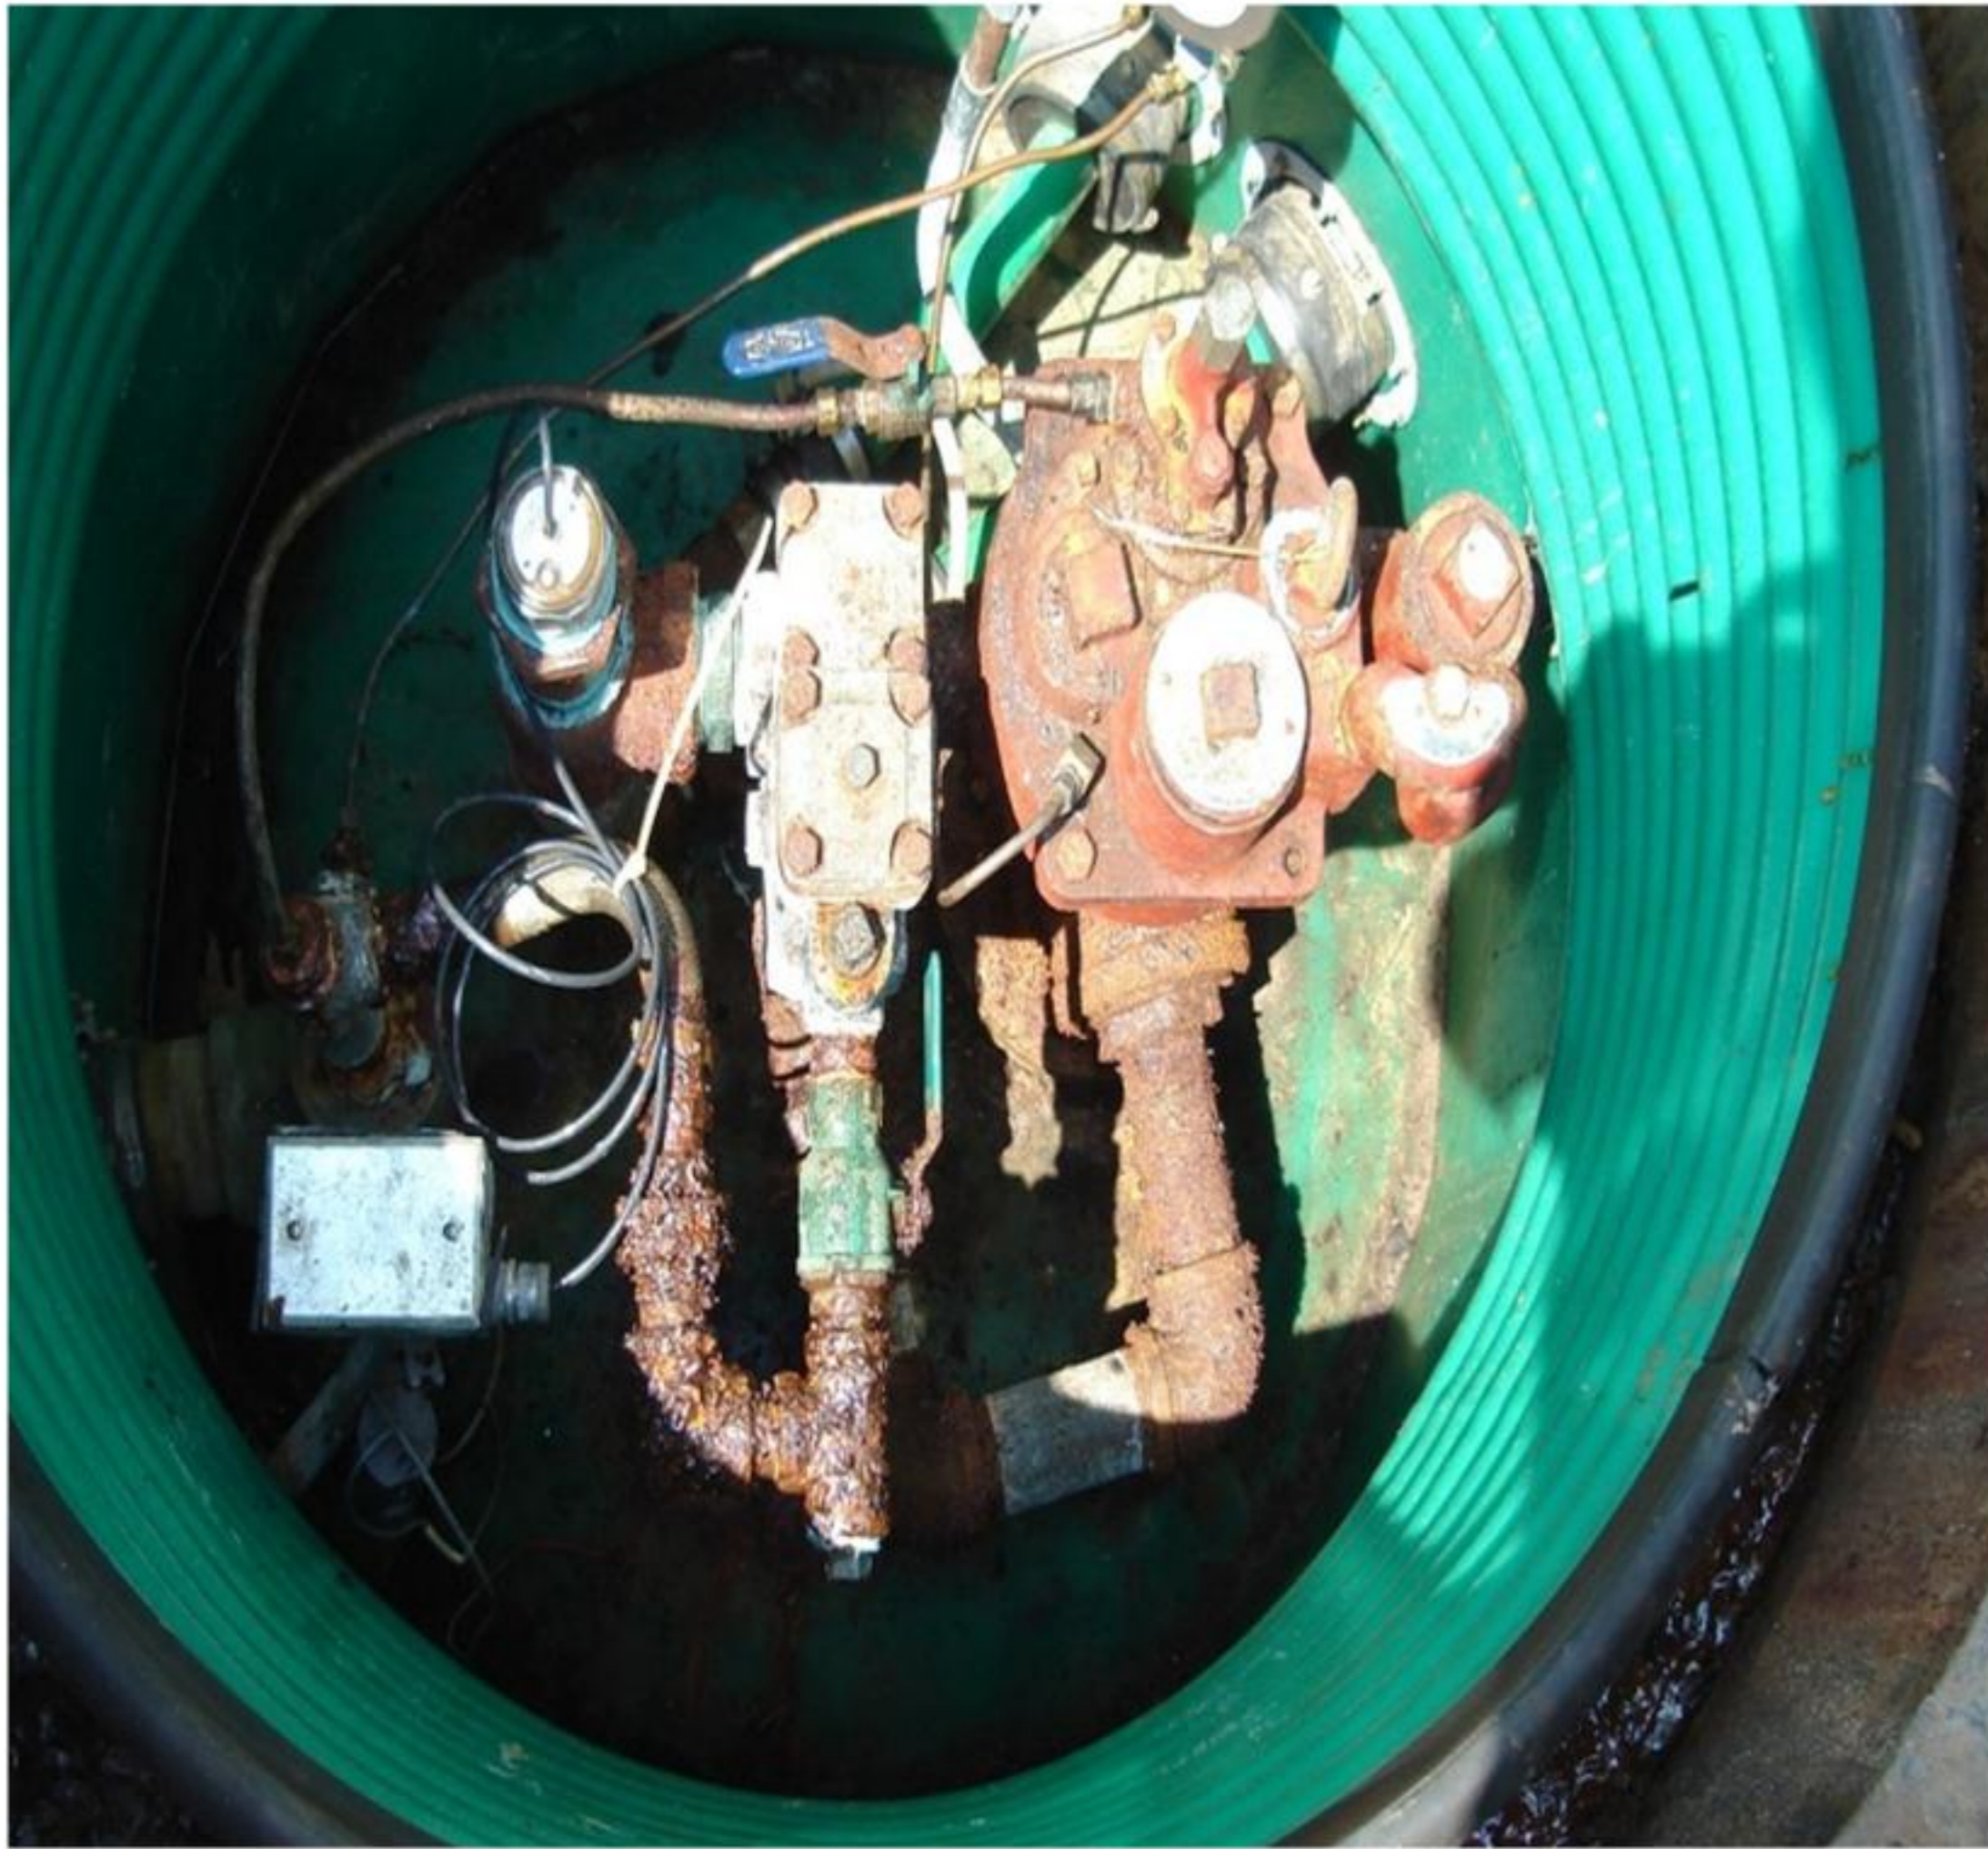
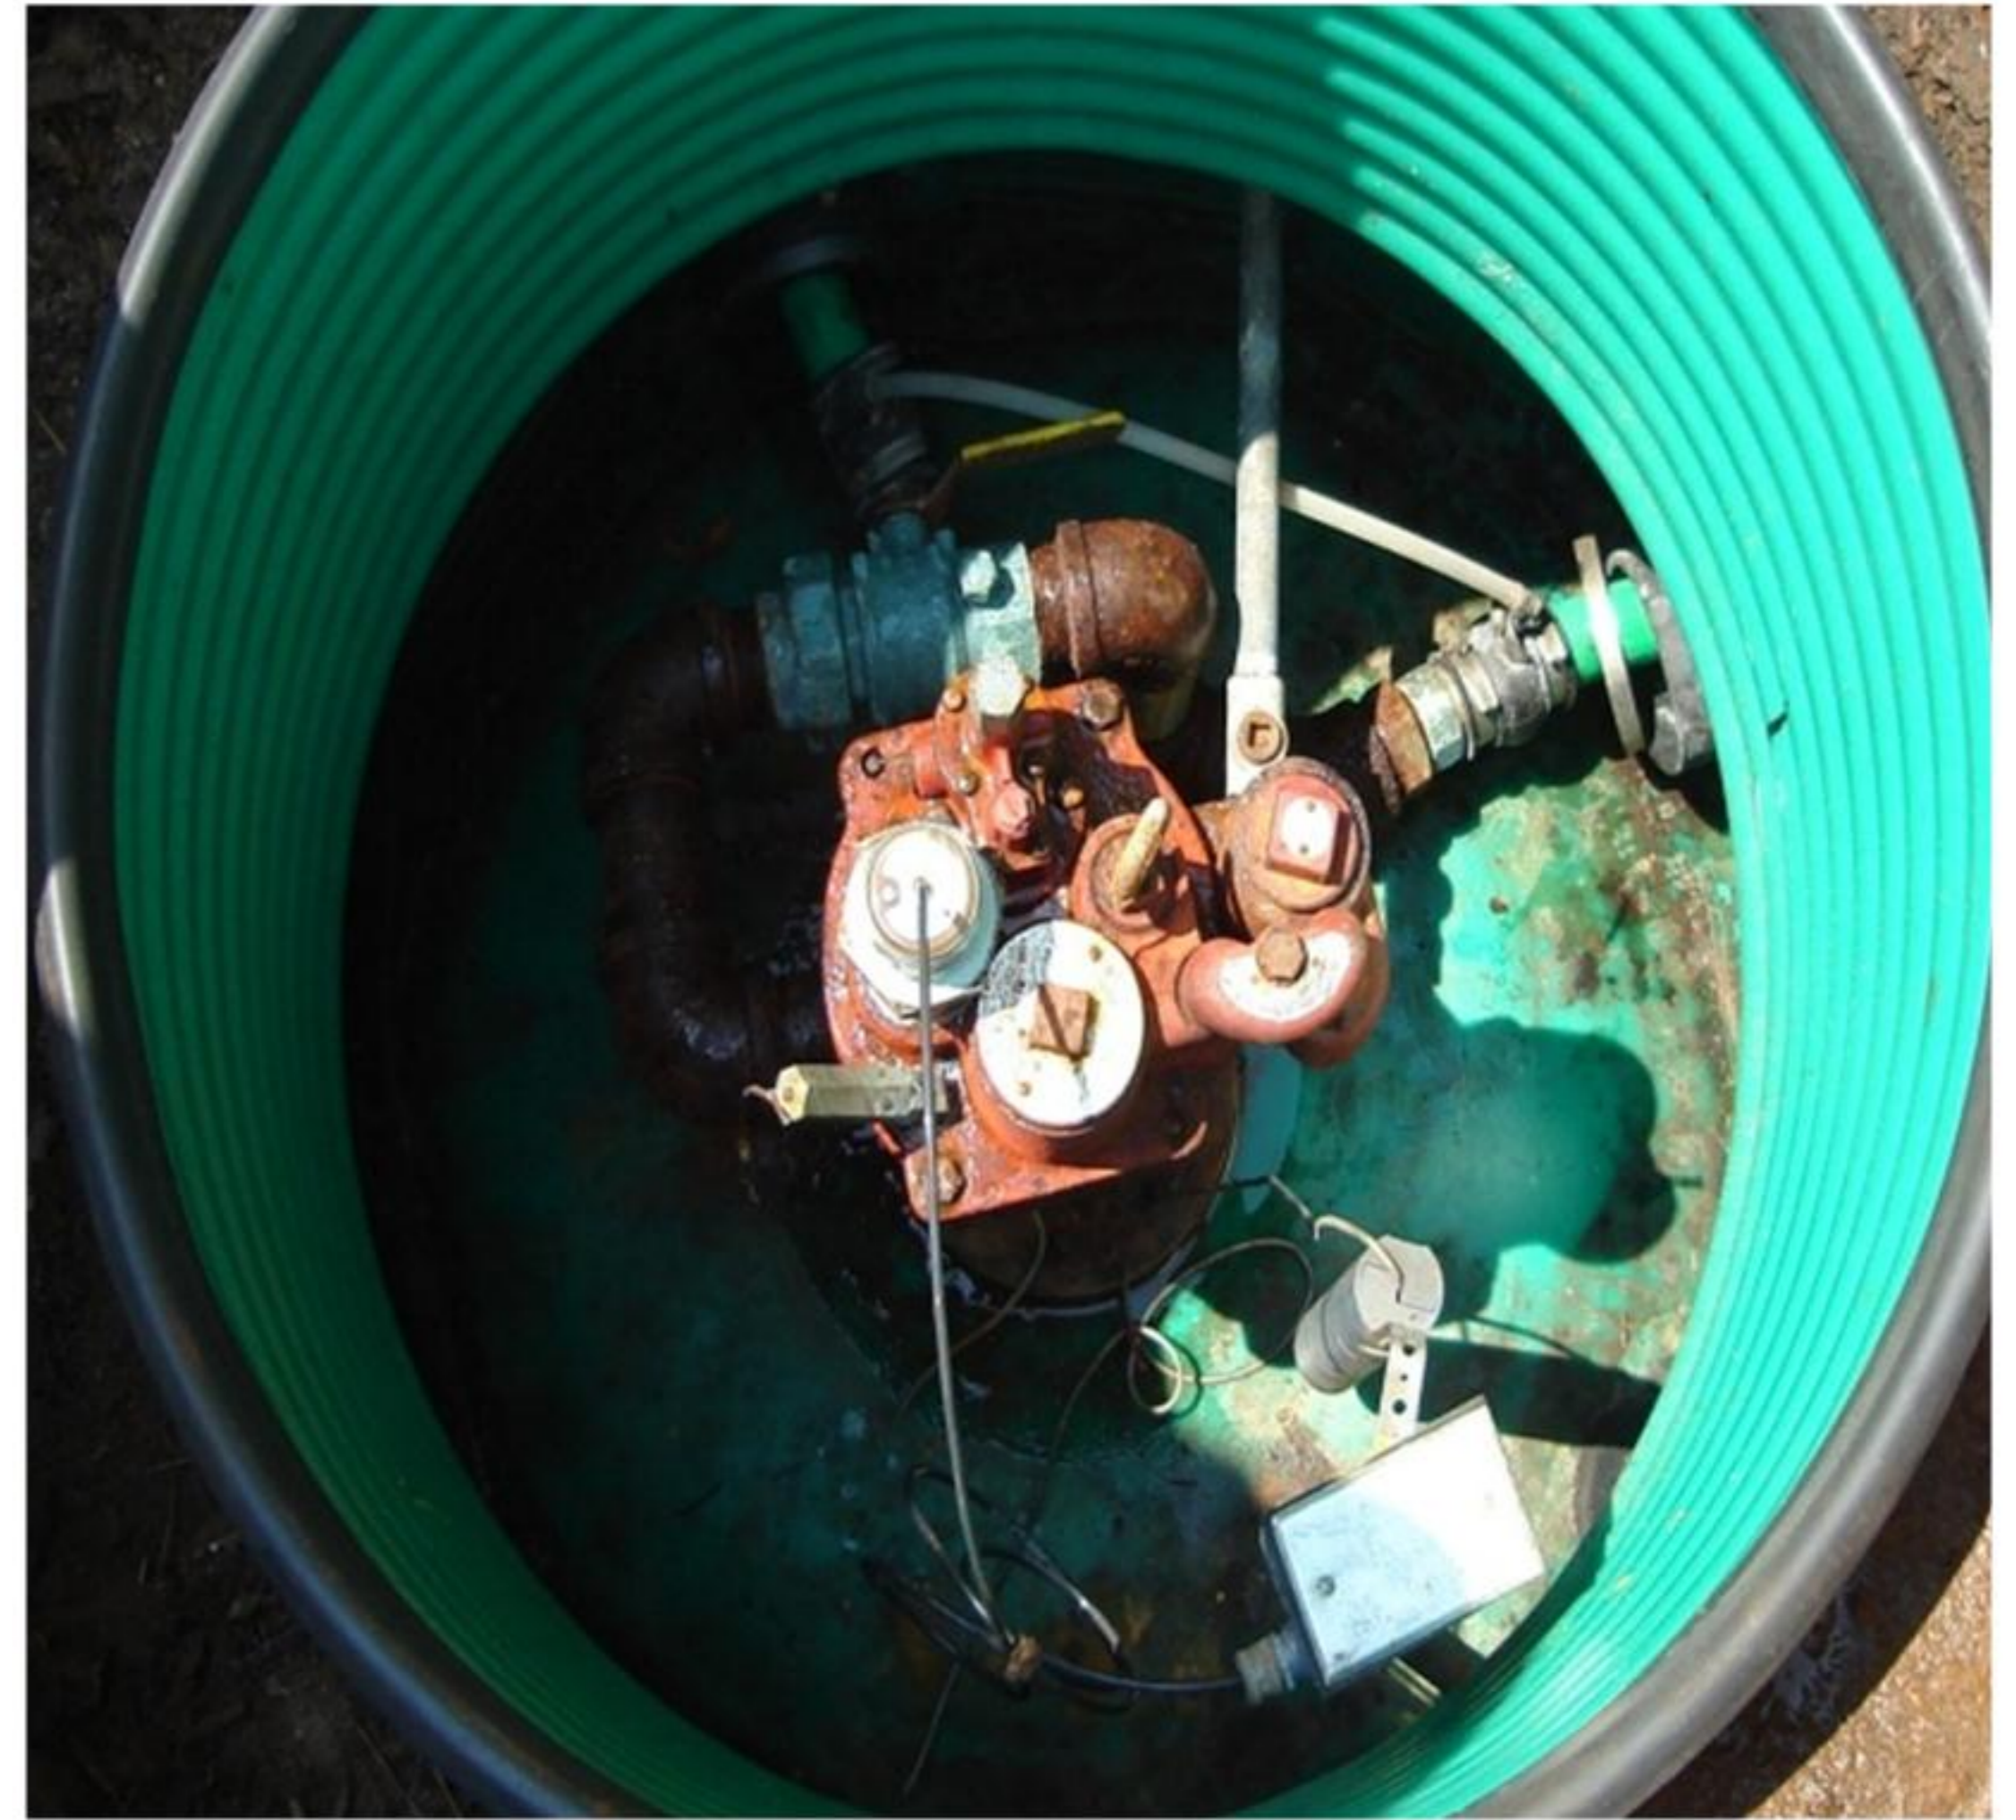
Stage II

Same Tank Field, Healy
system on left
