# L.U.S.T.LINE

A Report on Federal & State Programs to Control Leaking Underground Storage Tanks

# The Tale of a Legacy Release: A Montana Case Study

# The Cracked Case of the Fiberglass Tank's Disappearing Gasoline

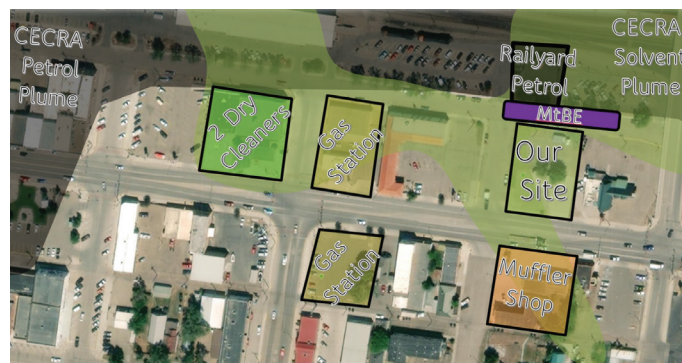
**Figure 2** A modified Google Maps rendition of the release site with potential sources of contamination identified.

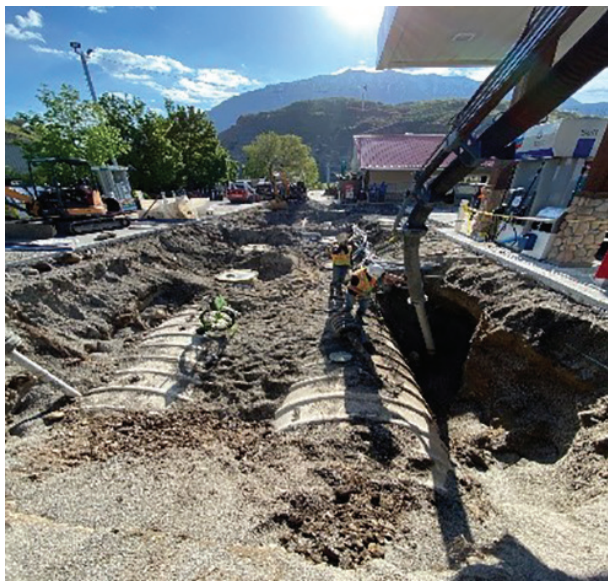
**Figure 1** View of the pea gravel fill being removed by a vacuum truck.

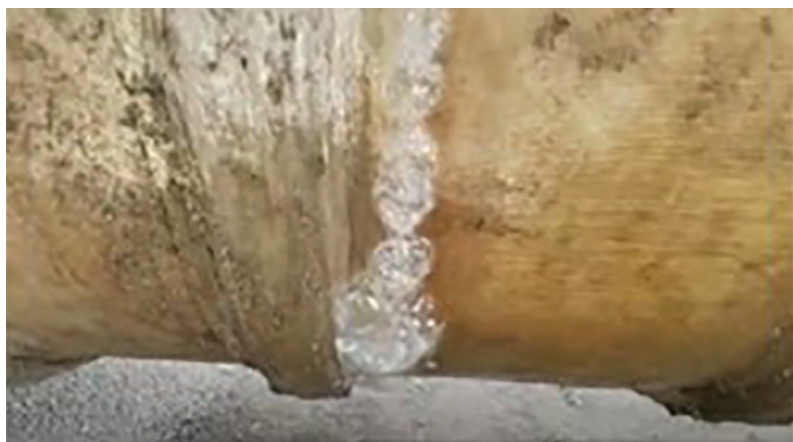
**Figure 3** Bottom of the FRP UST during the pressurized soap test showing the location of the crack.

The next day the consultant decided to seal and pressurize the UST. Once it was under pressure, a soapy water solution was used to test for leaks. It did not take long to see bubbles forming along the bottom of the UST near the seam of the rib. This confirmed that the UST in question had a crack in it that couldn't easily be seen.

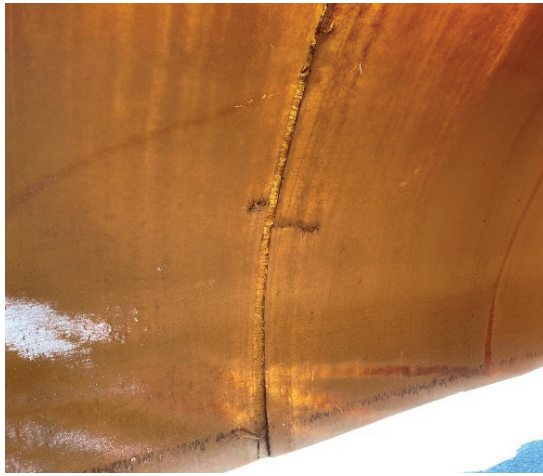
**Figure 5** View of inside of the FRP UST sample that was collected showing the groove.

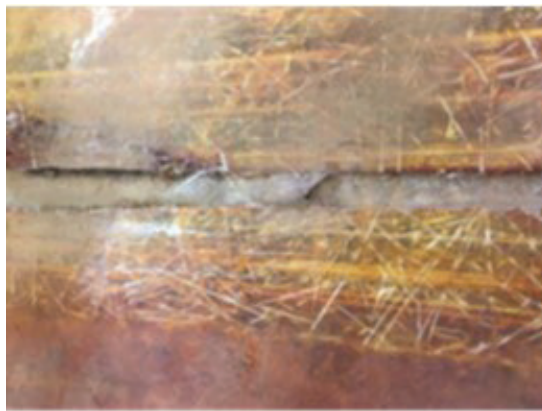
**Figure 6** Closeup view of the groove.

The results of the analysis provided additional details about the tank failure. Along the groove shown in Figure 6, there was a pathway for gasoline to permeate into the tank's wall, causing integrity issues. The protective gel coat was thinner near the groove, and you could see the fiberglass fibers in this section. As you can see, the gel coat is thicker near the bottom of Figure 6, and the fiberglass fibers are not visible.

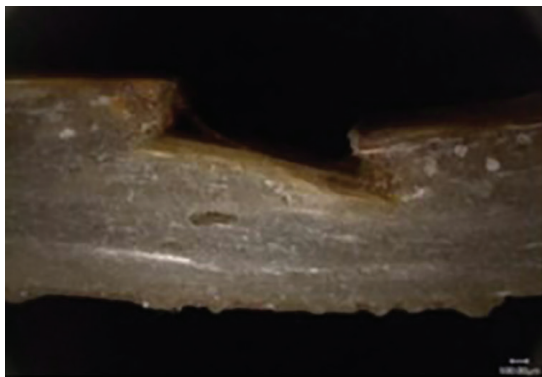
**Figure 7** Magnified groove cross section showing sand particles and a void space.

A look at a cross section of the groove in Figure 7 showed that it was approximately a quarter of the thickness of the wall. This was a weak spot in the UST. Sand is used in the construction of this type of UST. A few grains of sand can easily be seen on the right of the groove near the top. However, more sand should be present, and it should not be so close to the inner surface of the tank. A void space, which can weaken fiberglass reinforced plastic tanks, was also observed just left of the center of the photo under the groove.

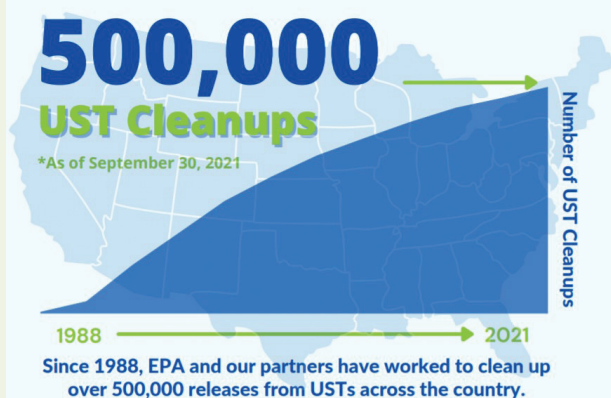
As of the end of September 2021, the national underground storage tank (UST) program cleaned up 502,786 releases. You can see our steady progress and significant achievement over the last 33 years as illustrated on this line chart. This is an impressive accomplishment for the national UST program, and it is certainly cause for celebration.
