Beaver River Watershed Assessment

**NARRAGANSETT BAY
ESTUARY PROGRAM**

Beaver River Watershed Assessment Report – FINAL

Town of Richmond, Rhode Island

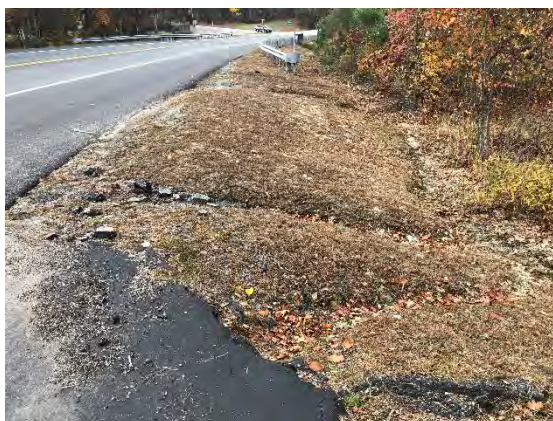
However, stormwater is likely a contributor to a recent (new in 2016) recreation impairment documented in Rhode Island's Impaired Waters List (March 2018) for *Enterococcus*. RIDEM, as well as URI Watershed Watch, has done limited water quality monitoring in recent years (2011, 2015-2017) at the Rte 138 bridge where *Enterococcus* was present above thresholds for recreational uses. More sampling should be done here to identify estimated stormwater contributions vs. potential wastewater sources. While there are no direct stormwater outfalls in this location, highway runoff concentrates along the shoulders and has created erosion gullies down to the river.

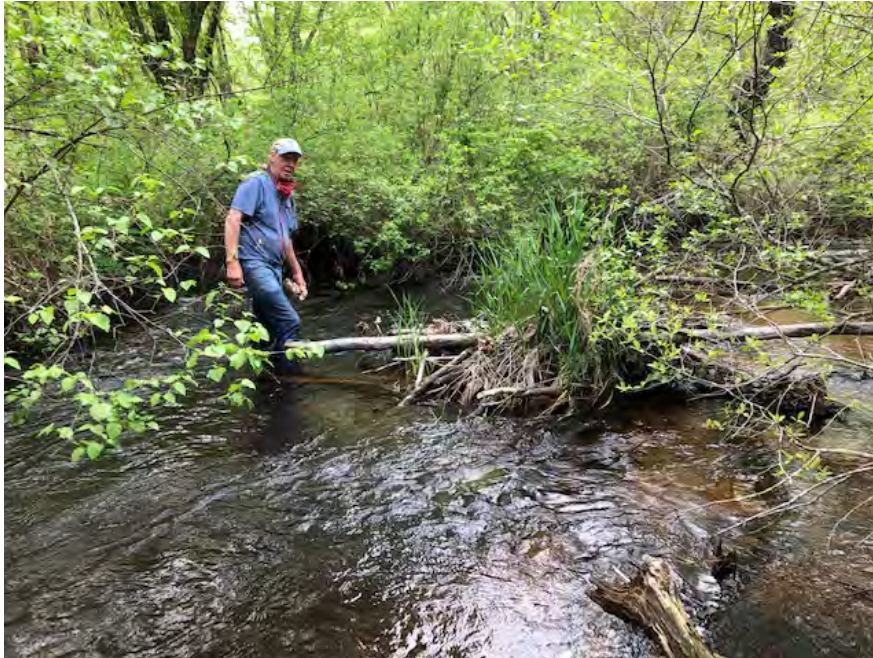
Volunteer during temperature logger installation (photo provided by Jim Turek).

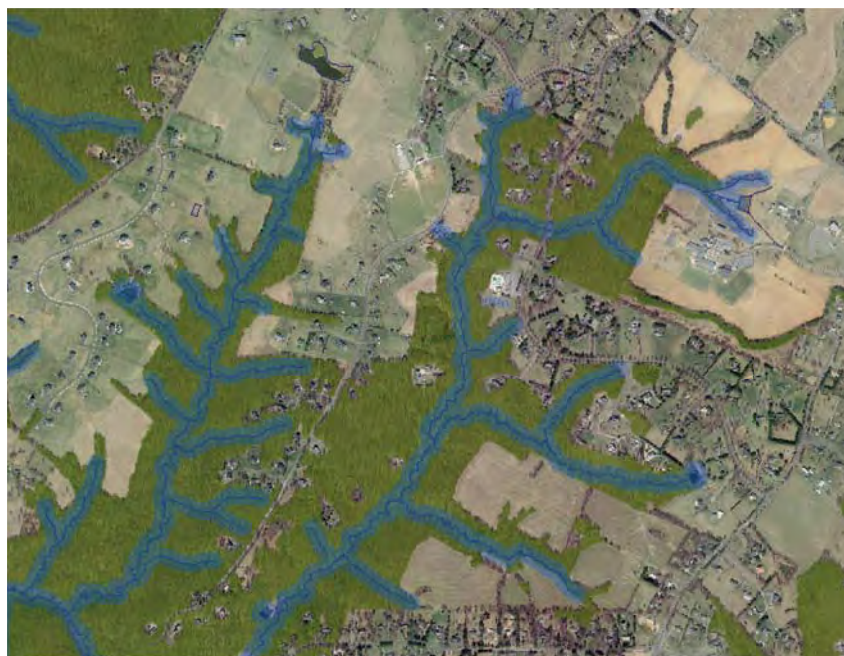
Figure 3-2 Example of Vegetated Riparian Buffers.

The green area in the figure represents the vegetated riparian buffer and the shaded blue area indicates a buffer zone of 100 feet on either side of the stream. (HW graphic)

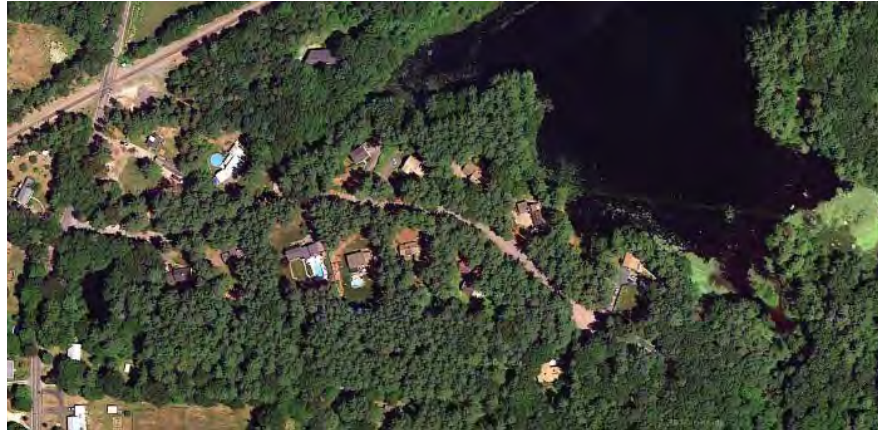
Uniform requirements for lot size and setbacks cause subdivisions like the one in this aerial photo to consume far more land than necessary. This subdivision has encroached into wetland and pond buffer areas causing visible signs of eutrophication as indicated by the light green algal bloom. (Google Maps)

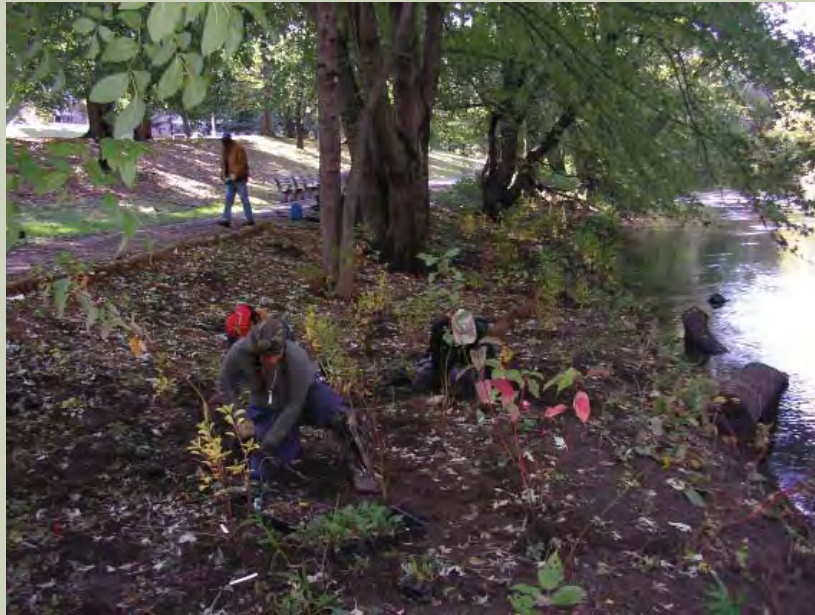
Careful placement and installation of native vegetation is required for restoring buffer areas that were cleared. (HW photo)

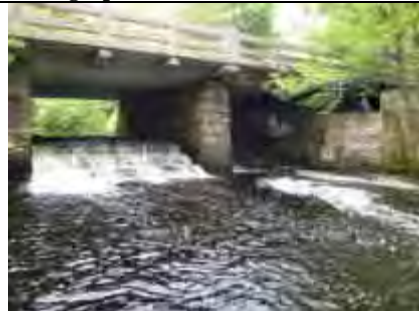
GAS-2	Hopkinton, RI		41.431	-71.790	High	Dam not in use, partially broken down, blocking fish passage to high quality habitat

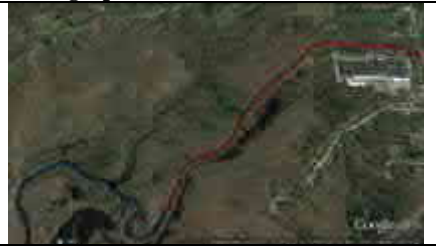
BER-2	Richmond, RI		41.478	-71.624	Low	Pond takes lots of water out of stream, potential avulsion risk
