Reviewing Residual Risk at Closed LUST Sites In Utah

Residual Risk Review (R3)

R3 Demonstration: Brigham Street Service

located at 479 E South Temple
Salt Lake City, Utah
Institutional Controls
NFA issued July 2016

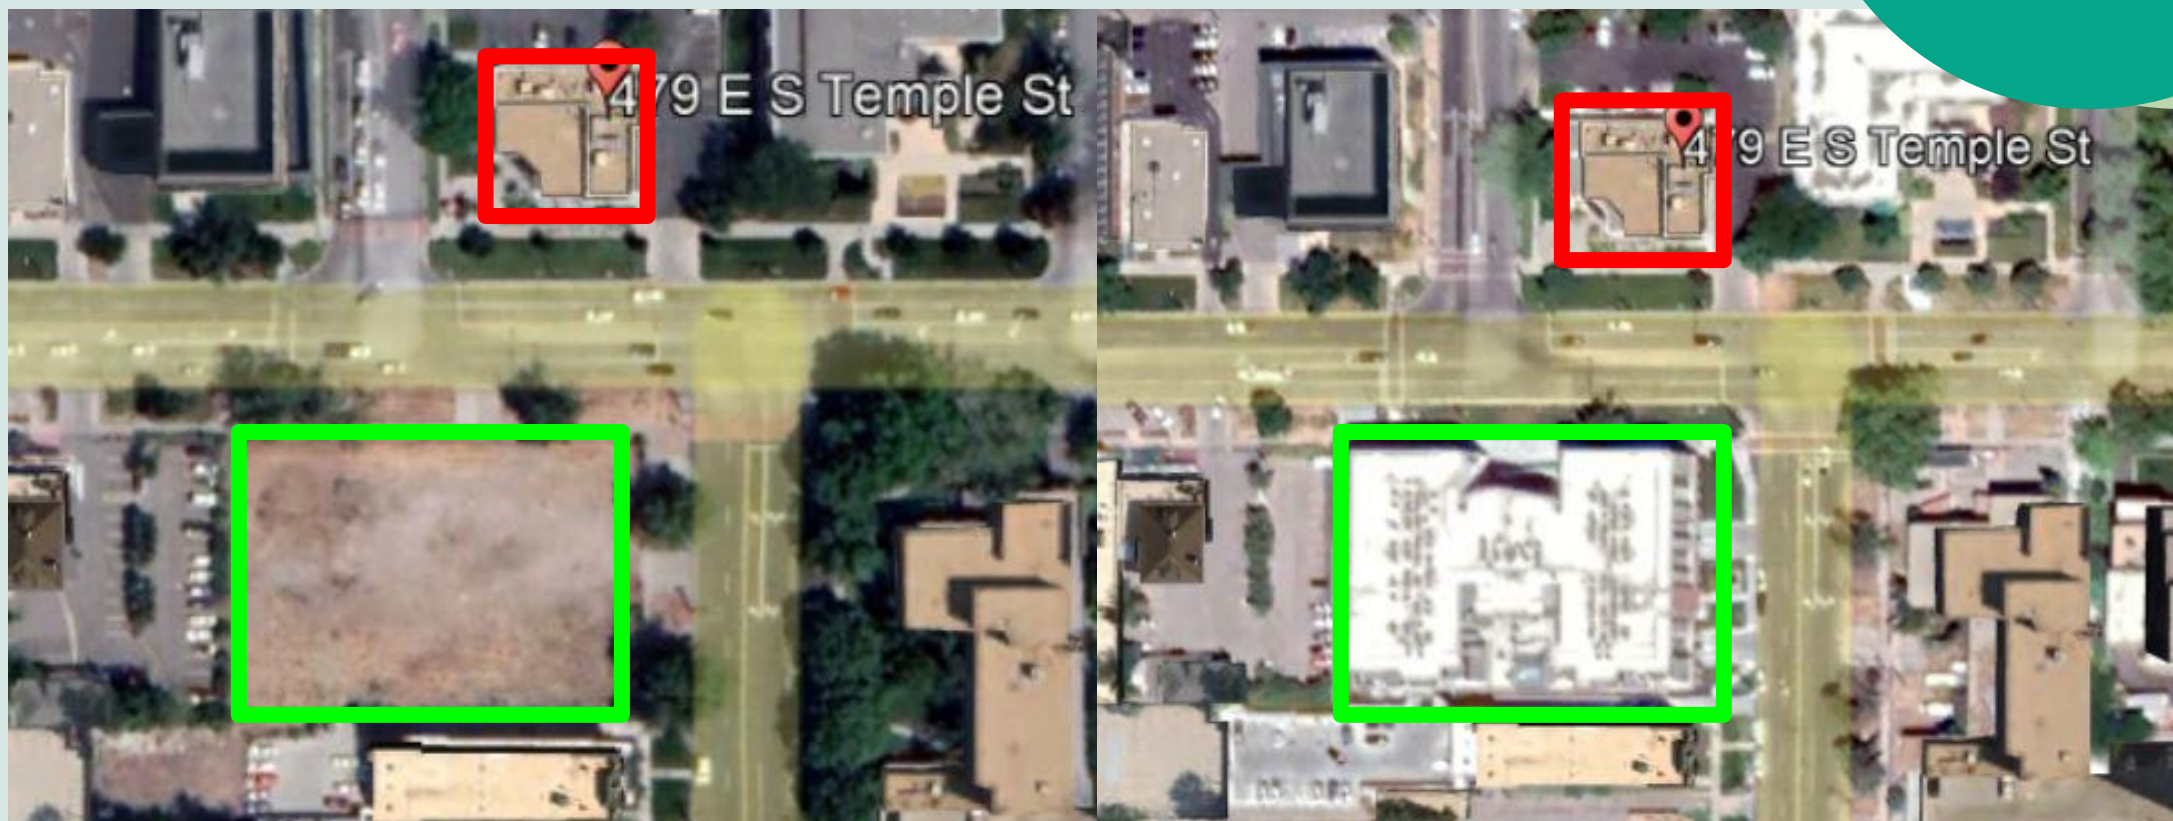
Are there differences between closure
aerial imagery and current aerial
imagery?

Set 1
Question 1
Answer:
Yes!

Brigham Str. Service, 2016

Brigham Str. Service, 2022

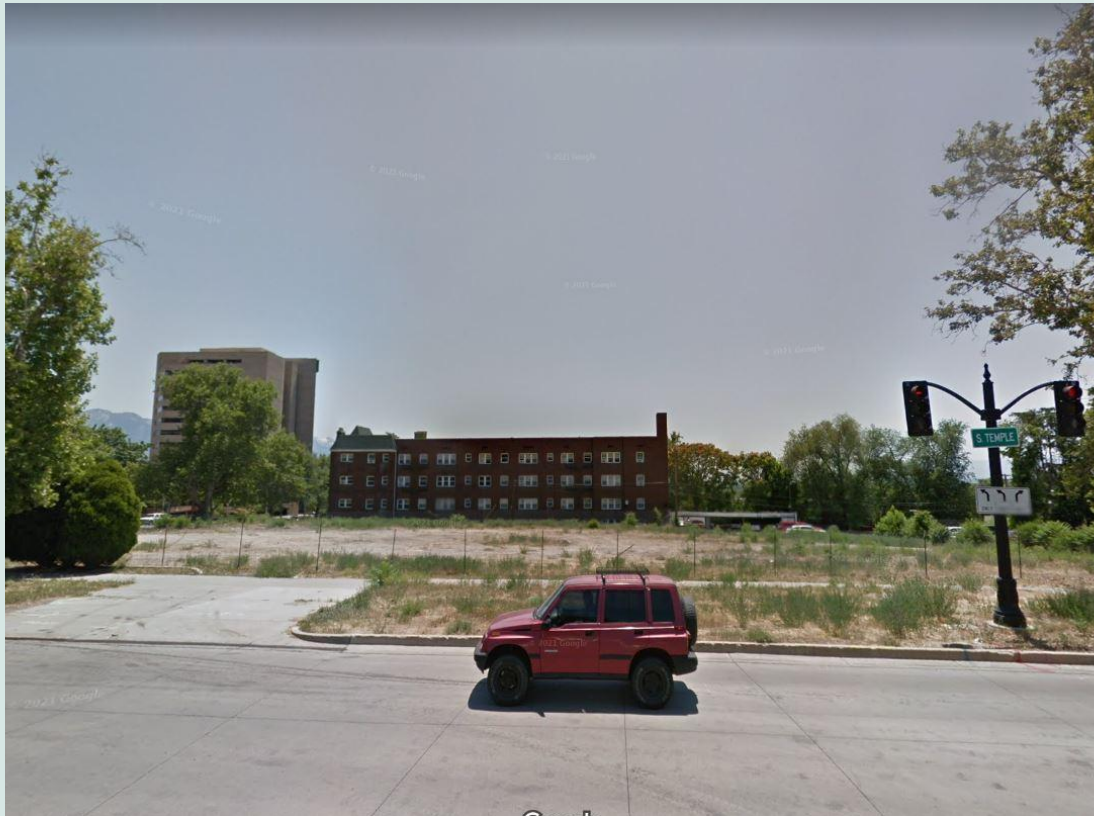
Brigham Str. Service, 2016

Have buildings been demolished, replaced, modified, or added?

Set 1
Question 2
**Answer:
Yes!**

Empty lot to apartment building.

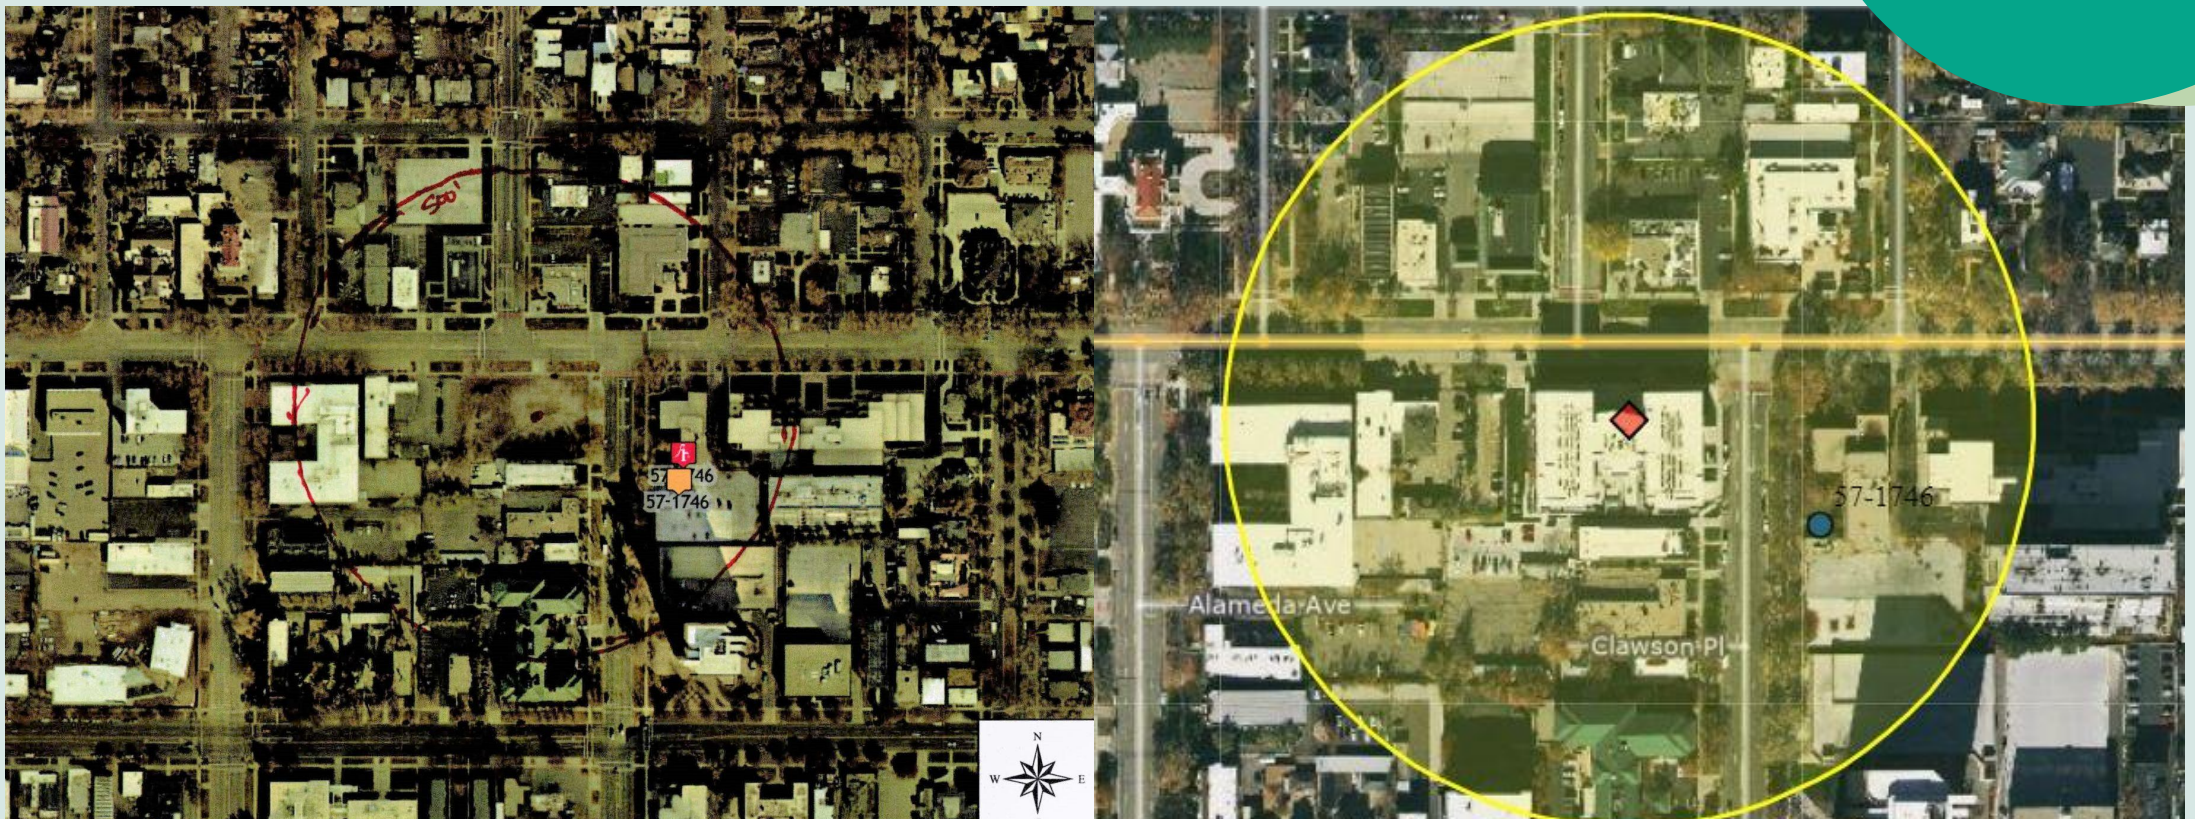
Have Water Rights been added within the critical distance, or have pre-existing Water Rights been modified?

Set 1
Question 6
Answer:
No.

Brigham Str. Service, 2016

Brigham Str. Service, 2022

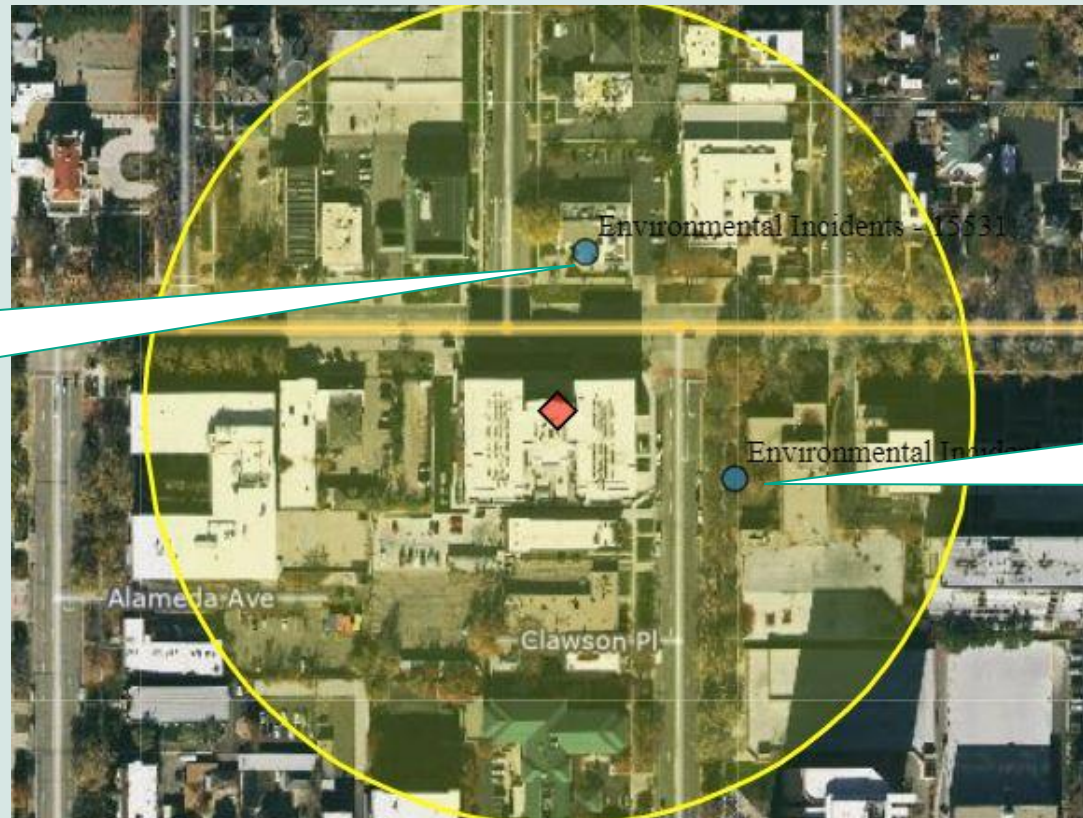
Have any environmental incidents occurred on the subject property or adjoining properties which may impact the residual risk?

Set 1
Question 9
Answer:
No.

surface diesel
spill < 30 gallons

transformer oil
spill at power
company
