BRIDGING LUST EXCAVATIONS WITH UST CLOSURES AND INSTALLATIONS

Proactive Notification and Excavation Requirements for UST closures at known LUST sites.

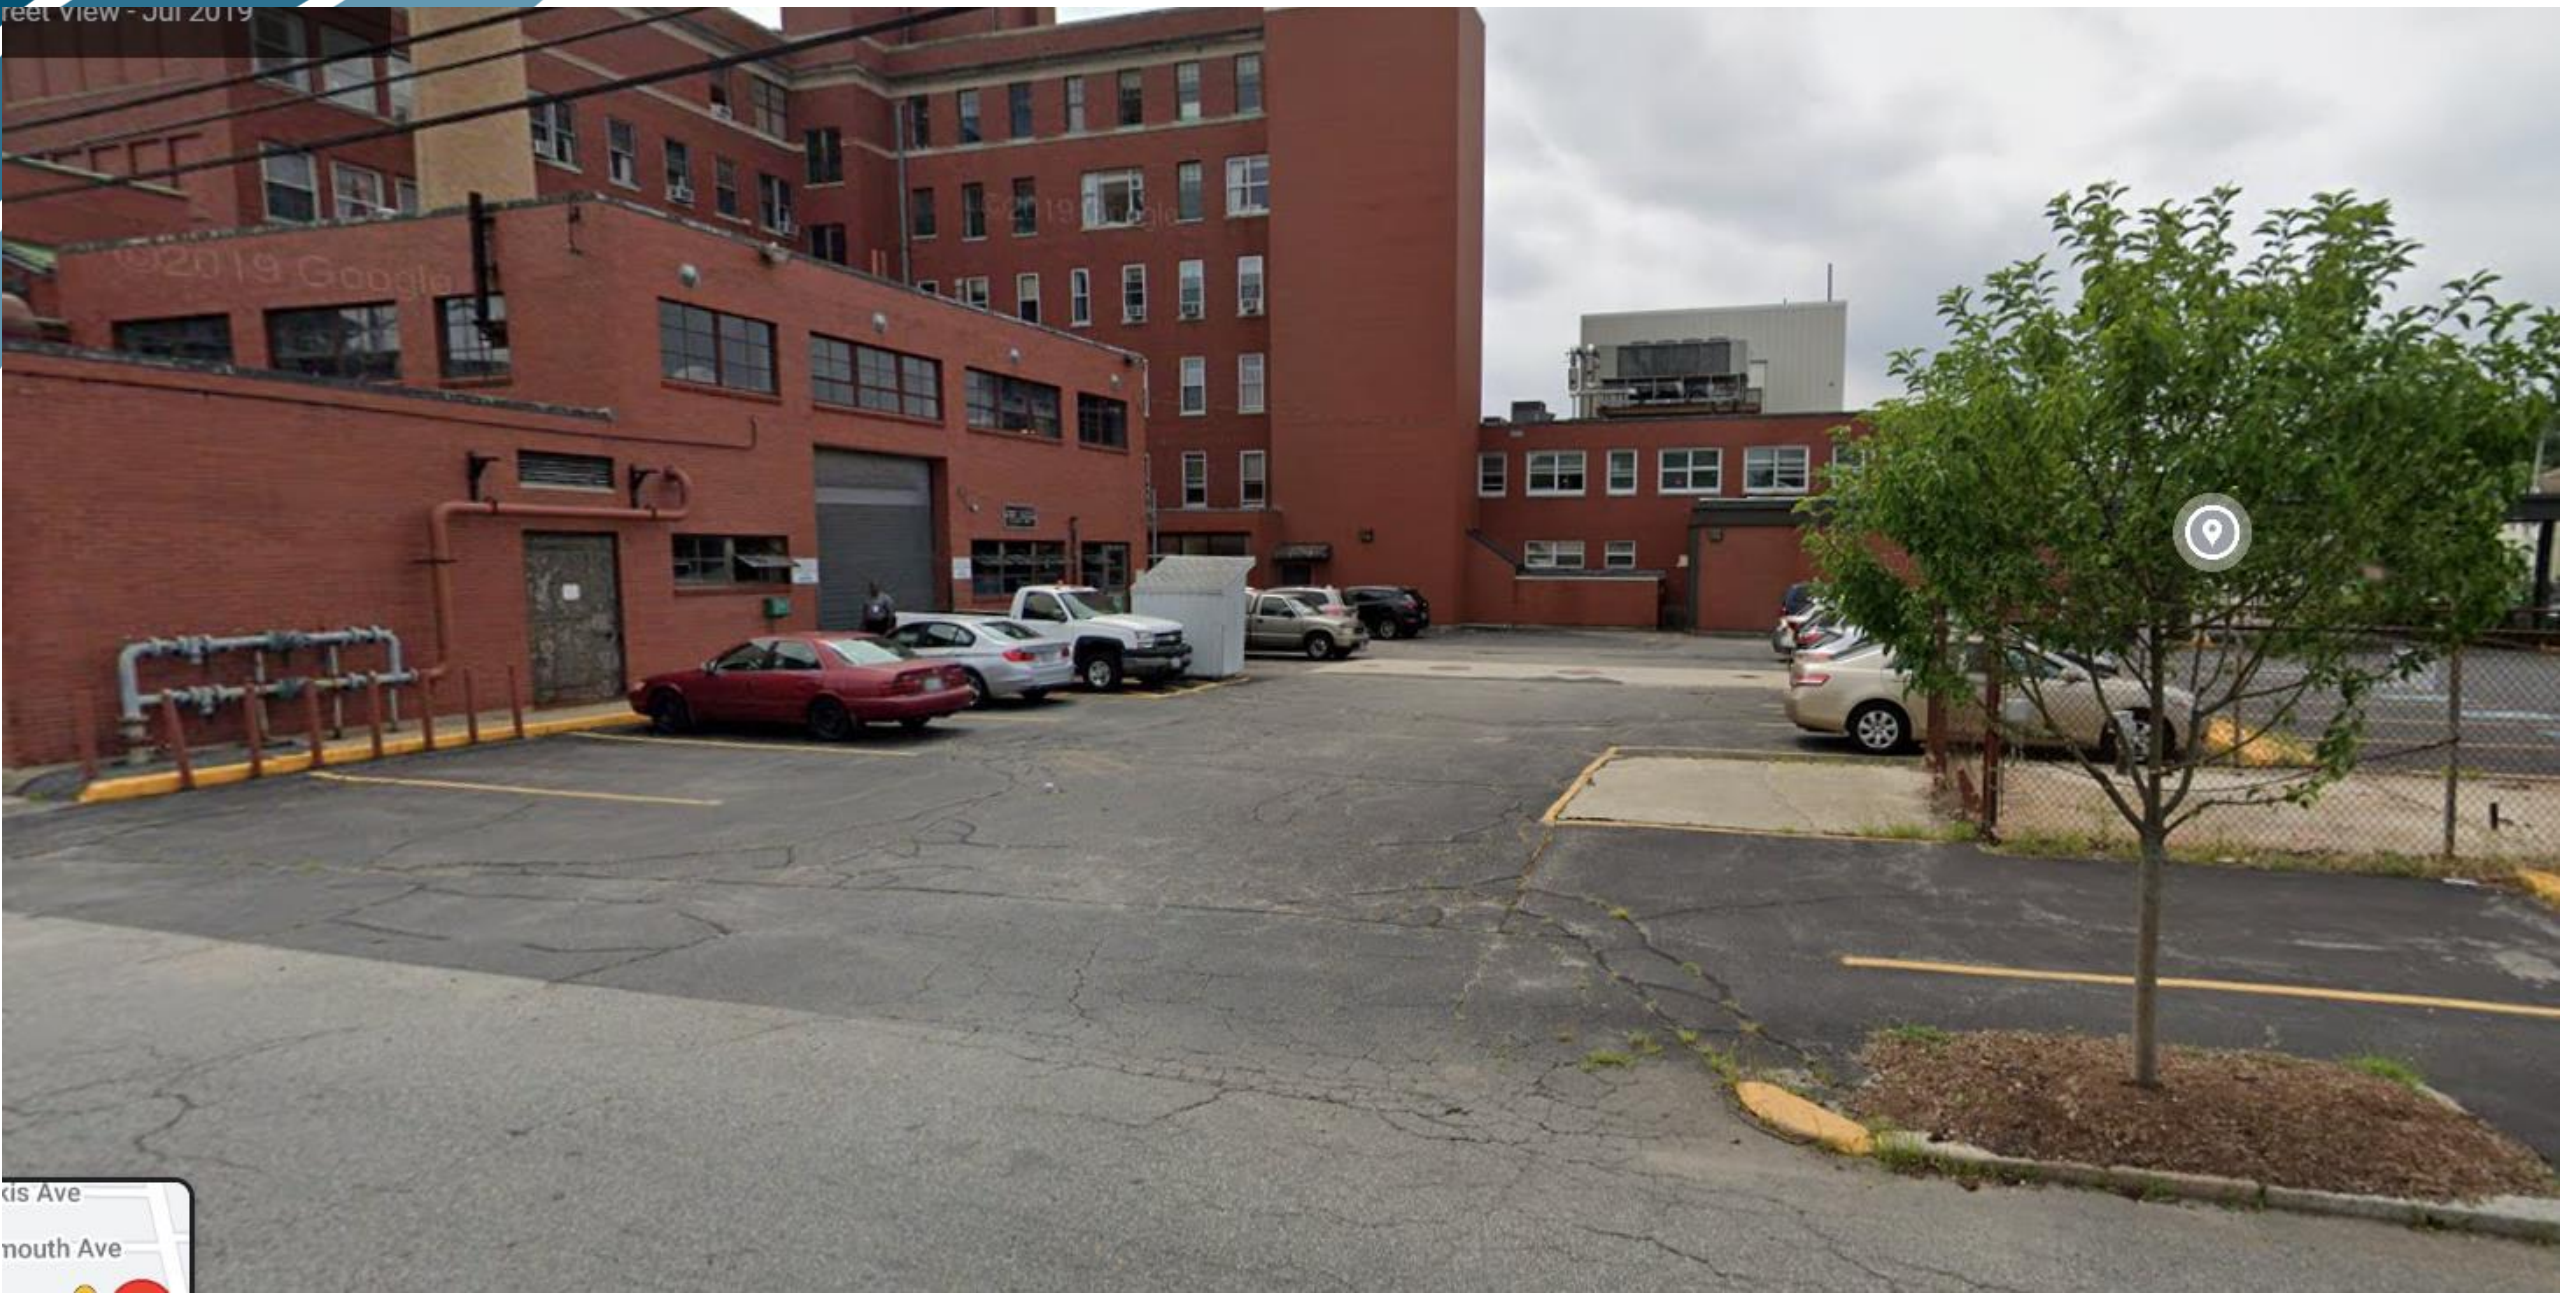
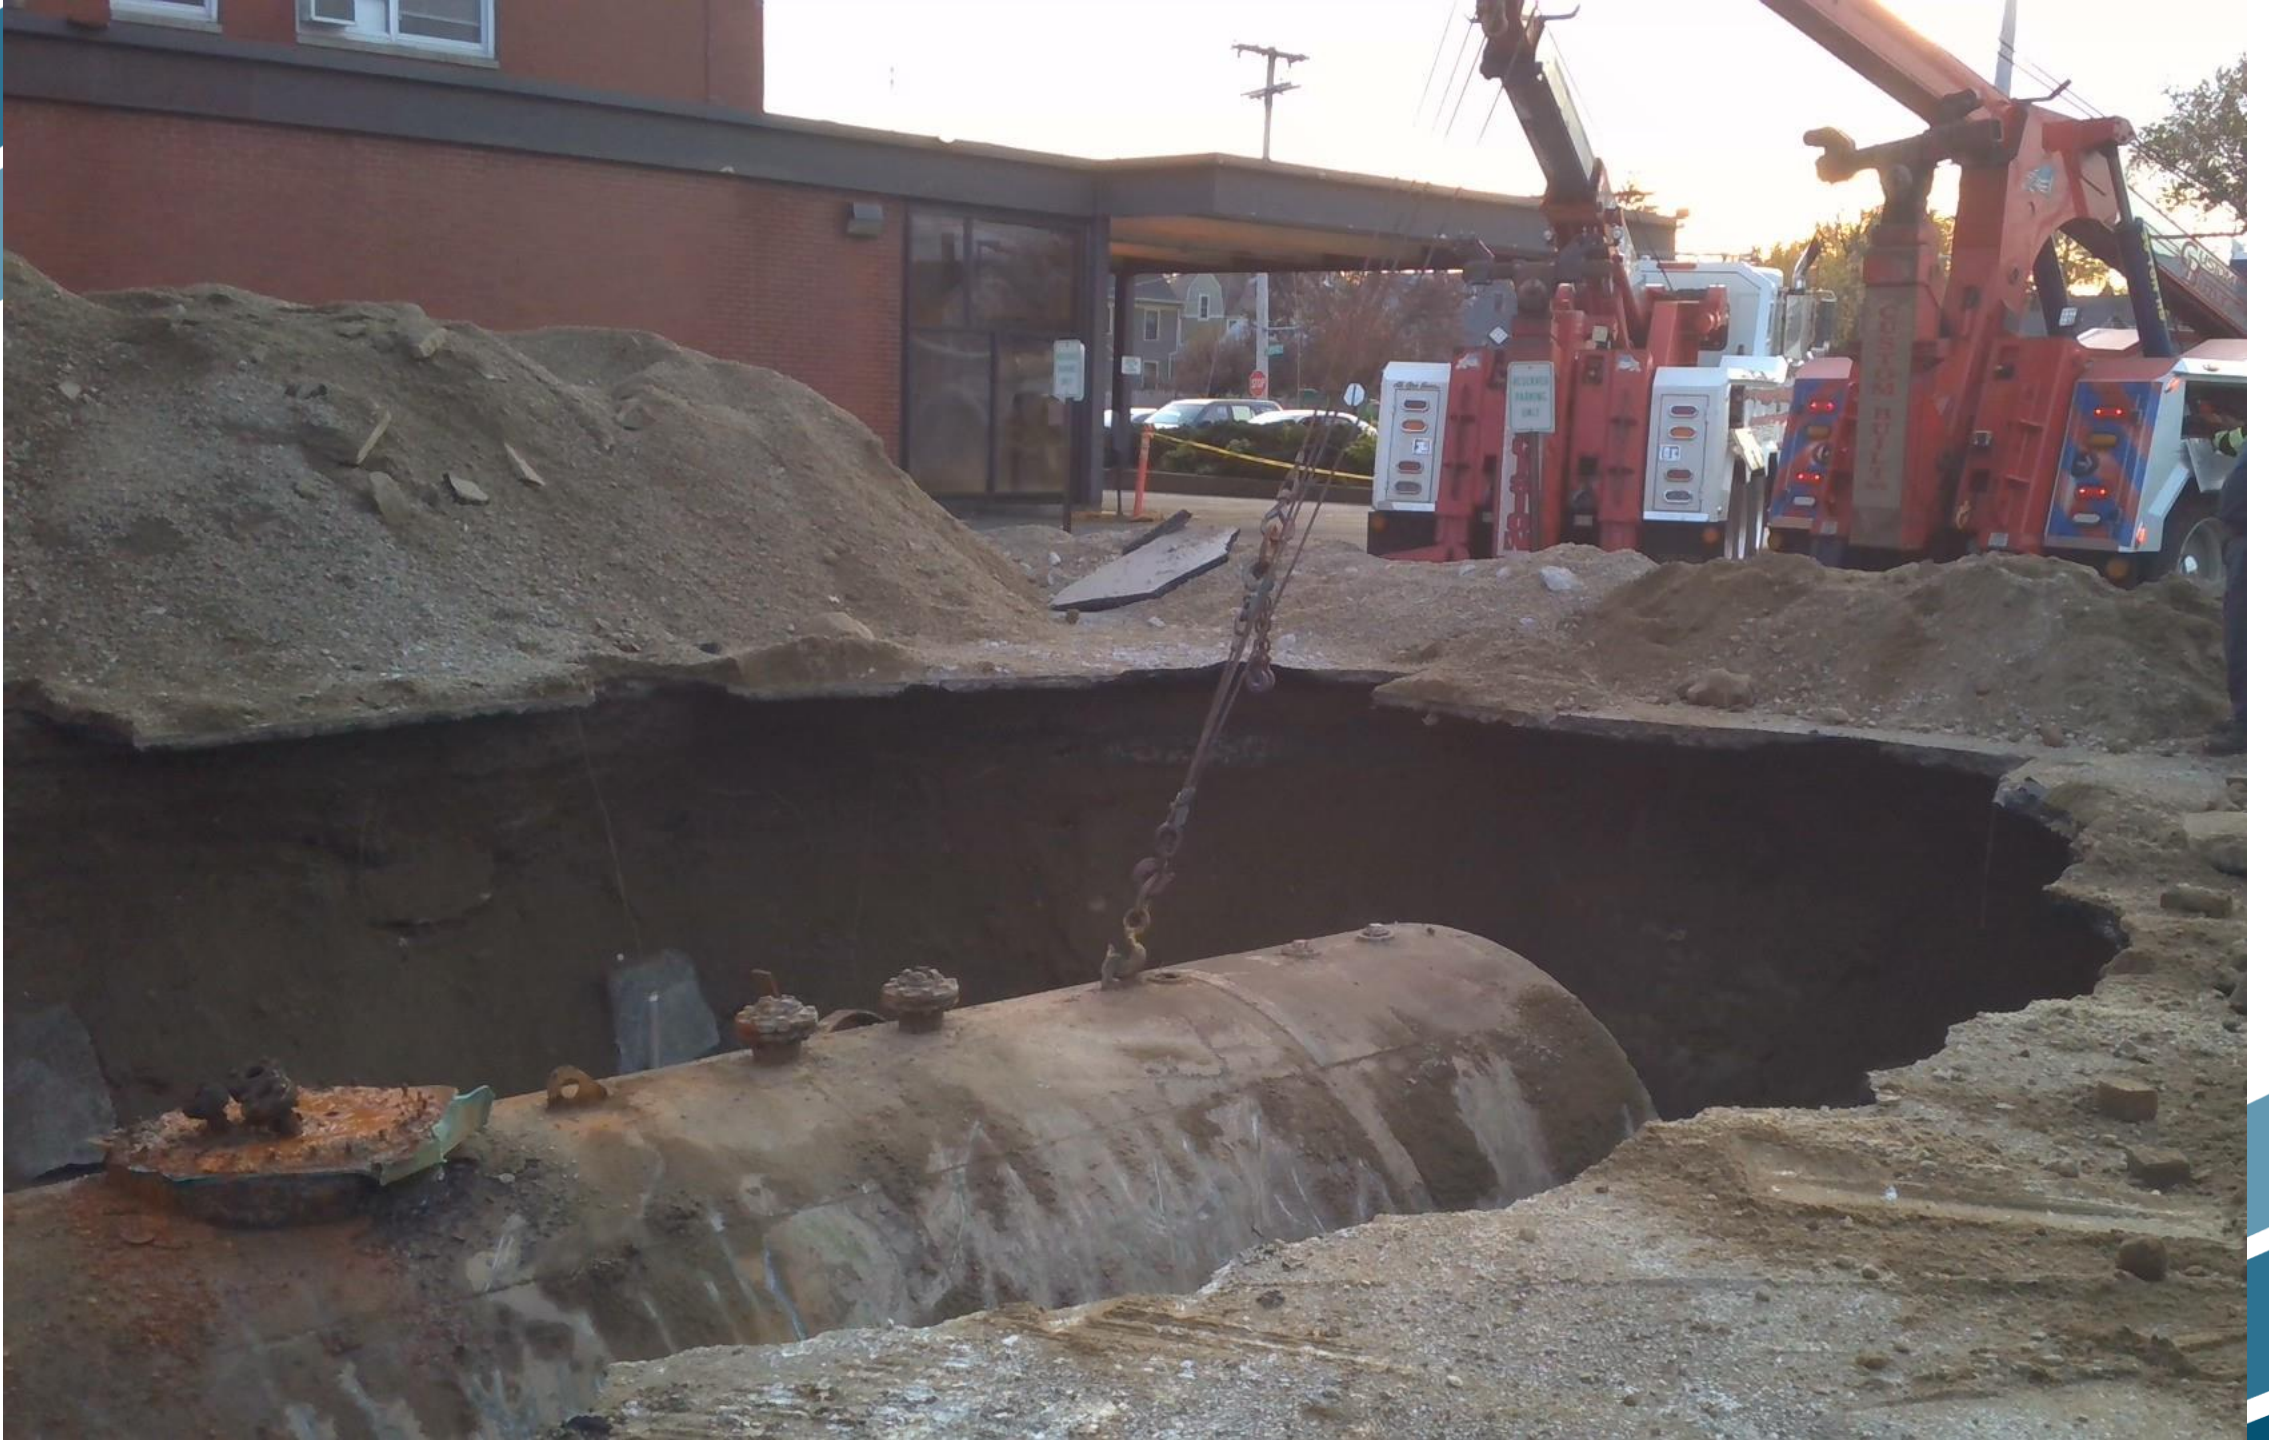
AN EXAMPLE OF FAILURE: HOSPITAL IN PROVIDENCE

- Could not be excavated in 1998 due to use as active hospital
- Corrective Action plan required in 2020
- We “lightly” recommended excavation in the CAP letter
- Owner decided to close the tanks and excavate

AN EXAMPLE OF FAILURE: HOSPITAL IN PROVIDENCE

- Decided (at the closure) not to dig at the UST closure, instead opted to install 10-15 new borings and wells several months later
- Separate excavation plan now needed, now it is September and the project has not moved forward
