# **A PILOT STUDY IN HIGH RESOLUTION SITE CHARACTERIZATION AT SOUTH CAROLINA LUST SITES: LESSONS LEARNED AND BEST FUTURE USE**

# PILOT STUDY PURPOSE

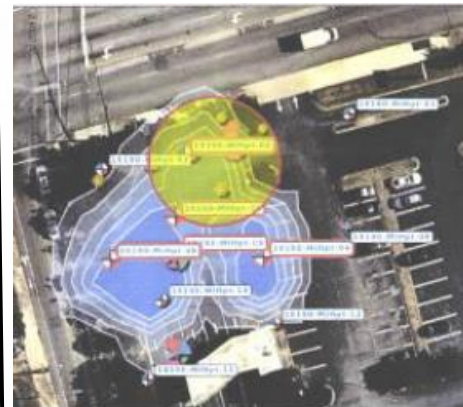
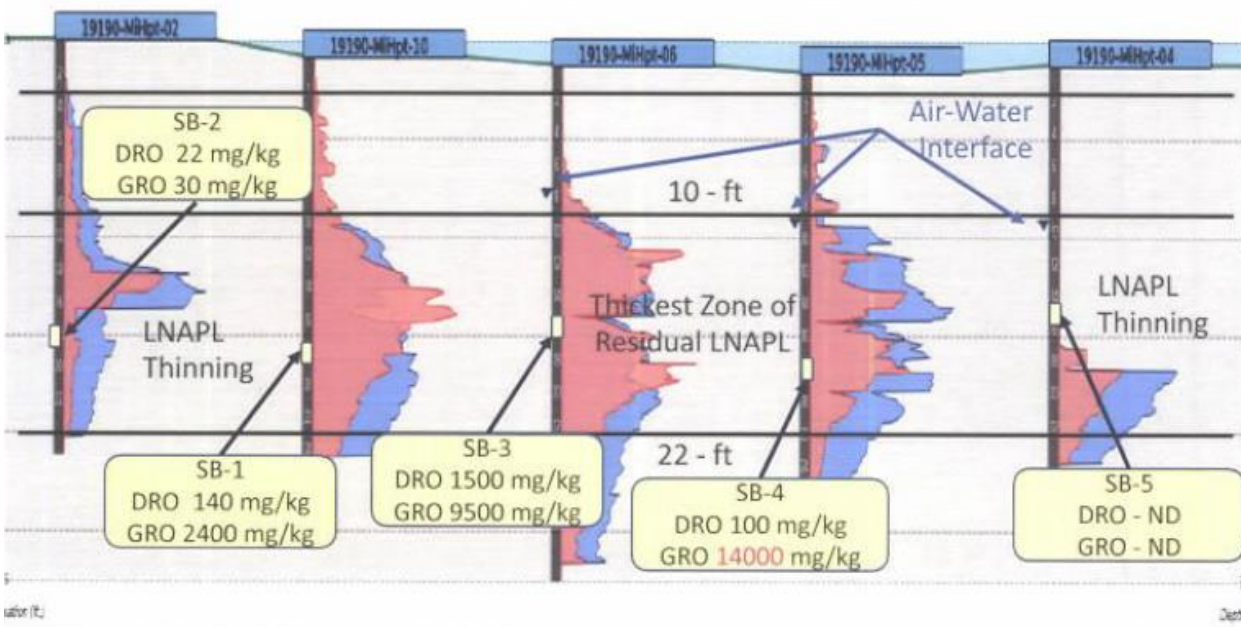
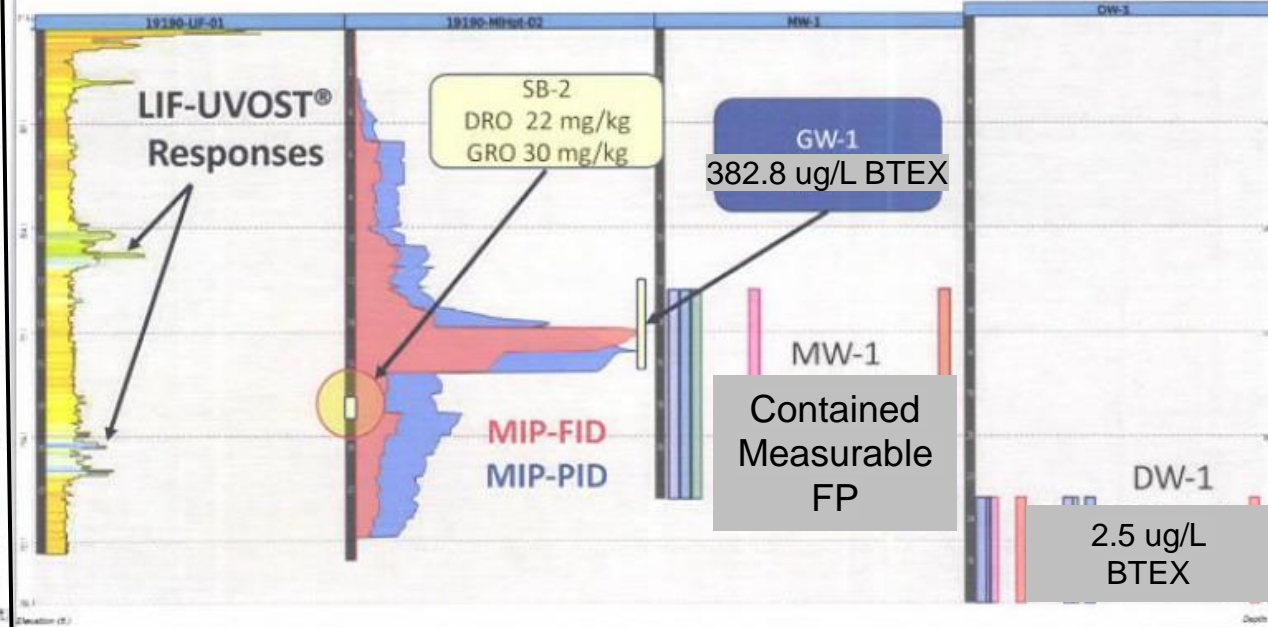
MIP-FID  
MIP-PID

Transect through B of A Source Area

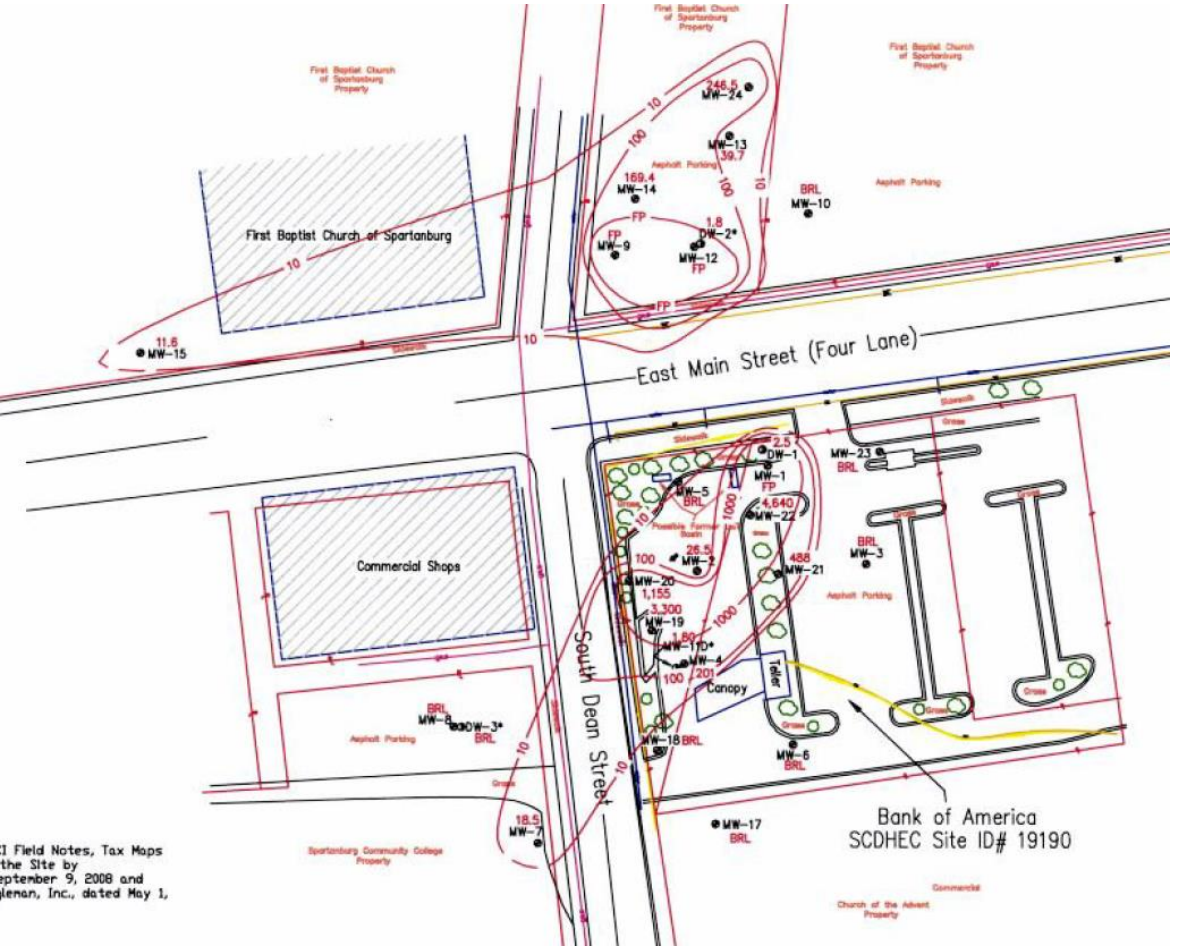
# Site Conceptual Model Based in HRSC Data

- Hydraulic LNAPL recovery efforts (AFVR) would not be effective based on LNAPL saturation present
- Two distinct source areas
  - One Due to Solvents
  - One Gasoline/Motor Oil
- Diffusion possibly causing co-mingling

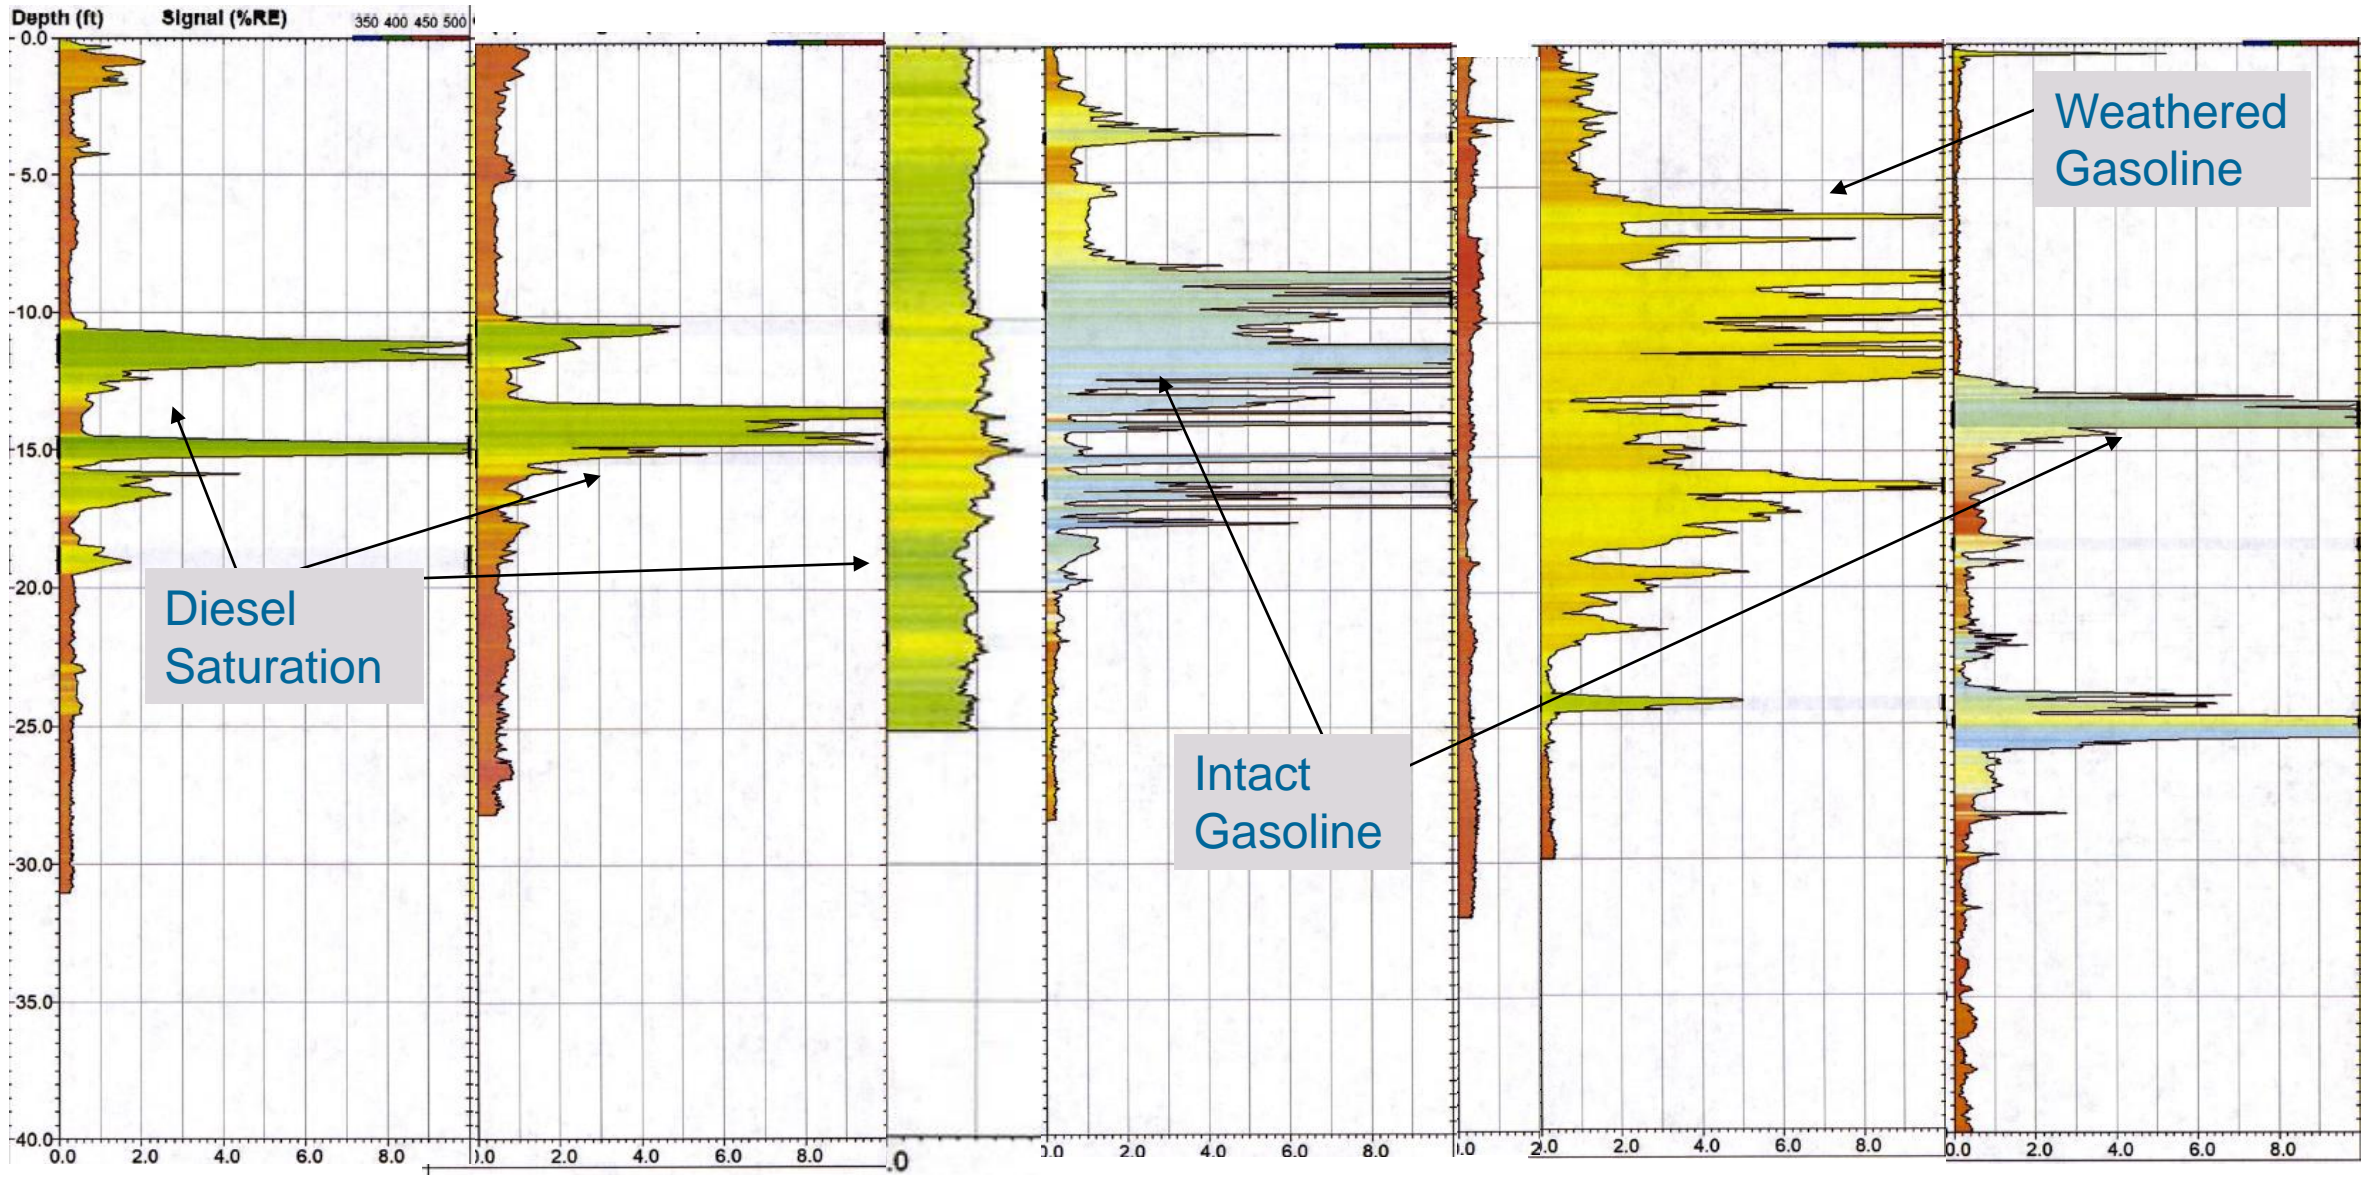
Weathered Gasoline

Diesel Saturation

Intact Gasoline

- Two Distinct Plumes
  - Gasoline/Weather Gasoline to the North
  - Diesel to the South
- Better Site Conceptual Model
- Targeted Clean-up Effort

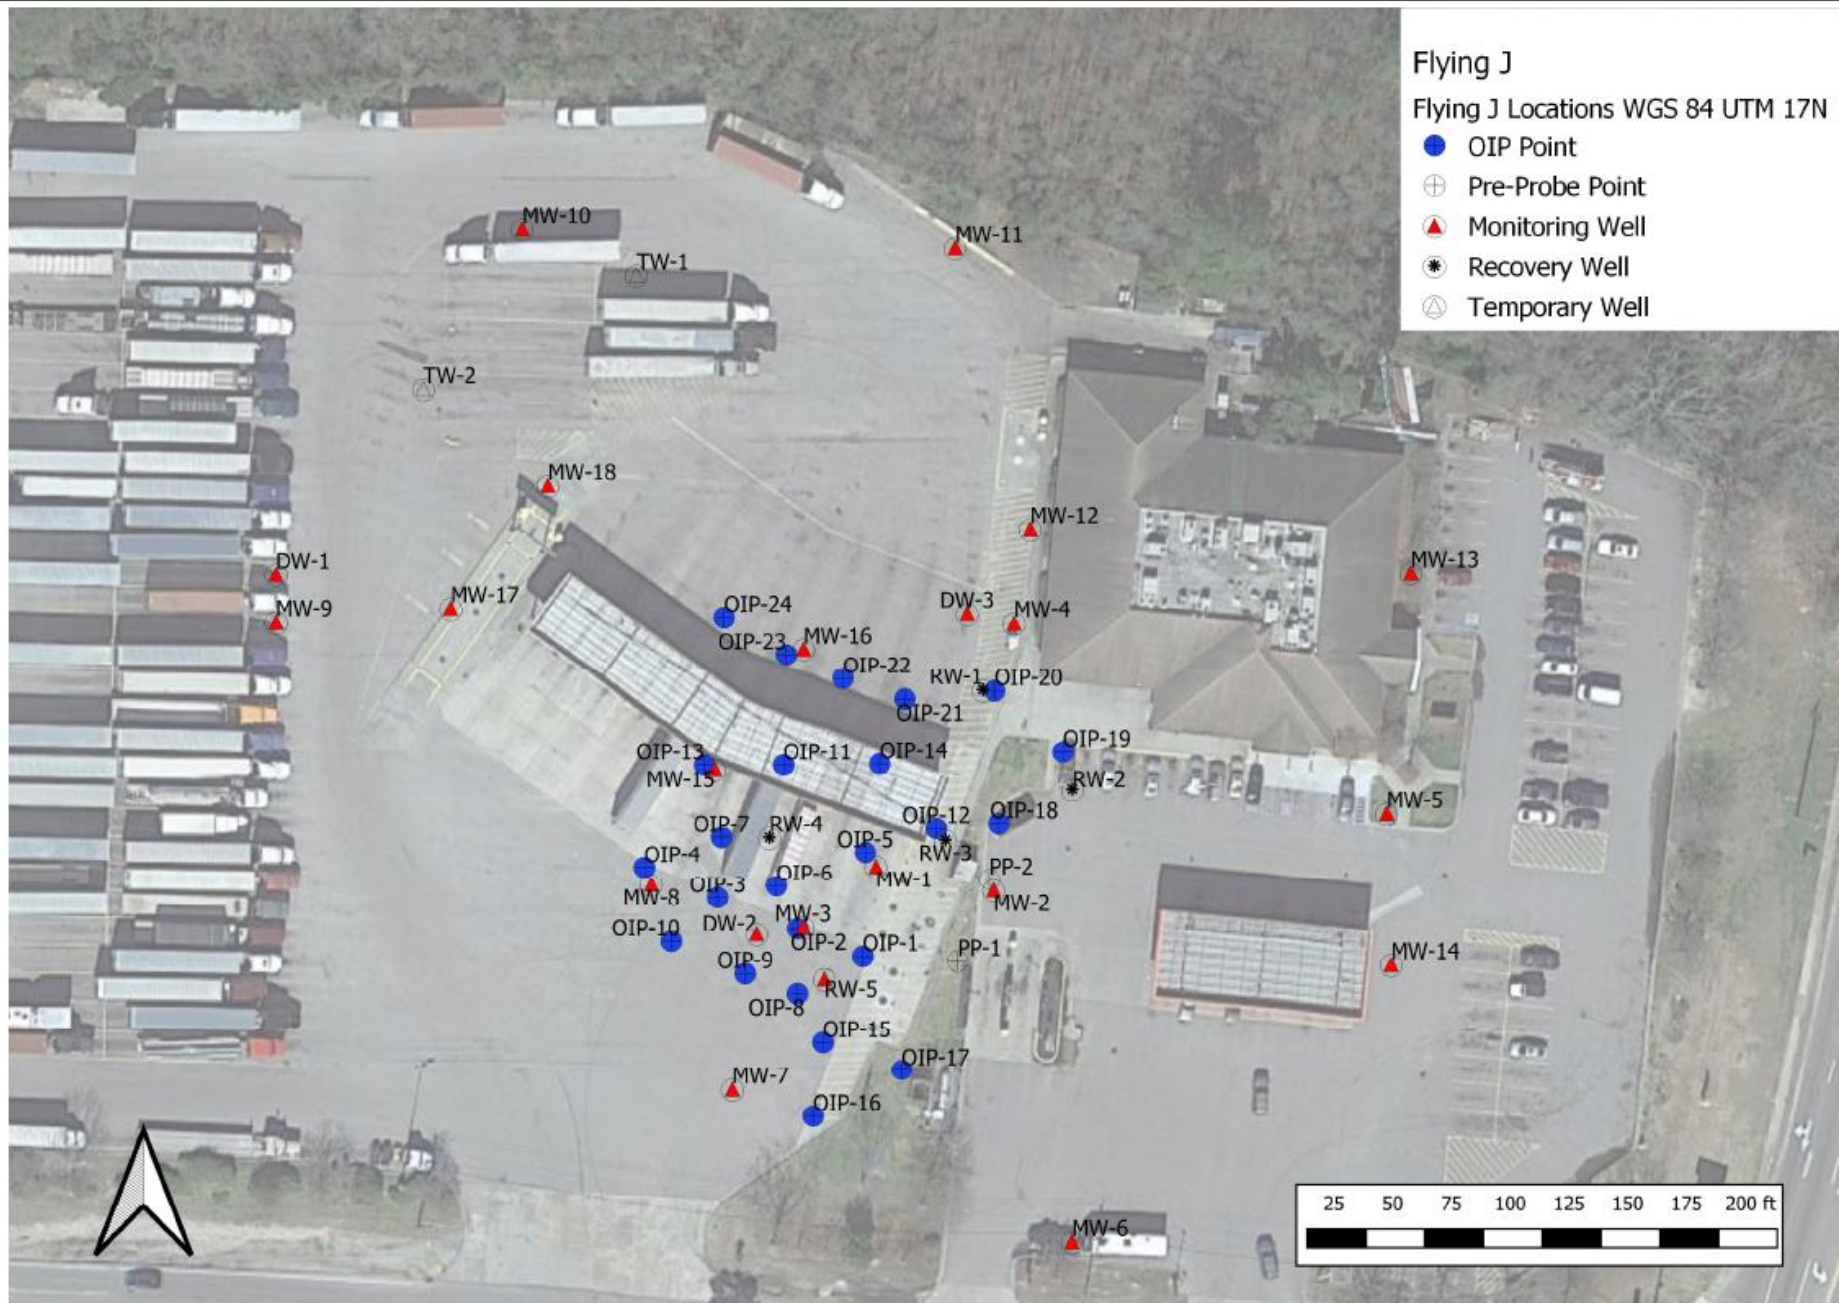
Flying J Locations WGS 84 UTM 17N

- OIP Point
- ⊕ Pre-Probe Point
- ▲ Monitoring Well
- ⊛ Recovery Well
- ⊙ Temporary Well
