SOUTH CAROLINA  
PROSPECTIVE:

TREATMENT TRAINS FOR  
ENHANCED REMEDIATION  
EFFECTIVENESS

# SOUTH CAROLINA UST

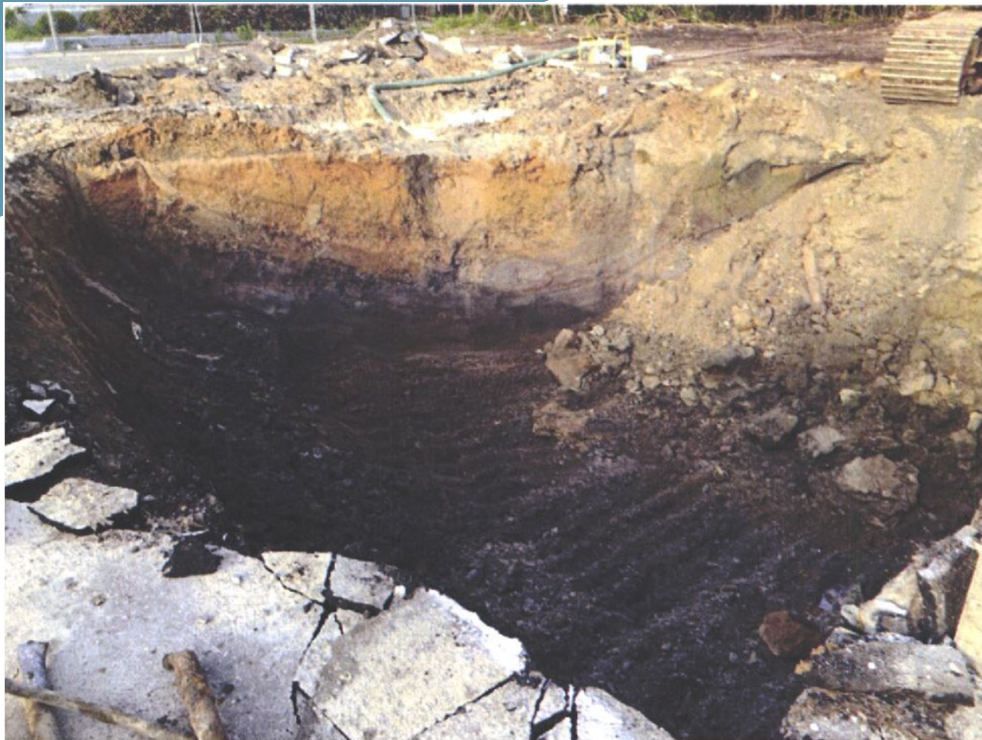
## South End Excavation

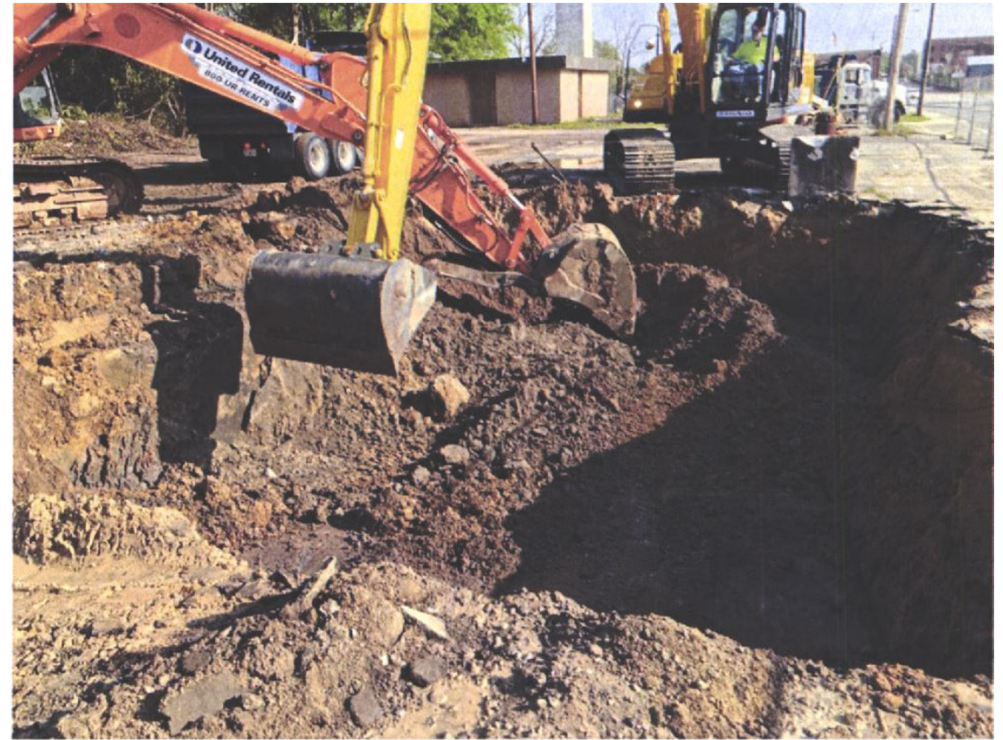
## Excavation toward North End

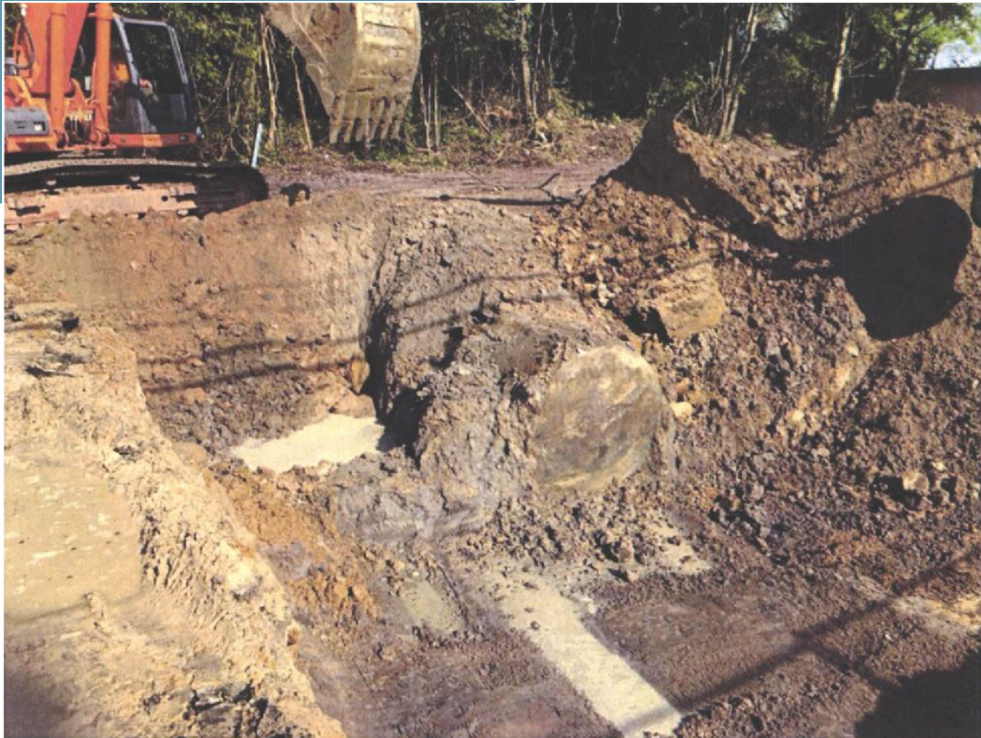
Orphan 3,000 gallon tank

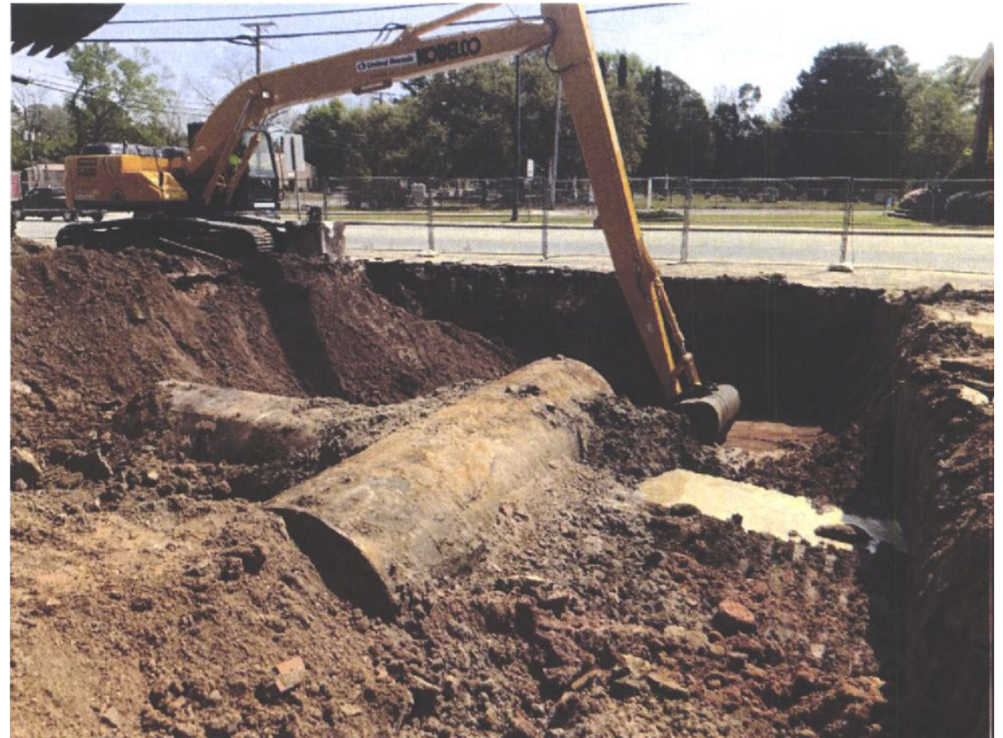
3,000 gallon & 1,000 gallon tank

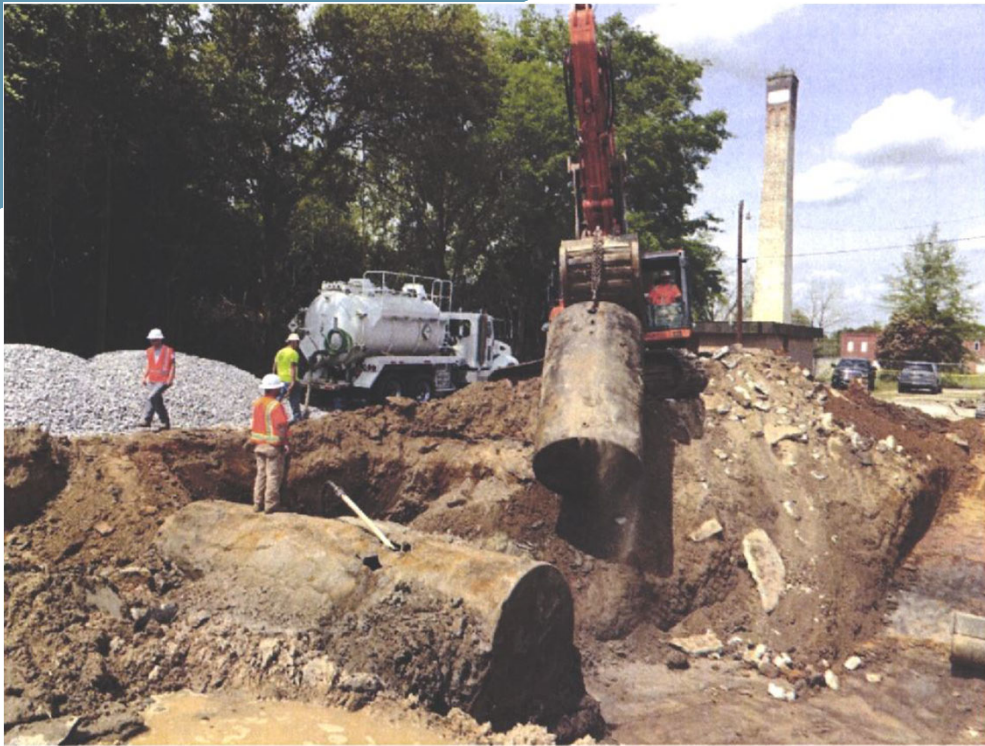
## Removing USTs for transport

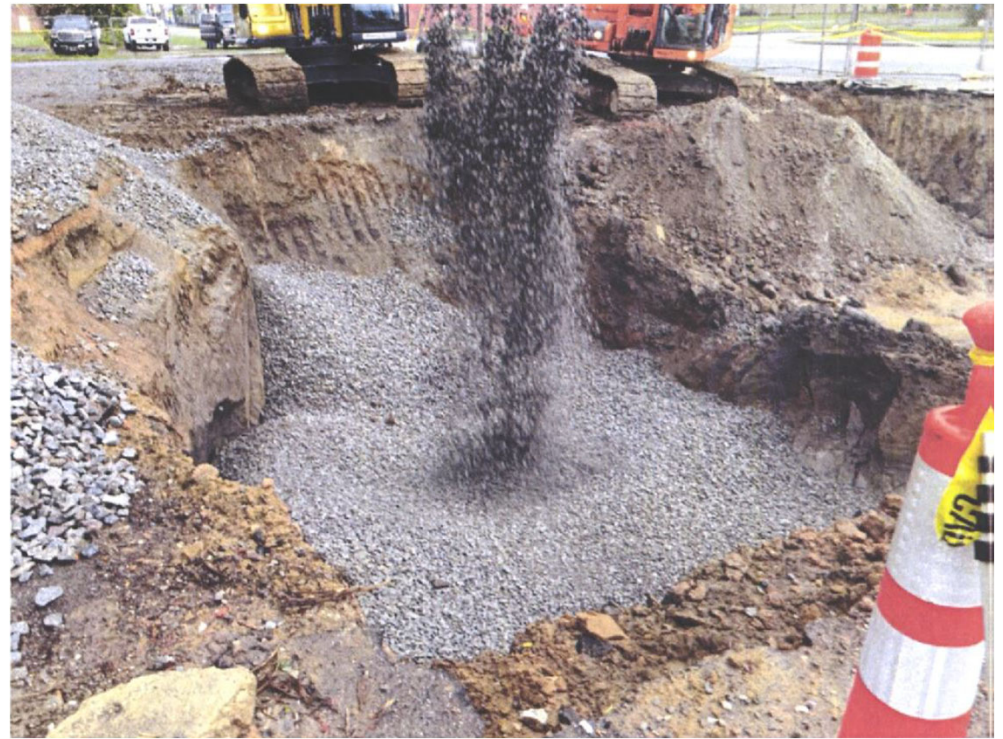
## Crushed stone placement

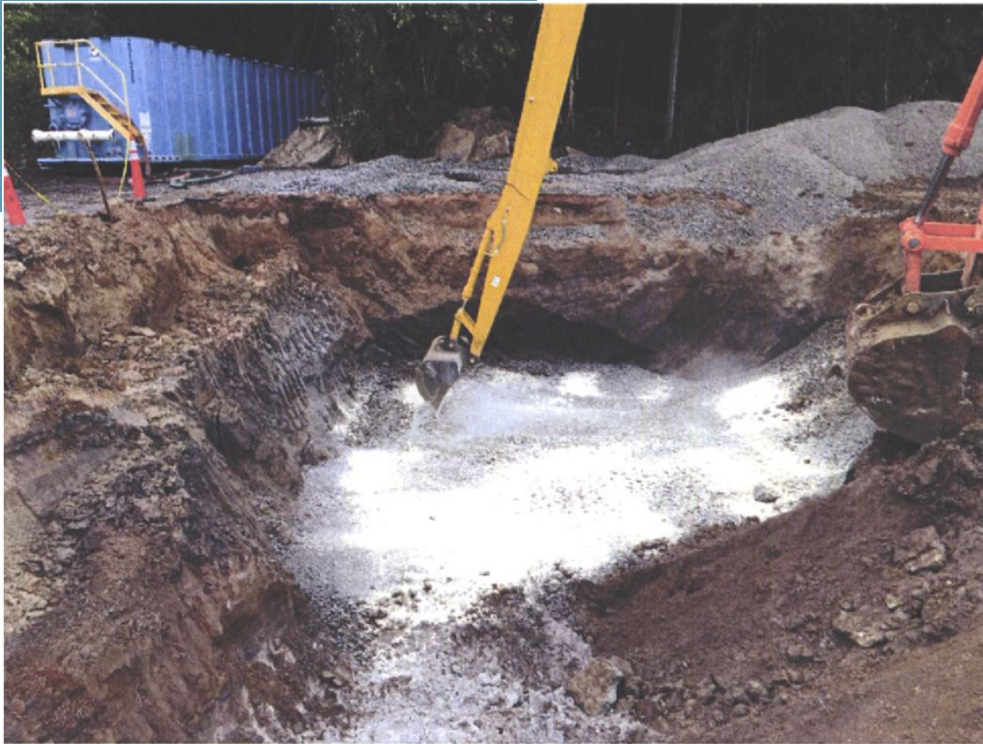
## Placement of ORC

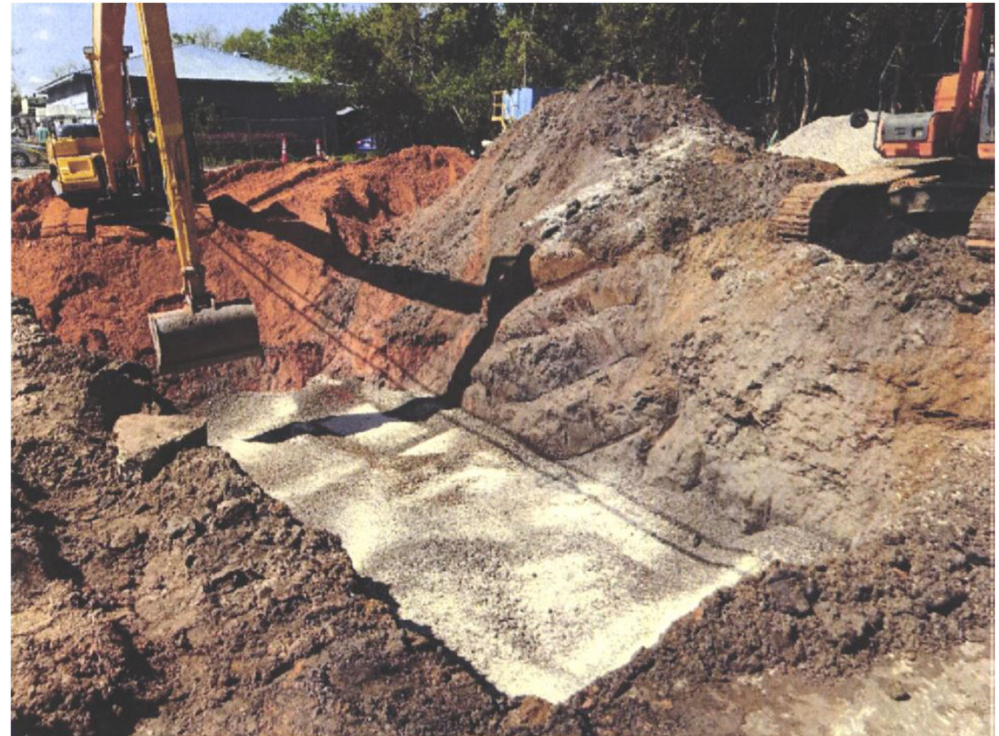
## Crushed Stone mixed with ORC

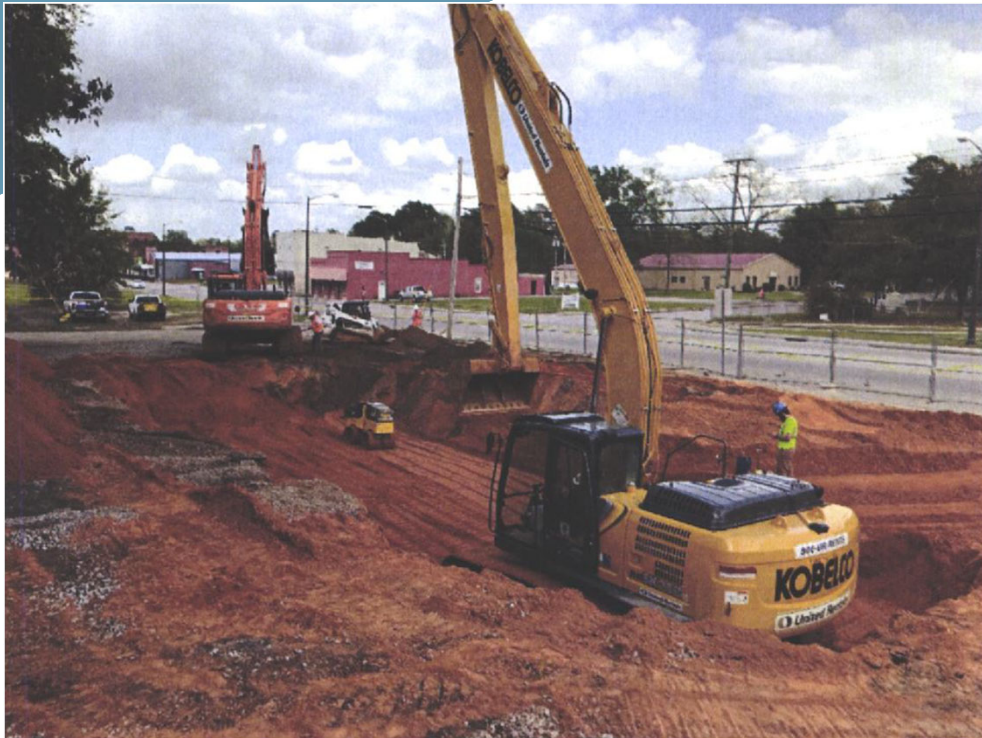
## Backfill & Compaction

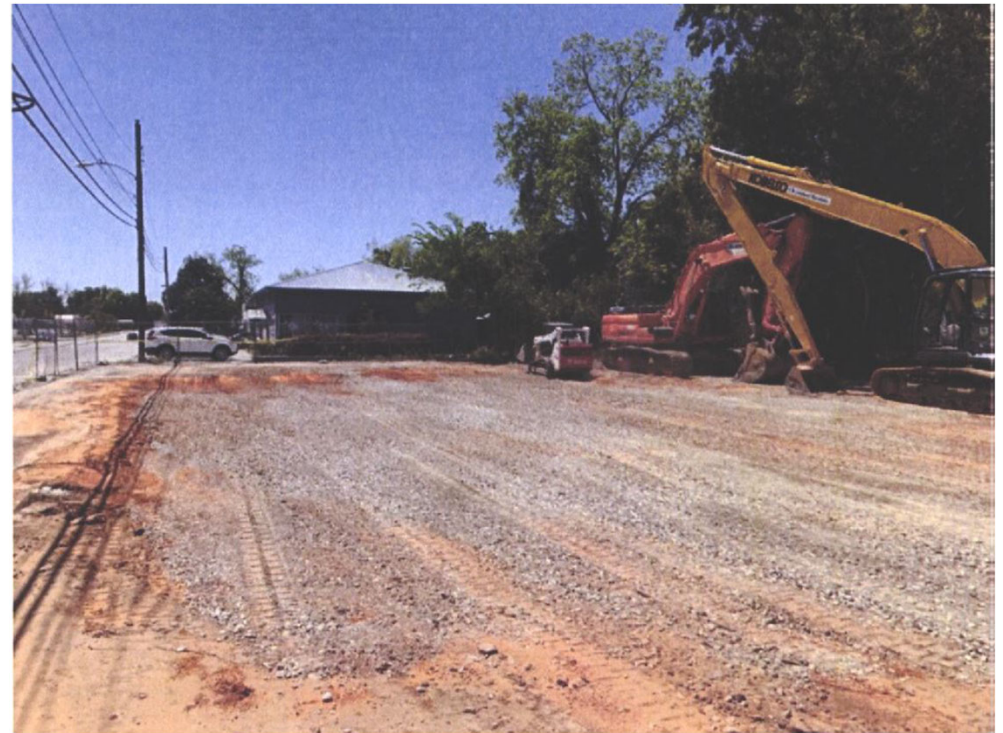
## Leveled Surface before Asphalt

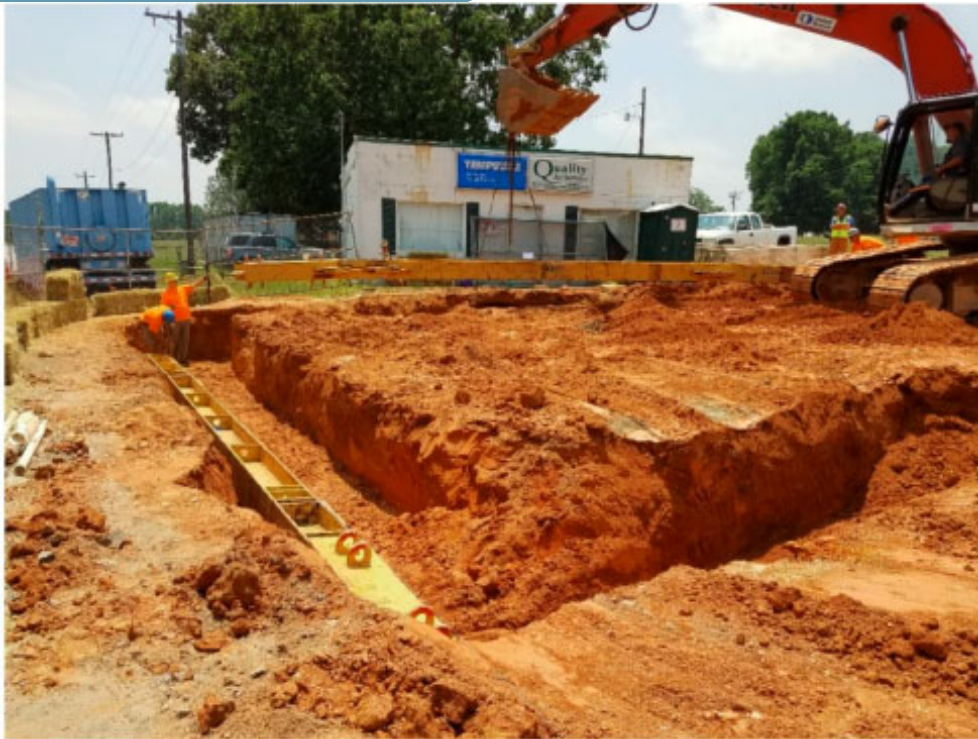
Trench dug to install hydraulic abutment beams for sheet pilings

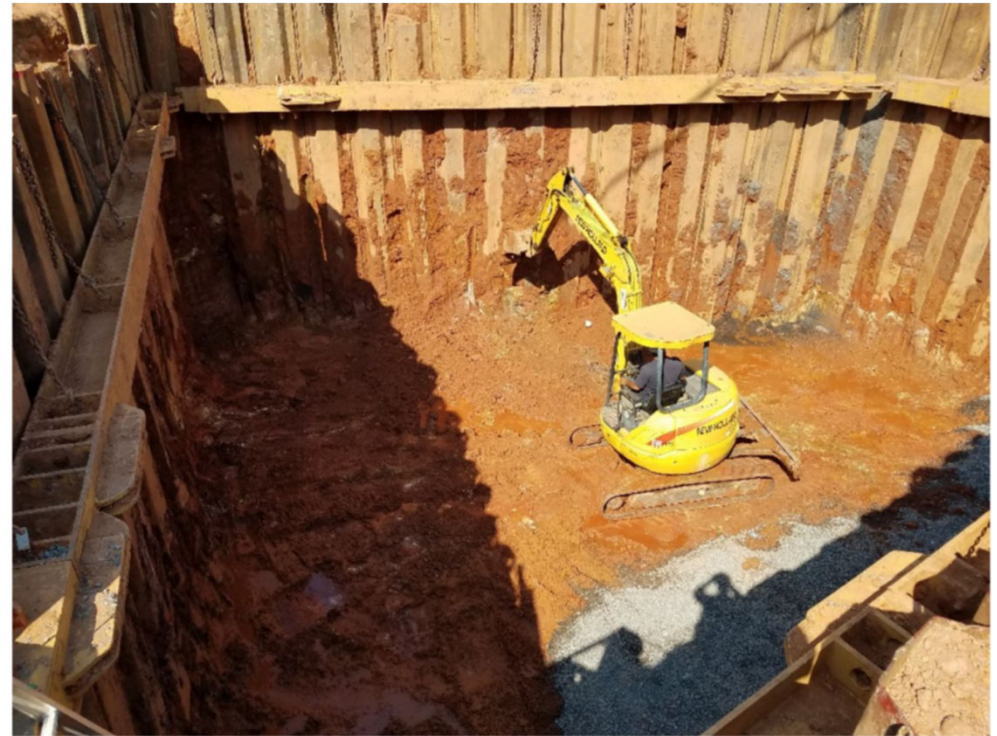
Excavation completed to 20 feet

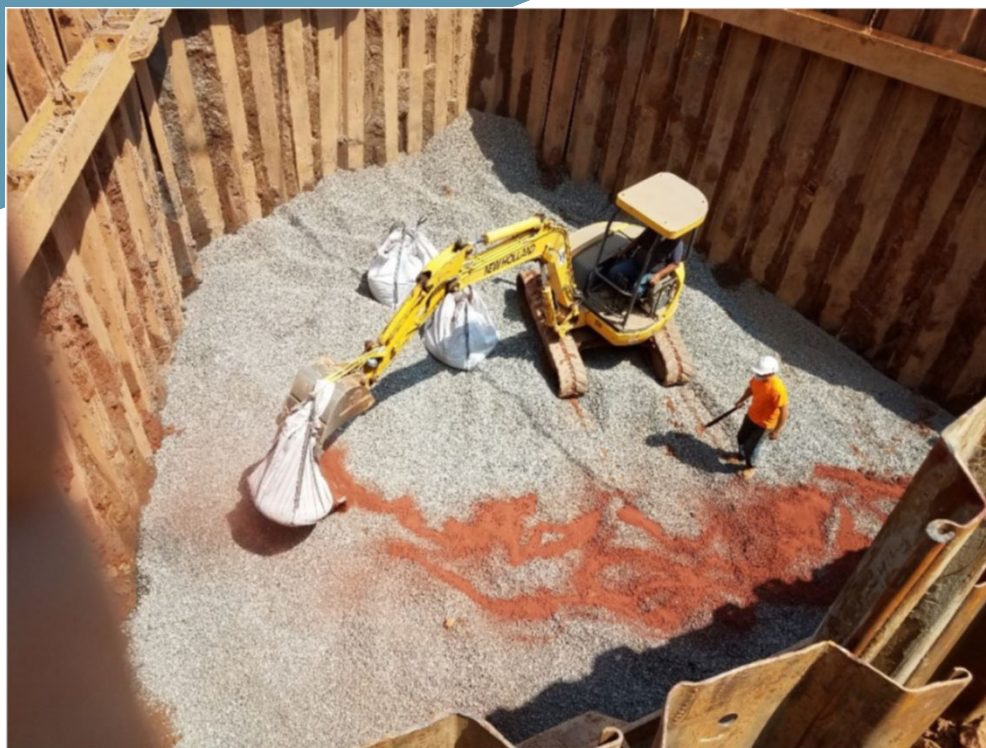
Provect-Oxs compound being distributed

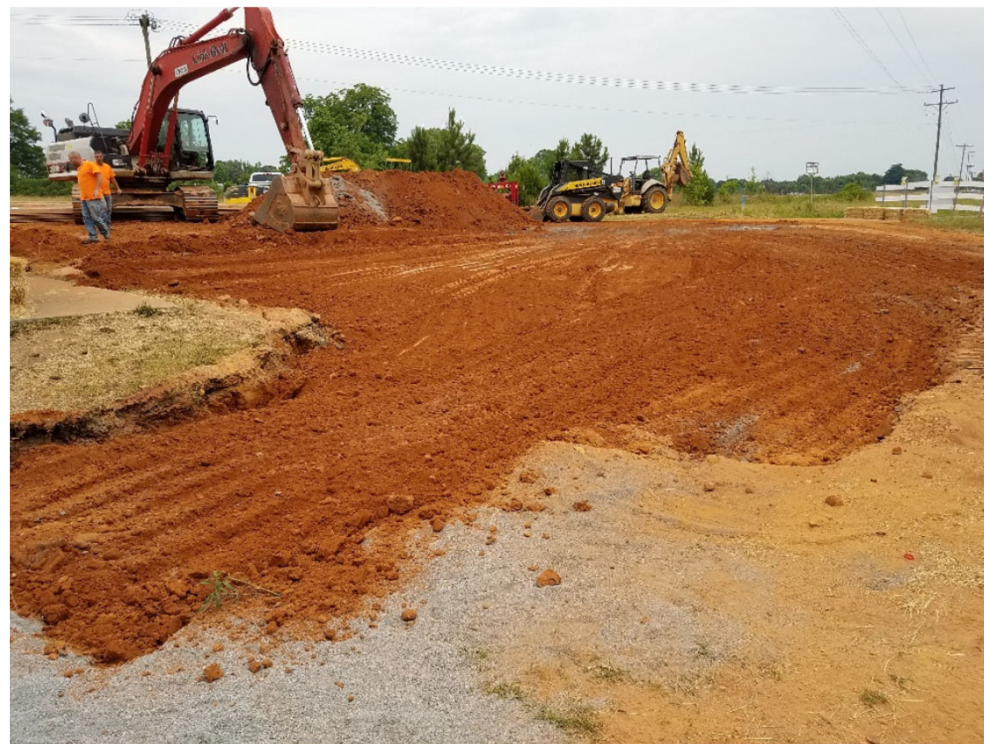
Completion of backfill and compaction

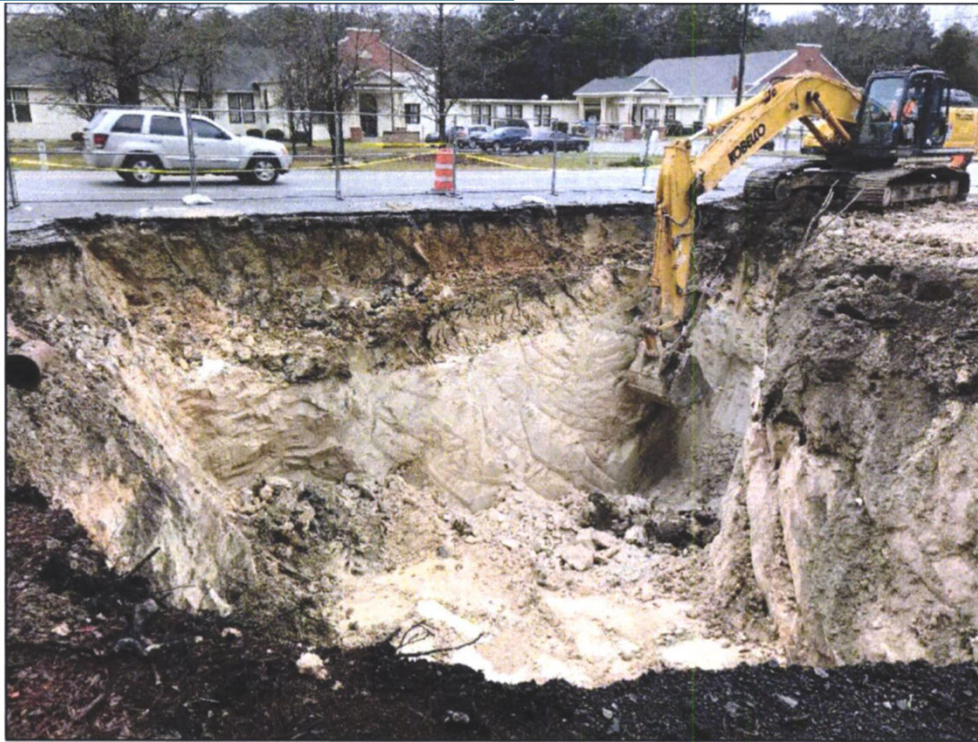
## Excavation Activities

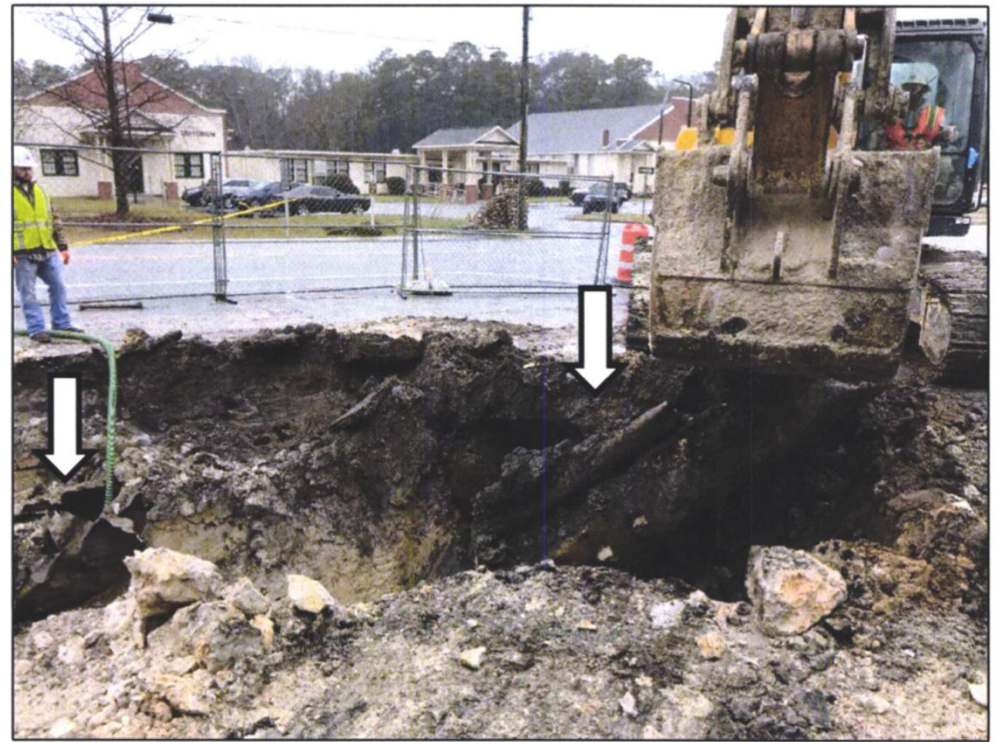
## Abandoned Tanks

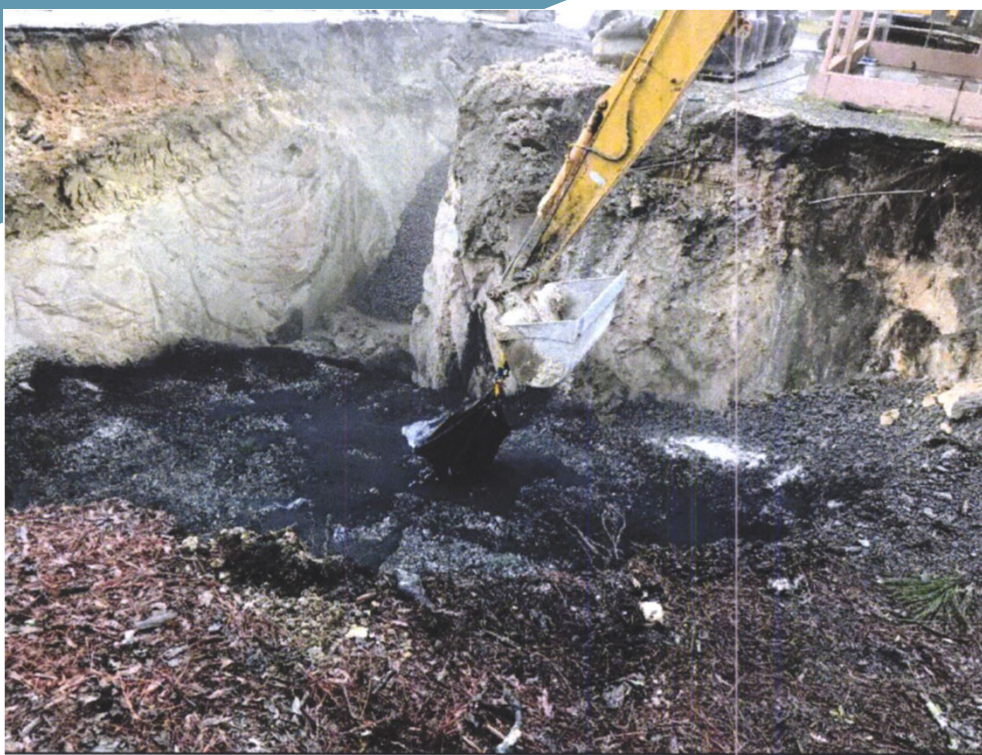
## Mixing Gravel with ORC & Carbon

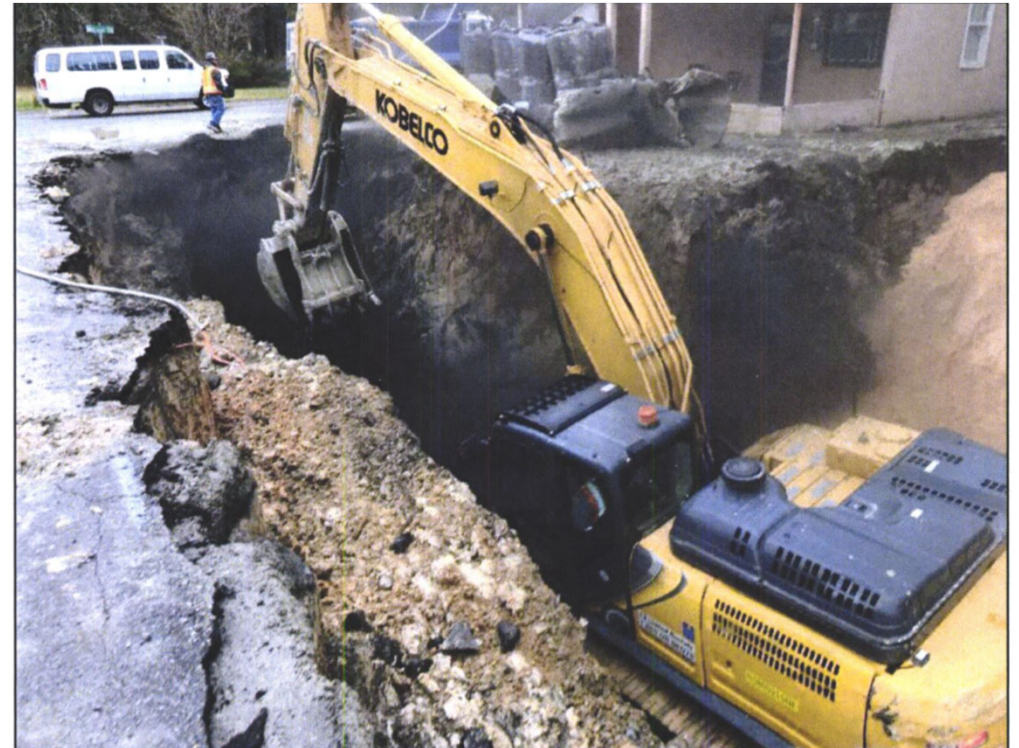
## Mixing Gravel with ORC & Carbon

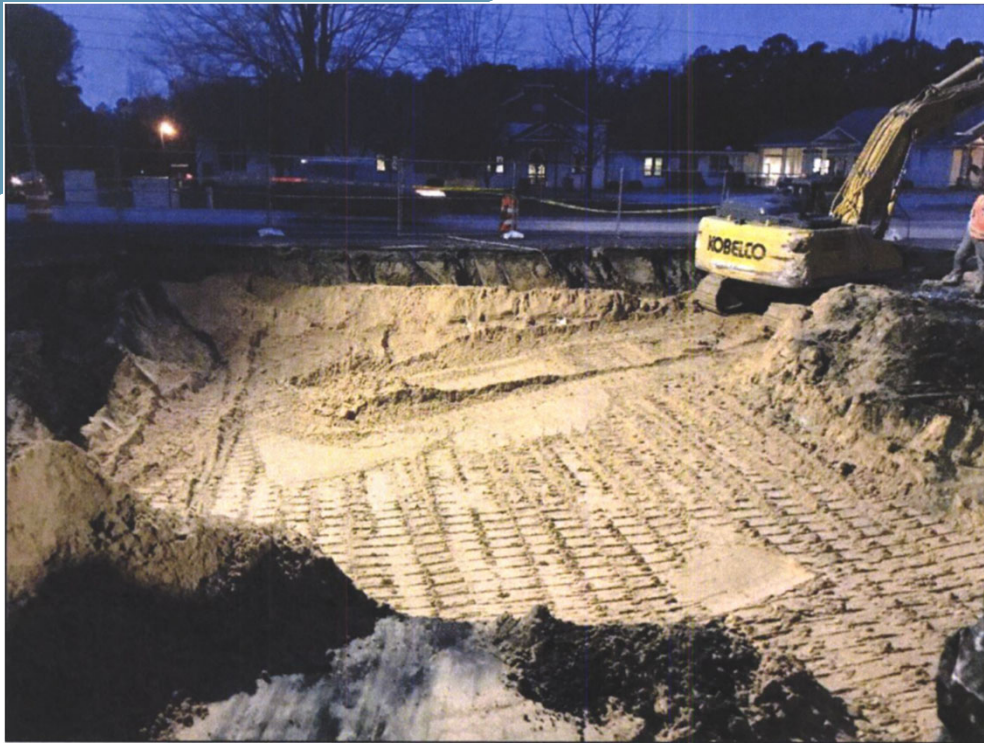
## Site Compaction

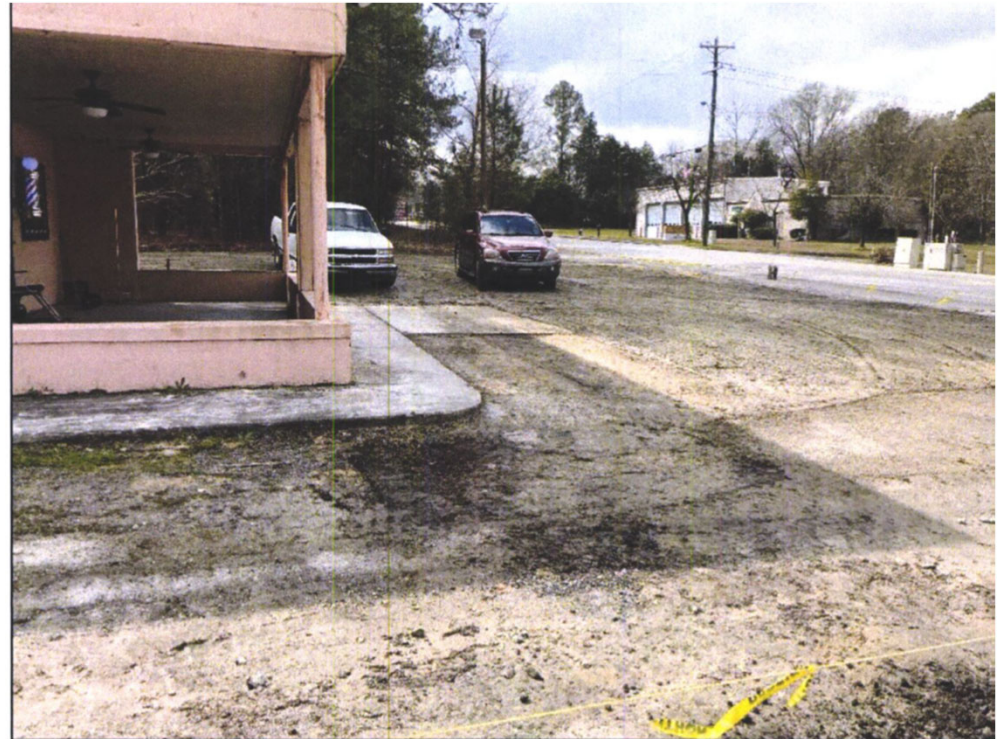
## Completed Site View

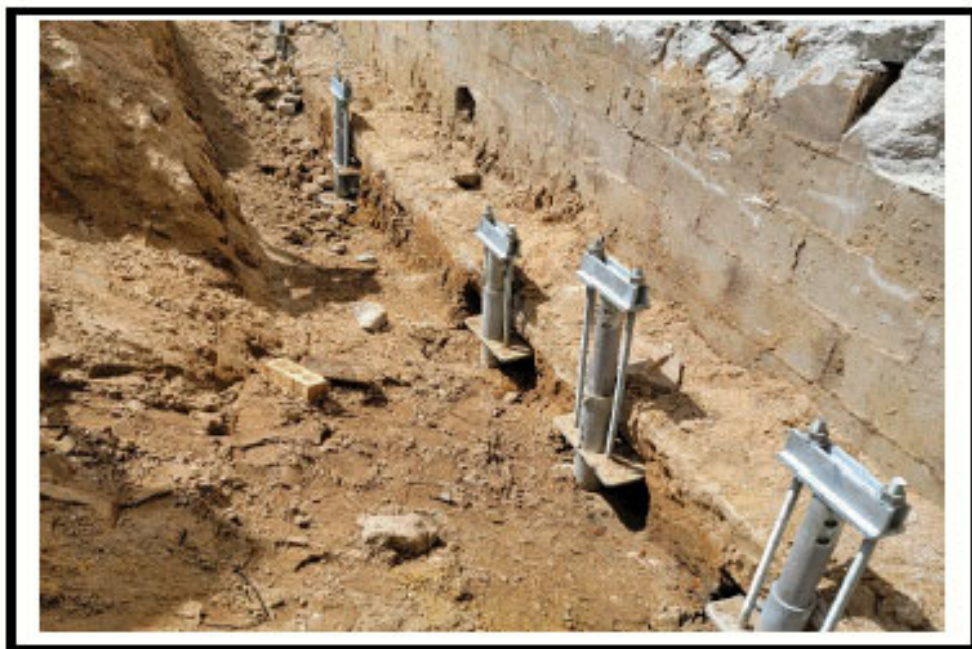
Helical anchors were installed below the concrete footings to support the residence foundation.

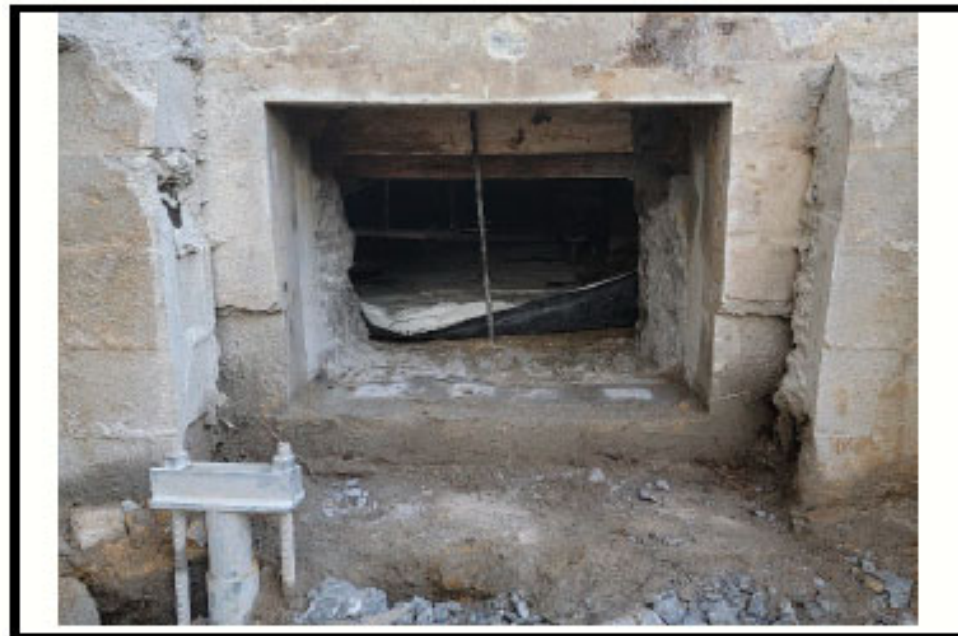
An access point to the crawlspace was installed beneath the rear entrance of the residence.

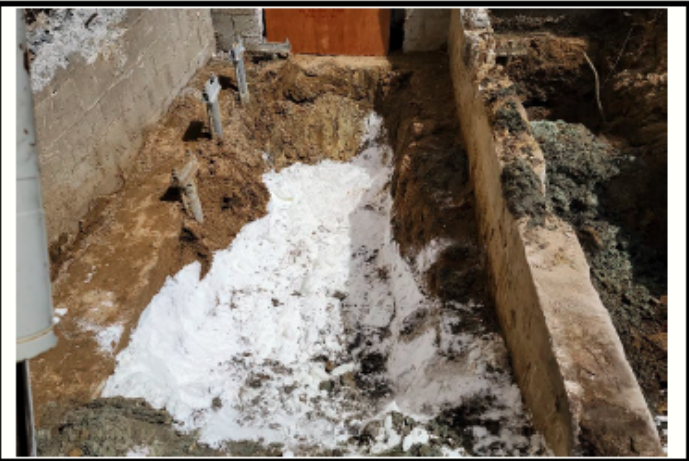
Sodium persulfate mixed with gravel was added to the excavation.

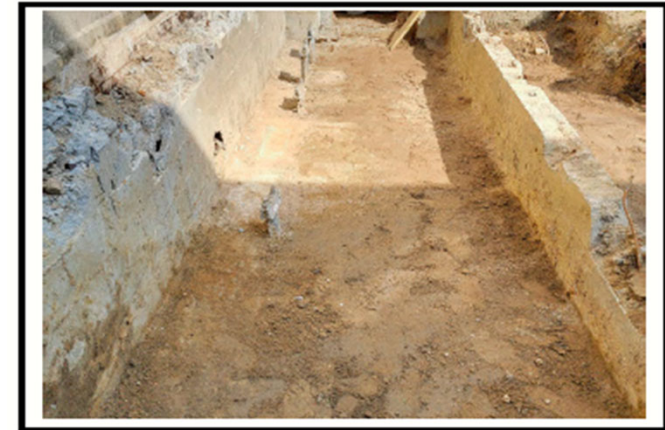
Excavation was backfilled with subsoil type S-1 (structural fill). Compaction of the backfill material occurred in approximate one-foot lifts using a vibrating compactor. Old cinderblock patio support is visible.

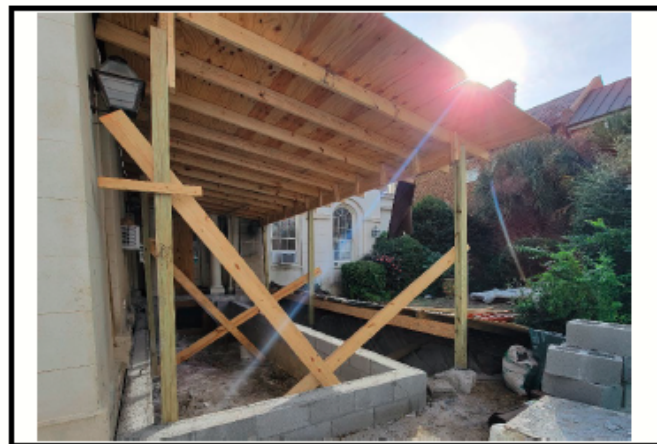
A temporary rain cover was installed during reconstruction of the cinderblock wall/patio supports.
