L.U.S.T.LINE

A Report on Federal & State Programs to Control Leaking Underground Storage Tanks

The Tale of a Legacy Release: A Montana Case Study

The Cracked Case of the Fiberglass Tank's Disappearing Gasoline

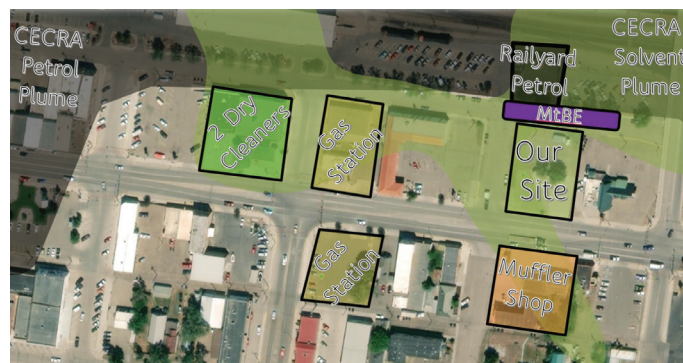
Figure 2 A modified Google Maps rendition of the release site with potential sources of contamination identified.

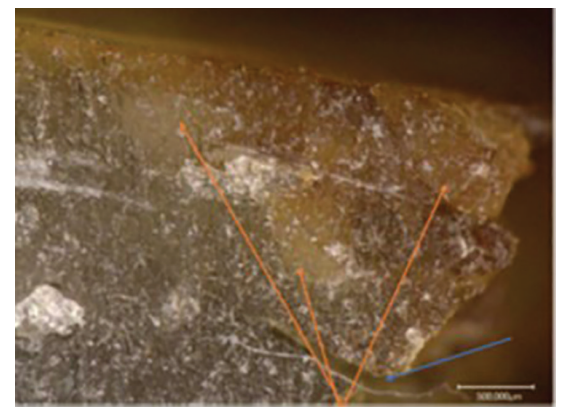
Figure 11 Magnified photo of crack location with permeation in the gel coat.

Figure 11 shows permeation of gasoline into the gel layer (upper right of the photograph), as illustrated by the orange arrows in the location of the crack. Notice the color near the crack versus the bottom left of the photograph for comparison. The blue arrow shows another crack perpendicular to the main crack. I have noticed this discoloration in other FRP USTs on other tank removals but did not realize it was an indication of gasoline permeation of the gel coat.
