FINAL REPORT

NEIW PCC Job Code: 0346-002-001
Project Code: LS-2020-056
Contractor: Northwest Regional Planning Commission
Prepared By: B Remmers, D Pierce, M Yandow
Project Period: 5/7/2020 to 09/01/2023
Date Submitted: August 18, 2023
Date Approved: August 24, 2023

IDENTIFYING AND FIXING EROSION ISSUES ON PRIVATE AND PARK ROADS IN THE LAKE CARMİ WATERSHED

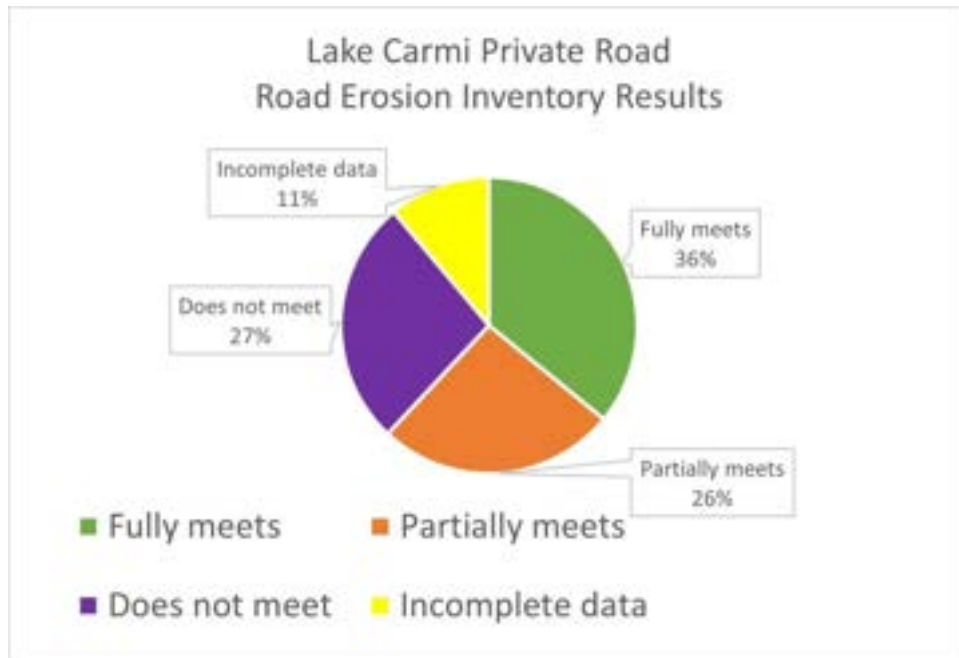
Figure 1. Results of the lake Carmi Road Erosion Inventory.

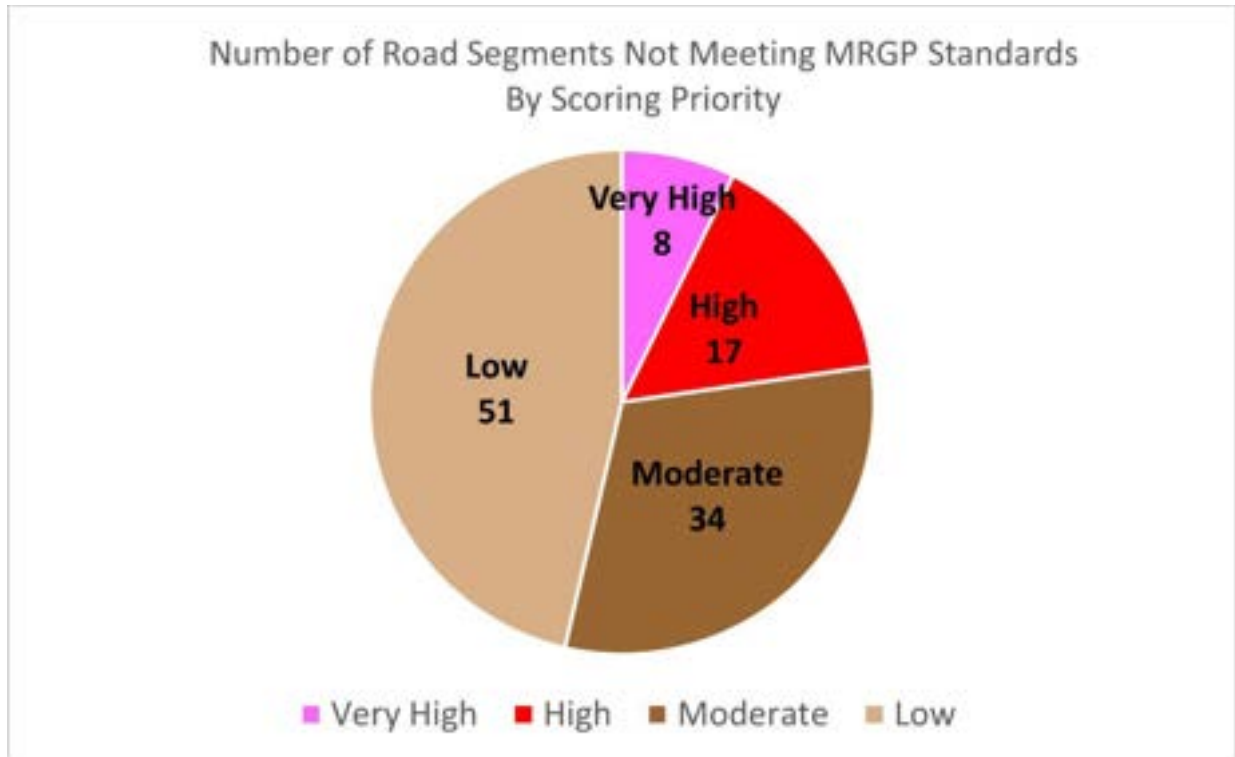
Figure 2. Road erosion inventory results by scoring priority.

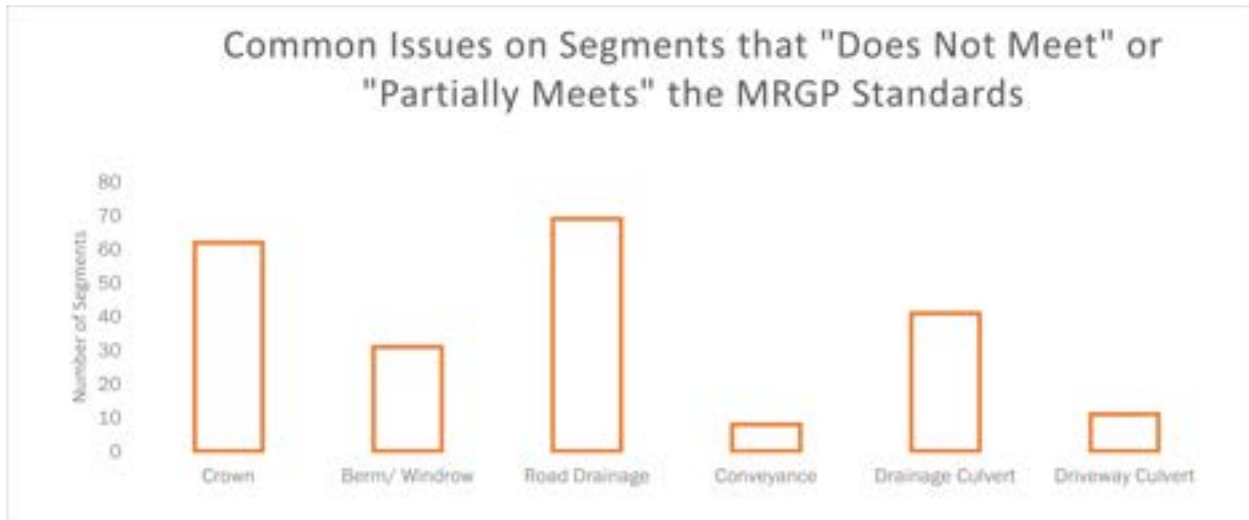
Figure 3. Common issues that cause segments to be scored as "Does Not Meet" or "Partially Meets" MRGP standards.

The Best Management Practice (BMP) that is most absent from the hydrologically connected roads is crowning. Crowning ensures that stormwater runoff on the roadways can flow in a distributed manner and sheet flow off the sides of the roads. Proper crowning can ensure that flow runs into roadside ditches. This is required whether or not there has been erosion present on the road. Many private roads in the Lake Carmi watershed and elsewhere lack crowns. A lack of crowns can cause substantial problems. Stormwater flow can become channelized, forming gullies or eroded channels like ruts, rather than sheet flowing off the side of the roads. Channelized flow can travel long distances picking up speed on steeper slopes, becoming more erosive, and damaging to the road surface. It is important to maintain the crown of a gravel road, even on private roads. It is one of the baseline standards for gravel and paved roads with ditches under the Municipal Roads General Permit. Regrading and crowning may need to occur on a gravel road multiple times a year to ensure the proper drainage. This regular maintenance is necessary. However, crowning is not an eligible project type within the Clean Water Initiative Program (CWIP). Grants authorized by CWIP, such as Water Quality Restoration Formula Grants, cannot be used to cover the cost of routine maintenance of this practice type, per the CWIP Funding Policy. A “disconnect” exists between what is required by the MRGP standards on gravel roads and the ability to have funding assistance to implement these practices and maintain them. The most recent question and answer document released on the CWIP State Fiscal Year 2023 Funding Policy notes, “road projects should work to meet the MRGP standard, and this requirement sets a high bar which presumably narrows eligible projects to larger private road/driveway networks.” This is a barrier to successful implementation of private roads projects

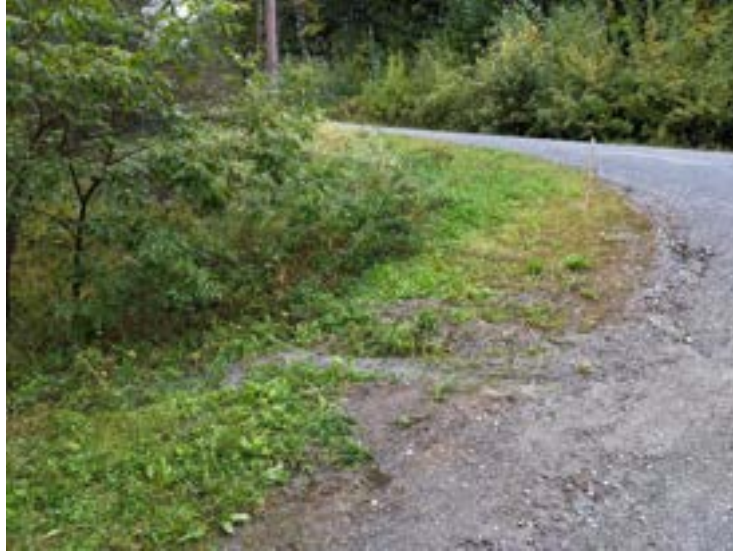
Figure 4. Black Woods Road before work was completed.

Projects were designed for sites at the intersection of Sandy Bay & Black Woods Roads, on Mullen Shore Road, and along Patton Shore Road. Design level of detail was consistent with the level of detail provided for projects funded through the Better Roads and/or Municipal Roads Grant-In-Aid programs. BMPs were implemented at the intersection of Sandy Bay & Black Woods Roads and along Patton Shore Road (including intersections of Scottish Lane and Ledge Road).

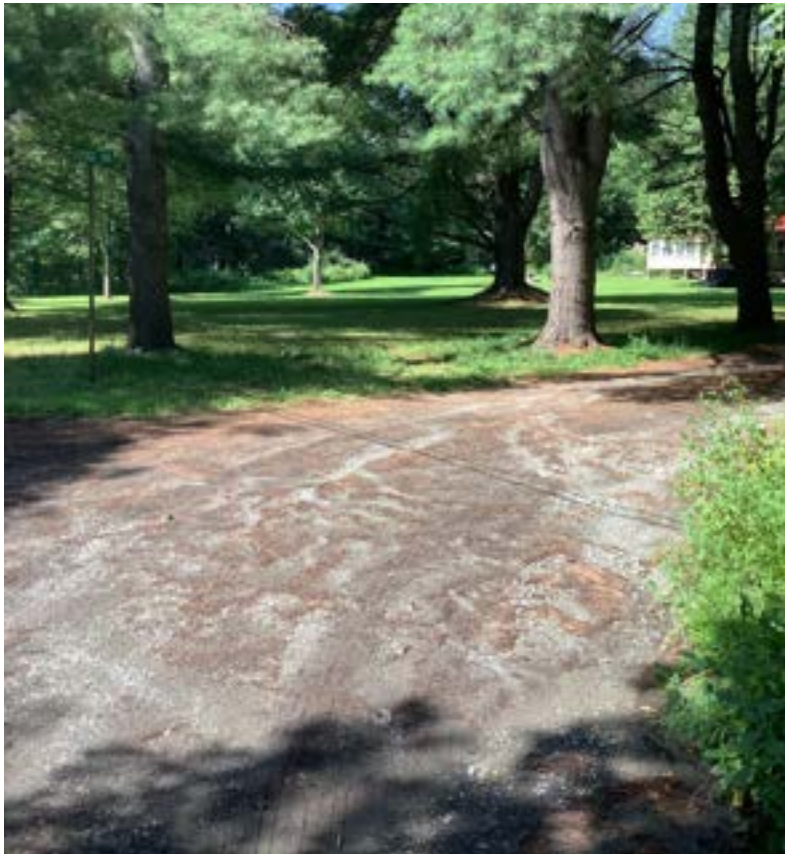
Figure 5. Existing conditions of the intersection of Patton Shore and Ledge Drive.

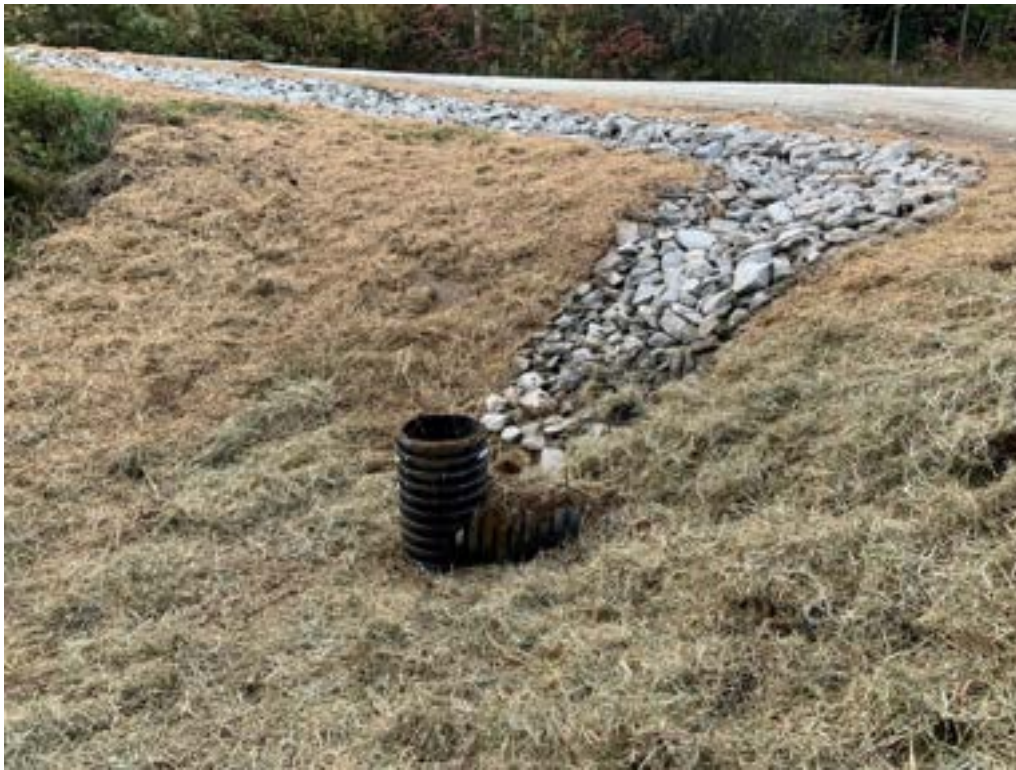
Figure 6. Black Woods Road recently after construction was completed.

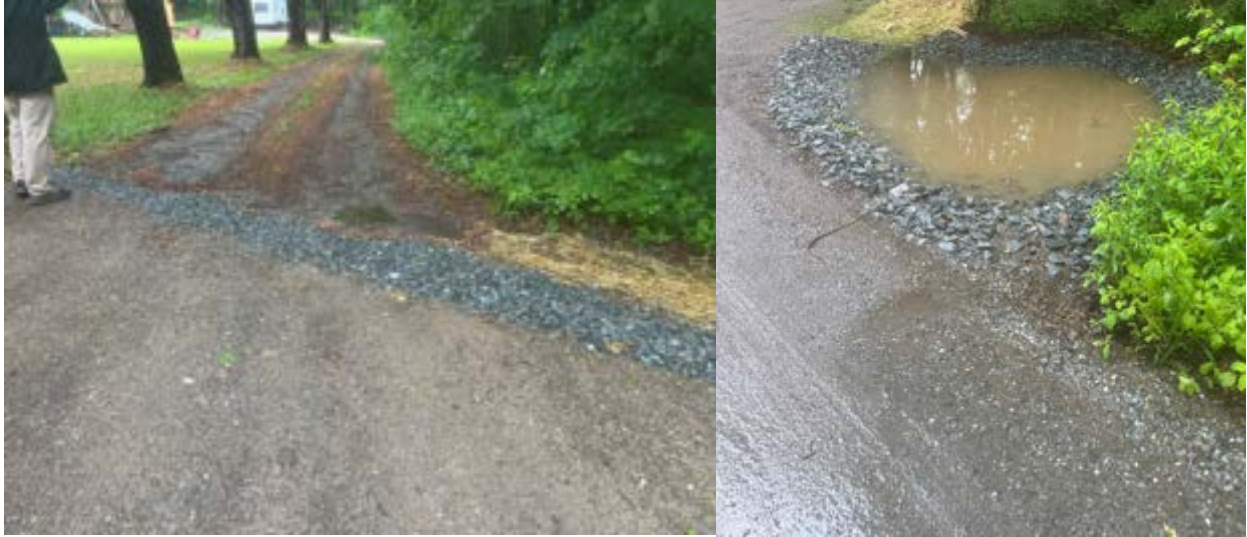
Figure 7. Post construction conditions of the Patton Shore Ledge Drive intersection. To note these photos are after a recent rain storm. Sedimentation basin does not have consistent pooling water.
