STI-P3
voltage
below
criteria

The easy scenarios Scenario 1A

Corner Gas Station with three P3 tanks

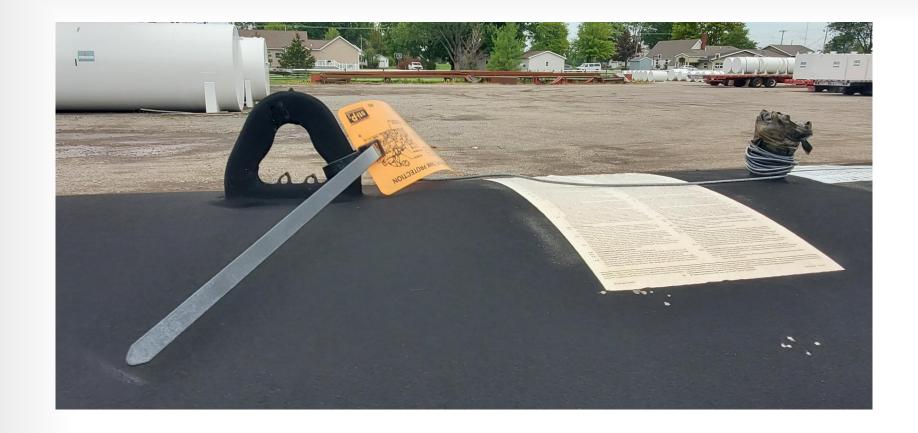
RECOMMENDED PRACTICE FOR THE ADDITION OF SUPPLEMENTAL ANODES TO STI-P3® USTs R972

RECORD KEEPING FORM WHEN ADDING ANODES TO STI-P3® TANKS FOLLOWING STEEL TANK INSTITUTE'S RECOMMENDED PRACTICE R972 Date Anodes Added: INSTALLER INFORMATION BEFORE ANODE INSTALLATION: Tank (top view) Indicate Location and Value of All Potential Readings Tank is isolated from other metallic structures: Current Requirement Measurement (mA): Soil Resistivity: Number of Anodes Installed Weight of Each Anode: AFTER ANODE INSTALLATION: Tank (top view) Indicate Location and Value of All Potential Readings Indicate Placement, Depth and Orientation of Anodes on the Tank: Tank (top view)
