# Aging Tanks: They're Not Getting and Younger!

Strategies for Inspecting, Managing,  
Upgrading, and Replacing UST's

## *28<sup>th</sup> National Tanks Conference*

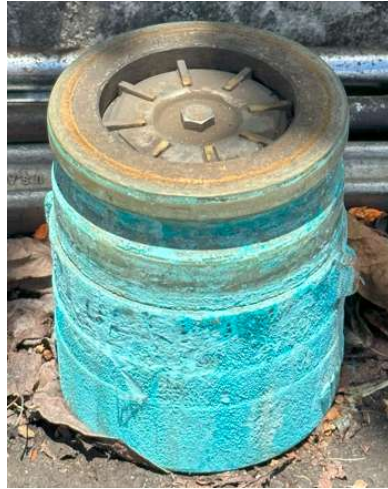
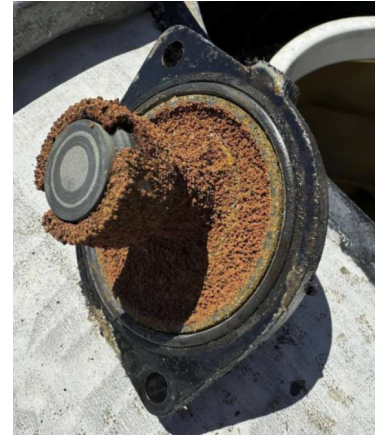
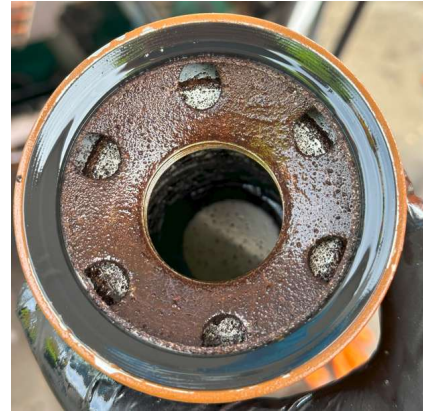
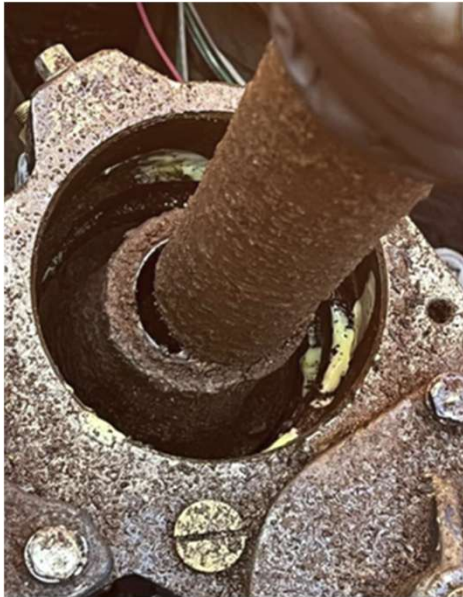
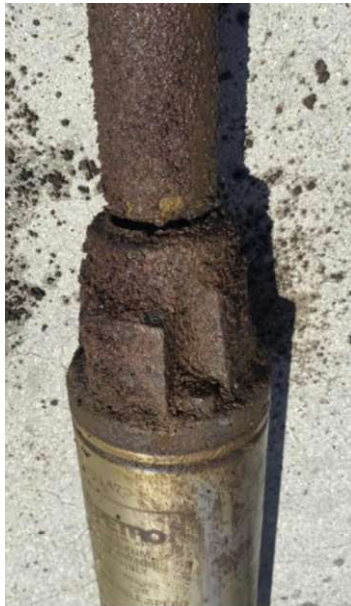
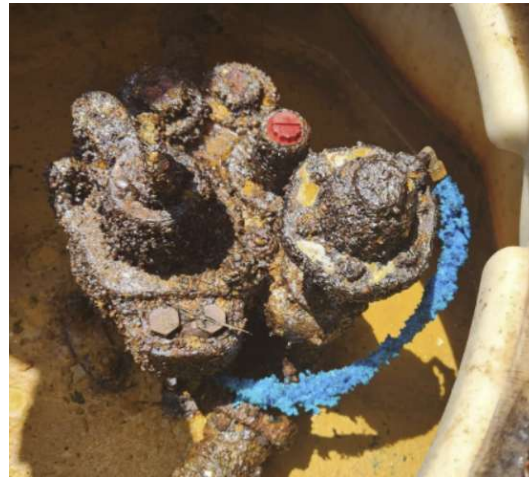
## Corrosion in ULSD (tank) or Ethanol (sumps)

- Impacts multiple components

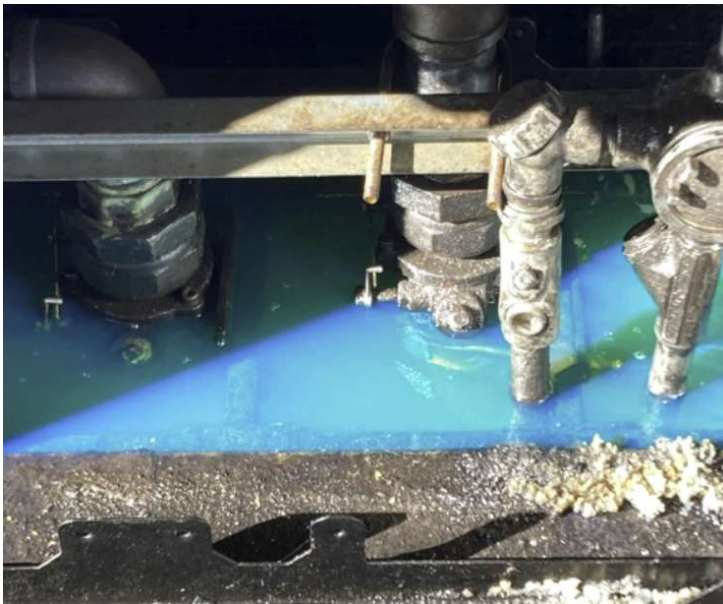
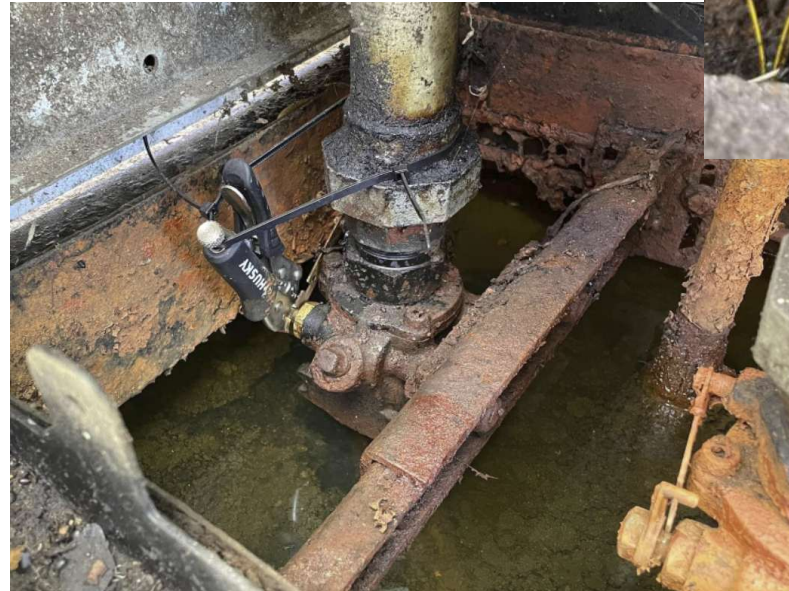
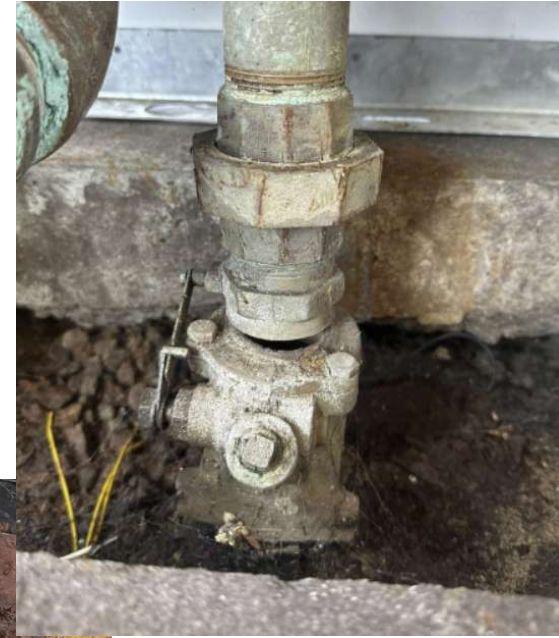
## Single Wall Systems

- No UDC's
- Any leaks go directly into the ground
- Site will likely have existing contamination

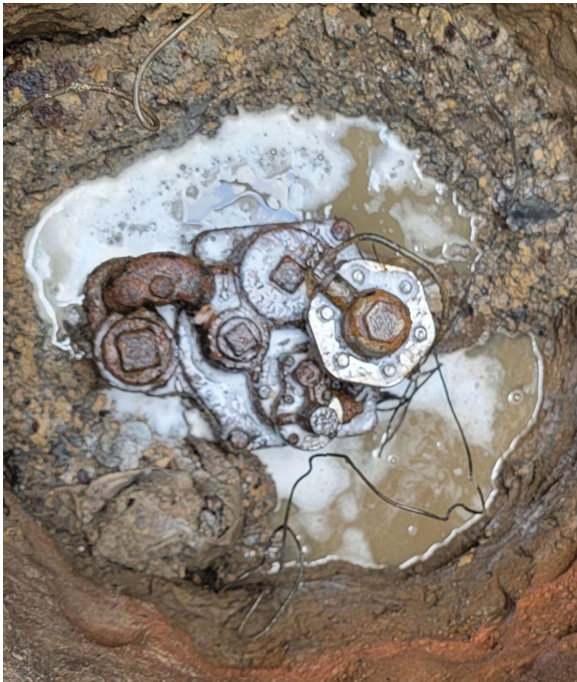
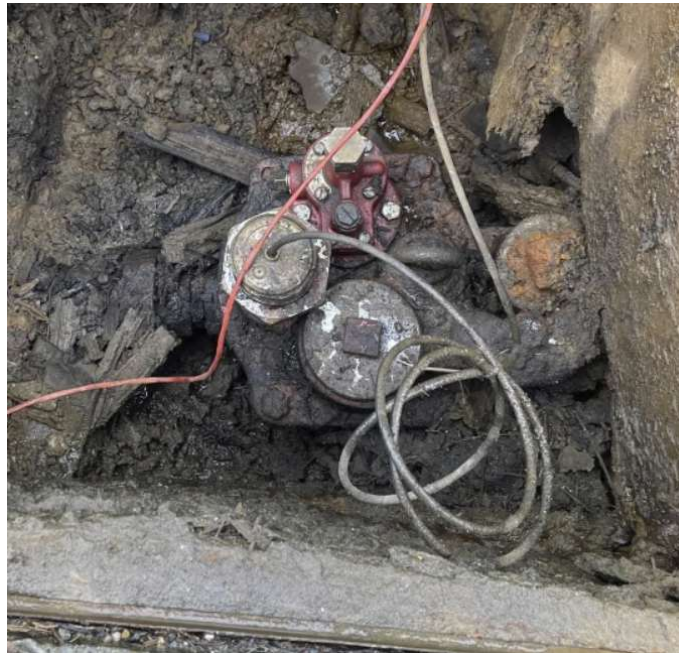
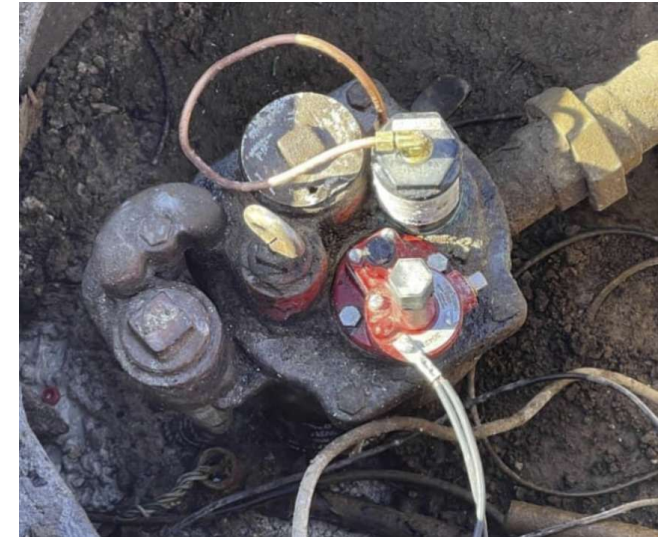
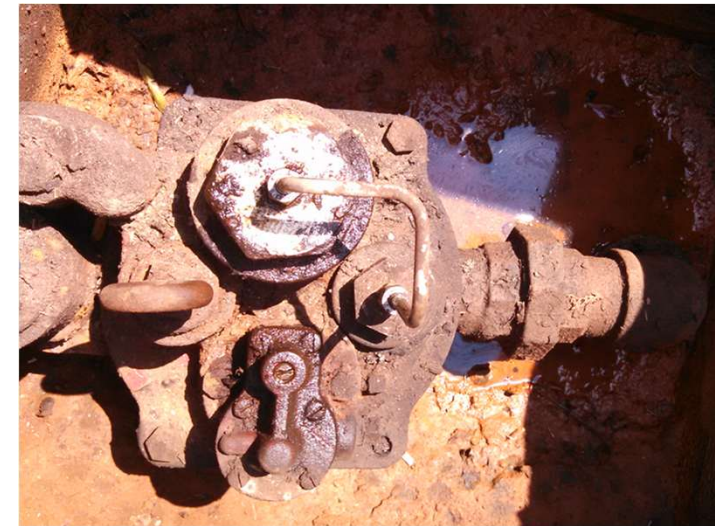
## Single Wall Systems

- No STP Sumps
- Leaks go directly into the ground
- Site will likely have existing contamination

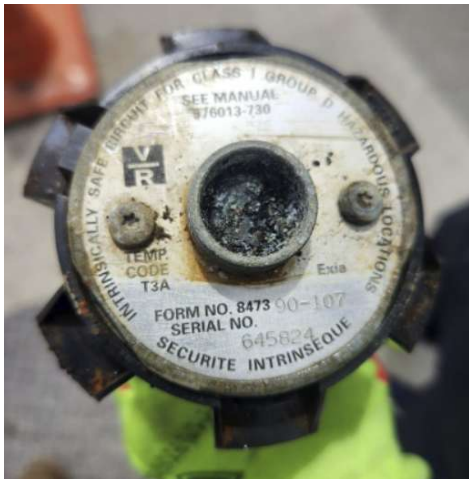
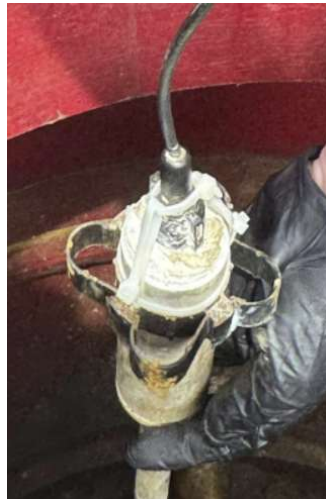
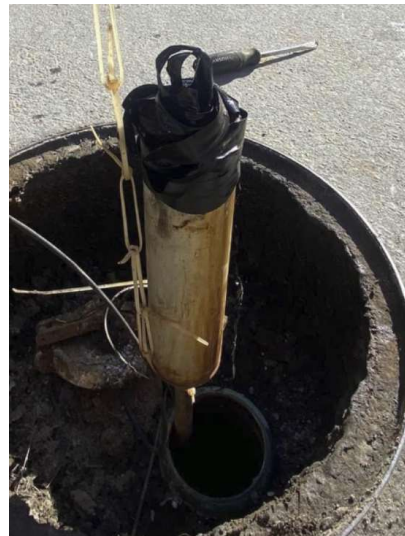
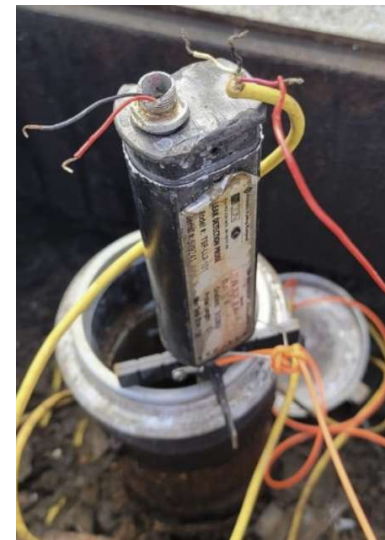
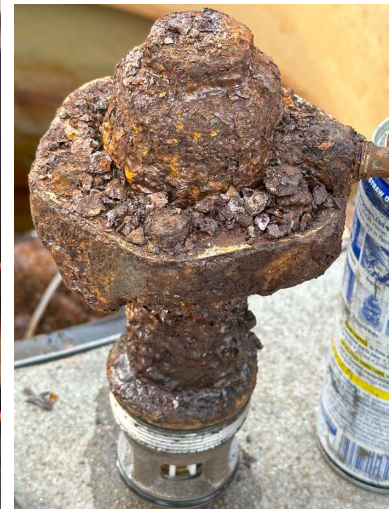
## ATG and Leak Detection

- Faulty sensors may not detect leak
- Many problems caused by corrosion

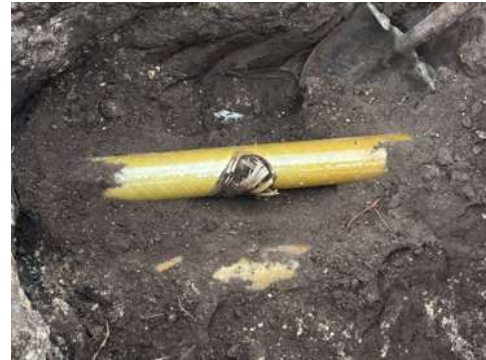
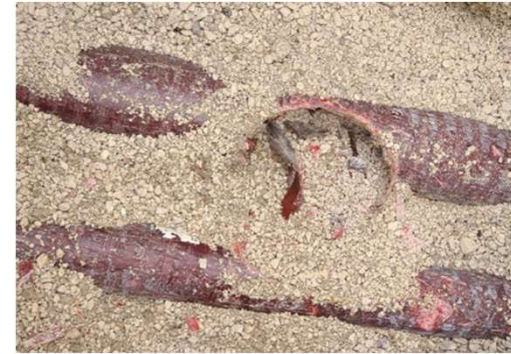
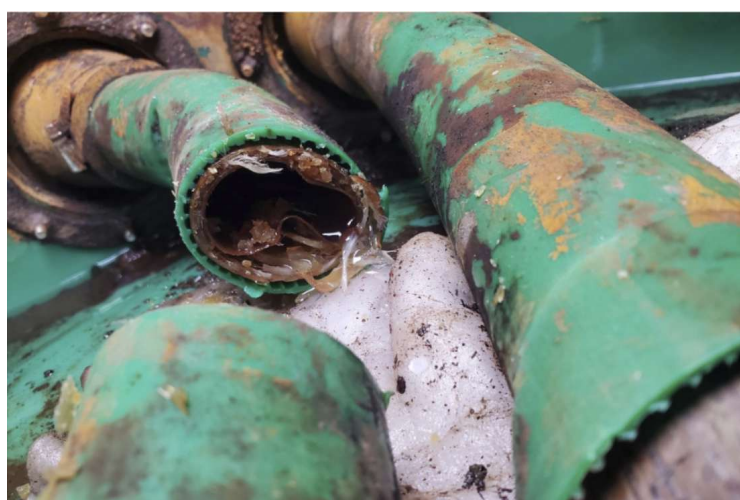
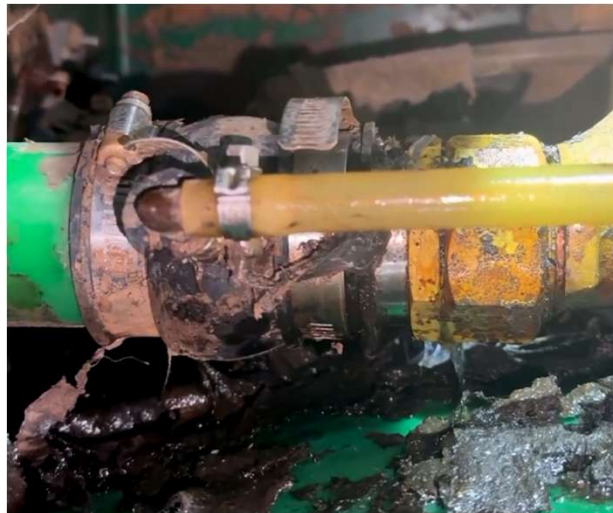
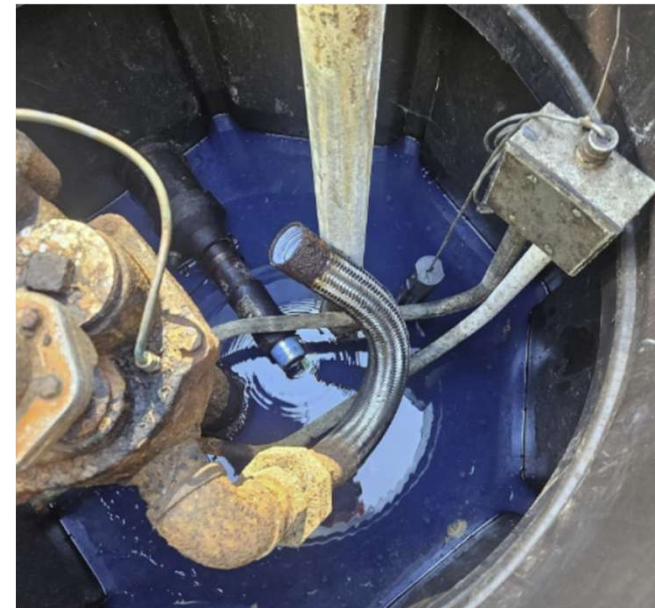
## Piping Concerns

- Single wall higher risk
  - No containment if leak occurs
- Some leaks from damage
- Early generation flex piping
  - Higher risk of failure

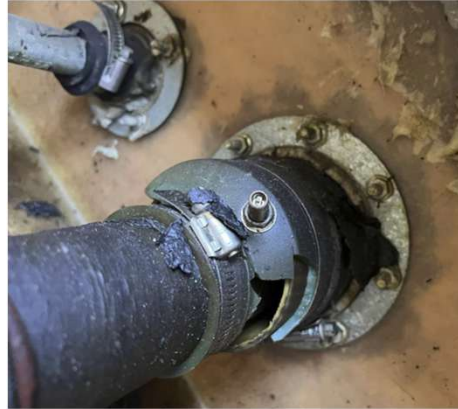
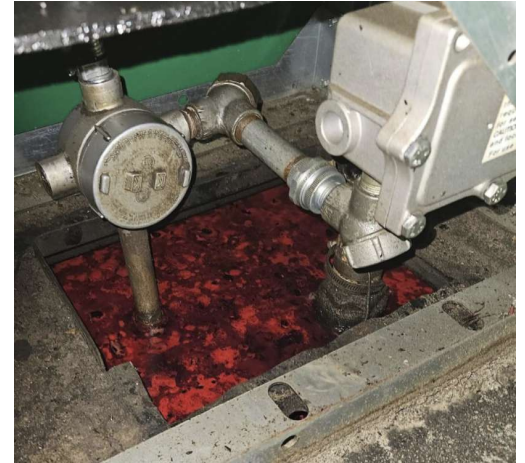
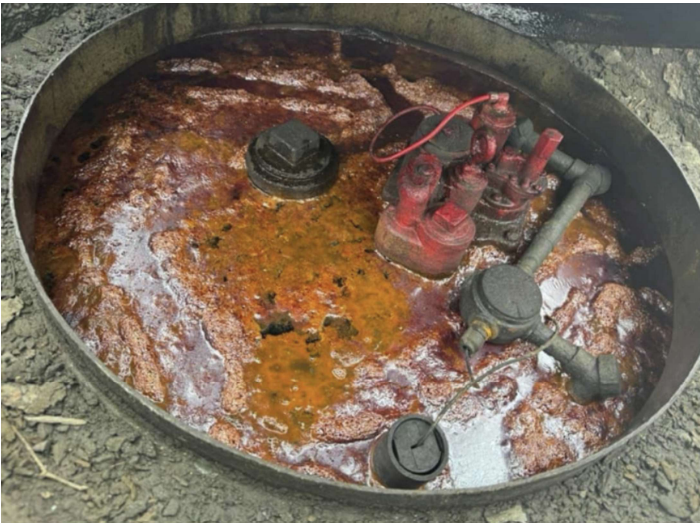
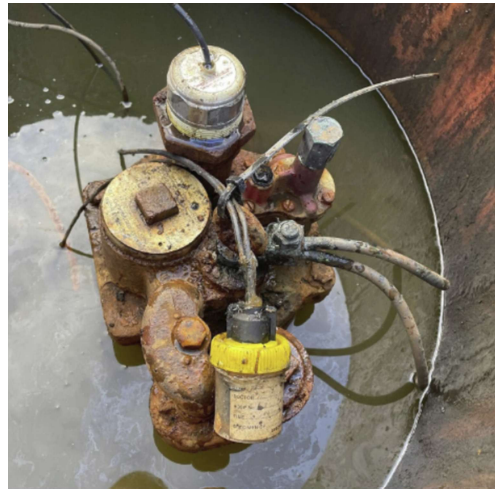
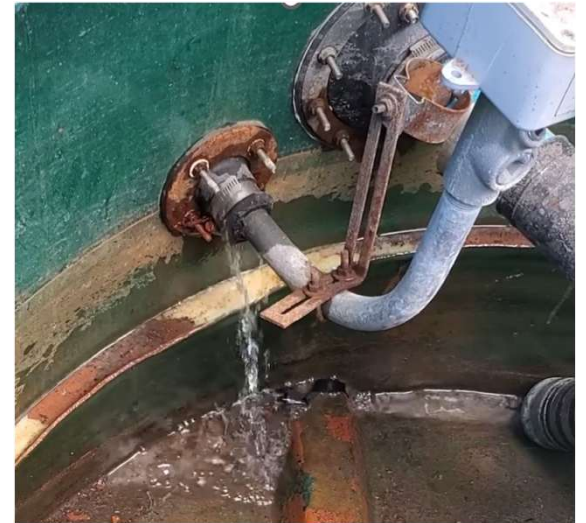
## STP Sumps & UDC's

- Water Intrusion
- Lack of Containment
- Boot Failure
- Cracks/Splits

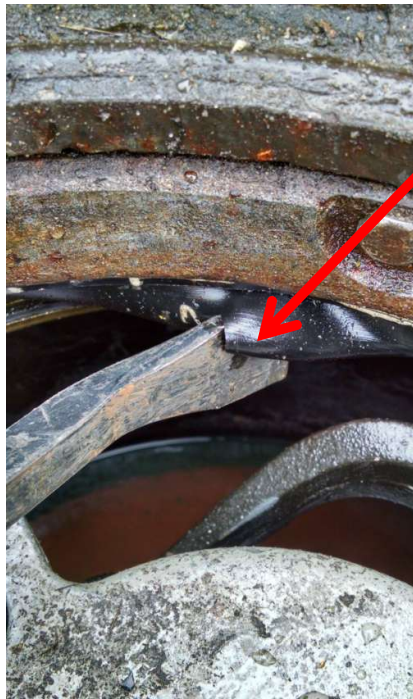
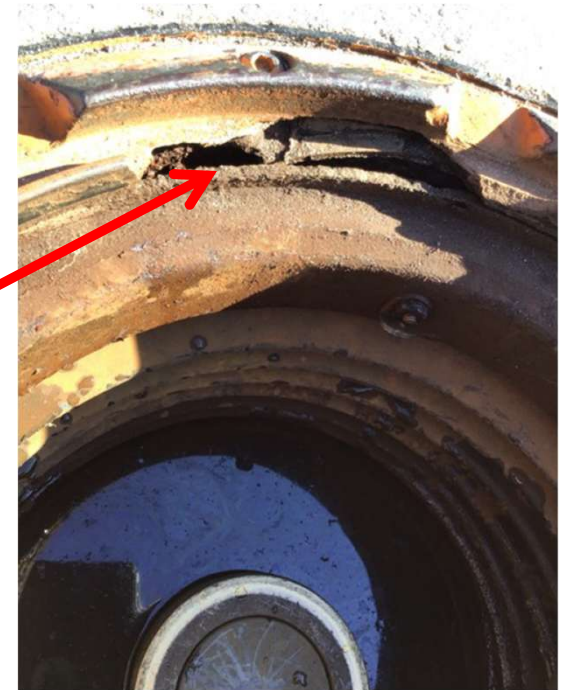
## Spill Containers – Cracks & Tears

- Faulty equipment may allow leak into ground or water into tank.
- Pre-1988 UST systems had some time without spill buckets

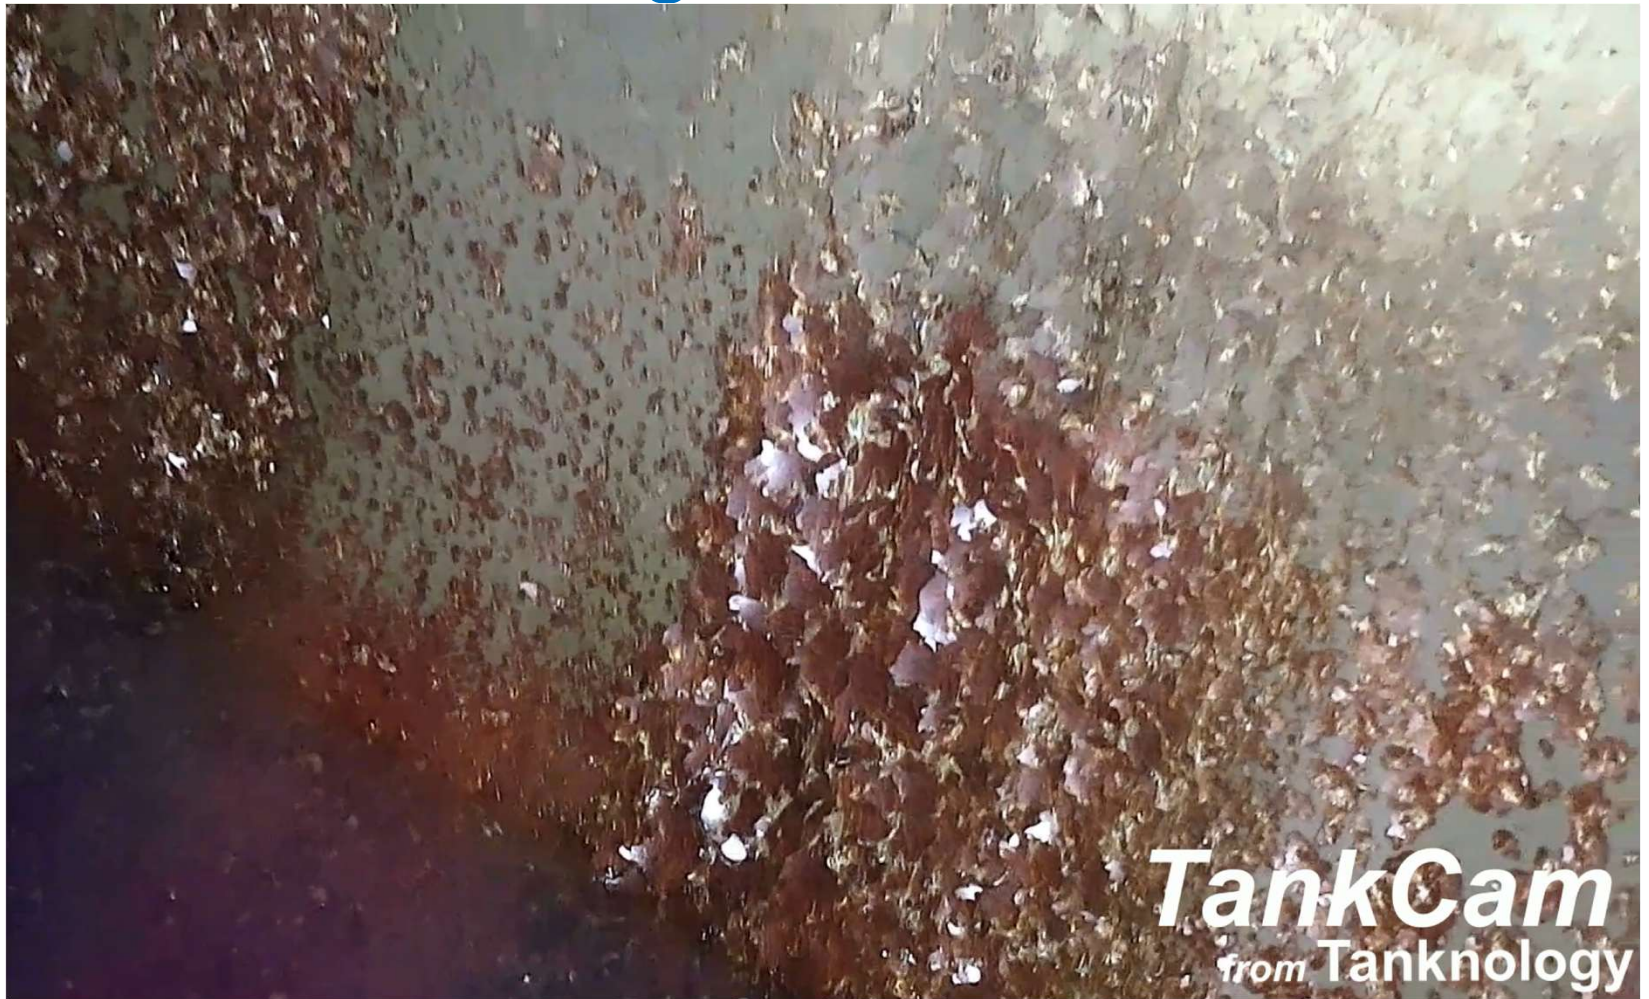
## SWF – Blisters & Ingress

PUL

Age  
33

OH

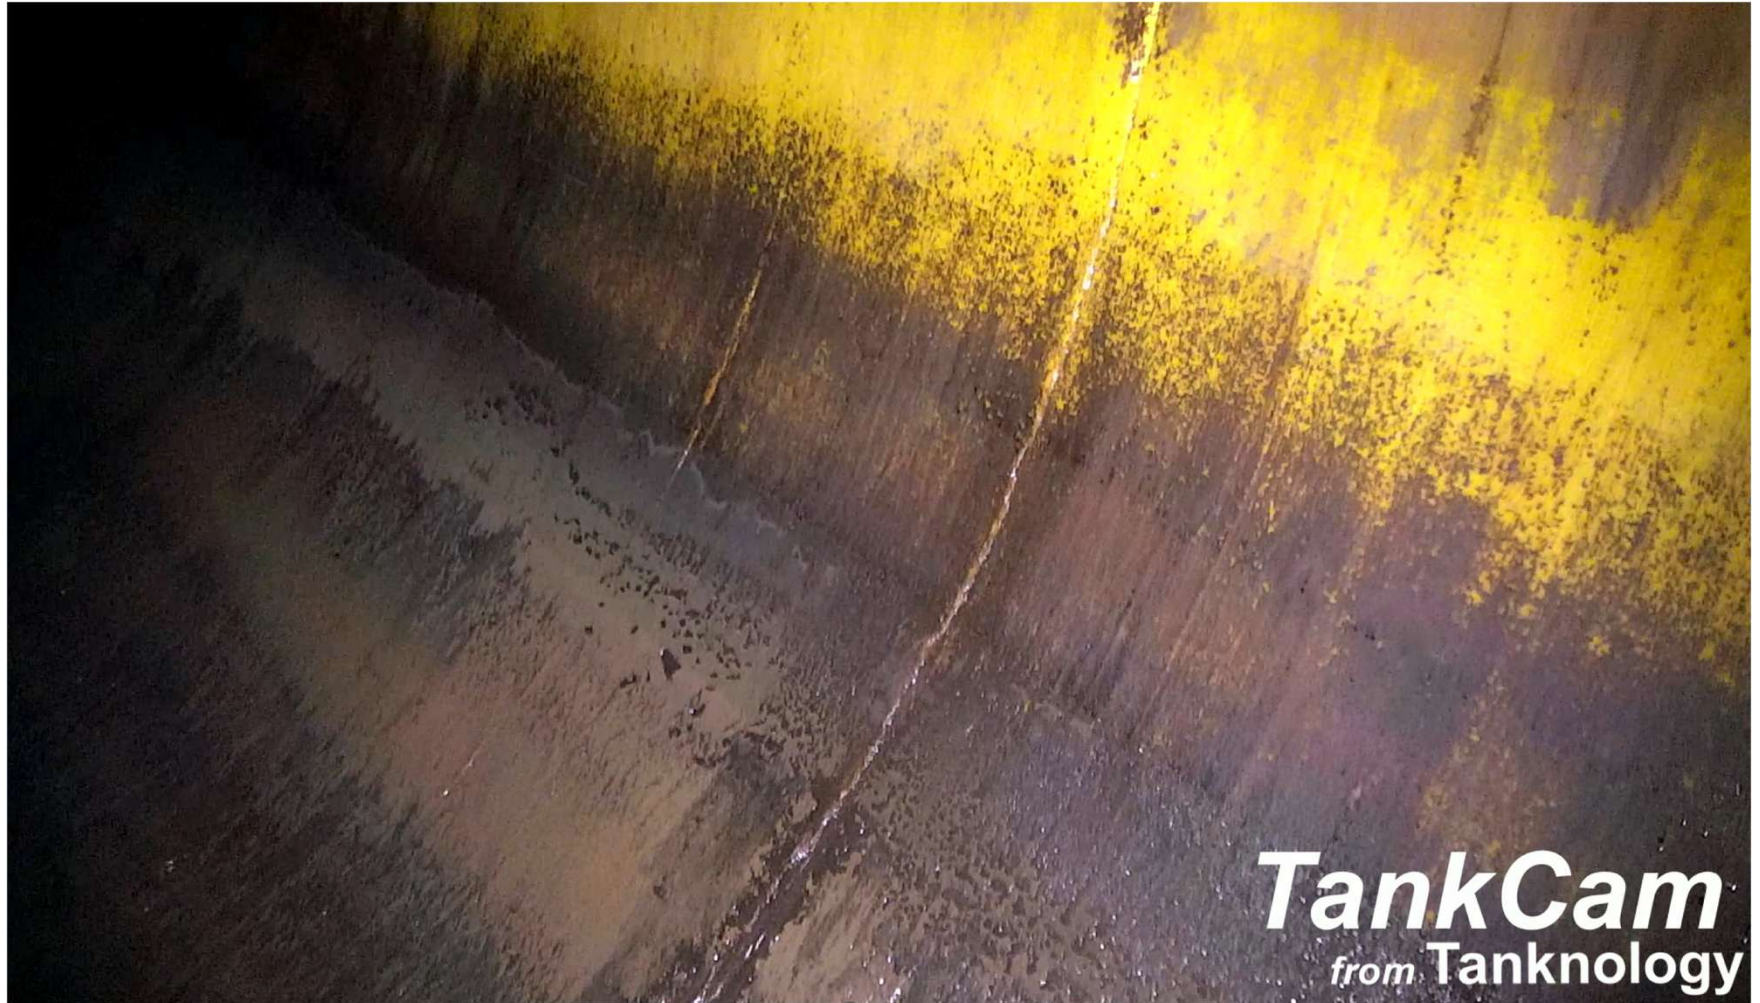
## SWF – Multiple Cracks & Ingresses

PUL

Age  
37

TN

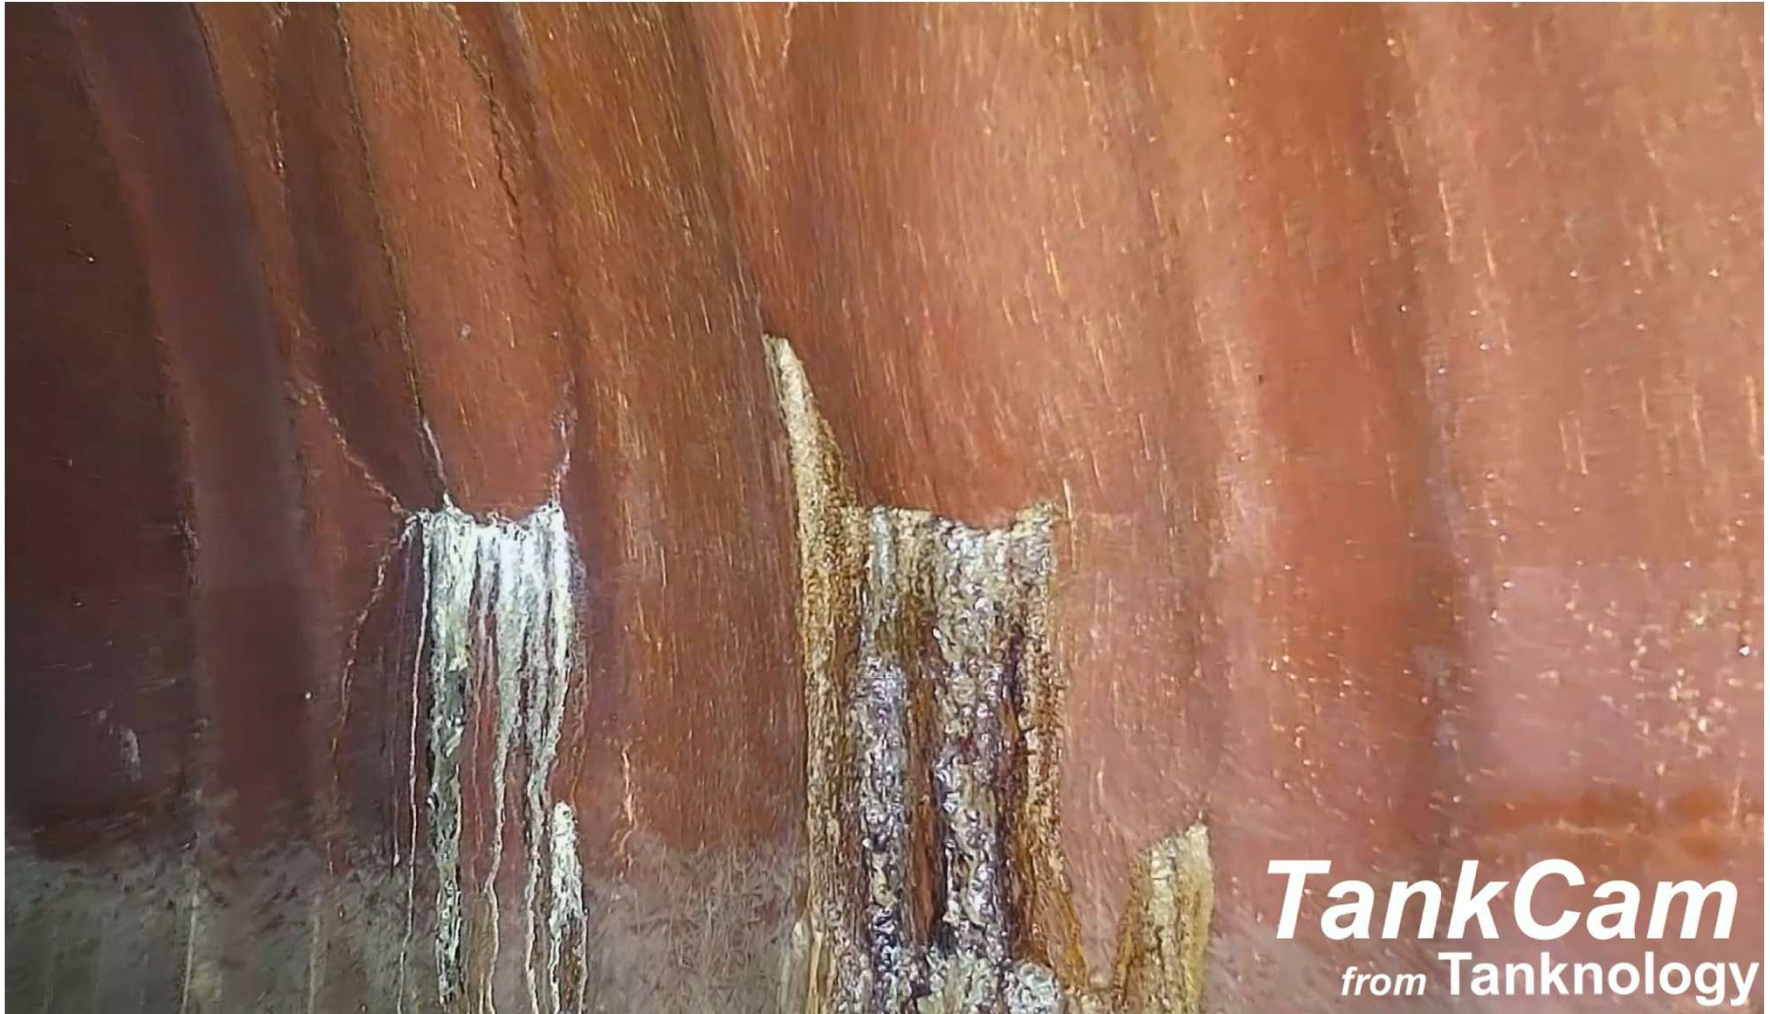
## SWF – Deflection, Cracks, & Ingresses

PUL

Age  
42

LA

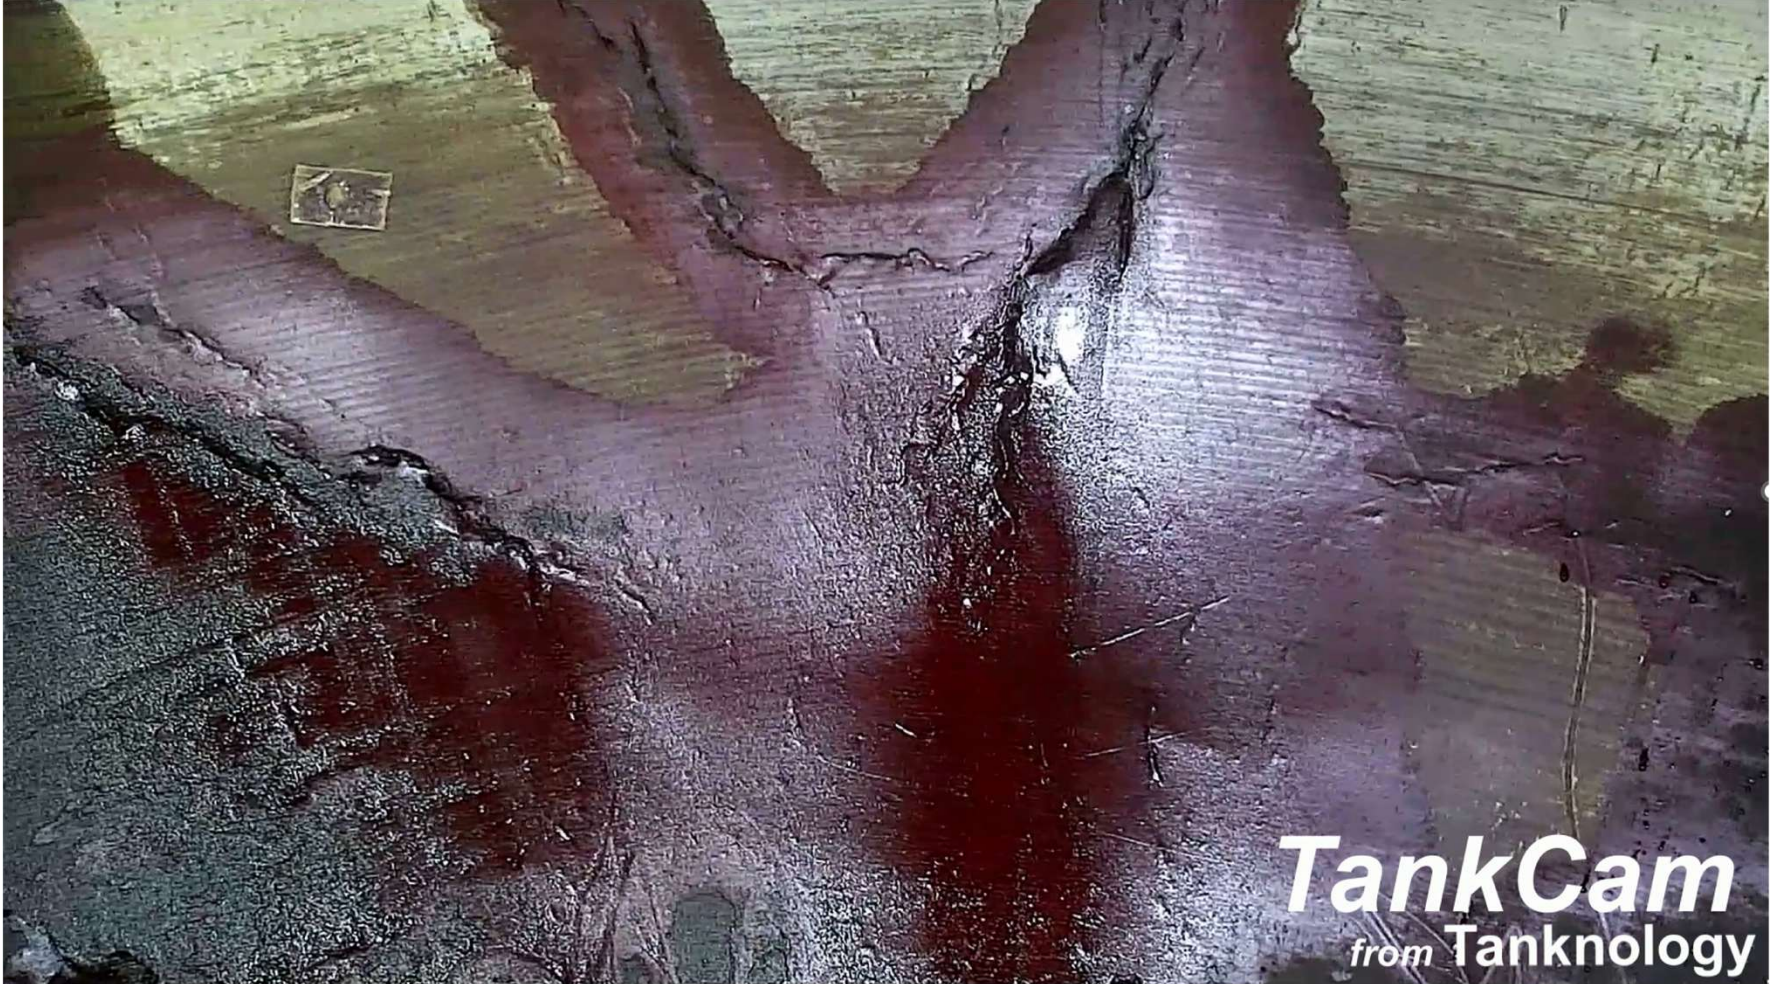
## SWF Crack & Ingress

PUL

Age  
44

VA

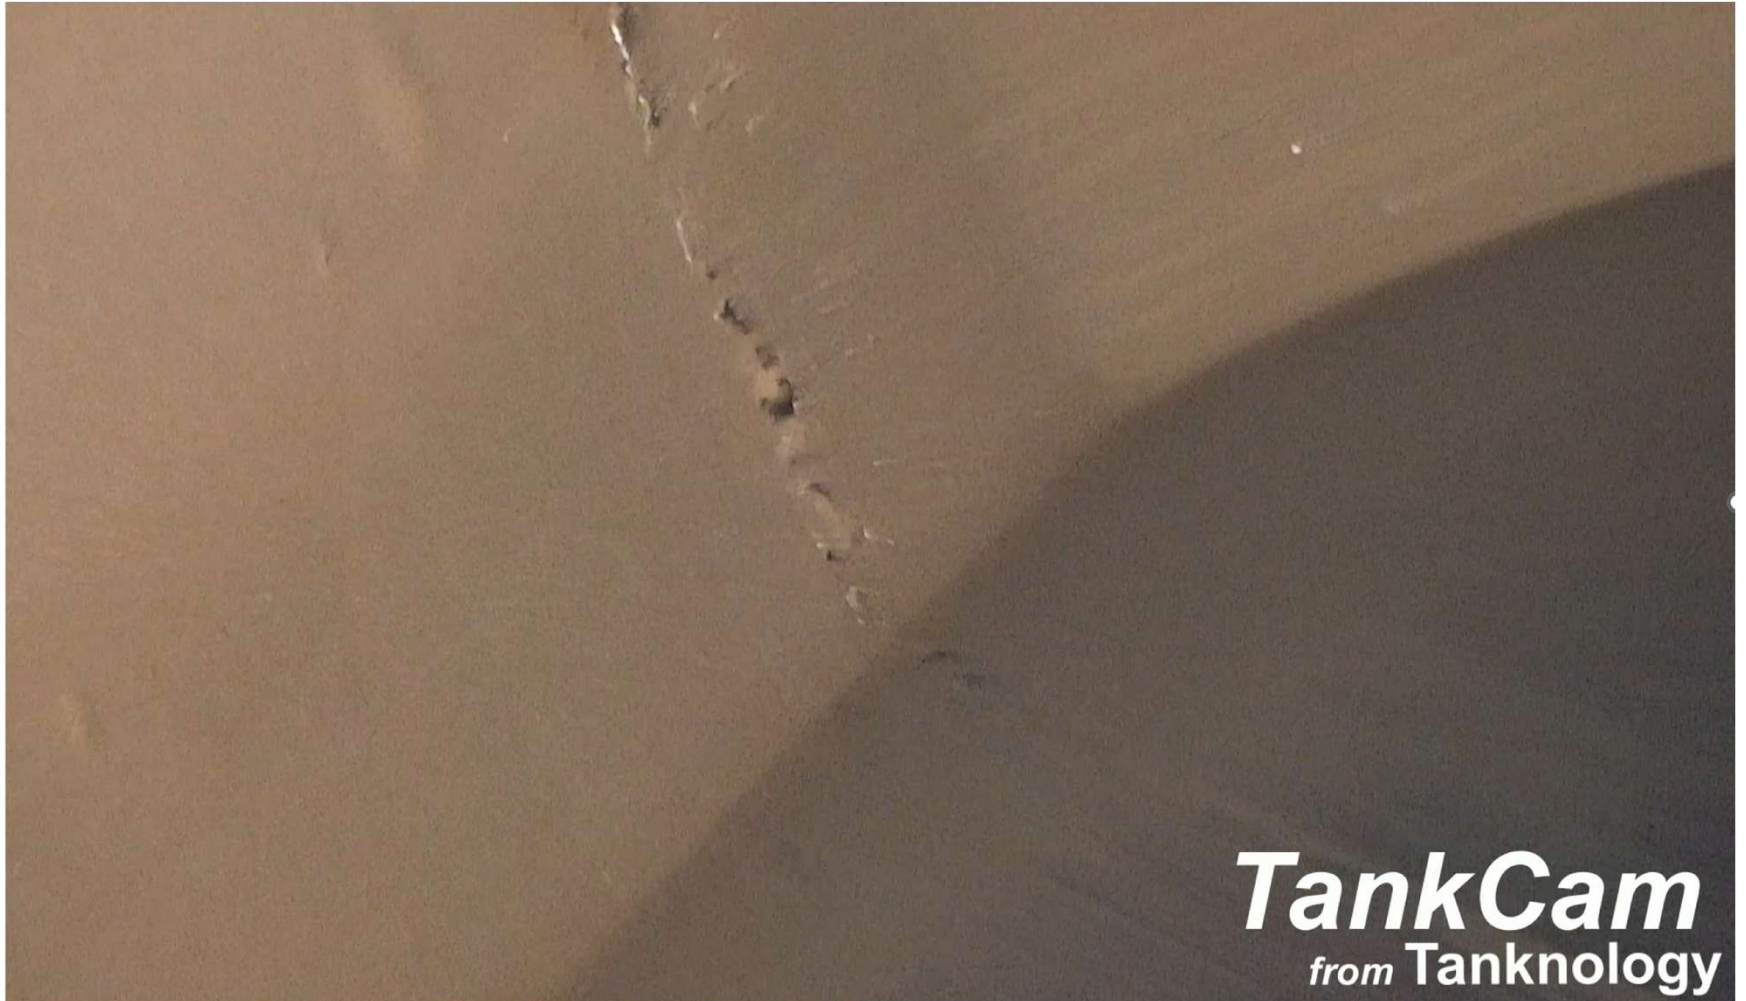
## Crack in SWF (Looking for spare bung)

RUL

Age  
46

IL

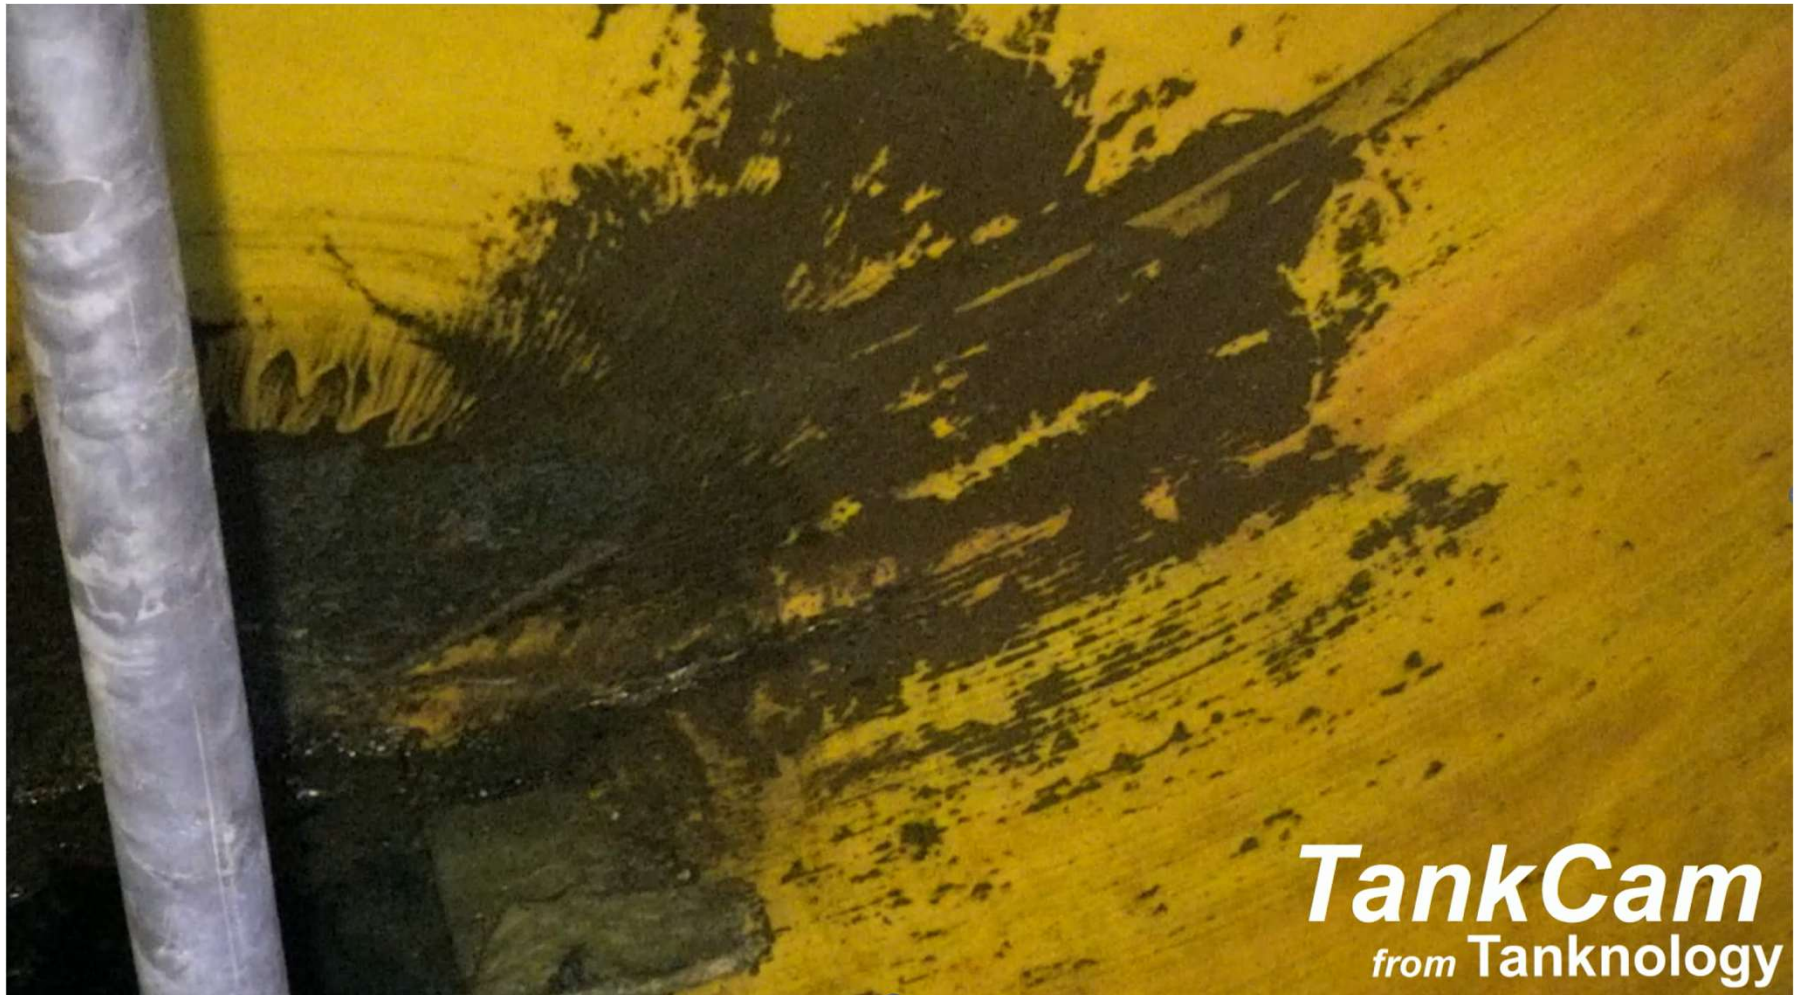
## Brine Ingress - DWF

PUL

Age  
24

TX

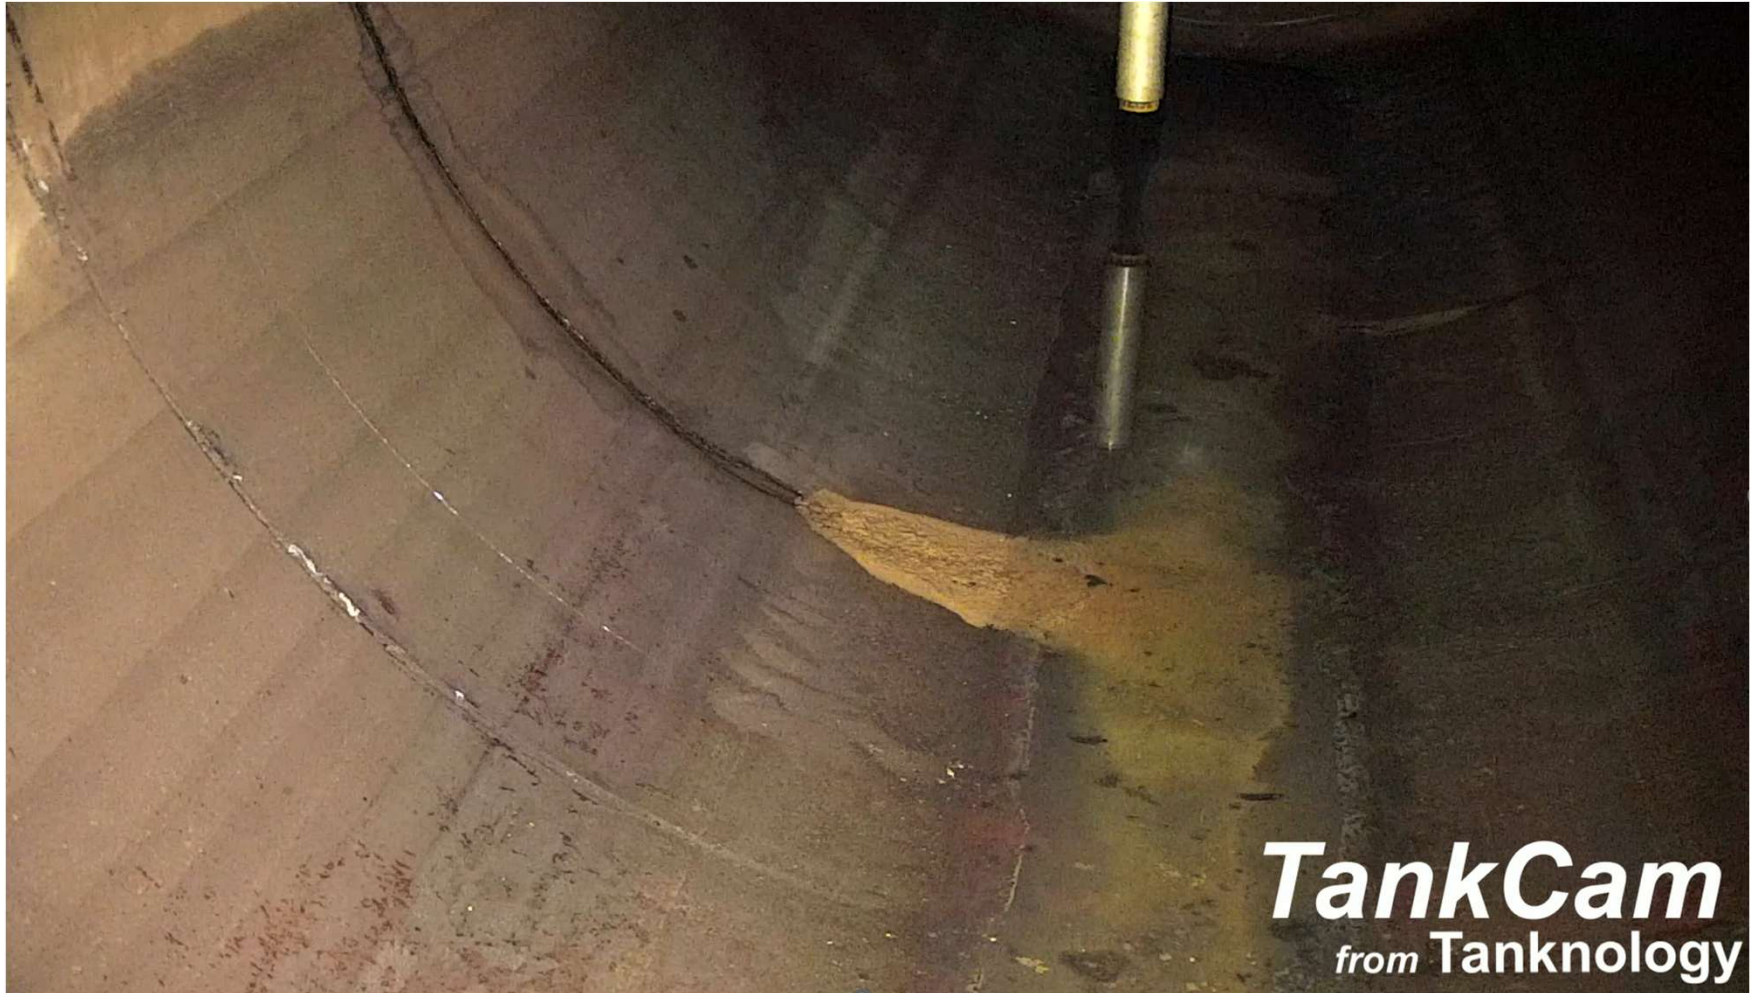
## DWF – Loss Brine & Ingress

PUL

Age  
35

FL

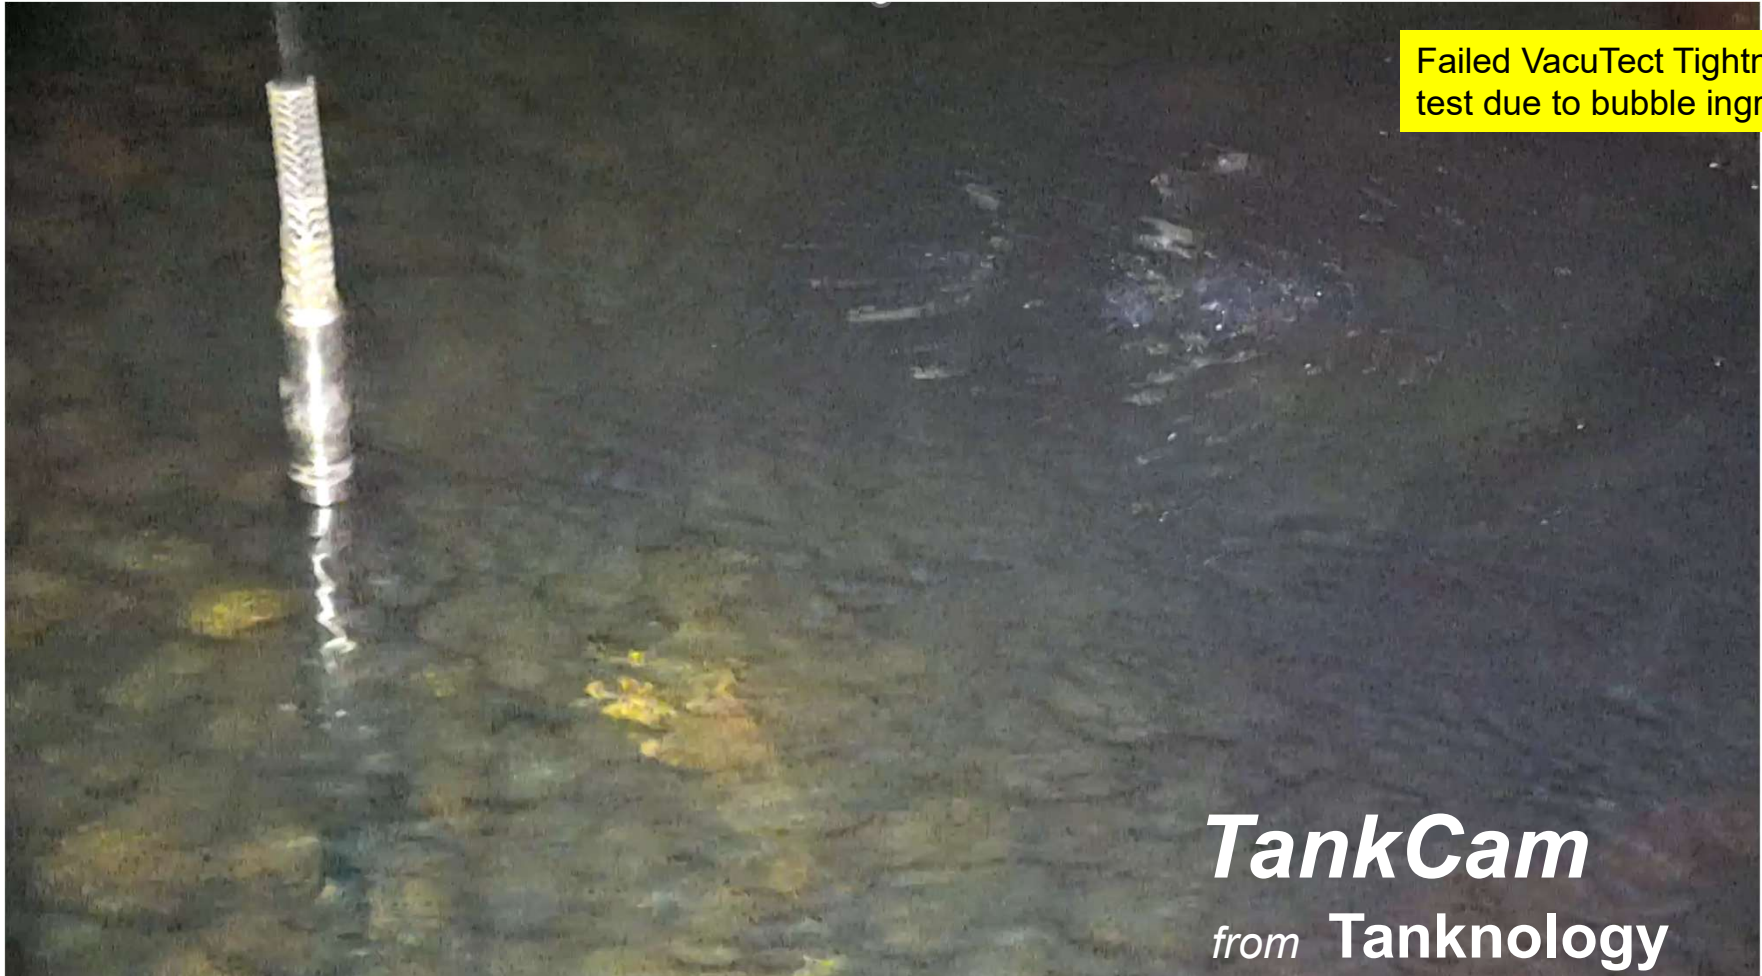
## Crack/Leak in FRP Tank – Tank Test & Video

PUL

Age  
27

IL

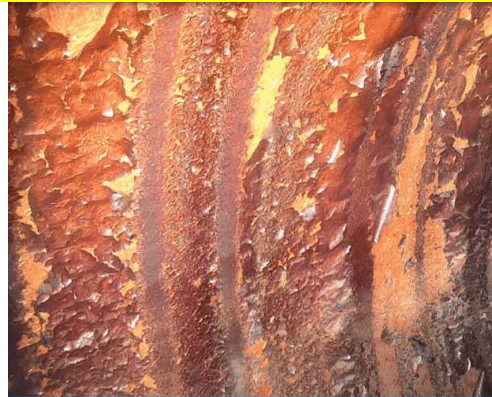
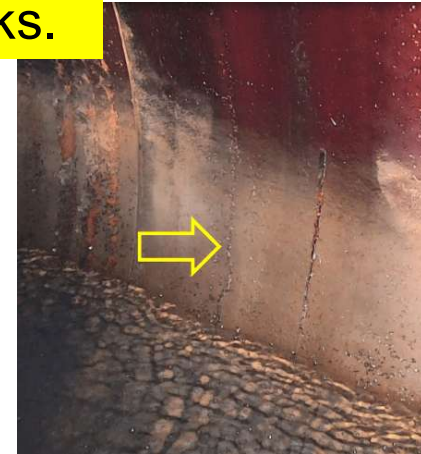
# Aging FRP Tanks: Gas vs DSL; Same Site

Gasoline tank has flaking, blisters, and cracks.

Diesel tank has none, just minor residue.
