# Aging Tanks: They're Not Getting and Younger!

Strategies for Inspecting, Managing,  
Upgrading, and Replacing UST's

## *28<sup>th</sup> National Tanks Conference*

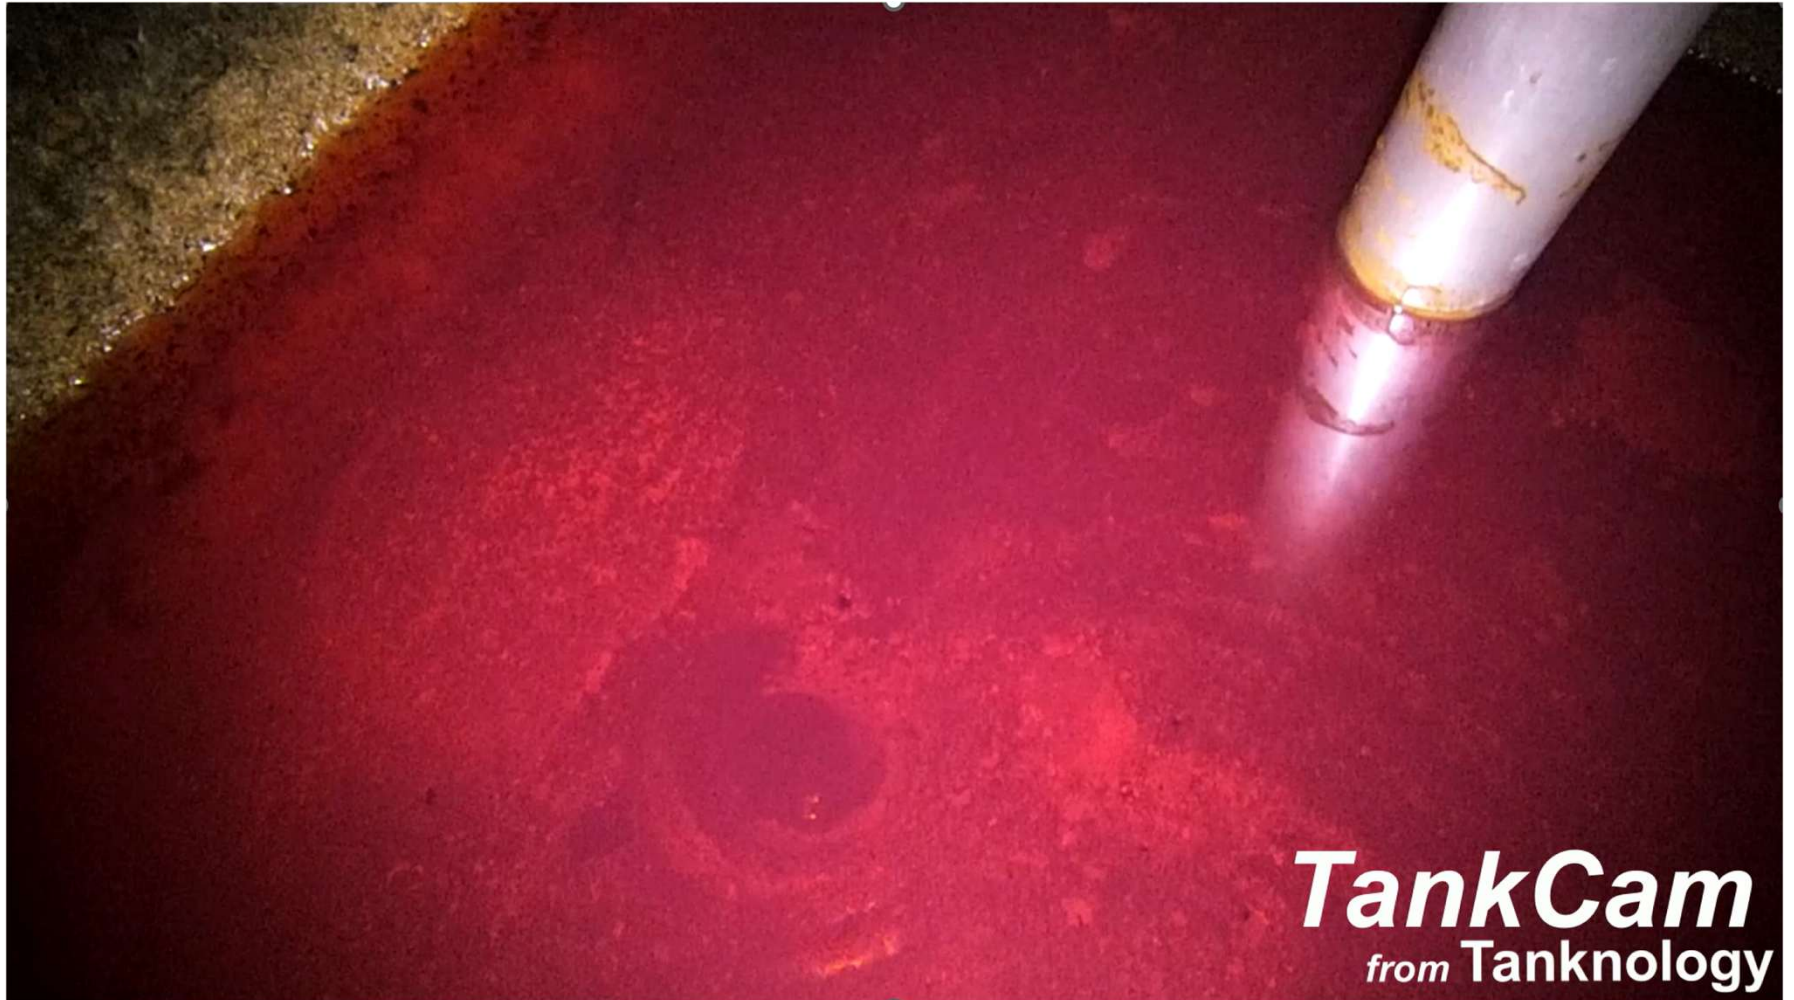
## Ingress in Steel Tank

Off  
Road  
DSL

Age  
47

AL

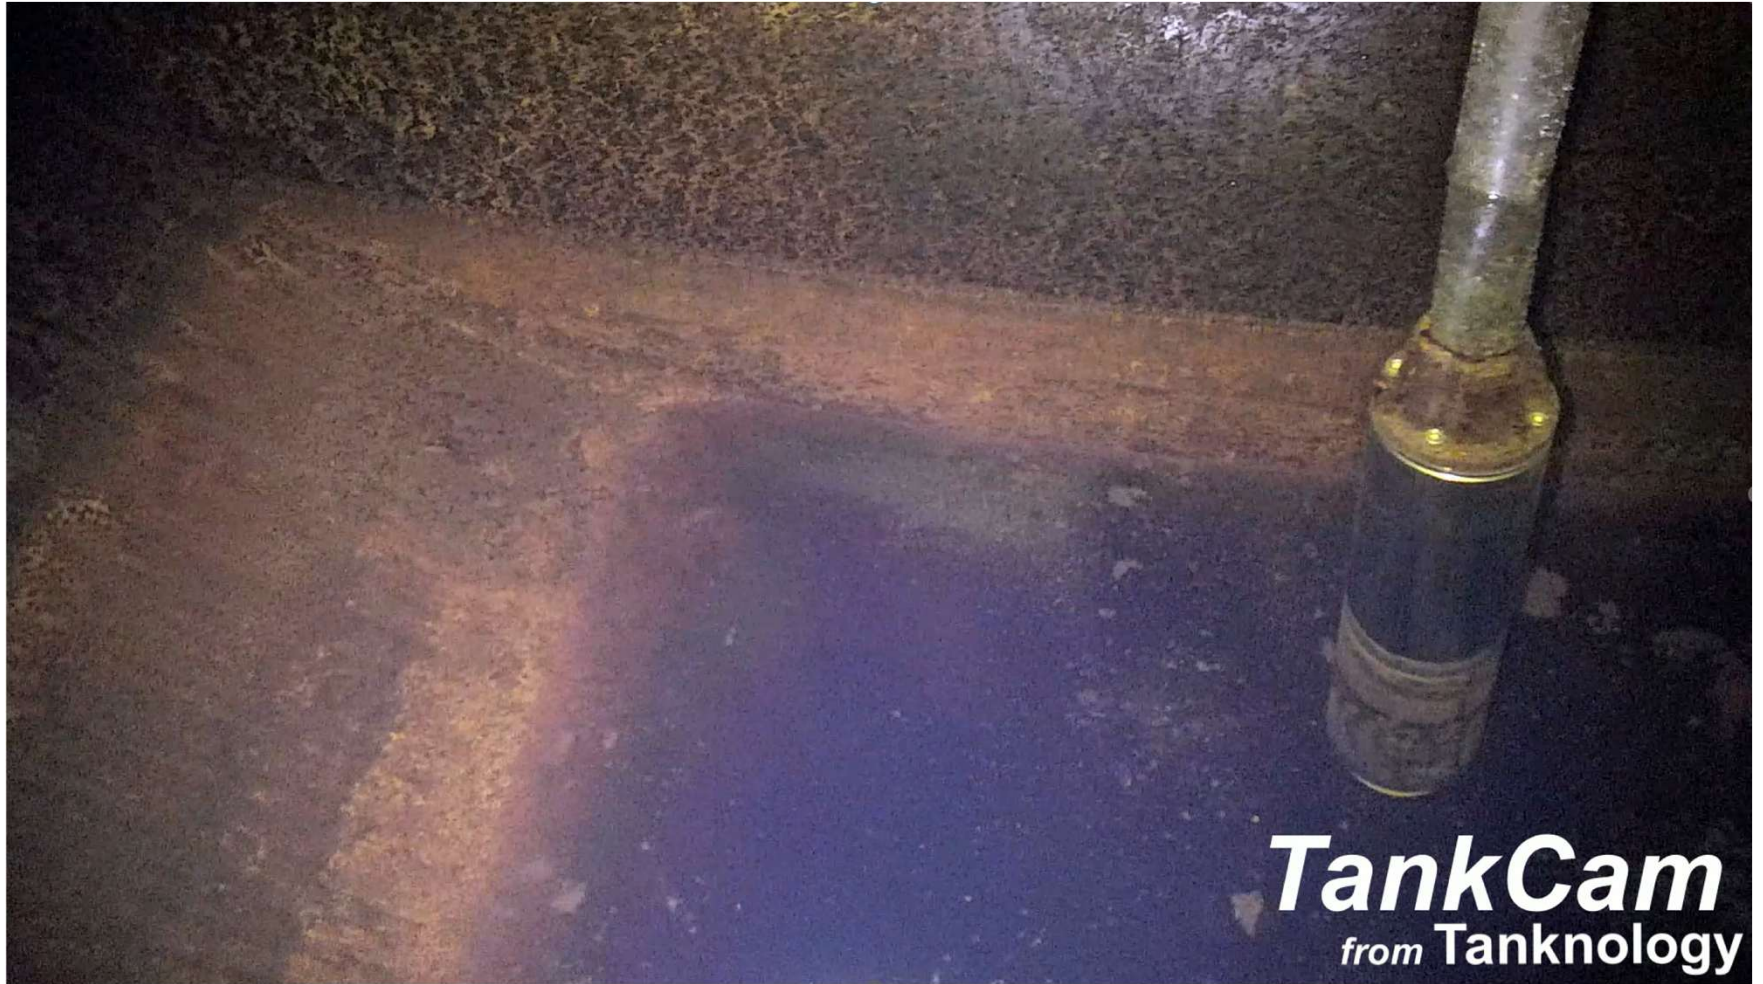
## Ingress in Steel Tank

RUL

Age  
45

MS

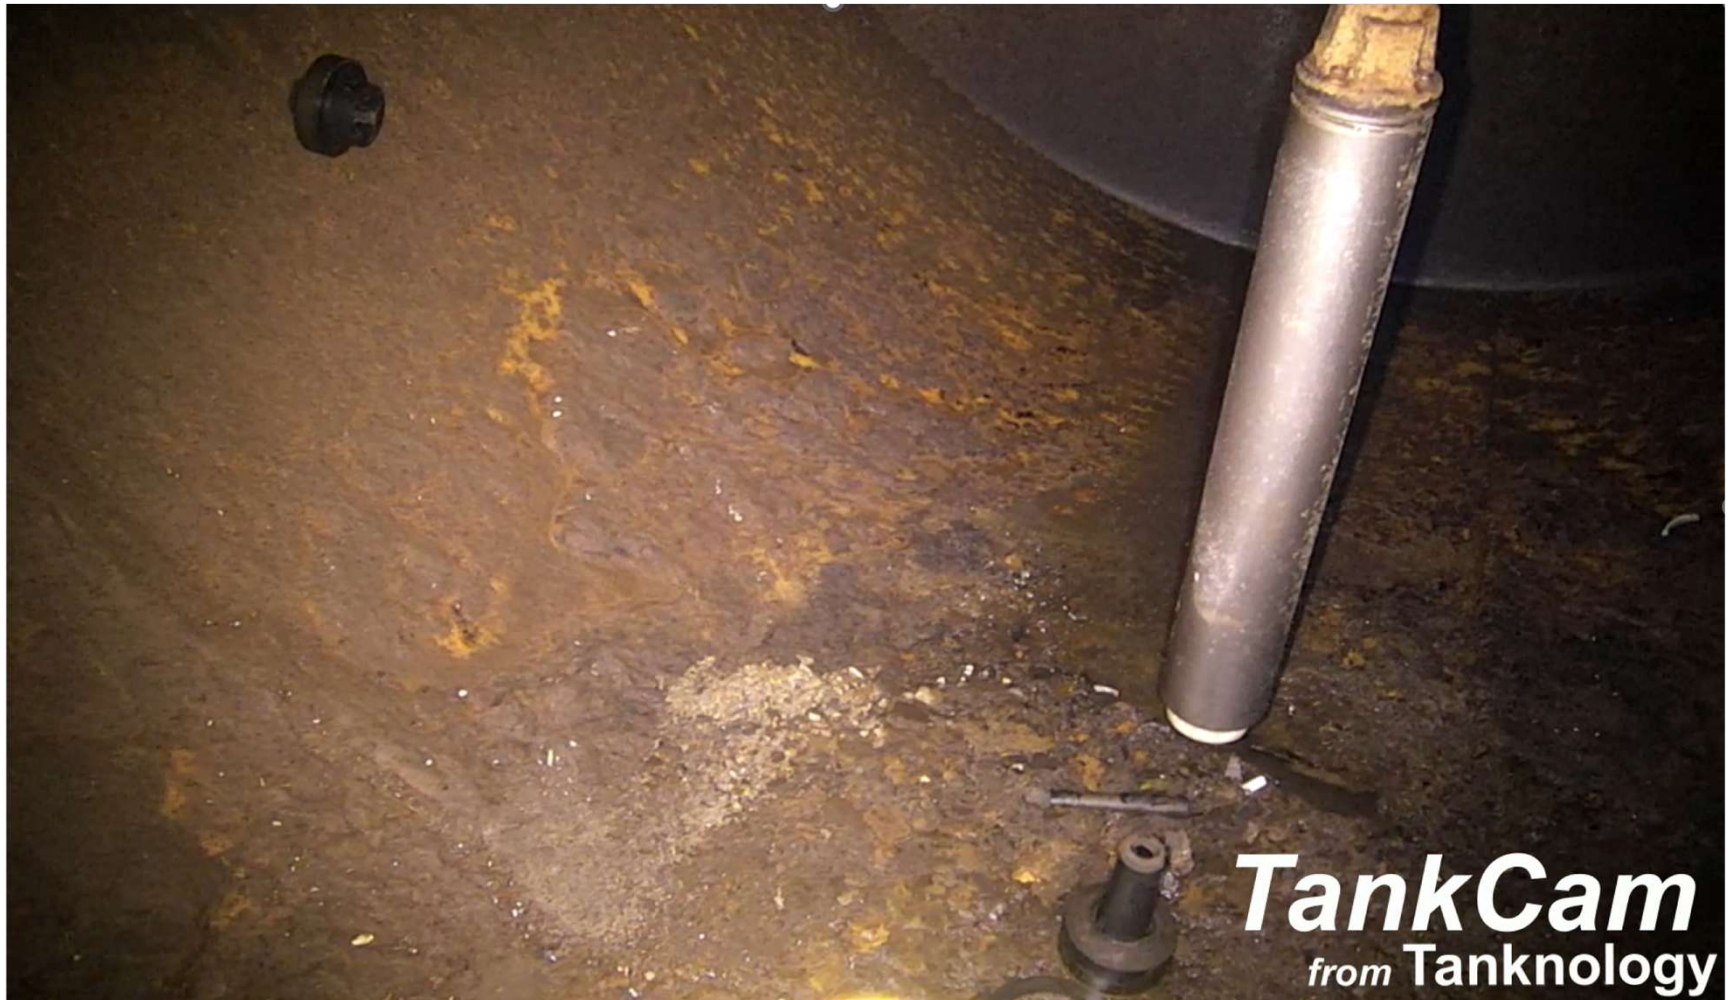
## Ingress in Steel Tank – visible after TankClean™

E85

Age  
30

TX

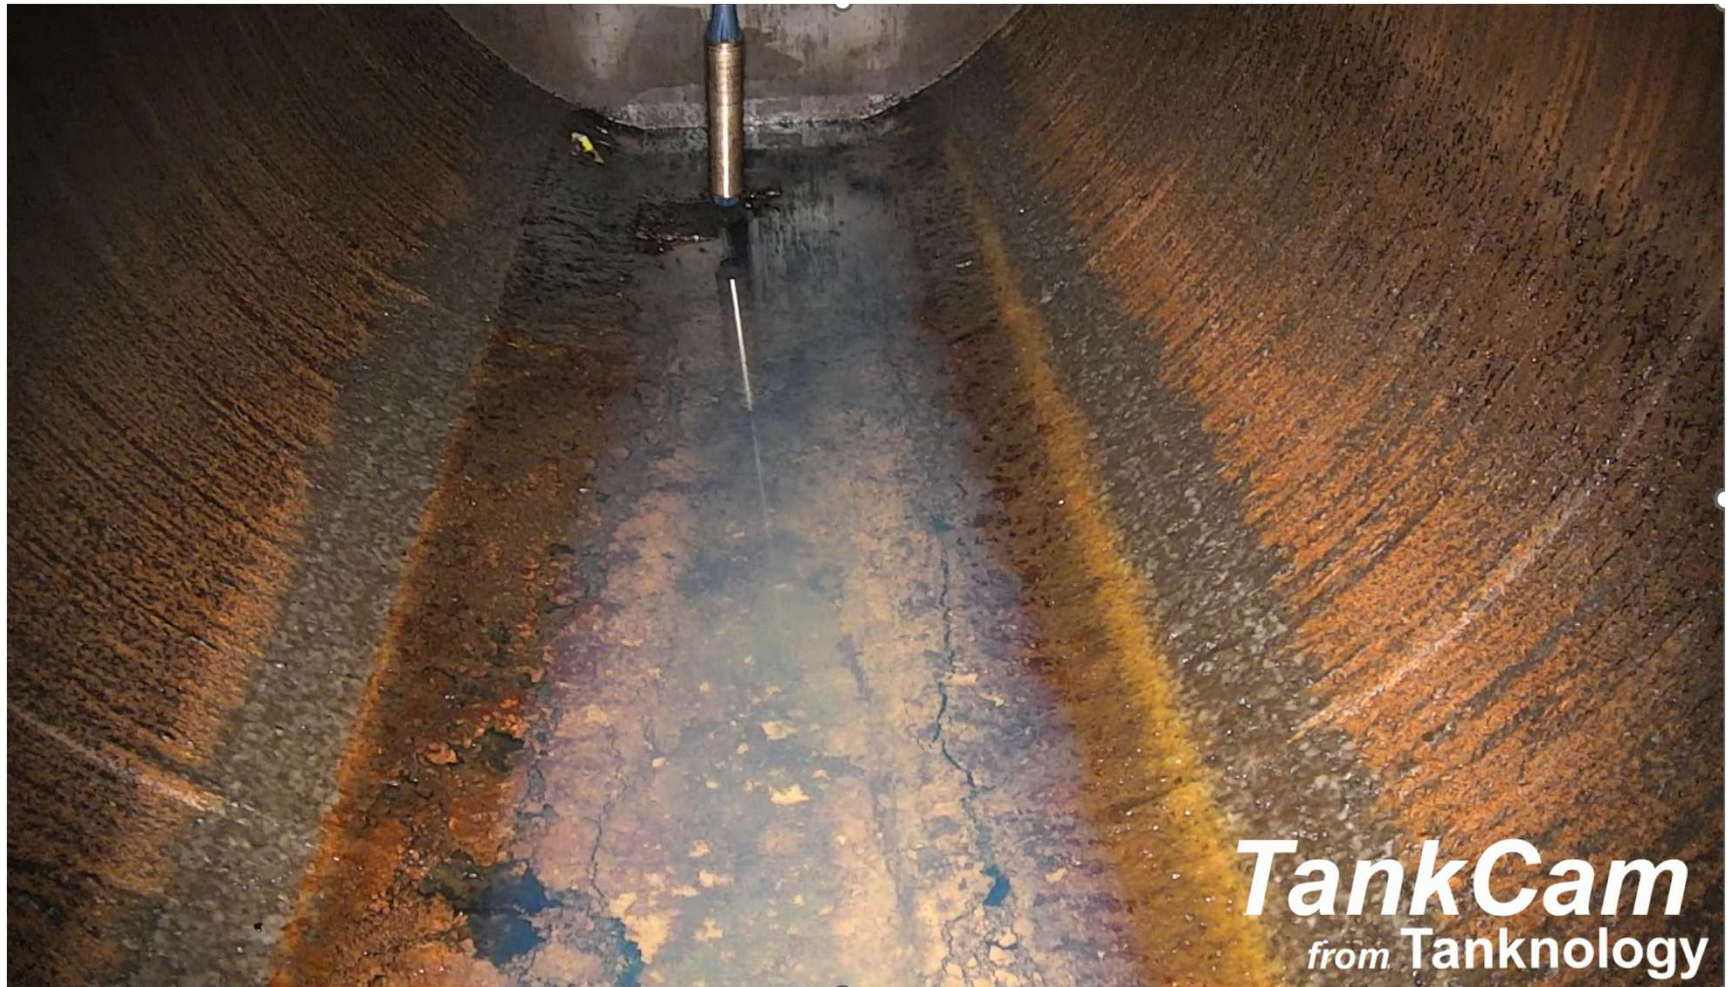
## Ingress in Steel Tank

DSL

Age  
23

GA

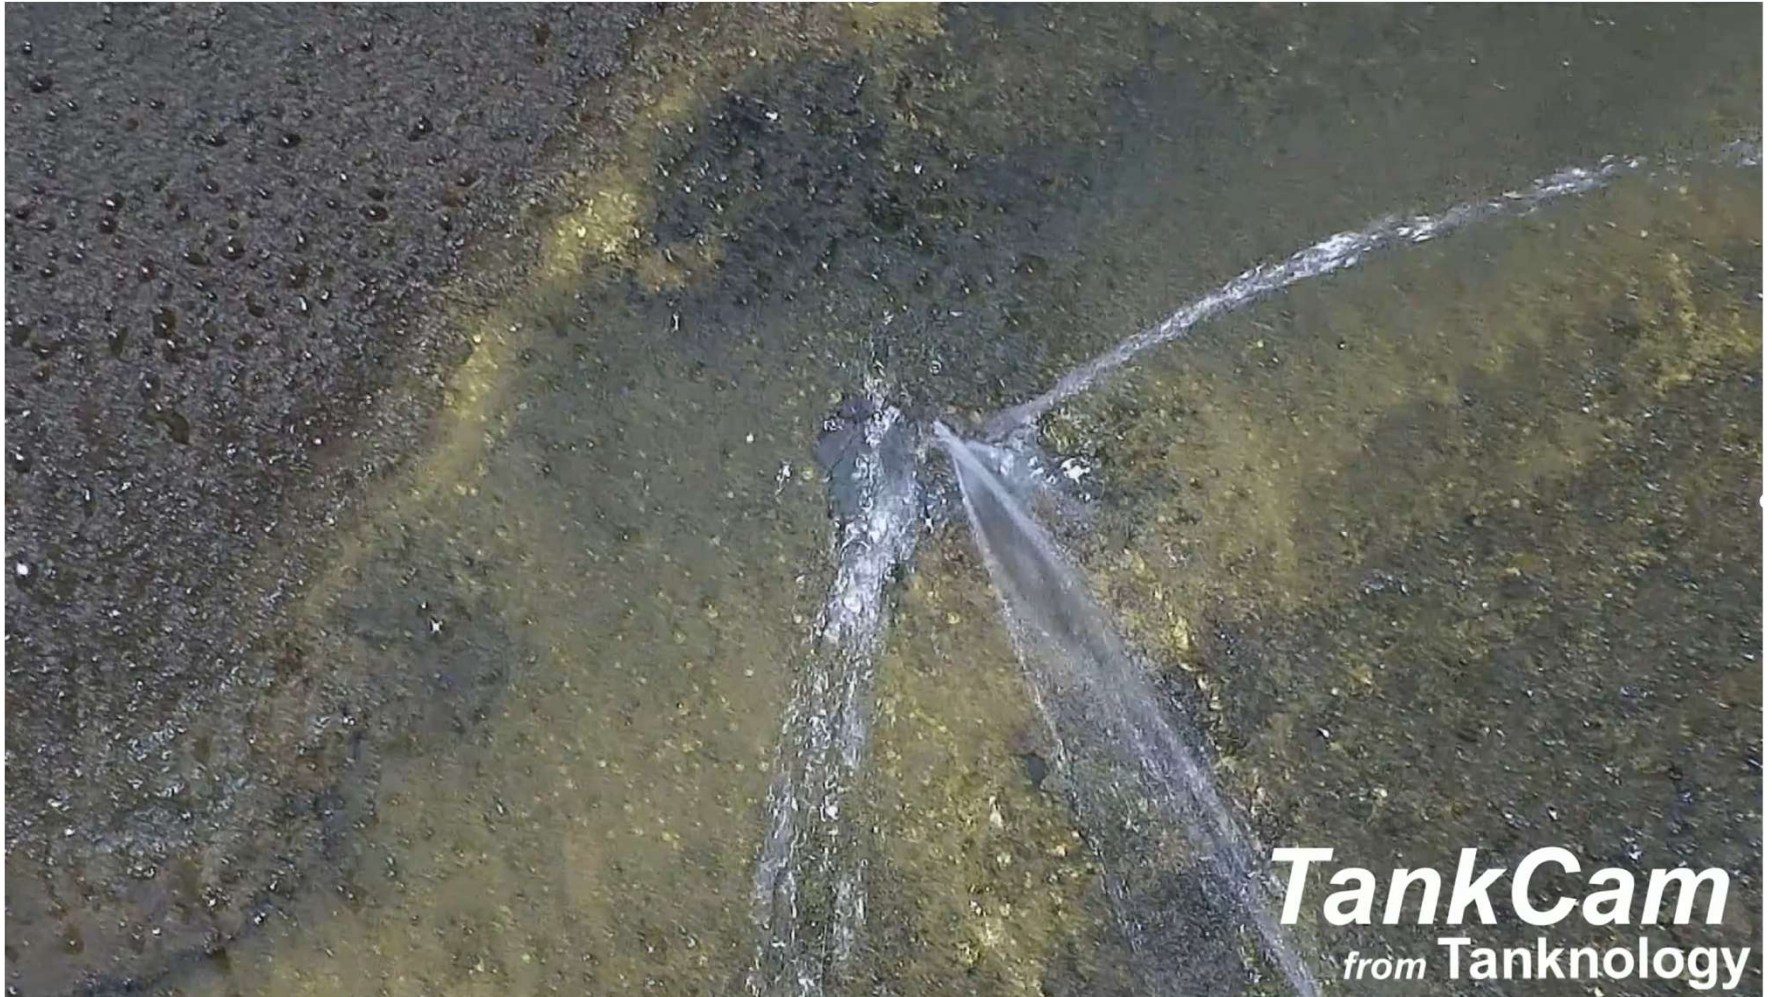
## DW Steel – Product in Interstitial

DSL

Age  
19

TX

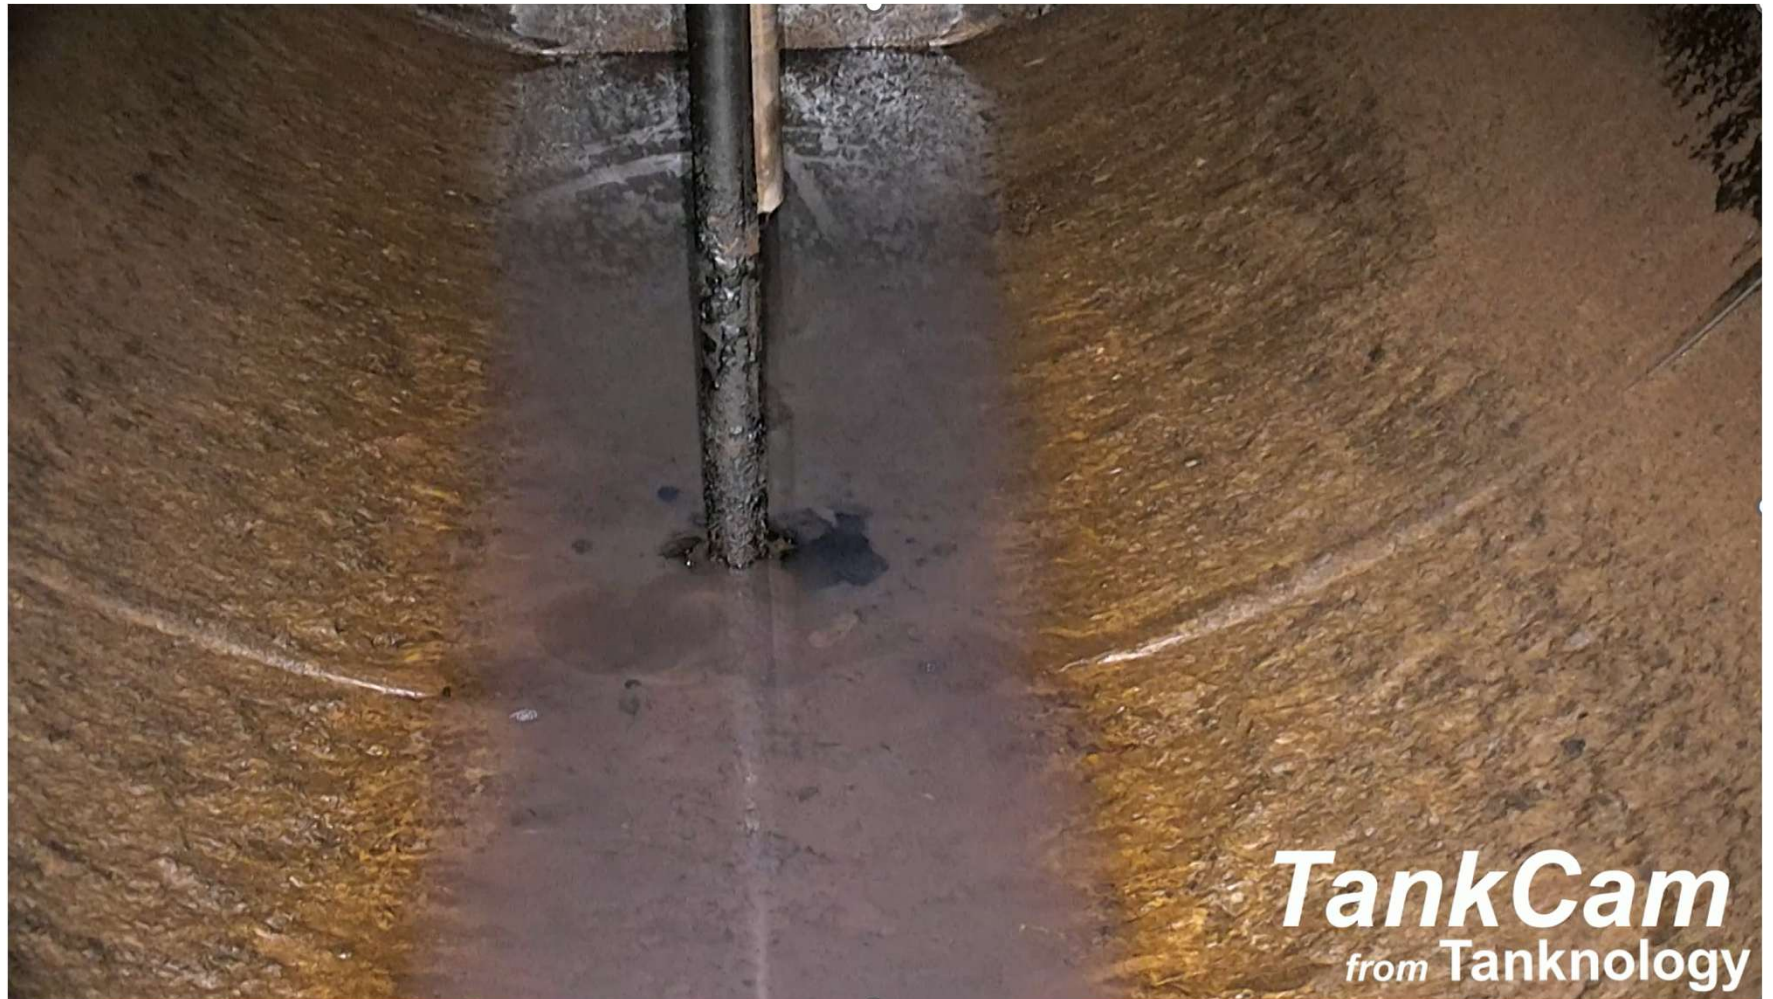
## Jacketed Steel – Product in Interstitial

DSL

Age  
28

MI

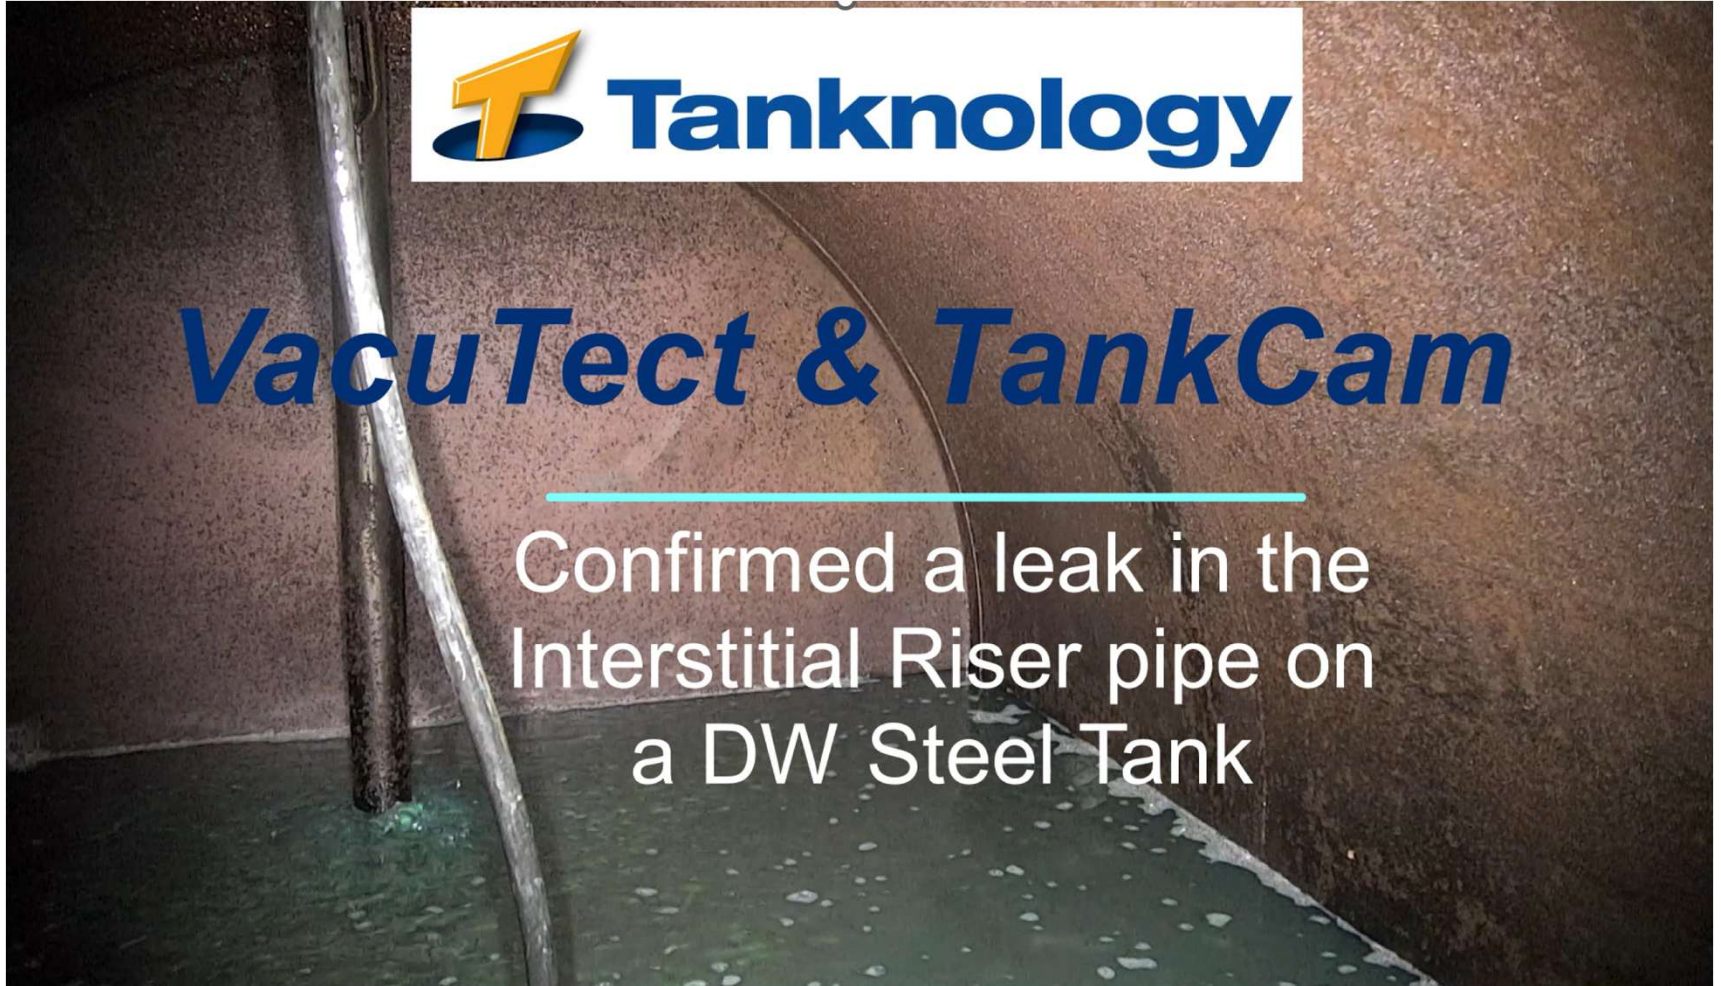
## Jacketed Steel – Bubble at Interstitial Riser

Confirmed a leak in the  
Interstitial Riser pipe on  
a DW Steel Tank

DSL

Age  
UNK

WI

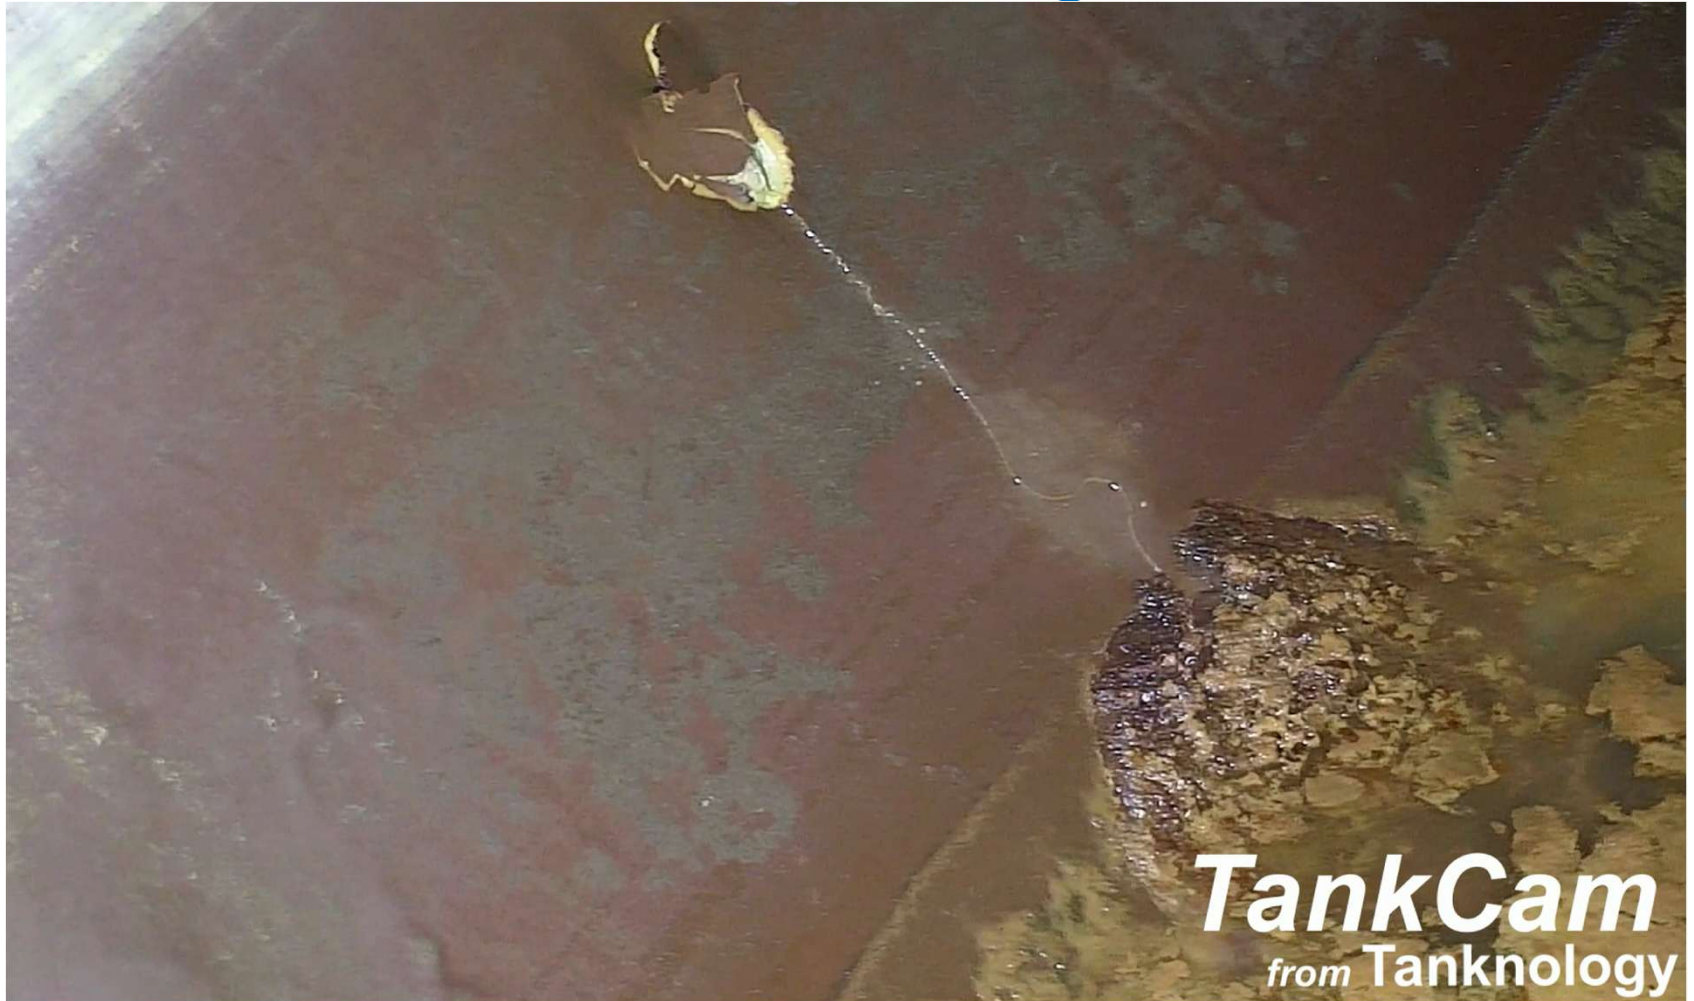
## Lined Steel Tank Failure & Ingress.

RUL

Age  
48

OH

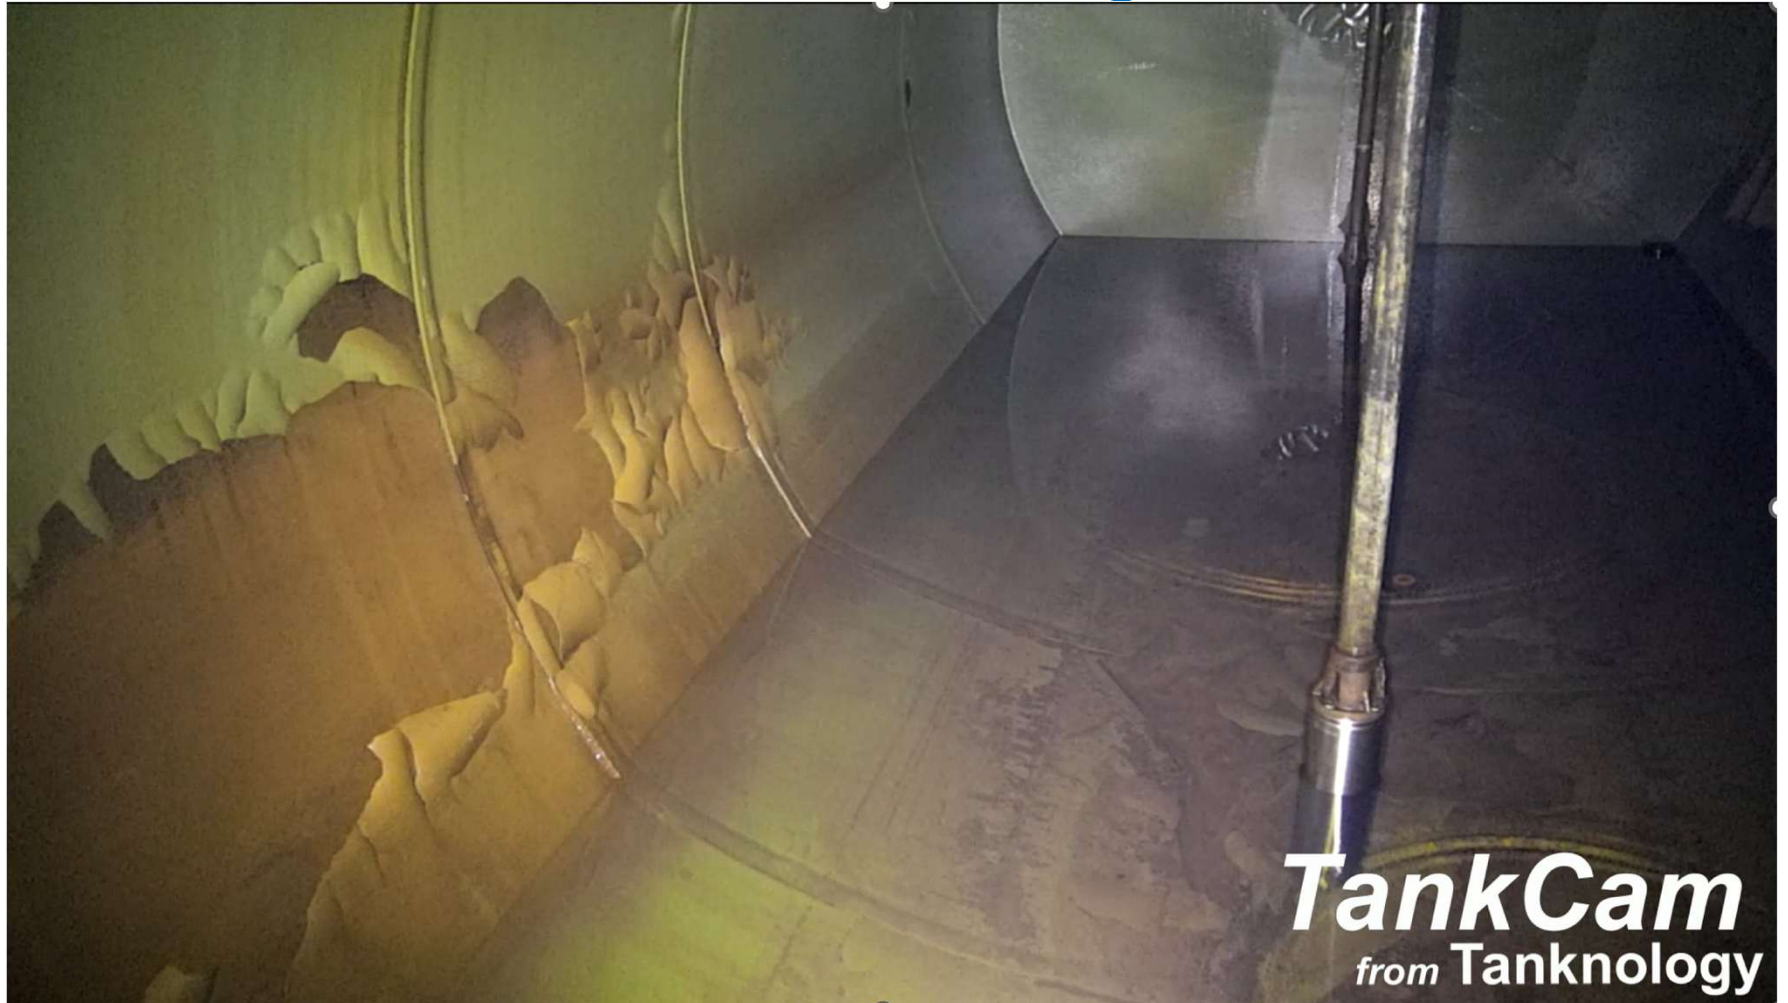
## Lined Steel Tank Failure & Ingress

RUL

Age  
49

OK
