# Public Viewing of Remediation Data in Tennessee

*Mapping Success; How Tennessee Communicates  
Environmental Cleanup and Redevelopment*

# Sharing Cleanup Achievements through StoryMaps

# Gallatin Town Creek Greenway Project

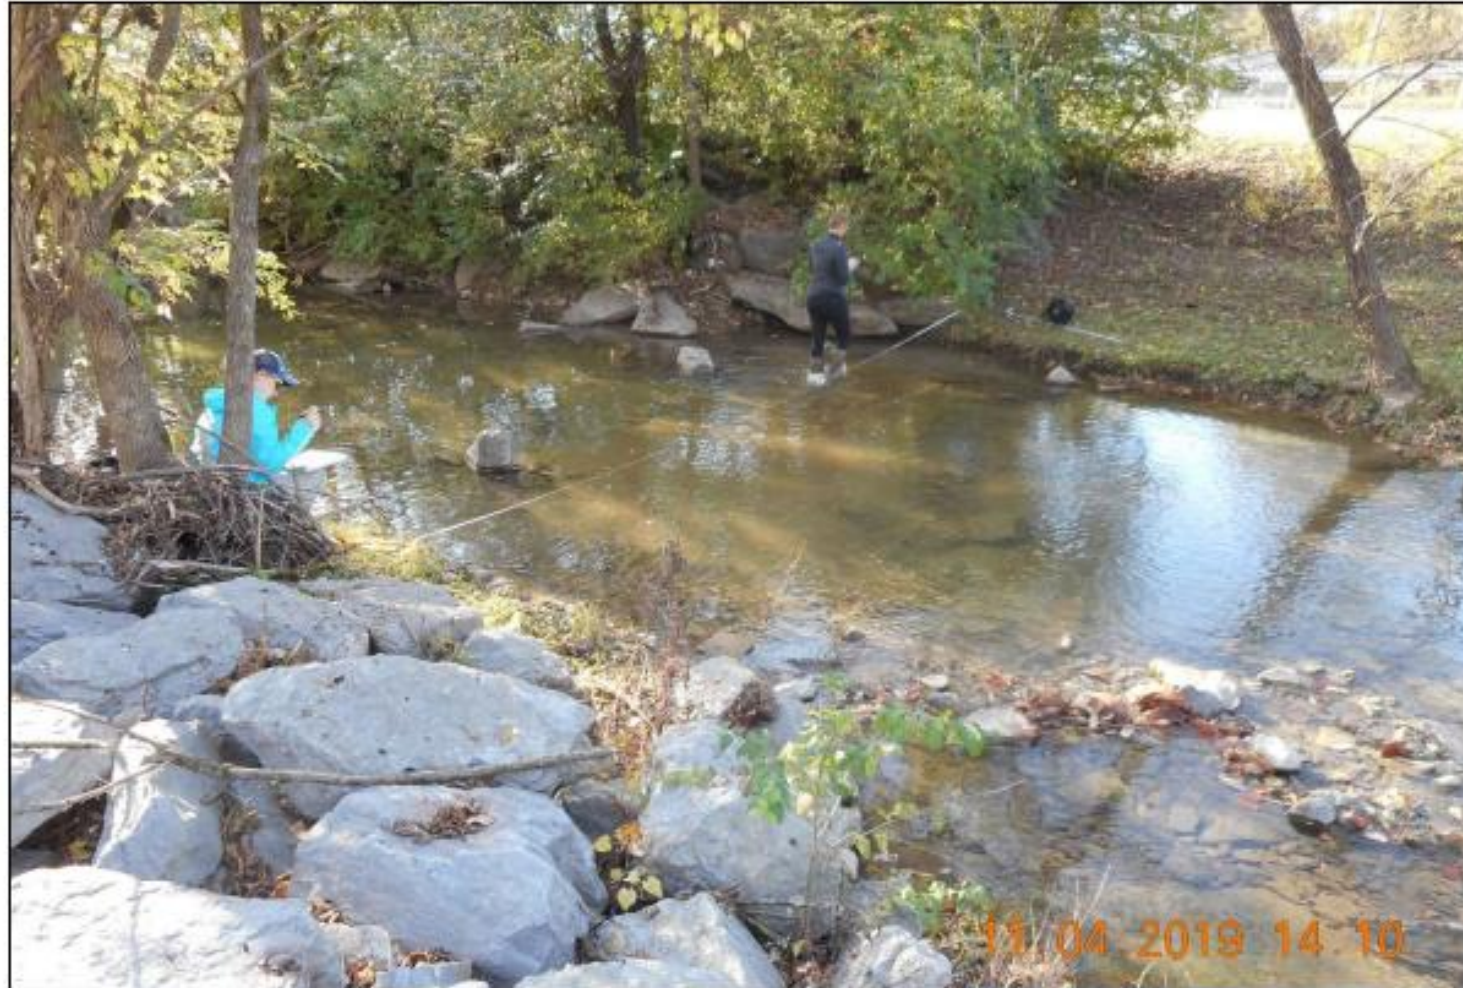
12 of 14: CHL conducting stream gauging upstream of seep #1

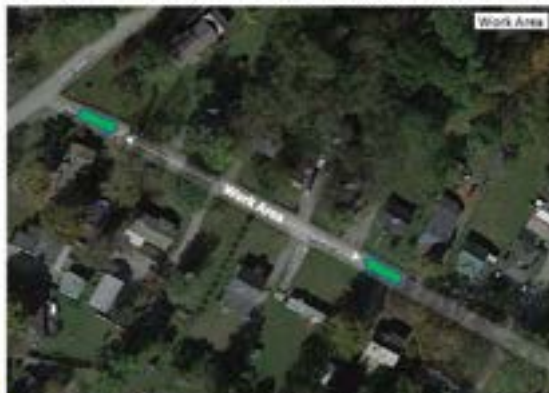
At right, are photos of the typical drill rig and injection equipment that you will be seeing in the roadway on Morton Avenue.

This is a photo of the activated carbon mixture when seen on the ground surface. While it may look unpleasant, it is not hazardous. It is similar to the carbon in your home water filter and is quite harmless.

Work Area

Drilling

Injection

Carbon Mixture
