Calvin Cole Road Culvert Replacement Project Planning and High Valley View  
Project Replacement – Town of Stephentown and Copake

# FINAL REPORT

*High Valley View Road Over UNT to Bash Blish Creek, Hudson River Watershed, NY*

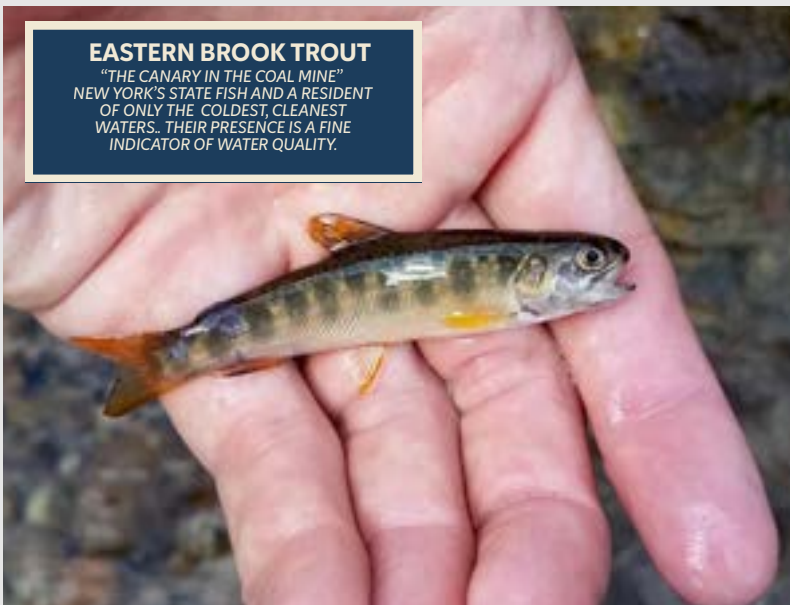
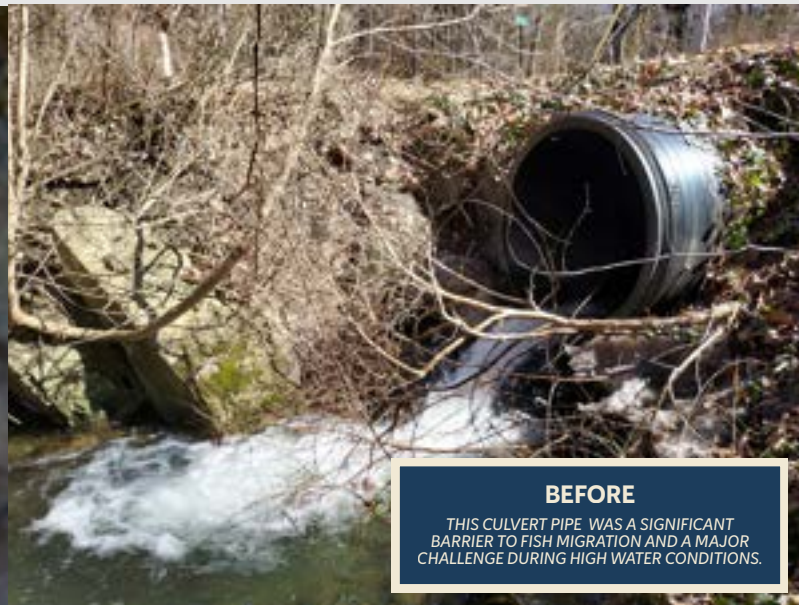
## BEFORE

THIS CULVERT PIPE WAS A SIGNIFICANT  
BARRIER TO FISH MIGRATION AND A MAJOR  
CHALLENGE DURING HIGH WATER CONDITIONS.

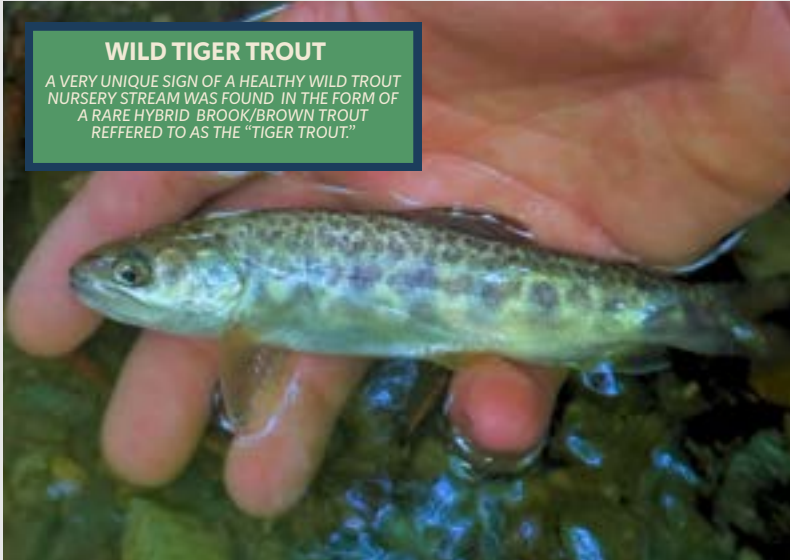
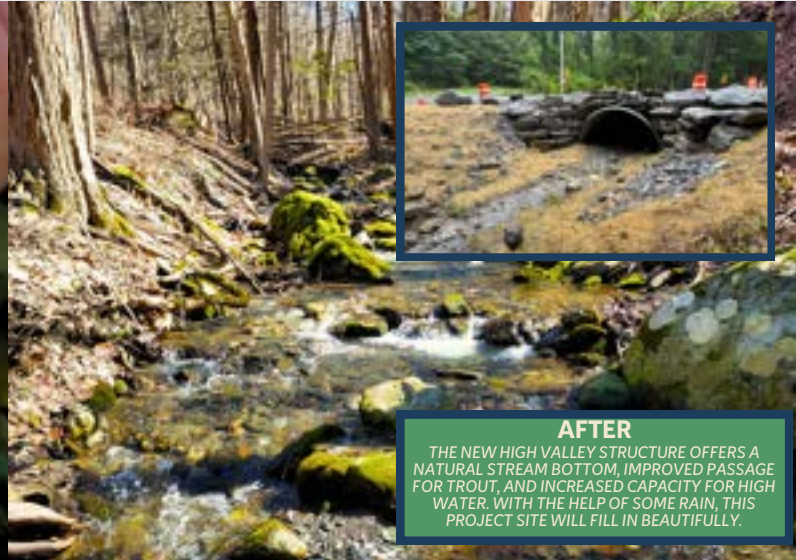
### AFTER

THE NEW HIGH VALLEY STRUCTURE OFFERS A NATURAL STREAM BOTTOM, IMPROVED PASSAGE FOR TROUT, AND INCREASED CAPACITY FOR HIGH WATER. WITH THE HELP OF SOME RAIN, THIS PROJECT SITE WILL FILL IN BEAUTIFULLY.
