# Feasibility Study for Anadromous Fish Passage

Blackamore and Cranberry Ponds  
Cranston and Warwick, Rhode Island

Project No. P310-000  
Revised March 3, 2017

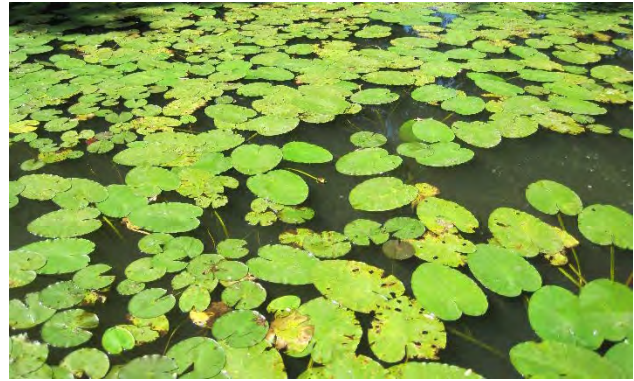
Blackamore Pond appears to host a limited number of aquatic plant species. The most frequently observed were water lilies (*Nymphaea odorata* and *Nuphar lutea variegata*), primarily at the southern end of the pond near the outlet. One exotic species of aquatic plant (curly-leaf pondweed) was observed at very low levels. However, due to this species's life cycle, most plants would have senesced by the time of the field survey. Therefore, it is possible that curly-leaf pondweed is actually more widespread in the pond than observed. Several emergent plant species were also observed at the pond, including exotic purple loosestrife and common reed.

*Water lilies were the most frequently observed aquatic plant at Blackamore Pond.*

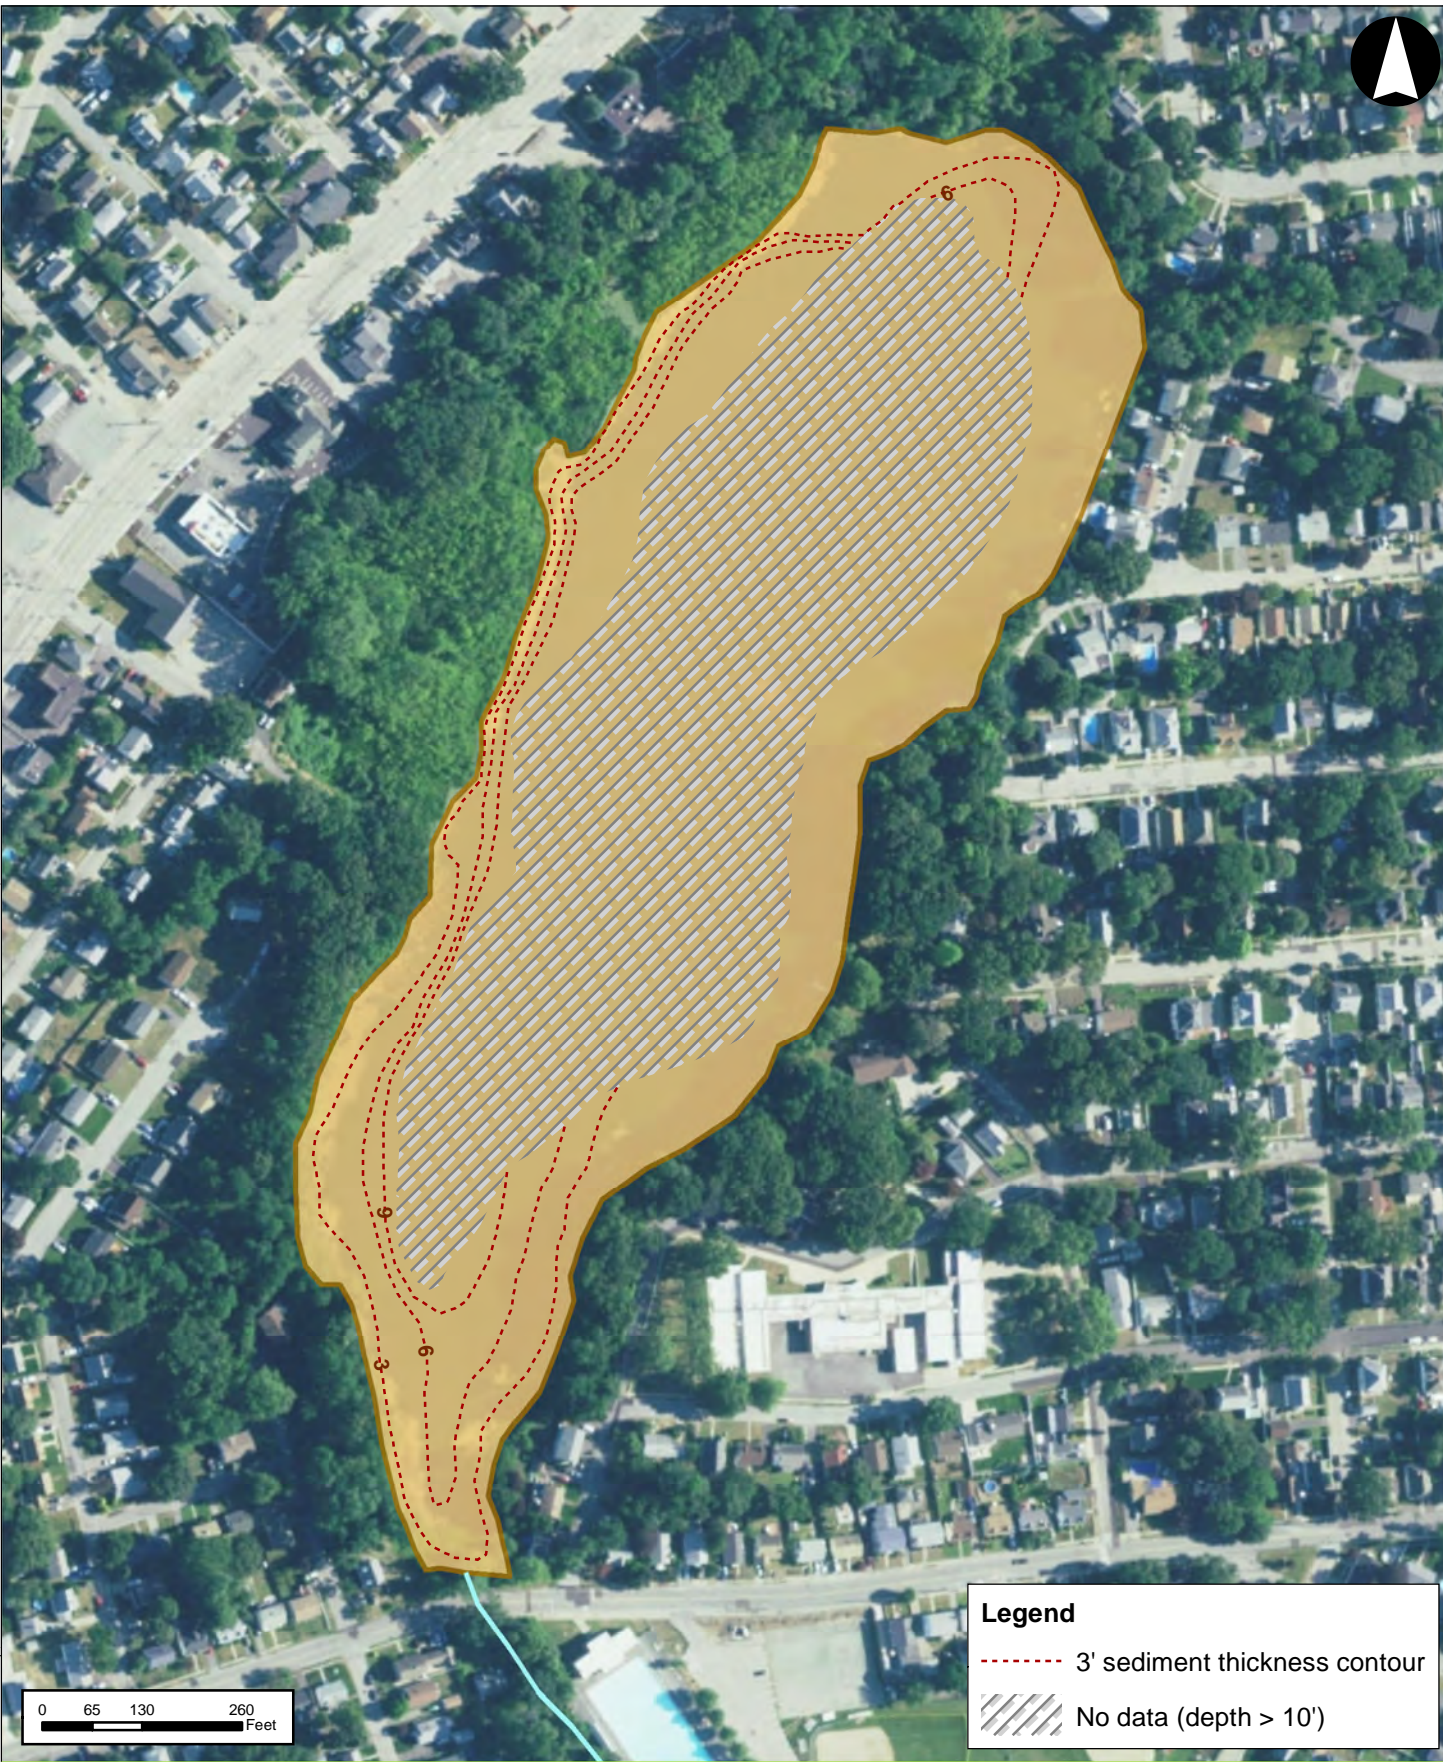
**Figure 5**

A total of 24 sediment thickness measurements were taken at Blackamore Pond. Sediment thickness data are absent for the center portion of the pond, where water depths were too deep to record an accurate measurement.

Soft sediment thickness generally increased from the shoreline toward the center of the pond, although sediments tended to be thinner on the eastern side of the pond than the west (Figure 5). The thickest deposits measured in the pond were more than 10 feet thick.

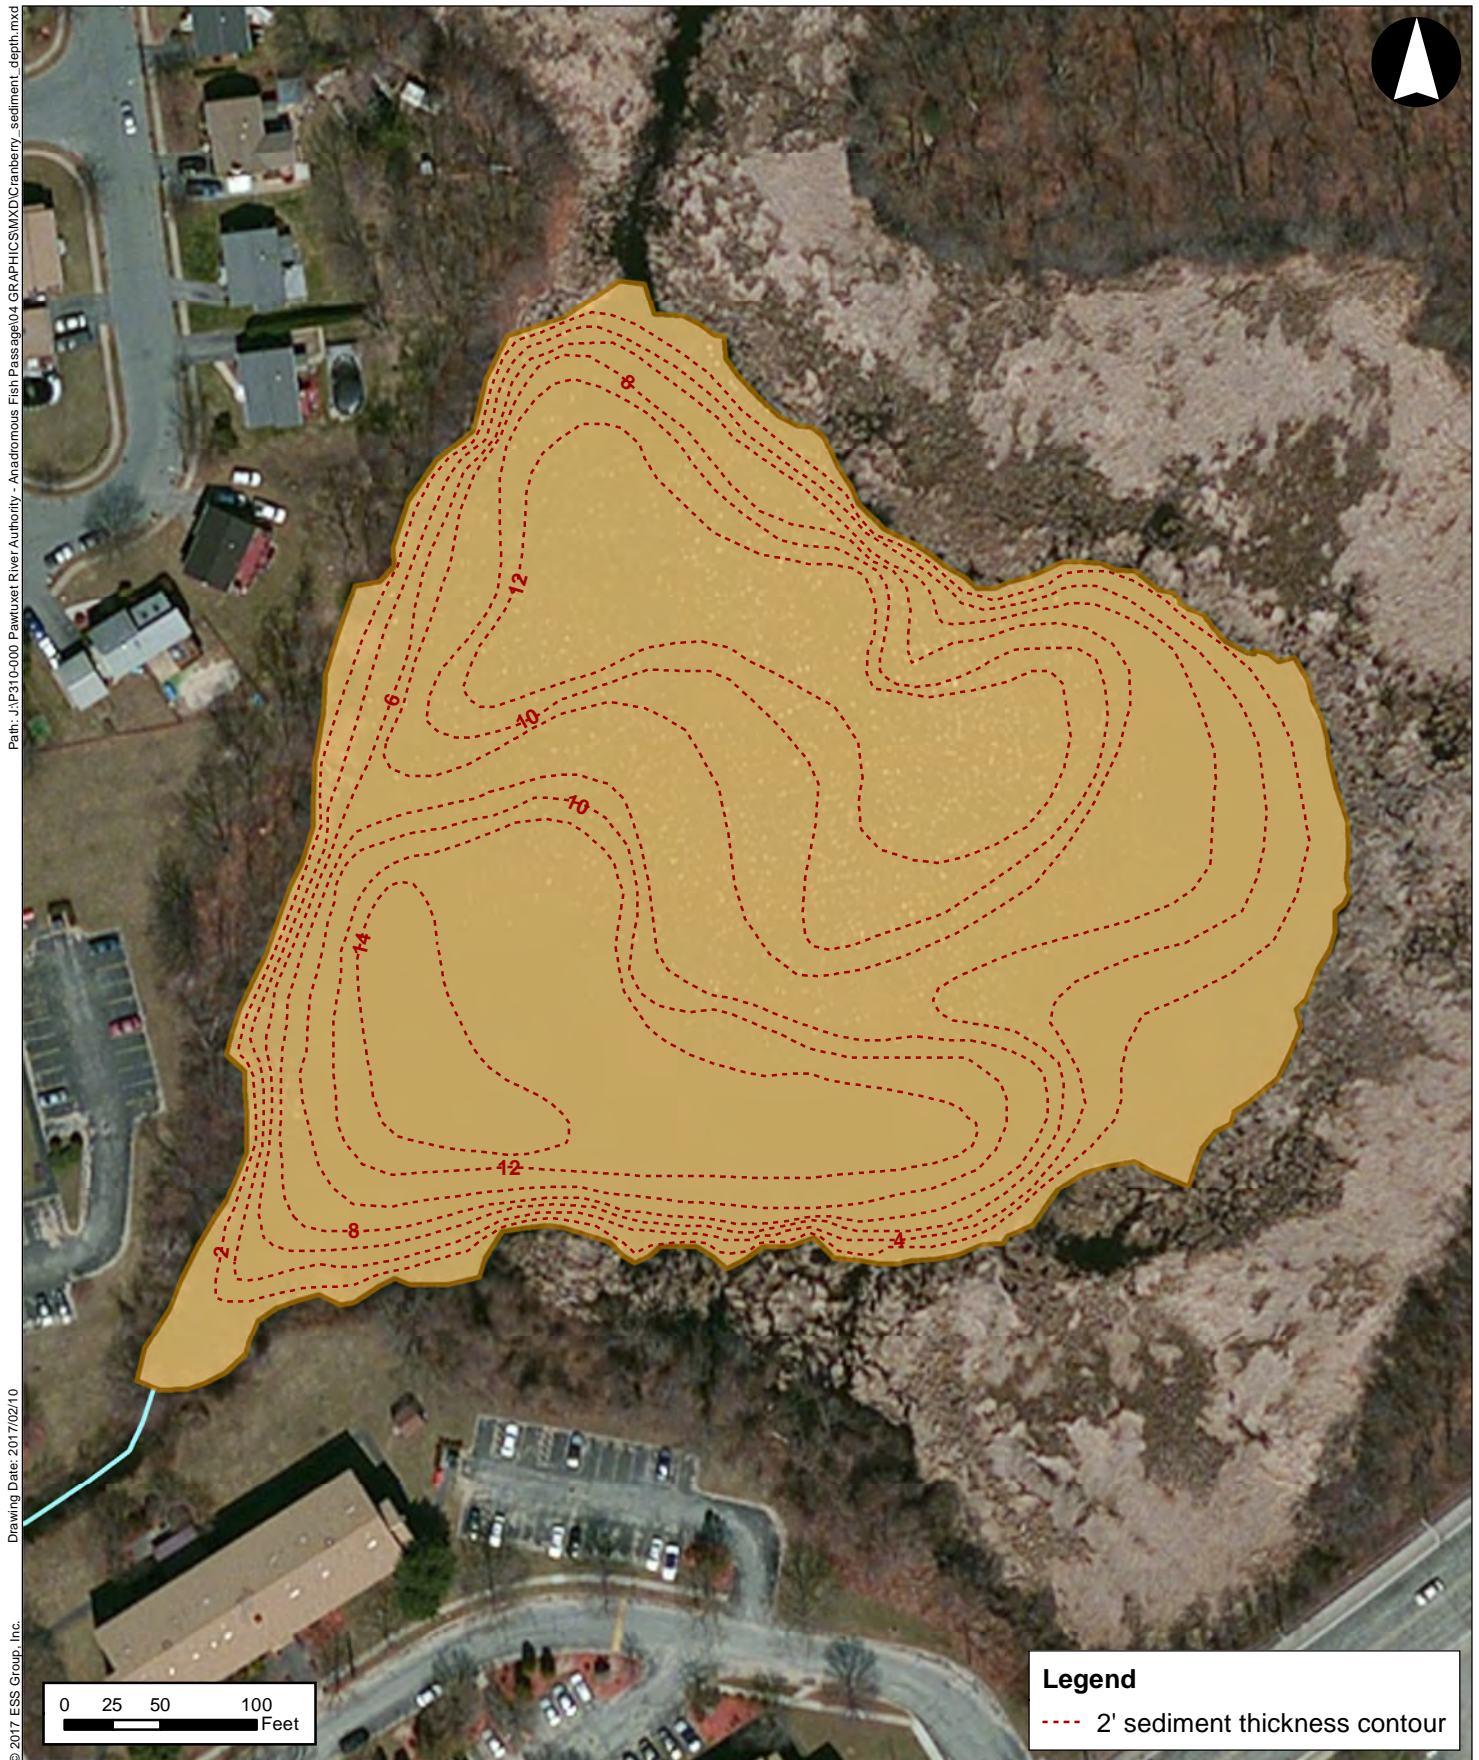
A total of 50 sediment thickness measurements were taken at Cranberry Pond. Thick deposits of soft sediments were found across much of the pond, with maximum thicknesses found in the north-central and south-central portions of the pond. Soft sediment thickness exceeded 14 feet in some locations. A map of sediment thicknesses in the pond is provided in Figure 9.

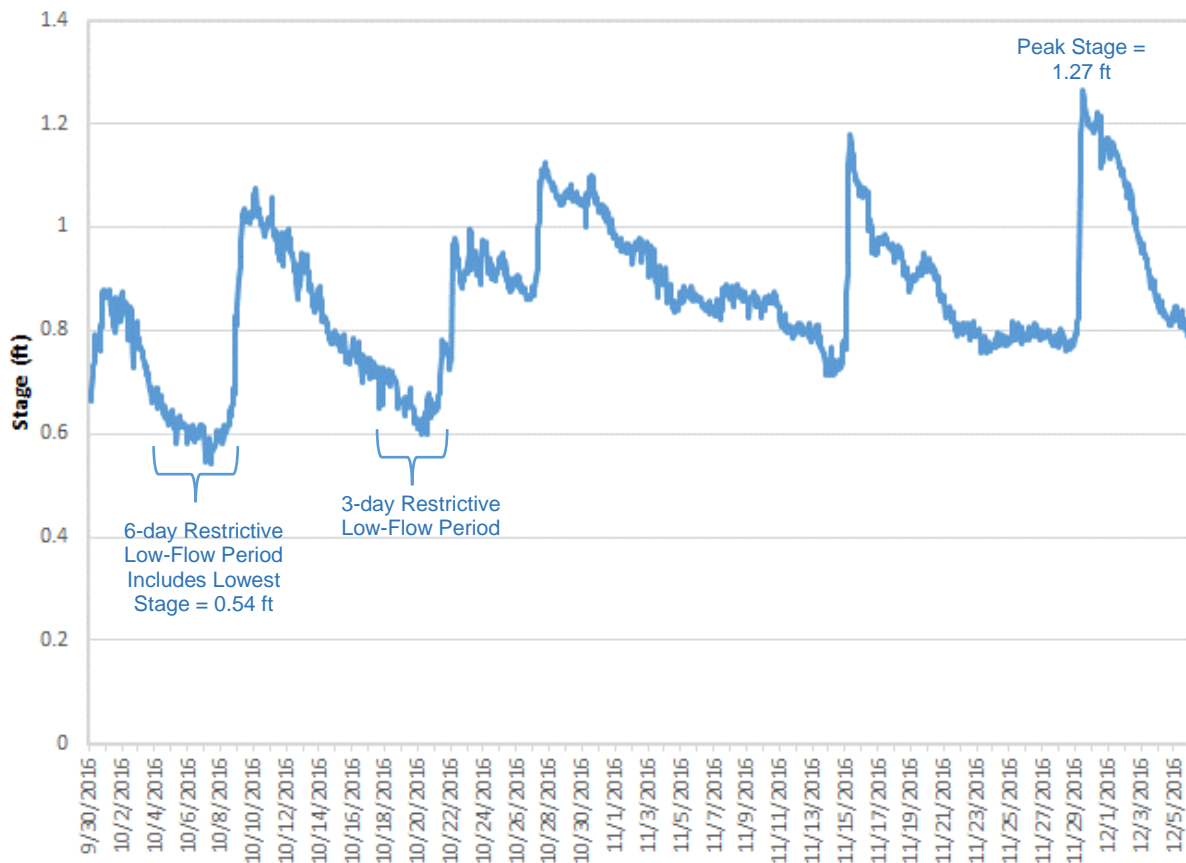
Figure 10. Continuous Stage Recorded at the Cranberry Pond Outlet

- Flow data at the Cranberry Pond outlet was collected between September and December 2016 (Figure 10), a period anticipated to include typical low-flow conditions. Given the restrictive flow conditions observed on the date of the initial field visit (September 30), it is clear that at least two additional periods of restrictive low flows occurred over the period of this study. These

periods extend from October 4 to October 9 and from October 19 to October 21 (Figure 10). The minimum water level over the period of study was recorded on October 7 and was 0.14 feet below the stage observed on the date of the initial field visit.

None of the water levels recorded over the period of this study appeared to be excessively high. The peak stage of 1.27 feet was recorded on November 29 and is 0.59 feet higher than the water levels observed on the date of the initial field visit.

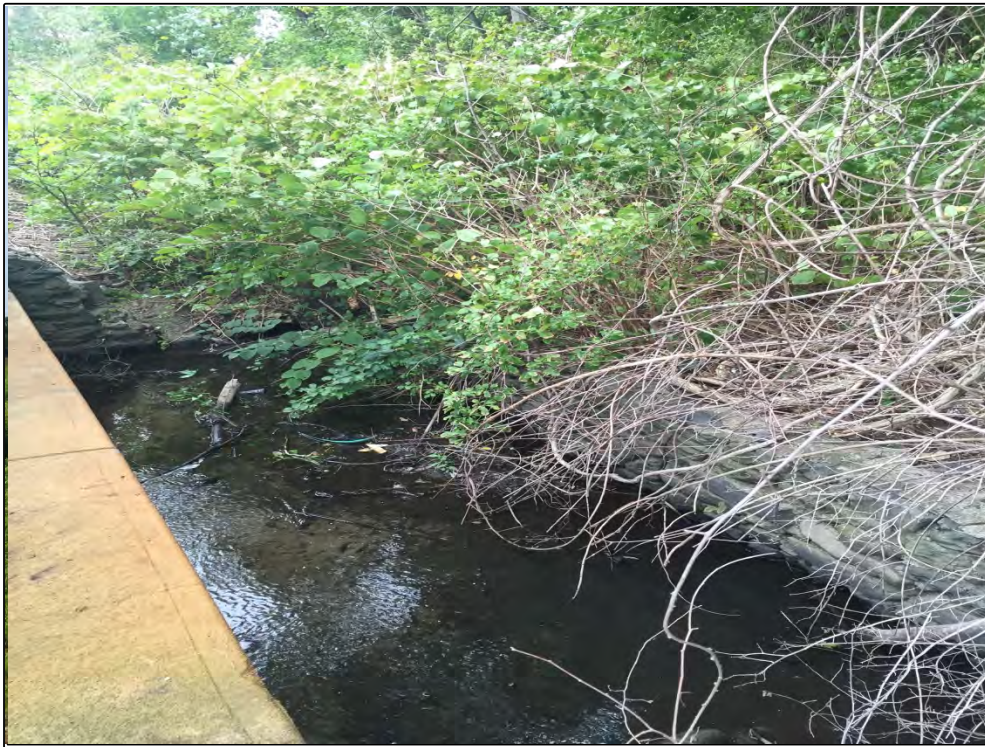
**Downstream of Blackamore Pond outlet, altered segment of stream that runs parallel to Budlong Pool – September 30, 2016**

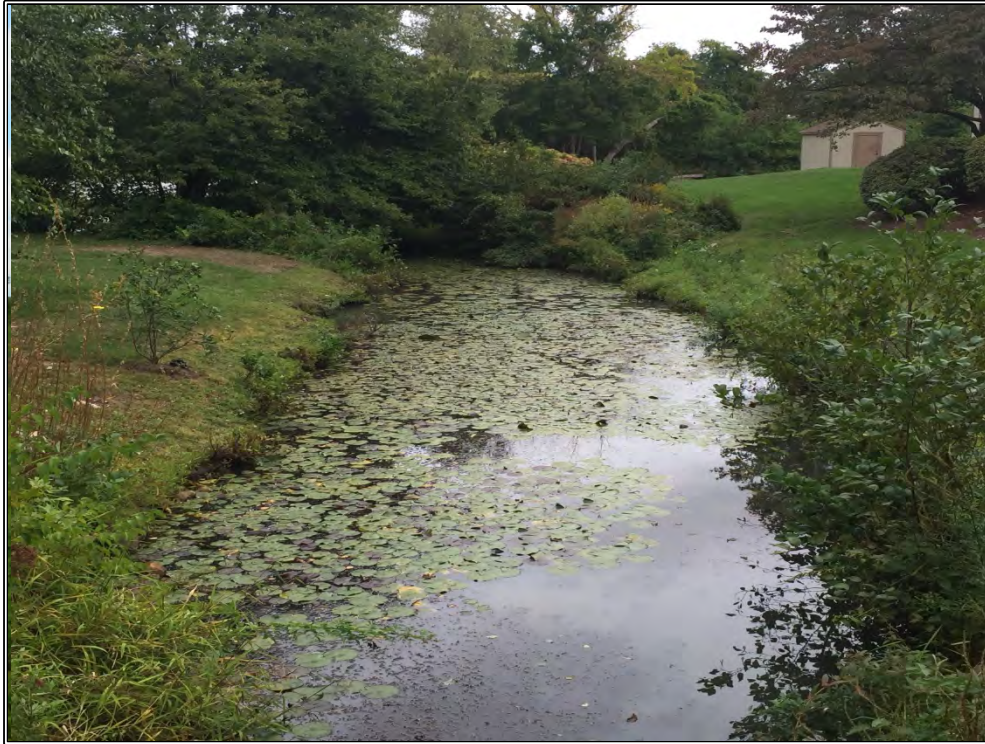
**Cranberry Pond outlet– September 30, 2016**

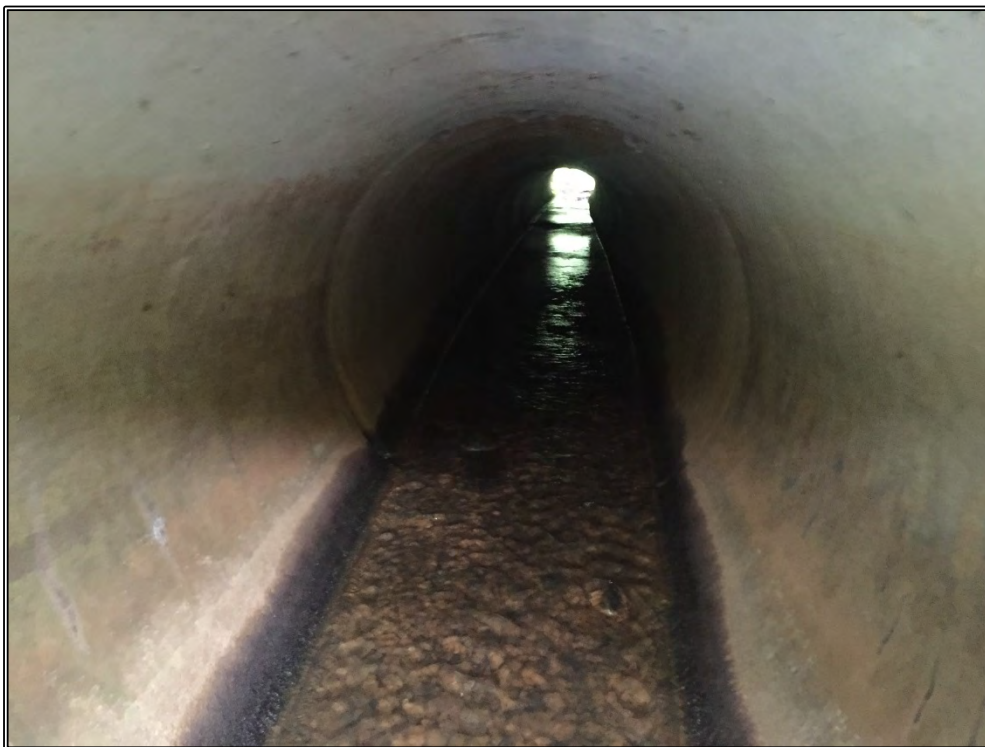
**Looking through extended culvert under Fifth Ave from downstream end – September 30, 2016**

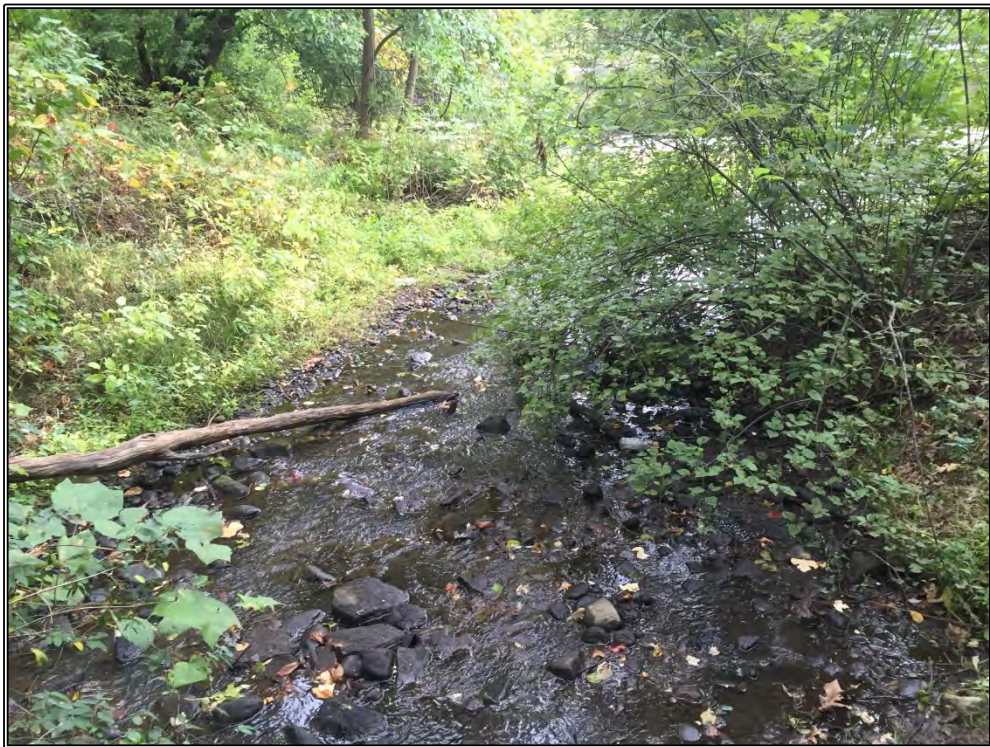
**Looking towards Cranberry Brook/Pawtuxet River confluence from mouth of culvert – September 30, 2016**
