CORROSION AND RELATED ISSUES FOUND DURING INSPECTIONS

Michael Hollis

NJDEP

ASTSWMO Emerging Fuels Task Force

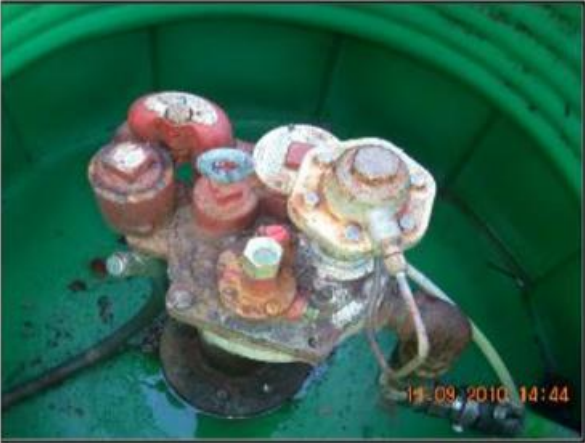
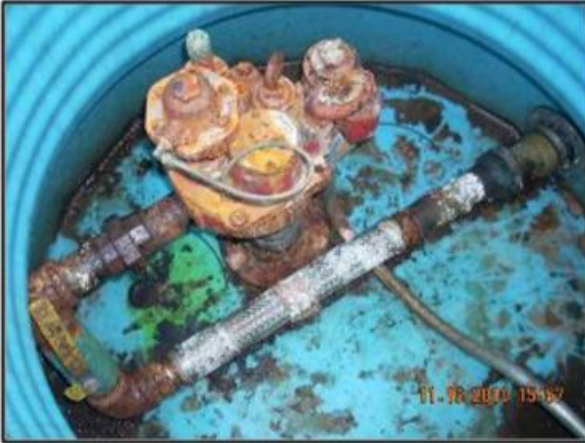
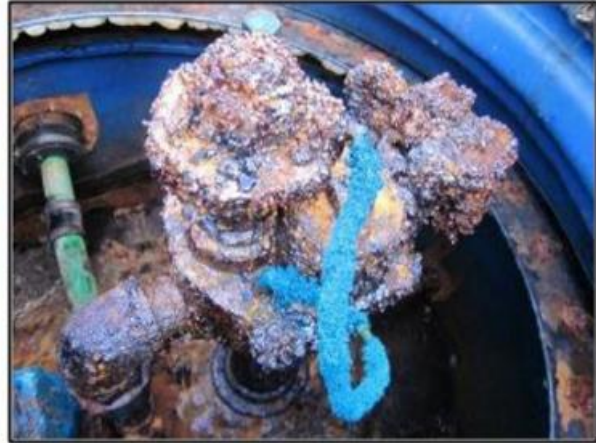
Low to Moderate	Significant	Severe

What equipment was corroded and how severe? Use the example photos below to help with your response.
