Managing a catastrophic release to achieve rapid decision making and minimize long term impacts

September 12, 2018

Petroleum Program

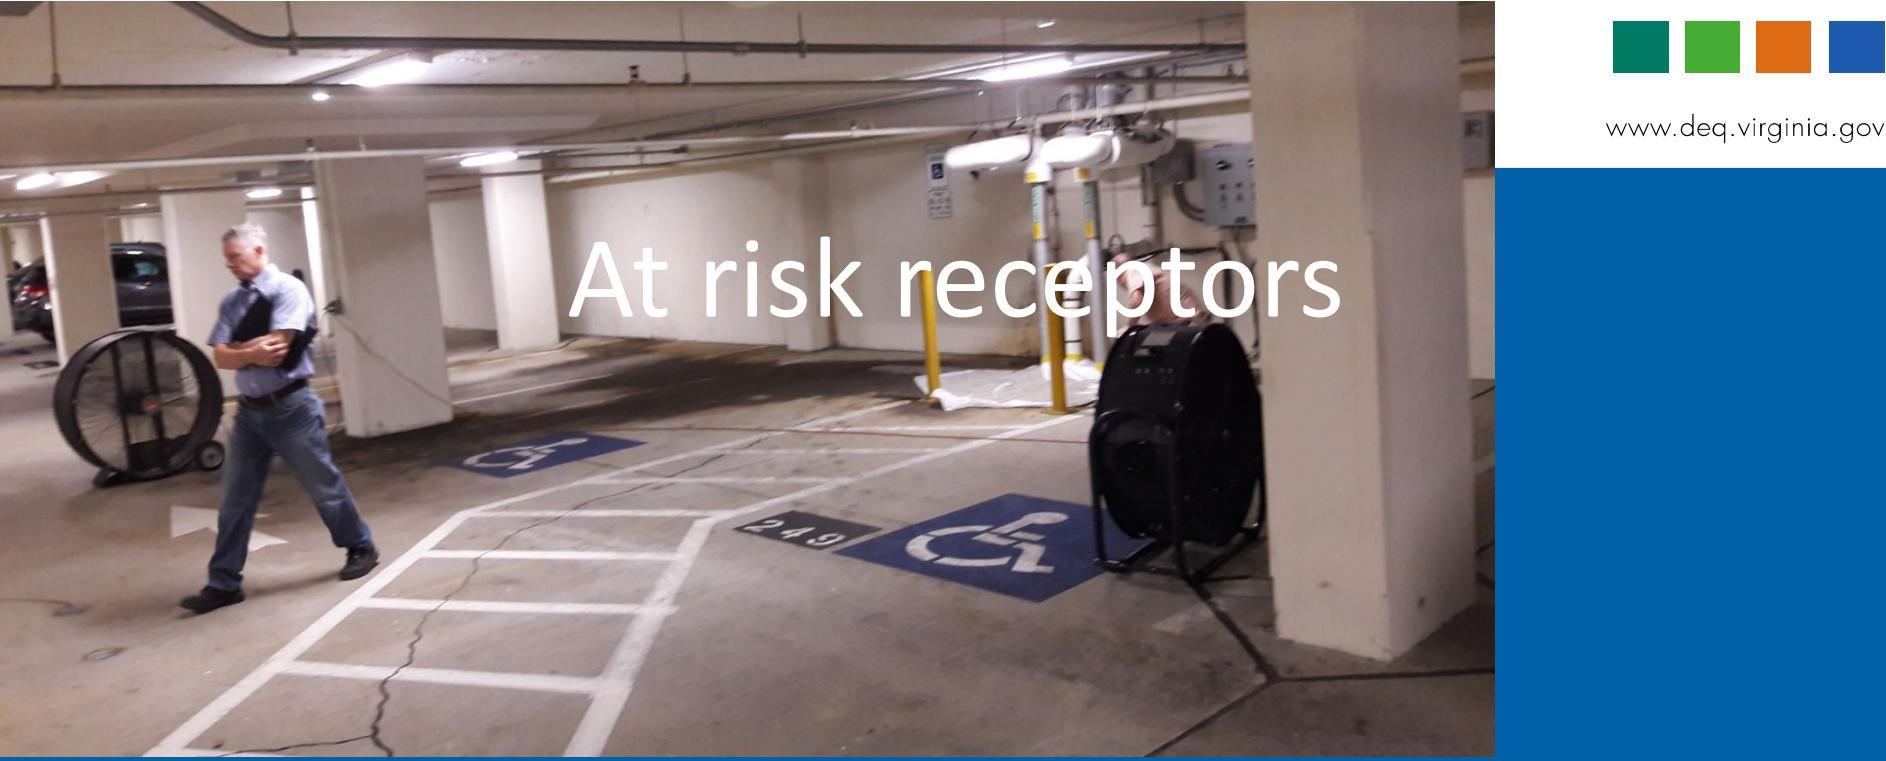
- Indoor Air
 - Residents
 - Workers
 - Customers
- Surface water
 - Storm drains
 - Nearby streams

Lobby/Elevator shafts 200-400 ppm in air Sump Water • TPH 130 mg/l • Benzene 5.2 mg/l • MTBE 1.1 mg/l

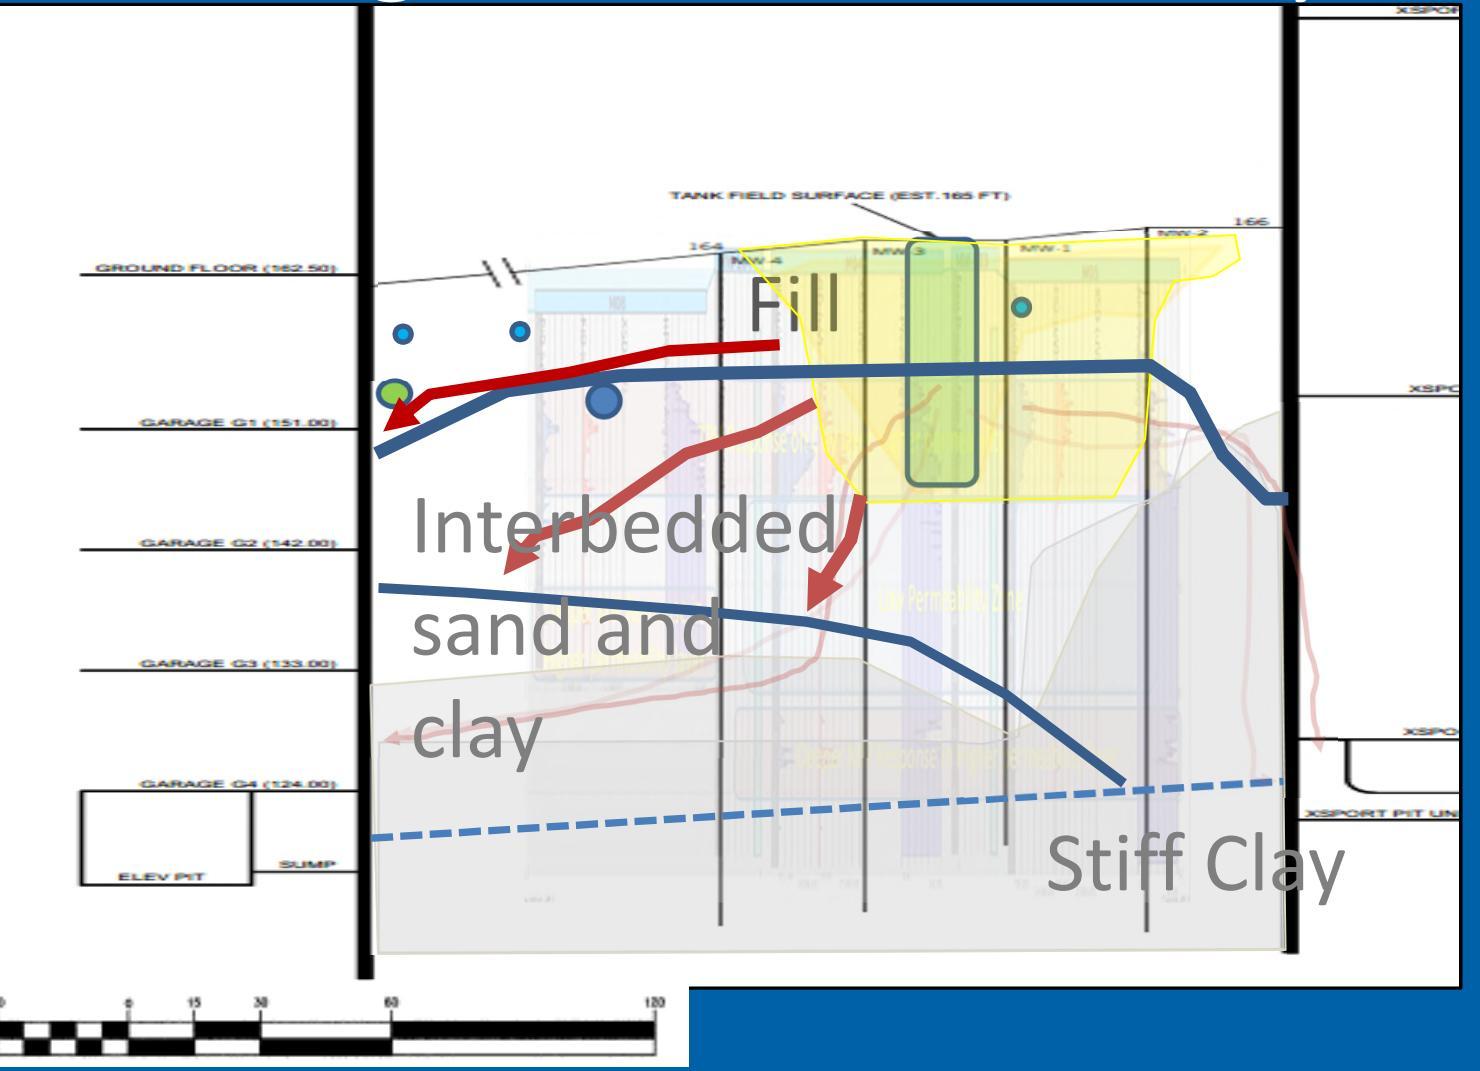
Monitoring and SVE wells May to August

- Two definitive groundwater bodies: shallow (10-15) and deep (35-50)
- Deeper groundwater mounded against Halstead or third deep groundwater unit?

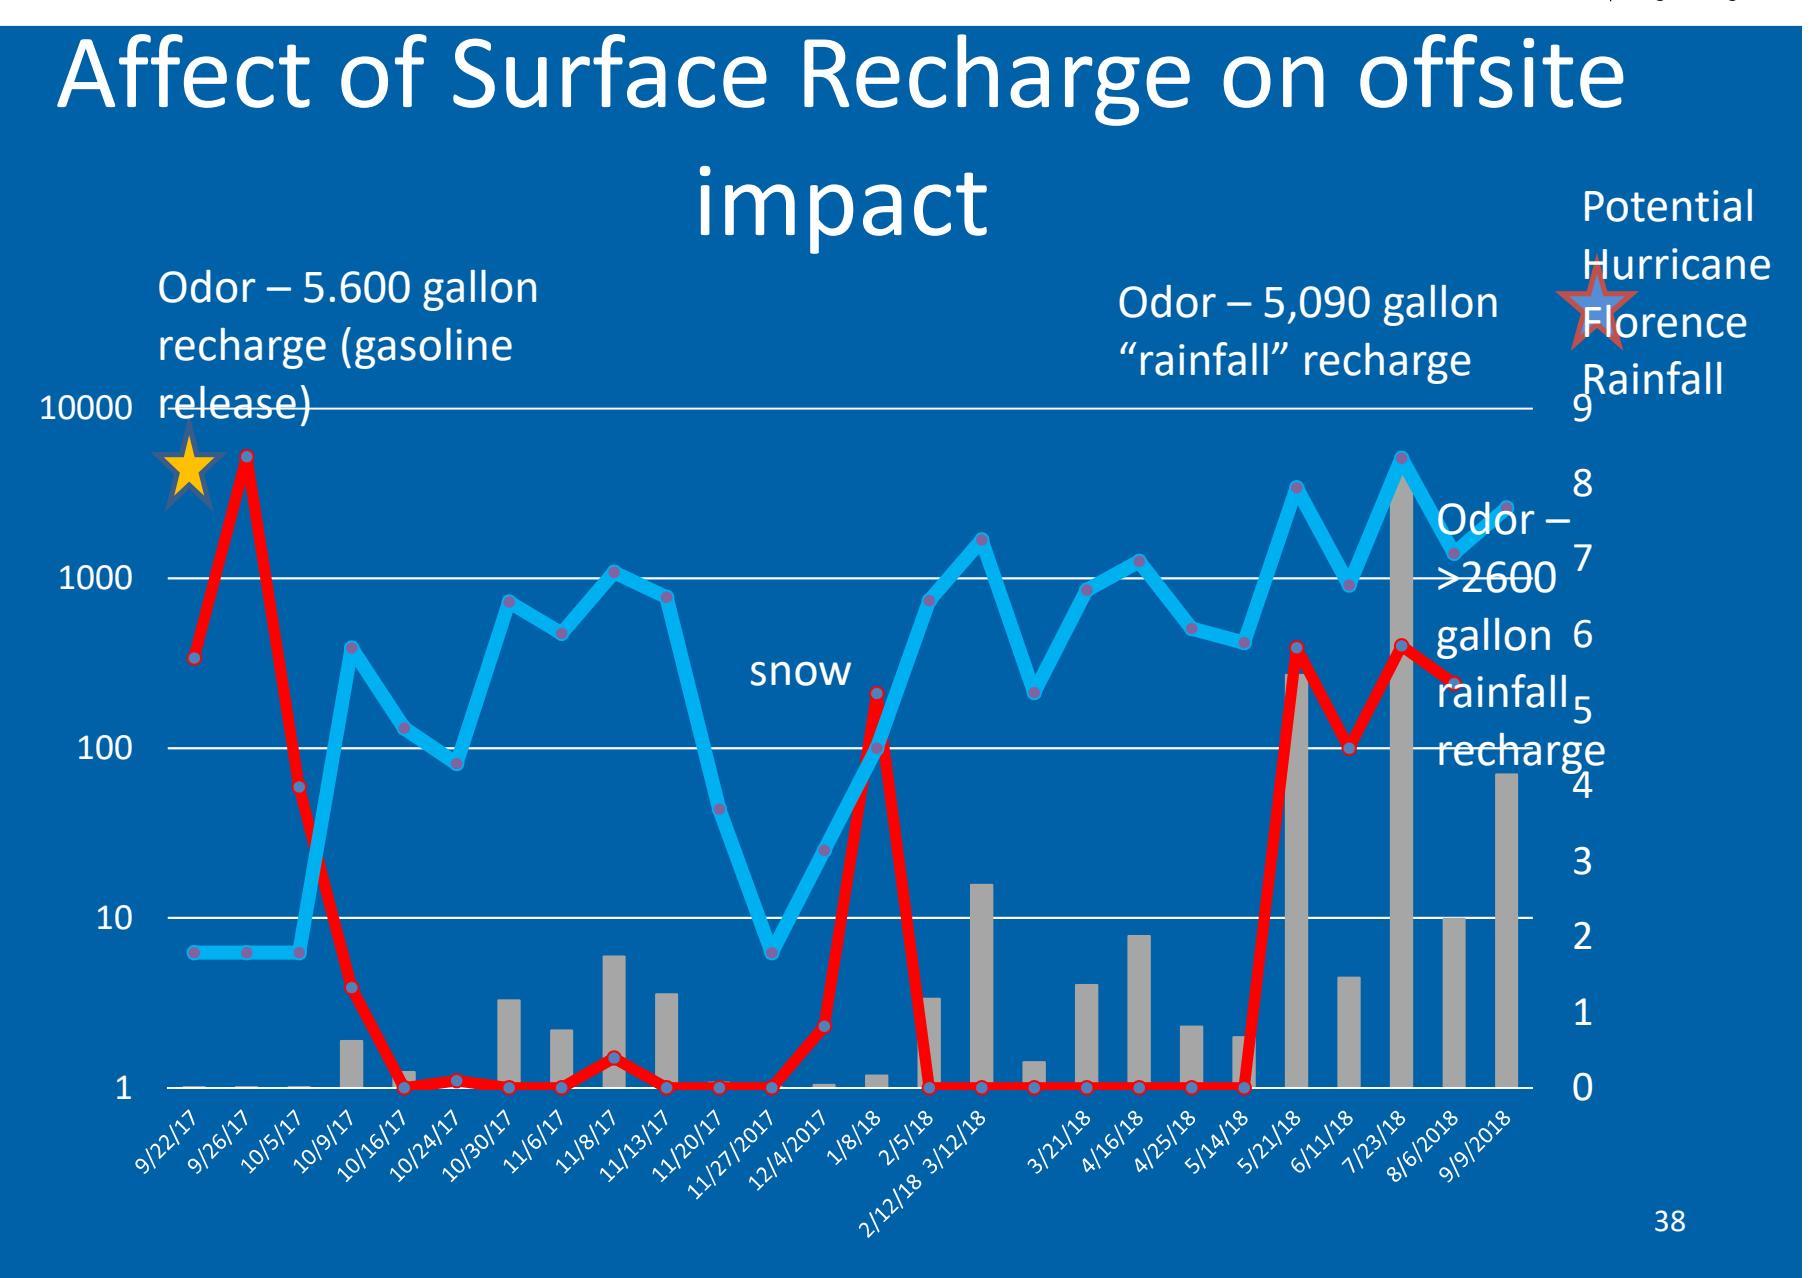
- Residents complaining of odors in lobby, elevators and ground floor residences
- Discovered roof storm drain with vents within building with petroleum vapors
- Influenced by rising shallow groundwater?
- Apparent communication failure as complaints went unreported to DEQ
