# FRP Tank Autopsy

Presented by Mike Pecorelli

# Will's Canyon Stop

Investigation and Tank Autopsy

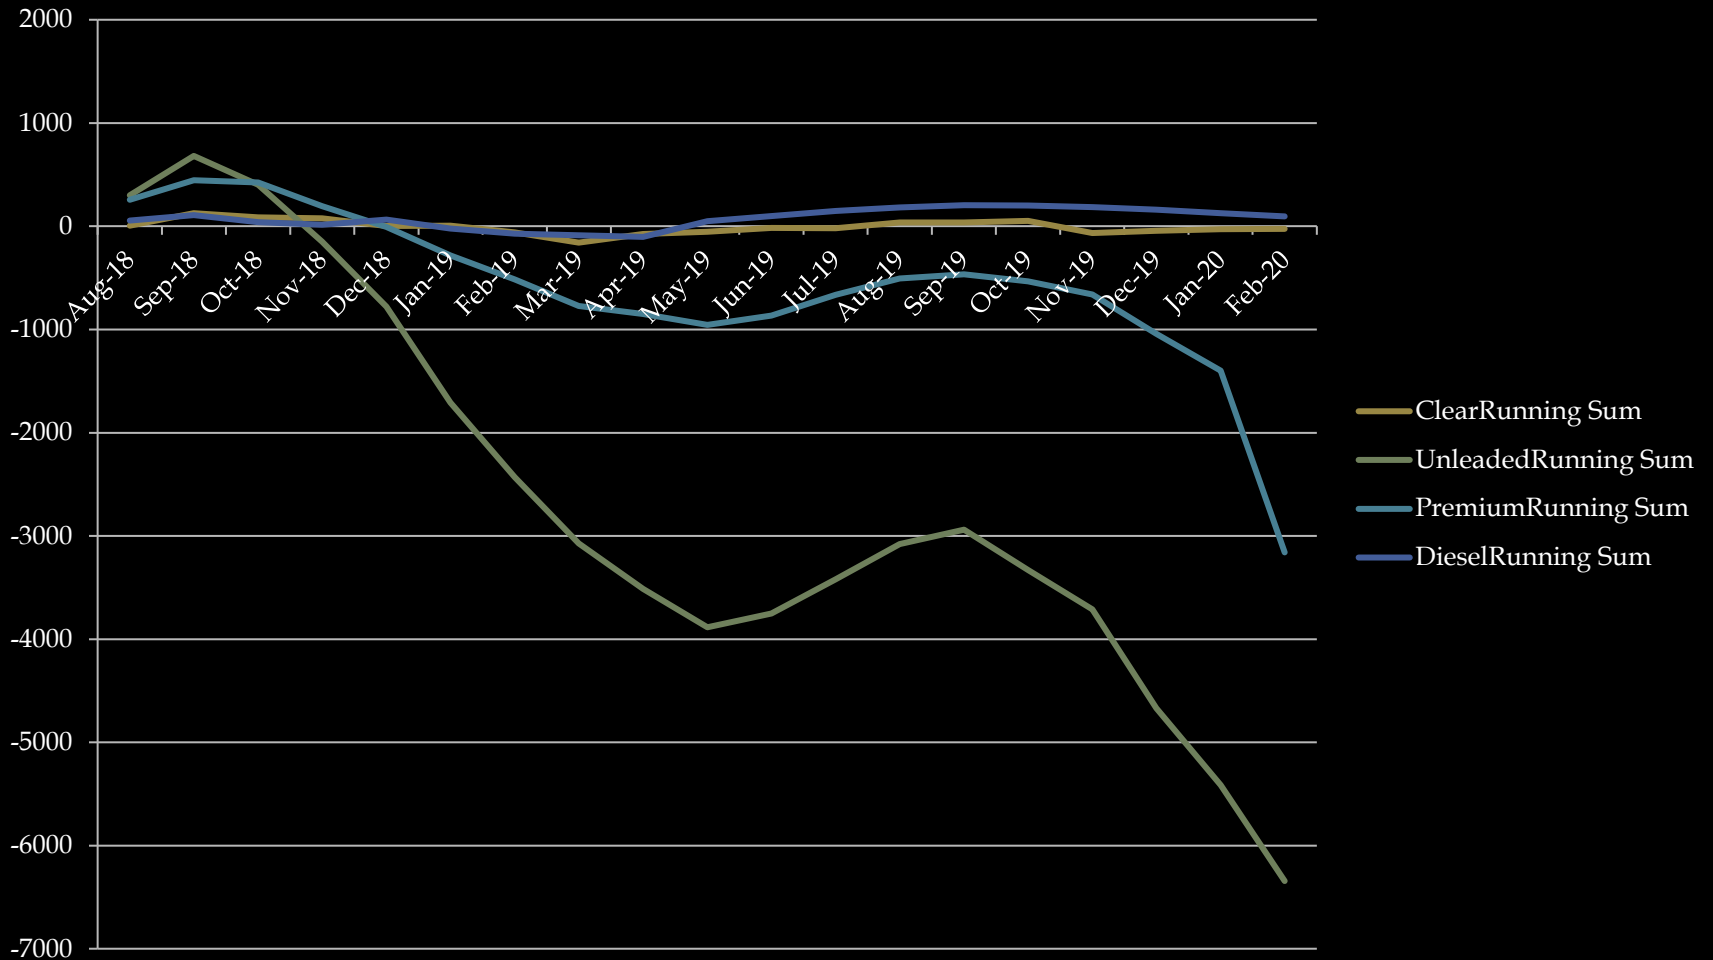
# Inventory chart

Called a UST tester who confirmed the release.

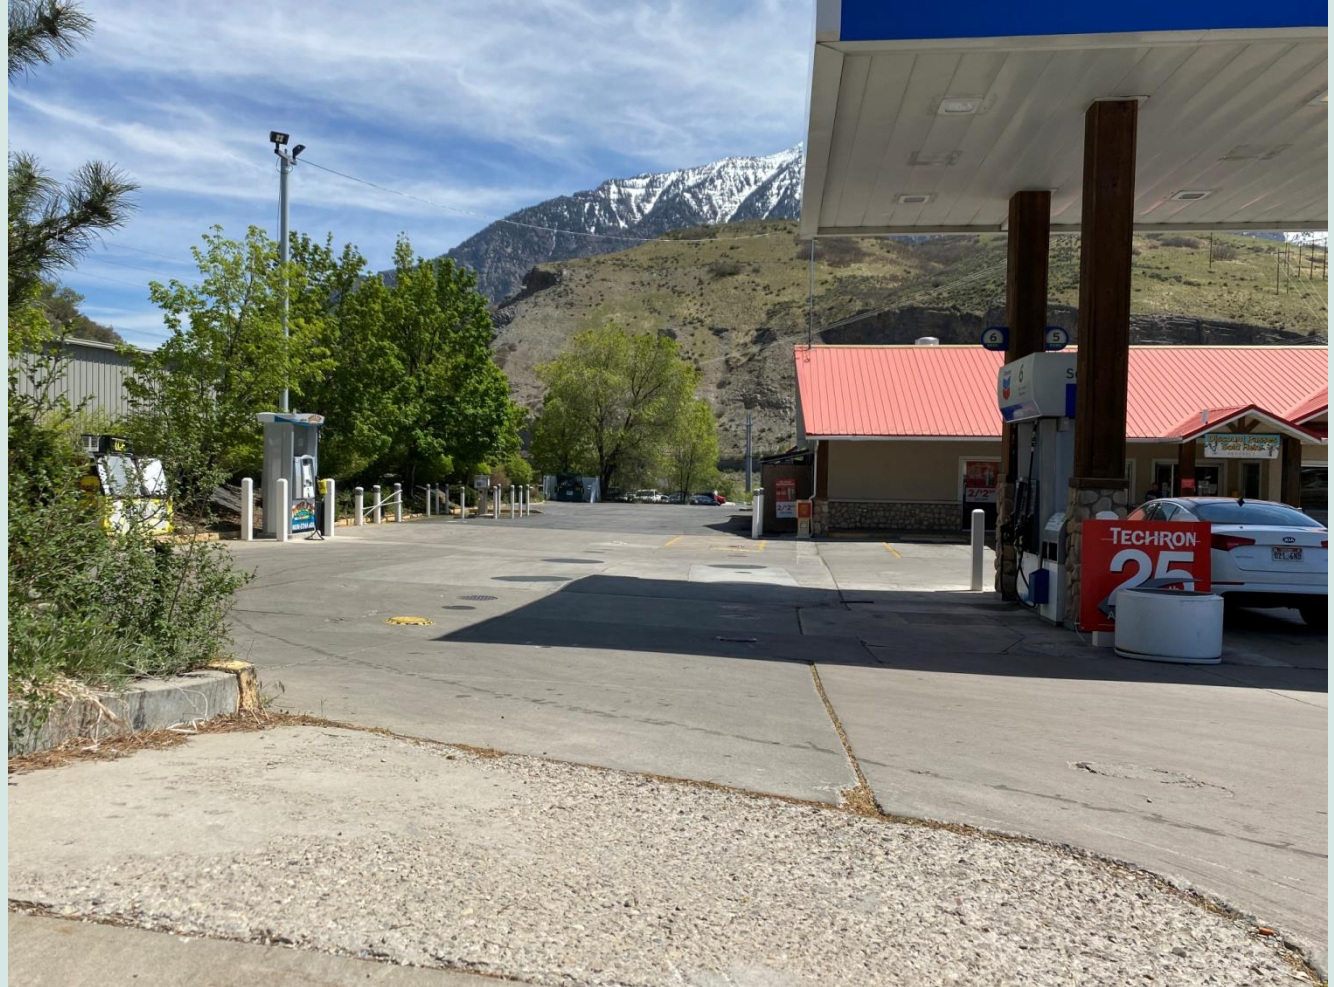
# Before Closure

- View of UST location.
- Larger property.

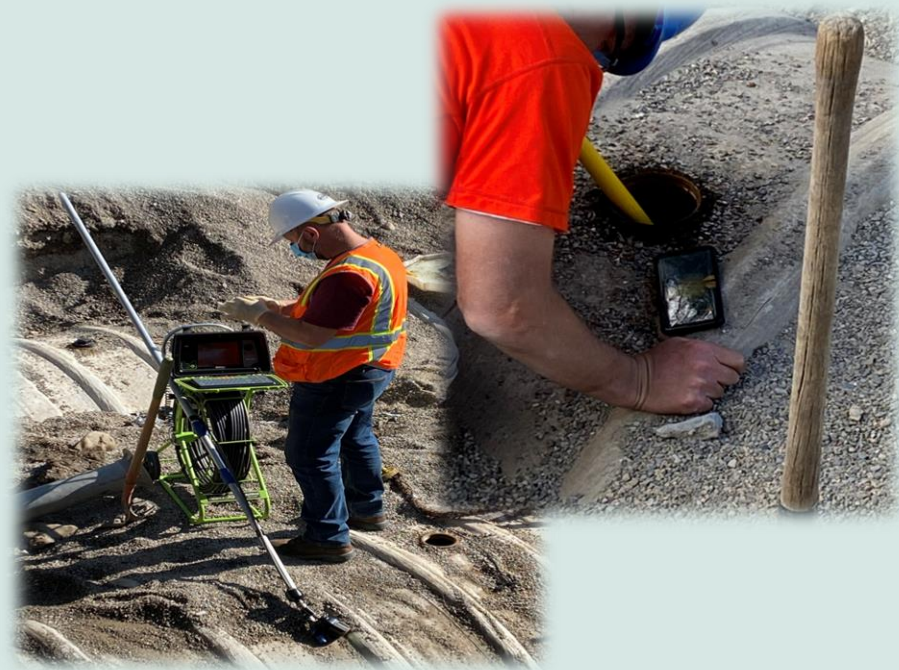
# Collecting information - Video

- Consultant using a GoPro
- Utah County Health reached out to the local sewer district to see if they could help scope the tank.
- Sent a camera and the necessary equipment. This enabled an inside view of all of the tanks and saved to flash drive.

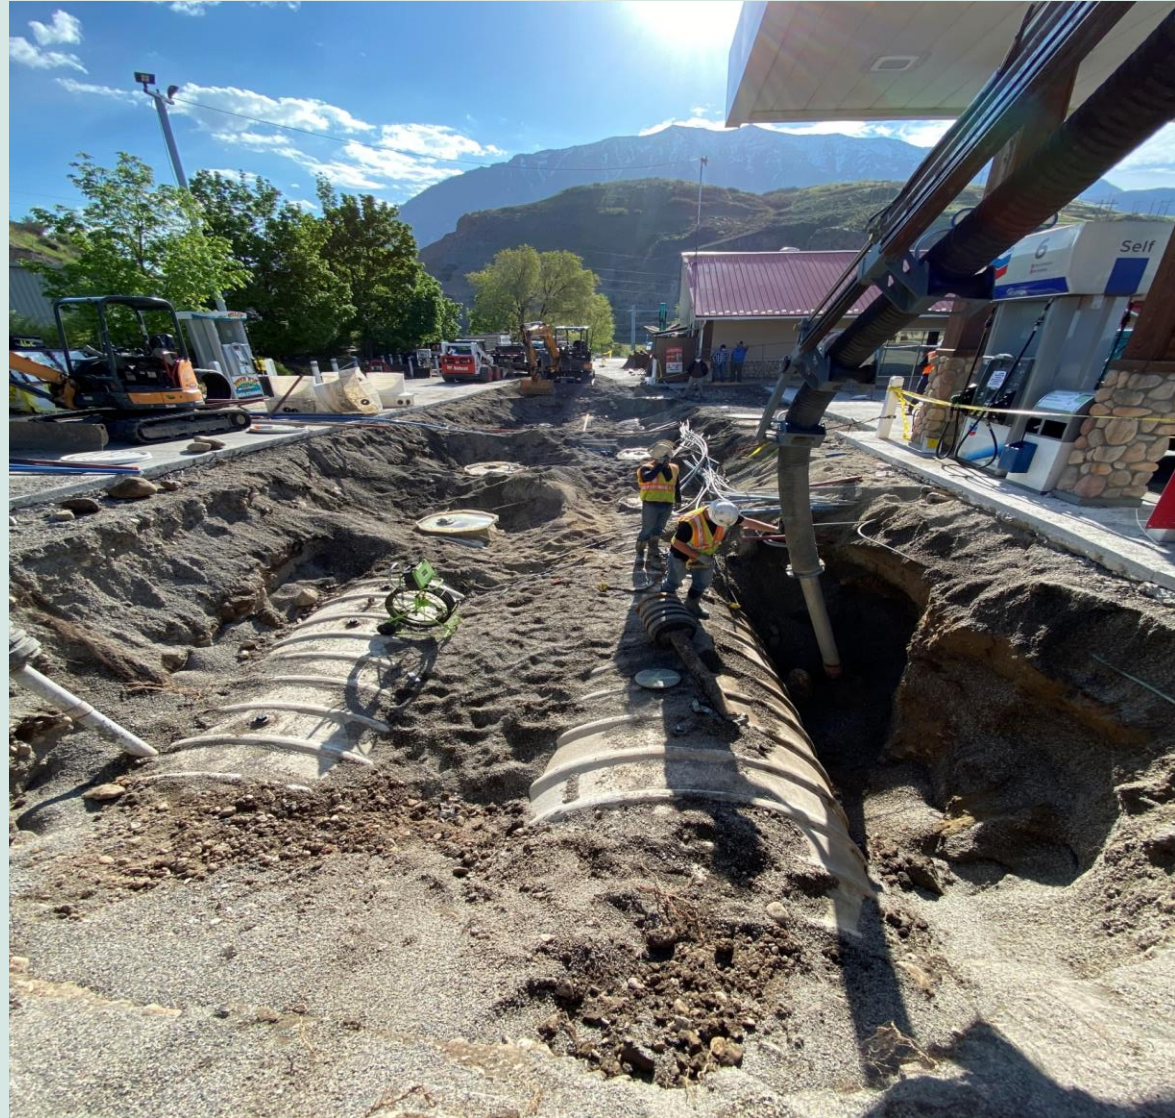
# Vac Truck of Pea Gravel

- Pea gravel was removed using a vacuum truck that had to be emptied frequently.
- This removal helps prevent damage to the FRP USTs.
- Adds significant time to removal.

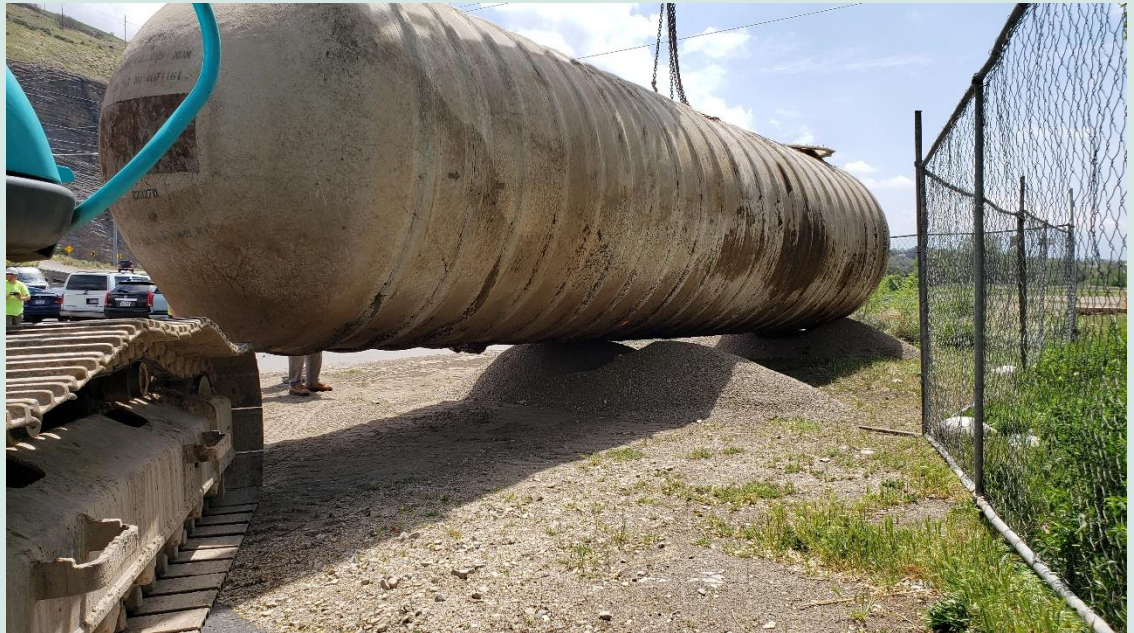
# Storage of the UST

- After removal of UST what are you going to do with it? Location, location, location.
- Store on site if possible.
- Block tank from rolling and cover with a tarp if possible.
- Photos to document how the tank was moved and stored.

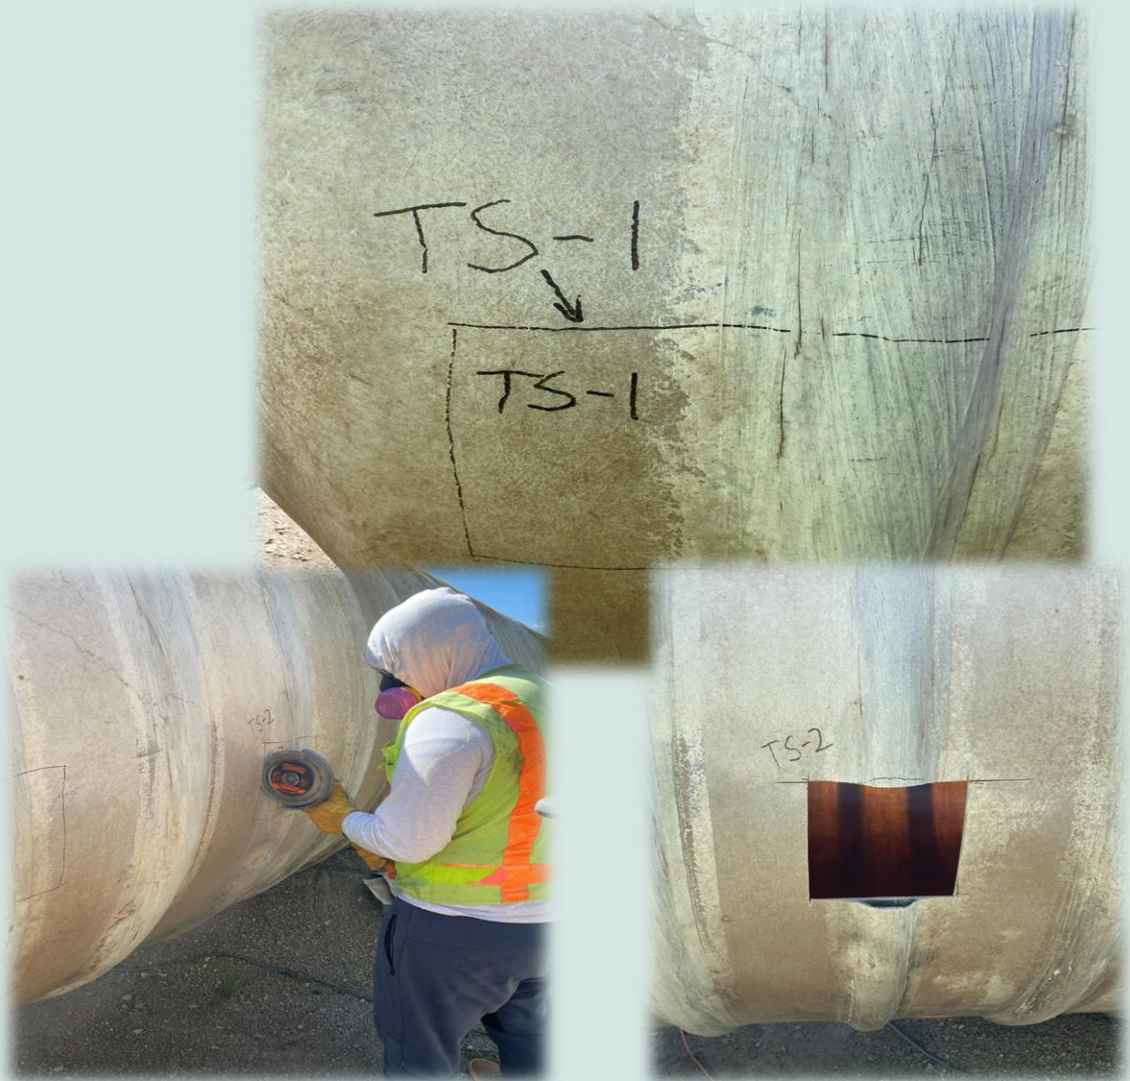
# Sampling the Tank

- Locations for sampling are marked, labeled, and photographed.
- Samples use a chain of custody.
- Hard to cut into a FRP tank. Sawzall met it's match. Used a masonry grinding wheel.
- Need safety equipment because of fiberglass particles and silica used in FRP tanks.
