Photographic Documentation of Equipment and Components Pulled from Removed USTs Used to Evaluate Trends in Interior Degradation and Corrosion for USTs Formerly Storing Biodiesel B98, Diesel (Clear and Dyed), Ethanol E99, and Regular E10 in Lawrence, Kansas.

Photographic Documentation of Equipment and Components from Removed USTs Storing Biofuels

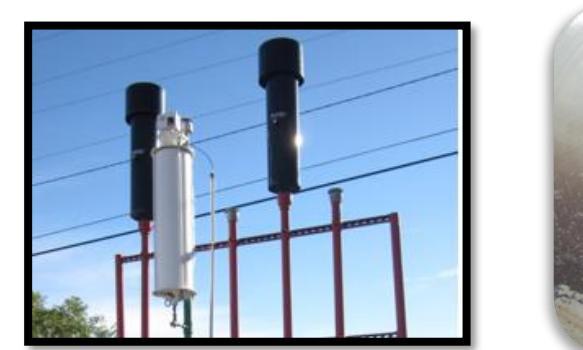
Figure 1: Photo showing equipment installed on vent lines. From left to right are a black canister holder containing a water-absorbent sock for Tank U004, a white vapor recovery system for Tank U005, and another black canister for Tank U007.

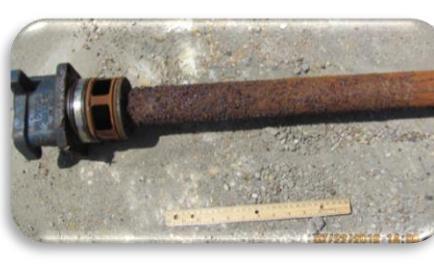
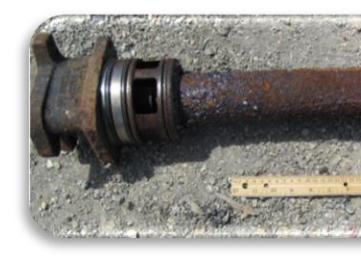
U006: Severe

Figure 2: Minimal to severe corrosion occurred on submersible turbine pump (STP) shafts pulled from designated USTs. Corrosion rating criteria appearing in the 2016 EPA Diesel Corrosion Study were used to make these determinations

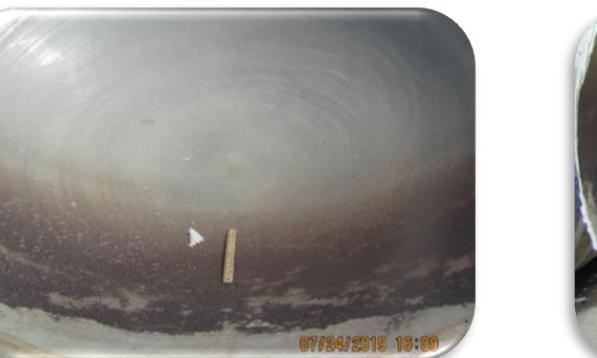
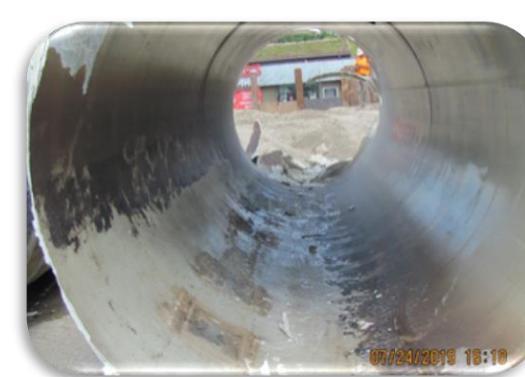
U006: B – Minimal to Moderate Issues

U008: B – Minimal to Moderate Issues

Figure 3: Photographs of endcaps and barrels of designated, removed single-wall Containment Solutions USTs show a range of staining remaining behind after removers used detergent to clean out the sludge. The condition of these tanks ranged from "A - No Issues" to having "B - Minimal to Moderate Issues" using criteria developed for the 2018 Arizona Tank Scoping Study. Foot-long (30-centimeter) ruler

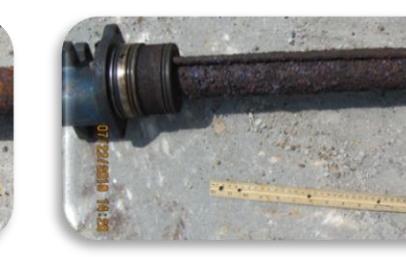
> U007: Severe U008: Severe Corrosion
